General Information: Overview

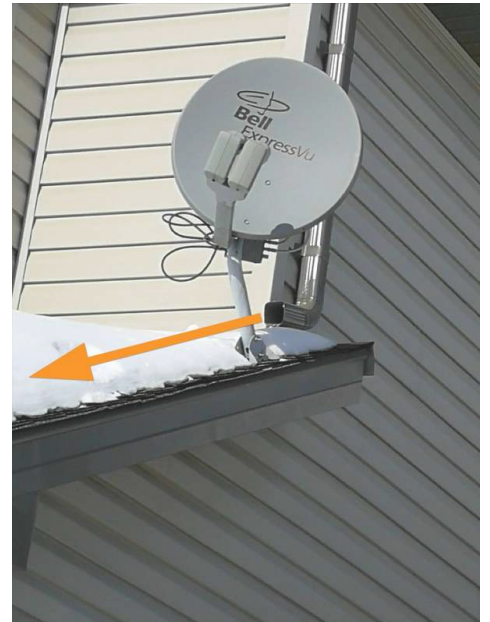
2.1.1 Coverings

SIGNS OF POPPING

Observed signs of popping shingles where water discharge on lower roof , recommend downspouts extension to void further damage, also recommend professional roofer for evaluation, when weather per

Contact a qualified roofing professional.

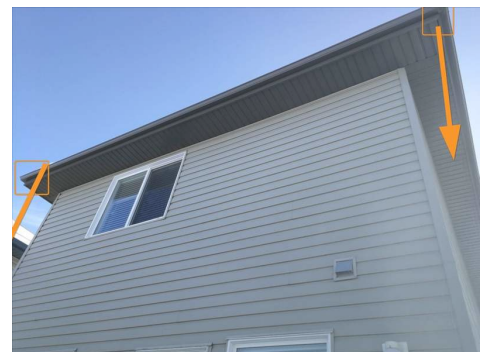
2.2.1 Roof Drainage Systems

DOWNSPOUTS MISSING

The home was missing downspouts in one or more areas. This can result in excessive moisture around the exterior, which can lead to significant damage. Recommend a qualified contractor install two downspout extensions that drain at least 6 feet from the foundation.

Contact a qualified roofing professional.

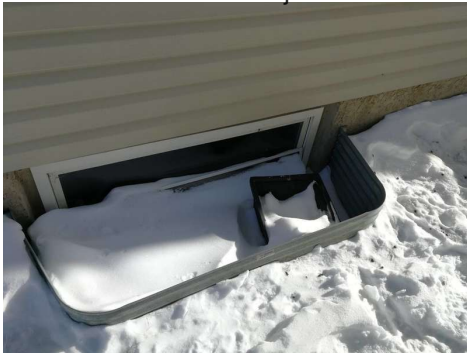
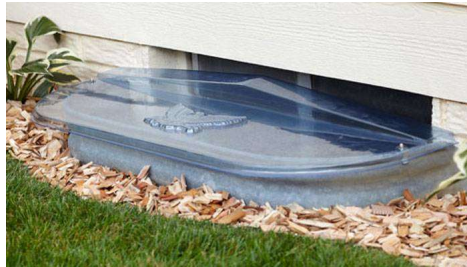
3.2.1 Exterior Doors

EGRESS WINDOW

Recommend window well covering to avoid excessive moisture accumulating near the foundation.

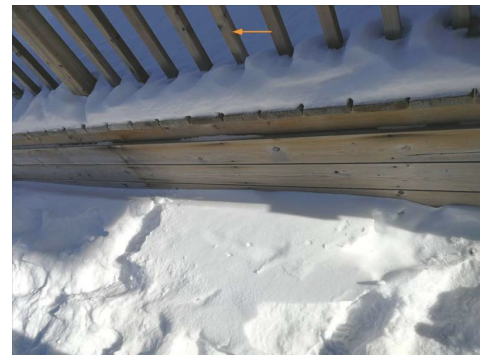
3.4.1 Decks, Balconies, Porches & Steps

RAILING UNSAFE

There is an unsafe opening in the railing. The spacing on the rail should not exceed 4". An opening greater than 4" is a serious safety hazard especially for children as their head or other body part can become trapped.

Observed 4.5" and 5"

Recommendation
Contact a qualified deck contractor.

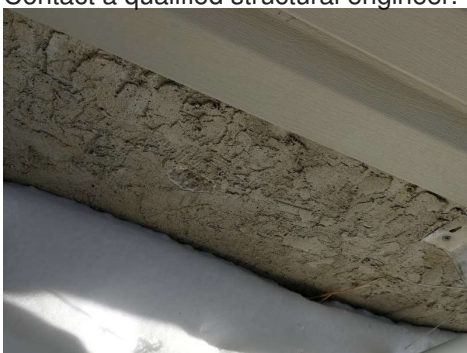
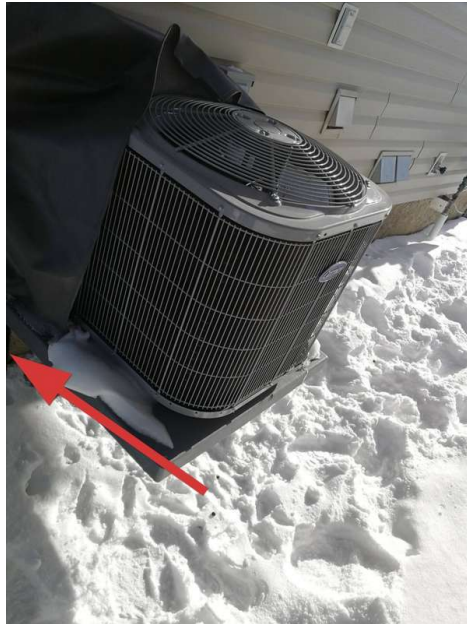
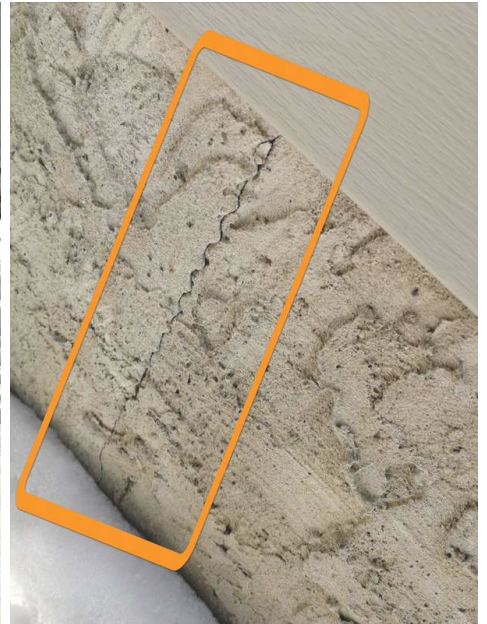
4.1.1 Foundation

FOUNDATION CRACKS - MINOR

Minor cracking was noted at the foundation. This is common as concrete ages and shrinkage surface cracks are normal. Recommend installing AC unit on the ground to avoid movement into the foundation monitoring for more serious shifting/displacement.

Ac unit attached to the foundation.

Recommendation
Contact a qualified structural engineer.

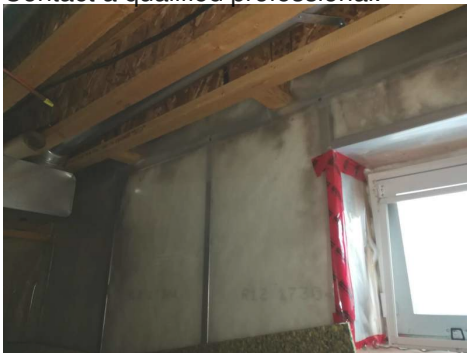
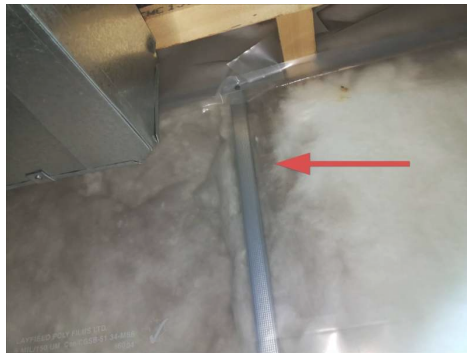
4.2.1 Basements

MOISTURE INTRUSION

Observed Moisture trap in insulation on a large area in the basement. The insulation discoloured, recommend for mould testing, the sample has been sent out to the lab. Mould sampling report will be updated once received.

IMMEDIATE/SAFETY ITEM

Contact a qualified professional.

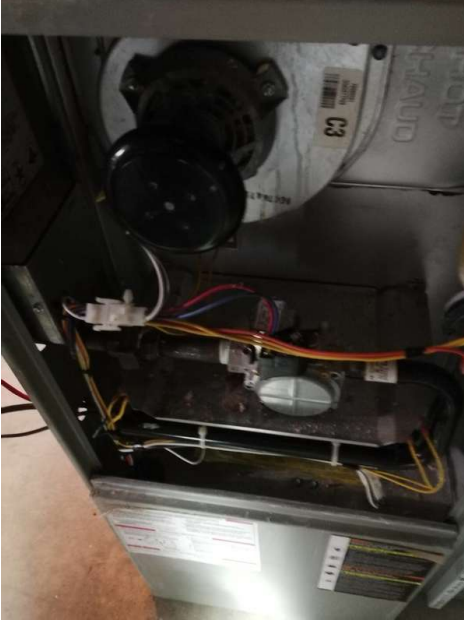
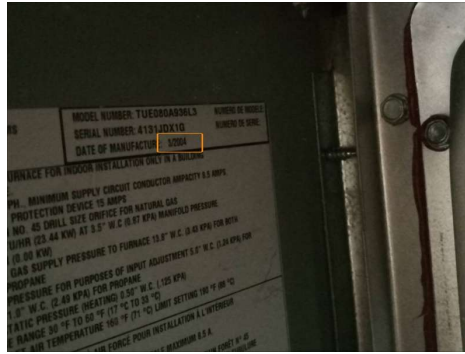
5.1.2 Equipment

FILTER DIRTY

The furnace filter is dirty and needs to be replaced every 2 months.

NEEDS SERVICING/CLEANING

Furnace should be cleaned and serviced annually. Recommend a qualified HVAC contractor clean, service and certify furnace.

Recommendation
Contact a qualified HVAC professional.

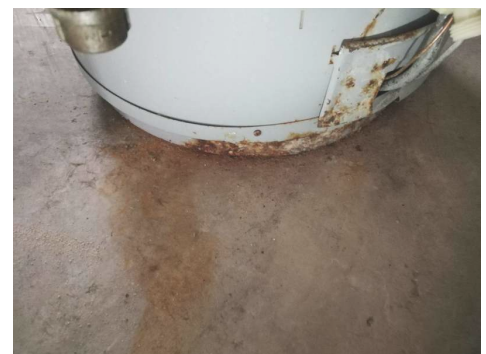
7.4.2 Hot Water Systems, Controls, Flues & Vents

WATER STAINS - LEAKAGE

Water stains were observed beneath water heater, indicating a past or present leak. Recommend further evaluation and repair by a qualified plumber.

Recommendation
Contact a qualified plumbing contractor.

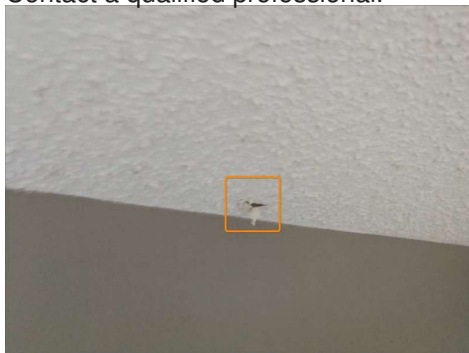
2nd Floor Full Bathroom

MINOR DAMAGE

Minor damage or deterioration to the ceiling was visible at the time of the inspection.

Recommendation
Contact a qualified professional.

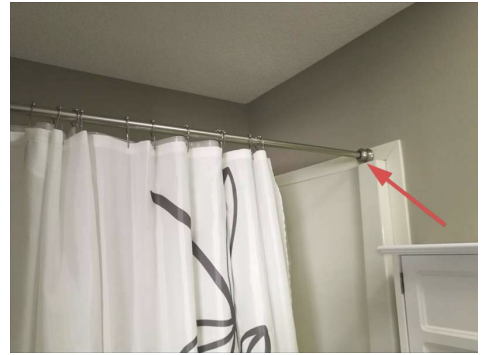
10.5.2 Ceilings

LOOSE BATHROOM'S CURTAINS HANGER

Observed loose/not secure , Reommed

Recommendation
Contact a qualified handyman.

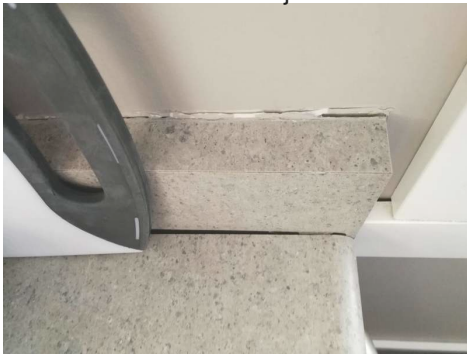
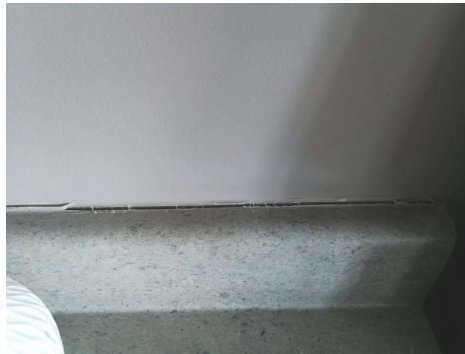
10.7.1 Countertops & Cabinets

POOR/MISSING CAULK

Bathroom countertop was missing sufficient caulk/sealant at the wall. This can lead to water damage. Recommend adding sealant at sides and corners where counters touch walls.

Recommendation
Recommended DIY Project

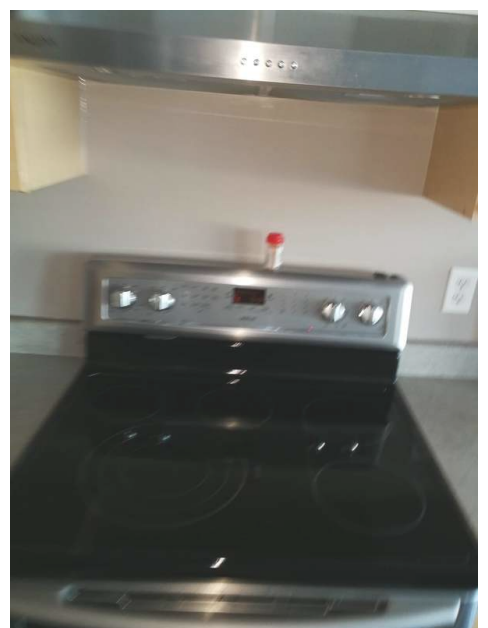
10.7.2 Countertops & Cabinets

BACK SPLASH

Observed fire hazard. Recommend 12" Backsplash in the kitchen and 18" behind Stove

Recommendation
Contact a qualified professional.
