premieronehomeinspections@gmail.com

Deficiency Definitions

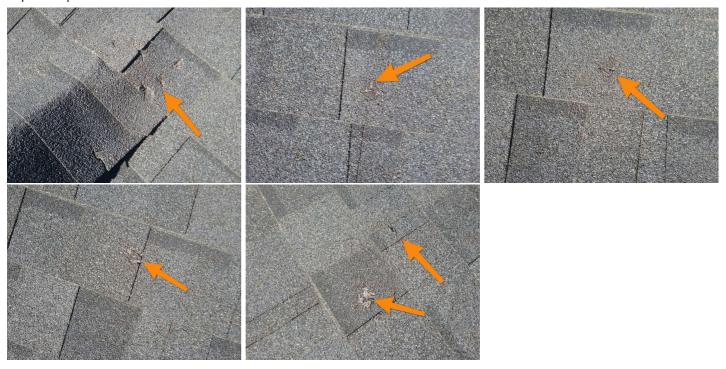
2.1.2 Coverings

DAMAGED - MODERATE

Roof coverings showed moderate damage. Recommend a qualified roofing professional evaluate for repair/replacement.

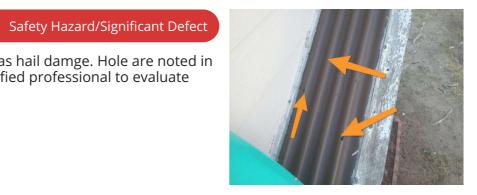
2.1.3 Coverings

ROOF

Roofing material on fireplace angle has hail damge. Hole are noted in roofing material. Recommend a qualified professional to evaluate repair.
