SUMMARY

1234 Main St. Maple Valley WA 98038

Brian Dodds
WA Inspector #2151
Titan Inspection Services
206-235-9641
brian@titaninspectionsservices.com

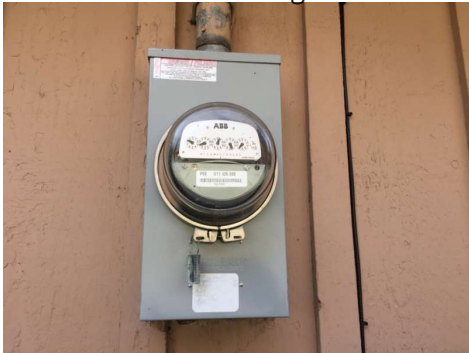
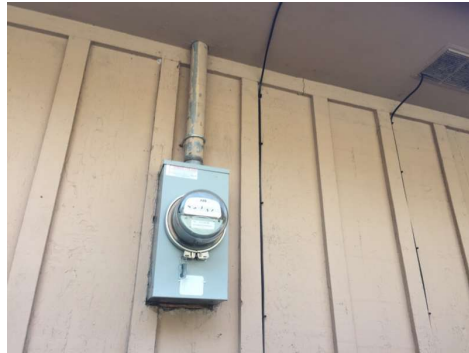
1.3.1 Utilities

METER INFO

Here is your utility meter info:

Recommend monitoring.

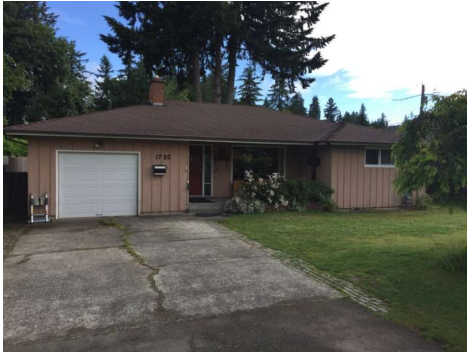
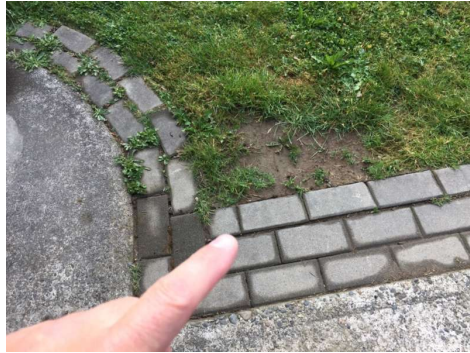
1.4.2 Natural Hazards

THERE IS SOME RUN OFF WATER THAT COMES OF THE ROADWAY IN FRONT.

I would keep an eye on this to see if it needs A catch basin and drain it into the downspout drain.

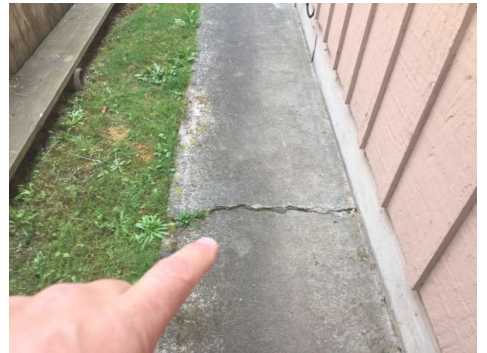
2.1.2 Walkways, Patios & Driveways

CONCRETE IS LEVEL OR SLOPING TOWARDS THE HOUSE

Any surface water from the concrete should be sloped away from the house. It is not uncommon for older homes to have concrete that may slope towards the house. I would keep an eye on this to make sure it is not settling more or affecting the foundation in a negative way. If it does, I would recommend repairing or replacing the concrete to mitigate this water issue.

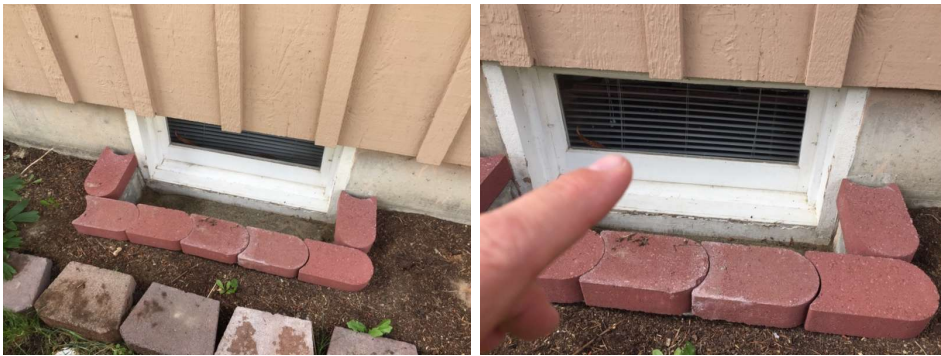
2.4.2 Windows

WINDOWS - NEED TEMPERED GLASS ON SOME OF THEM

There are some windows that are in need of tempered glass due to them being: within 18 of the floor or ground, in a bathroom or they are within the swing of a door.

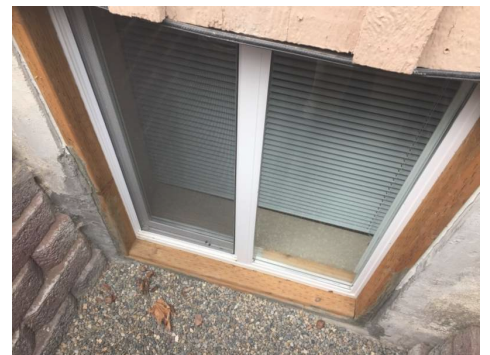
2.4.3 Windows

EGRESS WINDOW IS NOT TO CODE

The egress window is not to code and could be a problem for someone trying to get out of the house in the event of a fire. Recommend installing the proper window and exit.

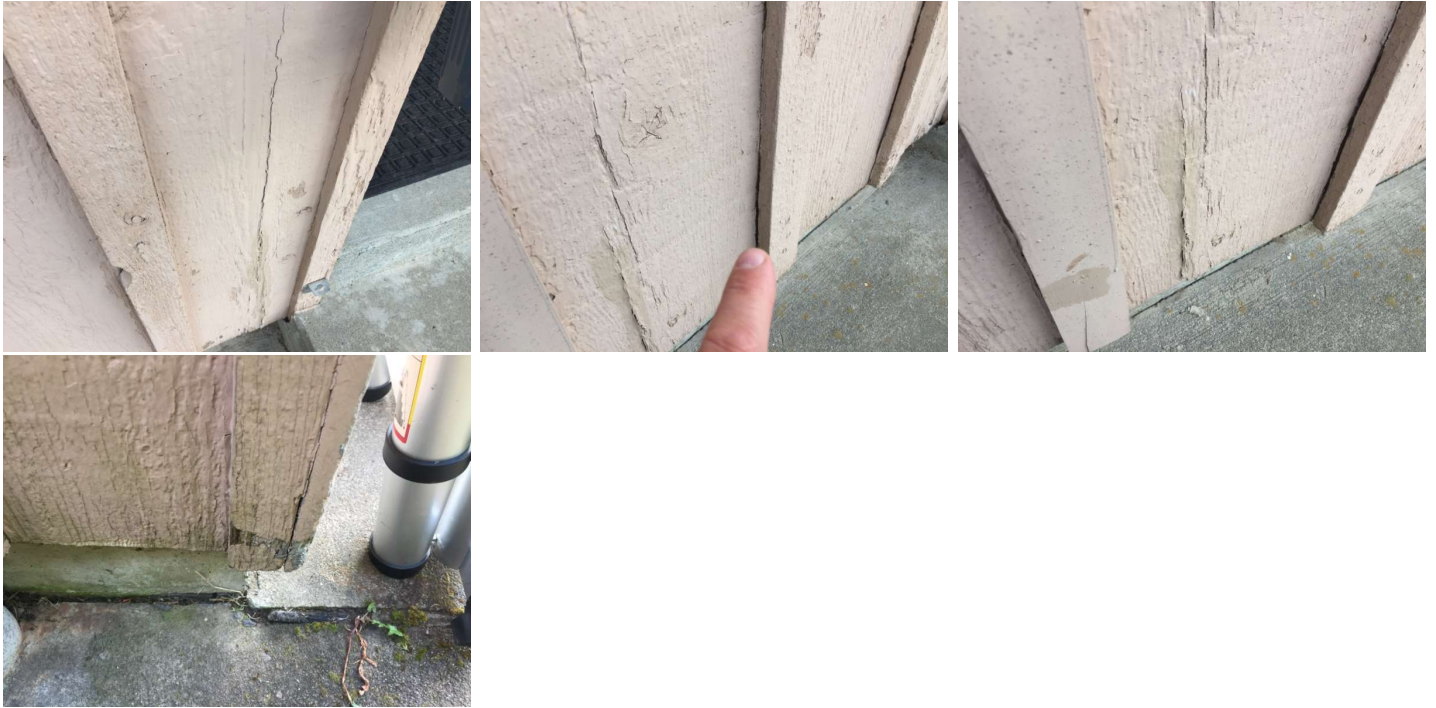
2.5.2 Siding, Flashing & Trim

SIDING - LACKS MAINTENANCE AND DETERIORATED

The siding overall needs caulking, repairs and paint to hold up over time. This is not uncommon on houses that are this age. I recommend repairs, caulking and repainting to preserve the life of the siding.

I recommend properly prepping, using good QUAD caulk and a good grade of paint product to preserve the life of the paint job and the siding.

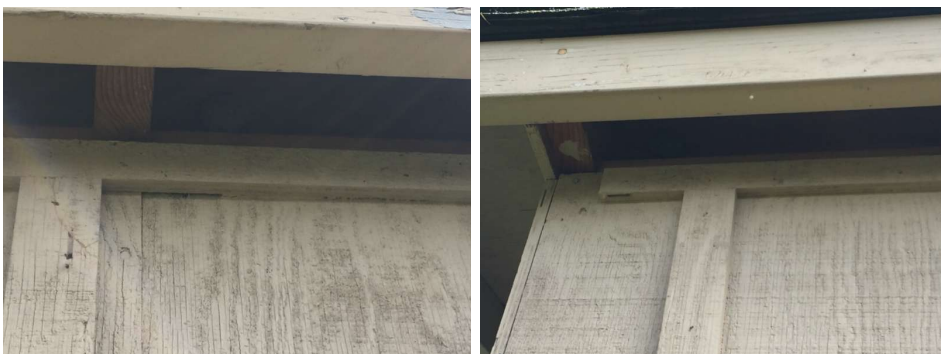
2.5.4 Siding, Flashing & Trim

BEES NEST

There was evidence of some small bees nests on the soffits. They do not appear to be active at this time. Just need to monitor.

On the shed soffit.

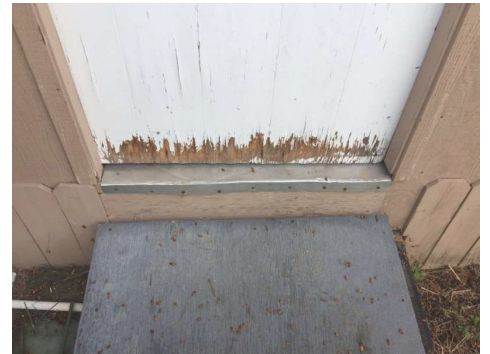
2.6.3 Exterior Doors

WOOD DOOR ON SHED IS SHOWING SIGNS OF EXTREME EXPOSURE TO THE ELEMENTS.

Recommend painting as needed.

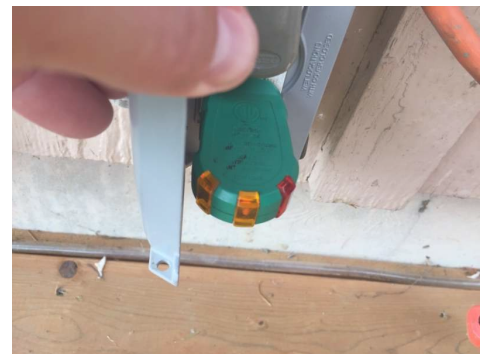
2.7.2 Exterior Electrical Wiring

GFCI - THE EXTERIOR PLUGS ARE NOT GFCI PROTECTED

The exterior plugs are supposed to be GFCI protected for safety. I recommend that you install a GFCI plug and properly protect it from the weather.

Recommendation
Contact a qualified professional.

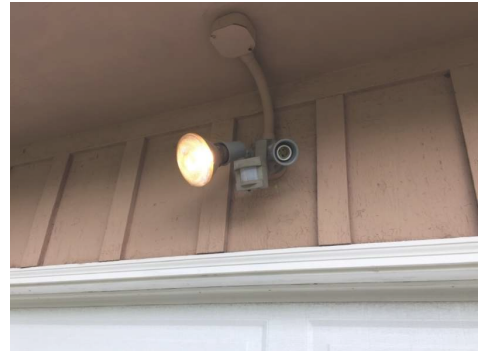
2.9.1 Exterior Lighting

EXTERIOR LIGHT INOPERABLE

A light fixture was inoperable at the time of the inspection. This condition can be caused by a burned out bulb, or a problem may exist with the light fixture, wiring or the switch. This light fixture should be re-tested after the bulb is replaced. If after bulb replacement the light still fails to respond to the switch, this condition may be a potential fire hazard, and an inspection and any necessary work should be performed by a qualified electrical contractor.

Contact a qualified professional.

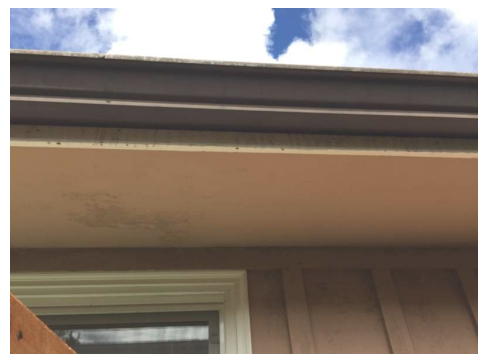
2.10.1 Eaves, Soffits & Fascia

EAVES - WATER STAINS OR SURFACE DISCOLORATION

Water stains or surface discoloration was observed under the roof eaves. This may indicate an active leak or improper ventilation at the attic vents. I would recommend cleaning the surface with a pressure washer, prep and paint accordingly and if there is an active leak or blocked vent, I would clear the insulation away from the vent for the attic and the soffit wood to breathe properly.

Contact a qualified roofing professional.

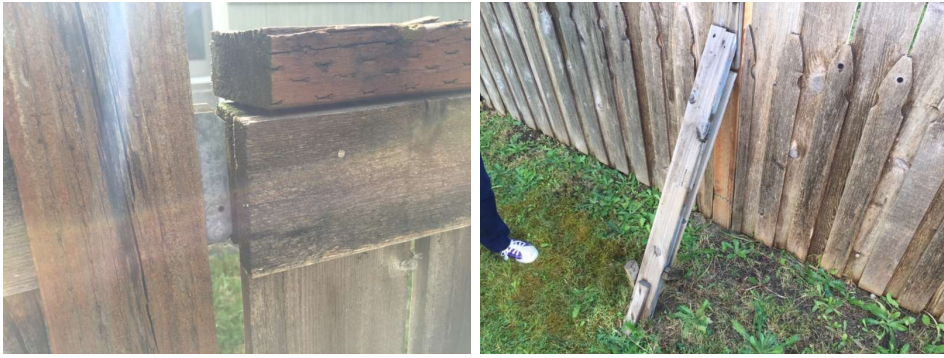
2.11.2 Fence

FENCE POSTS ARE ROTTING AND SOME OF THE FENCE IS DUE FOR REPLACEMENT

You can just replace the damaged posts vs replacing all of the fence at this time.

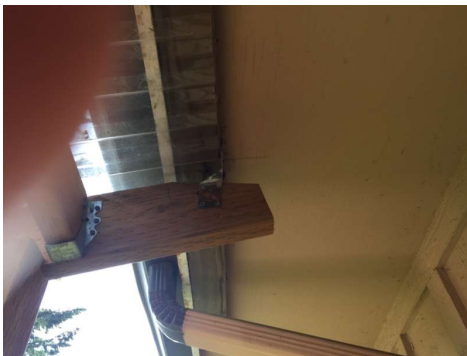
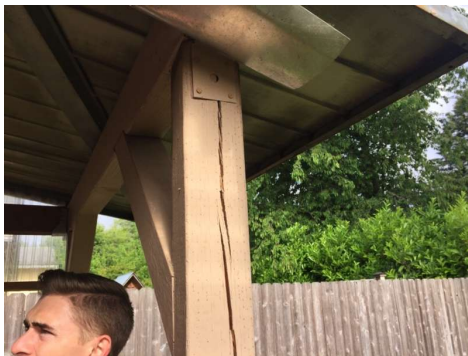
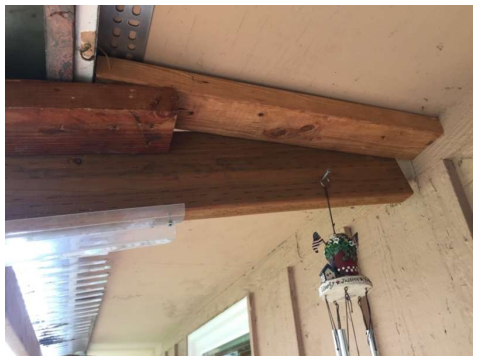
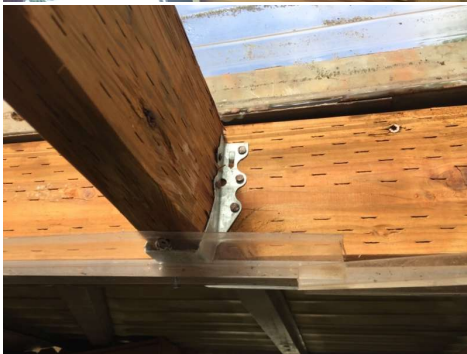
2.12.1 Decks, Balconies, Porches & Steps

Patio is in good shape at this time. One of the posts is showing a large crack, but is functioning fine at this time.

The porch was not built per code and it appears that the roof over the back door is a steel garage door. The hardware used and the way it was all built is functional, but not secured properly at the joists , posts or at the house. Also the screws used vs Tico nails is not the proper application. The screws used will eventually rust out.

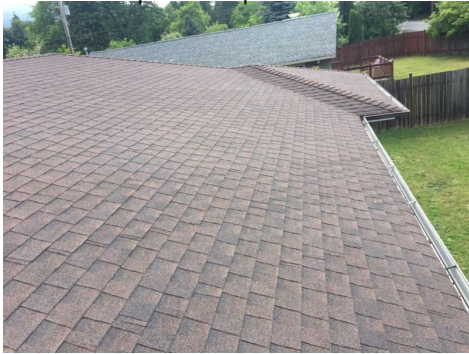
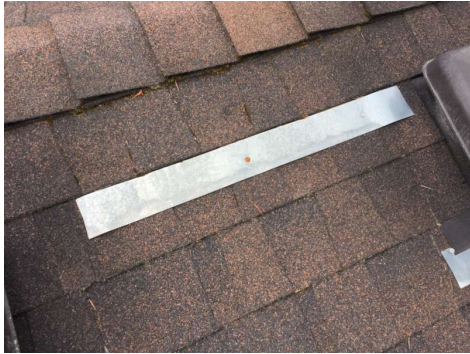
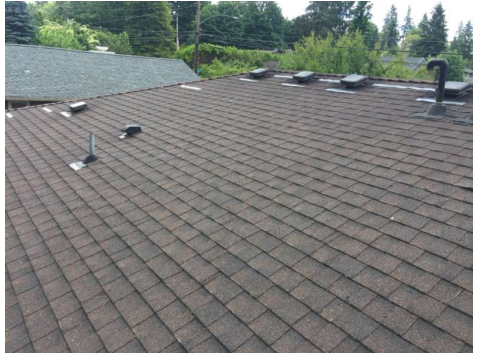
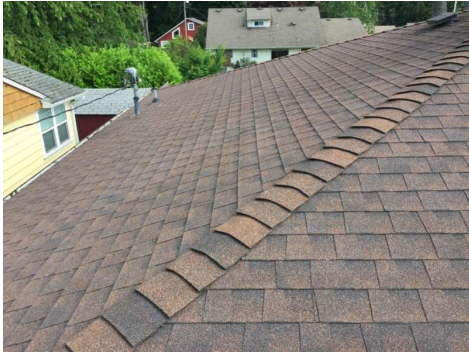
THE ROOF ON THE HOUSE IS IN GOOD CONDITION AT THIS TIME

I observed no notable deficiencies in the condition of the exterior roof structure at this time. The roof on the house is 5-10 years old and has aged consistent with its lifespan. I recommend regular care of the roof and I believe you can extend the life of the roof.

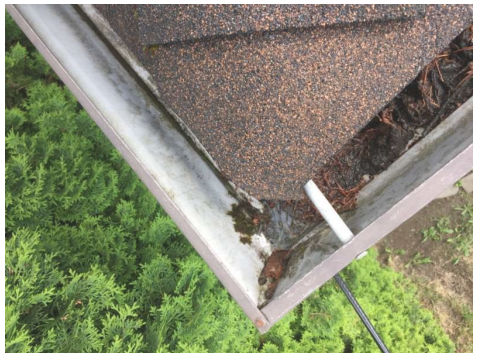
3.2.2 Coverings/Facia/Sheeting

ROOF CORNERS ARE NOT PROPERLY DRAINING INTO THE GUTTERS.

Will need to clean, prep and properly repair as needed.

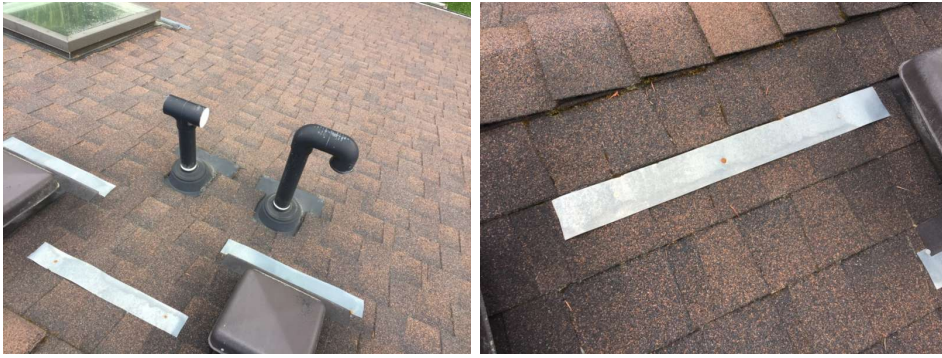
3.2.3 Coverings/Facia/Sheeting

ZINC STRIPS ARE INSTALLED ON THE ROOF TO INHIBIT MOSS GROWTH.

This is normal. I still recommend getting up on the roof and cleaning as needed.

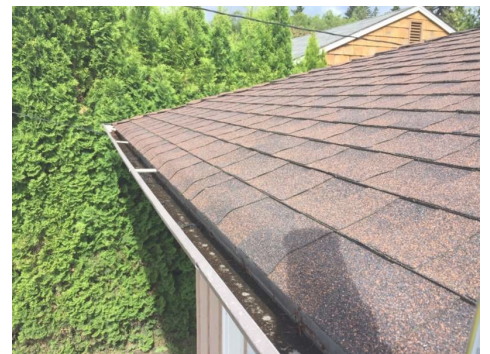
3.4.2 Gutters and Downspouts

GUTTERS HAVE LONG RUNS DUE TO THE ROOF DESIGN. THIS CAN CREATE LOW SPOTS THAT WATER CAN COLLECT.

Keep an eye on the water flow and adjust the fall of the gutters if needed to preserve the life and function of the gutters.

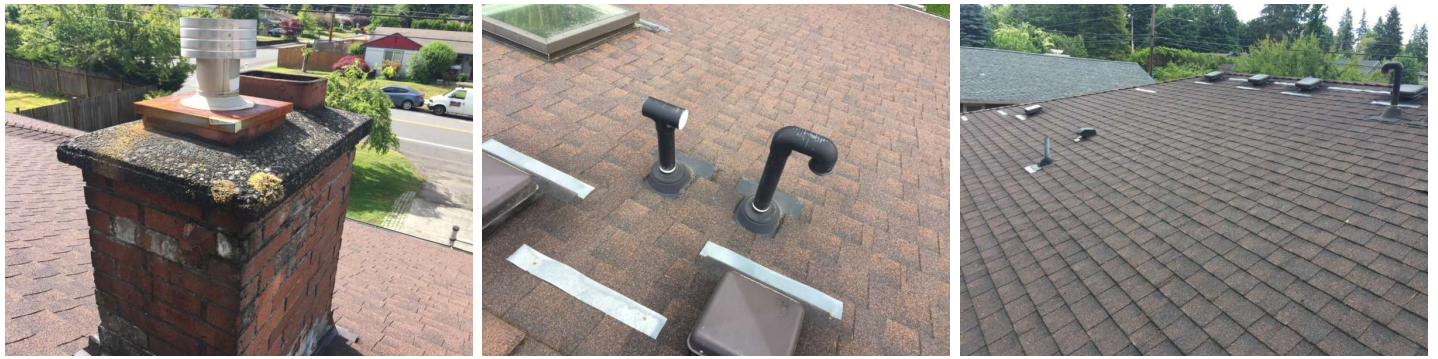
Plumbing and ventilation boots are in good shape at this time.

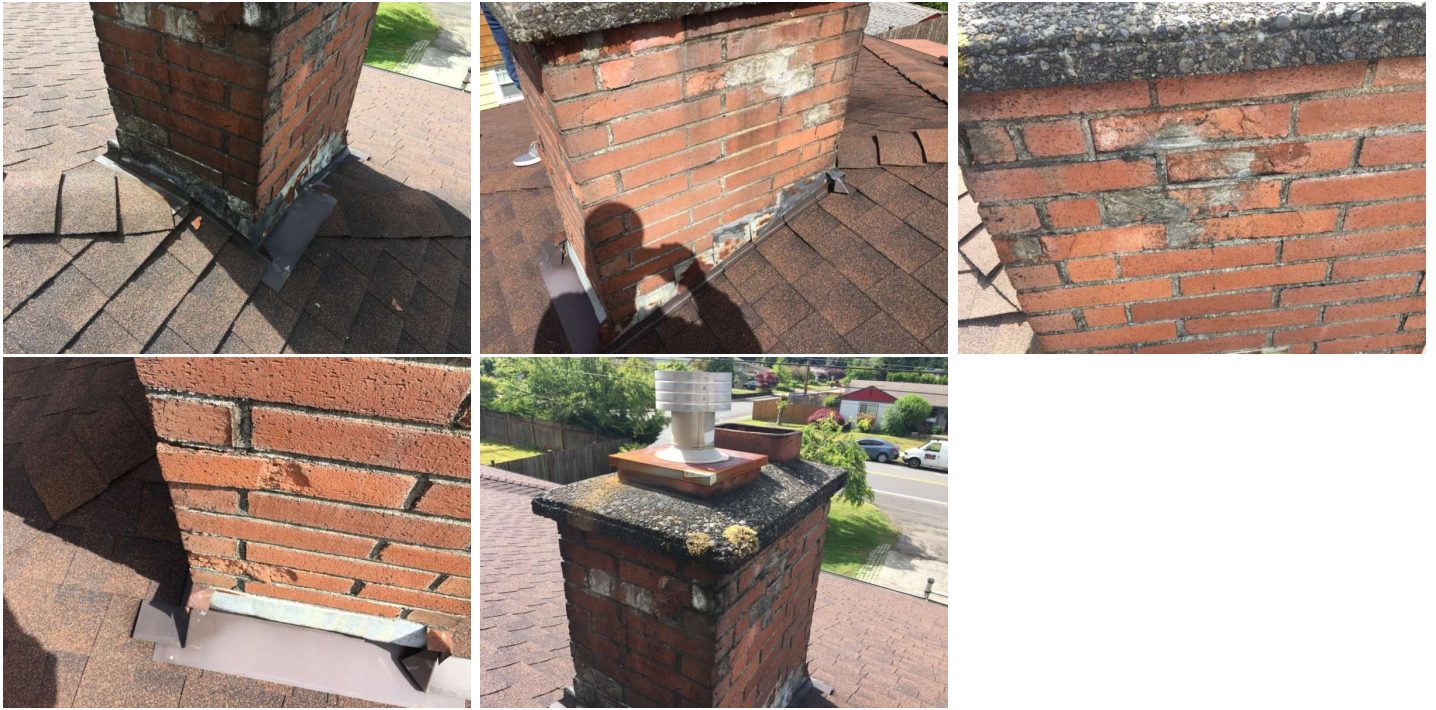
3.8.3 Chimneys

MINOR DETERIORATION AND SPRAWLING ON THE CHIMNEY

I recommend keeping an eye on this and maintain as needed. This is normal for houses of this age.

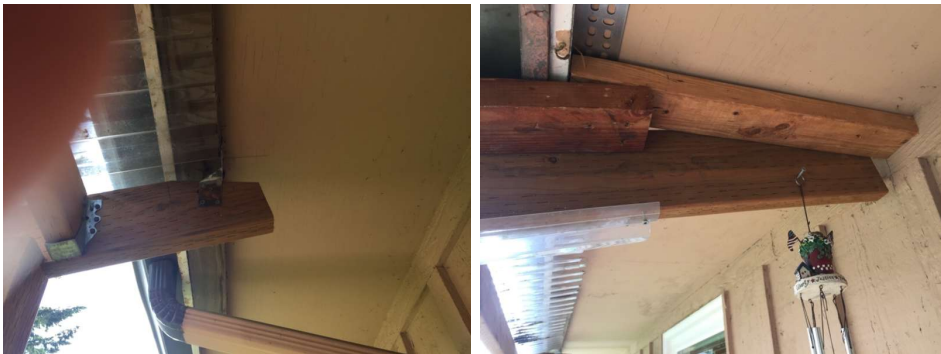
3.9.1 Porch roof attachment to header

THE PORCH ROOF IS NOT PROPERLY ATTACHED TO THE HEADER.

I recommend using a hurricane clip and Tico nail to attach the rafters to the beam and attaching it to the house properly.

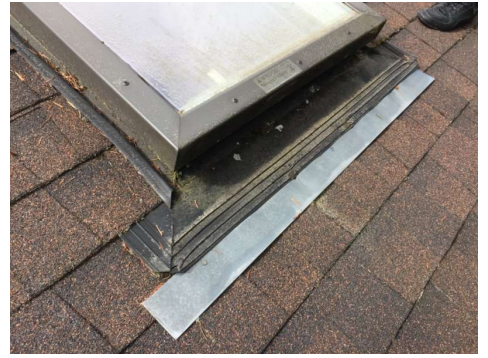
3.10.2 Skylights

THE RUBBER FLASHING WILL EVENTUALLY DRY OUT AND CRACK

I would keep an eye on this and repair or replace as needed.

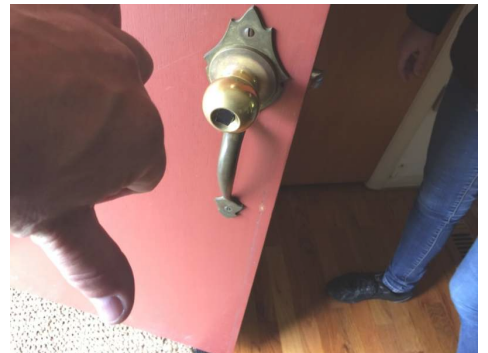
4.1.2 Doors

INOPERABLE DOOR HARDWARE

The door hardware was inoperable at the time of the inspection. I recommend repair, adjustment or replacement as necessary.

The front door.

Contact a qualified professional.

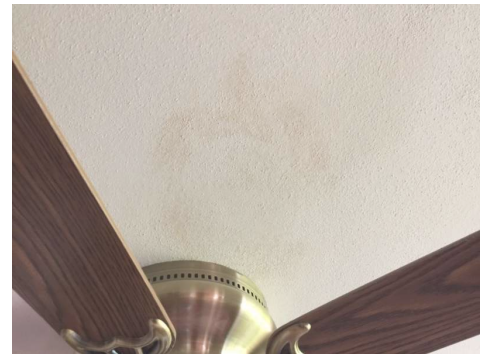
4.5.2 Walls / Ceilings

SOME PAST WATER DAMAGE WAS NOTICED.

It does not look like a current problem. I would repair as needed and keep an eye on it for further deterioration. In one of the upper bedrooms.

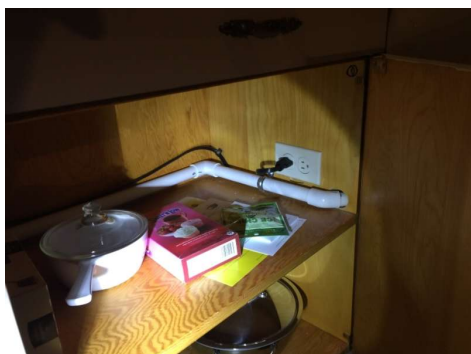
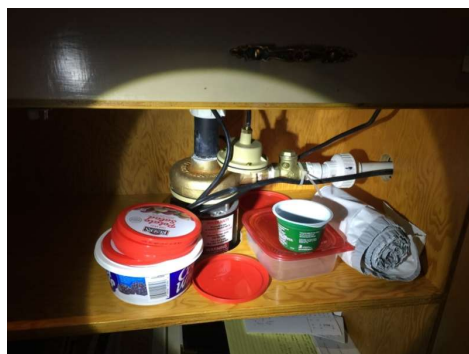
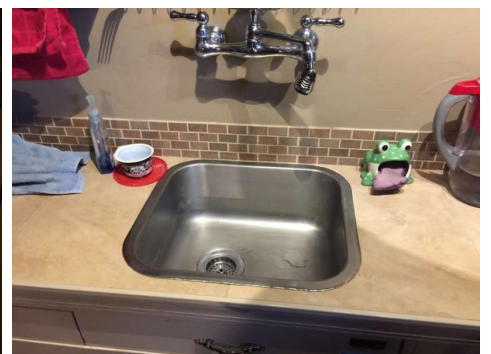
5.1.2 Garbage Disposal

THERE IS A UNIQUE DRAINAGE MOTOR WITH A SWITCH IN THE BASEMENT KITCHEN.

This sink was not installed per code. There is a switch on the cabinet that controls the pumping of the water in the sink because it does not drain on its own to the sewer line or even a grinder pump in the basement and then to the sewer.

The system is functioning, but is not to code. In order to make this all up to code, I recommend contacting a licensed plumber. This could cost up to \$5000 or more to properly rectify this issue if you want it up to code.

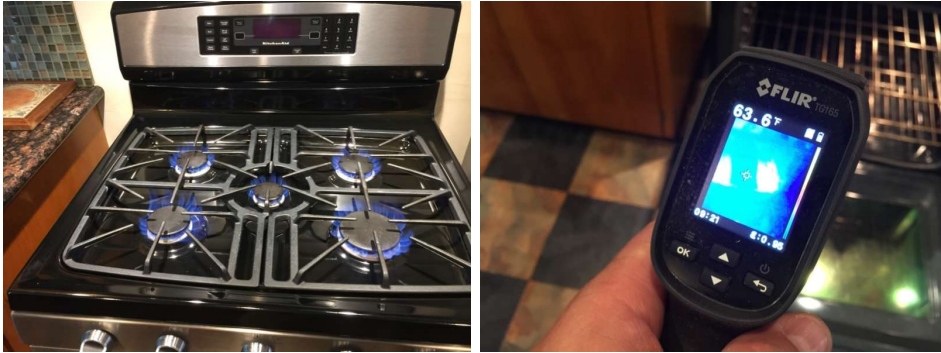
The range appears to be in good working condition at this time. The burners and oven elements turned on.

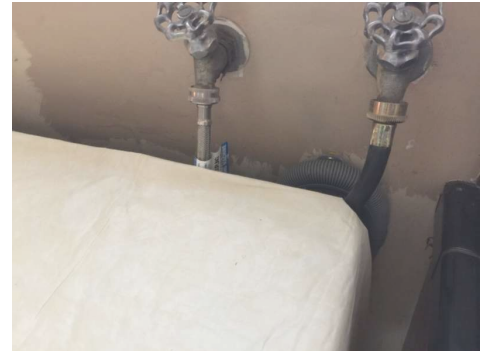
I recommend installing steel braided hoses to the washer.

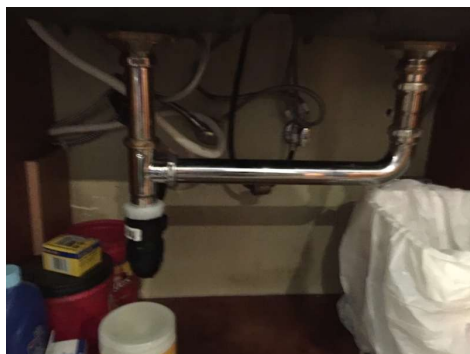
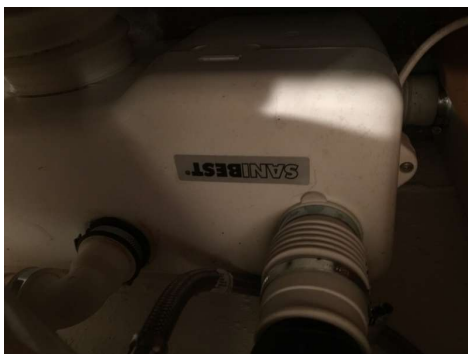
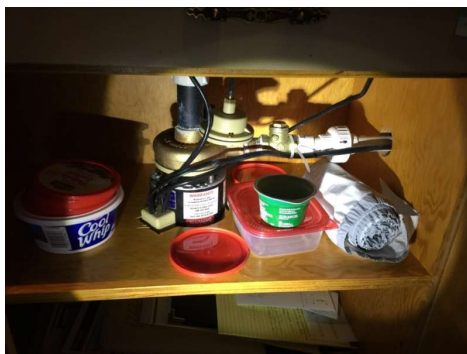
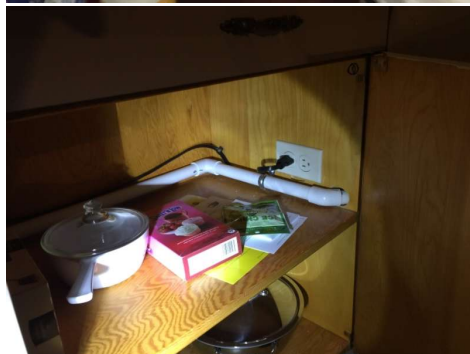
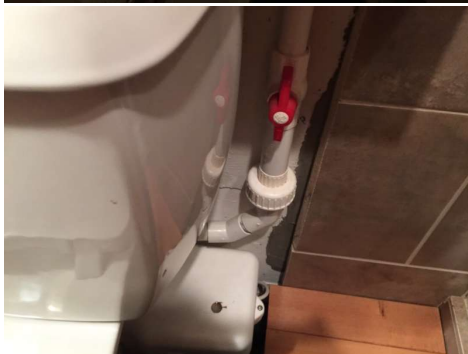
The drains and vents appear to be properly installed under the sinks. I ran the hot and cold water and the stopper and everything appeared to run correctly at this time.

There are unconventional drains in the basement for all of the plumbing. None of this is up to code, but is currently working at this time. If you are concerned with its future use, I would contact a licensed plumber for repair or replacement options.

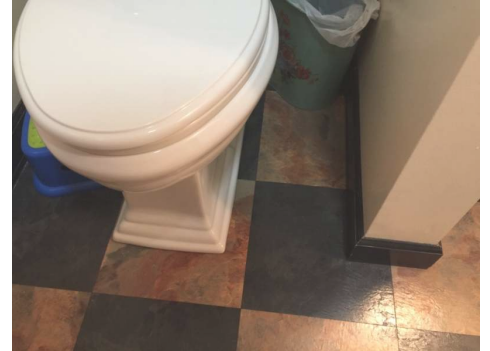
WATER HEATER - OK

The water heater appears to be working correctly at this time and is installed correctly.

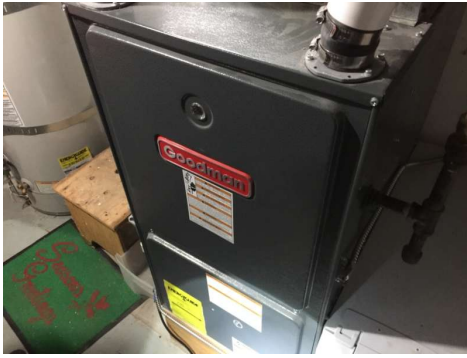
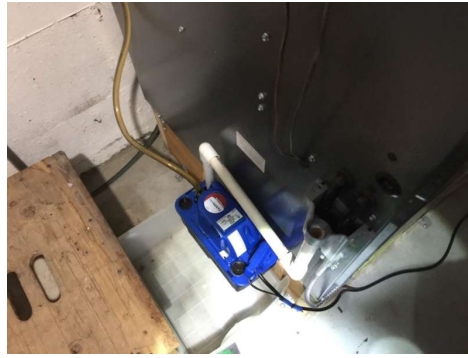
The furnace or heating system appears to be in good working condition at this time. It is always a good idea to have a certified heating contractor or electrician take a look at the equipment periodically.

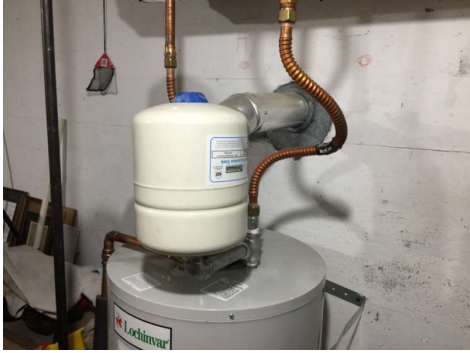
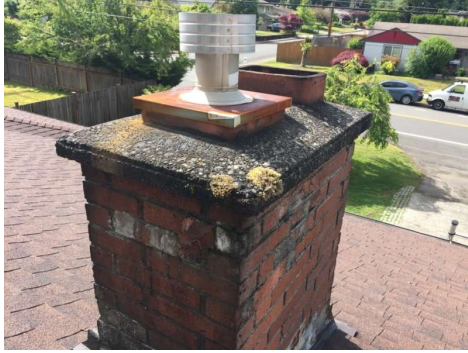
Exhaust flue from water heater vents into chimney. This is common. Just FYI.

Recommendation
Contact a qualified HVAC professional.

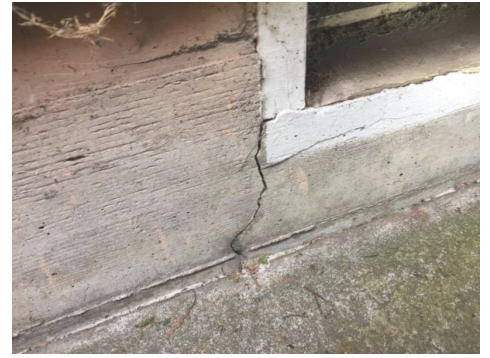
The foundation appears to be in good condition at this time. There are no sizeable cracks or settling to be noted from areas inspected.
