SUMMARY

1234 Main St. Las Vegas NV 89156

Michael O'Connor
IOS.0002736-RES
INSPEX Home Inspections
Mobile: 725-222-1001
inspex@cox.net

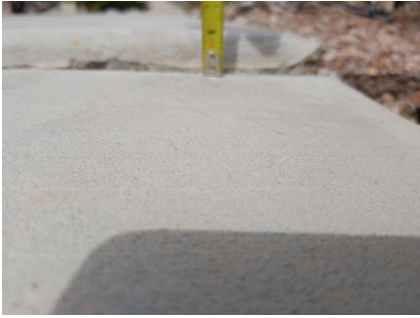
1.3.1 Driveway / Patio / Sidewalks

SIDEWALKS / PATIOS - TRIP HAZARD

SIDE WALK - FRONT OF THE HOUSE

Cracks, holes, settlement, heaving and/or deterioration resulting in trip hazards were found in the sidewalks or patios. For safety reasons, recommend that a qualified contractor repair as necessary to eliminate trip hazards.

Contact a qualified concrete contractor.

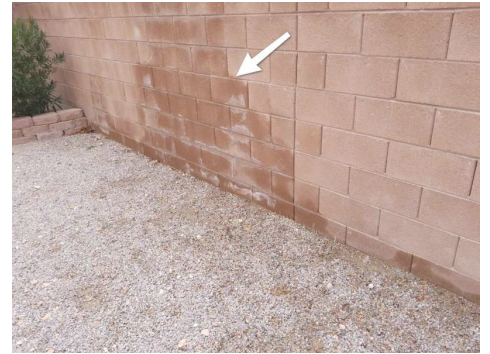
1.5.2 Fences / Gates

PERIMETER WALL - EFFLORESCENCE

Moderate

Evidence of water intrusion or accumulation was found in one or more sections of the perimeter wall. Recommend that a qualified contractor evaluate and repair as necessary.

Contact a qualified professional.

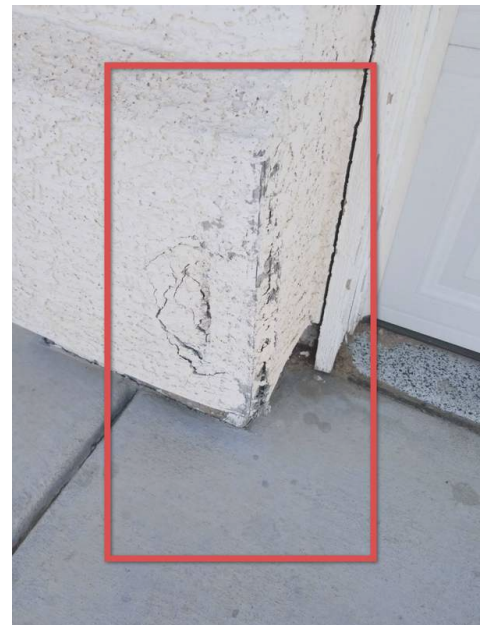
3.3.2 Exterior Walls / Trim

STUCCO CRACK(S) / DAMAGE NEEDS REPAIR

Moderate

GARAGE LEFT SIDE

Cracks, deterioration and/or damage were found in one or more areas of the exterior stucco finish. In damp climates, moisture can enter cracks or damaged areas and further deteriorate the stucco. Also the wall behind the stucco can become damaged from moisture. Note that areas behind the stucco are inaccessible and excluded from this inspection. Recommend that a qualified contractor repair or replace stucco as necessary.

Contact a stucco repair contractor

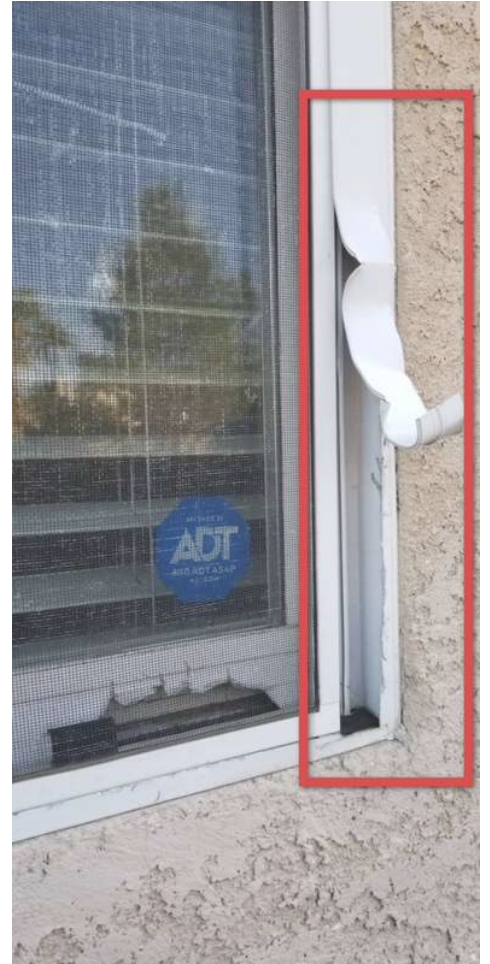
3.4.1 Exterior Windows

WINDOW FRAME LOOSE / DAMAGED

Moderate

Window frame was damaged at one or more windows. Recommend repairs be made by a qualified contractor.

Contact a qualified window repair/installation contractor.

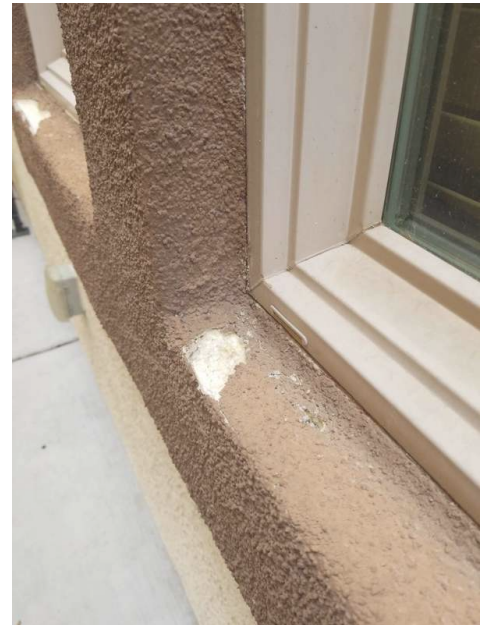
3.4.2 Exterior Windows

WINDOW TRIM DAMAGED

Moderate

LEFT SIDE OF THE HOUSE

Window sill appeared to be damaged and in need of repair. Recommend repairs be made by a qualified licensed contractor.

Contact a qualified professional.

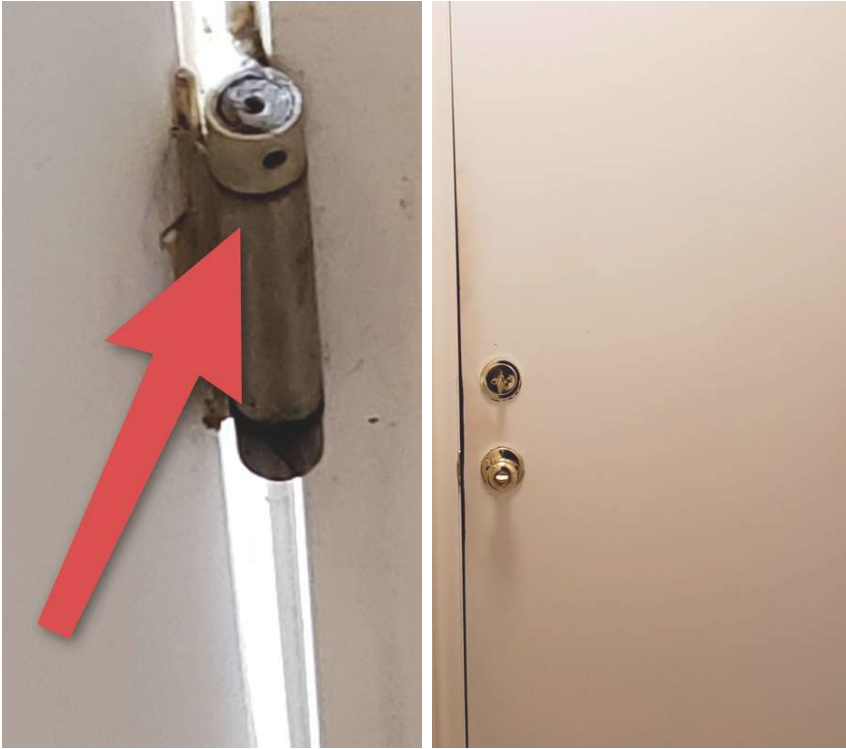
4.2.1 House Door

SELF-CLOSING DEVICE NEEDS REPAIR OR REPLACEMENT

Safety / Major

The self-closing device on the door between the garage and the house didn't close and latch the door. These devices are installed to keep the door closed to prevent possible fire and fumes from the garage from spreading to the house. Recommend that a qualified person repair as necessary.

Recommendation
Contact a qualified professional.

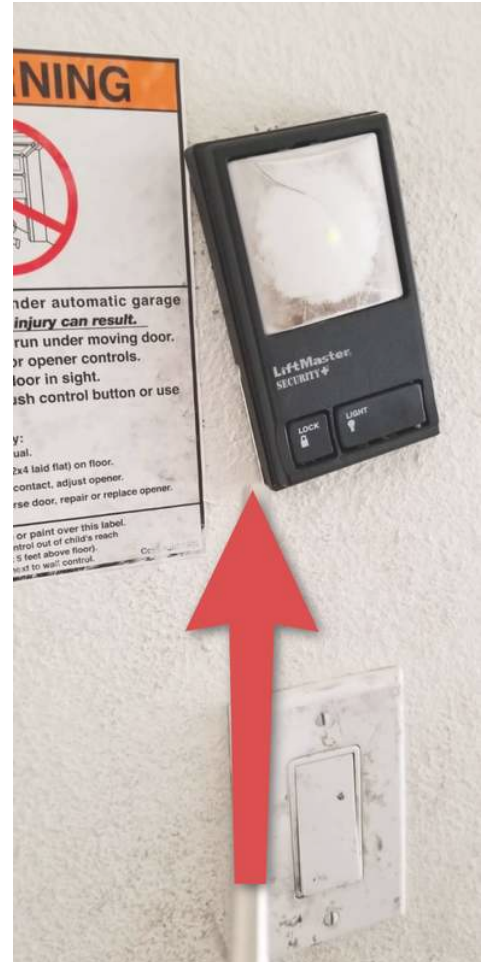
4.4.1 Automatic Opener

CONTROL LOOSE

Moderate

The control button or panel for operating one or more automatic garage vehicle door openers was loose. A qualified person should repair as necessary so buttons or control panels are securely attached to wall surfaces.

Recommendation
Recommended DIY Project

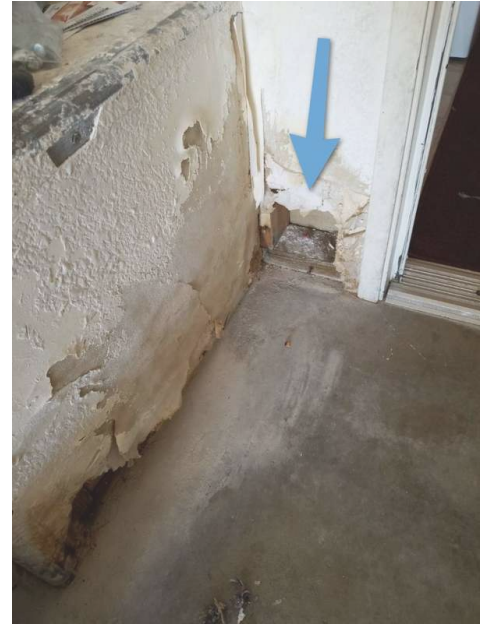
4.5.1 Floor, Walls, Ceiling

FIRE WALL / CEILING GAPS, HOLES AND/OR DAMAGED

Safety / Major

One or more gaps, holes, and/or areas with missing or substandard surface materials were found in the attached garage walls or ceilings. Current standard building practices call for wooden-framed ceilings and walls that divide the house and garage to provide limited fire-resistance rating to prevent the spread of fire from the garage to the house. Recommend that a qualified person repair per standard building practices. For example, by patching openings or holes, firestopping holes or gaps with fire-resistant caulking, and/or installing fire-resistant wall covering (e.g. Type X drywall).

Contact a qualified drywall contractor.

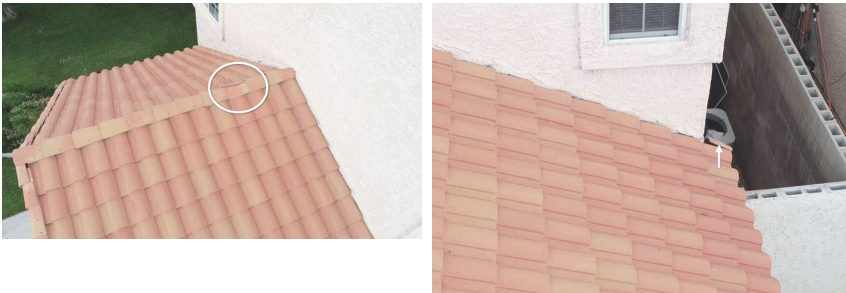
5.2.2 Roof Coverings

ROOF TILES CRACKED, BROKEN OR LOOSE

Moderate

Roof tiles were cracked, broken or loose. Leaks may occur as a result. This is a conducive condition for wood-destroying organisms. Recommend that a qualified person replace tiles or make repairs as necessary.

Contact a qualified roofing professional.

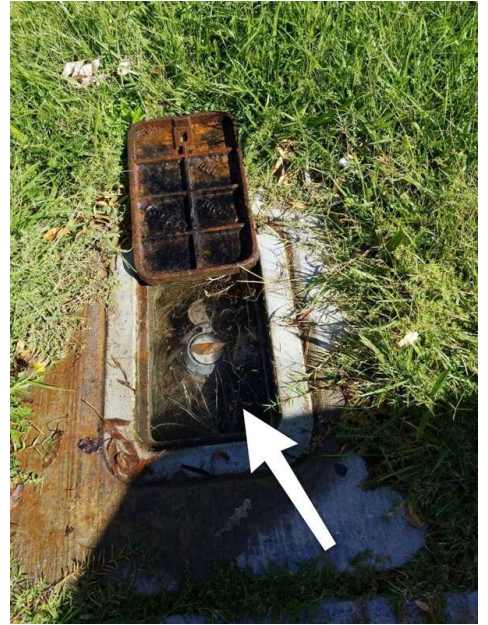
6.2.1 Service

WATER METER LEAKING

Safety / Major

The water was leaking at the water meter. Recommend that a qualified plumber repair or replace the valve as necessary.

Contact a qualified plumbing contractor.

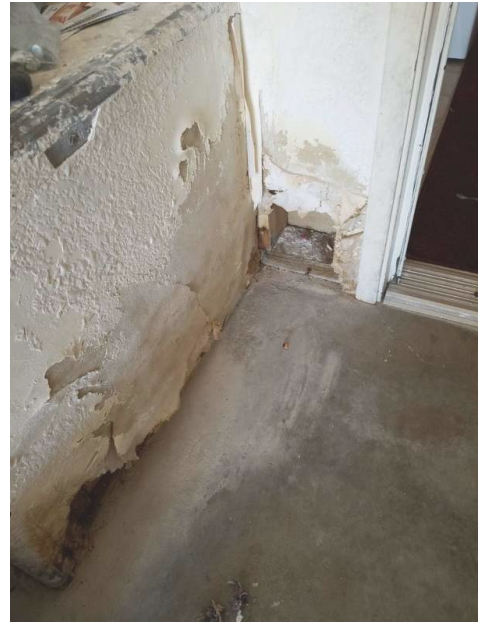
6.6.1 Water Heater

WATER HEATER STAND DAMAGED OR DETERIORATED

Moderate

Water heater stand deteriorated. Recommend a qualified person repair or replace the stand.

Recommendation
Contact a qualified professional.

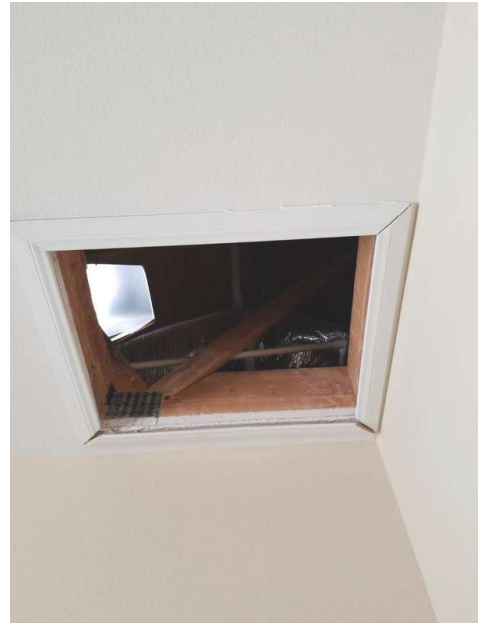
9.1.1 Attic Access

HATCH COVER MISSING / DAMAGED

Moderate

One or more indoor attic access hatch covers or doors were missing, damaged and/or substandard. When located indoors, conditioned air can enter the attic. Energy efficiency can be reduced, moisture can form in the attic, attic air laden with insulation fibers can enter living spaces, and/or pets can enter the attic. This is also a fire hazard as attic access hatch covers and doors are meant to stop or slow the spread of fire into the attic. A qualified person should replace, install or repair hatches or doors as necessary and per standard building practices. Each access point should be insulated and sealed with weatherstripping.

Contact a handyman or DIY project

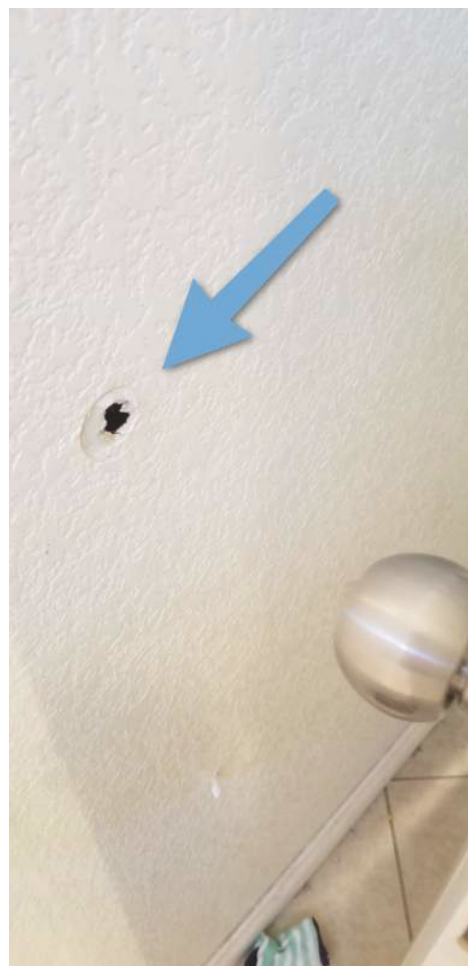
10.4.1 Walls

WALL DAMAGED

Moderate

One or more walls were damaged or had substandard repairs. Recommend that a qualified person repair as necessary.

Recommendation
Contact a qualified drywall contractor.

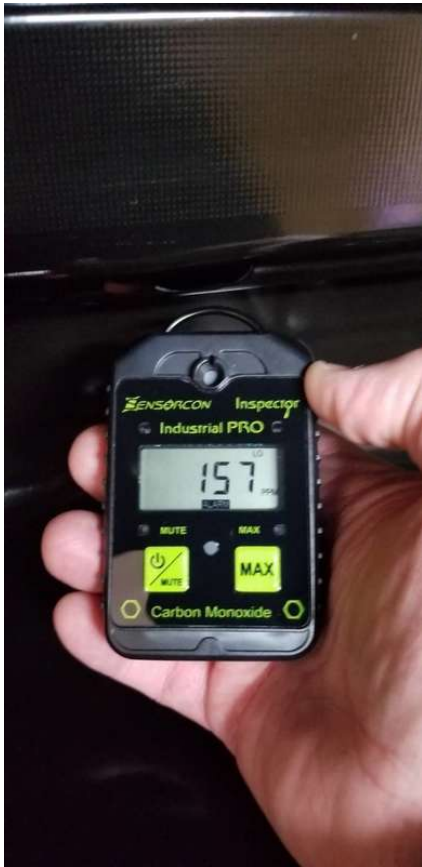
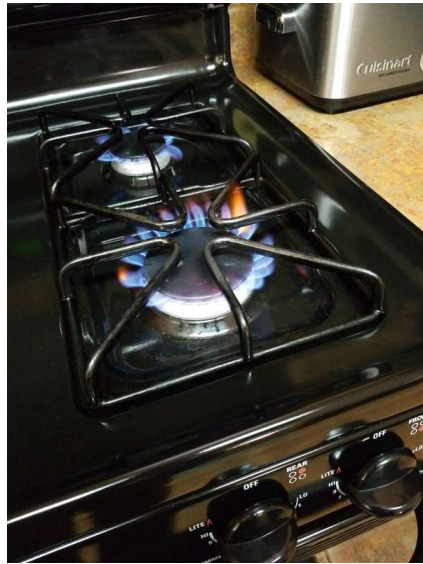
14.3.1 Range/Oven/Cooktop

COOKTOP / STOVE BURNER CO2 LEVEL TOO HIGH

Safety / Major

High levels of carbon monoxide were registered at cooktop/stove. 35 PPM is the maximum concentration allowed by federal law for continuous exposure over an eight-hour period. At 200 PPM, you may experience mild headaches, dizziness or even nausea after two or three hours. Recommend a qualified appliance repair person evaluate and repair as necessary.

Recommendation
Contact a qualified appliance repair professional.

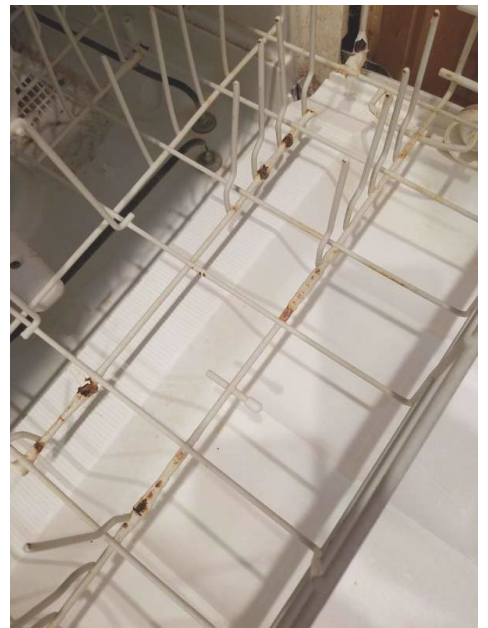
14.5.1 Dishwasher

INTERIOR PARTS MISSING / DAMAGED

Moderate

Dishwasher interior parts such as trays, tray wheels and/or spray arms etc. missing and/or damaged Recommend a qualified appliance repair person to evaluate and repair or replace as necessary.

Contact a qualified professional.

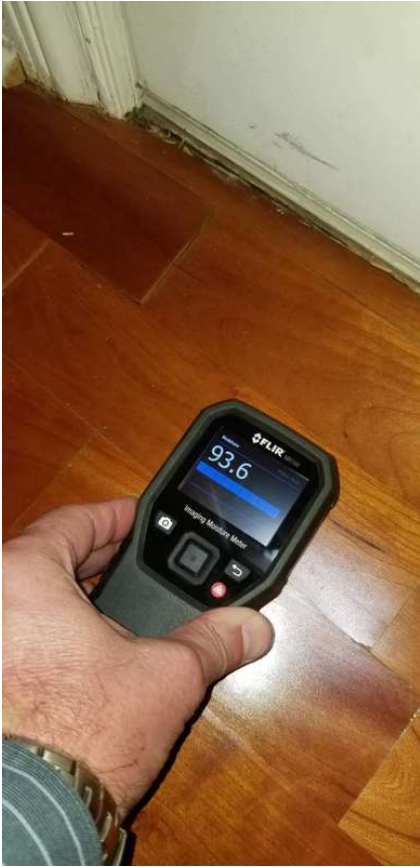
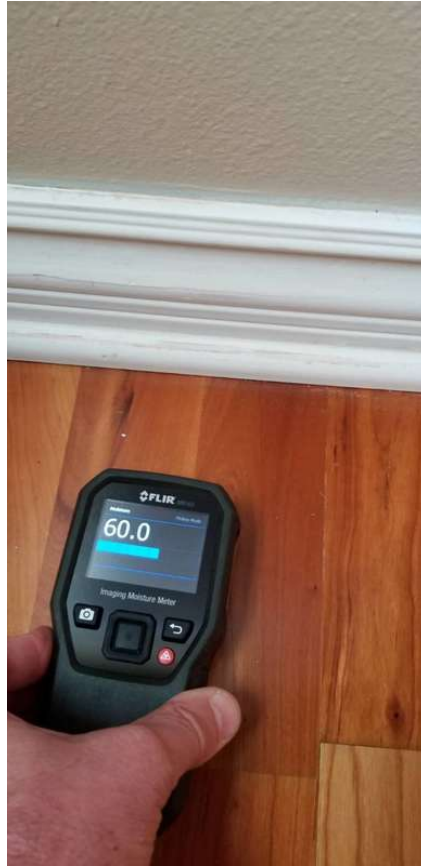
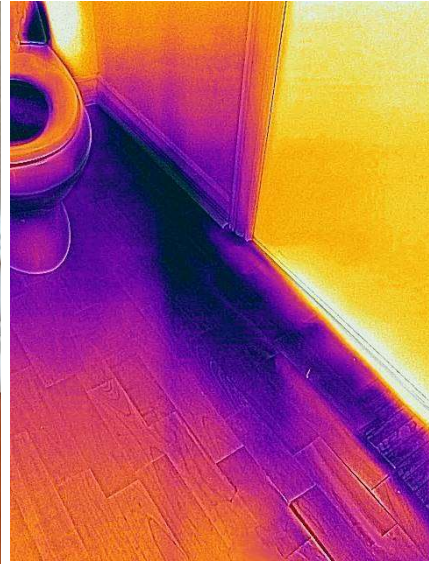
15.2.1 Floors

MOISTURE INTRUSION

There is evidence of moisture entering the structure. We recommend contacting a contractor experienced in exterior systems to evaluate the area and suggest repair options. Areas behind wall surfaces may have further damage that cannot be determined from a limited visual inspection.

Safety / Major

Recommendation
Contact a qualified professional.

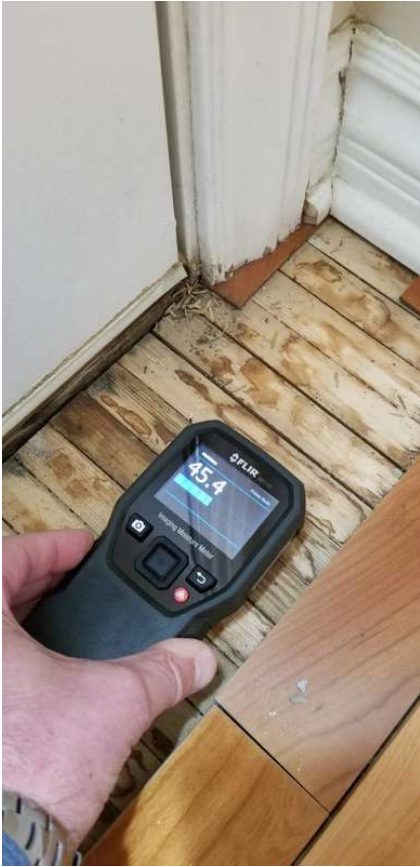
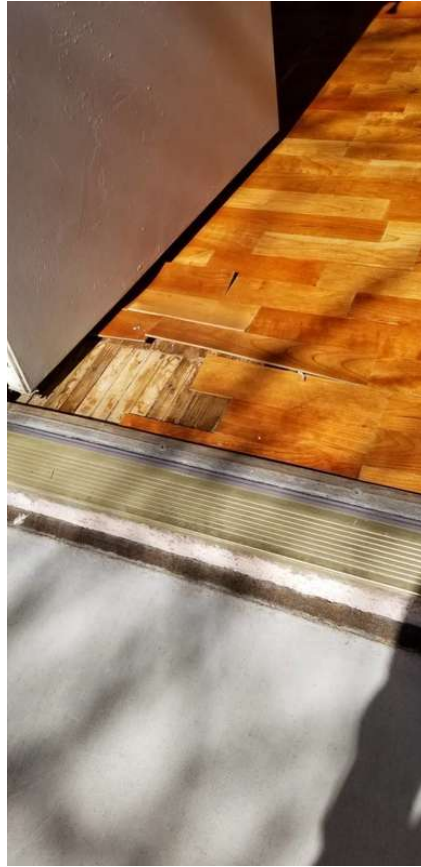
15.2.2 Floors

WOOD FLOOR DAMAGED

1ST FLOOR BATHROOM ACROSS FROM LAUNDRY ROOM

Wood flooring in one or more areas was worn, deteriorated or damaged. Recommend that a qualified contractor refinish and/or repair wood flooring as necessary.

Contact a qualified flooring contractor

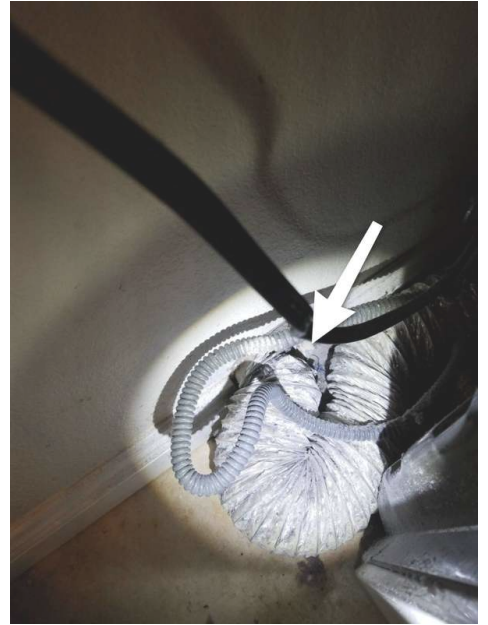
16.1.1 General

DRYER DUCT SEPARATED

Safety / Major

The dryer duct appears to be separated at one or more locations. Clothes dryers produce large amounts of moisture which should not enter structure interiors. Moisture can accumulate and result in mold, bacteria or fungal growth. Recommend a qualified person repair as necessary.

Recommendation
Contact a qualified HVAC professional.

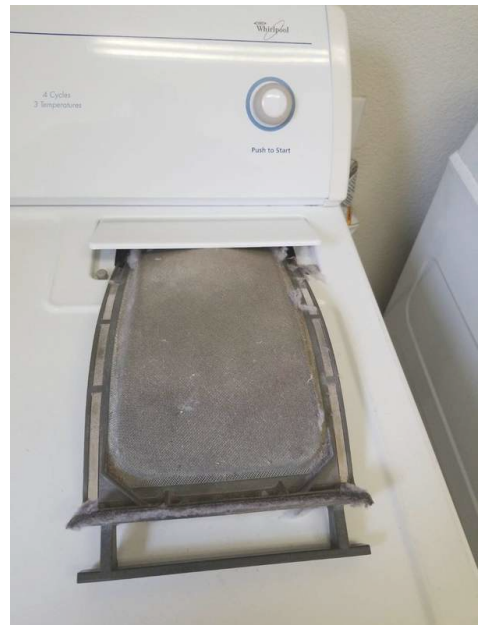
16.1.2 General

LINT SCREEN NEEDS CLEANING

Safety / Major

The clothes dryer lint screen appeared to be in the need of cleaning. As a result, this may reduce air flow. This can become a fire hazard if not properly maintained. Recommend that a qualified person clean the lint screen and as necessary in the future.

Recommendation
Contact a qualified professional.

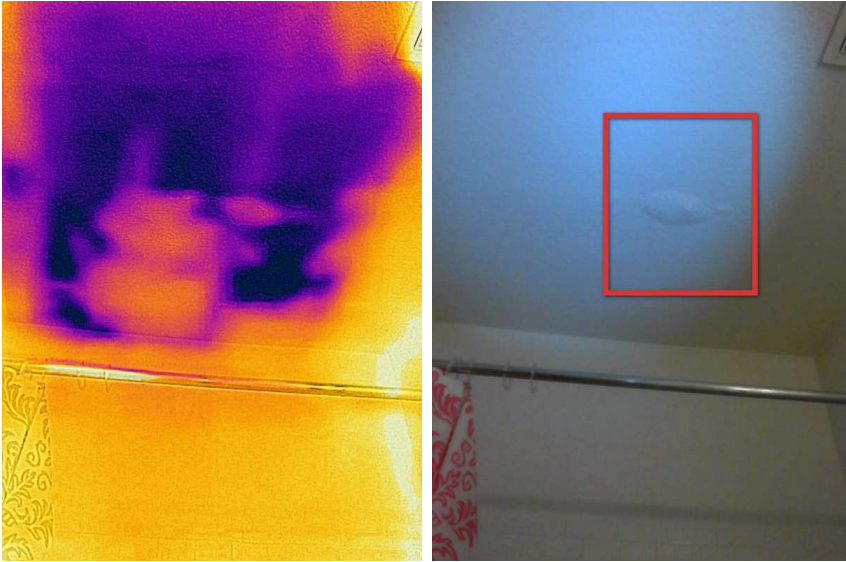
19.3.1 Walls / Ceiling

CEILING WET STAINS - MOISTURE INTRUSION

Safety / Major

Stains and/or elevated levels of moisture were found in one or more ceiling areas. The stains / moisture appear to be due to an active plumbing leak and/or moisture intrusion. Recommend that a qualified contractor evaluate and repair as necessary.

Recommendation
Contact a qualified professional.

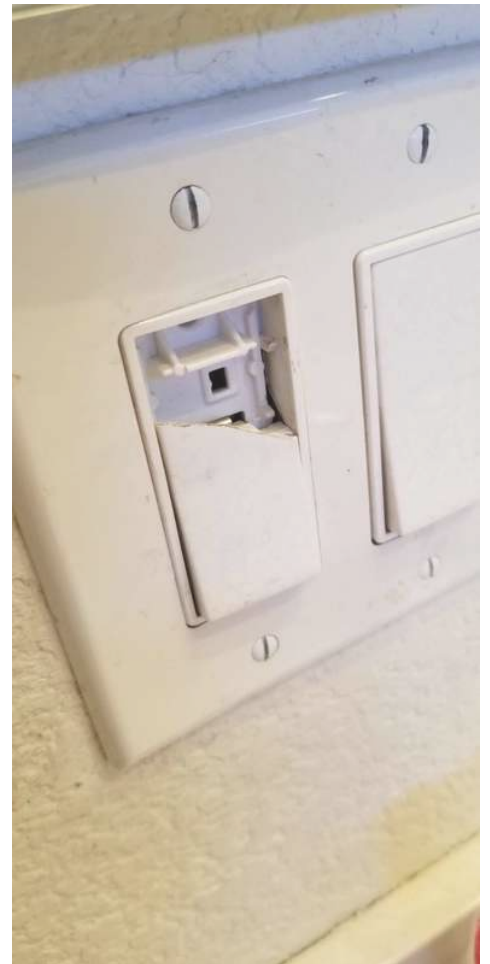
19.9.1 Electrical - Switches and Receptacles

SWITCH DAMAGED

Moderate

One or more wall switches were broken or damaged. Recommend that a qualified electrician replace wall switches as necessary.

Contact a qualified electrical contractor.

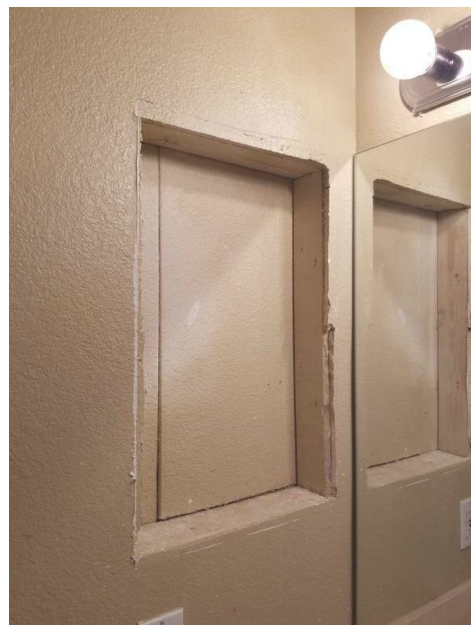
21.8.1 Countertops & Cabinets
MEDICINE CABINET MISSING
MASTER BATHROOM

— Moderate

One or more cabinets were missing. Recommend that a qualified person replace as necessary.

Recommendation
Contact a qualified cabinet contractor.
