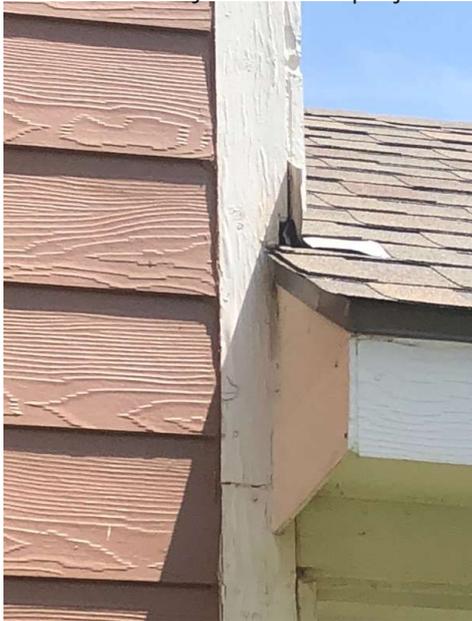
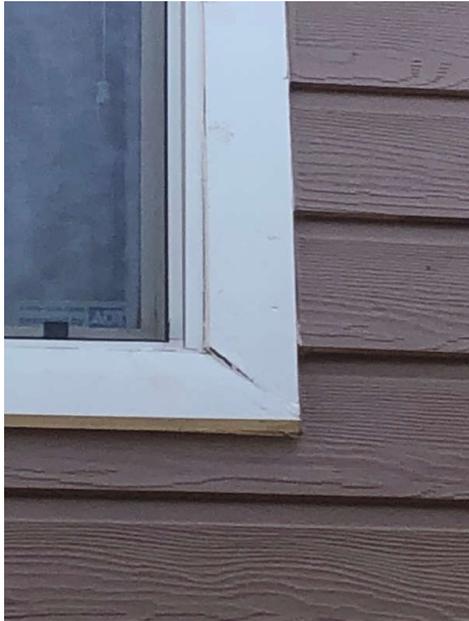
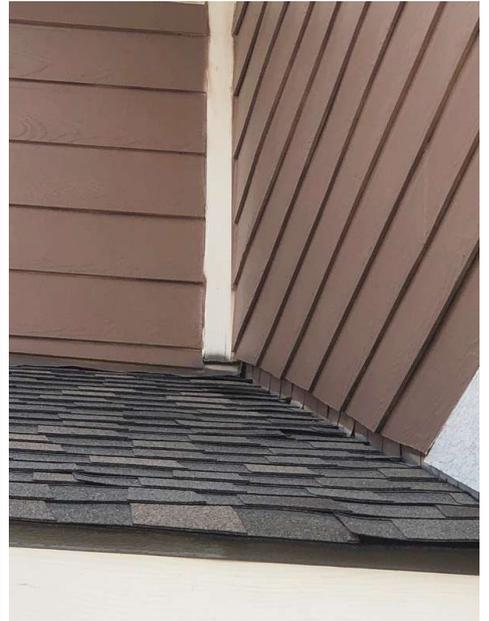
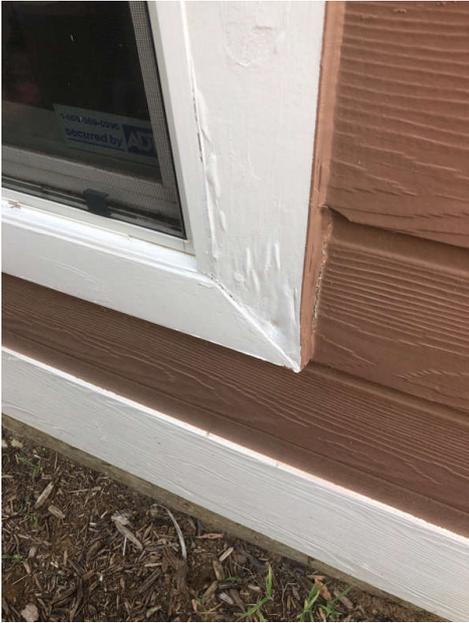
2.5.2 E. Walls (Interior and Exterior)

**TRIM DAMAGED**

FRONT, LEFT & BACK

The wood veneer trim has some deterioration or damage.

Recommendation  
Contact a handyman or DIY project

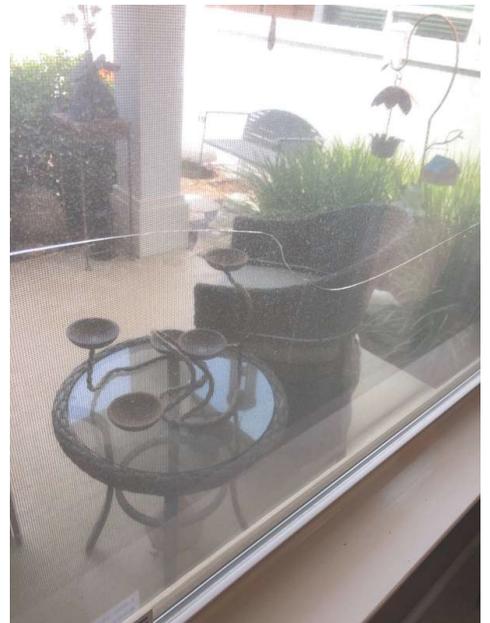
2.8.1 H. Windows

**WINDOW GLASS BROKEN**

BREAKFAST

Cracked and/or broken window glass was observed.

Recommendation

Contact a qualified window repair/installation contractor.

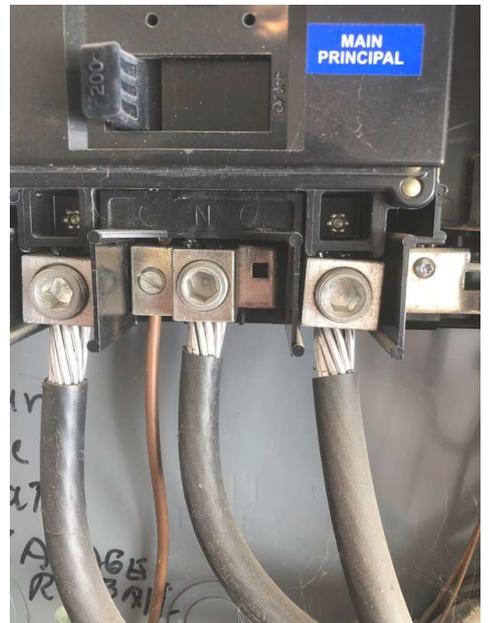
### 3.1.3 A. Service Entrance and Panels **NO ANTI-OXIDANT ALUMINUM**

There was no anti-oxidant gel observed on the exposed aluminum conductor terminations.

Recommendation  
Contact a qualified electrical contractor.

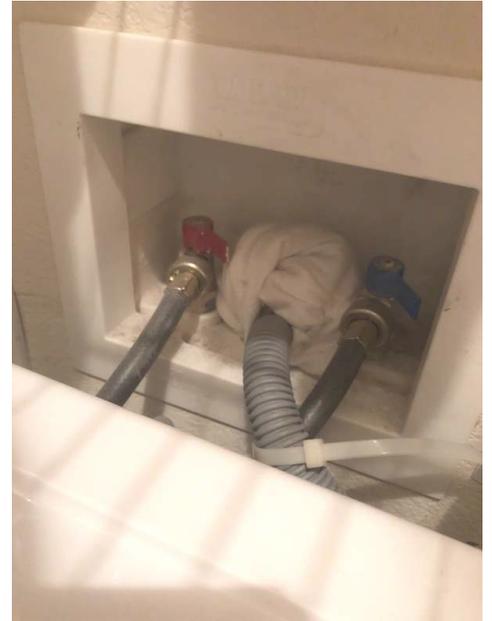
5.2.2 B. Drains, Wastes, & Vents

**LAUNDRY DRAIN**

Deficiency

Laundry drain is wrapped. This indicates previous issues. Recommend that you request disclosure.

Recommendation  
Contact a qualified professional.

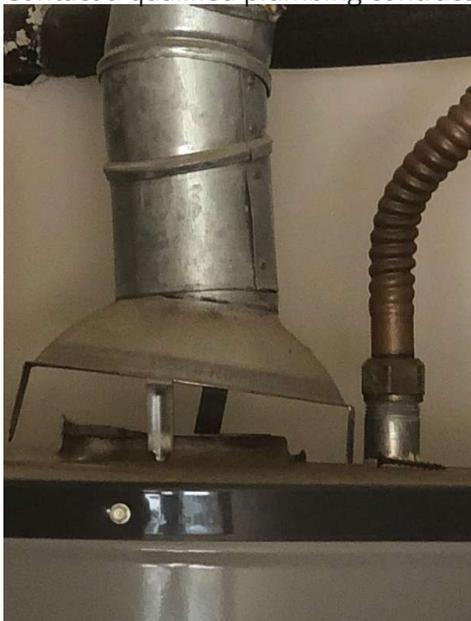
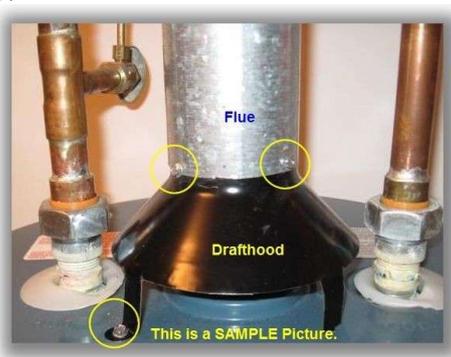
5.3.2 C. Water Heating Equipment

**FLUE NOT MOUNTED PROPERLY TOP**

Safety

The draft hood is not properly mounted on the water heater. This configuration will emit Carbon Monoxide into the heater compartment, which is a known safety hazard

Recommendation  
Contact a qualified plumbing contractor.

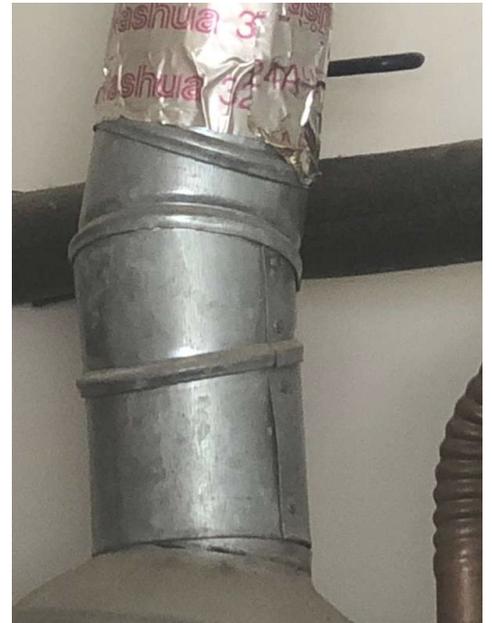
### 5.3.3 C. Water Heating Equipment

## MECHANICAL ATTACH FLUE

The water flue should be mechanically attached to the draft hood with a minimum of three sheet metal screws. Improperly attached flue can come loose and emit carbon monoxide.

#### Recommendation

Contact a qualified plumbing contractor.
