SUMMARY

1234 Main St. Largo Florida 33771

Donald Smeller
Florida Home Inspectors License...
Bayside Building Inspectors LLC
727-455-0669
don@baysideinspectors.com

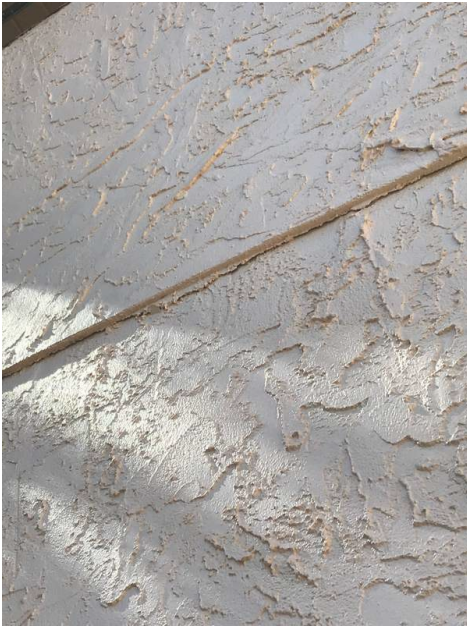
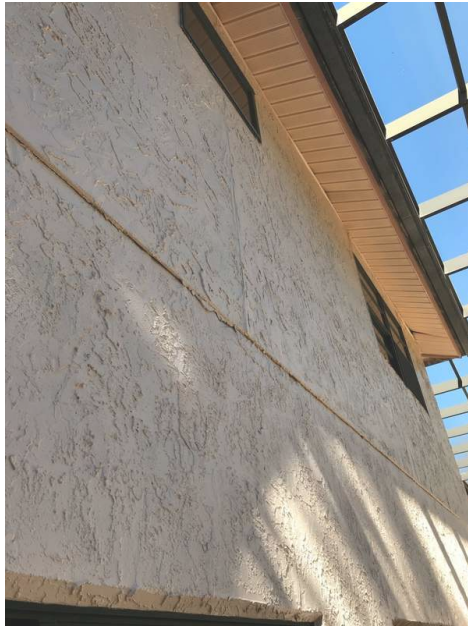
2.1.1 Siding, Flashing & Trim

CRACKING - MINOR

Siding showed cracking in one or more places. This is a result of temperature changes, and typical as homes with stucco age. Recommend monitoring.

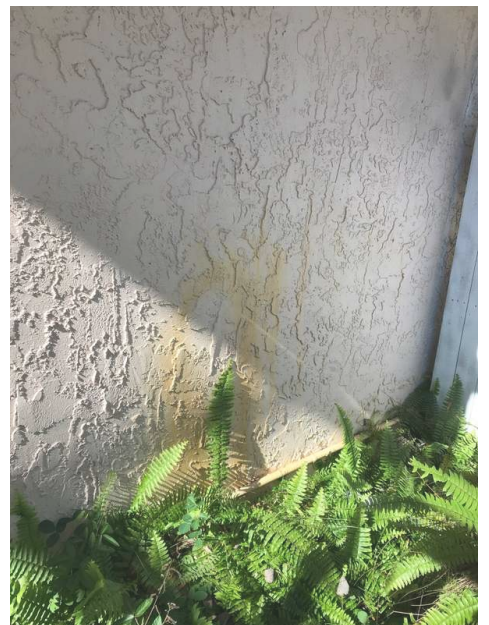
2.1.2 Siding, Flashing & Trim

PAINT NEEDED

Areas of siding were worn and in need of maintenance. Recommend a qualified painter or siding specialist correct.

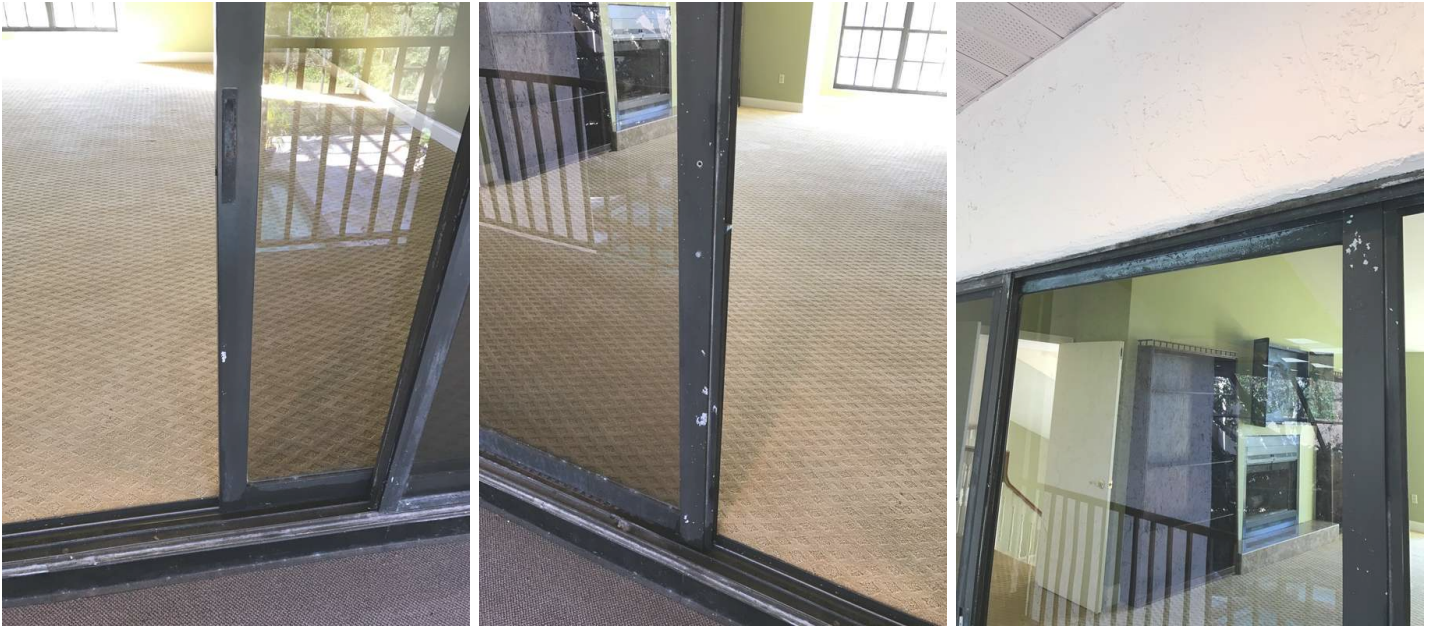
2.2.1 Exterior Doors

PAINT/REFINISH NEEDED

Door finish is worn. Recommend refinish and/or paint to maximize service life.

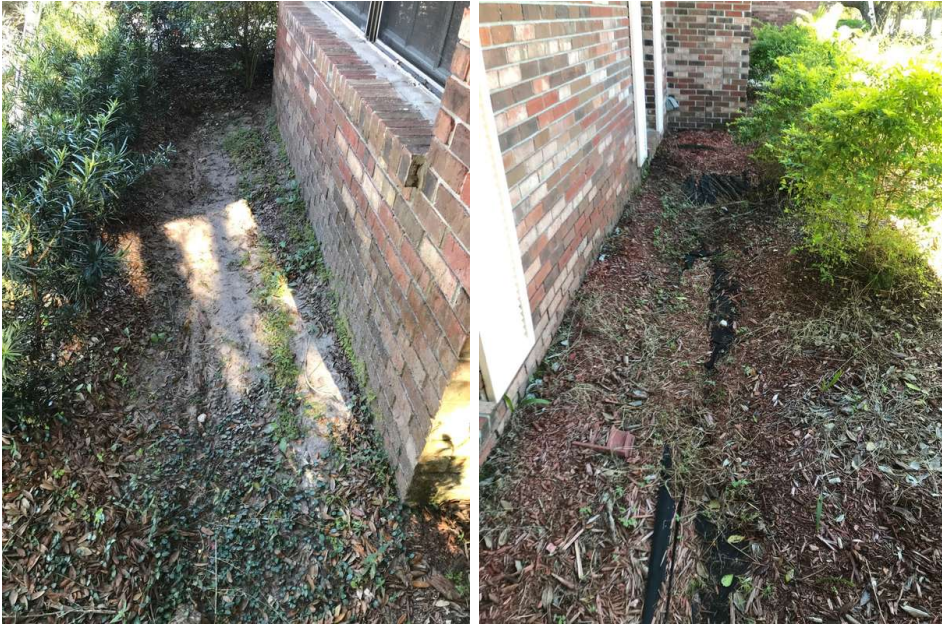
2.5.1 Vegetation, Grading, Drainage & Retaining Walls

NEGATIVE GRADING

Grading is sloping towards the home in some areas. This could lead to water intrusion and foundation issues. Recommend qualified landscaper or foundation contractor regrade so water flows away from home.

Most of this is caused from rain eroding the ground because of the lack of gutters. simple backfilling of soil will resolve the issue.

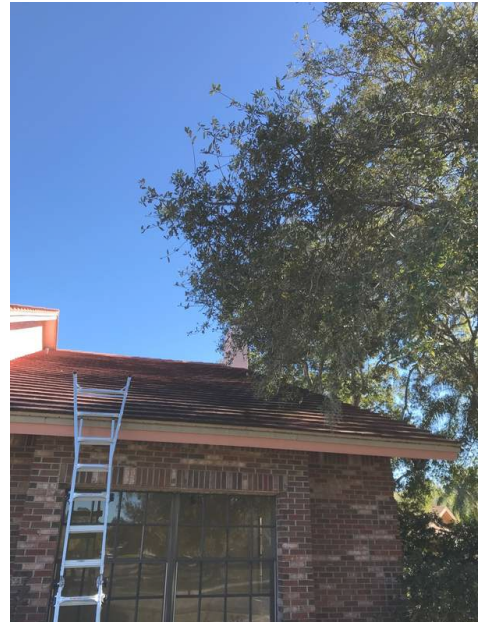
2.5.2 Vegetation, Grading, Drainage & Retaining Walls

TREE DEBRIS ON ROOF

Tree debris observed on roof. This can cause improper drainage to gutters and downspouts. Recommend clearing debris.

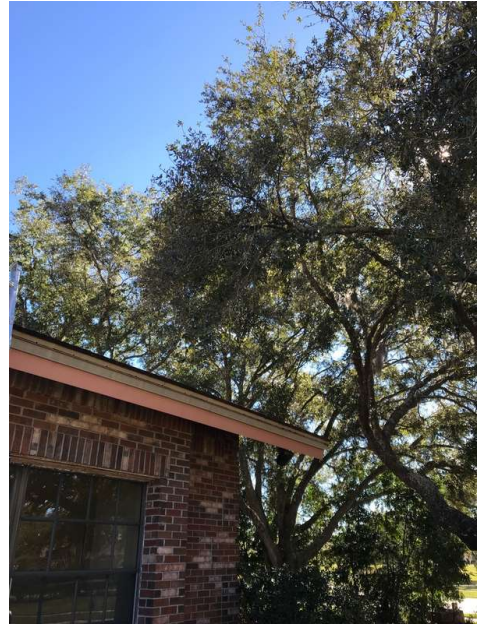
2.5.3 Vegetation, Grading, Drainage & Retaining Walls

TREE OVERHANG

Trees observed overhanging the roof. This can cause damage to the roof and prevent proper drainage. Recommend a qualified tree service trim to allow for proper drainage.

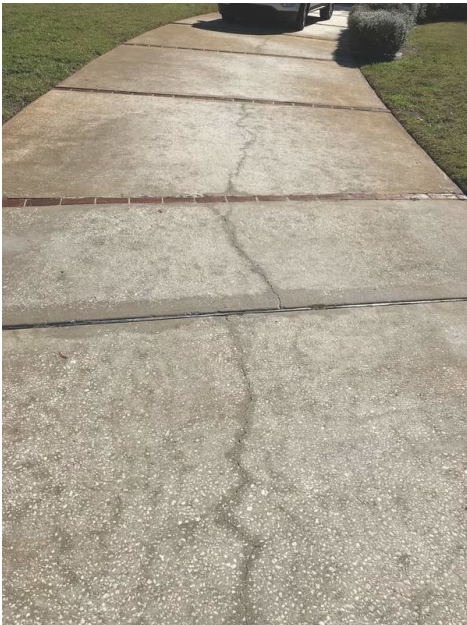
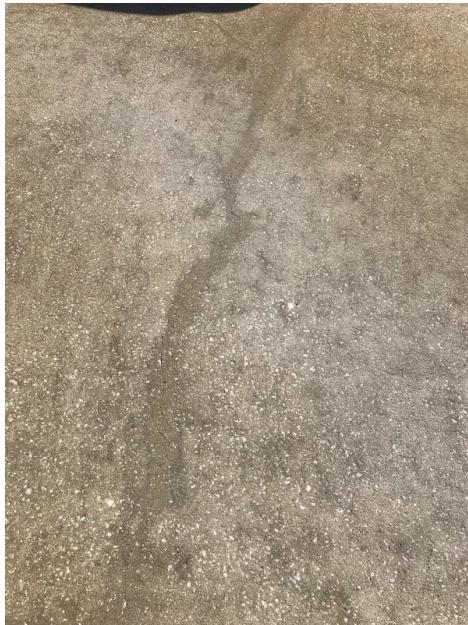
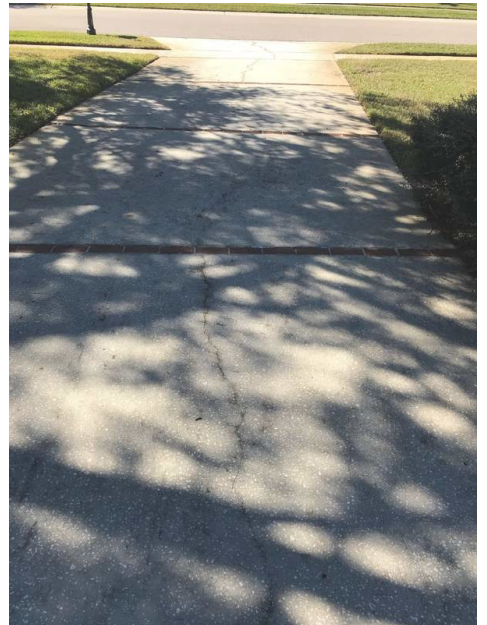
2.6.1 Walkways, Patios & Driveways

DRIVEWAY CRACKING - MINOR

Minor cosmetic cracks observed, which may indicate movement in the soil. Recommend monitor and/or have driveway contractor patch/seal.

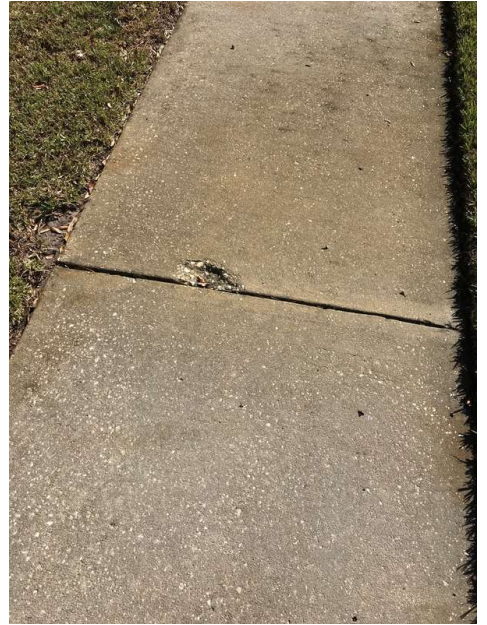
2.6.2 Walkways, Patios & Driveways

WALKWAY CRACKING - MAJOR

Major cracks observed. Recommend concrete contractor evaluate and correct to prevent trip hazard & preserve appearance.

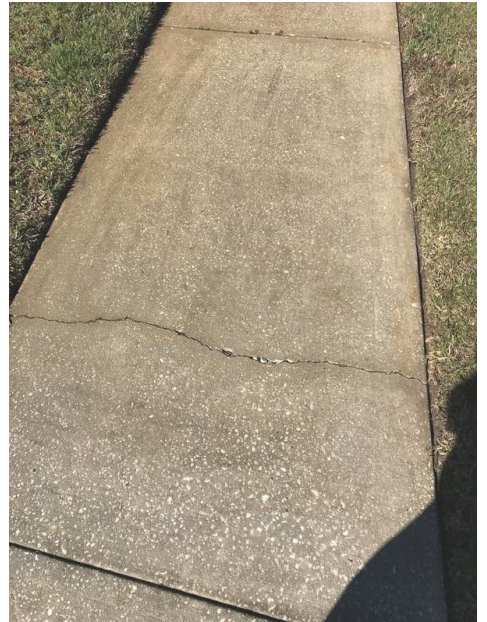
2.6.3 Walkways, Patios & Driveways

WALKWAY CRACKING - MINOR

Minor cosmetic cracks observed. Recommend monitor and/or patch/seal.

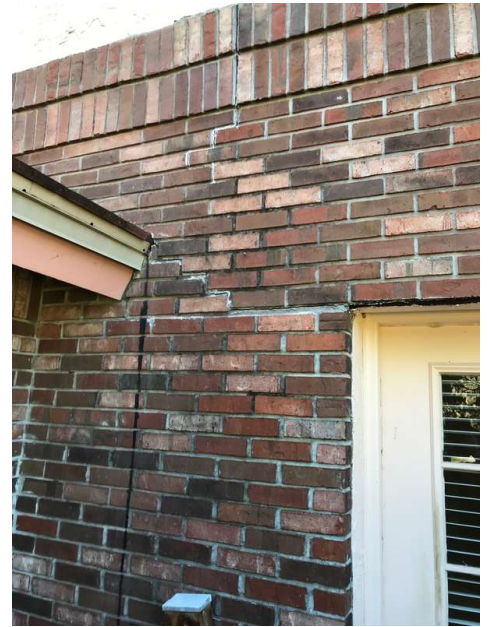
3.3.1 Wall Structure

CRACKS - MINOR

Minor cracking was observed in wall structure. This is common in homes this age. Recommend monitoring.

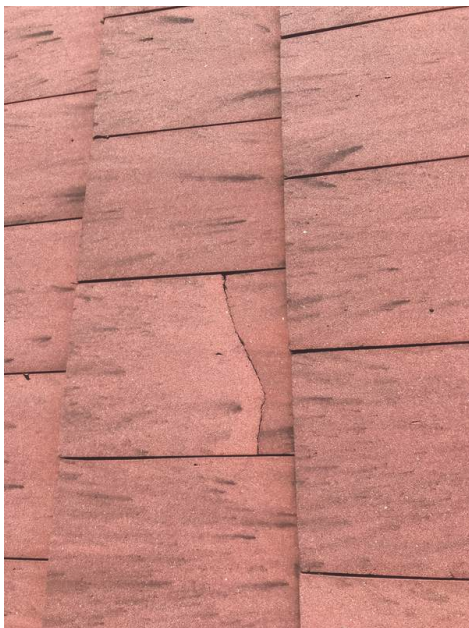
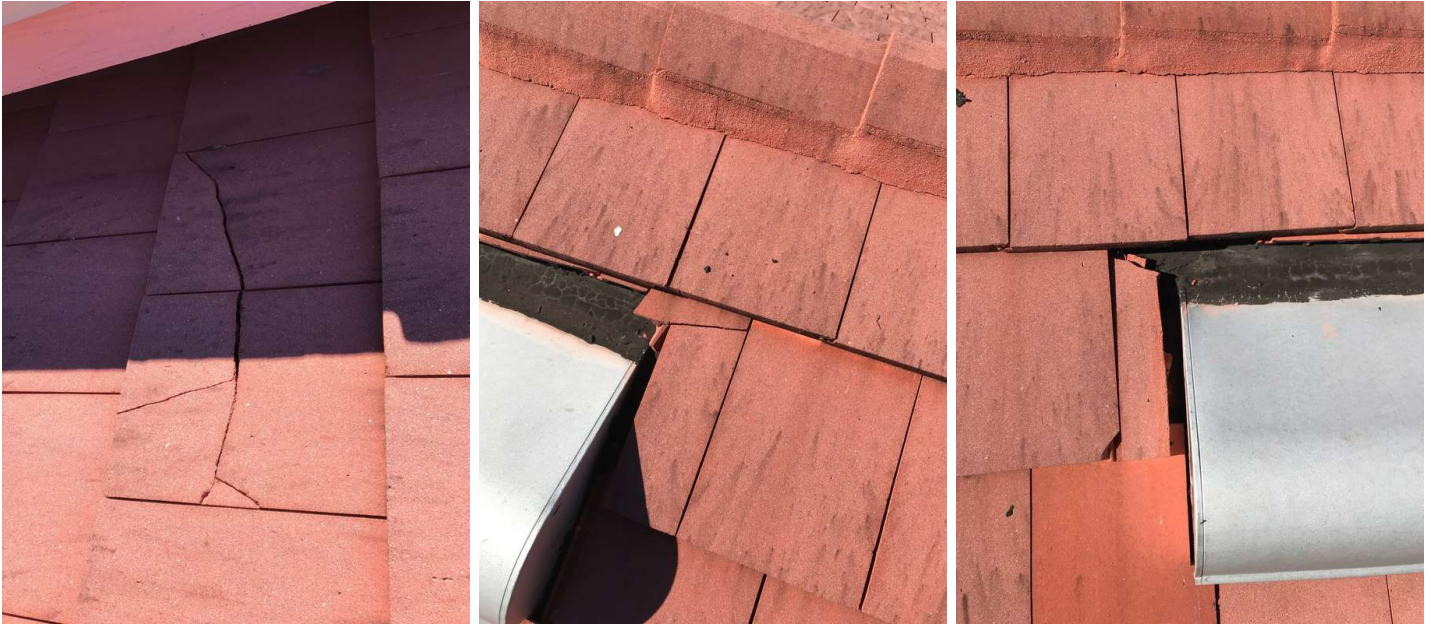
4.1.1 Coverings

TILES CRACKED/BROKEN

Roof had cracked/broken tiles. Recommend a qualified roof contractor repair or replace to prevent moisture intrusion and/or mold.

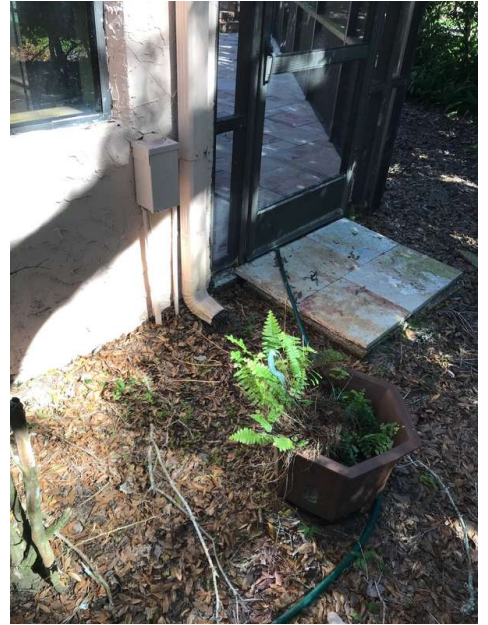
4.2.2 Roof Drainage Systems

DOWNSPOUTS DRAIN NEAR HOUSE

One or more downspouts drain too close to the home's foundation. This can result in excessive moisture in the soil at the foundation, which can lead to foundation/structural movement. Recommend a qualified contractor adjust downspout extensions to drain at least 6 feet from the foundation.

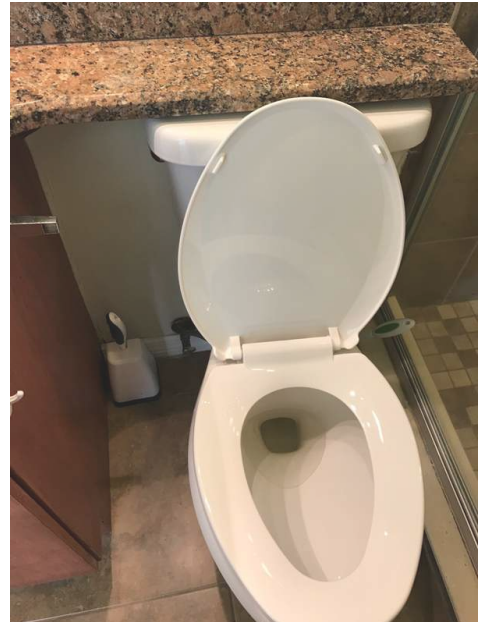
5.1.1 Fixtures / Faucets

TOILET ON FIRST FLOOR

Will not flush

Contact a qualified professional.

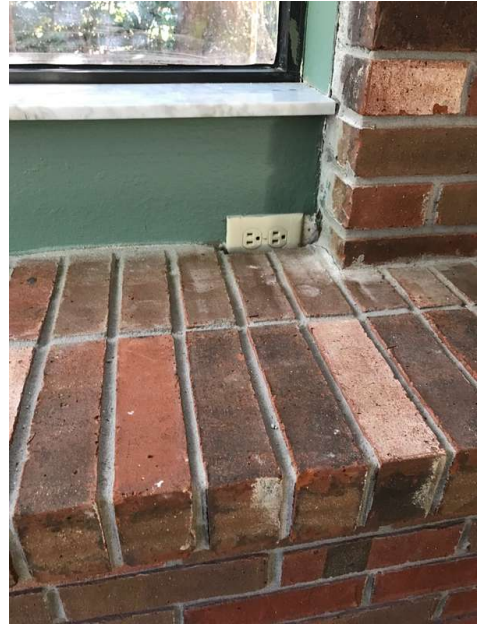
6.7.2 Polarity and Grounding of Receptacles
PLUG INACCESSIBLE

Recommendation
Contact a qualified professional.

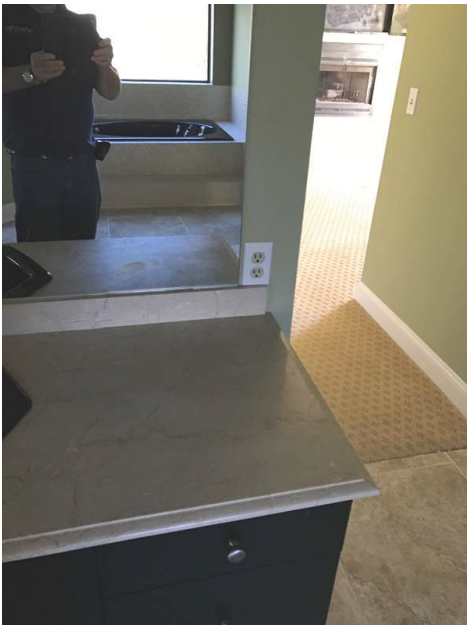
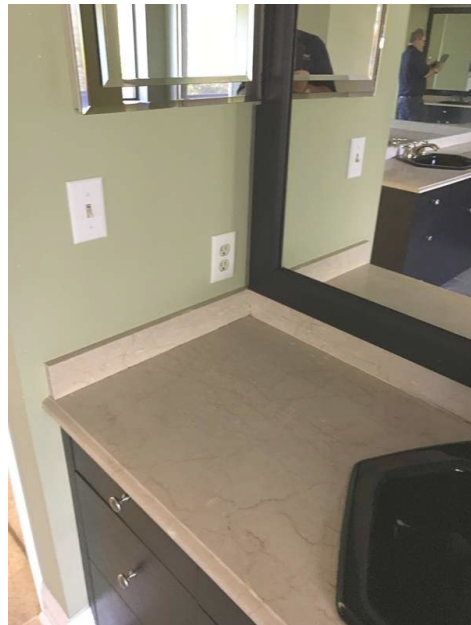
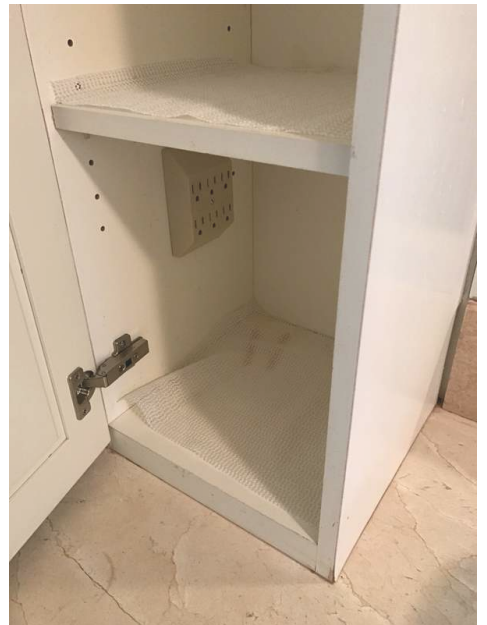
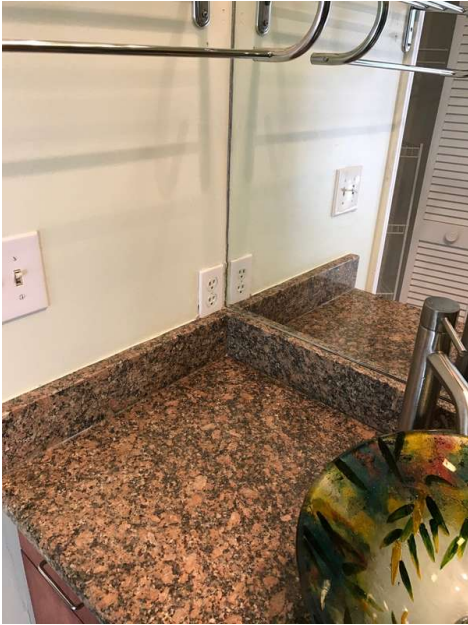
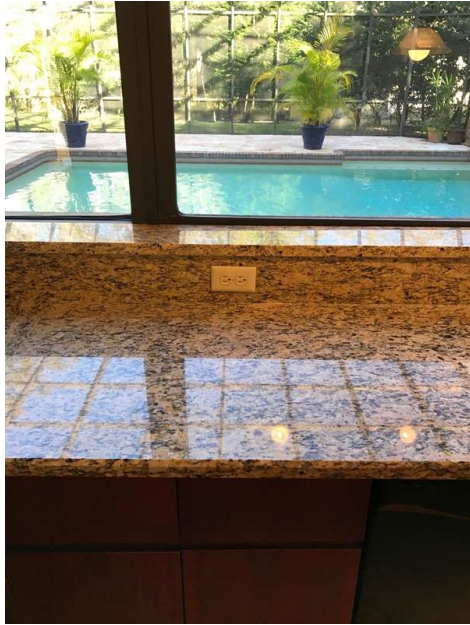
6.8.1 GFCI & AFCI

NO GFCI PROTECTION INSTALLED

No GFCI protection present in all locations. Recommend licensed electrician upgrade by installing ground fault receptacles in all locations.

Kitchen, baths and outdoor outlets all need to be upgraded to GFCI'S

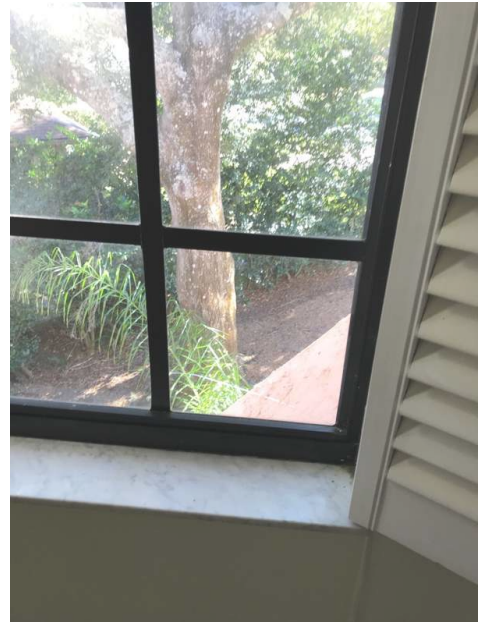
8.7.3 Windows

BROKEN PANE

Cracked glass observed at time of inspection. recommend qualified contractor replace

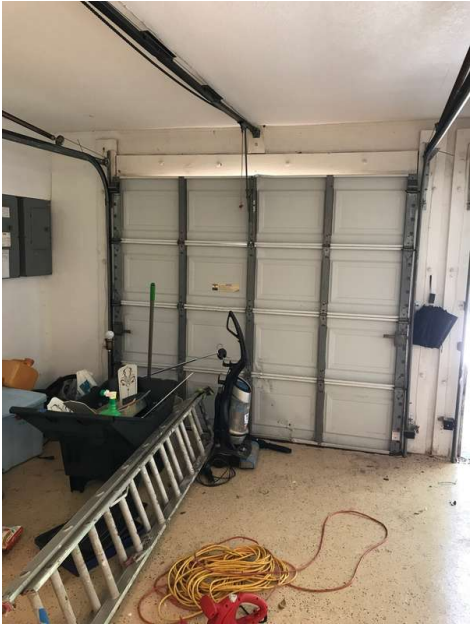
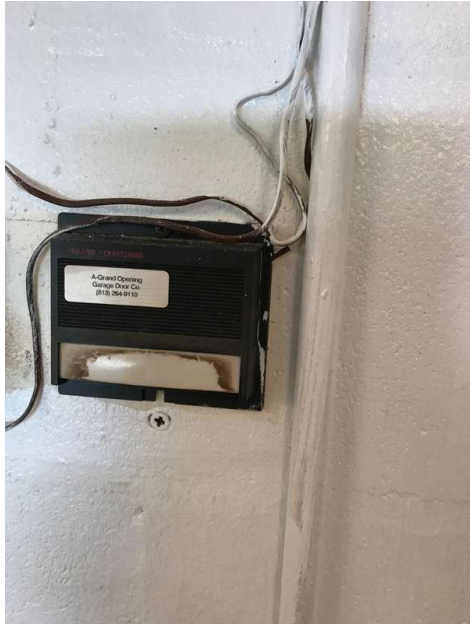
8.8.1 Garage Door

INOPERABLE

One of three garage doors would not open at time of inspection. recommend qualified contractor make necessary repairs.
