SUMMARY

1234 Main St. Yreka CA 96097

Shacks & Shanties Inspection Services
530-598-7856
mike@shacksandshanties.com

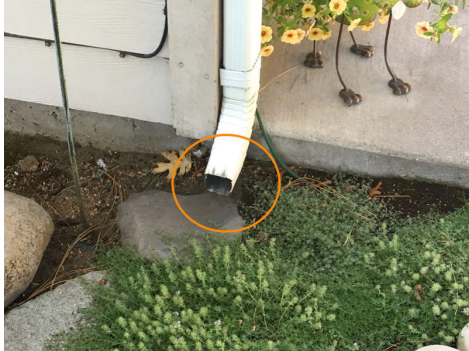
East

DOWNSPOUT TERMINATION

One or more downspouts drain too close to the foundation. This can result in excessive moisture in the soil at the foundation, which can lead to foundation/structural movement. Recommend a installing downspout extensions to direct water at least 4 feet from the foundation.

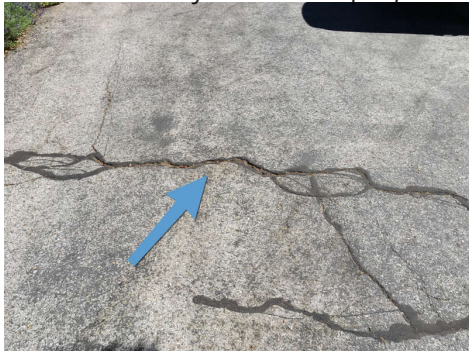
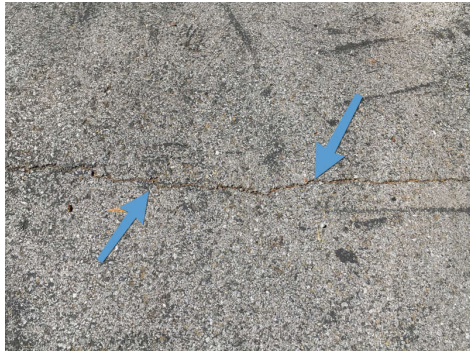
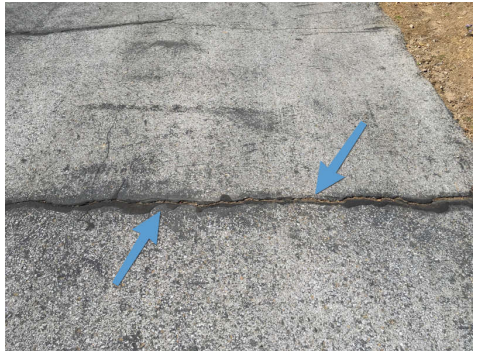
ASPHALT CRACKS

Cracks were observed in asphalt driveway. Cracking is a normal occurrence in asphalt driveways; however, in cold climates, water seeps in and further destroys the asphalt when it expands and contracts during freeze/thaw cycle. Asphalt driveway cracks may be sealed to prevent further damage to the asphalt and extend service life.

Contact a handyman or DIY project

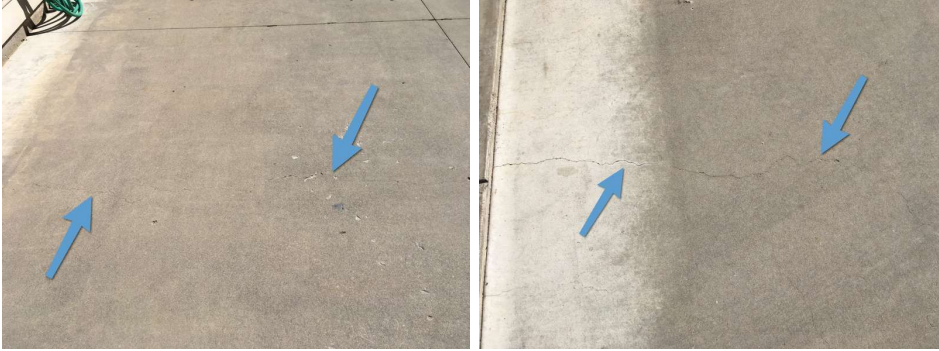
CEMENT CRACKS

Cement cracks were observed in driveway. These cracks are likely from normal concrete shrinkage. These do not impact the foundation, nor do they represent failure of the concrete. Shrinkage and minor settling cracks causes the cement to become vulnerable to further deterioration when water penetrates and the freeze/thaw cycle starts to damage the concrete. Sealing cracks with the proper sealant can help prevent weathering deterioration at these cracks and prolong service life. Also, using a cement stain, or paint will help prevent spalling. Otherwise, monitor for further, or widening of the cracks and repair as necessary.

Contact a handyman or DIY project

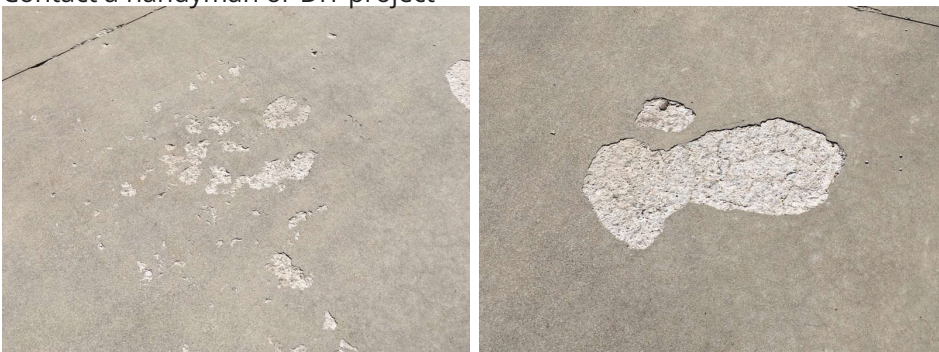
SPALLING IN CEMENT

Spalling was observed in the cement driveway. Spalling occurs when water in the capillaries of the concrete freezes, creating pressure. Over time, repeated freeze/thaw cycles breaks away the top surface of the concrete, leaving pit marks and exposing the coarse aggregate. De-icing chemicals aggravate the already stressed concrete, thus increasing the damage when a freeze occurs. De-icing chemicals are picked up from the road drip onto the surface. Polymer-modified cementitious overlay may be applied to repair spalled areas and prevent further deterioration. Once the overlay cures, apply a waterproofing sealer to prevent the problem from reoccurring.

Contact a handyman or DIY project

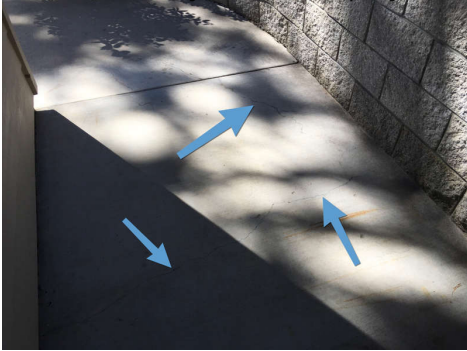
Back

CEMENT CRACKS

Cement cracks were observed in driveway. These cracks are likely from normal concrete shrinkage. These do not impact the foundation, nor do they represent failure of the concrete. Shrinkage and minor settling cracks causes the cement to become vulnerable to further deterioration when water penetrates and the freeze/thaw cycle starts to damage the concrete. Sealing cracks with the proper sealant can help prevent weathering deterioration at these cracks and prolong service life. Also, using a cement stain, or paint will help prevent spalling. Otherwise, monitor for further, or widening of the cracks and repair as necessary.

Contact a handyman or DIY project

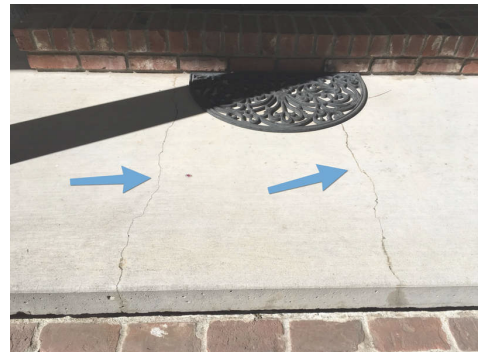
CEMENT CRACKS

Cement cracks were observed in porch. These cracks are likely from normal concrete shrinkage. These do not impact the foundation, nor do they represent failure of the concrete. Shrinkage and minor settling cracks causes the cement to become vulnerable to further deterioration when water penetrates and the freeze/thaw cycle starts to damage the concrete. Sealing cracks with the proper sealant can help prevent weathering deterioration at these cracks and prolong service life. Also, using a cement stain, or paint will help prevent spalling. Otherwise, monitor for further, or widening of the cracks and repair as necessary.

Contact a qualified professional.

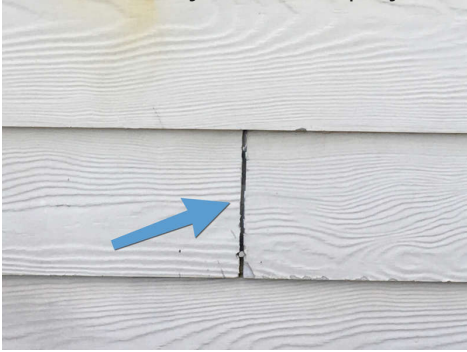
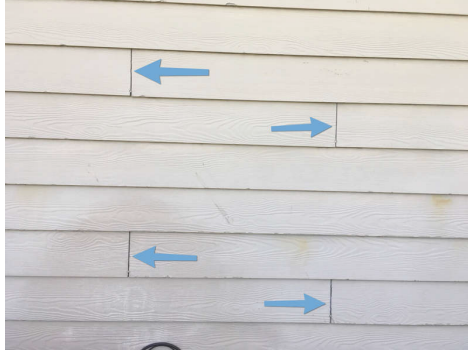
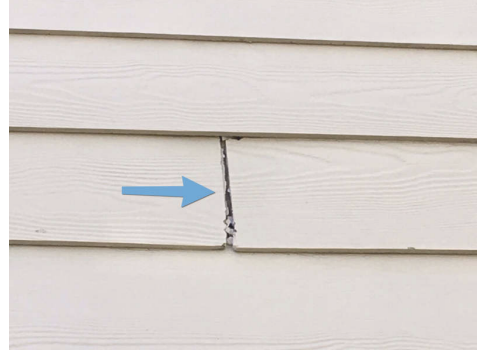
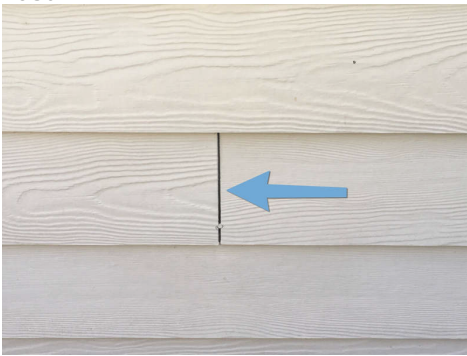
SEAMS UNSEALED

One or more siding boards were observed to have open, or unsealed ends, (butt ends, joints or seams), which may be allowing moisture intrusion. All joints should be properly sealed with appropriate sealant. Recommend repair.

Contact a handyman or DIY project

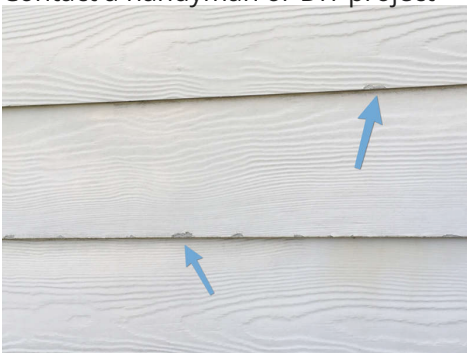
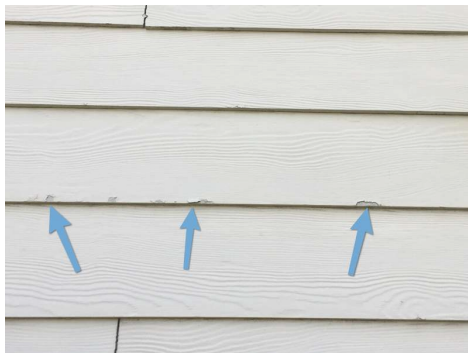
MINOR DAMAGE AND/OR HOLES

Area(s) of damage, and/or holes, to the siding material was observed. When siding is damaged or holes are present, the siding material is more vulnerable to water damage and deterioration, even fiber-cement material. Recommend these areas be painted, or sealed to prevent further deterioration.

Contact a handyman or DIY project

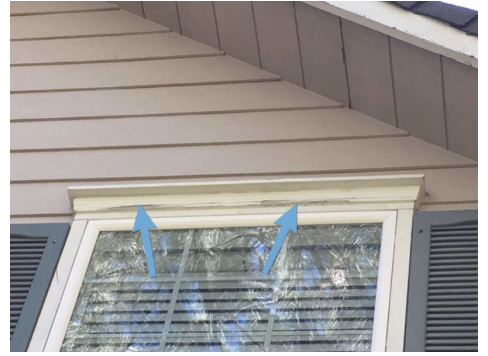
South East

PAINT OR SEAL

Trim was observed to have slightly deteriorated/peeling/missing paint, or seal. Wood trim that is unsealed and open to weathering will deteriorate and be vulnerable to wood rot (dry rot) conditions. Recommend painting all trim after moving into the house.

Recommendation
Contact a handyman or DIY project

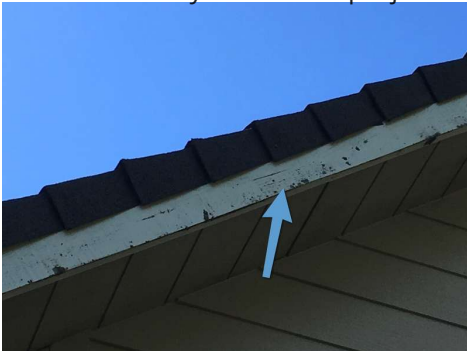
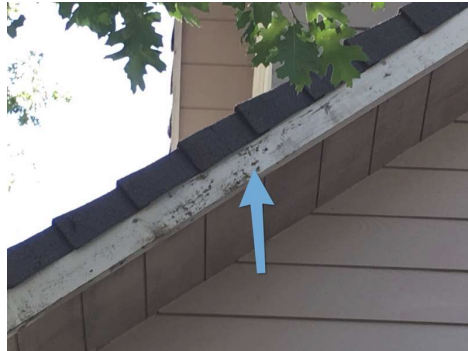
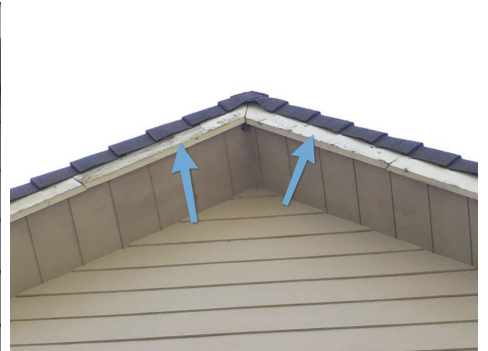
FASCIA PAINT OR SEAL

The fascia was observed to have peeling/missing paint. Wood exposed to moisture and weather becomes vulnerable to deterioration and dry rot conditions. Recommend painting, as necessary.

Recommendation
Contact a handyman or DIY project

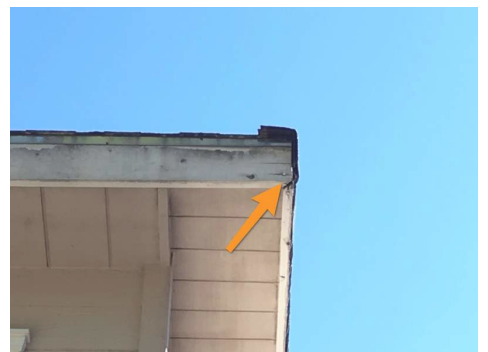
Northwest

FASCIA - MOISTURE DAMAGED

One or more sections of the fascia were observed to have moisture damage with wood rot (dry rot) conditions. Recommend qualified contractor evaluate and make recommendation for repair.

Dry Rot: Wood rot/dry rot is caused by biological fungal organisms that require a certain amount of moisture to thrive. The fungus digests the parts of the wood that give the wood strength and stiffness. Scraping/painting only will not stop dry rot from continuing to infiltrate the wood and compromise its integrity.

Treating and preventing dry rot is a three-step process. Step 1 is to locate and stop the source of the moisture. Step 2 is to remove and replace any damaged wood that has become structurally weakened. Step 3 is to treat new and existing wood with borate wood preservative to prevent growth of the dry rot fungus and kill any fungus already in the wood.

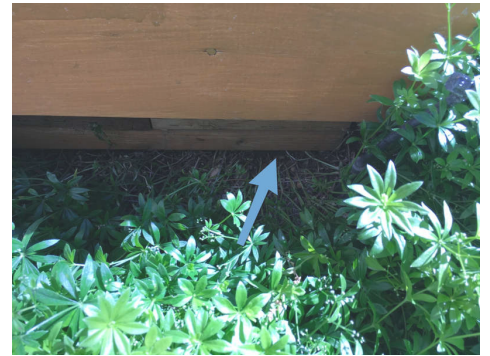
West

GROUND CONTACT

Wood structures were observed to be in contact with the ground. This will cause moisture damage and encourage wood destroying pests. All soil should be pulled away from wood structures.

Recommendation
Recommended DIY Project

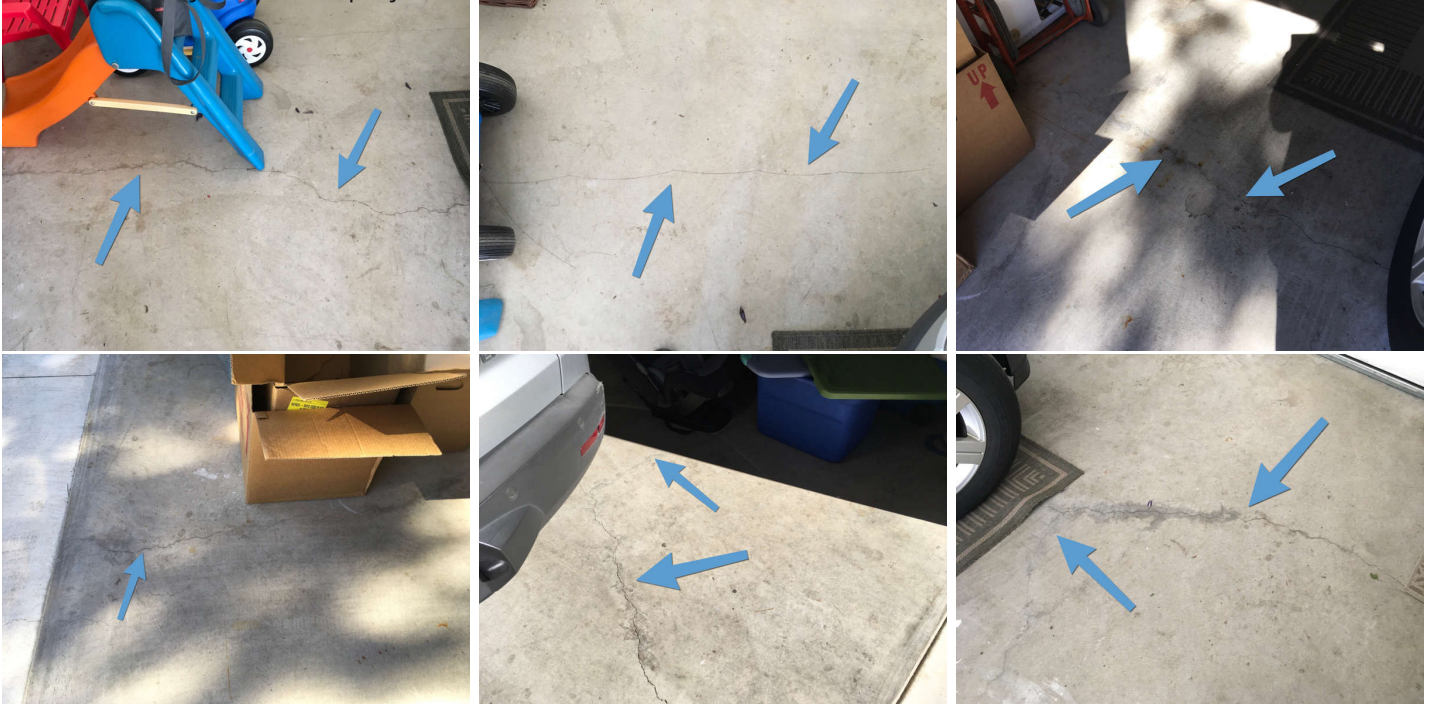
CEMENT CRACKS

Cement cracks were observed in garage floor. These cracks are likely from normal concrete shrinkage. These do not impact the foundation, nor do they represent failure of the concrete. Shrinkage and minor settling cracks causes the cement to become vulnerable to further deterioration. Sealing cracks with the proper sealant can help prevent deterioration at these cracks and prolong service life. Otherwise, monitor for further, or widening of the cracks and repair as necessary.

Contact a handyman or DIY project

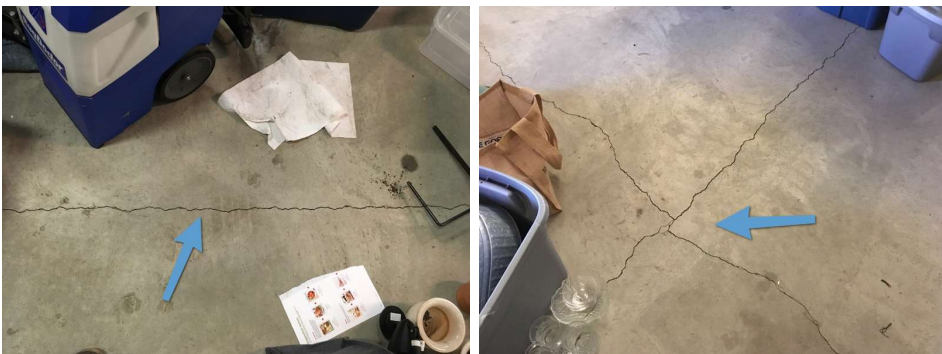
CEMENT CRACKS

Cement cracks were observed in garage floor. These cracks are likely from normal concrete shrinkage. These do not impact the foundation, nor do they represent failure of the concrete. Shrinkage and minor settling cracks causes the cement to become vulnerable to further deterioration. Sealing cracks with the proper sealant can help prevent deterioration at these cracks and prolong service life. Otherwise, monitor for further, or widening of the cracks and repair as necessary.

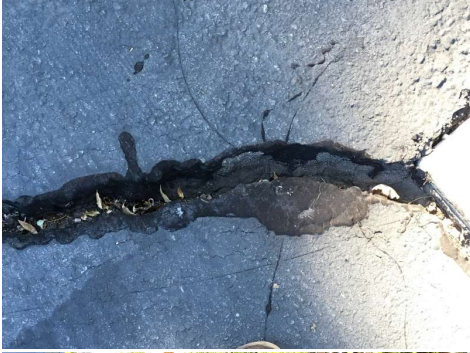
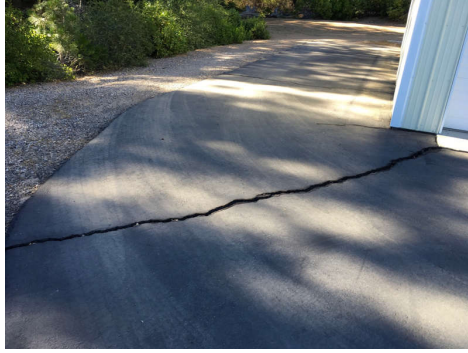
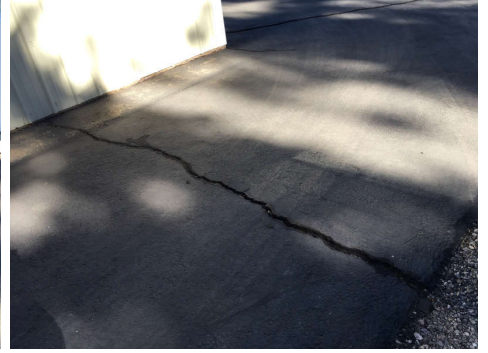
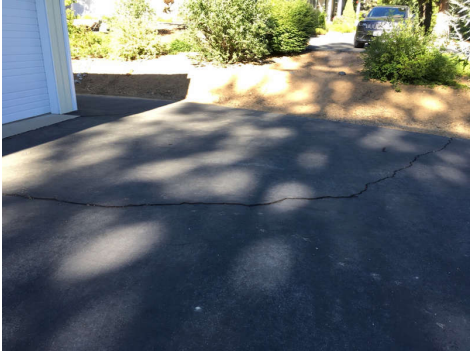
ASPHALT CRACKS

Cracks were observed in asphalt driveway. Cracking is a normal occurrence in asphalt driveways; however, in cold climates, water seeps in and further destroys the asphalt when it expands and contracts during freeze/thaw cycle. Asphalt driveway cracks may be sealed to prevent further damage to the asphalt and extend service life.

Contact a handyman or DIY project
