SUMMARY 1234 Main St. Harleysville PA 19438 Buyer Name 07/29/2019 9:00AM

JONATHAN MUSSELMAN ASHI Certified Inspector MUSSELMAN HOME INSPECTION LLC 267-664-2056

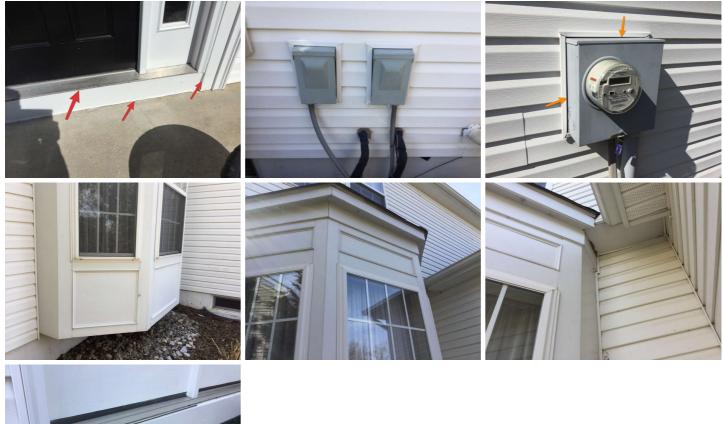
3.1.1 Siding, Flashing & Trim CAULKING AND PAINTING

It's important that all exterior components are properly maintained and sealed. Wood and metal products should be painted to prevent material decomposition. Caulking around dissimilar materials and exterior penetrations will help prevent water infiltration to the structure. Monitoring these areas during your bi-annual inspection of the property is very important to keeping a healthy and safe home.

Recommendation Recommended DIY Project

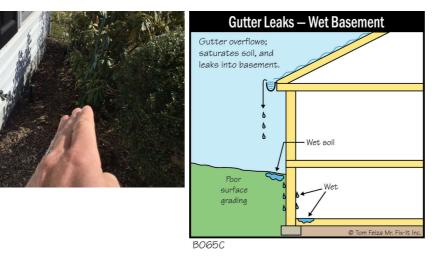
3.5.1 Vegetation, Grading, Drainage & Retaining Walls **NEGATIVE GRADING**

Grading is sloping towards the home in some areas. This could lead to water intrusion and foundation issues. Recommend qualified landscaper or foundation contractor regrade so water flows away from home.

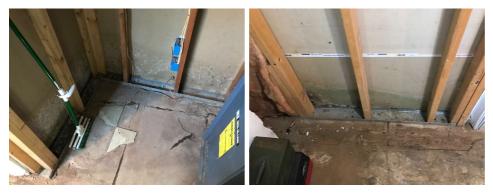
9.3.1 Walls MOLD-LIKE SUBSTANCE

BASEMENT

There are signs of a mold-like substance on the wall/s. It is unknown if this is a safety hazard without testing it first to understand what it is. Recommend a qualified mold inspector evaluate and understand proper clean-up procedures.

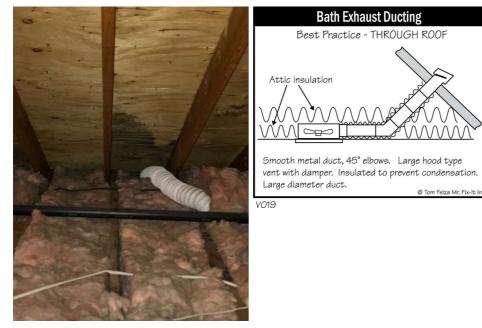
10.5.1 Exhaust Systems BATHROOM VENTS INTO ATTIC

Bathroom fan vents into the attic, which can cause moisture and mold. Recommend a qualified attic contractor property install exhaust fan to terminate to the exterior.
