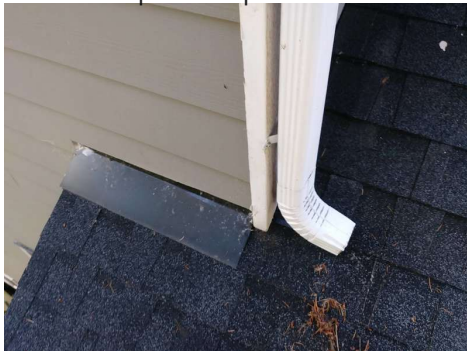
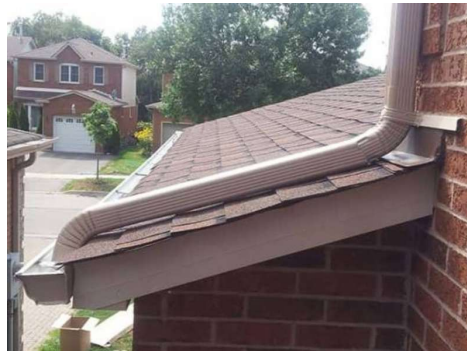
2.2.1 Gutters/drains

GUTTER DRAINS ON ROOF

One or more downspouts terminated above a roof surface, and concentrated rainwater from the downspouts washes over the roof surface below. This is a common configuration, but in some cases large quantities of rainwater can damage shingles by removing granules and reduce the life of the roof surface. I recommend installing extensions to route the rainwater directly to the closest gutter below to prevent such damage to the roofing material.

Contact a qualified professional.

Preferred Installation Method

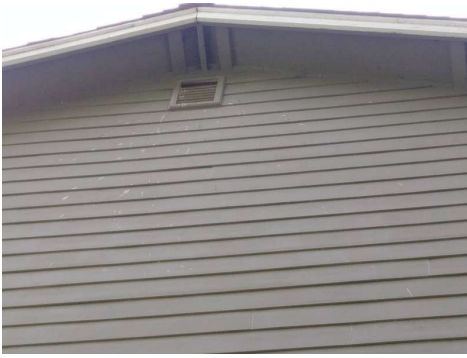
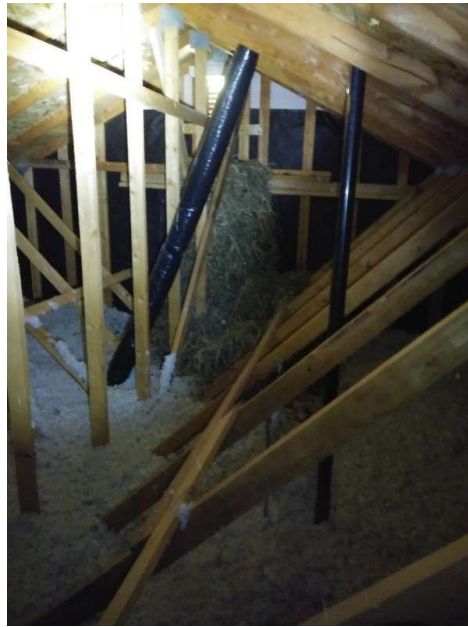
3.3.1 Exterior issues

GABLE VENT DAMAGE

One gable vent on the left of the house was damaged. Their purpose is to allow air into the attic, and keep out birds, rodents and bugs. The screen on one of the gable vent appears to be damaged and birds have built a nest in the attic space. I recommend the nest is removed/cleaned from the attic, and new screen is installed over the gable vent.

Contact a qualified professional.

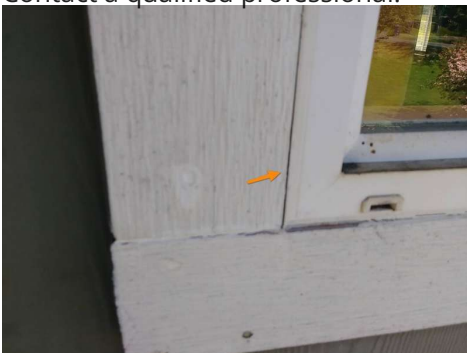
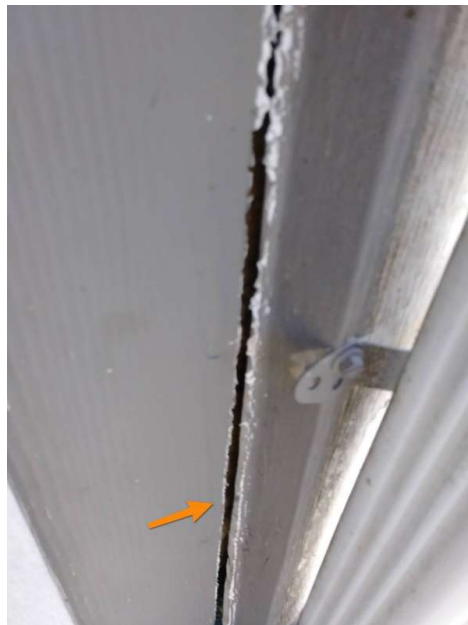
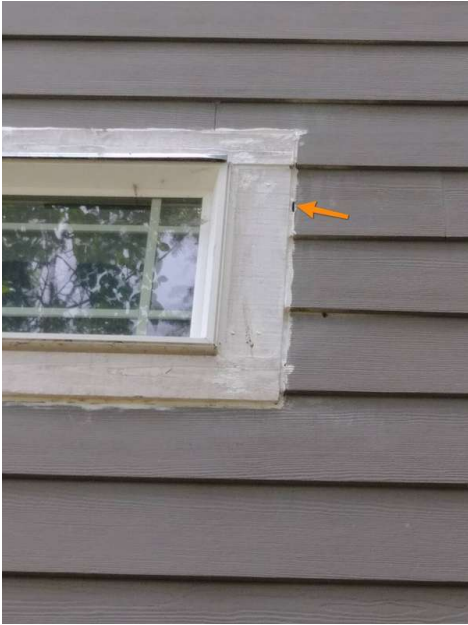
3.3.2 Exterior issues

SEALANT MAINTENANCE

Some of the caulking in various places around the exterior need to be sealed. Around windows, doors, siding seams, siding meets trim, etc...I recommend that these areas are re-sealed to prevent any potential moisture intrusion issues.

Contact a qualified professional.

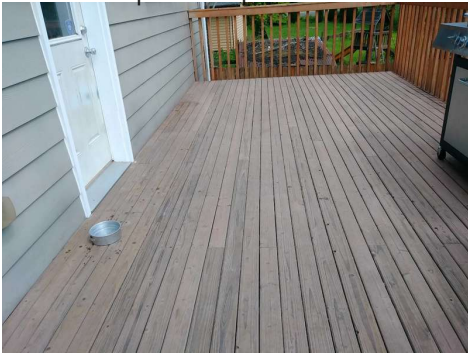
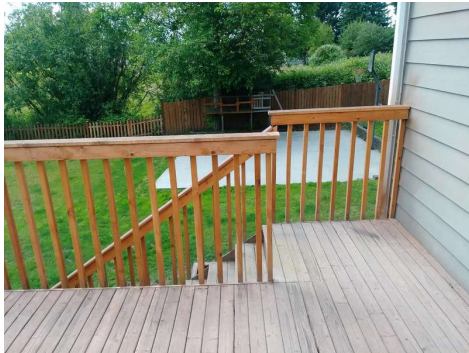
3.3.3 Exterior issues

DECK SEALANT

The deck is staining/water sealing is faded. It is important to keep the deck stained/water sealed to prevent decking from decay. Decking wears out not only from rain, but also from UV rays. A good quality stain will help extend the life of the deck and protect it from the weather. I recommend the deck is stained/water sealed.

Recommendation
Contact a qualified professional.

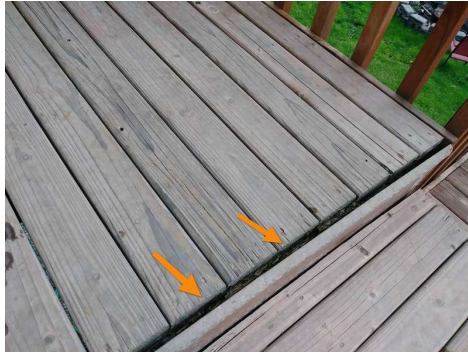
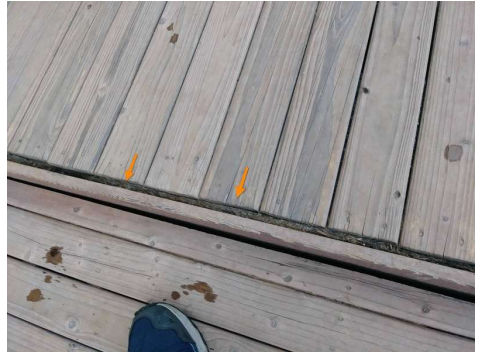
3.3.4 Exterior issues

DECK BOARD DAMAGE

Several deck boards were starting to show some signs of wear/decay. It is recommended these are repaired and replaced before staining or water sealing the deck

Recommendation
Contact a qualified professional.

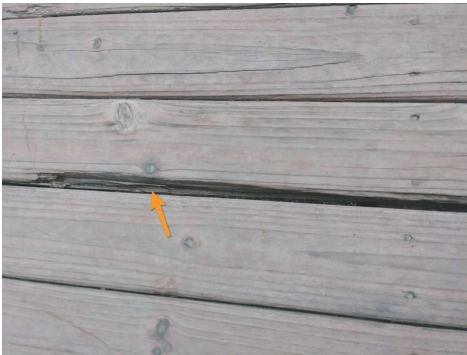
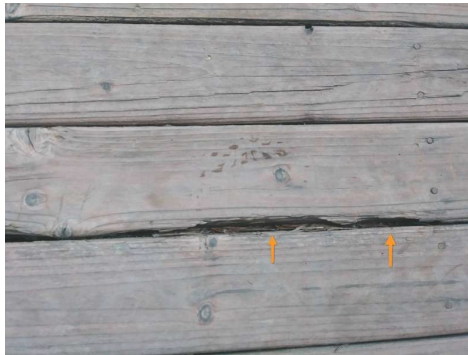
Debris is filled in-between the deck and fascia board.

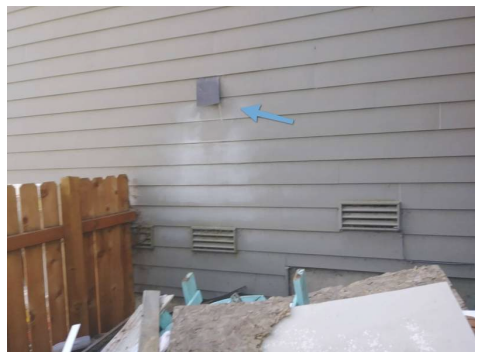
3.3.6 Exterior issues

DRYER VENT CLEANING

I recommend the dryer vent is cleaned on an annual basis. This is good maintenance for the house and the dryer. A clogged dryer vent can lead to dryer failure an extended dry times.

Contact a qualified professional.

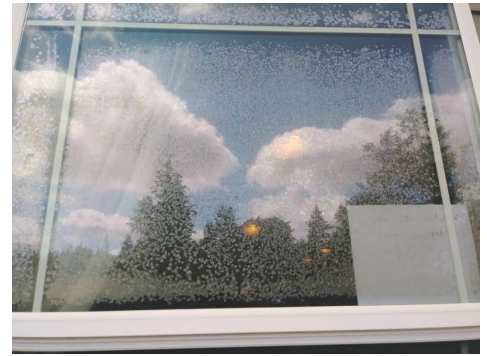
3.5.1 Windows and Door

FAILED SEAL

One window overlooking the back deck had a failed seal. I was informed during the inspection that the window was on order and is being replaced. This is an informational comment. Verify the window pane replacement is completed.

Contact a qualified professional.

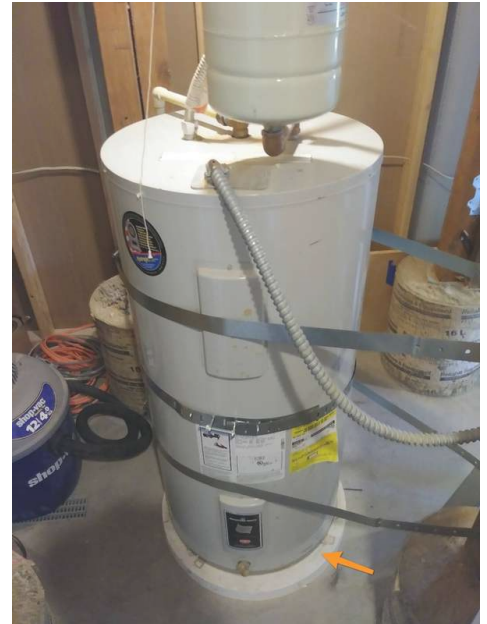
5.1.1 Water Heater

PAN MISSING SAME ELEVATION

A water heater is installed at the same elevation as the finished living spaces and has no catch pan and drain installed. Recommend having a qualified contractor install a catch pan and drain to prevent water damage to finished interior spaces if/when the water heater develops a leak or is drained.

Contact a qualified plumbing contractor.

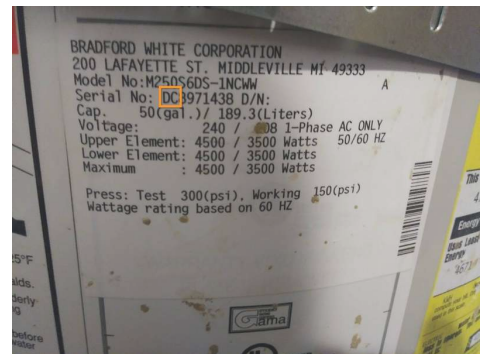
5.1.2 Water Heater

NEAR LIFE EXPECTANCY

The estimated useful life for most water heaters is 8 to 12 years. This water heater appears to be approaching this age and may need replacing in the near future. Recommend budgeting for a replacement in the near future. Everything was functional at the time of inspection and in good working order. The hot water tank was manufactured in 2007 making it about 11 years old.

Here is a link to showing the age. On these tanks it is done by the first 2 letters of the serial number. DC on this tank.

Contact a qualified plumbing contractor.

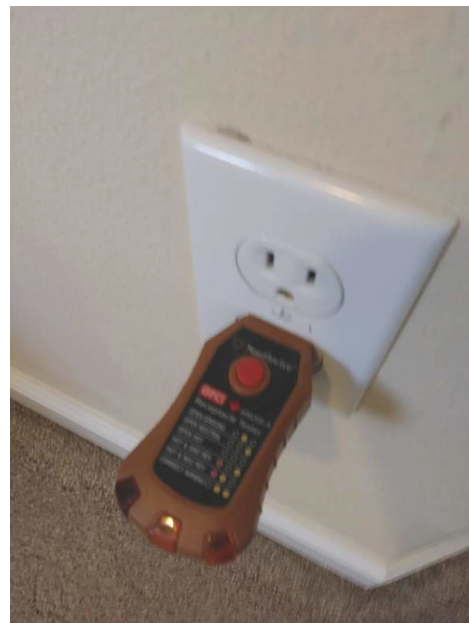
6.3.1 Outlets, Switches, Lights

BEDROOM OUTLET

One bedroom outlet was not working on my tester. The bedroom to the left at the top of the stairs. The outlet is to the left as you walk in the door. I recommend this outlet is diagnosed and repaired/replaced by a electrical contractor.

Contact a qualified professional.

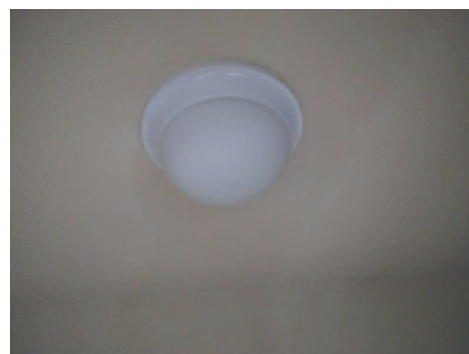
6.3.3 Outlets, Switches, Lights

CLOSET LIGHT OUT

Light in one of the closets was not working. More than likely just needs a new bulb. I recommend replacing the bulb and verifying the light fixture is working.

Contact a qualified professional.

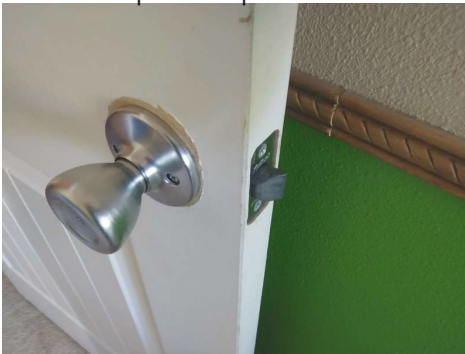
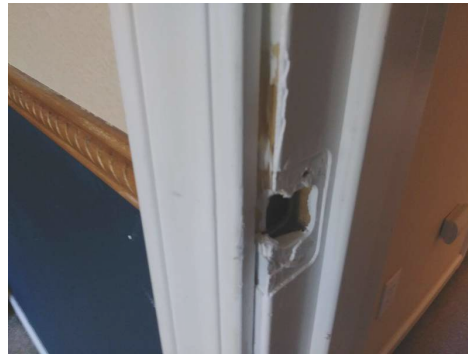
9.4.2 Windows and Door

DOOR LATCH DAMAGED

One of the bedroom door latches was damaged and prevent the door from closing/latching. I recommend repairs are made so the door can latch properly when closed.

Contact a qualified professional.

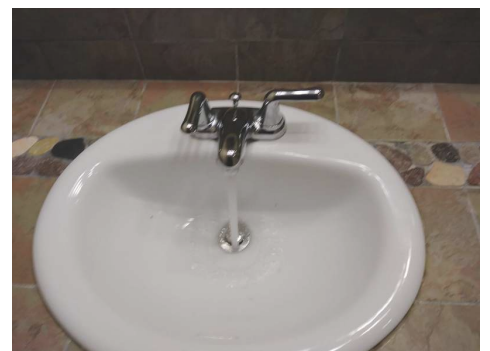
10.7.1 Sink/countertop

SINK DRAINS SLOW

The master bathroom sink was clogged and draining very slowly. Drain(s) should be cleared as necessary, and by a qualified plumber if necessary.

Contact a qualified plumbing contractor.

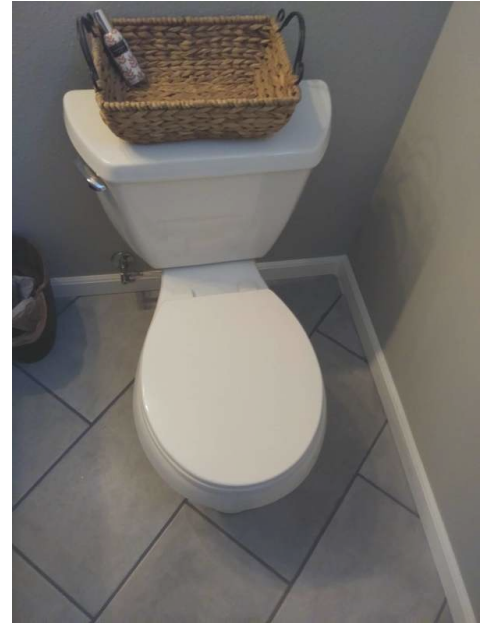
10.8.1 Toilets

LOOSE

One toilet was loose during inspection. A qualified contractor should remove the toilet(s) for further evaluation and repairs if necessary. A new wax ring should be installed and toilet(s) should be securely anchored to the floor to prevent movement and leaking.

Contact a qualified plumbing contractor.

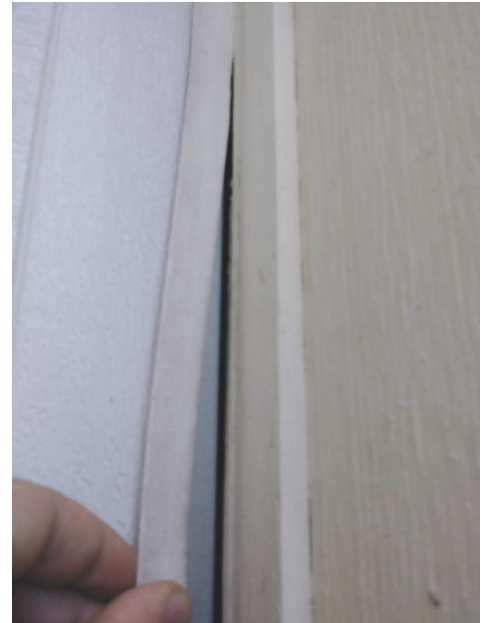
11.4.1 Vehicle door

WEATHER STRIP DETERIORATED

Weatherstrip at the sides vehicle door is damaged and/or deteriorated. It should be replaced where necessary to prevent intrusion of the exterior elements.

Contact a qualified garage door contractor.
