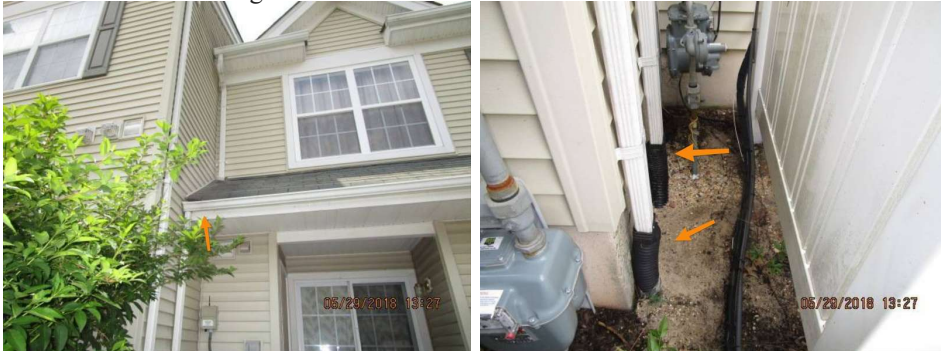
FRONT

### 2.2.1 Roof Drainage Systems

Monitor for spillage during heavy or continuous rain

Recommend monitoring.

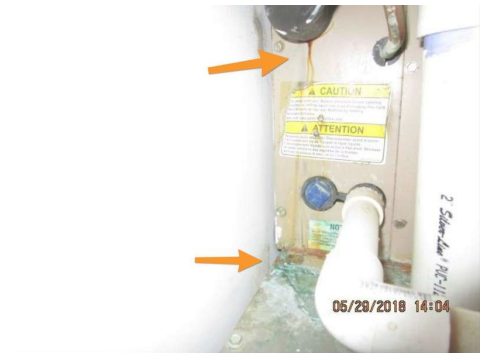
2 FL UTILITY ROOM

#### **CORROSION**

Furnace was corroded in one or more areas. This appears to be condensate, dripping on the unit. Recommend a HVAC contractor evaluate and repair.

Contact a qualified HVAC professional.

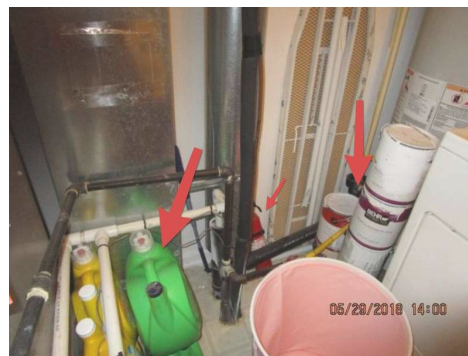
2ND FLOOR UTILITY ROOM AND KITCHEN

Area around furnace and water heater should be kept clear.

Fire extinguisher should be mounted in a accessible location. . **For safety**..Advise a extinguisher mounted and accessible for the furnace area as well as the kitchen area.

Recommendation  
Recommended DIY Project

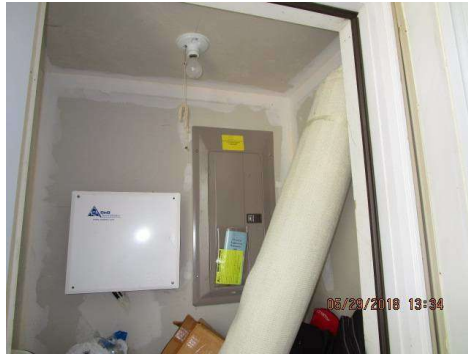
EXTERIOR CLOSET

Keep area clear in front of panel.

## WORKING SPACE DEPTH

Recommendation  
Recommended DIY Project

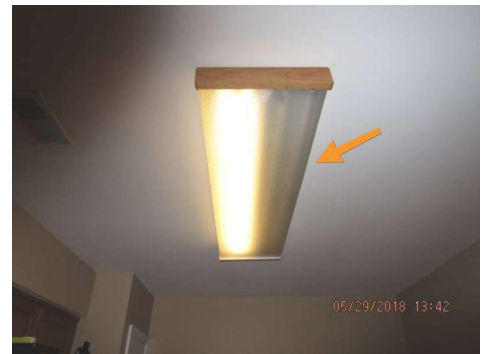
##### KITCHEN

Ceiling light in the kitchen is not operating as intended. New ballast or light bulb possibly needed. Further evaluation needed by a qualified electrical contractor

one side not working

Contact a qualified electrical contractor.

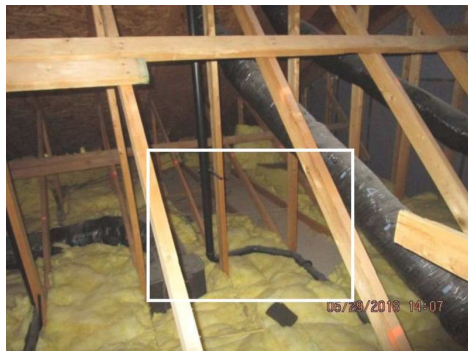
##### ATTIC

The insulation appears to still be in the attic, just tossed aside

Area in the attic above the master bedroom. Insulation appears to just be tossed aside.

Contact a qualified insulation contractor.

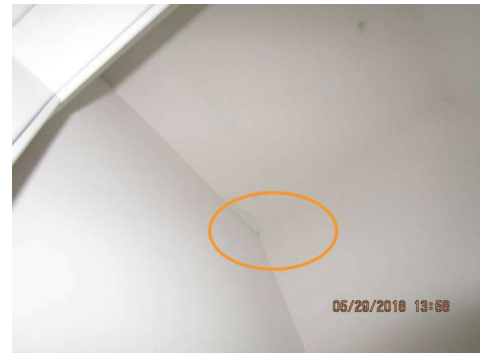
HALL CLOSET 2ND FLOOR

Minor damage or deterioration to the ceiling was visible at the time of the inspection. Appears to be damaged from a old leak in the roof.

upper corner in closet

Monitor area for moisture. repair sheetrock as desired

Recommend monitoring.

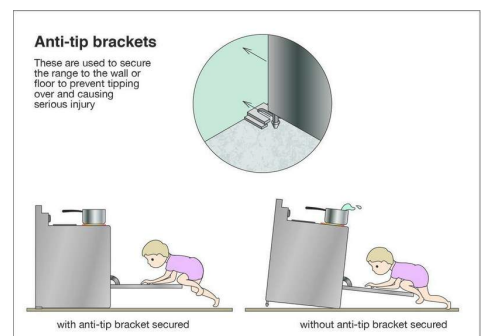
KITCHEN

Tilt bracket should be installed for safety Can be purchased at most home improvement stores such as Lowes.

Contact a handyman or DIY project
