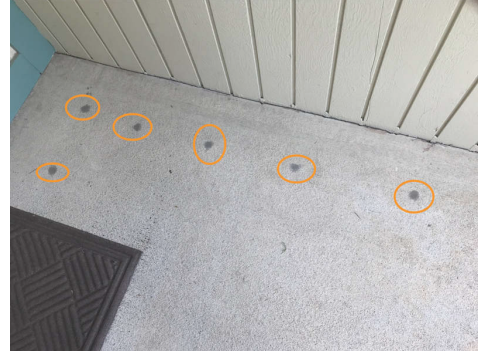
FRONT PORCH

3.3.1 Walkways, Patios & Driveways

POSSIBLE TERMITE TREATMENT

Recommendation

Contact a qualified professional.

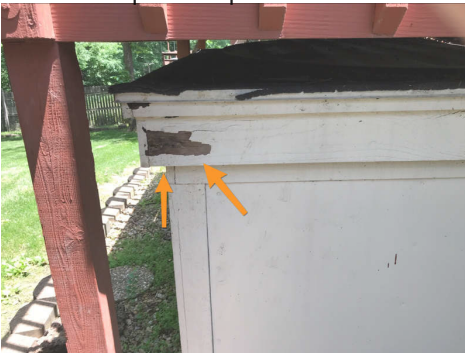
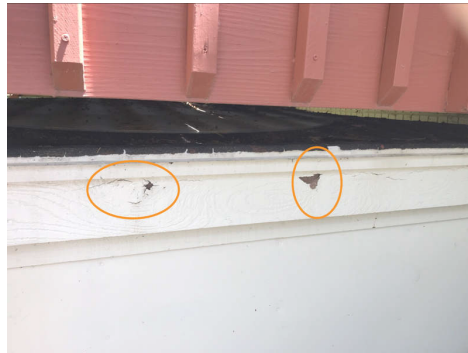
SHED UNDER DECK

SHED SIDING ROTTEN AND PEELING PAINT

Recommendation

Contact a qualified professional.

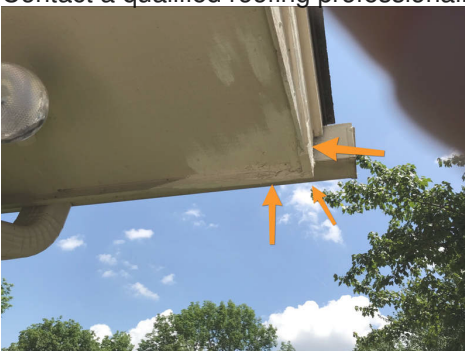
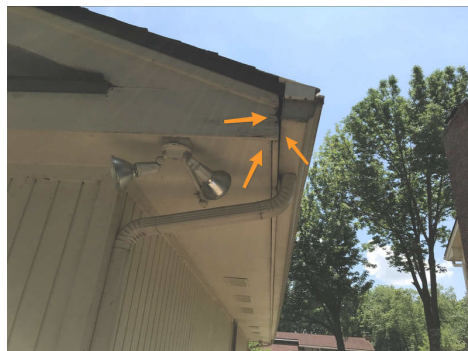
SOUTHEAST AND NORTHWEST SIDE OF HOUSE

FASCIA - ROTTED

One or more sections of the fascia are rotted. Recommend qualified roofer evaluate & repair.

Recommendation

Contact a qualified roofing professional.

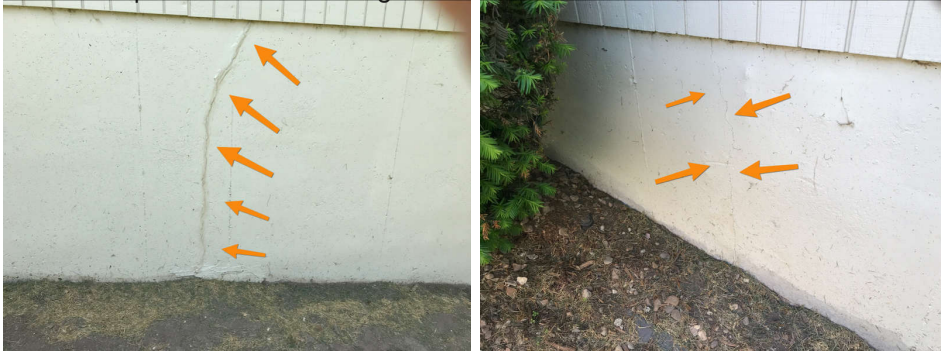
EAST SIDE OF HOUSE

FOUNDATION CRACKS - MINOR

Minor cracking was noted at the foundation. This is common as concrete ages and shrinkage surface cracks are normal. Recommend monitoring for more serious shifting/displacement.

Recommendation

Contact a qualified structural engineer.

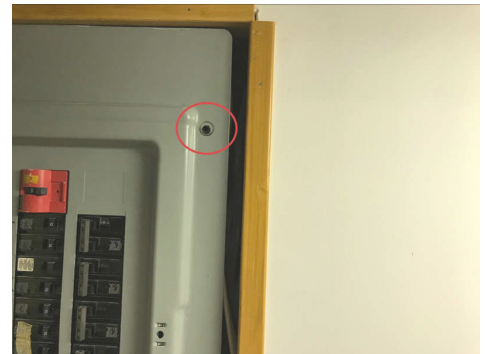
BASEMENT

MAIN PANEL COVER MISSING SCREW

Safety Hazard

Recommendation

Recommended DIY Project

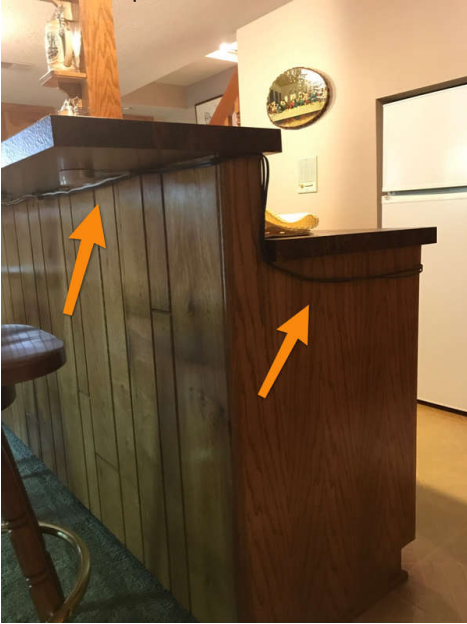
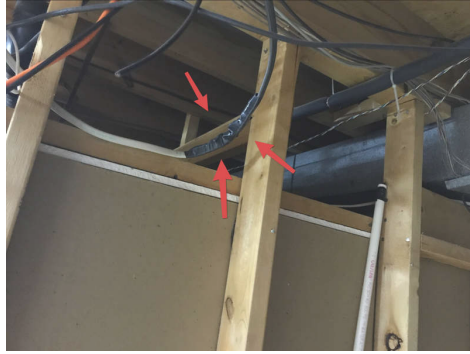
BASEMENT UTILITY ROOM AND BASEMENT BAR

IMPROPER WIRING

Improper wiring needs attention.

Recommendation
Contact a qualified electrical contractor.

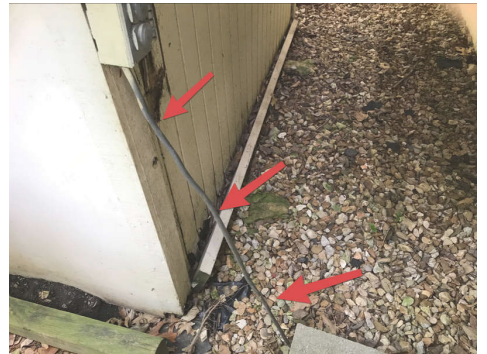
ON SHED UNDER DECK

IMPROPER ELECTRICAL RECEPTACLE INSTALLATION

Safety Hazard

Recommendation

Contact a qualified professional.

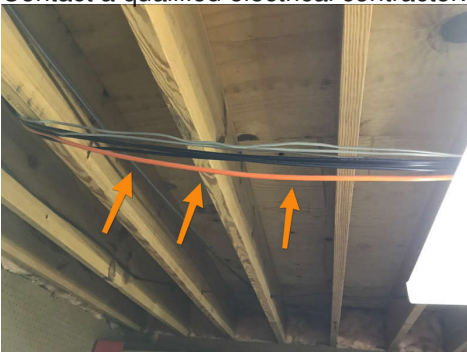
BASEMENT UTILITY ROOM

IMPROPER ELECTRICAL WIRING

Recommendation

Contact a qualified electrical contractor.

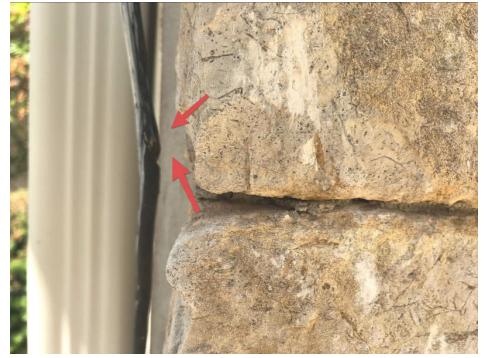
WEST CORNER OF GARAGE UNDER LIGHT FIXTURE

SPLIT ELECTRICAL WIRE

Recommendation

Contact a qualified professional.

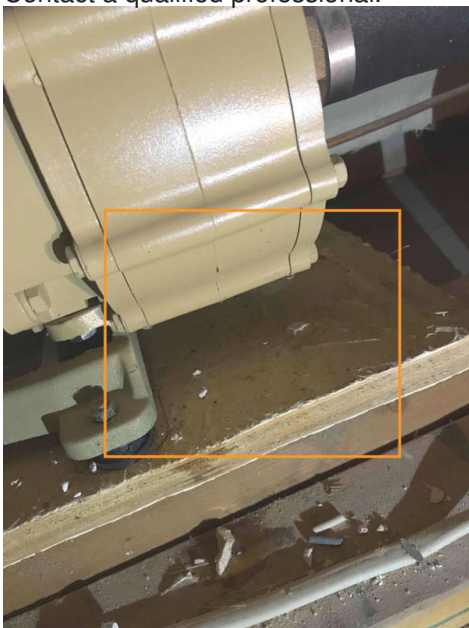
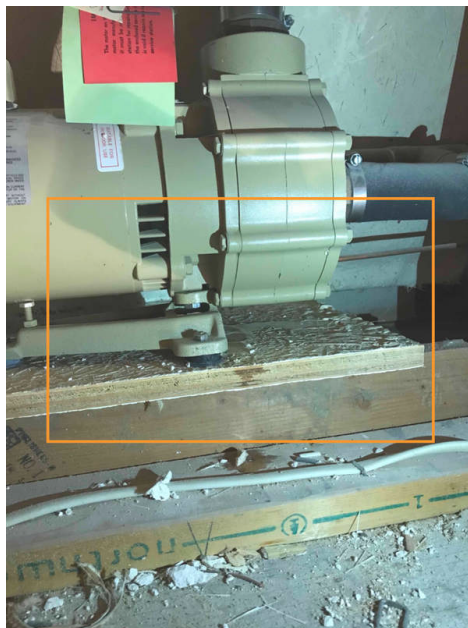
Tub Motor Access in Stairway

JETTED TUB PUMP LEAKING

Water dripping observed while jetted tub operating. Recommend inspection and repair by a plumbing professional.

Recommendation
Contact a qualified professional.

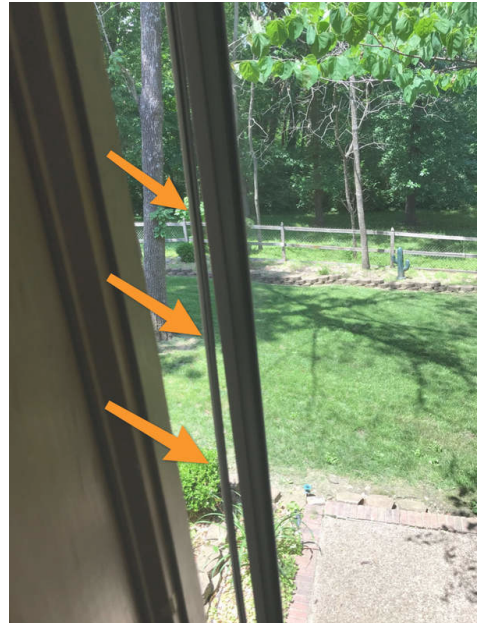
NORTH WALL IN MASTER BEDROOM

FAILED SEAL

Seal separated from window frame; not allowing casement window to properly close. Recommend securing to allow window to completely close.

Recommendation

Contact a qualified window repair/installation contractor.

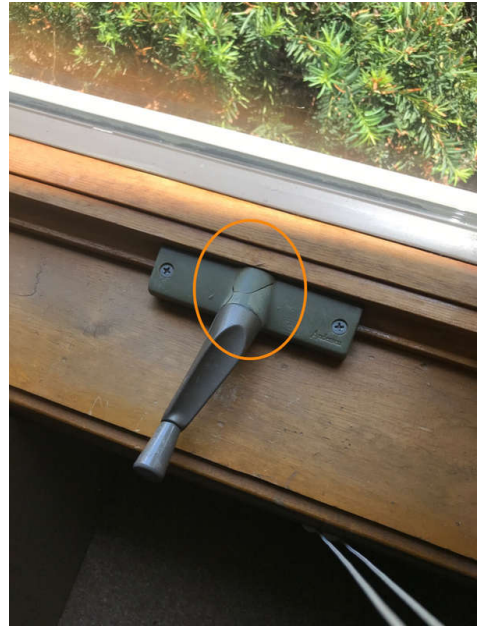
SOUTHWEST MAIN FLOOR BEDROOM

MINOR CRANK DAMAGE

Minor cosmetic damage to crank. Window still opens properly.

Recommendation

Recommended DIY Project

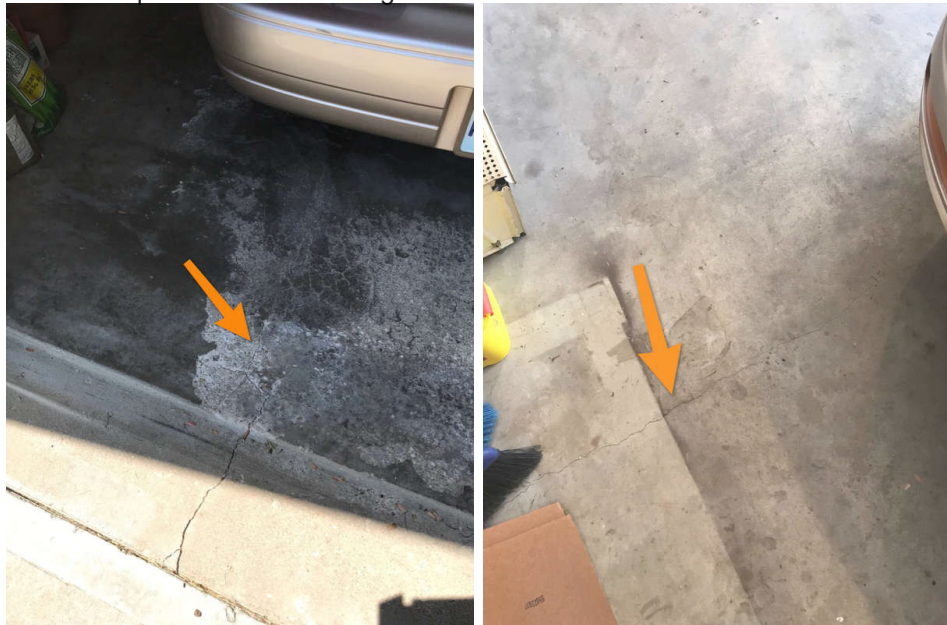
Garage

CRACKING

Cracking visible in the garage floor. I recommend a structural engineer evaluate.

Recommendation

Contact a qualified structural engineer.
