SUMMARY

1234 Main St. Lawton Ok 73505

Zack Wing
Lic. #70001952
Wing Brothers Home Inspections
580-284-9332
zackwing2015@gmail.com

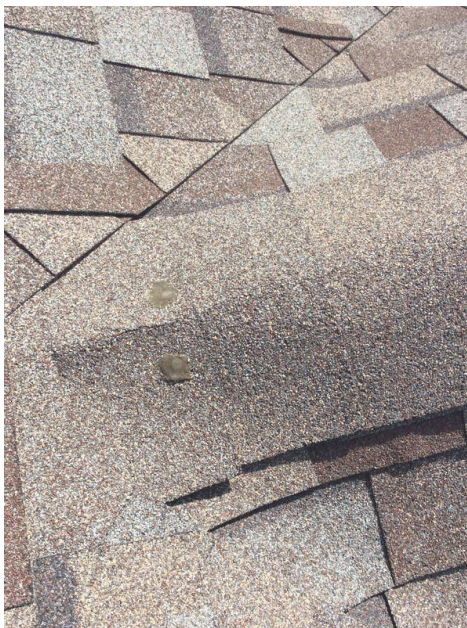
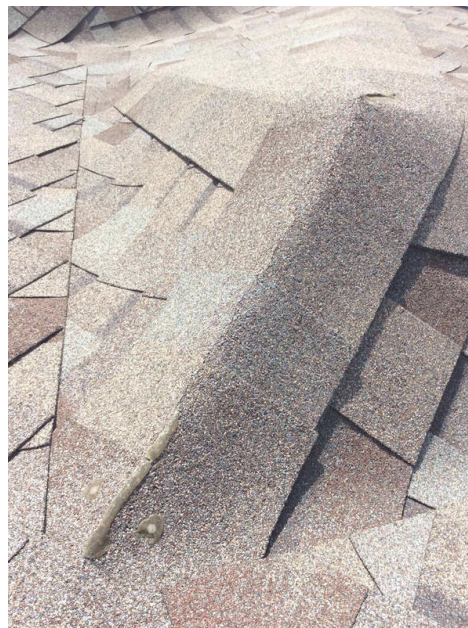
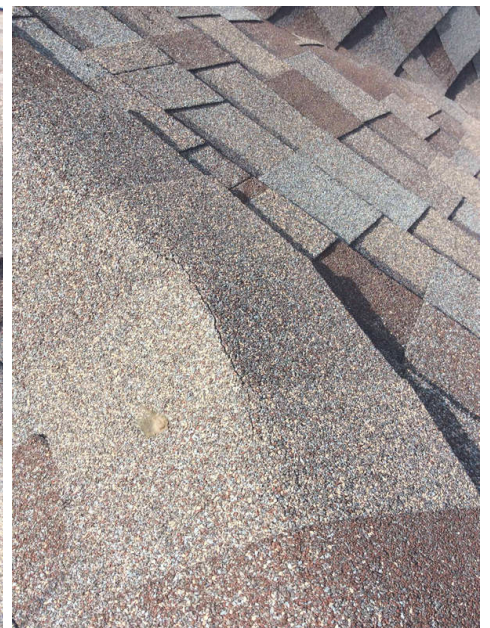
2.1.1 Coverings

CRACKED

The asphalt composition shingle roof has cracked ridge shingles. This can lead to moisture intrusion. Recommend Repair/Replace.

Recommend Repair/Replace or Correction

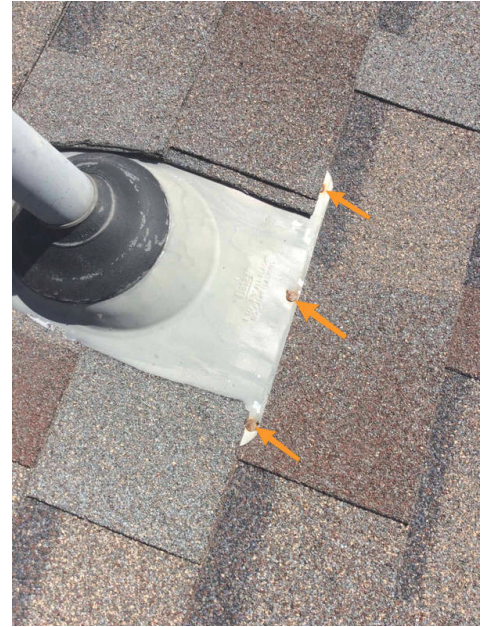
2.2.1 Flashings

EXPOSED NAILS

Exposed nails were observed in one or more roof flashings. This can lead to moisture intrusion. Recommend Repair: Seal with an approved sealant.

Recommend Repair/Replace or Correction

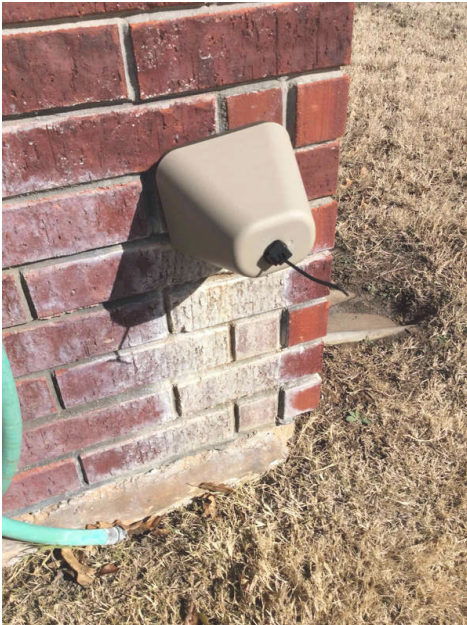
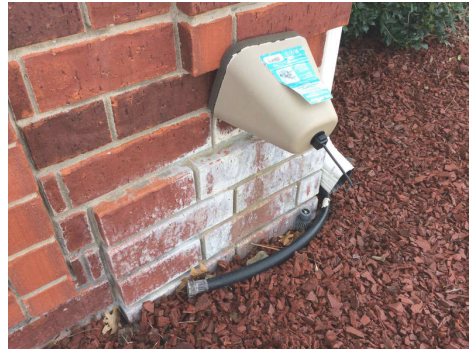
3.2.1 Siding, Flashing & Trim

EFFLORESCENCE

Efflorescence was observed on the wall coverings due to leaking faucets. Faucets did not appear to be currently leaking.

Low Concern & Discretionary Items

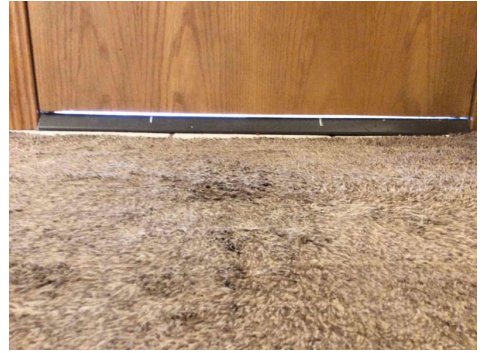
3.3.1 Exterior Doors

**DAMAGED/MISSING
DOOR SWEEP**

Door sweep is damaged or missing. This can effect the energy efficiency of the property. Recommend Replacement/Installation.

Low Concern & Discretionary Items

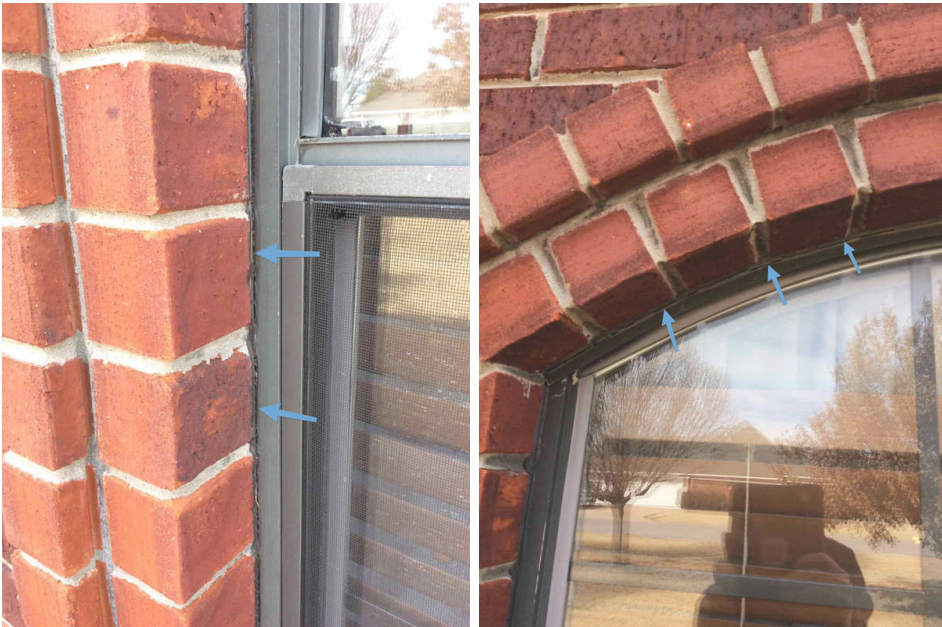
3.7.1 Windows

DETERIORATED/MISSING SEALANT

One or more windows have deteriorated/missing sealant. This can effect the energy efficiency of the property. Recommend Repair: Seal with an approved sealant.

Low Concern & Discretionary Items

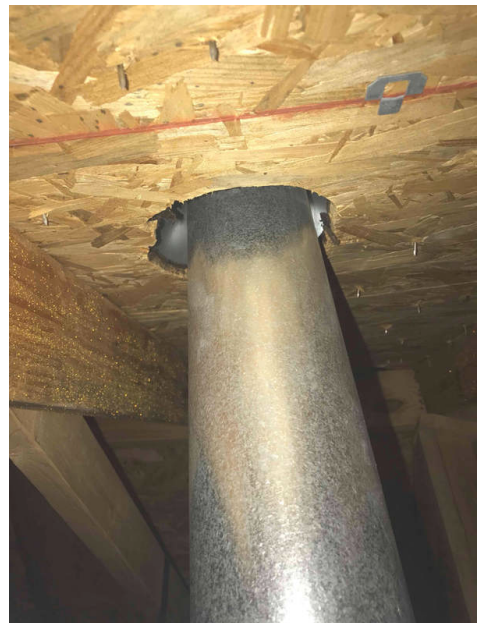
4.1.1 Roof Structure & Attic

INSUFFICIENT FLUE AND COMBUSTIBLE CLEARANCE

The type B gas vent serving the water heater has improper clearance. Type B gas vent requires one inch clearance to combustibles. Recommend Repair.

Recommend Repair/Replace or Correction

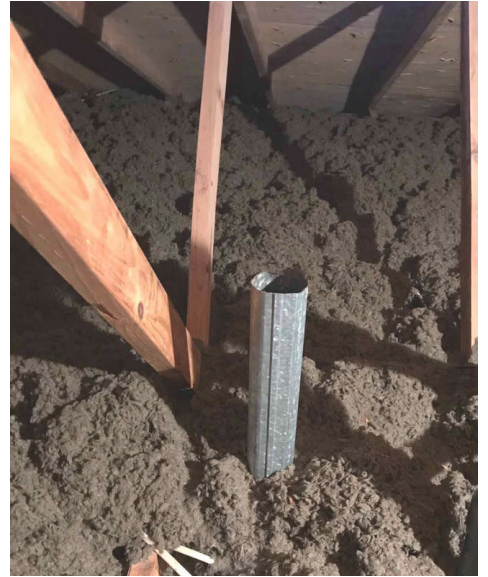
5.3.1 Exhaust Systems

**BATHROOM
VENTS INTO ATTIC**

Bathroom fan vents into the attic. This can cause unwanted moisture issues in the attic. Recommend Repair: Route exhaust to the exterior of the property.

Recommend Repair/Replace or Correction

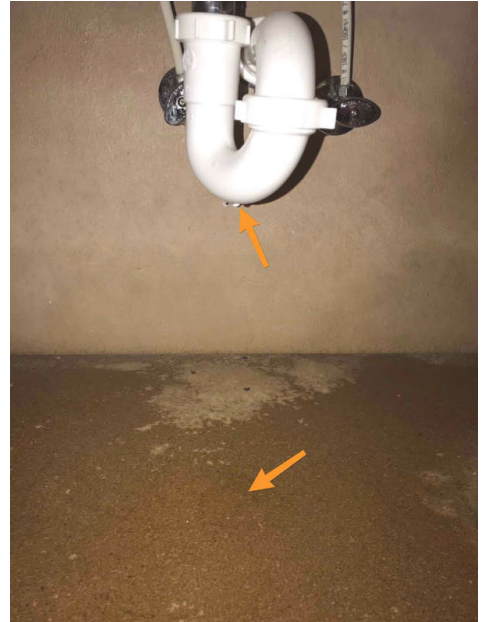
8.6.1 Drain, Waste, & Vent Systems

LEAKING

GUEST BATHROOM

Plumbing leaks were observed in one or more areas of the property. This can cause damage to interior components and furnishings. Recommend Repair/Replace.

Recommend Repair/Replace or Correction

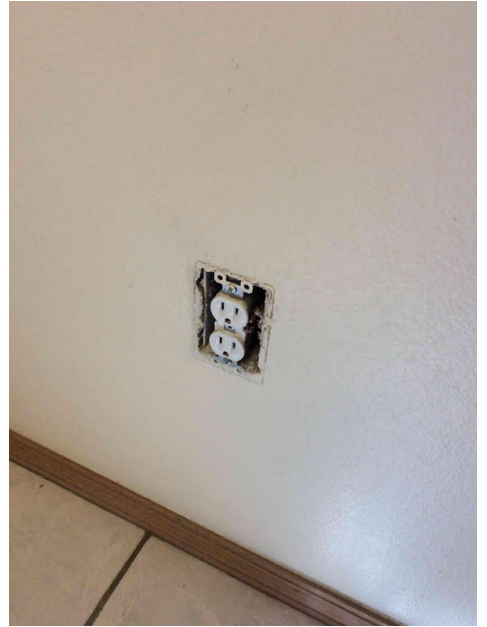
9.5.1 Connected Devices and Fixtures

**COVER PLATES
MISSING**

KITCHEN

One or more receptacles are missing a cover plate. This causes short and shock risk. Recommend Repair: Install cover plates.

Safety & Immediate Attention Items

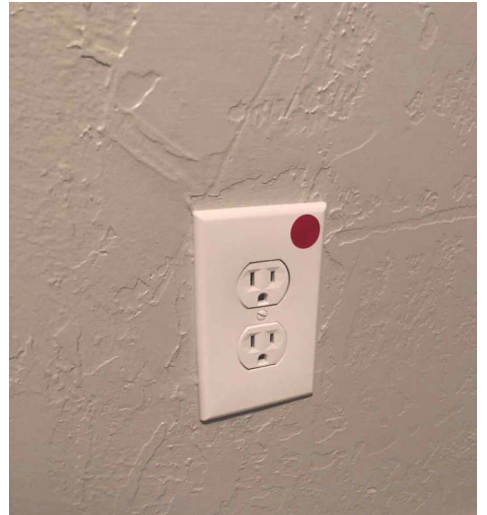
9.6.1 Polarity and Grounding of Receptacles

REVERSE POLARITY

MASTER BEDROOM, LIVING ROOM

One or more outlets have been wired with reverse polarity (marked with a red dot). Reverse polarity is when the hot and neutral connections at an outlet are wired backwards, which means there is always electricity flowing out of the outlet, even if the appliance is supposed to be off. This causes a shock hazard. Recommend Repair.

Safety & Immediate Attention Items

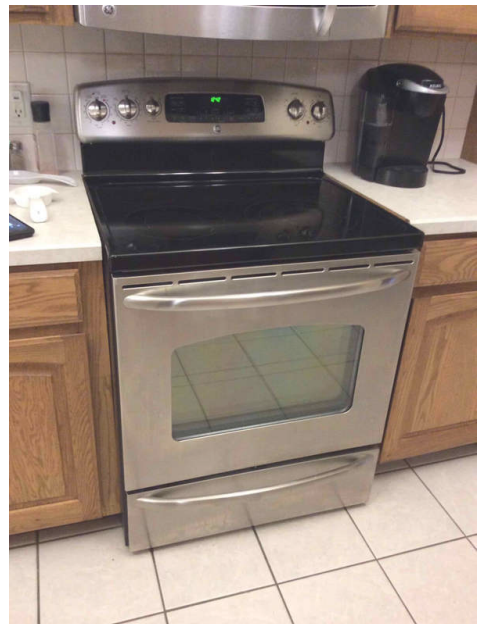
11.3.1 Range/Oven/Cooktop

RANGE NOT FASTENED

Range was not fastened to the floor. This poses a safety hazard to children. Recommend Repair: Secure range according to manufacturers specifications.

Safety & Immediate Attention Items
