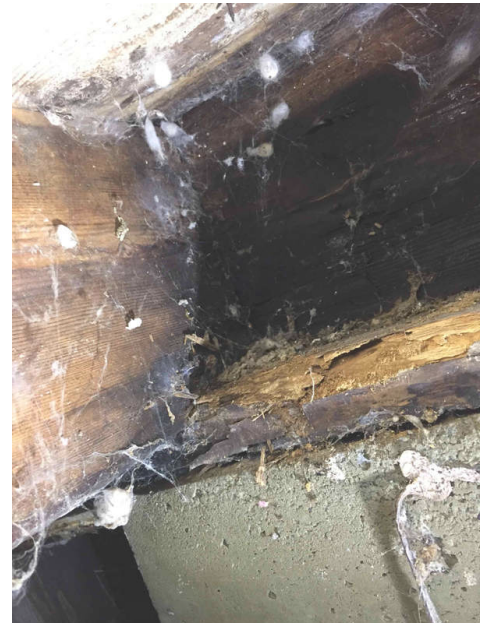
SILL PLATE

Sill plate is deteriorated from moisture absorption or water intrusion under the home. Repairs are needed. I recommend a qualified contractor repair or replace as needed.

Recommendation
Contact a qualified general contractor.

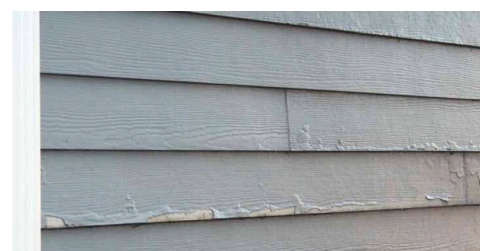
EVIDENCE OF WATER INTRUSION

Siding showed signs of water intrusion. This could lead to further siding deterioration and/or mold. Recommend a qualified siding contractor evaluate and repair.

Recommendation
Contact a qualified siding specialist.

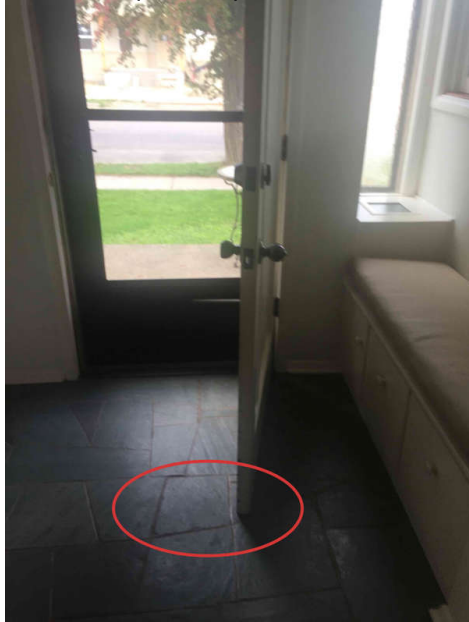
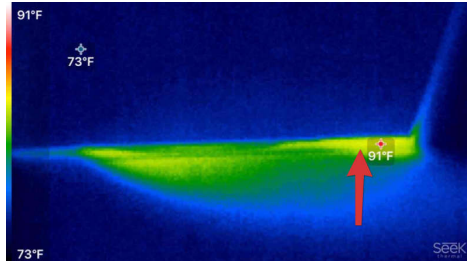
DOOR ADJUSTMENT/ SEALS MISSING OR DEFECTIVE

Front door needs adjustment and seals replaced. The door is dragging on tile entry. Using thermal camera I detected heat loss around door seal.

Recommendation
Contact a qualified professional.

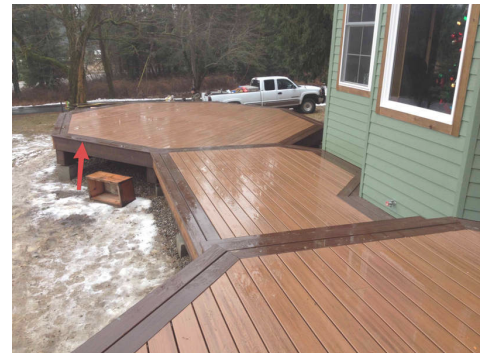
NO HANDRAIL

Deck in many areas was over 30" from ground. Recommend hand railing be installed by a qualified contractor.

Recommendation
Contact a qualified deck contractor.

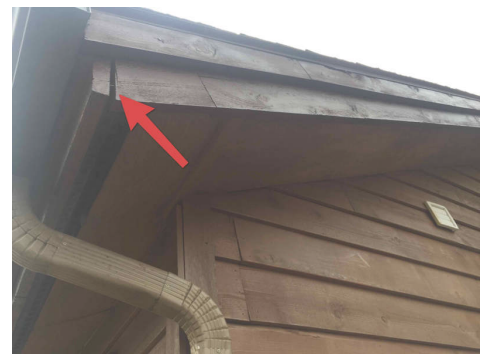
FASCIA - DAMAGED

One or more sections of the fascia are damaged. Recommend qualified roofer evaluate & repair.

Recommendation
Contact a qualified roofing professional.

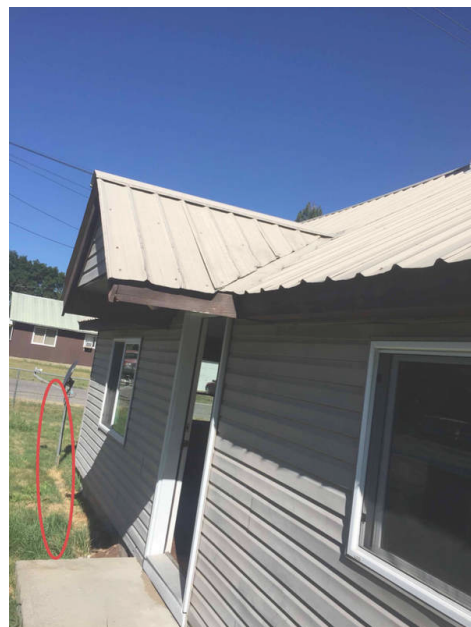
NEGATIVE GRADING

Grading is sloping towards the home in some areas. This could lead to water intrusion and foundation issues. Recommend qualified landscaper or foundation contractor regrade so water flows away from home.

Contact a qualified landscaper or gardener.

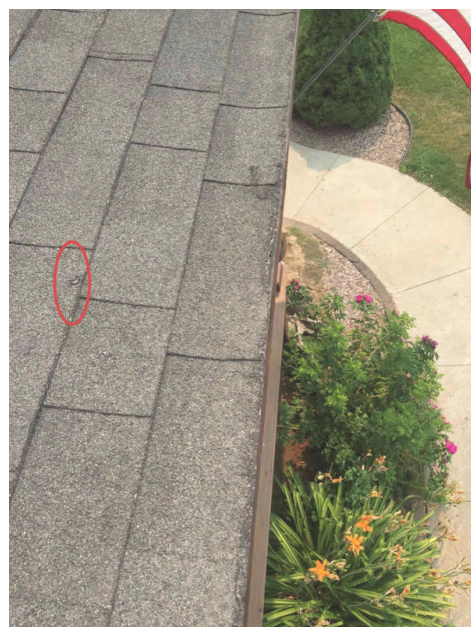
EXPOSED NAILS

Under-driven or exposed nails were found in one or more roof coverings. Recommend a qualified roofer evaluate and correct.

Contact a qualified roofing professional.

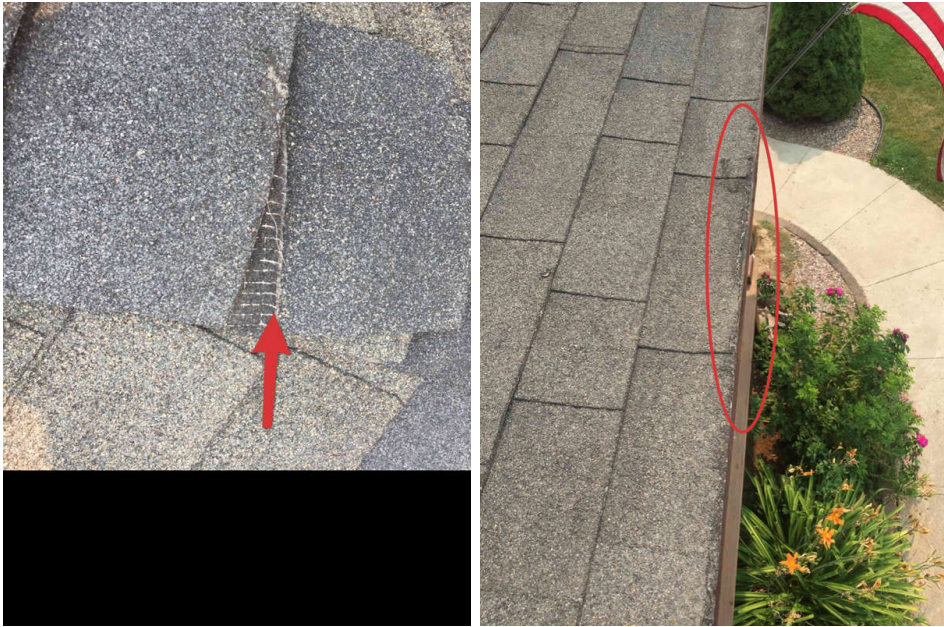
END OF USEFUL LIFE

At the time of the inspection, asphalt composition shingles covering the roof of this home appeared to be at or near the end of their useful lives. The Inspector recommends that before the expiration of your Inspection Contingency Period, you consult with a qualified roofing contractor to discuss options and costs for replacement.. There were a few torn roof shingles, and several areas where the shingles were not adhered to the layer beneath. The inspector recommends an evaluation by a licensed roofing contractor to determine the cost of repair or replacement.

Contact a qualified roofing professional.

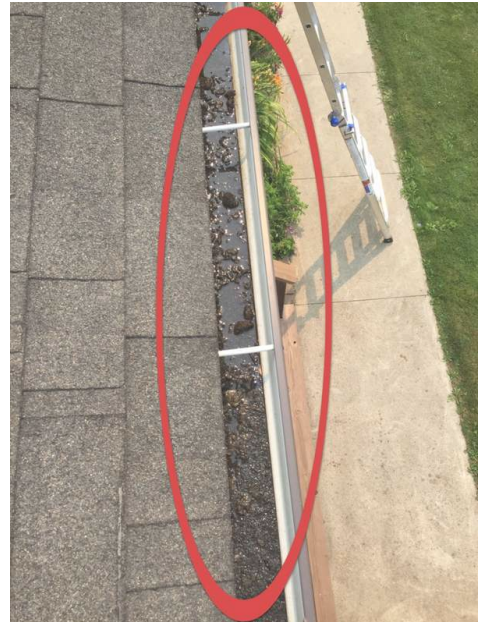
DEBRIS

Debris has accumulated in the gutters. Recommend cleaning to facilitate water flow.

Contact a handyman or DIY project

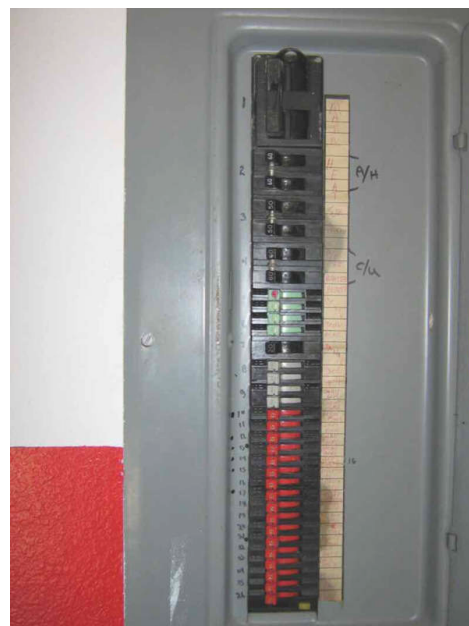
ZINSCO PANEL

Zinsco panels may overheat and portions of it melt. If a breaker melts to the bus bar of the panel and can no longer adequately trip in case of an overcurrent or short circuit, an extreme amount of power from the outside electrical supply surges into a homes panel and circuits. Once that happens, it cannot be stopped or shut off manually. Electricity will burn until it runs out of fuel or the wires melt. The panel could overheat and catch fire, causing serious harm to a home and its occupants. Recommend immediate replacing of panel by qualified electrician.

Contact a qualified electrical contractor.
