SUMMARY

1234 Main St.Cambridge Wisconsin

53523 Buyer Name 10/16/2018 9:00AM

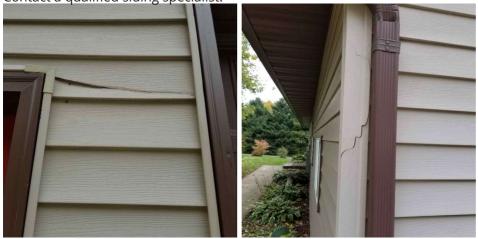
2.8.1 Siding, Flashing & Trim **VINYL DAMAGE**

One or more areas of vinyl siding was damaged. Recommend repairing to prevent water intrusion.

Recommendation Contact a qualified siding specialist.

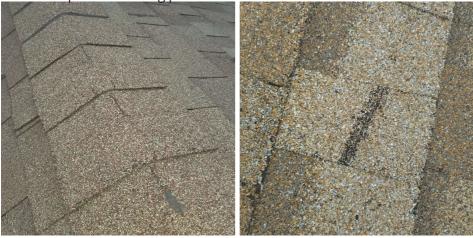
4.1.1 Coverings SPLITTING

The asphalt composition shingle roof had torn or split shingles which could lead to moisture intrusion. Recommend a qualified roofing contractor repair. You should also inquire to the seller regarding shingle manufacturer information to see if roof qualifies for a warranty claim.

Recommendation

Contact a qualified roofing professional.
