General Information: Overview

A home inspection is a non-invasive, visual examination of the accessible areas of the property, designed to identify areas of concern within specific systems or components defined by the City Of Edmonton Standards of Practice, that are both observed and deemed material by the inspector at the exact date and time of inspection. Any and all recommendations for repair, replacement, evaluation, and maintenance issues found, should be evaluated by the appropriate trades contractors within the clients inspection contingency window or prior to closing, which is contract applicable, in order to obtain proper dollar amount estimates on the cost of said repairs and also because these evaluations could uncover more potential issues than able to be noted from a purely visual inspection of the property. This inspection will not reveal every concern or issue that exists, but only those material defects that were observable on the day of the inspection. This inspection is intended to assist an evaluation of the overall condition of the dwelling only. This inspection is not a prediction of future conditions and conditions with the property are subject to change the

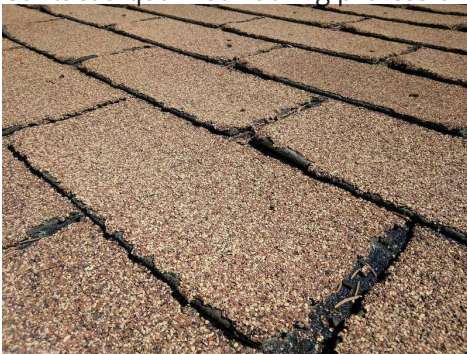
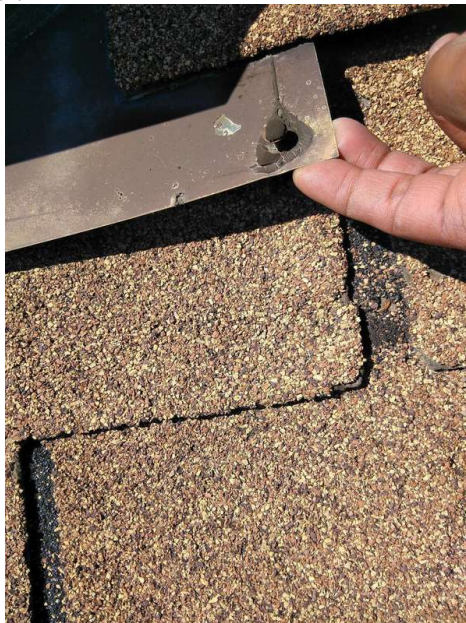
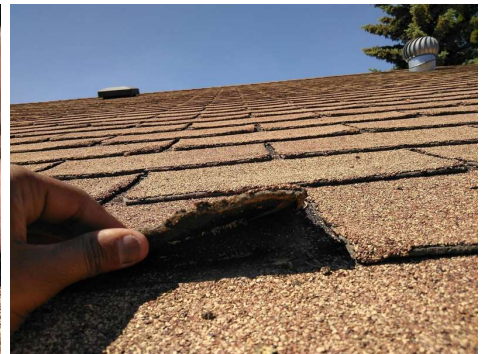
2.1.1 Coverings

SIGNS OF CURLING/POPPING

Observed signs of curling on roof shingles, appeared functional though near the end of its service life and will likely need replacing within 3 to 5 years. Recommend further evaluation and Repair/replace by qualified professional.

Contact a qualified roofing professional.

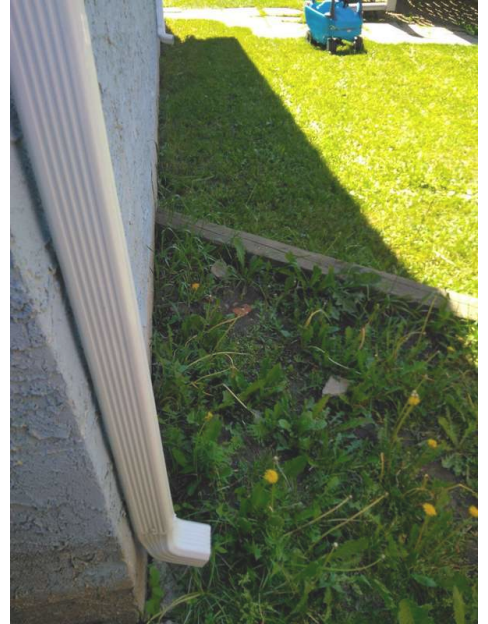
2.2.2 Roof Drainage Systems

DOWNSPOUTS DRAIN NEAR HOUSE

GARAGE

One or more downspouts drain too close to the home's foundation. This can result in excessive moisture in the soil at the foundation, which can lead to foundation/structural movement. Recommend a qualified contractor adjust downspout extensions to drain at least 6 feet from the foundation.

Recommendation
Contact a qualified roofing professional.

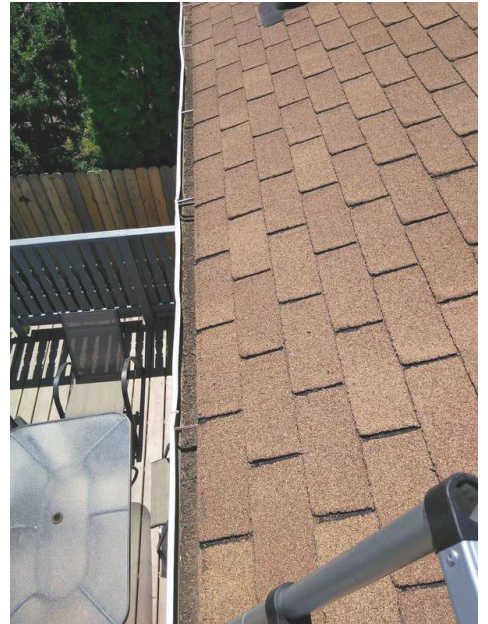
2.2.3 Roof Drainage Systems

GUTTER IMPROPERLY SLOPED

WEST-SOUTH

Gutter are improperly sloped in areas, which could result in runoff drainage around the foundation and possible structural shifting. Recommend qualified roofing or gutters contractor repair.

Recommendation
Contact a qualified roofing professional.

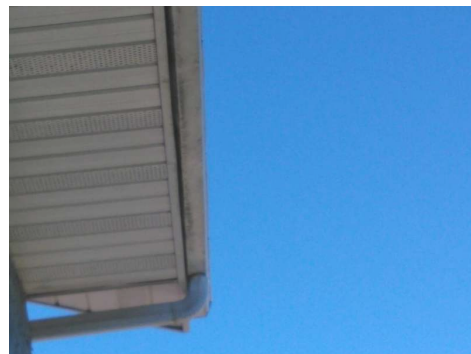
2.2.4 Roof Drainage Systems

OVERFLOW STAIN

EAST

Stains were found at the front of the gutters and indicate that the gutters have overflowed. If they have overflowed, it's usually due to debris clogging gutters or downspouts. The inspector was unable to verify that the gutters and downspouts drained adequately due to lack of recent, significant rainfall. Monitor the roof drainage system in the future while it's raining to determine if problems exist. Then if necessary, recommend that a qualified person clean, repair or replace gutters, downspouts and/or extensions.

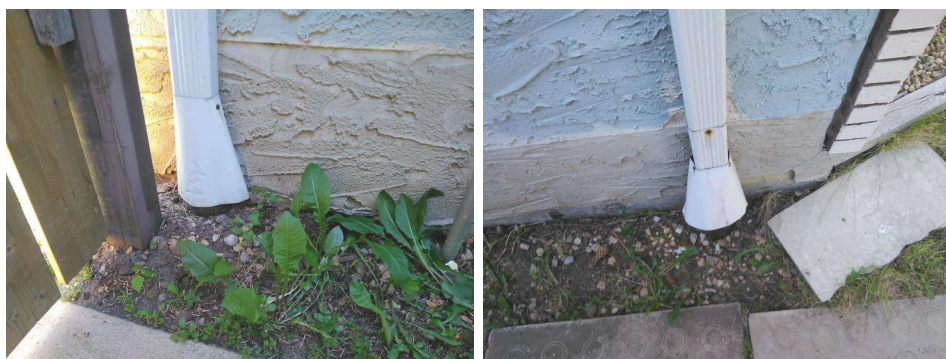
2.2.5 Roof Drainage Systems

UNDERGROUND ROOF DRAINAGE

Underground roof drainage observed- recommend discharging rain water 6ft away from the foundation as underground drainage tend to damage or clogged overtime & undetermined of its effectiveness/operation. This can result in excessive moisture in the soil at the foundation, which can lead to foundation/structural movement.

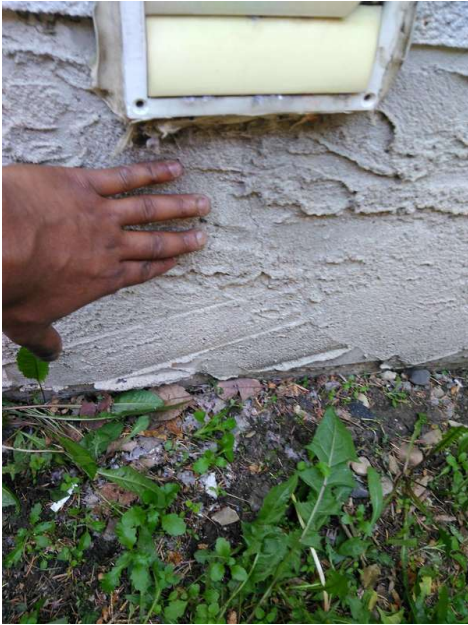
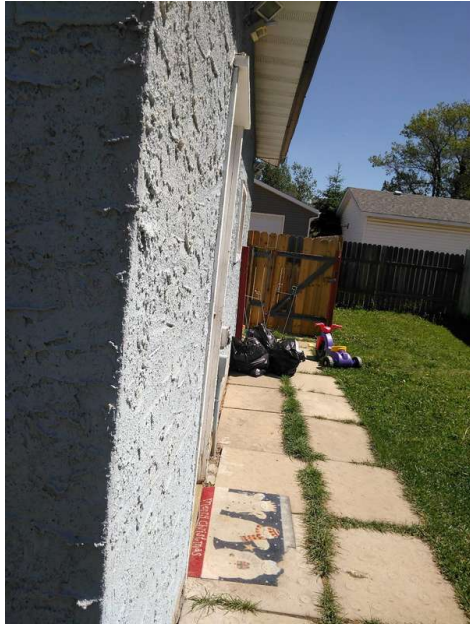
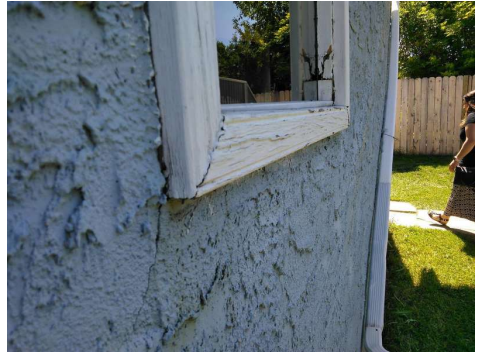
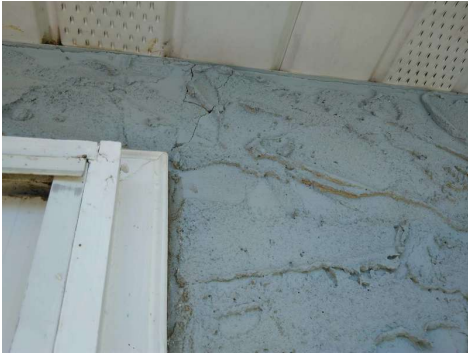
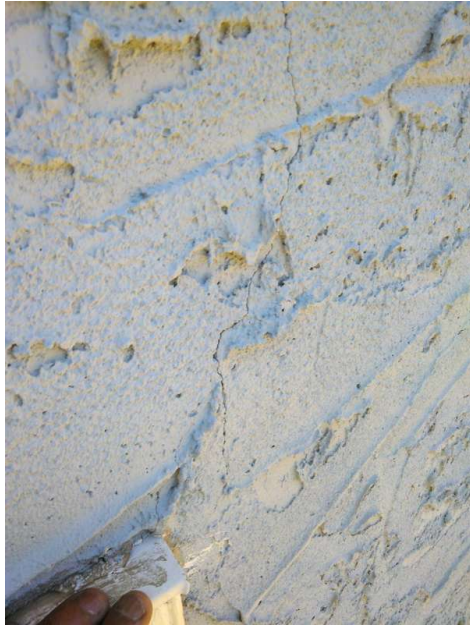
3.1.1 Siding, Flashing & Trim

CRACKING - MINOR

NORTH, SOUTH, WEST, EAST AND GRARAGE

Siding showed minor cracking in one or more places. This is a result of temperature changes, and typical as homes with age. Recommend Repair and monitoring.

Recommendation
Recommended DIY Project

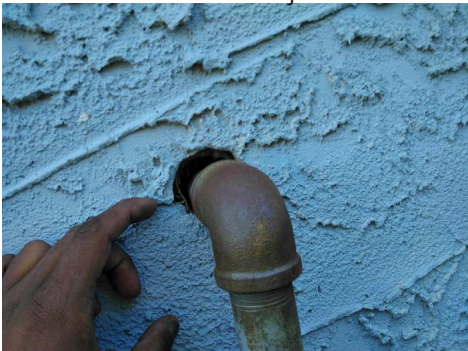
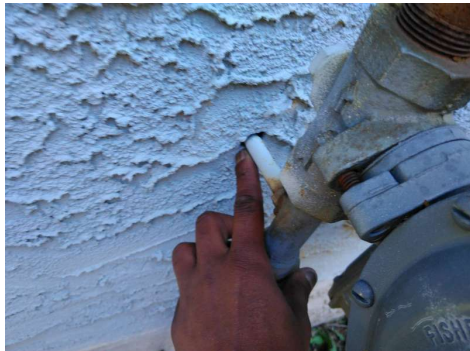
3.1.2 Siding, Flashing & Trim

EXTERIOR PENETRATION

Observed missing exterior sealant , recommend sealing all opening to void moisture intrusion.

Recommendation
Recommended DIY Project

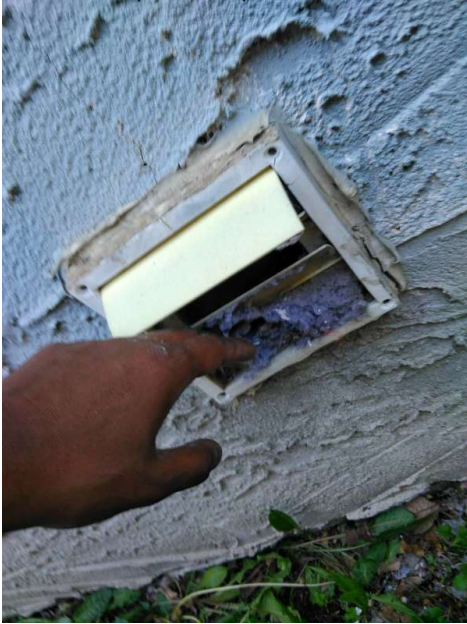
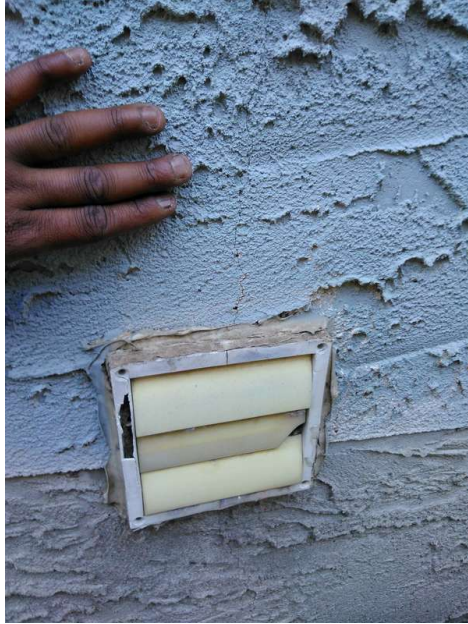
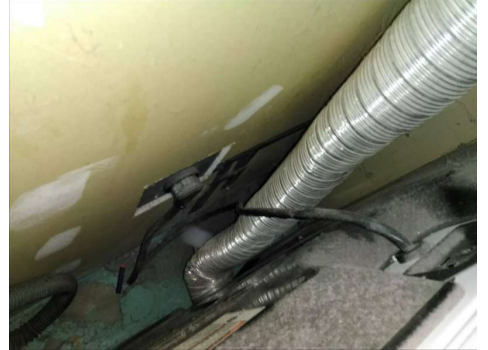
3.1.3 Siding, Flashing & Trim

VENT CAP

NORTH

Observed Dryer Vent cap is damage & Clogged, recommend replacing and cleaning to avoid moisture and fire hazards.

Damage replace recommended

Contact a qualified professional.

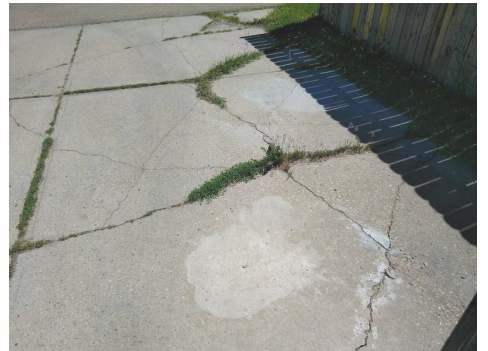
3.3.1 Walkways, Patios & Driveways

DRIVEWAY CRACK - MODERATE

GARAGE

Moderate cracks observed. Recommend concrete contractor evaluate and repair.

Contact a qualified concrete contractor.

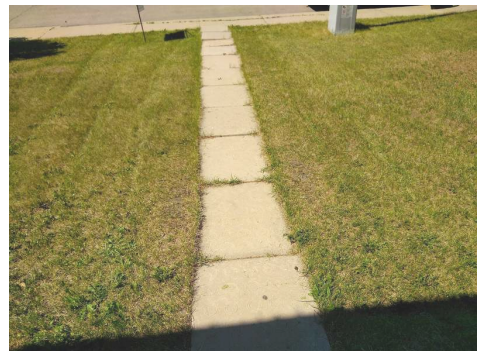
3.3.2 Walkways, Patios & Driveways

UNEVEN WALKWAYS

WEST

Observed uneven concrete block on walkways, its a trip hazards recommend correction.

Contact a qualified professional.

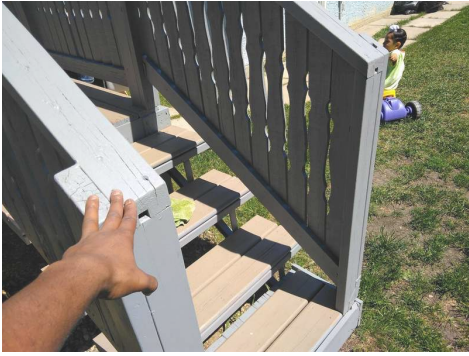
3.4.1 Decks, Balconies, Porches & Steps

HANDRAIL/GUARDRAIL

EAST

Observed loose, recommend monitoring if worsen seek repair to avoid fall hazards.

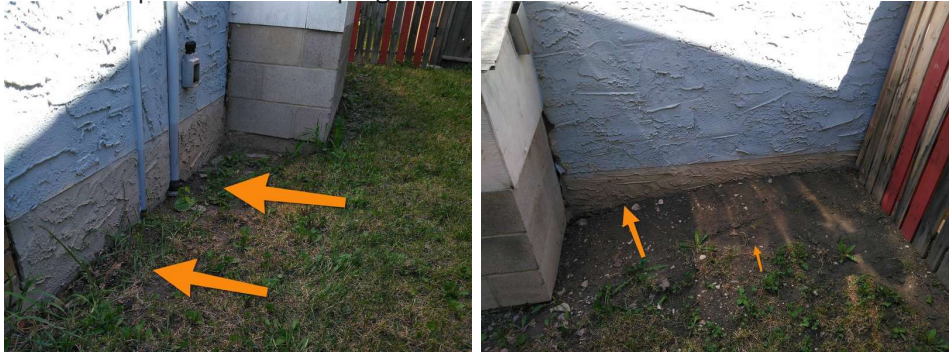
3.6.1 Vegetation, Grading, Drainage & Retaining Walls

NEGATIVE GRADING

SOUTH

Grading is sloping towards the home in some areas. This could lead to water intrusion and foundation issues. Recommend qualified landscaper or foundation contractor regrade so water flows away from home.

Contact a qualified landscaping contractor

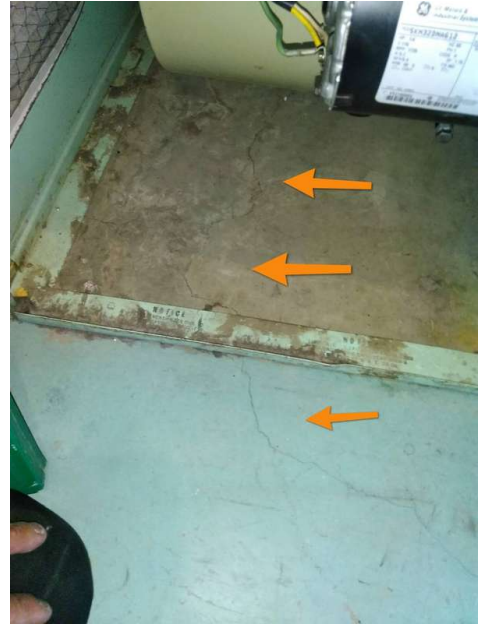
4.3.1 Floor Structure

MINOR CRACK

UTILITY ROOM

Minor crack observed in the basement concrete floor near sum pump, these cracks are common when the pumps are install near edge of the slab, recommend monitoring.

Recommend monitoring.

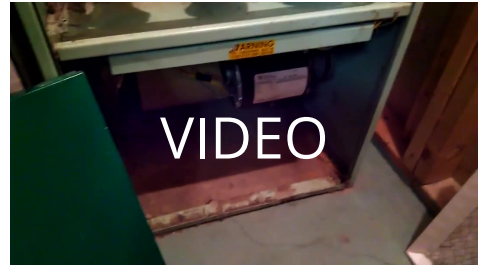
5.1.1 Equipment

BLOWER - EXCESSIVE NOISE

Furnace blower was excessively noisy during operation. Recommend a qualified HVAC technician evaluate and repair.

Contact a qualified HVAC professional.

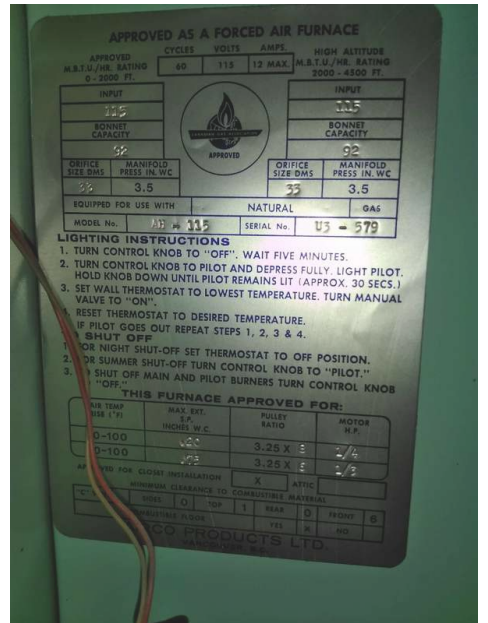
5.1.2 Equipment

NEAR/BEYOND END OF FURNACE LIFE

Observed 39 years old Airco furnace functional at the of inspection. Recommend upgrading in near future for better efficiency and Air quality.

Contact a qualified HVAC professional.

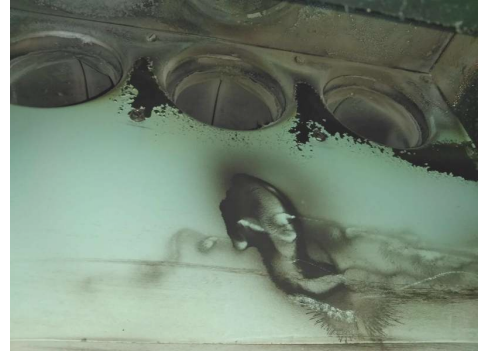
5.1.4 Equipment

NEEDS SERVICING/CLEANING

No cleaning label found- Recommend a qualified HVAC contractor clean, service and certify furnace.

Recommendation
Contact a qualified HVAC professional.

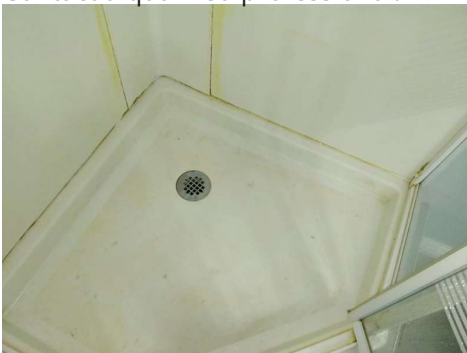
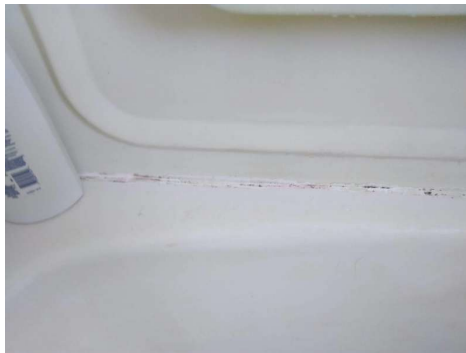
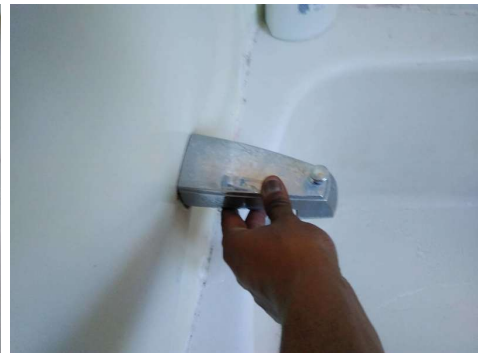
6.2.1 Drain, Waste, & Vent Systems

BATH TUB

BASEMENT AND MAIN FLOOR

Bath tub and shower had some poor caulking/sealant, Bath Faucet in main floor were loose. this can lead to water damage, recommend replacing or repair.

Recommendation
Contact a qualified professional.

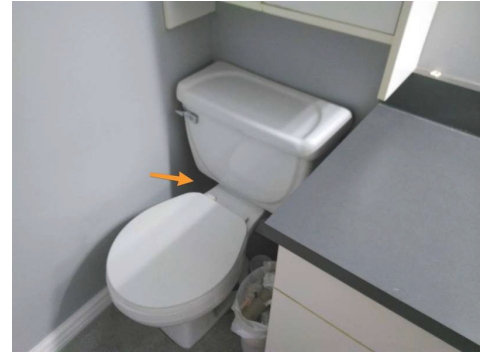
6.2.2 Drain, Waste, & Vent Systems

SHUT OFF VELVE

BASEMENT FULL BATHROOM

Observed no shut off valve near toilet, recommend upgrading.

Recommendation
Contact a qualified plumbing contractor.

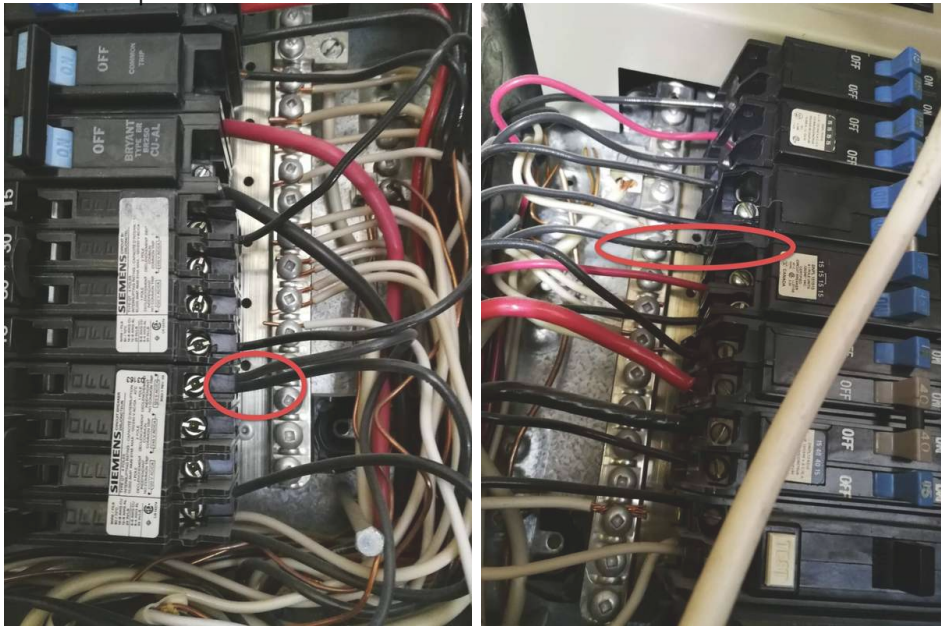
7.2.1 Main & Subpanels, Service & Grounding, Main Overcurrent Device

BREAKER INCORRECTLY WIRED

BASEMENT

Circuit breaker was incorrectly wired / installed, observed double tapping and overheated wiring that poses a safety hazard. Recommend that a licensed electrician check the entire panel and repair and replace as need.

Recommendation
Contact a qualified electrical contractor.

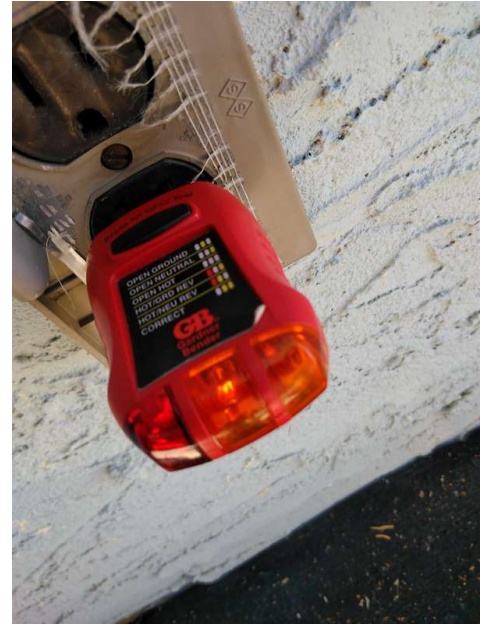
7.4.1 Lighting Fixtures, Switches & Receptacles

REVERSE POLARITY

EAST-DECK

receptacle had been wired with reverse polarity. This can create a shock hazard. Recommend licensed electrician evaluate & repair.

Recommendation
Contact a qualified electrical contractor.

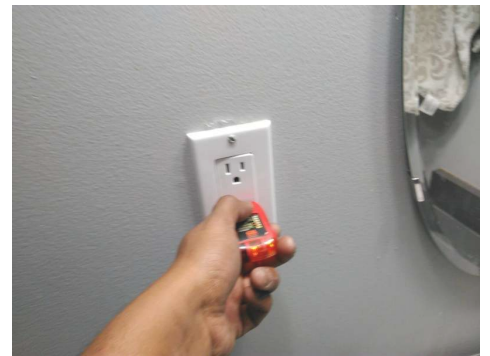
7.5.1 GFCI & AFCI

NO GFCI PROTECTION INSTALLED

BASEMENT FULL BATHROOM

No GFCI protection present. Recommend licensed electrician upgrade by installing ground fault receptacles in all locations, except 2nd floor washroom.

Contact a qualified electrical contractor.

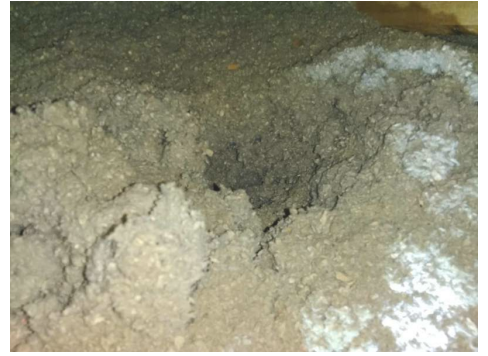
8.1.1 Attic Insulation

INSUFFICIENT INSULATION

ATTIC

Insulation depth was inadequate. Recommend a qualified attic insulation contractor install additional or replacing the insulation.

Recommendation
Contact a qualified insulation contractor.

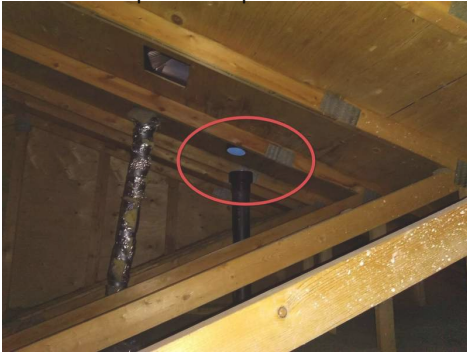
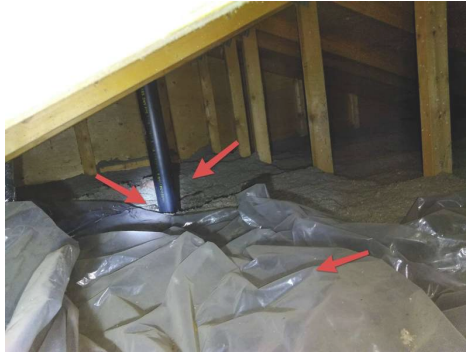
8.3.1 Ventilation

PLUMBING VENTS LOOSE

ATTIC

observed damage/loose Plumbing Vent into attic and signs of previous moisture intrusion near the vent. recommend correction to avoid moisture intrusion or possibly mold.

Recommendation
Contact a qualified professional.

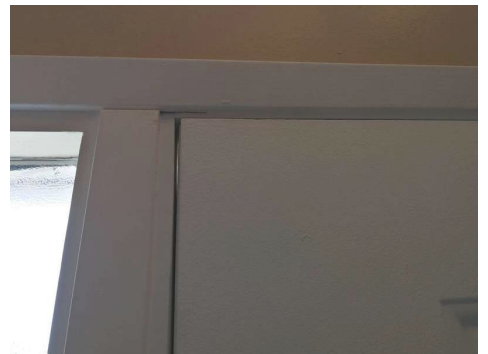
9.1.1 Doors

NOTICEABLE GAP

gaps could result in energy loss. Recommend handyman or door contractor evaluate.

Recommendation
Contact a qualified door repair/installation contractor.

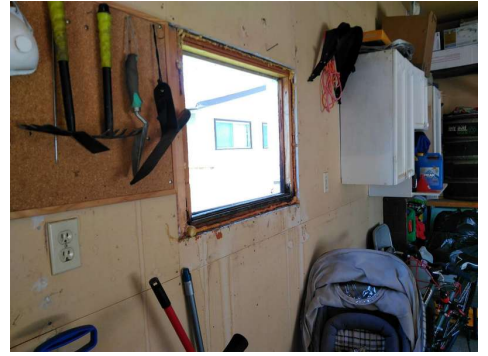
9.1.2 Doors

WATER STAINING

GARAGE

Doors and windows near garage shows noticeable water staining, which could lead to further deterioration. Monitor for future repair or replacement.

Recommendation
Contact a qualified handyman.

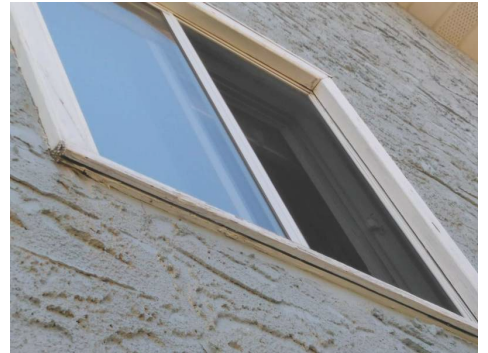
9.2.1 Windows

BEYOND LIFESPAN

Observed signs of deterioration but functional, recommend maintenance like repair and/or upgrading in future .

Contact a qualified window repair/installation contractor.

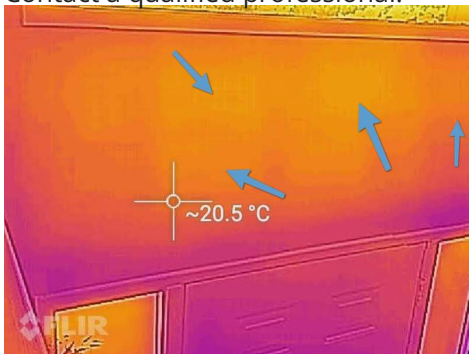
9.4.1 Walls

COLD SPOT

MAIN FLOOR

Observed Cold spot one or more area, no active leak or moisture detected at the time of inspection. could be missing insulation.

Missing Insulation above main door.

Contact a qualified professional.

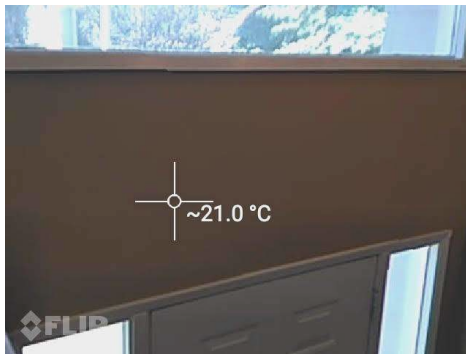
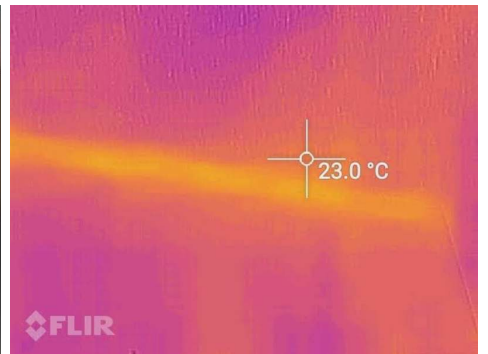
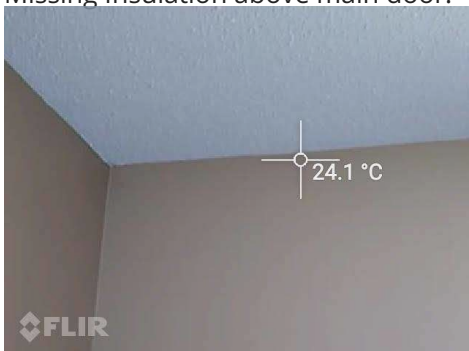
Main floor Bedroom

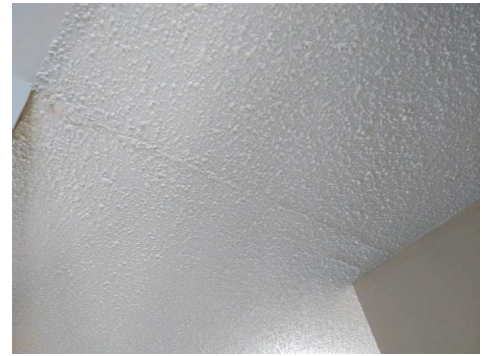
9.5.1 Ceilings

PREVIOUSLY REPAIRED

MAIN FLOOR

Observed previously repaired ceiling cracks, Recommend knowing more about these areas from seller and monitor in future.

Recommendation
Recommend monitoring.

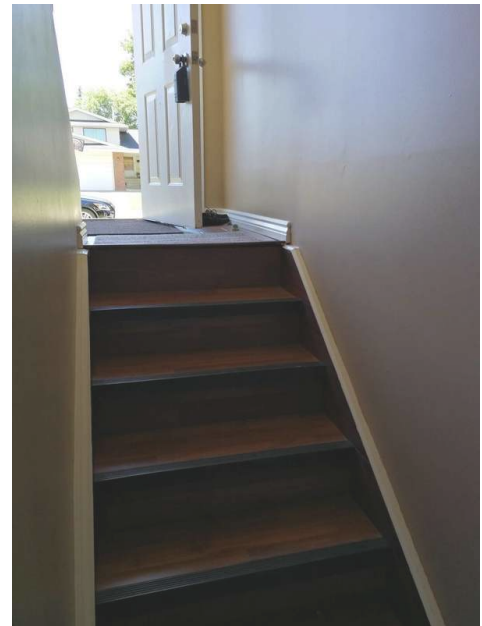
9.6.1 Steps, Stairways & Railings

NO HANDRAIL

Staircase had no handrails. This is a safety hazard. Recommend a qualified handyman install a handrail.

Recommendation
Contact a qualified handyman.

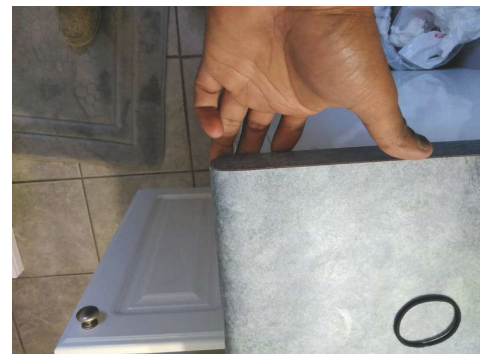
9.7.1 Countertops & Cabinets

COUNTERTOP NOT SECURED

MAIN FLOOR FULL BATHROOM

Main Floor Full Bathroom countertop appeared insecure/loose. Recommend qualified countertop contractor evaluate and secure countertop properly.

Recommendation
Contact a qualified countertop contractor.

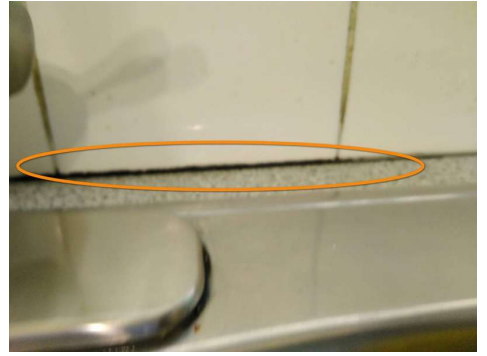
9.7.2 Countertops & Cabinets

GROUT DETERIORATING

Grout lines were cracked or severely deteriorated. Recommend a qualified contractor repair or replace grout.

Recommendation
Contact a qualified countertop contractor.

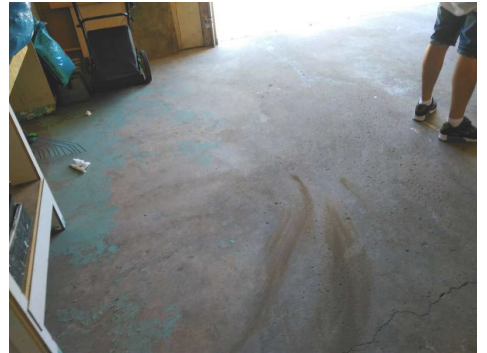
10.2.1 Floor

MINOR CRACK/DAMAGE

GARAGE

Observed minor crack and some damage, recommend repair and monitoring.

Recommendation
Recommended DIY Project

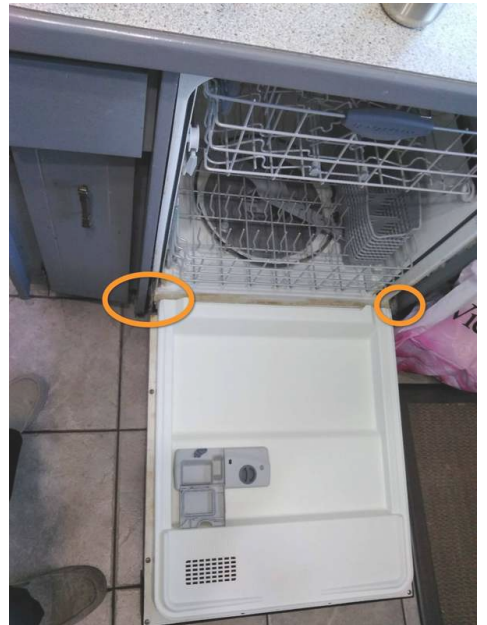
11.1.1 Dishwasher

DISHWASHER DOOR

Observed the latch is damage, recommend correction.
