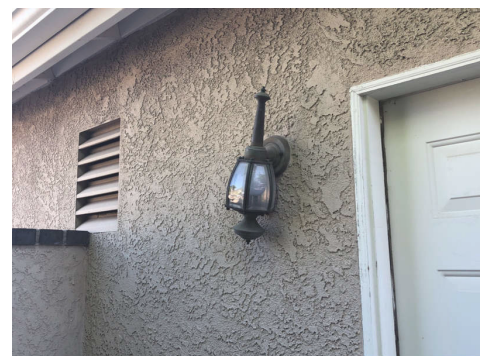
Right Side

3.3.2 Electrical

LIGHT FIXTURES - LOOSE OR SUBSTANDARD

One or more light fixtures are loose or installed in a substandard way. A qualified contractor or electrician should evaluate and make repairs as necessary so light fixtures are securely mounted and installed in accordance with the manufacturer's installation instructions.

Contact a qualified electrical contractor.

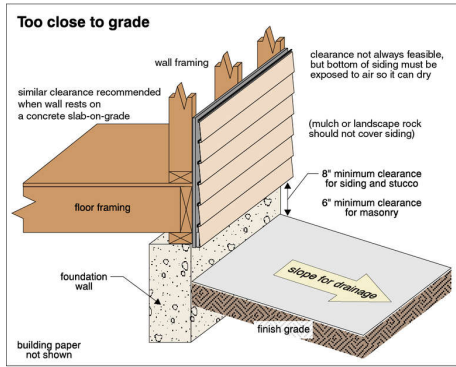
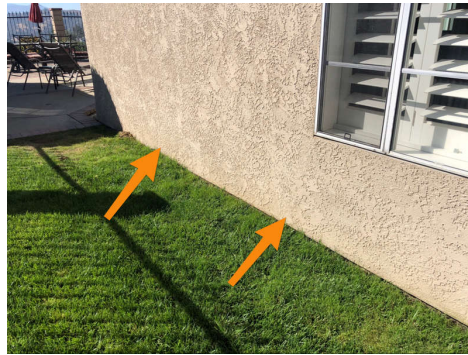
Left Side

3.9.1 Soil Contact

SOIL W/IN 6" OF SIDING/TRIM

Soil is in contact with or less than six inches from siding and/or trim. This is a conducive condition for wood destroying insects and organisms. Soil should be graded and/or removed as necessary so there are at least six inches of space between the siding and trim and the soil below.

Contact a qualified landscaping contractor

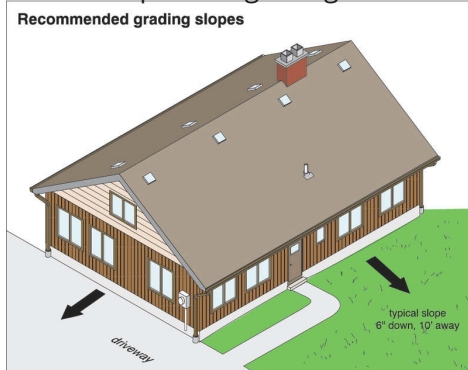
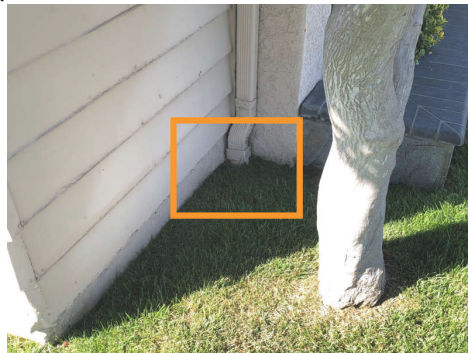
Outside Front

3.11.1 Drainage

NEGATIVE PERIMETER SLOPE - SOIL

The perimeter grading slopes towards the structure in one or more areas. This can result in water accumulating around the structure's foundation, or in basements and crawl spaces if they exist. Accumulated water is a conducive condition to wood destroying insects and organisms. Wet soil may also cause the foundation to settle and possibly fail over time. Recommend grading soil so it slopes down and away from the structure with a slope of at least 5% (10% or better is optimal) for at least 6 feet.

Contact a qualified grading contractor.

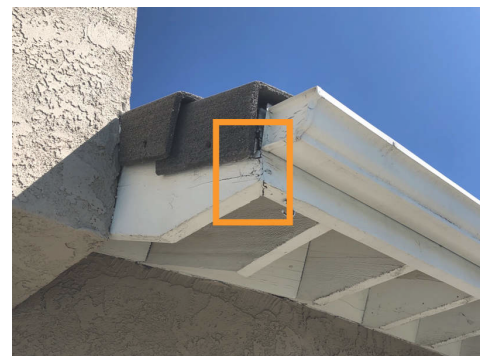
Outside Rear

3.16.1 Fascia

DETERIORATED

Fascia boards are damaged or deteriorated in one or more areas. A qualified contractor should evaluate and make repairs as necessary.

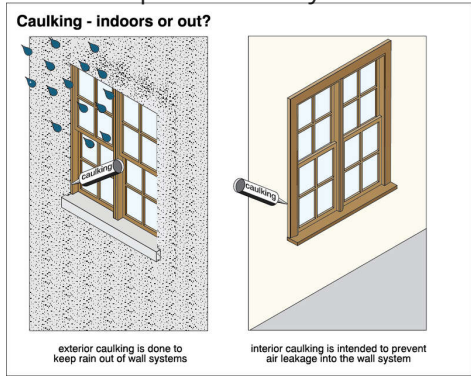
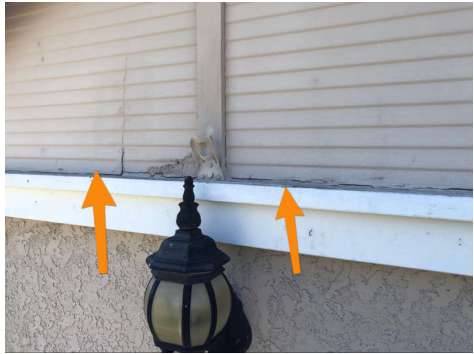
Outside Front

3.21.1 Paint & Caulk

CAULK MISSING OR DETERIORATED

Caulk is missing or deteriorated in some areas and should be replaced and/or applied where necessary.

Recommendation
Contact a qualified handyman.

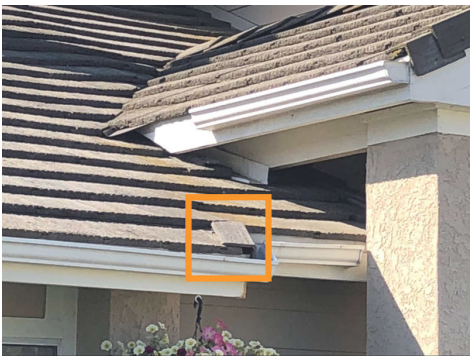
Outside Front

One or more roofing tiles have slipped, and are loose. A qualified roofing contractor should evaluate and repair as necessary.

Recommendation
Contact a qualified roofing professional.

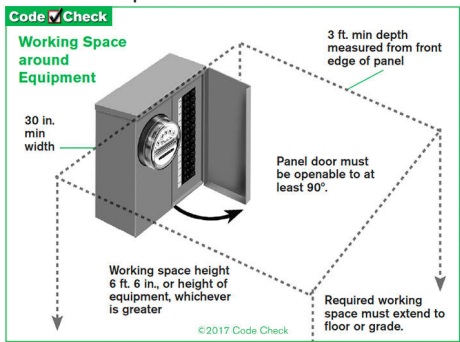
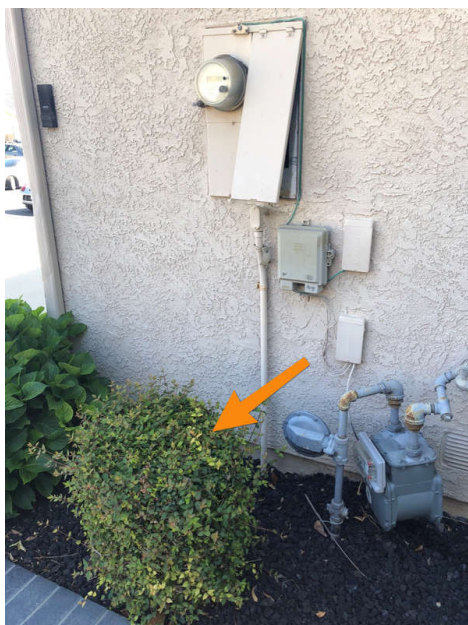
5.3.1 Service and/or Panel

INADEQUATE WORKING SPACE

Inadequate working space exists for the main service panel. Standard building practices require the following clearances:

A qualified contractor and/or electrician should evaluate and make modifications as necessary.

Recommendation
Contact a qualified electrical contractor.

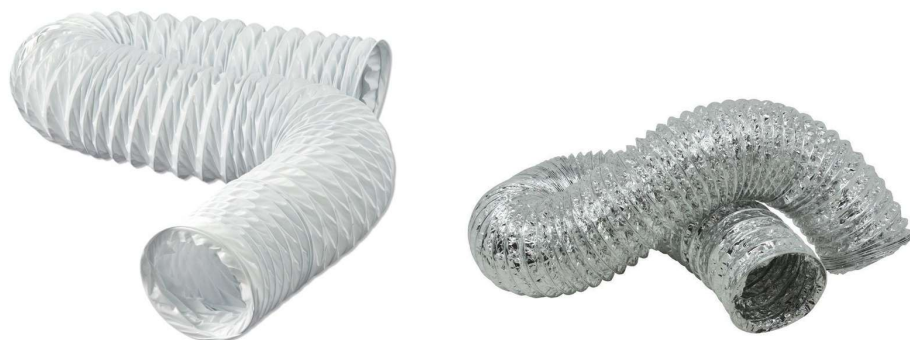
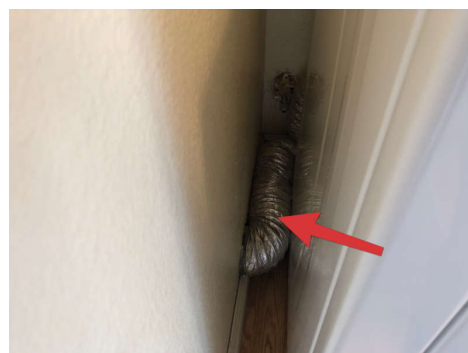
Laundry

The clothes dryer is equipped with a vinyl or foil, accordion-type, flexible exhaust duct. The U.S. Consumer Product Safety Commission considers these types of ducts to be unsafe, and a fire hazard. These types of ducts can trap lint and are susceptible to kinks or crushing, which can greatly reduce the air flow. This duct should be replaced with a rigid or corrugated semi-rigid metal duct, and by a qualified contractor if necessary. Most clothes dryer manufacturers specify the use of a rigid or corrugated semi-rigid metal duct.

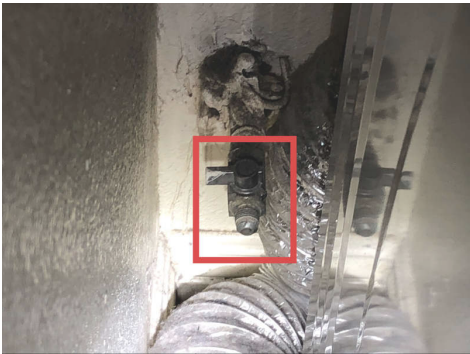
Laundry

7.3.1 Plumbing
GAS LINE CAP MISSING

One or more propane or natural gas supply terminations were unused (no appliance connected) and no cap was installed on the gas shut-off valve(s). Gas can flow directly out of the termination with the shut-off valve is opened. This is a potential fire hazard. Recommend that a qualified person install caps where missing per standard building practices.

Recommendation
Contact a handyman or DIY project

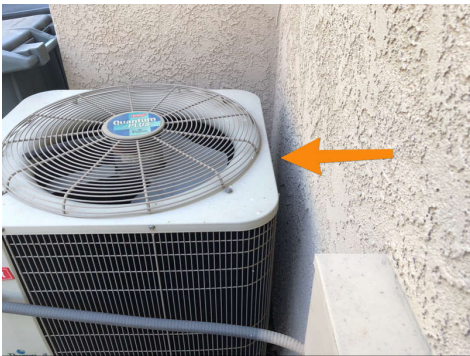
Right Side

8.2.2 Outside Condensing Unit
INADEQUATE CLEARANCE - STRUCTURE

Permanent structures are too close to the outdoor condensing unit. Standard building practices require that there be at least 12 inches of clearance on all sides and at least four to six feet above. Inadequate clearances around the condensing unit can result in reduced efficiency, increased energy costs and/or damage to equipment. Modifications should be made to structures around and/or above the condensing unit by a qualified contractor as necessary to maintain these clearances.

Recommendation
Contact a qualified HVAC professional.

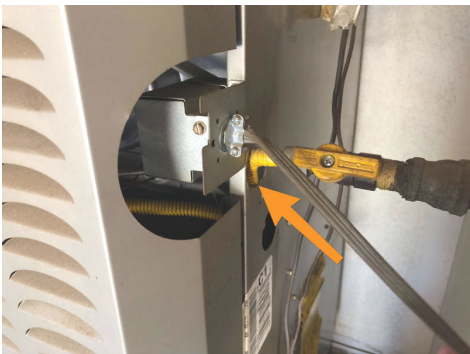
8.3.2 Gas Heat
FLEX CONNECTOR - THROUGH CABINET

One or more flexible gas supply connectors are routed through a metal cabinet. Standard building practices require that solid iron pipe be used where gas supply lines are routed through holes in metal cabinets. Continued vibration from this equipment may cause the edge of the metal cabinet to wear through the flexible connector, resulting in gas leaks. This is a safety hazard. A qualified heating and cooling contractor should evaluate and make repairs and/or modifications as necessary.

Recommendation
Contact a qualified HVAC professional.

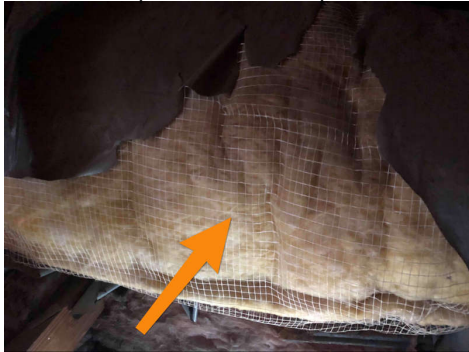
Attic

DUCT INSULATION - DETERIORATED

Insulation on one or more heating/cooling ducts in unconditioned spaces is damaged, delaminating and/or deteriorated. A qualified contractor should evaluate and replace insulation and/or ducts as necessary and as per standard building practices.

Contact a qualified HVAC professional.

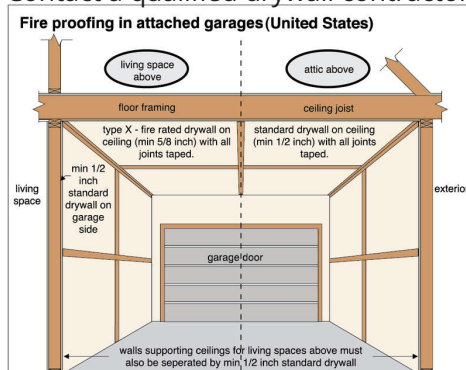
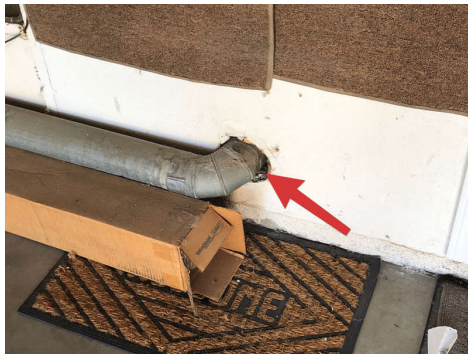
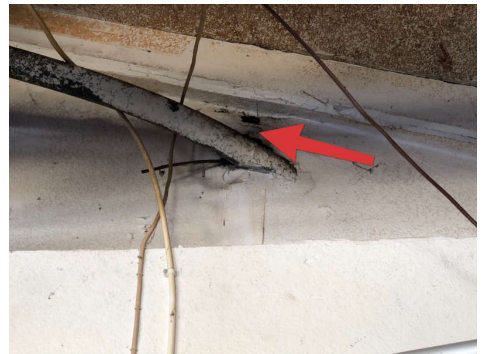
Garage

One or more wall and/or ceiling surfaces between the attached garage and interior living spaces have gaps, holes, or missing or inadequate surface materials. These surfaces are intended to prevent vehicle fumes from entering living spaces, and to slow the spread of fire from the garage to living spaces. A qualified contractor should evaluate and make repairs as necessary so the attached garage wall and ceiling surfaces that adjoin living spaces are tightly sealed and fire rated as per standard building practices. Typically these surfaces require a one-hour fire rating.

Contact a qualified drywall contractor.

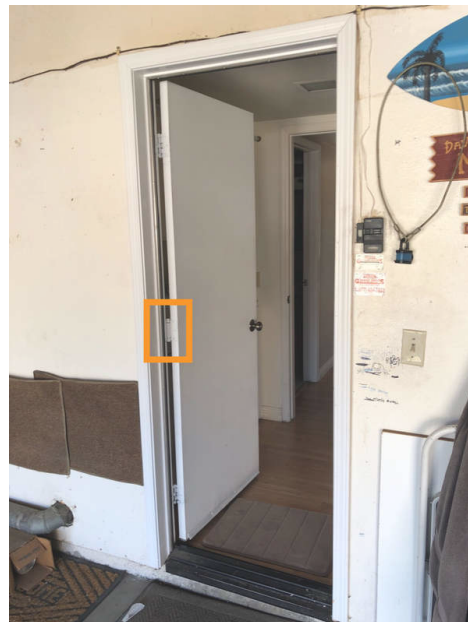
9.3.1 Garage - House Door

REPAIR/REPLACE AUTO-CLOSE

The automatic door closing device (sprung hinges, etc.) on the garage-house door needs adjustment, repair or replacing. The door doesn't close and latch easily and/or completely via the force of the automatic closing device. This door is intended to prevent vehicle fumes from entering living spaces and to slow the spread of fire from the garage to living spaces. A qualified contractor should evaluate and make repairs as necessary.

Contact a qualified door repair/installation contractor.

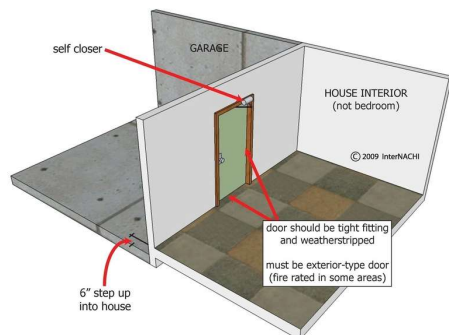
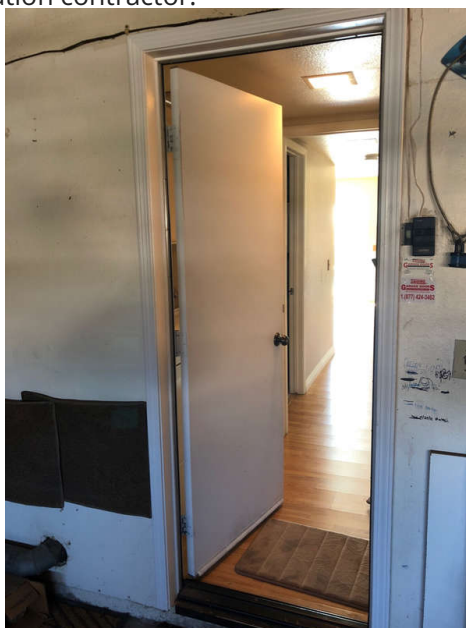
9.3.2 Garage - House Door

The garage-house door poses a fire risk because it's not fire-rated (metal or solid-core construction or **no rating tag visible**). A qualified contractor should replace this door with a fire-rated door.

Contact a qualified door repair/installation contractor.

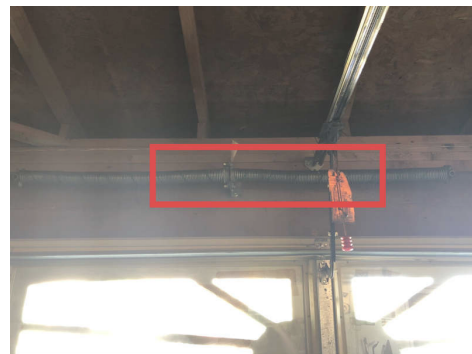
Garage Right Side

9.4.1 Vehicle Door

The vehicle door isn't balanced. The door won't stay in place when it's partially opened and falls to the ground instead. This is a safety hazard since the door may fall when open. A qualified contractor should evaluate and make repairs as necessary.

Contact a qualified garage door contractor.

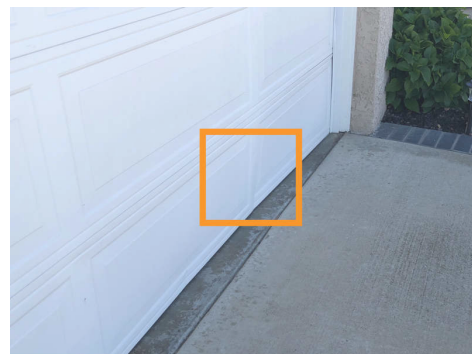
Garage Right Side

9.4.2 Vehicle Door

REPAIR/REPLACE

The garage vehicle door is damaged or deteriorated. A qualified contractor should evaluate and repair or replace the door as necessary.

Contact a qualified garage door contractor.

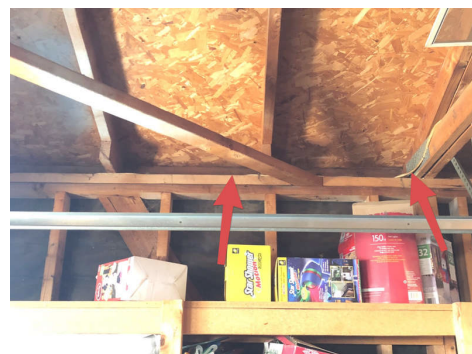
Garage

9.11.1 Electrical

Non-metallic sheathed wiring is routed in one or more areas so it is subject to damage, such as on wall or ceiling surfaces. The insulation can be damaged by objects coming in contact with it and/or it being repeatedly moved. This is a safety hazard due to the risk of shock and fire. A qualified electrician should evaluate and repair as necessary. For example, rewire using conduit, or re-routing through wall cavities.

Contact a qualified electrical contractor.

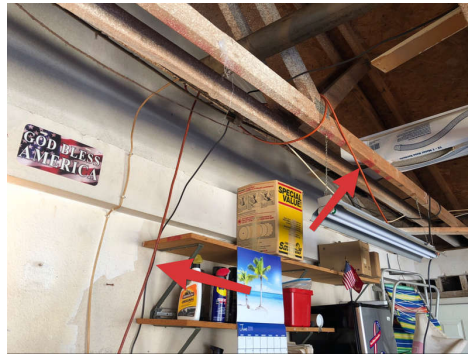
Garage

Extension cords are being used as permanent wiring in one or more areas. They should only be used for portable equipment on a temporary basis. Using extension cords as permanent wiring poses a fire and shock hazard, and is an indication that wiring is inadequate and should be updated. Extension cords may be undersized. Connections may not be secure, resulting in power fluctuations, damage to equipment, and sparks that could start a fire. Extension cords should be removed as necessary, or a qualified electrician should evaluate and make repairs as necessary. For example, install additional circuits and/or electric receptacles.

Contact a qualified electrical contractor.

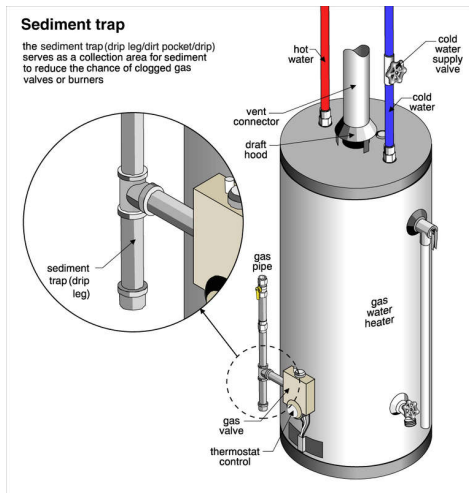
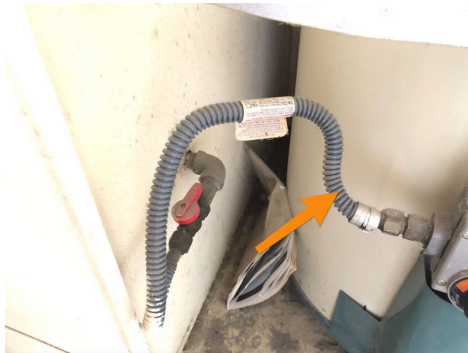
10.2.1 Gas Water Heater

No drip leg is installed on the water heater gas supply line. Drip legs are intended to trap oil, scale, water condensation and/or debris from the gas supply lines before they reach and damage the water heater components. A qualified contractor should install a drip leg as per standard building practices.

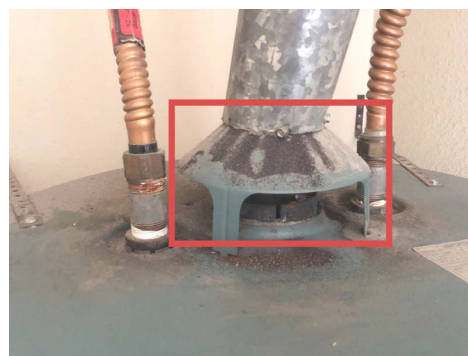
10.2.2 Gas Water Heater **DRAFT HOOD LOOSE**

The draft hood for the water heater flue was loose. This is a potential safety hazard due to the risk of exhaust gases entering living spaces. A qualified person should permanently secure the draft hood with appropriate fasteners per standard building practices.

Contact a qualified plumbing contractor.

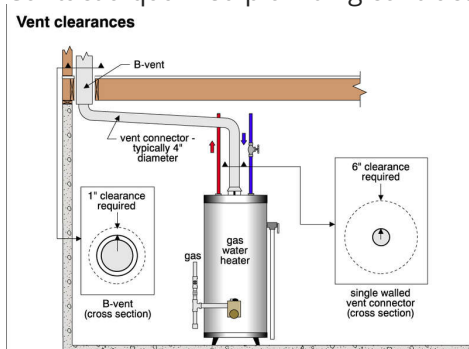
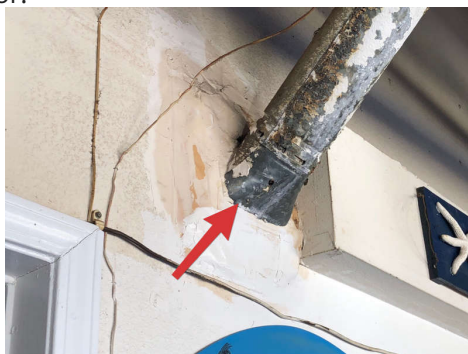
Garage

10.2.3 Gas Water Heater **< 1 INCH**

Combustible materials were found less than one inch from the B-vent flue pipe for the gas-fueled furnace or boiler. This is a fire hazard. Combustible materials should be moved, or repairs made by a qualified contractor, as necessary to maintain this clearance.

Contact a qualified plumbing contractor.

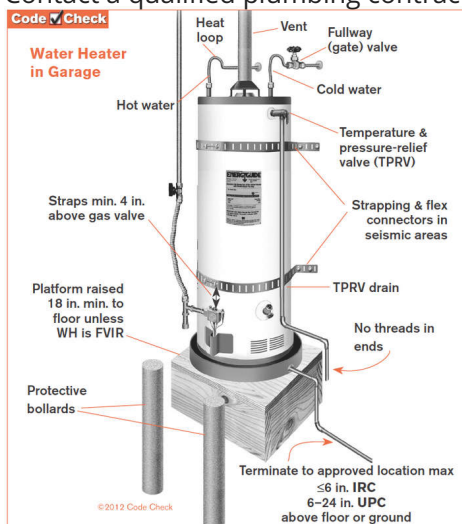
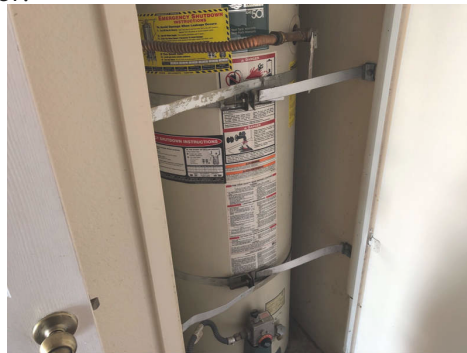
The water heater's seismic straps or struts are substandard. For example, they may allow significant movement or use improper fasteners. This is a potential safety hazard since movement can cause leaks in the gas supply lines or damage wiring. Leaks may also occur in water supply pipes. A qualified contractor should evaluate and either repair existing straps or install new straps or struts as necessary and as per [standard building practices](#).

Recommendation
Contact a qualified plumbing contractor.

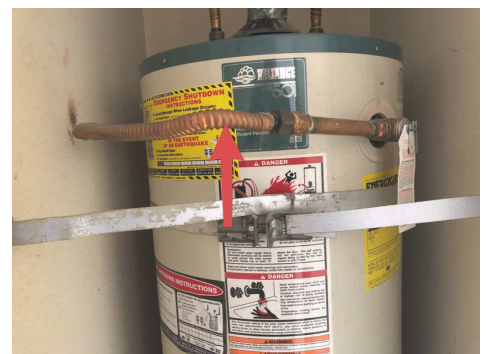
10.9.1 Drain Line

DRAIN LINE ROUTED UP

The temperature-pressure relief valve drain line is routed upwards. This drain line should be routed either down or horizontally. This is a safety hazard as water may not be able to flow through the drain line adequately when the valve releases due to accumulated water. Also, accumulated water may corrode the valve and prevent it from working. A qualified plumber should evaluate and repair so the drain line is routed down or horizontally, but not up.

Recommendation
Contact a qualified plumbing contractor.

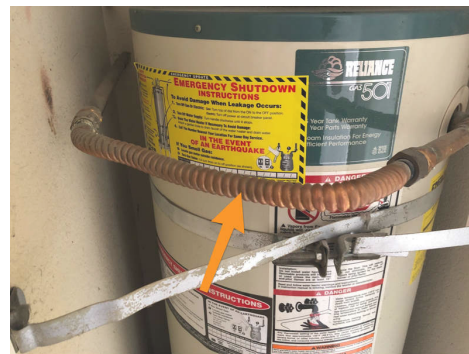
10.9.2 Drain Line

IMPROPER MATERIAL

The discharge pipe of the water heater temperature/pressure relief (TPR) valve was of an improper material. TPR discharge pipes should be galvanized steel, copper pipe, or CPVC. The Inspector recommends correction by a qualified contractor.

Contact a qualified plumbing contractor.

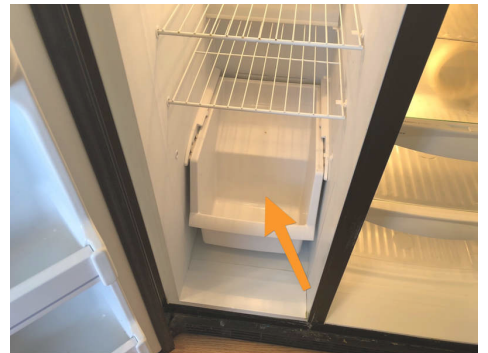
11.3.2 Refrigerator

BROKEN OR MISSING SHELVE

Refrigerator shelving is broken and/or missing and should be replaced or repaired as necessary.

Contact a qualified appliance repair professional.

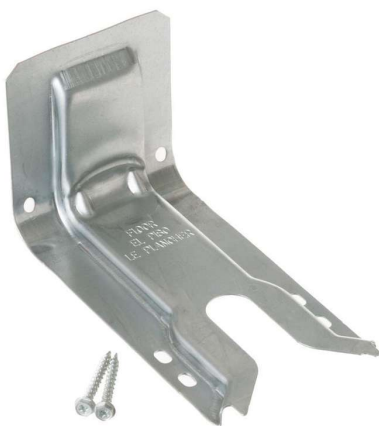
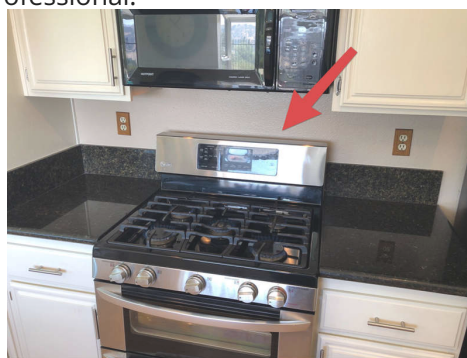
Kitchen

11.6.1 Range/Oven/Stove top

NO ANTI-TIP BRACKET

The range can tip forward, and no anti-tip bracket appears to be installed. This is a safety hazard since the range may tip forward when weight is applied to the open door, such as when a small child climbs on it, or if heavy objects are dropped on it. Anti-tip brackets have been sold with all free standing ranges since 1985. An anti-tip bracket should be installed to eliminate this safety hazard.

Contact a qualified appliance repair professional.

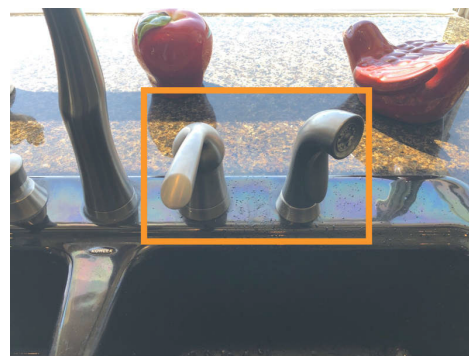
Kitchen

LOOSE OR MISSING HANDLE

One or more faucet handles are loose or missing and should be repaired or replaced as necessary. All work should be performed by a qualified plumbing contractor.

Contact a qualified plumbing contractor.

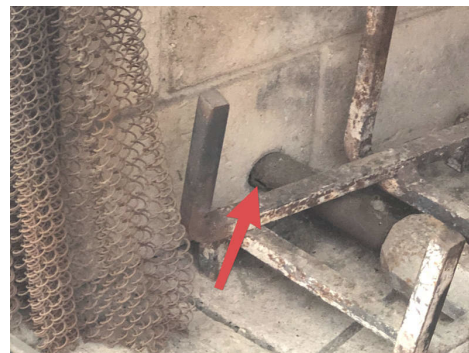
Family Room

One or more gaps exist in the fireplace and or the fire box. This is a fire hazard since heat from fires may reach wood wall cavities surrounding the fireplace. A qualified chimney service contractor should evaluate and repair as necessary.

Contact a qualified fireplace contractor.

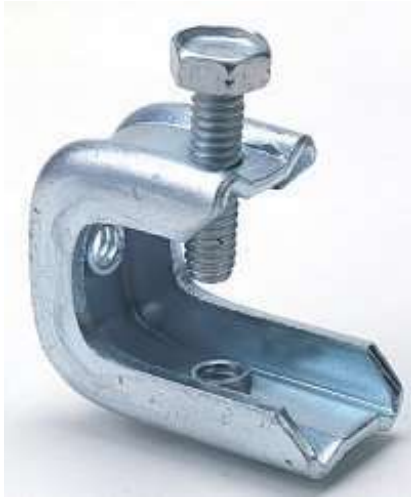
Damp Clamp

12.5.1 Gas

One or more fireplaces equipped with a gas burner has a damper that can be closed. This is a safety hazard due to the possibility of burner or pilot light exhaust gases entering living spaces. A qualified chimney service contractor should make repairs as necessary so the damper is made permanently open. Typically a bracket or bolt is installed for this purpose.

Contact a qualified handyman.

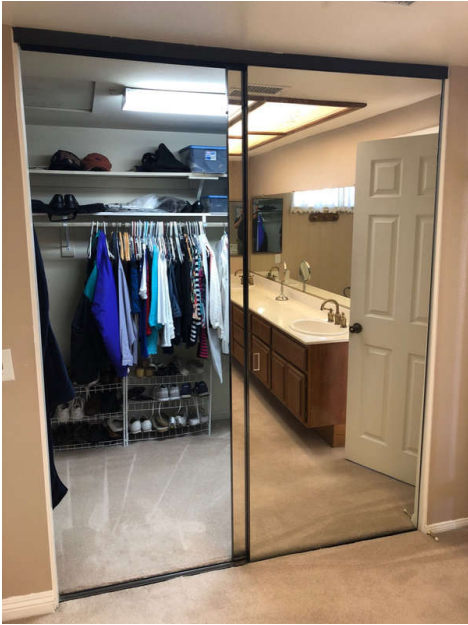
Master Bedroom Closet

13.3.1 Doors (Representative Number)

One or more doors bind in their jamb and cannot be closed and latched, or are difficult to open and close. A qualified contractor should evaluate and repair as necessary. For example, adjusting jambs or trimming doors.

Contact a qualified door repair/installation contractor.

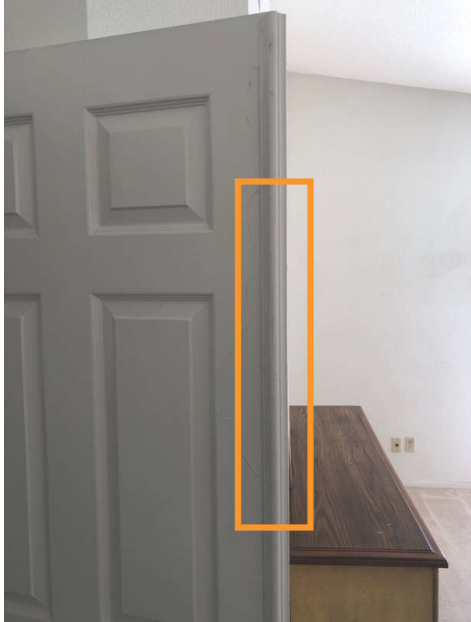
Master Bedroom

DETERIORATED/DAMAGED

One or more interior doors are deteriorated and or damaged and should be repaired or replaced by a qualified contractor.

Recommendation
Contact a qualified door repair/installation contractor.

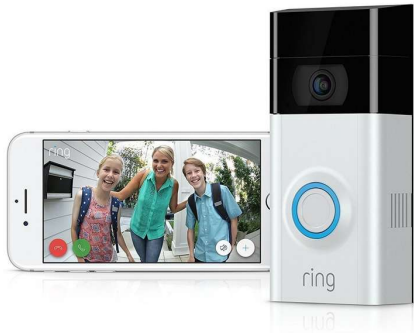
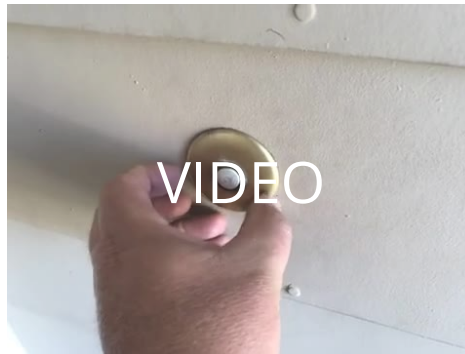
13.4.1 Door Bell

BUTTON LOOSE OR DAMAGED

The doorbell button is loose or damaged. It should be repaired or replaced as necessary, and by a qualified contractor if necessary.

Contact a handyman or DIY project

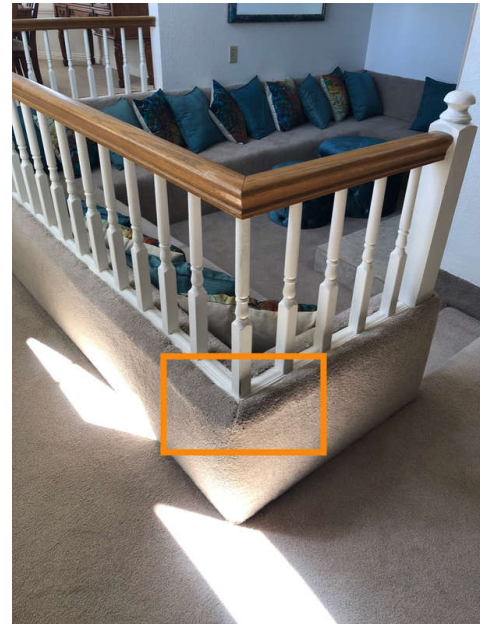
Living Room

13.17.1 Floors

CARPET - DETERIORATED

Carpeting in one or more rooms is damaged and/or significantly deteriorated. Recommend replacing carpeting where necessary.

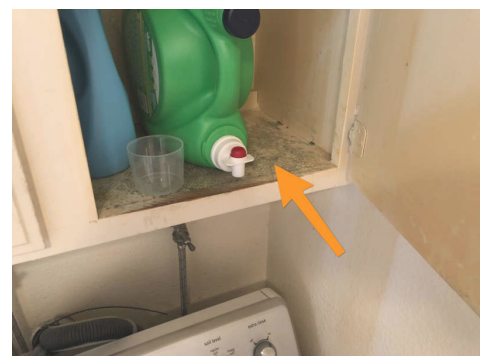
Laundry

Microbial growths were found at one or more locations. It is beyond the scope of this inspection to identify what substance or organism this staining is. However such staining is normally caused by excessively moist conditions, which in turn can be caused by plumbing or building envelope leaks and/or substandard ventilation. These conducive conditions should be corrected before making any attempts to remove or correct the staining. Normally affected materials such as drywall are removed, enclosed affected spaces are allowed to dry thoroughly, a mildewcide may be applied, and only then is drywall reinstalled. For evaluation and possible mitigation, consult with a qualified industrial hygienist or mold/moisture mitigation specialist.

Contact a qualified mold inspection professional.

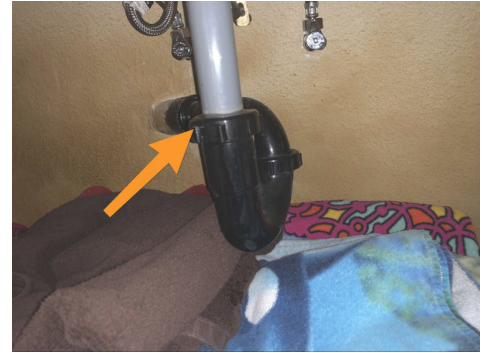
1st Floor Bathroom

14.5.1 Sinks

SINK DRAIN - LEAK

One or more sink drains have an active leak. For example, at pipe fittings and/or junctions between pipe and sink. A qualified plumber should evaluate and repair as necessary.

Contact a qualified plumbing contractor.

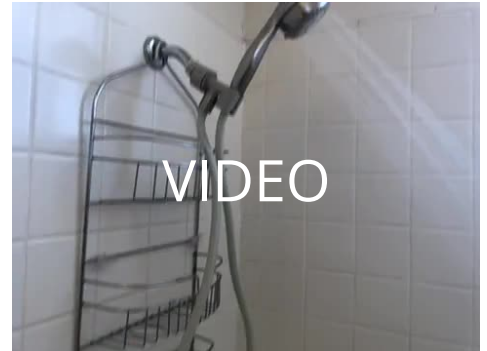
14.8.1 Showers

DIVERTER VALVE DEFECTIVE

The shower diverter valve for one or more bathtub faucets is defective. A significant amount of water comes out of the bathtub spout when the shower is turned on. Water will be wasted as a result. A qualified plumber should evaluate and replace components or make repairs as necessary.

Contact a qualified plumbing contractor.

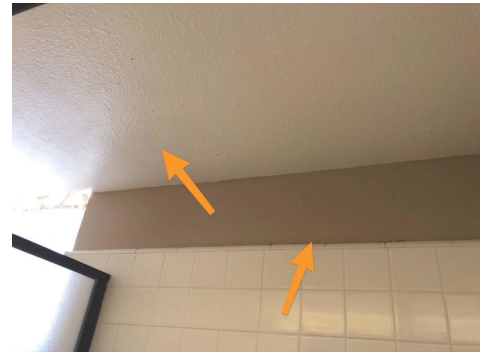
Master Bathroom

14.11.1 Environmental

MICROBIO GROWTH

Microbial growths were found at one or more locations. It is beyond the scope of this inspection to identify what substance or organism this staining is. However such staining is normally caused by excessively moist conditions, which in turn can be caused by plumbing or building envelope leaks and/or substandard ventilation. These conducive conditions should be corrected before making any attempts to remove or correct the staining. Normally affected materials such as drywall are removed, enclosed affected spaces are allowed to dry thoroughly, a mildewcide may be applied, and only then is drywall reinstalled. For evaluation and possible mitigation, consult with a qualified industrial hygienist or mold/moisture mitigation specialist.

Contact a qualified mold inspection professional.

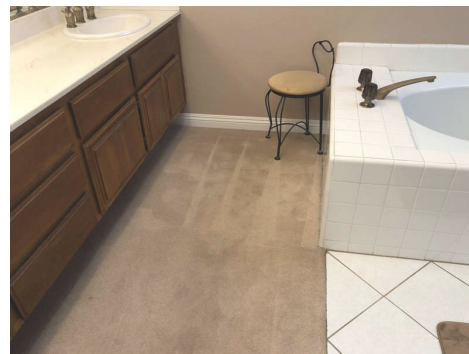
Master Bathroom

14.12.1 Floors

The carpet was permanently attached to the floor, rather than being installed loosely over another flooring type, more appropriate to use in a wet area. This installation is conducive to moisture retention in the carpeting. It is recommended that the carpets be removed and a more appropriate material be installed.

Contact a qualified professional.

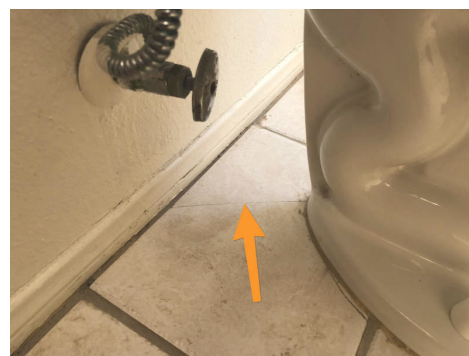
2nd Floor Hallway Bathroom

14.12.2 Floors

TILE, STONE AND GROUT - DETERIORATED

Tile, stone and/or grout flooring is damaged and/or deteriorated in one or more areas. A qualified contractor should evaluate and make repairs as necessary. For example, replacing broken tiles and deteriorated grout, and resealing grout.

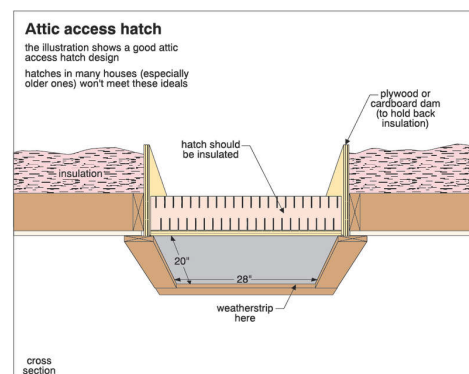
15.2.1 Access Hatch

No insulation is installed over the attic access hatch. Recommend installing insulation above hatch for better energy efficiency.

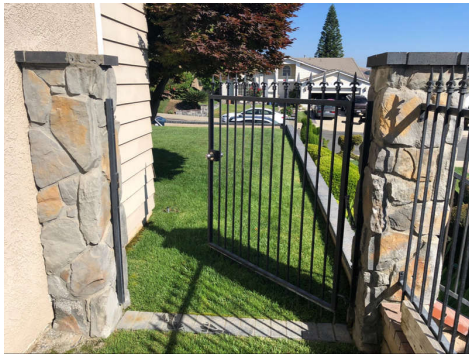
Left Side

16.2.1 Fences and Gates

SELF CLOSING DEVICE

Self-closing devices on one or more gates used with pool or spa fencing are missing or did not function as intended. This is a safety hazard because these devices are intended to control access to the pool or spa, especially for children. A qualified person should repair, replace or install as necessary.

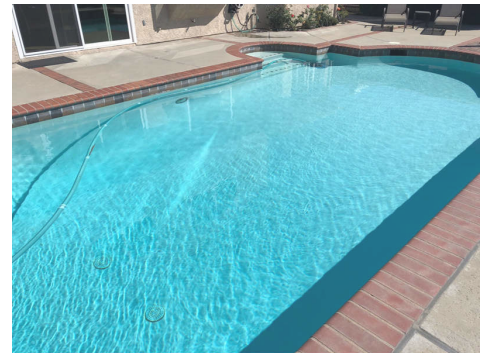
MISSING SAFETY FLOAT LINE

No safety float line was installed where the bottom slope begins to deepen. This is a safety hazard. Standards require that one be installed one to two feet on the shallow side of this transition when the transition is located in water deeper than four and a half feet deep. Recommend installing a safety float line.

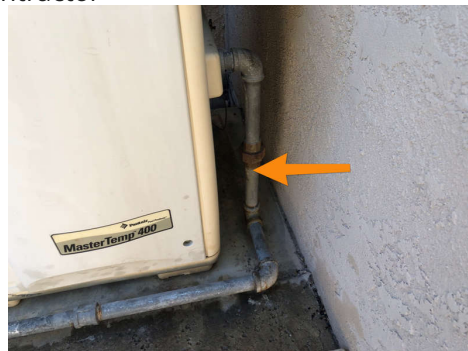
16.7.1 Heater

GAS PIPING - NO DRIP LEG

No drip leg was installed in the heater's gas supply line. Drip legs are intended to prevent damage to gas-fired appliances by trapping oil, scale, water condensation and/or debris. A qualified contractor should install a drip leg as per standard building practices.

Install a sediment trap and union located outside the heater panels in accordance with National code requirements.

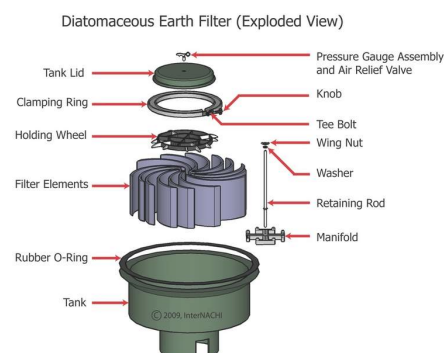
The reading at the Diatomaceous earth filter's pressure gauge was relatively high. Diatomaceous earth filters should be backwashed and have the medium replaced when the pressure gauge reads 7-10 lbs above the clean, starting pressure (after backwashing and replacing medium). If backwashing is ineffective then the septa may need replacing, or other repairs may be needed. A qualified person should evaluate and maintain or repair as necessary.

Recommendation
Contact a qualified Swimming Pool Contractor

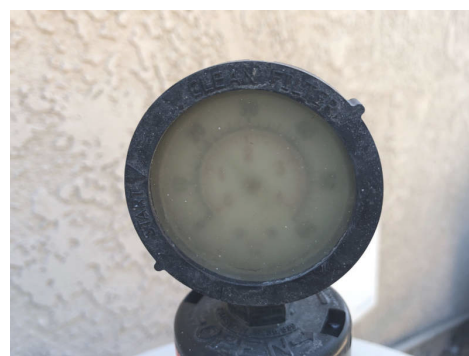
16.8.2 Filter

PRESSURE GAUGE ISSUES

The filter pressure gauge was inoperable, damaged, deteriorated and or corroded. A qualified contractor should evaluate and repair as necessary.

Recommendation
Contact a qualified Swimming Pool Contractor

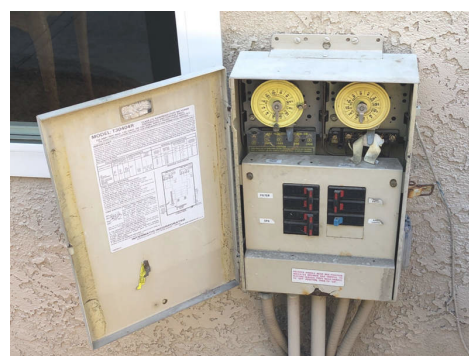
16.10.1 Electrical

TIMER NOT WEATHERPROOF

The timer mechanism's housing was not weather proof and/or the timer was not in a weather proofed location. This is a hazard for shock. A qualified person should evaluate and make repairs or modifications as necessary.

Recommendation
Contact a qualified electrical contractor.

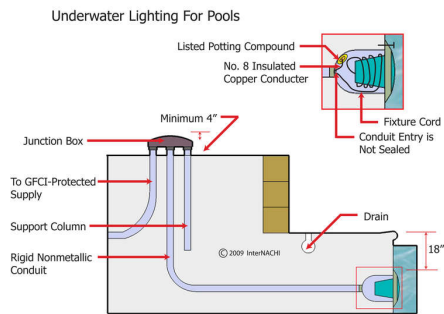
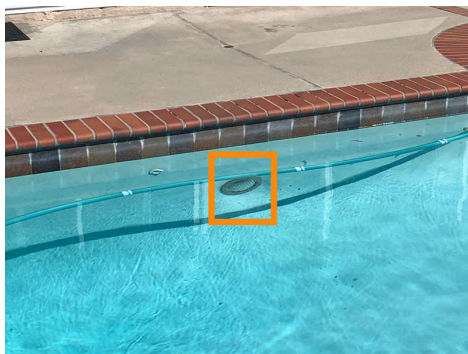
16.10.2 Electrical

UNDERWATER LIGHTS - INOPERABLE

One or more underwater lights were inoperable. Bulb(s) may be burned out or repairs may be needed. A qualified person should evaluate and repair as necessary.

Recommendation
Contact a qualified electrical contractor.

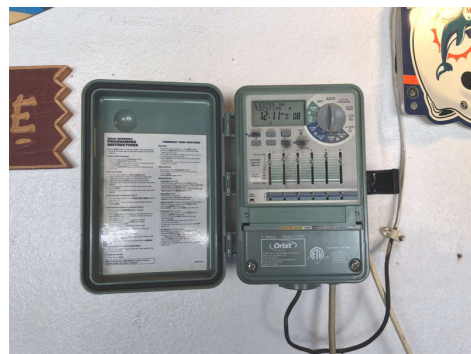
Garage

17.3.1 Control Panel Location

BOX LOOSE/DAMAGED
