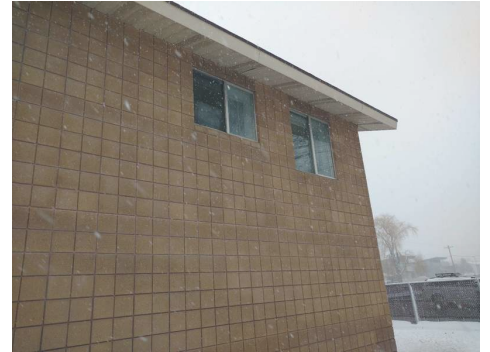
**DOWNSPOUTS MISSING**

The building was missing downspouts in one or more areas. This can result in excessive moisture in the soil at the foundation, which can lead to foundation/structural movement. Recommend a qualified contractor install downspout extensions that drain at least 6 feet from the foundation.

Contact a qualified professional.

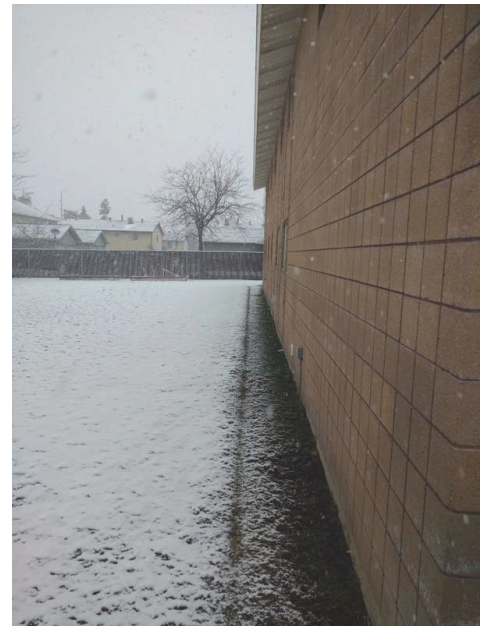
**GUTTERS MISSING**

There are no gutters present on the structure. Gutters are recommended because they collect rain water from the roof and direct it away from the building.

Contact a qualified professional.

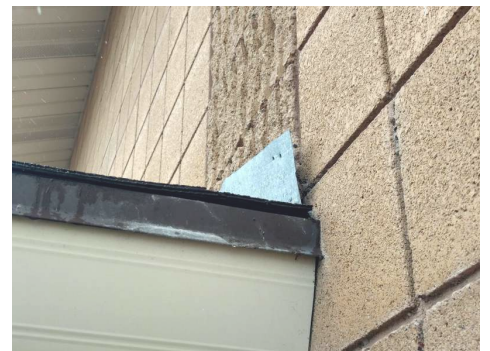
**LOOSE/SEPARATED**

Flashings observed to be loose or separated, which can lead to water intrusion and/or mold. Recommend a qualified roofing contractor repair.

Contact a qualified professional.

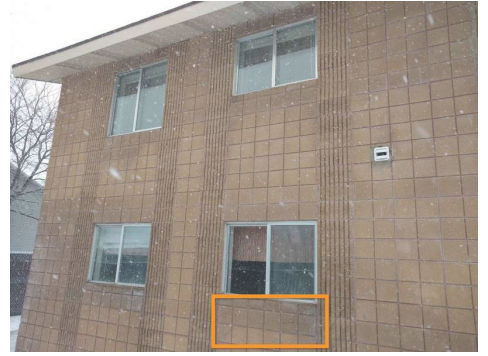
**CRACKING - MINOR**

Siding showed cracking in one or more places. This is a result of temperature changes and freezing water that enters the masonry, and typical as structures age. Recommend monitoring.

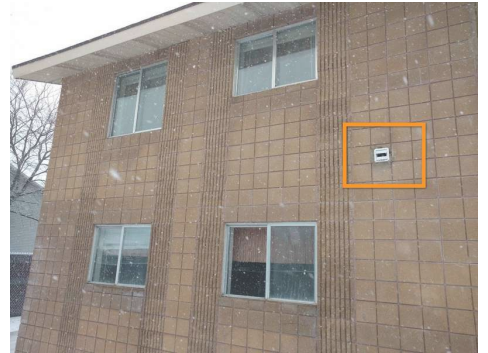
**VENT DAMAGE**

Vent cover damage was observed. Vent covers should be replaced to help limit moisture intrusion, unwanted airflow and pest entry.

Contact a qualified professional.

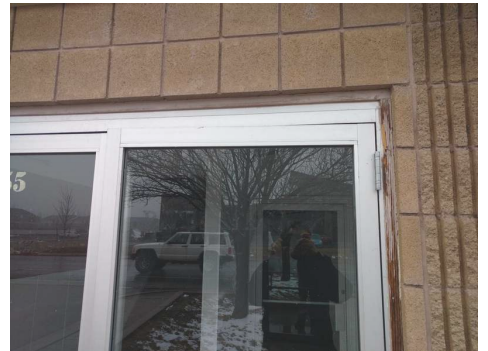
**DOOR DOES NOT CLOSE OR LATCH**

On the main entrance, the north door does not close properly. Recommend qualified handyman adjust door to close properly.

Contact a qualified professional.

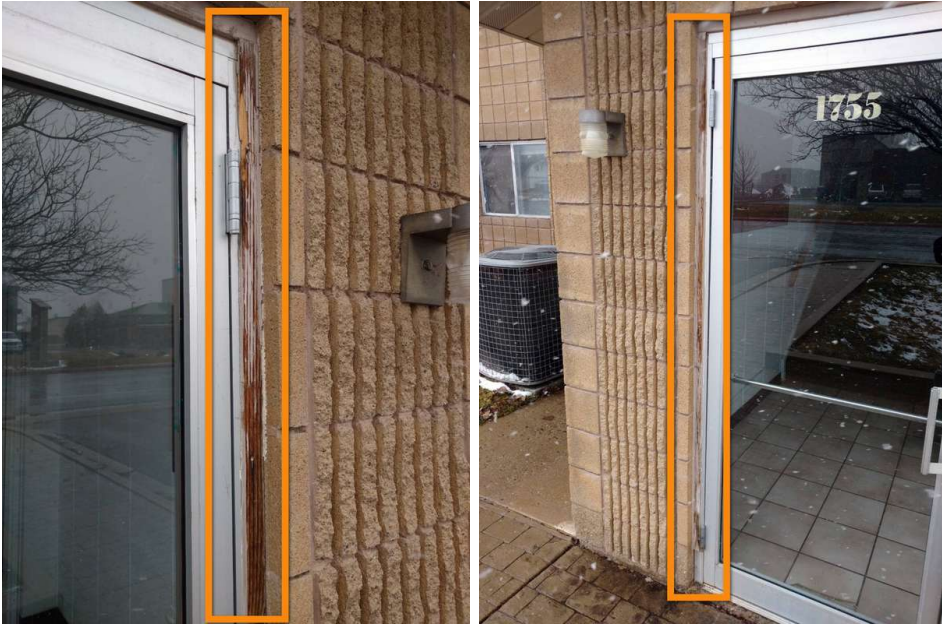
**DOOR SILL/TRIM**

Door sill and/or trim is loose, deteriorated or worn and repair or replacement should be considered.

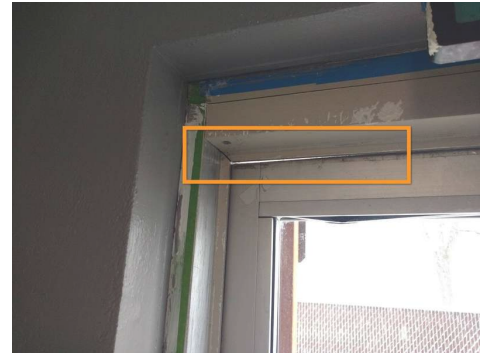
#### **WEATHERSTRIPPING NOT PRESENT**

Door is missing standard weatherstripping. This can result in significant energy loss and moisture intrusion. Recommend installation of standard weatherstripping.

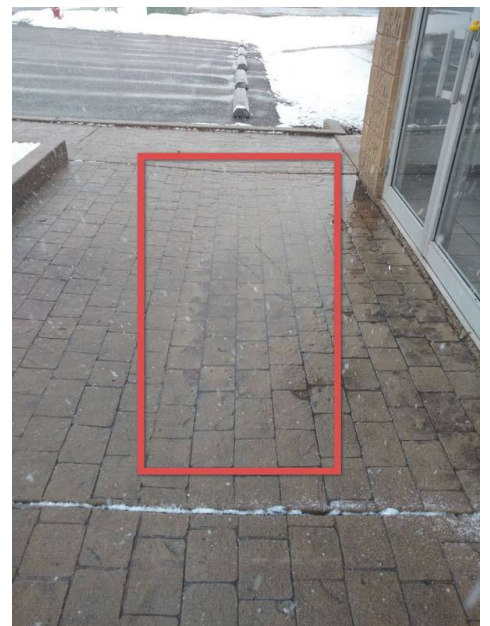
#### **PONDING ON WALKWAY**

Ponding (puddle formation) was observed in front of the main entrance. Accumulated water that freezes could pose a safety hazard.

Contact a qualified professional.

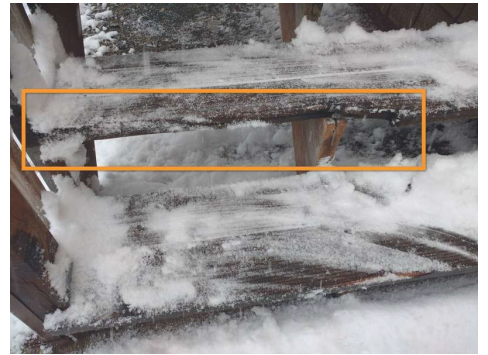
**STAIRS - DETERIORATED**

One sections of the exterior stairs is deteriorated. Second stair from the bottom. Recommend qualified contractor evaluate & repair.

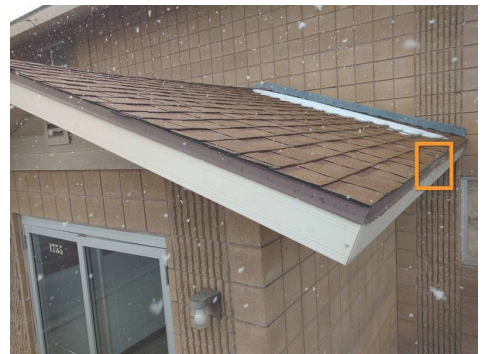
**PAINT/FINISH FAILING**

The paint or finish is failing. This can lead to deterioration and rot of the material. Recommend that the areas be properly prepared and painted / finished.

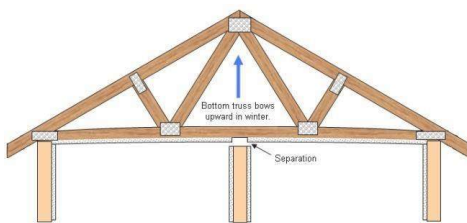
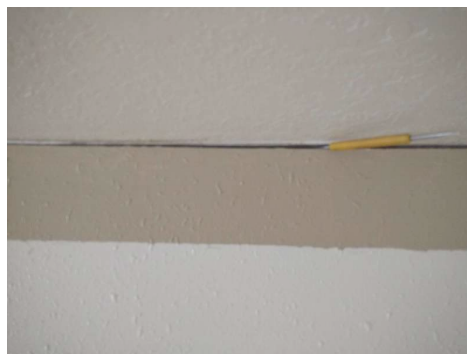
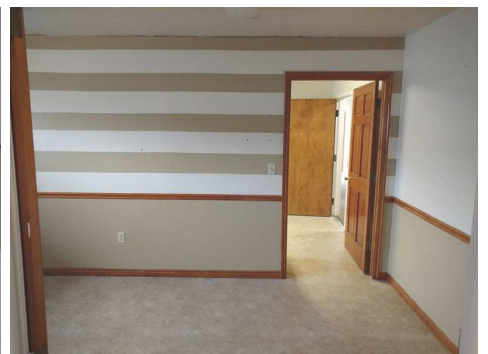
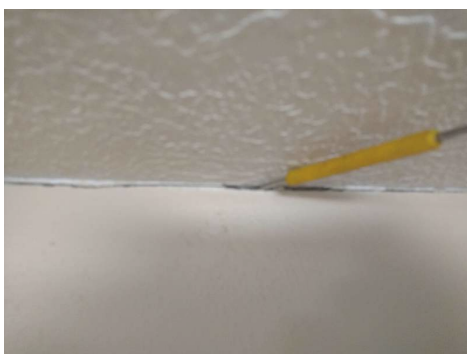
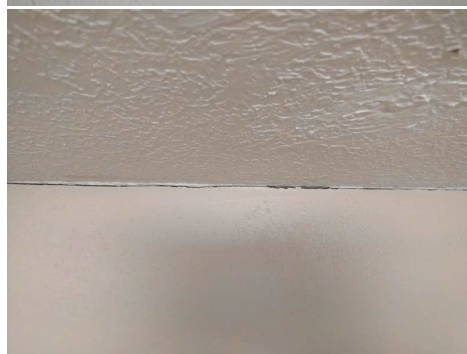
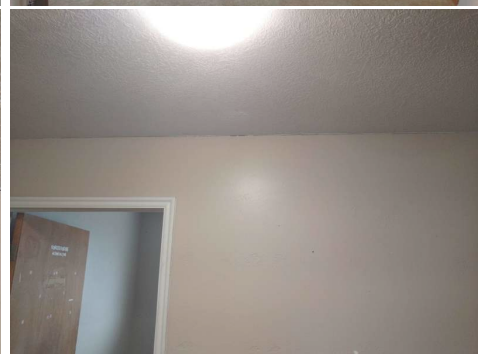
**TRUSS UPLIFT**

Due to temperature and humidity changes in the winter, trusses expand and contract which can cause the bottom of the truss (ceiling) to bow up in the middle and lift off of the top of the interior walls. This is not a structural issue, just a cosmetic issue.

Contact a qualified professional.

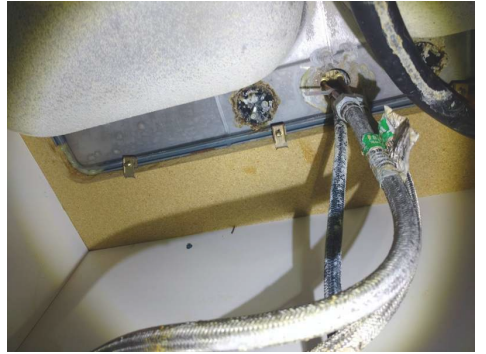
## LEAKING FIXTURES

Leaking fixtures were observed. The shower in the north bathroom on the first floor is leaking and is missing the handle to turn on the water. The first floor kitchen faucet leaks when turned on and drips in the cabinet underneath the sink.

North bathroom on the second floor shows signs of water damage. No leaks were observed during the inspection.

Recommendation  
Contact a qualified professional.

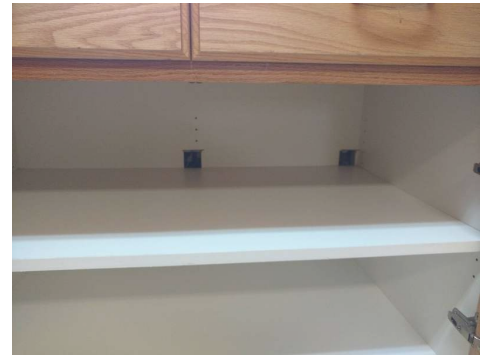
West wall in second floor kitchen.

**COVER PLATES MISSING**

One or more receptacles are missing a cover plate. This causes short and shock risk. Recommend installation of plates.

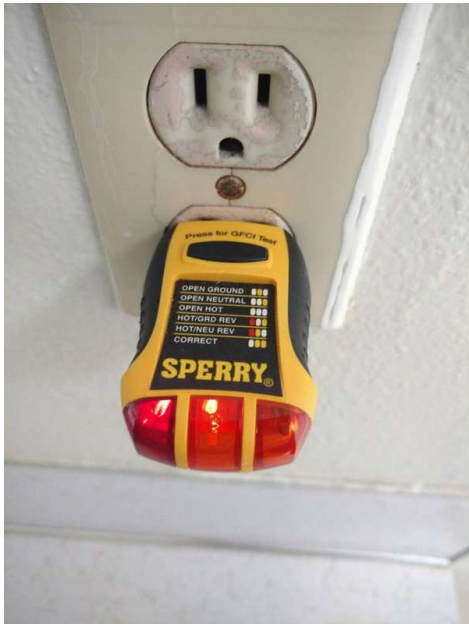
First Floor North Bathroom

**REVERSE POLARITY**

One or more receptacles have been wired with reverse polarity. This can create a shock hazard. Recommend licensed electrician evaluate & repair.

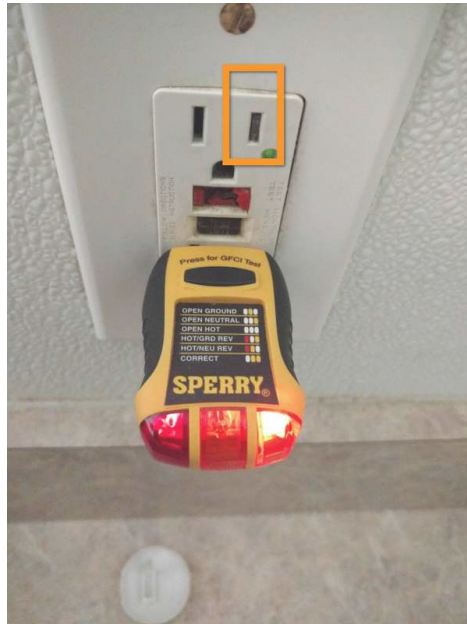
First Floor South Bathroom Top right outlet slot is blocked by a piece of an outlet protector that broke off inside. GFCI Test/Reset button broken.

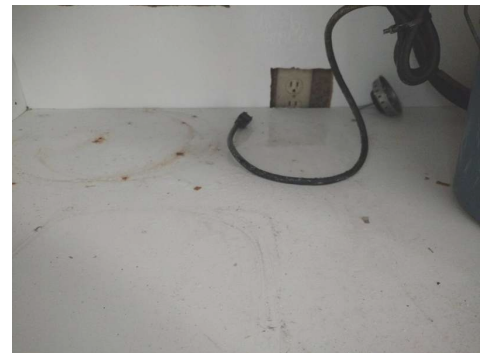
FIRST FLOOR KITCHEN, UNDER THE SINK

### UNSAFE RECEPTACLE LOCATION

In the first floor kitchen, under the sink is an outlet that is at the level of the cabinet floor. Water leaking from the sink could pour into the receptacle creating a potentially dangerous situation.

Contact a qualified electrical contractor.

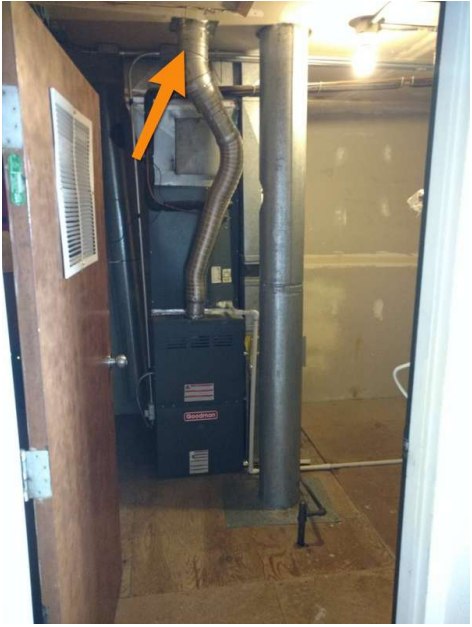
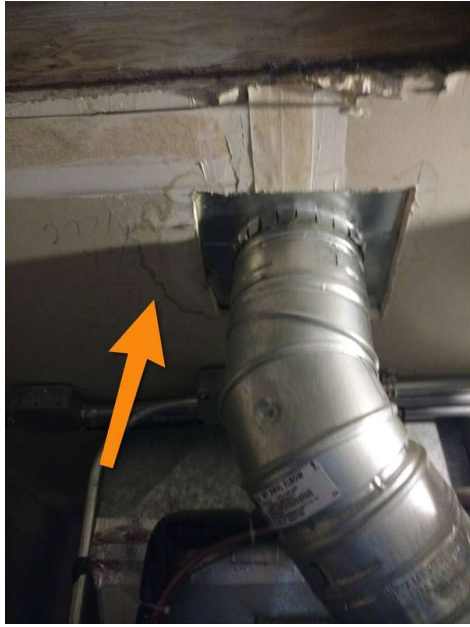
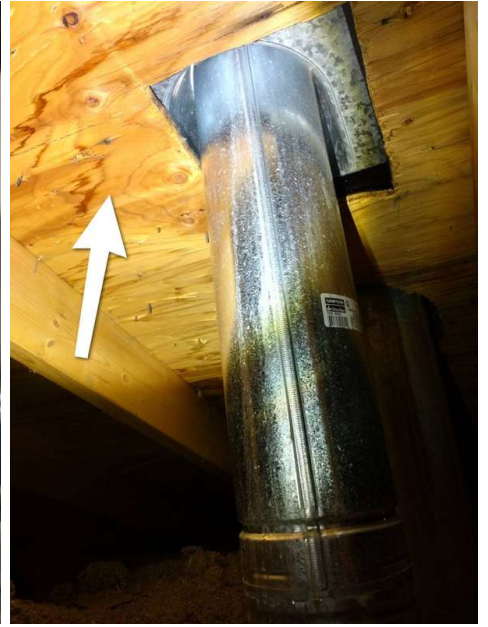
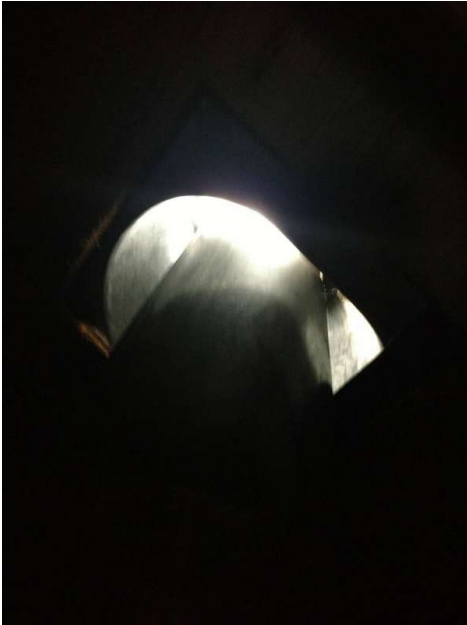
### SIGNS OF WATER ON FURNACE EXHAUST VENT

Signs of moisture intrusion were observed on the furnace exhaust vent. Snow was falling and melting on the roof at the time of inspection and not moisture was detected.

Daylight coming in from around vent pipe.

Contact a qualified professional.

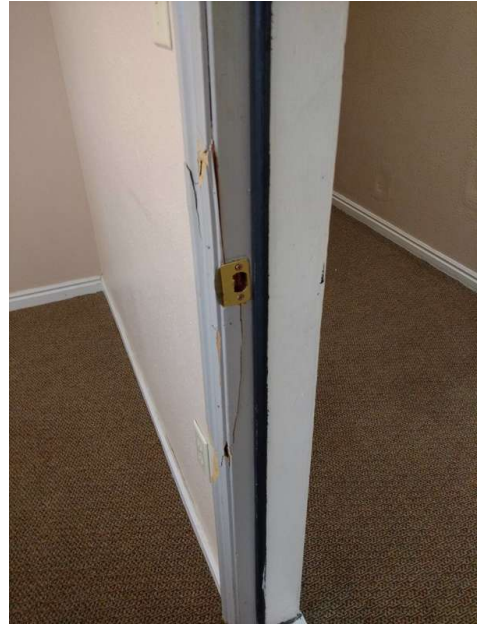
#### **FORCED ENTRY**

Signs of forced entry were observed on door frame in north east office on second floor.

Recommendation  
Contact a qualified professional.

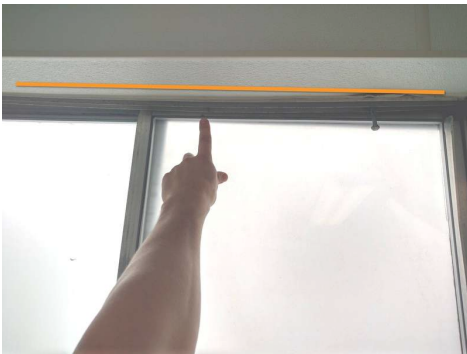
Top of window frame has bowed down in the first floor south bathroom.

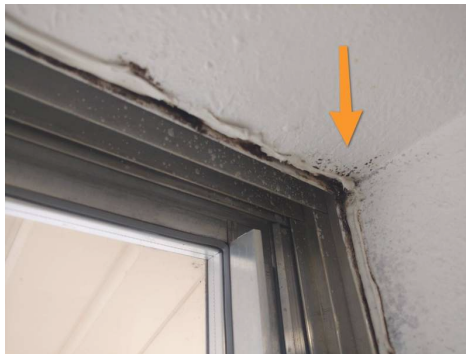
Mold observed around the window in the south bathroom on the second floor. Installing ventilation fans helps mitigate the risk of mold growth in bathrooms.

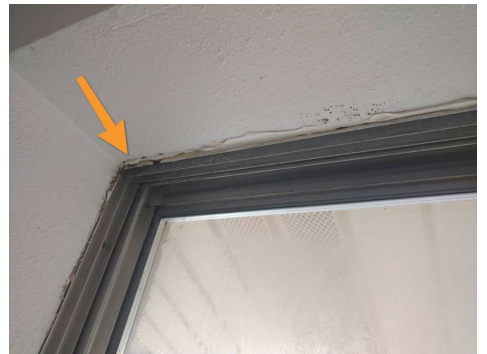
Mold observed around the window in the south bathroom on the second floor. Installing ventilation fans helps mitigate the risk of mold growth in bathrooms.

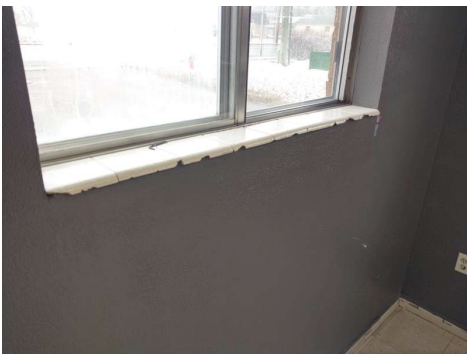
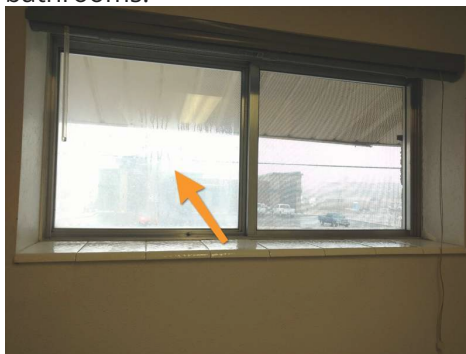
Moisture inside of the window.

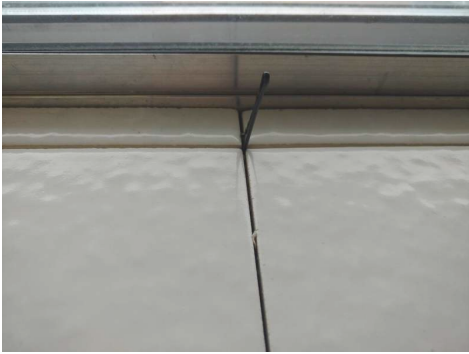
**IMPROPER INSTALLATION**

No grout was observed in a window sill in the north dorm room on the second floor.

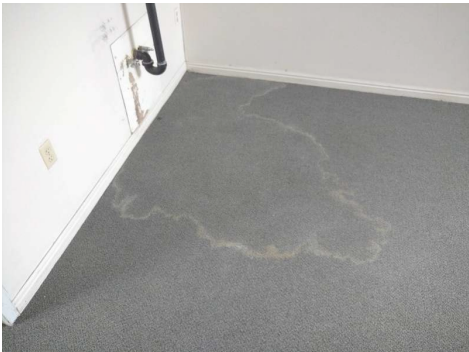
**CARPET STAINS**

Carpet had areas of staining or discoloration. Recommend a thorough steam clean by a qualified carpet cleaning company. No moisture was detected through visual or infrared imaging.

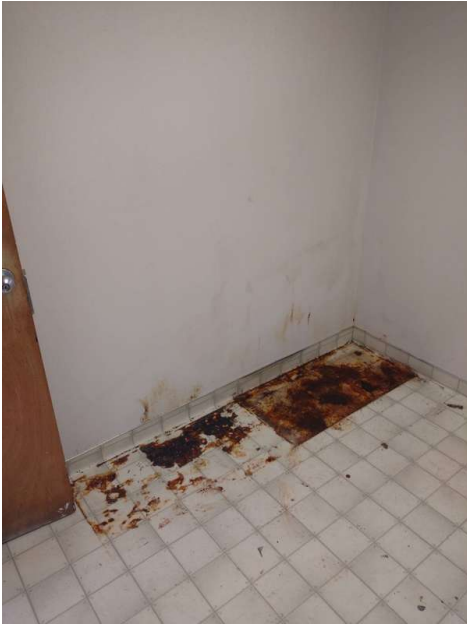
Second floor north bathroom.

**DAMAGED (GENERAL)**

The home had general moderate damage visible at the time of the inspection. Recommend service by a qualified contractor.

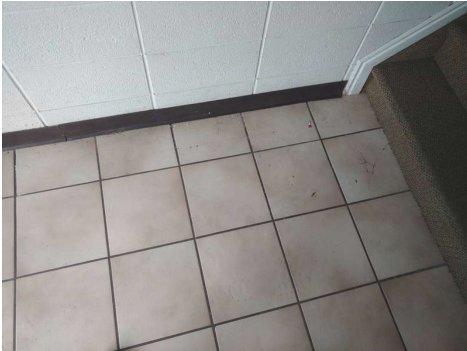
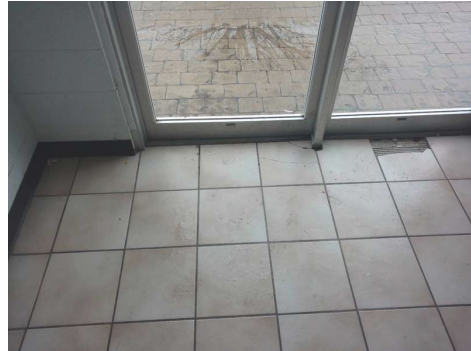
**TILES MISSING**

One or more floor tiles were missing or cracked. Recommend installing/replacing missing tiles in main entryway.

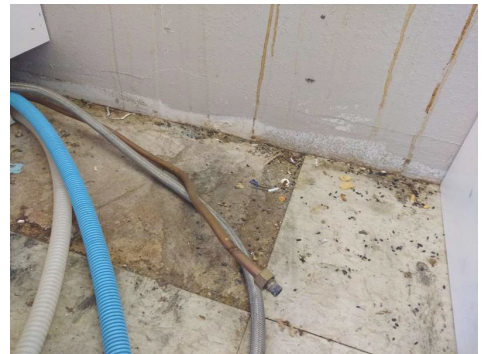
**RODENT DROPPINGS**

Rodent droppings were observed in the first floor kitchen where the dishwasher goes.

Recommendation  
Contact a qualified professional.

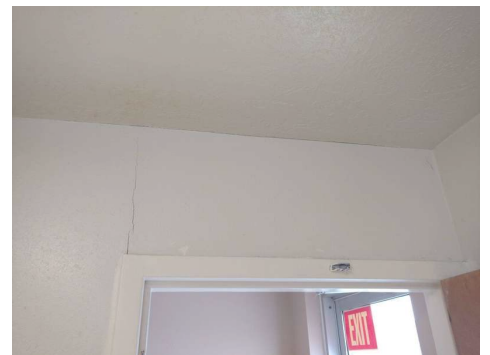
Second floor north bathroom

### MINOR CORNER CRACKS

Minor cracks at the corners of doors and windows in walls. Appeared to be the result of long-term settling. Some settling is not unusual in a home of this age and these cracks are not a structural concern.

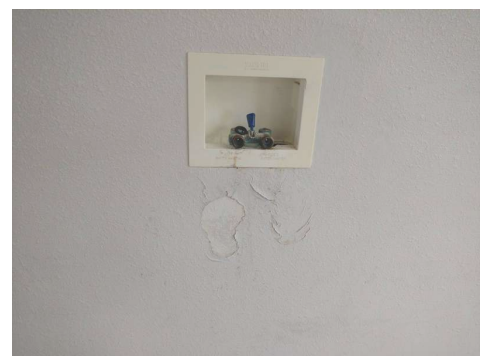
Second floor north dorm.

### MOISTURE DAMAGE

Stains on the walls visible at the time of the inspection appeared to be the result of moisture.

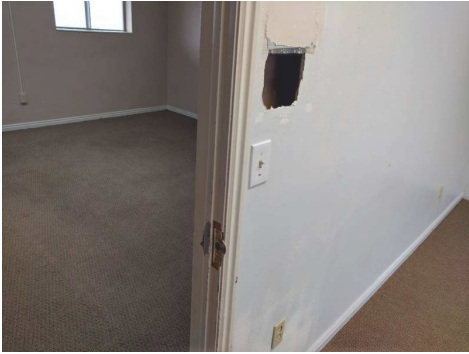
Second floor south dorm.

**POOR PATCHING**

Sub-standard drywall patching observed at time of inspection. Recommend re-patching.

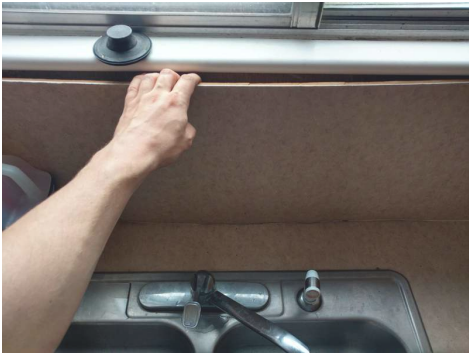
**LOOSE BACK SPLASH**

The back splash in the first floor kitchen is coming loose from the wall.

Recommendation  
Contact a qualified professional.

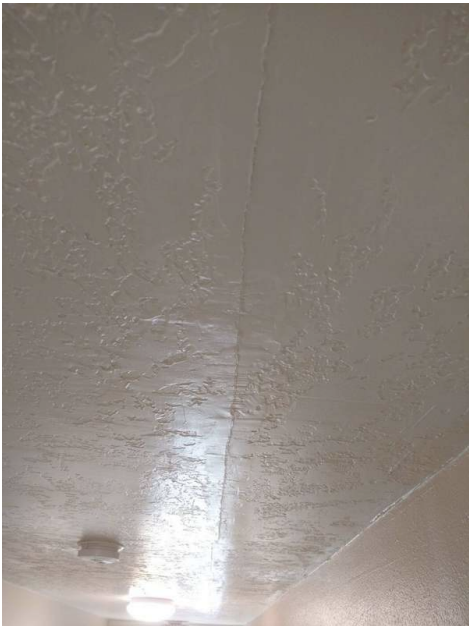
Second floor hallway.

**MINOR DAMAGE**

Paint cracking on the ceiling in the second floor hallway was visible at the time of the inspection. It appears to be cosmetic, possibly from the truss uplift.

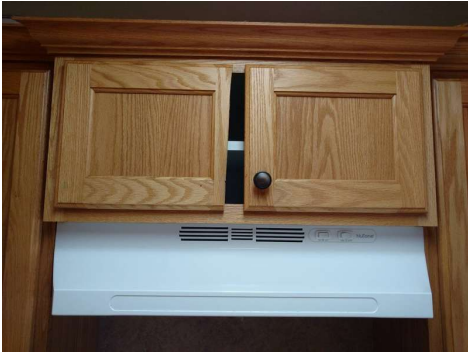
Second floor kitchen.

**CABINETS DAMAGED**

Cabinets had visible damage at time of inspection. Recommend a qualified cabinets contractor evaluate and repair.
