SUMMARY

1234 Main St.colden NY 14033

Bradley Beck
N.Y.S. Licensed Home Inspector...
Alto Home Inspection, LLC
716-222-2586
brad@altohi.com

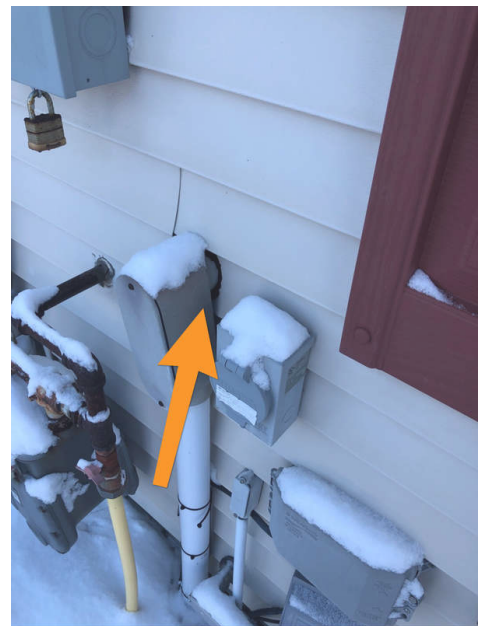
3.1.1 Siding, Flashing & Trim

SEAL GAP IN SIDING

RIGHT SIDE OF HOME

Gaps in the siding were observed which were not properly sealed. It is recommended that these gaps are properly sealed in order to prevent moisture intrusion and damage to underlying building materials.

Contact a qualified siding specialist.

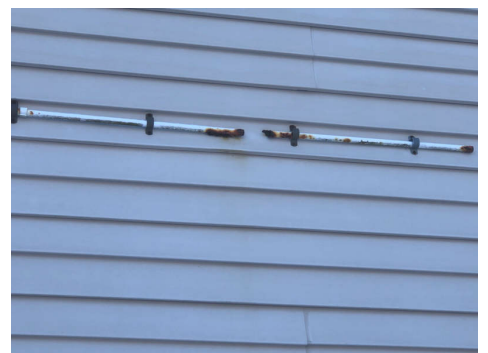
3.1.3 Siding, Flashing & Trim

NON-FUNCTIONAL ITEM

RIGHT SIDE OF HOME

Contact a qualified professional.

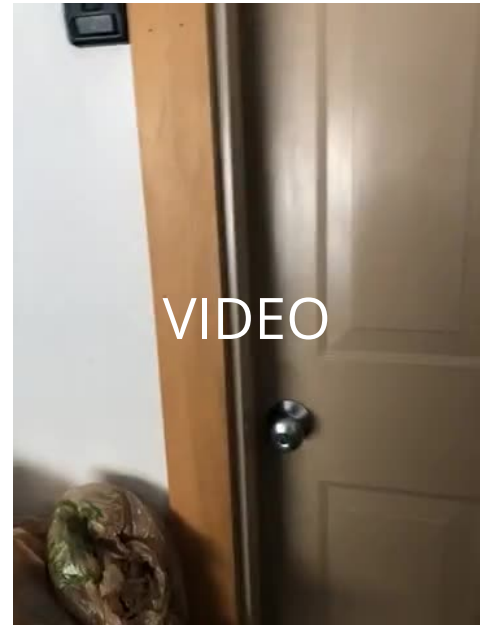
5.3.1 Occupant Door (From garage to inside of home)

NOT SELF-CLOSING

Door from garage to home should have self-closing hinges to help prevent spread of a fire to living space. Recommend a qualified contractor install self-closing hinges.

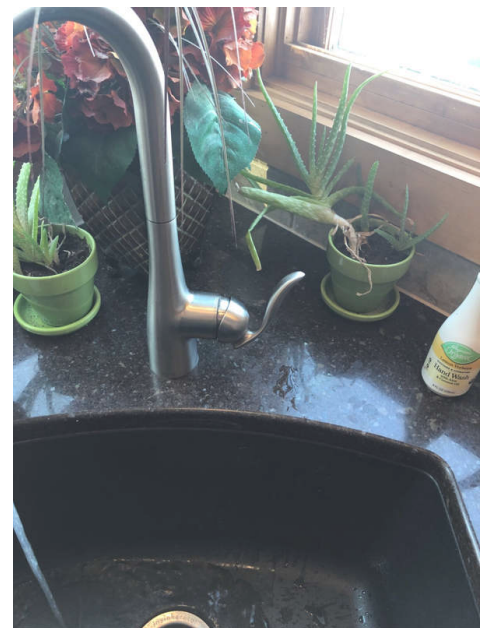
6.4.1 Sink(s), Faucet(s), Sprayer & Drain

HANDLE DIRECTION REVERSED

The kitchen sink faucet handle was installed so that hot water is produced when the handle is pulled toward the operator. This presents a safety concern for small children who are able to reach the handle, and may expect cool water to be produced. Typically the faucet can be reconfigured by a plumber at low cost.

Contact a qualified plumbing contractor.

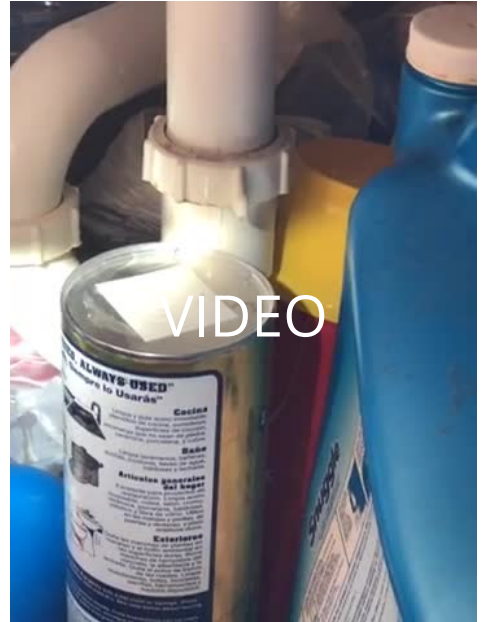
7.4.1 Visible Plumbing

ACTIVE LEAK

1ST FLOOR

An active leak in the exposed plumbing under the laundry sink was observed.

Contact a qualified plumbing contractor.

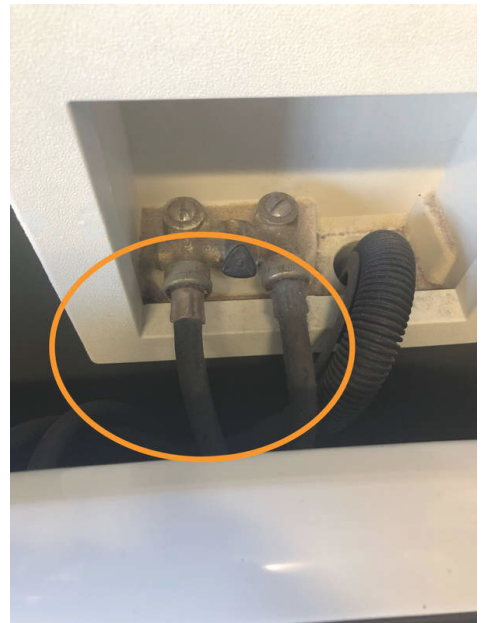
7.4.2 Visible Plumbing

REPLACE FLEXIBLE SUPPLY LINE

Burst flexible water supply lines that connect faucets, toilets, laundry washing machines and dishwashers to the home's plumbing system are a large cause of water damage to homes. Over time, the rubber in these becomes brittle, and the stainless steel that reinforces the rubber in certain types loses its integrity because of corrosion. It is recommended that these supply lines are replaced, unless it can be confirmed that they are less than five years old.

Contact a qualified plumbing contractor.

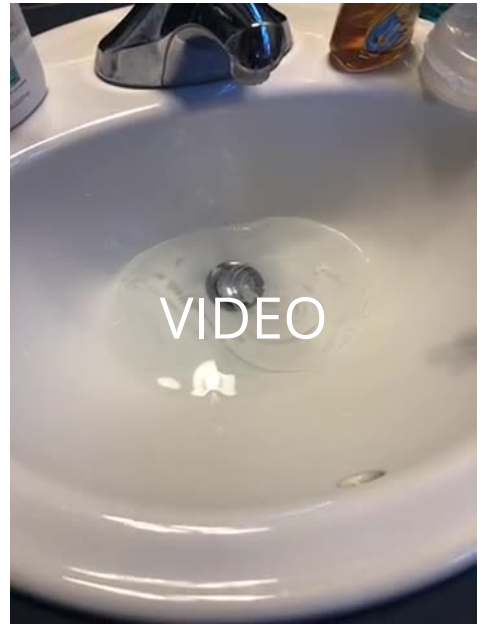
8.2.1 Sink(s)

SLOW DRAIN

2ND FLOOR

A bathroom sink drained slowly. Most likely, the drain needs to be cleaned.

Contact a qualified plumbing contractor.

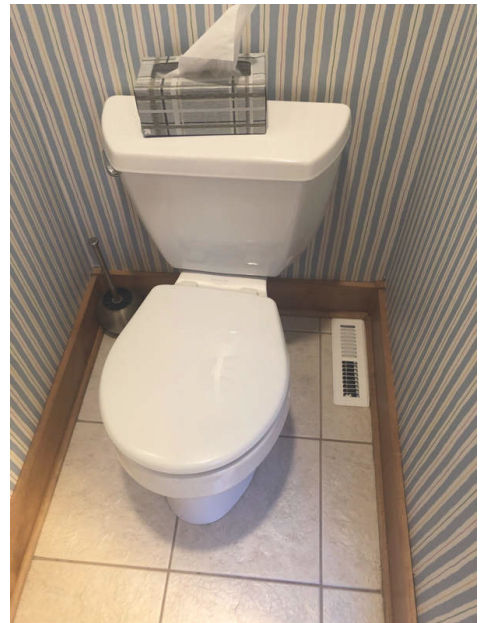
8.6.2 Toilet(s)

TOILET LOOSE

2ND FLOOR

A toilet was loosely attached to the floor. Generally, tightening the floor bolts will correct this condition.

Contact a handyman or DIY project

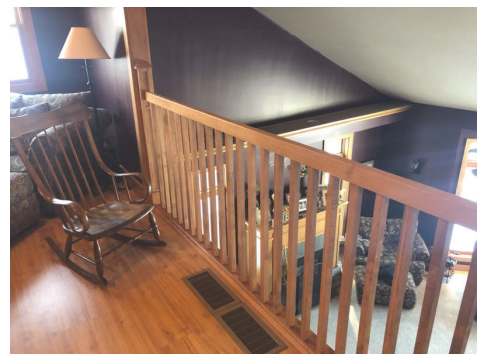
9.4.1 Steps, Stairways & Railings

LOOSE HANDRAIL

The railing at the loft area moved more than expected when shaken. It is recommended to bolster the strength of the handrail in order to better protect small children from potentially breaking the railing.

Contact a qualified carpenter.

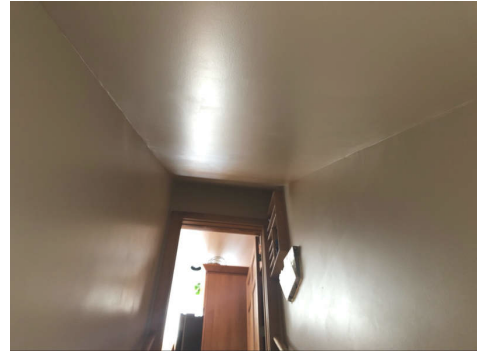
9.4.3 Steps, Stairways & Railings

MISSING STAIRWAY LIGHTING

BASEMENT

Contact a qualified professional.

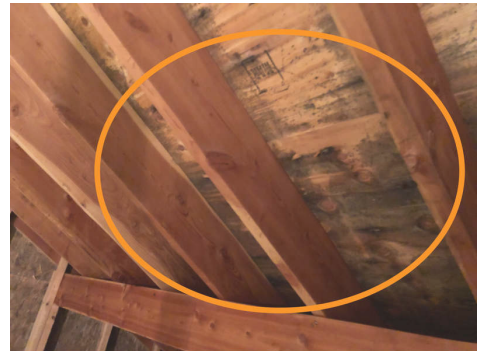
10.4.1 Attic Insulation & Air Leakage

INSUFFICIENT ATTIC VENTILATION

Ridge and soffit vents were installed in the home, however microbial growth in the underside of the roof sheathing was present. Less than adequate ventilation is a large contributor to microbial growth. Install additional ventilation in the attic, potentially at the gable ends of the roof.

MICROBIAL GROWTH

Signs of microbial growth were present. Improving air flow and insulation may reduce the likelihood of this condition worsening. Monitor the area and contact a mold assessment company for evaluation if it remains present.

Contact a qualified roofing professional.

Contact a qualified mold inspection professional.

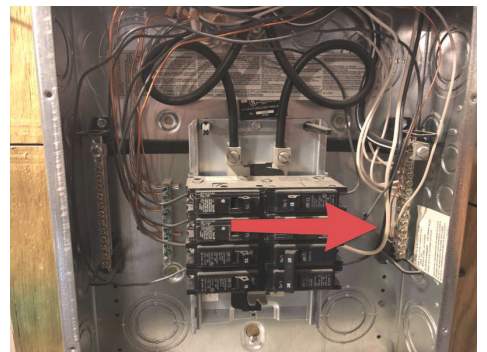
14.3.1 Distribution Panel/Sub-Panel

GROUND WIRE INSTALLED ON NEUTRAL BUS IN SUBPANEL

The sub panel has separate ground and neutral bus bars, as required. However, a circuit was wired to have its ground and neutral wired attached to the same bus bar. Have an electrician relocate the ground wire to the correct bus bar.

Contact a qualified electrical contractor.

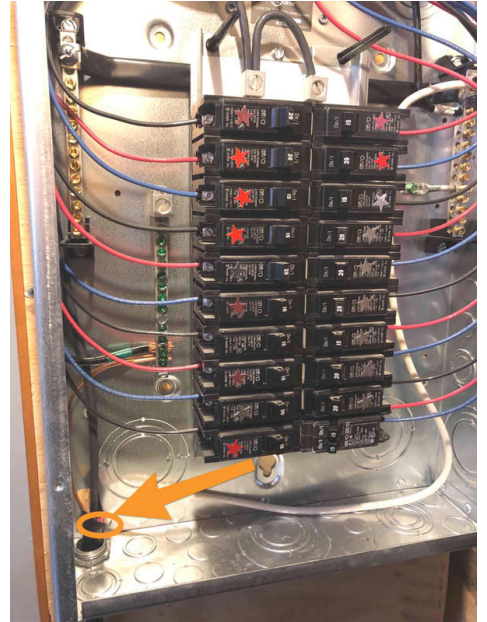
14.3.2 Distribution Panel/Sub-Panel

UNCAPPED AND EXPOSED WIRING

A stray uncapped wire was visible in the panel adjacent and to the right of the main service service panel. This wire should be capped or otherwise protected.

Recommendation
Contact a qualified electrical contractor.

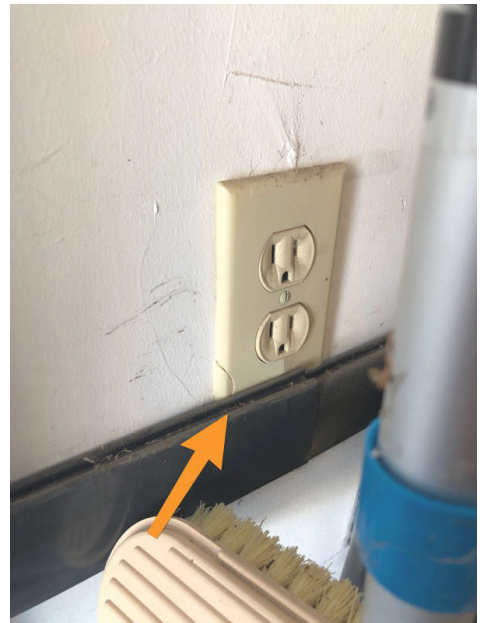
14.7.1 Receptacles

COVER PLATE(S) DAMAGED

A damaged electrical cover plate was observed. Cover plates are intended to keep hands, fingers, pets and vermin away from live electricity and are meant to contain any sparks or fires within the box. Replacement of the damaged cover plate by a qualified electrician is recommended.

Recommendation
Contact a qualified electrical contractor.

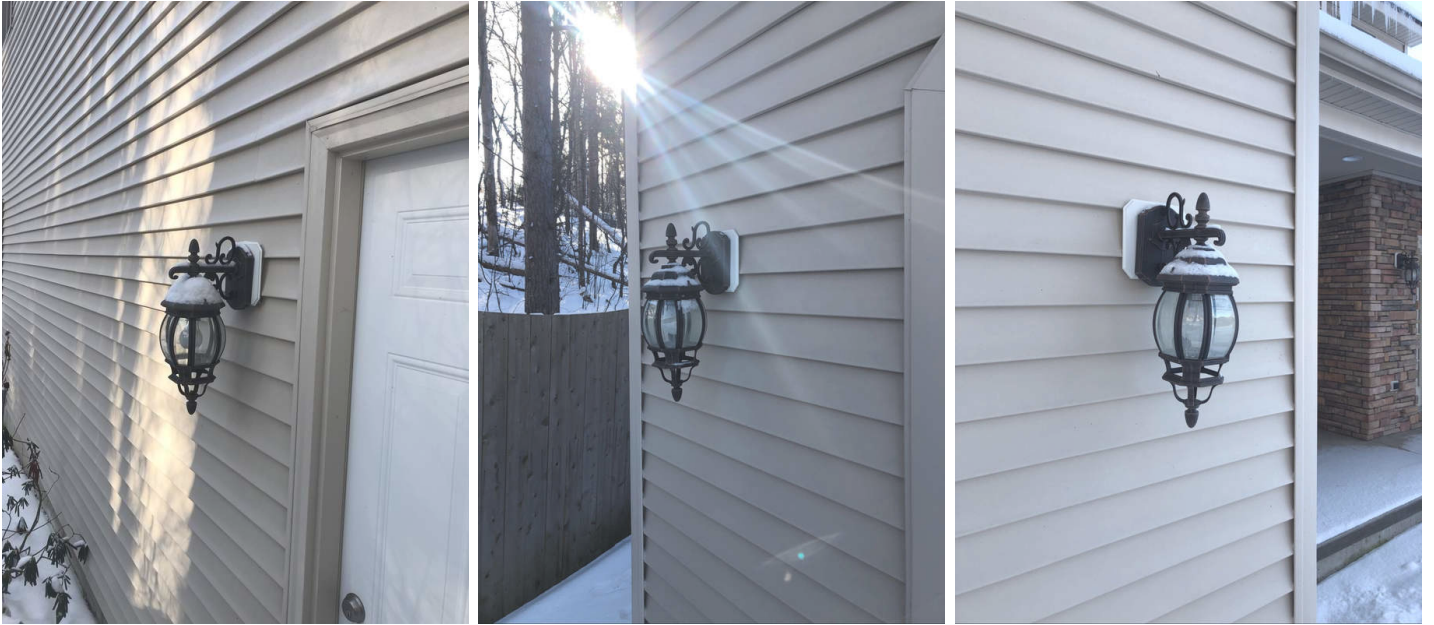
LOOSE FIXTURE

LEFT SIDE OF HOME FRONT OF HOME

Contact a qualified professional.
