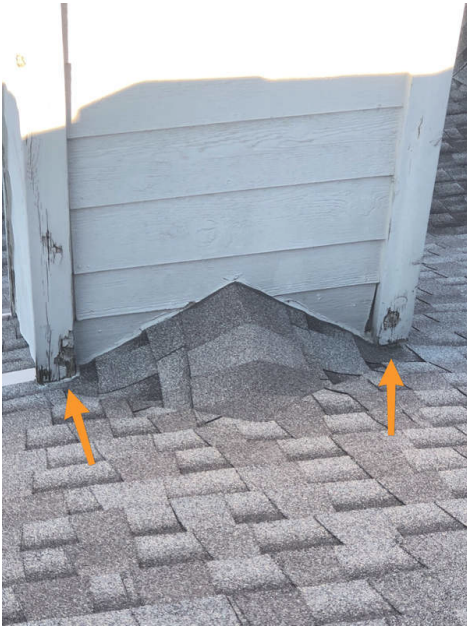
**CHIMNEY SIDING REPAIR**

Siding around chimney was seen to be worn and deteriorating. Recommend siding contractor evaluate and repair.

Contact a qualified chimney contractor.

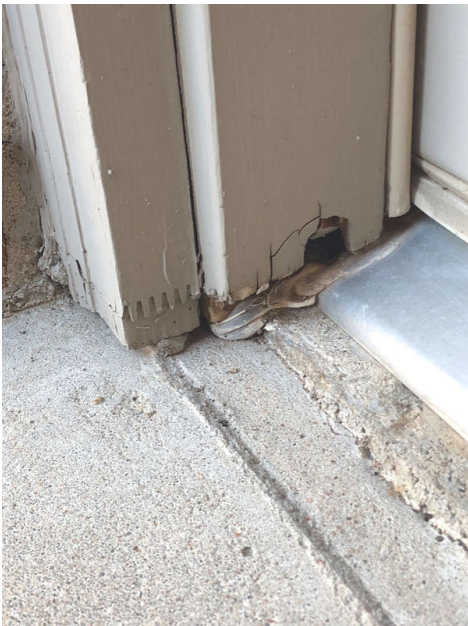
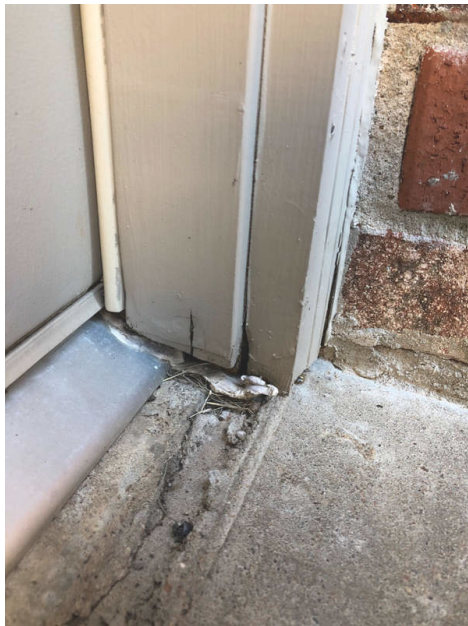
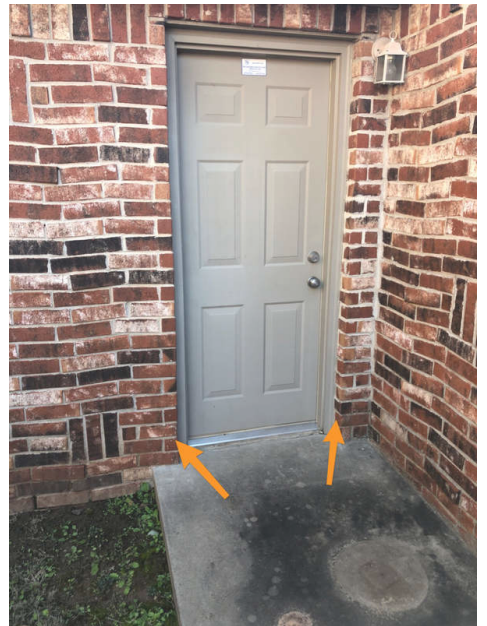
#### **DOOR SILL/TRIM**

Door sill and/or trim is loose, deteriorated or worn and repair or replacement should be considered.

Contact a qualified door repair/installation contractor.

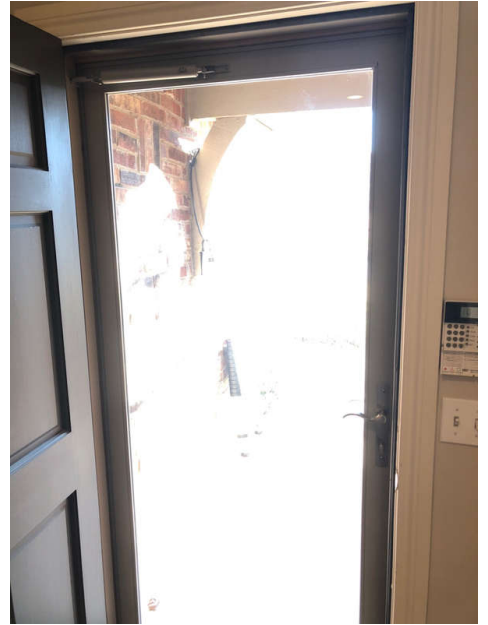
#### **HAZARD**

I recommend adjusting the front storm door. It closes quickly and could be a safety hazard.

Contact a qualified professional.

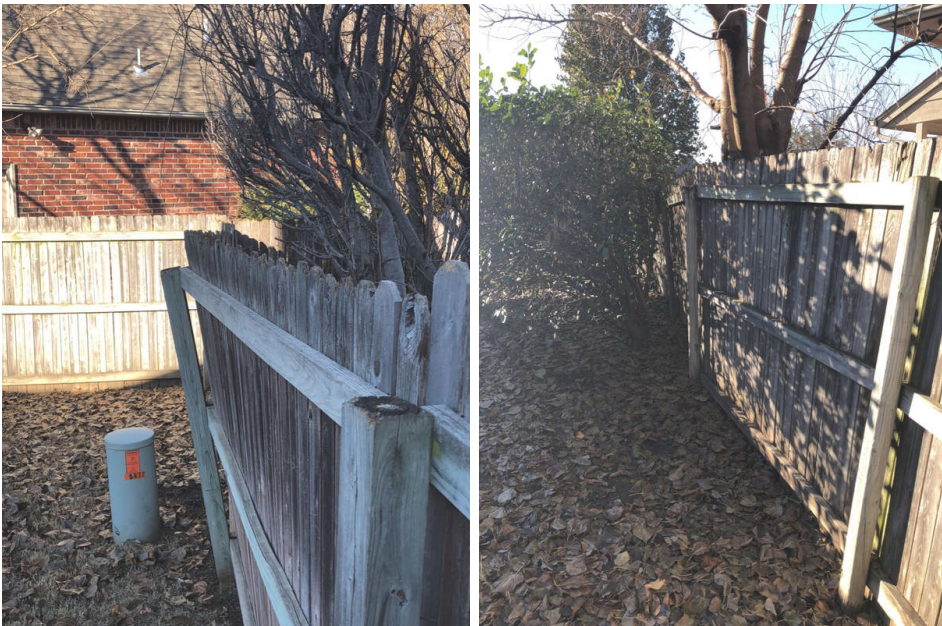
### 3.7.1 Fence **DAMAGE**

The fence was Leaning and uneven at several sections. I recommend repairing to keep fence structure from further failing.

Recommendation  
Contact a qualified fencing contractor

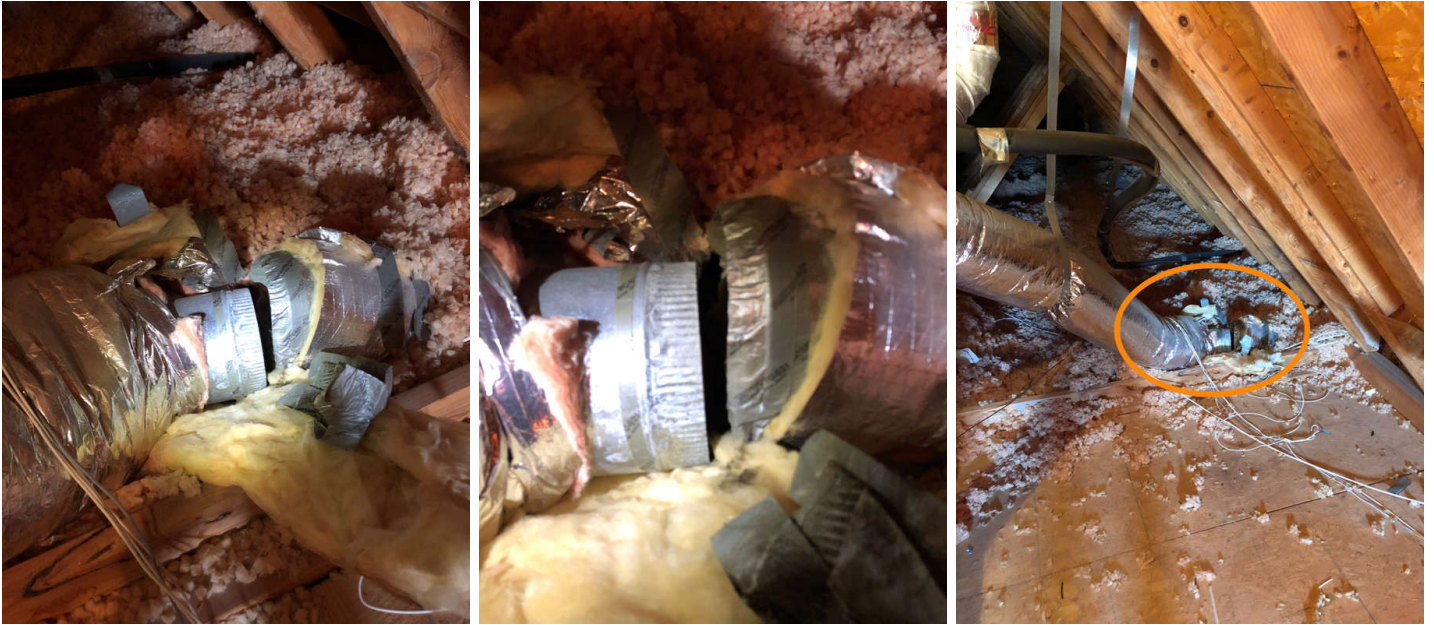
### 5.3.1 Distribution Systems **DUCTS NOT SEALED**

Air supply duct was not properly sealed in attic. Recommend a qualified HVAC contractor evaluate and repair.

Recommendation  
Contact a qualified HVAC professional.

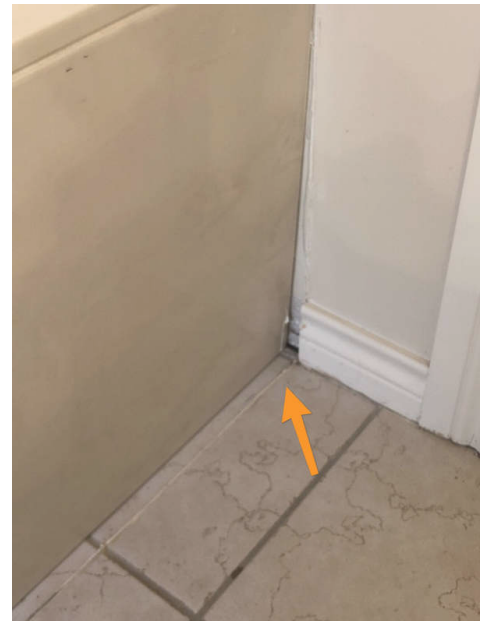
#### 7.6.2 Jetted Tub **LOOSE PANEL**

The master tub panel was seen to be pushing back. Recommend front panel be secure to avoid prematurely opening or causing damage.

Contact a qualified professional.

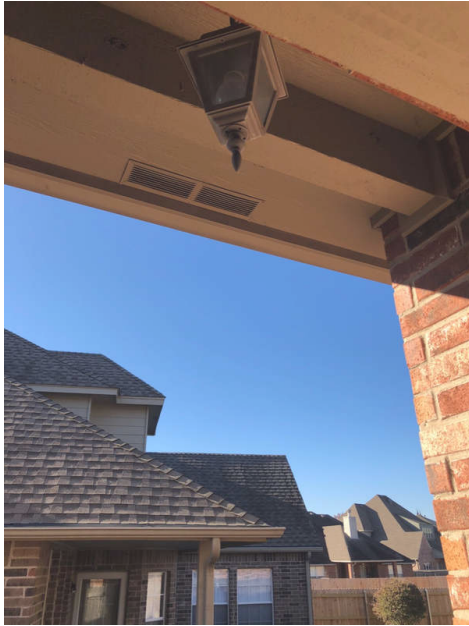
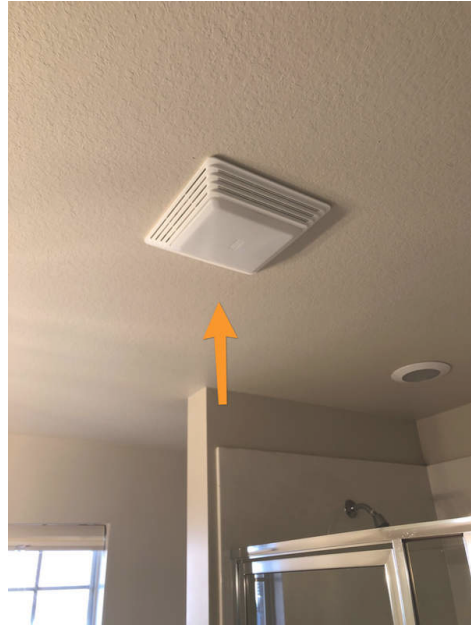
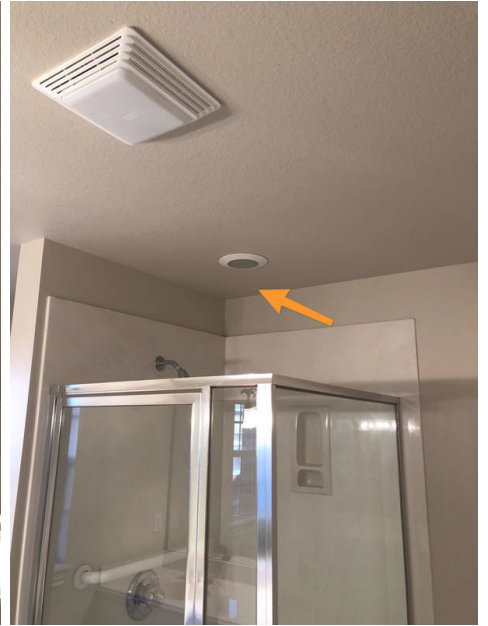
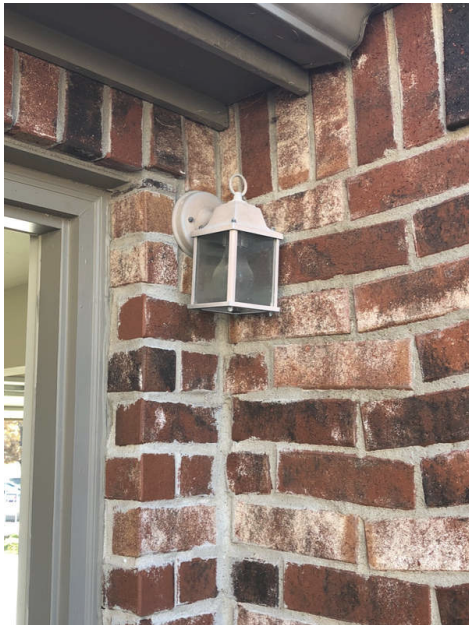
#### **LIGHT INOPERABLE**

One or more lights are not operating. New light bulb possibly needed.

Recommendation  
Contact a qualified electrical contractor.

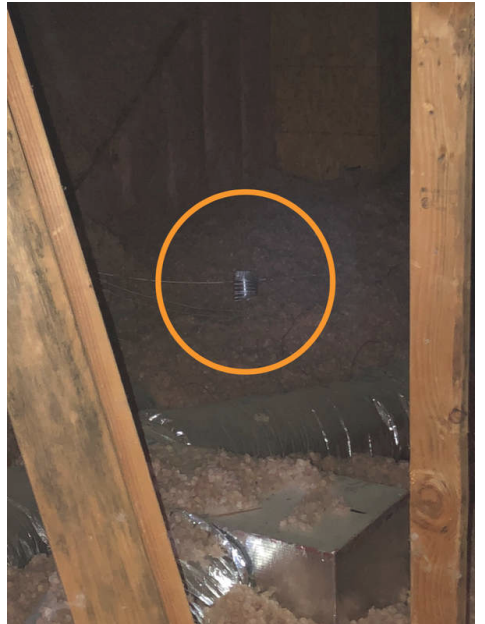
#### **BATHROOM VENTS INTO ATTIC**

Bathroom fan vents into the attic, which can cause moisture and mold. Recommend a qualified attic contractor properly install exhaust fan to terminate to the exterior or to a larger opening space into attic.

Contact a qualified HVAC professional.

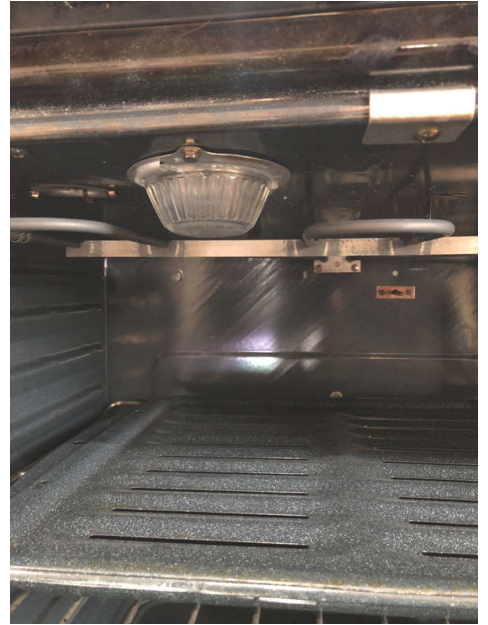
#### **BURNER NOT LIGHTING**

Oven light was inoperable during inspection. A new bulb may be needed.

Recommendation  
Contact a qualified handyman.
