SUMMARY

1234 Main St. Florence AL 35633

Kel Thomas
AL Licensed Inspector # HI-4205
Singing River Property Inspections
256-349-3815
kt@singingriverinspections.com

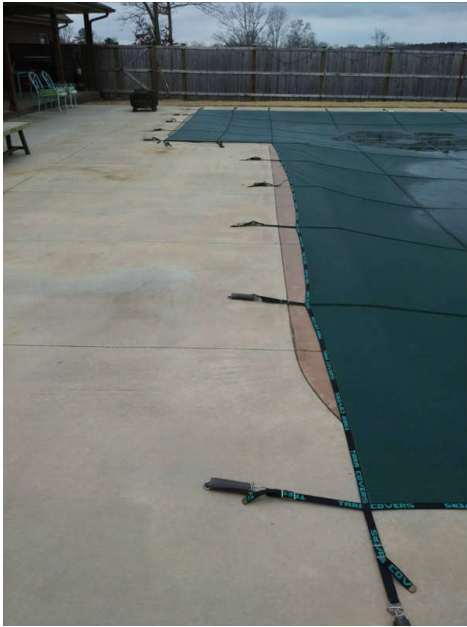
4.2.1 Safety

SAFETY BARRIER

INGROUND POOL

Safety Hazard

Recommendation
Contact a qualified professional.

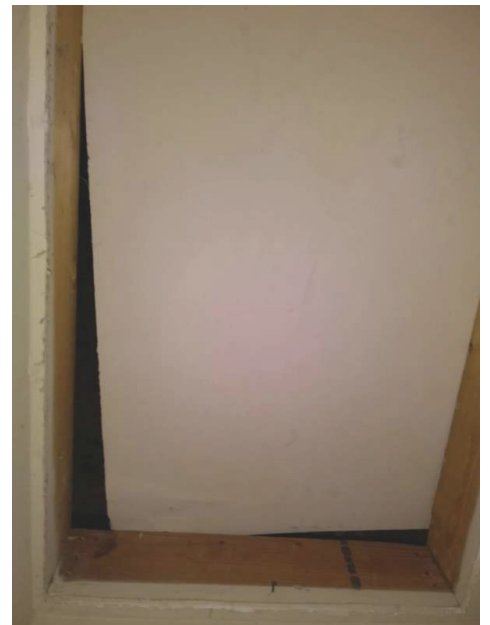
6.5.1 Roof Structure & Attic

ILL FITTING HATCH

2ND FLOOR HALLWAY CLOSET ATTIC ACCESS

It is recommended to repair/refit attic access hatch. This repair will increase energy efficiency by restricting heated or cooled air from escaping into the attic.

Contact a handyman or DIY project

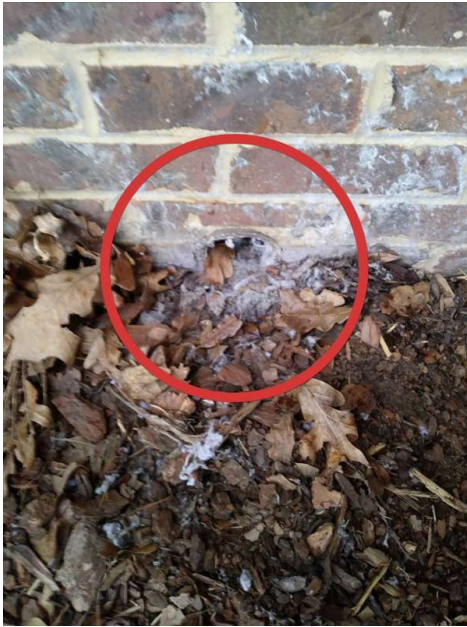
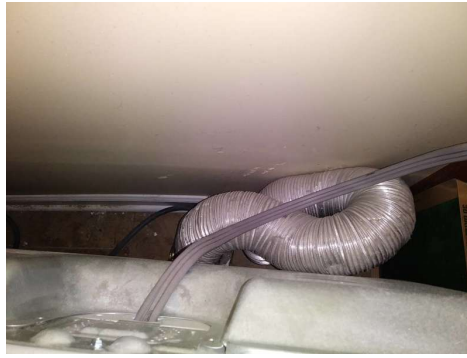
12.1.1 General

DRYER VENTING

Currently, the dryer vents directly to the exterior to just above grade level. There is no flapper to prevent rodents or water intrusion entering the vent. In addition, the dryer vent tubing appears to be too long for this application. It is recommended to evaluate and correct as needed.

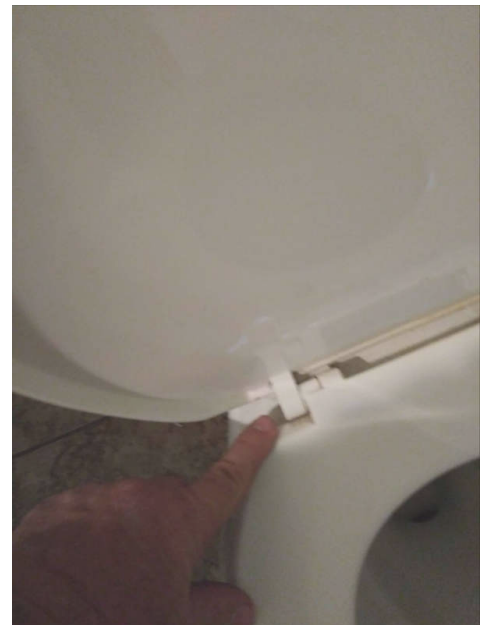
13.3.1 Toilets

TOILET SEAT LOOSE

2ND FLOOR BATHROOM

Toilet seat is loose. Recommend tightening to prevent further loosening.

Contact a handyman or DIY project

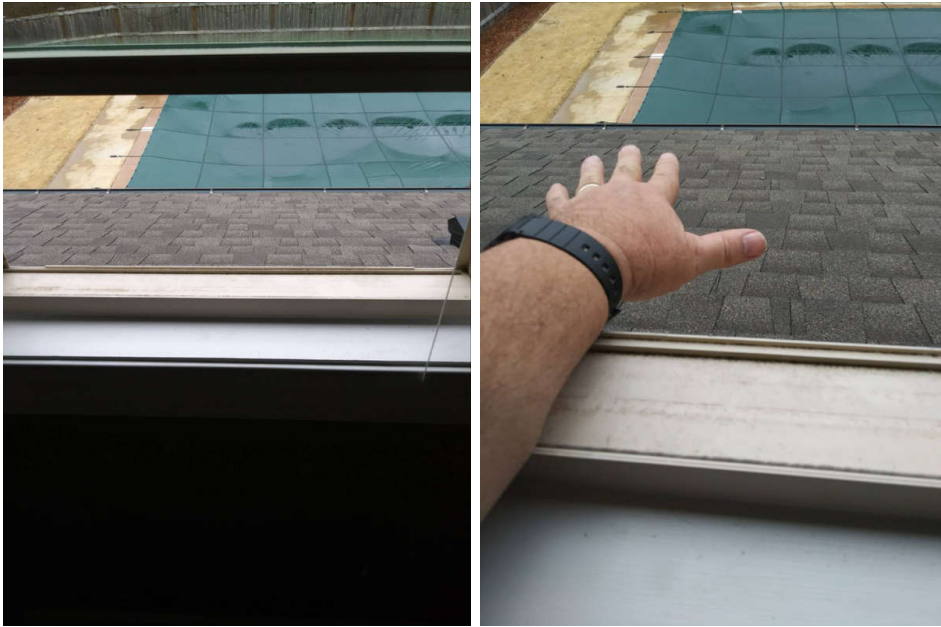
14.2.1 Windows

MISSING OR DAMAGED SCREEN

Window missing or damaged screen in numerous locations. Recommend replacement.

Contact a qualified window repair/installation contractor.

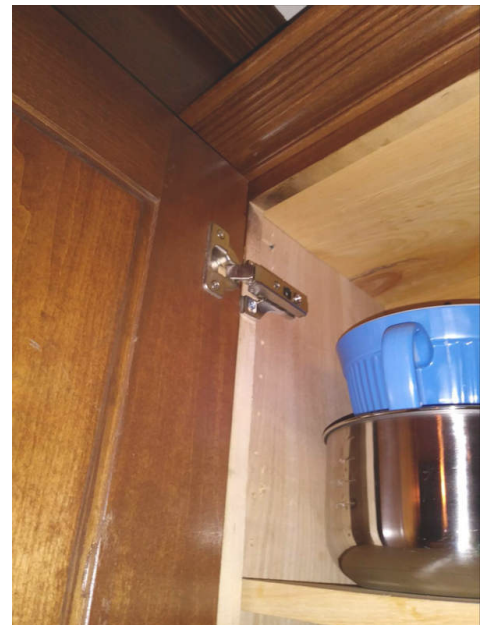
16.1.1 Countertops & Cabinets

CABINET HINGE LOOSE

KITCHEN

One or more cabinet hinges were loose. Recommend a qualified handyman or DIY repair.

Contact a handyman or DIY project
