SUMMARY
 1234 Main St. Tonawanda NY 14150
 Buyer Name
 09/05/2018 9:00AM

Summary of items inspected.

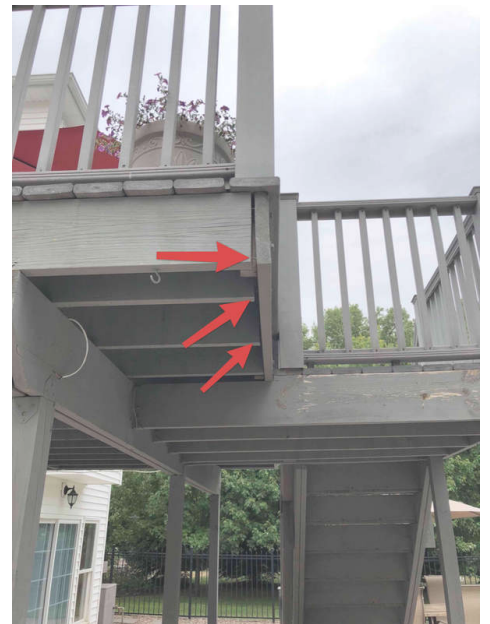
2.2.1 Decks, Balconies, Porches & Steps

DECK - LOOSE BOARDS

One or more deck boards were observed to be loose. Recommend they be refastened.

Recommendation
 Contact a qualified deck contractor.

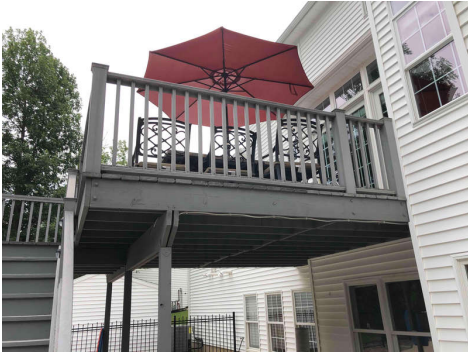
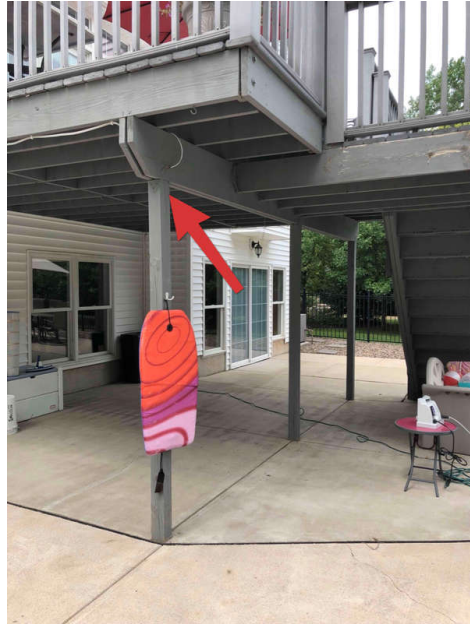
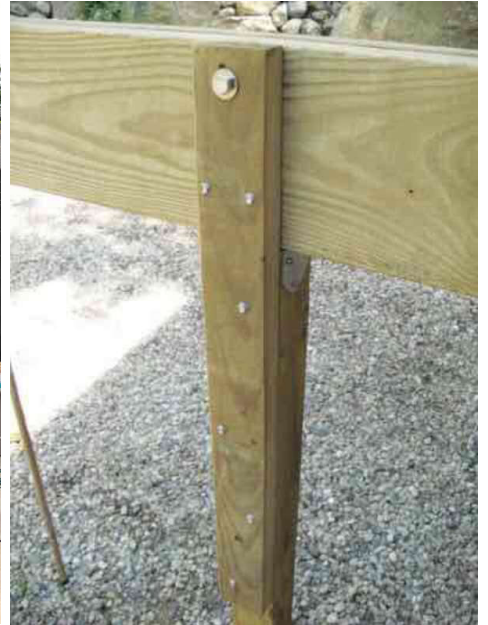
2.2.2 Decks, Balconies, Porches & Steps

IMPROPER DECK CONSTRUCTION PRACTICES

Deck was observed to have general poor construction. Recommend qualified deck contractor evaluate. These construction practices may have been normal at time of original construction, but do not meet current safety standards.

Example photo of a recommended repair for the improper post to beam connections

Recommendation
 Contact a qualified deck contractor.

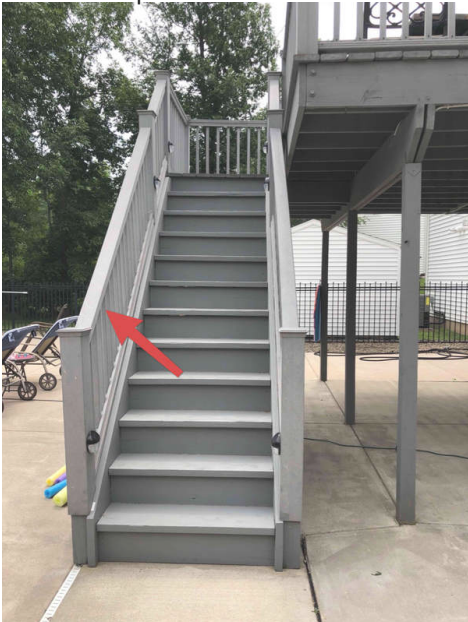
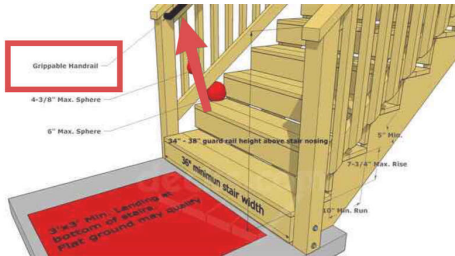
2.2.3 Decks, Balconies, Porches & Steps **IMPROPER HANDRAIL**

Potential Safety Hazard

Steps to deck handrail does not meet current safety standards recommend licensed contractor to repair to current standards to prevent possible injury

Recommendation
Contact a qualified deck contractor.

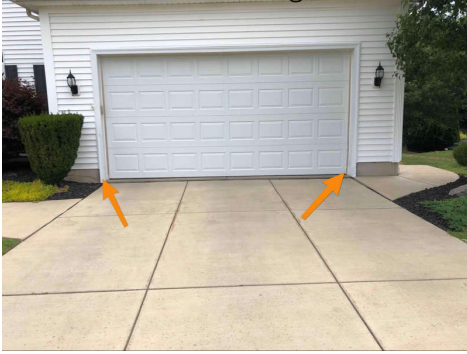
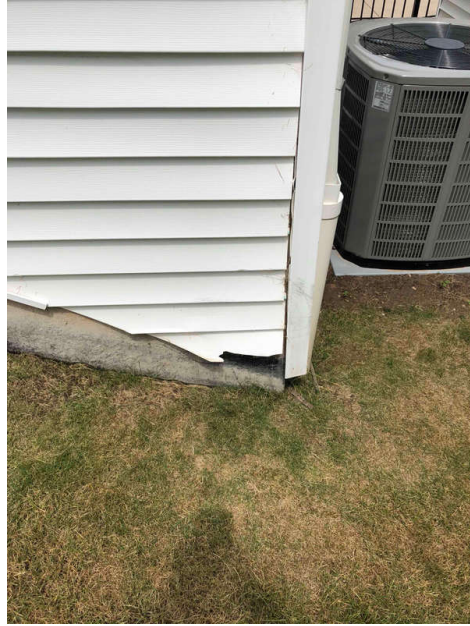
3.1.1 Siding, Flashing & Trim **SIDING FLASHING & TRIM STATUS**

Siding, flashing and trim were observed to be fair condition at time of inspection. Normal maintenance may be necessary to prevent damage from occurring.

Recommendation
Recommend monitoring.

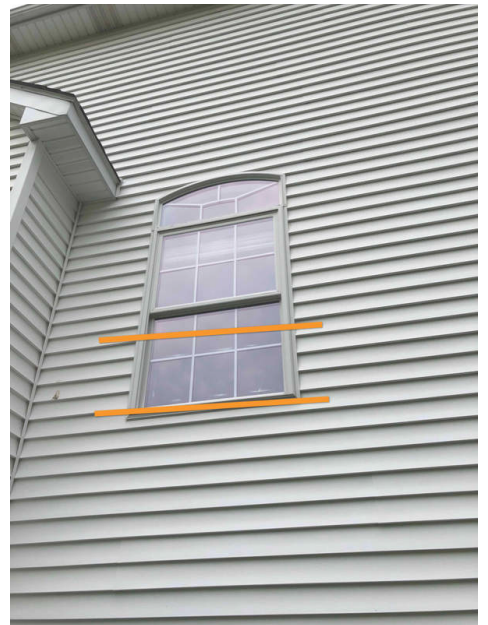
3.2.1 Exterior Windows

FAILED SEAL

Observed condensation between the window panes, which indicates a failed thermo pane seal. Recommend qualified window contractor evaluate & replace.

Northwest

Recommendation
Contact a qualified window repair/installation contractor.

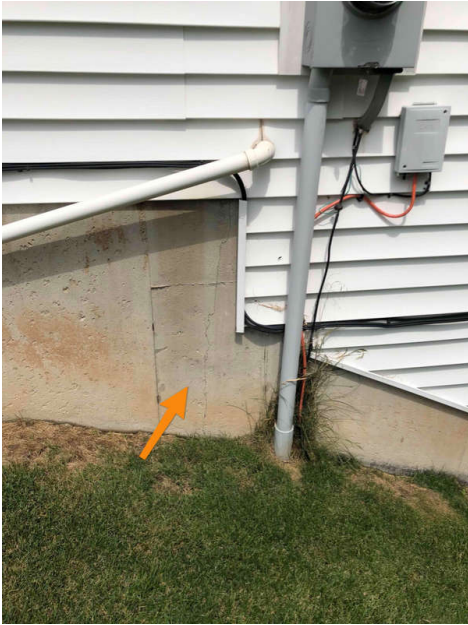
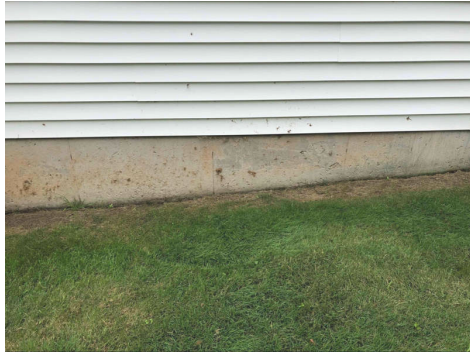
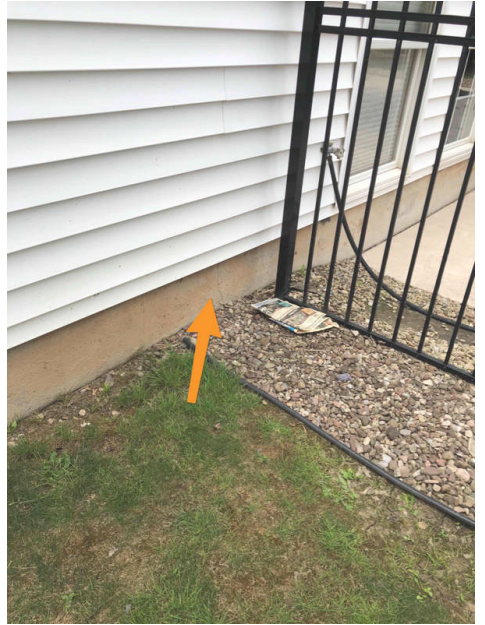
3.7.1 Exterior foundation

TYPICAL CRACKING

Exterior foundation contains typical cracks due to shrinkage and normal freeze thaw cycle. Recommend patching as needed to prevent moisture intrusion.

East

Recommendation
Contact a foundation contractor.

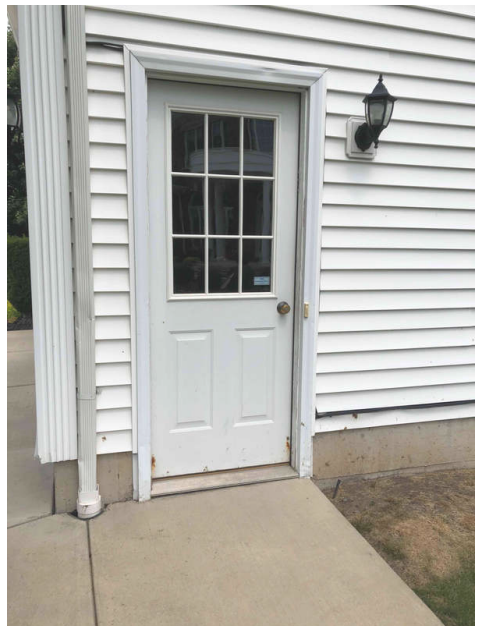
5.8.1 Manual door
MAN DOOR RUST

Garage man door has rust and appears to be corroding from inside out. Recommend replacement.

Recommendation
Contact a qualified door repair/installation contractor.

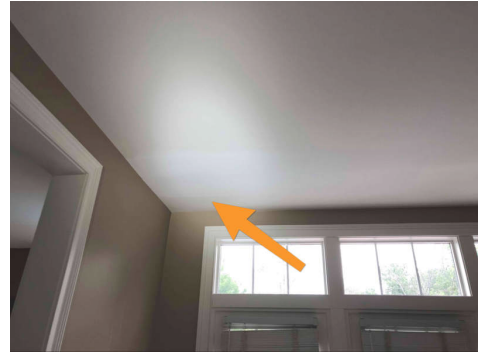
6.4.1 Walls and Ceilings
MOISTURE DAMAGE

Stains on the walls visible at the time of the inspection appeared to be the result of moisture intrusion. The source of moisture may have been corrected. Recommend further examination by a qualified contractor to provide confirmation.

Kitchen ceiling near door to deck has been repainted evidence of a prior water damage incident repair appears proper no further repair required at this time

Contact a qualified professional.

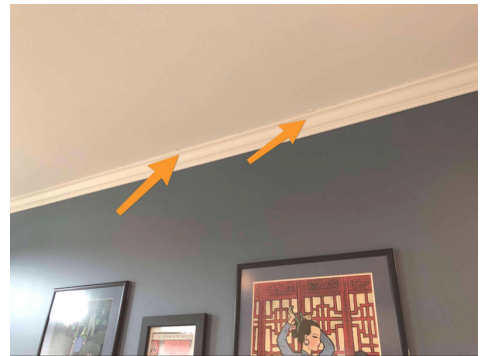
7.4.1 Walls and Ceilings

NAIL POPS

"Nail-pops" are evident in some areas of drywall where ceilings meet walls. This is common as a home ages due to expansion and contraction of building materials. Recommend repair as needed by licensed contractor.

Living Room Northwest

Contact a qualified drywall contractor.

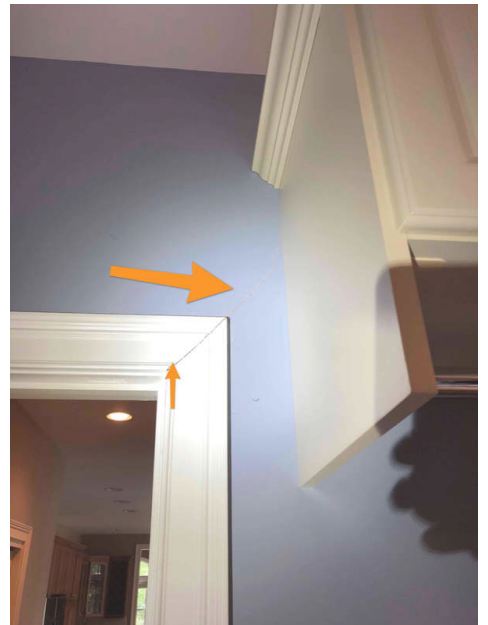
9.4.1 Walls and Ceilings

MINOR CORNER CRACKS

Minor cracks at the corners of doors and windows in walls. Appeared to be the result of cabinets installed on this wall. Recommend monitoring for change, consult with a licensed contractor if cracks progress further

Contact a qualified professional.

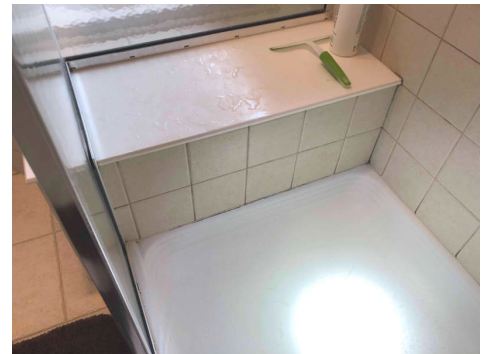
11.4.2 Walls and Ceilings

CAULKING/GROUTING IN SHOWER/TUB AREA

Tiles installed in Tub/Shower area have gaps or missing Grout/Caulk. Recommend licensed contractor to repair/replace as needed to prevent moisture damage.

Contact a qualified tile contractor

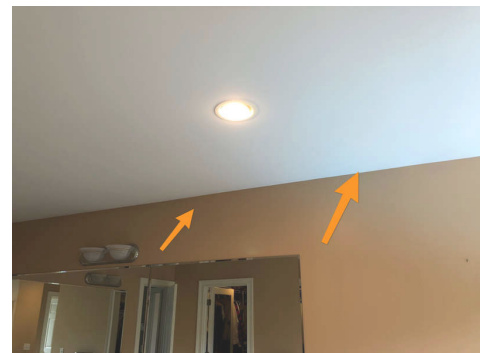
11.4.3 Walls and Ceilings

NAIL POPS

Protruding nail heads visible at the time of the inspection appeared to be the result of contact with moisture. After the source of moisture is located and corrected, protruding nails should be removed, drywall re-fastened and the drywall finished to match the existing wall surfaces. All work should be performed by a qualified drywall or painting contractor.

Contact a qualified drywall contractor.

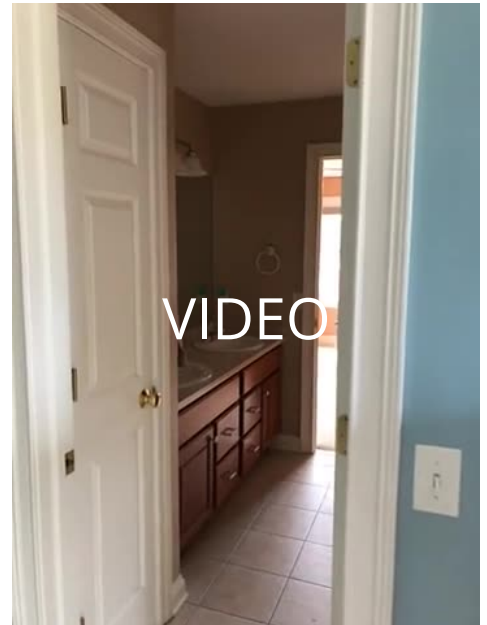
DEFECTIVE 3-WAY SWITCHING

Bathroom light three-way switch does not appear to be operating properly recommend licensed electrician to further evaluate and repair for proper operation.

Contact a qualified electrical contractor.

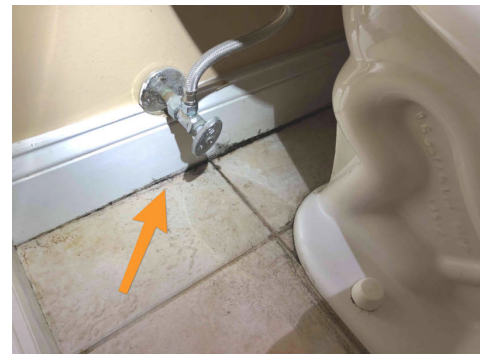
POSSIBLE MOLD

There are possible signs of fungi growth. It is unknown if this is a safety hazard. Recommend a qualified mold inspector evaluate.

Basement bathroom dark staining behind toilet appears as a possible mold like substance recommend further evaluation by a licensed environmental contractor

Contact a qualified mold inspection professional.

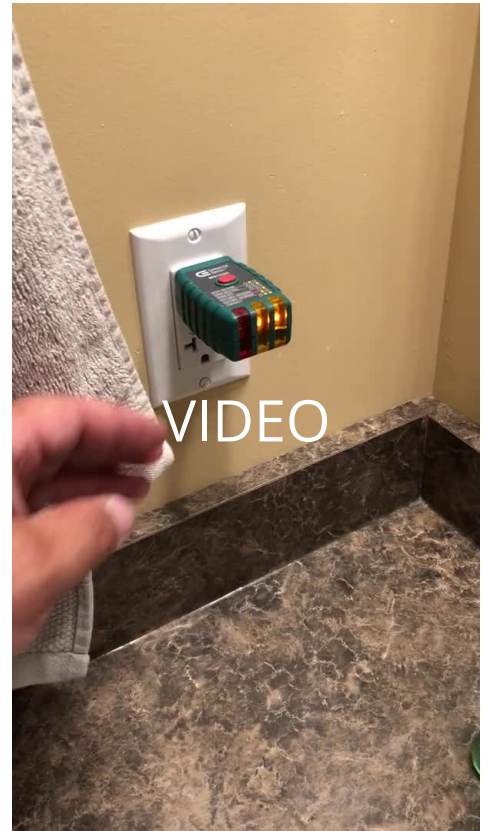
GFCI FAILED TO TRIP

Bathroom GFCI receptacle failed to trip when tested, recommend licensed electrician to evaluate and repair as needed to prevent possible injuries.

Contact a qualified electrical contractor.

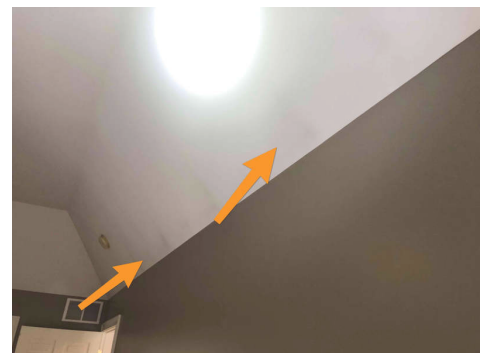
15.1.2 Walls and Ceilings

GHOSTING

Parallel consistent ghost like staining observed on surface of drywall this is typical evidence of improper installation or movement of air recommend licensed contractor to further evaluate

Contact a qualified professional.
