SUMMARY
1234 Main St. Colorado Springs CO
80920
Buyer Name
02/11/2019 9:00AM

Lance Hayward
Certified Master Inspector / Owner
A Precise Home Inspection, Inc.
719.466.1335
lance.aprecise@gmail.com

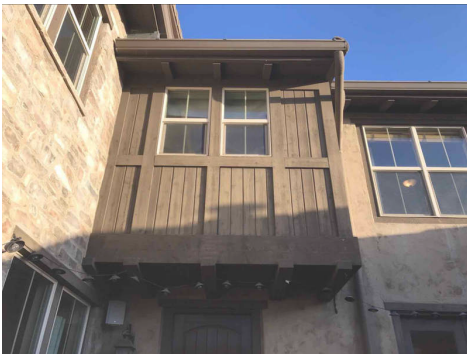
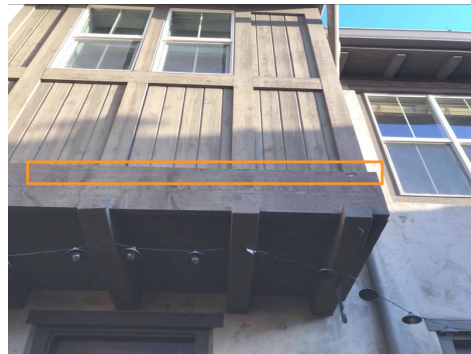
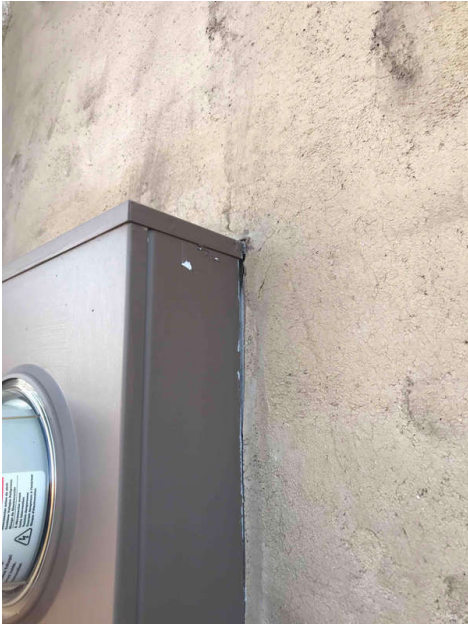
3.1.1 Siding, Flashing & Trim

SIDING/TRIM - MAINTAIN PAINT/CAULKING

Areas of the exterior paint and caulking are in need of maintenance/repairs. In order to prevent moisture intrusion and to extend the life of the siding and trim, I recommend having the caulking and exterior paint evaluated and repaired as necessary by a qualified painting contractor prior to closing.

Recommendation
Contact a qualified painter.

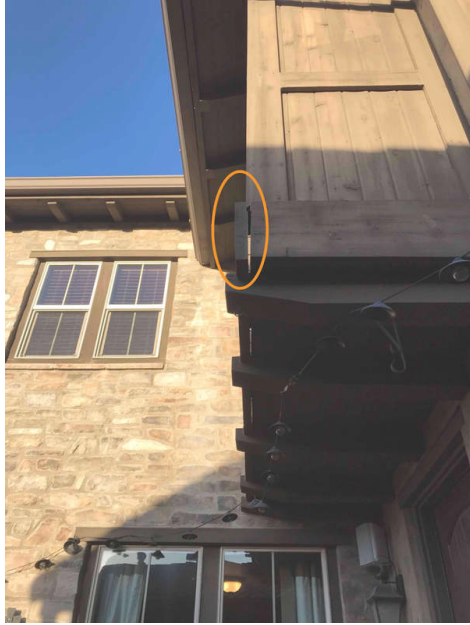
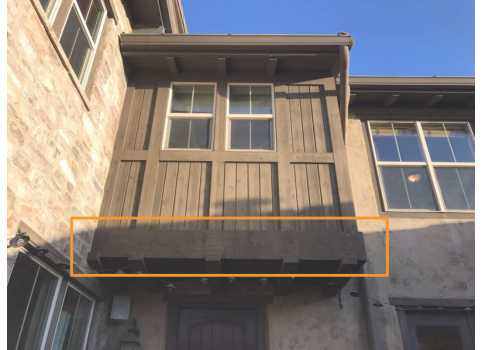
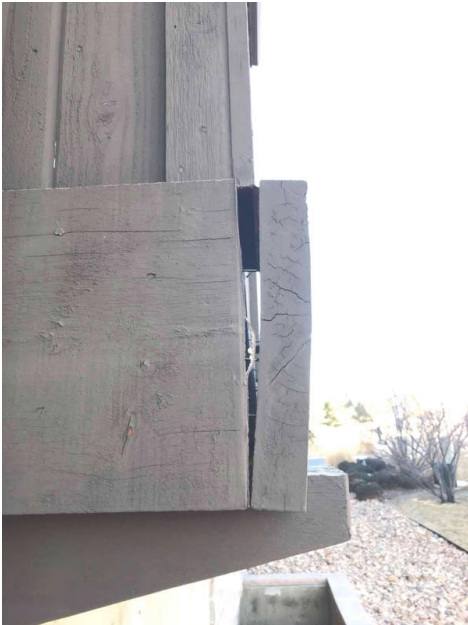
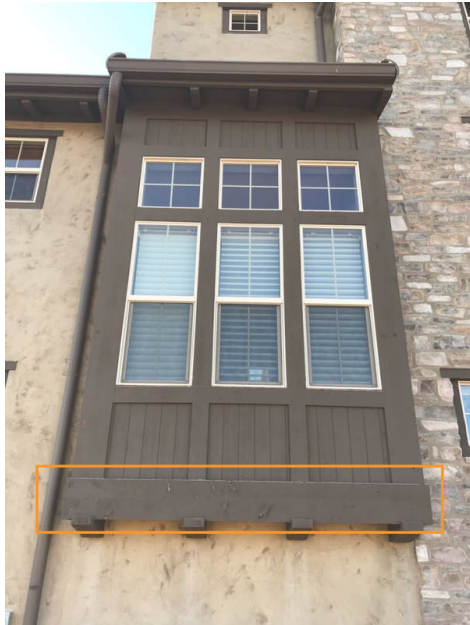
3.1.2 Siding, Flashing & Trim

SIDING/TRIM - LOOSE

SOUTH SIDE OF EXTERIOR

Siding/trim appeared to be loose in areas. I recommend having these areas evaluated and resecured/repared by a licensed siding contractor prior to closing.

Contact a qualified siding specialist.

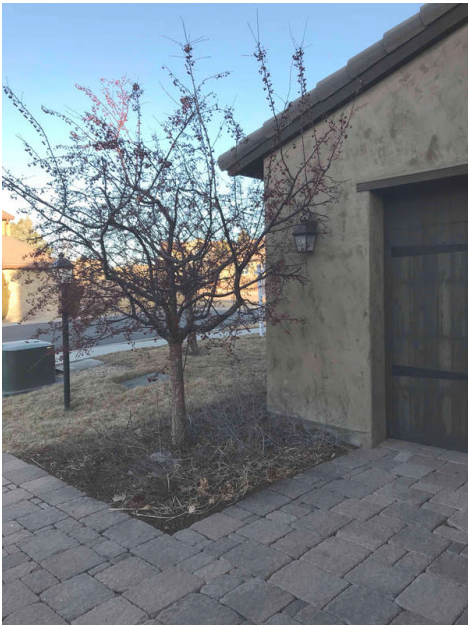
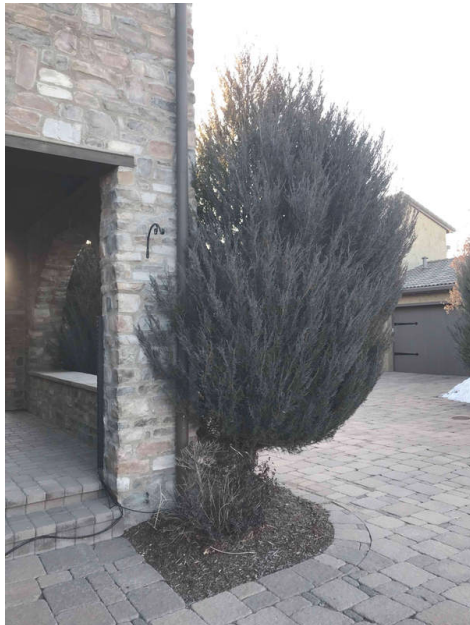
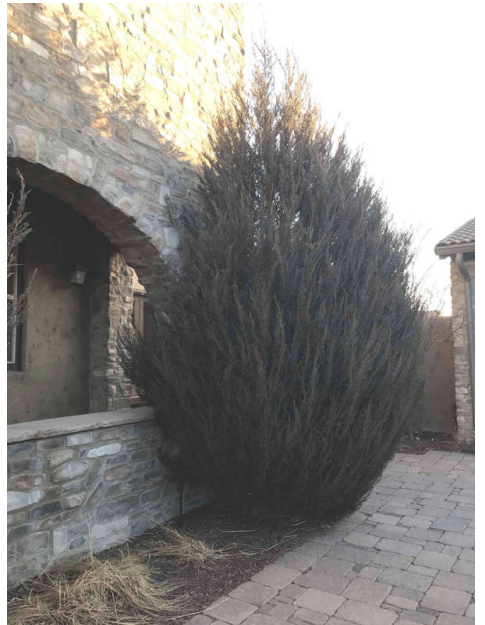
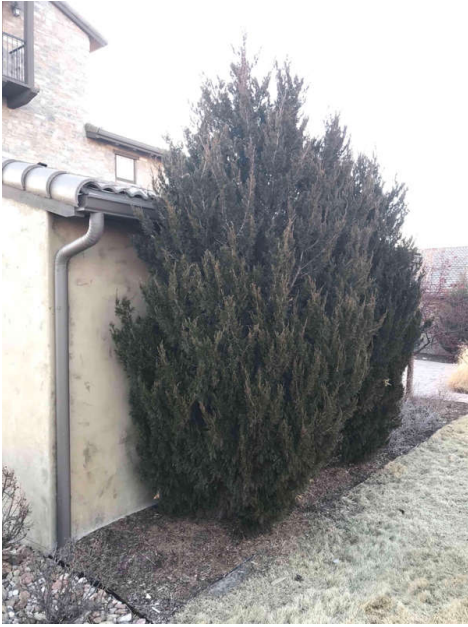
3.6.1 Vegetation, Grading, Drainage & Retaining Walls

VEGETATION - IN CLOSE CONTACT WITH HOUSE

Areas of vegetation are in close contact with the home. In order to prevent branches from chafing the siding or roof, leaves from clogging gutters, and roots from damaging the foundation, critters from having a way to get onto the roof, etc., I recommend having the vegetation evaluated and addressed as necessary.

Contact a qualified landscaping contractor

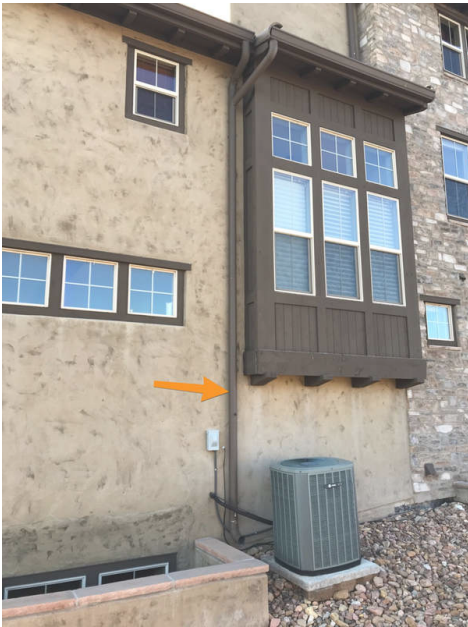
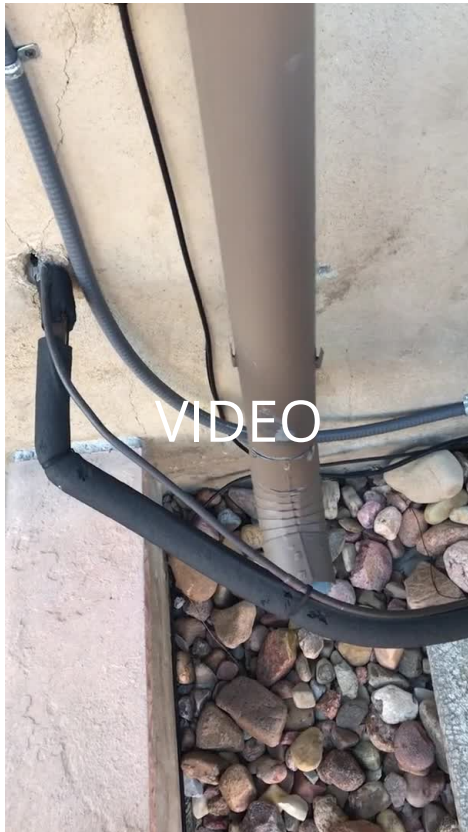
4.4.1 Gutters

GUTTER - LOOSE DOWNSPOUT

NORTH SIDE OF EXTERIOR

One or more downspouts appeared to be improperly secured. I recommend having the downspouts evaluated and properly secured.

Contact a qualified handyman.

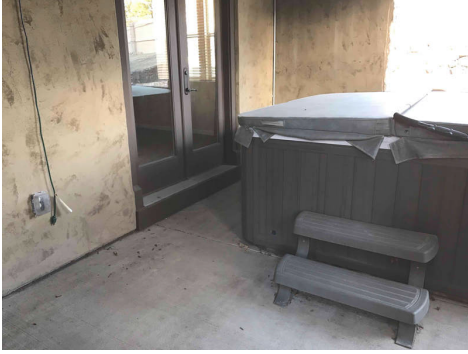
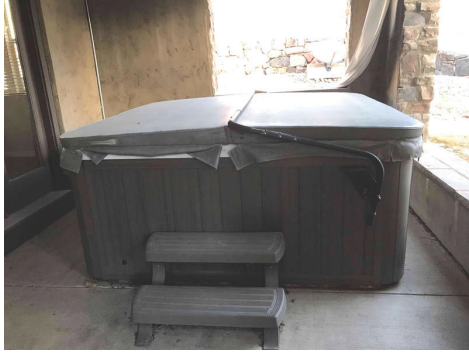
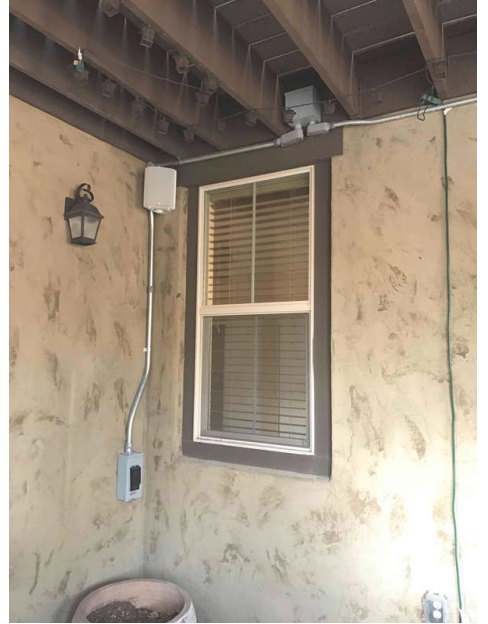
ELECTRICAL - HOT TUB CIRCUIT NOT PERMITTED

The electrical circuit for the hot tub does not appear to have been installed when the home was built, therefore a permit should have been pulled with the local Building Department. This would show that the work was done by a licensed Electrician and passed all necessary code/safety inspections by the Building Department. It is possible that the permits were pulled and just weren't available on their website, so I recommend consulting with them to confirm. In order to ensure that the work was done safely and properly, I recommend having it evaluated and that all repairs are made by a licensed electrician prior to closing, as well as having it permitted with the Building Department.

Recommendation
Contact a qualified professional.

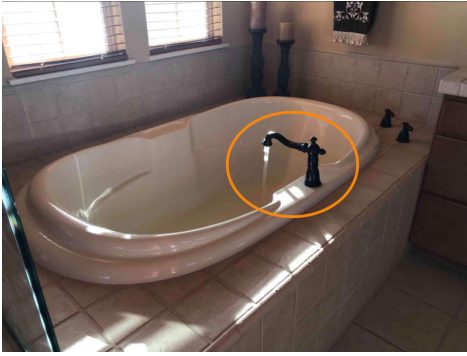
9.5.1 Fixtures

FAUCET - LOOSE

One or more faucets were not tightly secured to the counter top/sink. I recommend having the fixture properly secured by a qualified contractor prior to closing.

Contact a qualified professional.

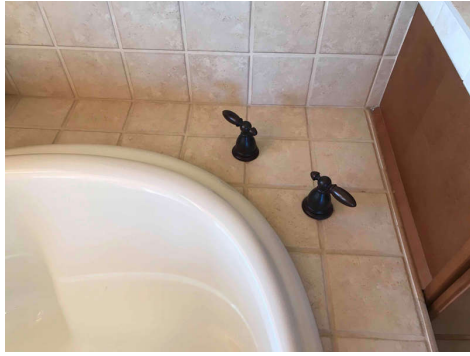
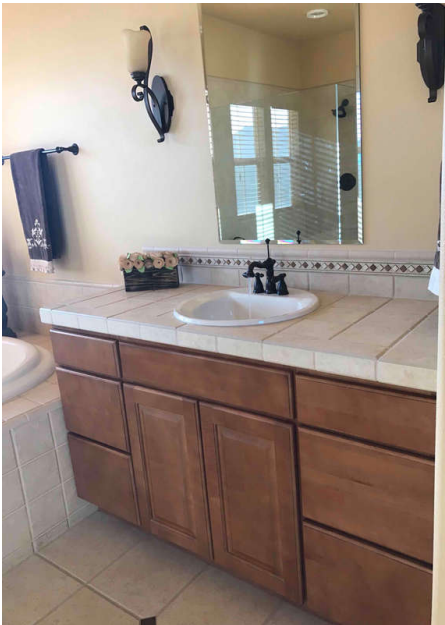
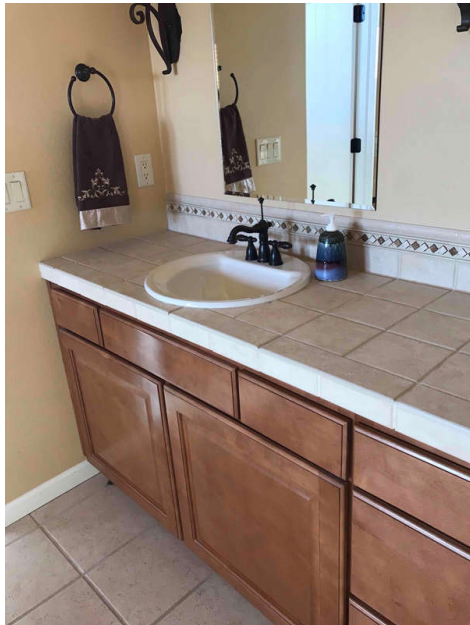
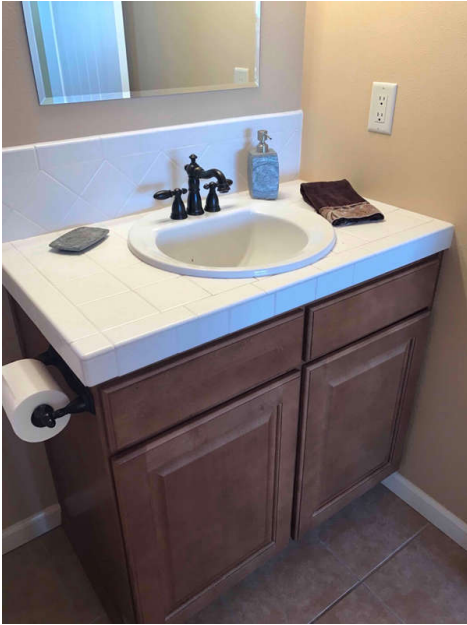
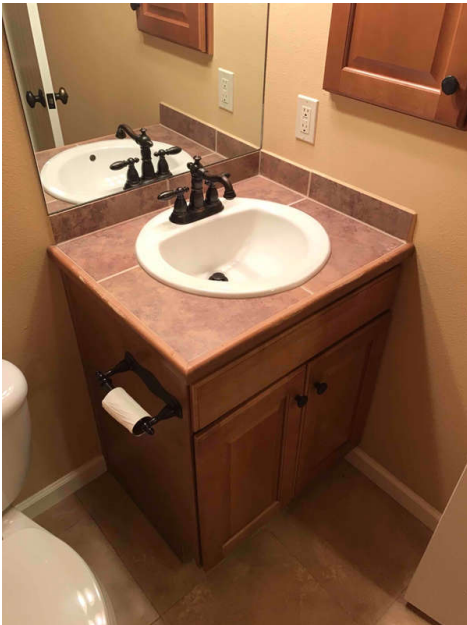
9.5.2 Fixtures

FAUCET - HANDLES NOT SECURED

MASTER BATHROOM, 2ND FLOOR GUEST BATHROOM, 1ST FLOOR GUEST BATHROOM, BASEMENT BATHROOM

One or more faucets appeared to be in need of repair. The handles were not properly secured to the valve stems. I recommend having these evaluated and secured by a qualified contractor prior to closing.

Contact a qualified plumbing contractor.

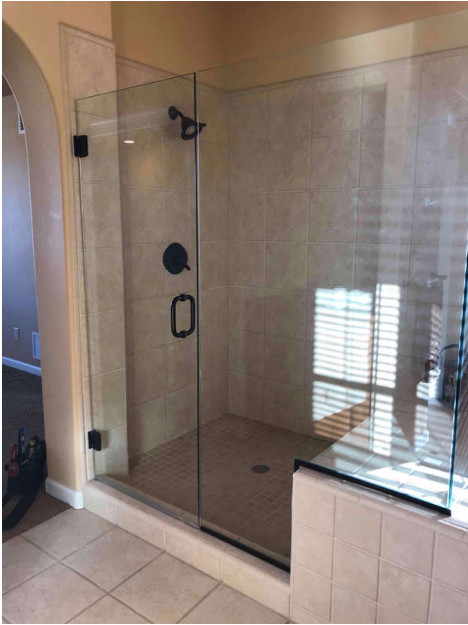
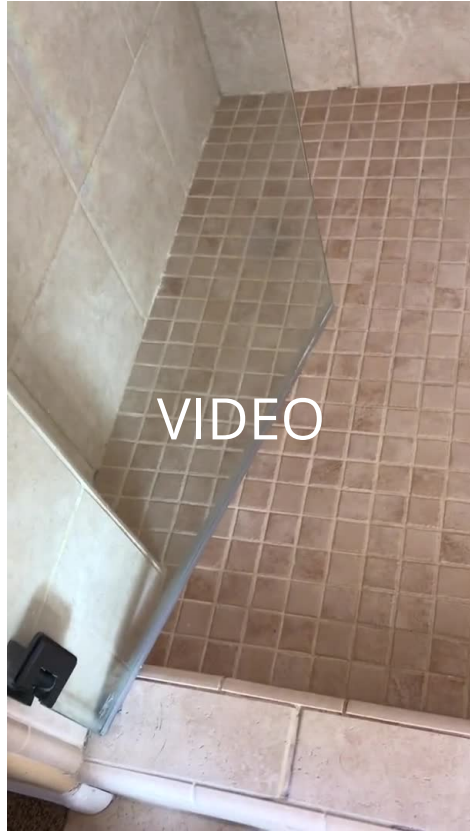
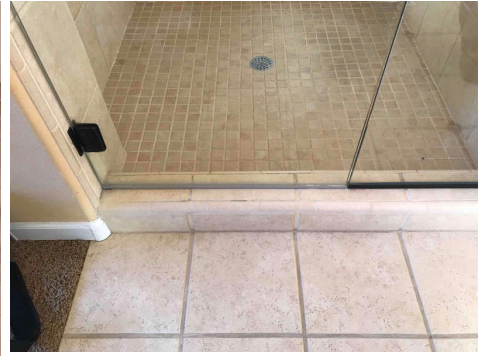
9.5.3 Fixtures

SHOWER DOOR - DOESN'T OPEN/CLOSE PROPERLY

MASTER BATHROOM

The tub/shower door does not open/close properly. It comes into contact with the curb. I recommend having it evaluated and adjusted/repared as necessary by a licensed contractor prior to closing.

Contact a qualified professional.

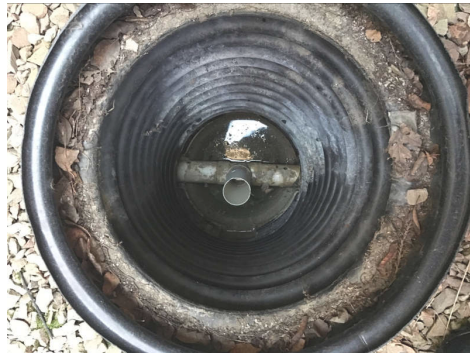
9.6.1 Sump Pump

NO SUMP PUMP - WATER PRESENT

Safety Issue/Major Concern

Water was observed in the sump pump pit but a pump was not installed. I recommend having this evaluated and a pump installed as necessary by a licensed and qualified plumber prior to closing.

Contact a qualified plumbing contractor.

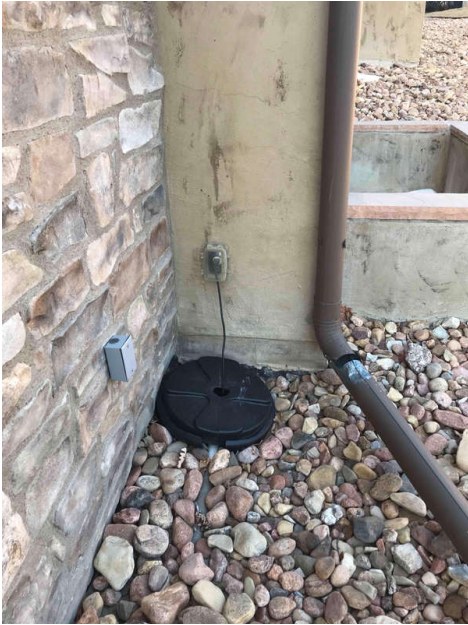
9.6.2 Sump Pump

SUMP PUMP - WATER PRESENT

Safety Issue/Major Concern

Water was present in the sump pit. The water level appeared to be high enough that the pump should have turned on, removing the water from the pit. This may be an indication that the pump is not operational. I recommend having this evaluated and repaired/replaced as necessary by a licensed plumber prior to closing.

Contact a qualified plumbing contractor.

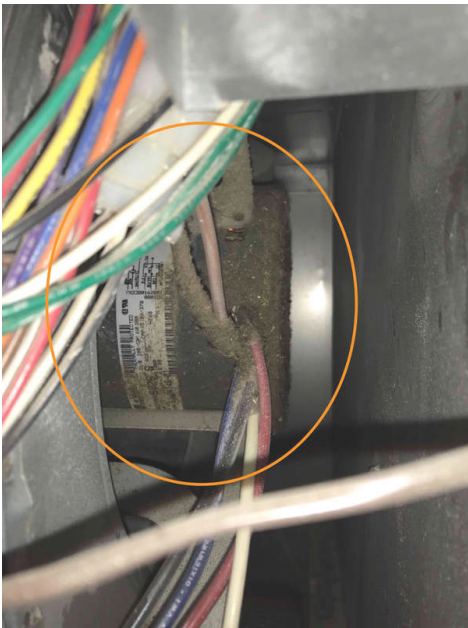
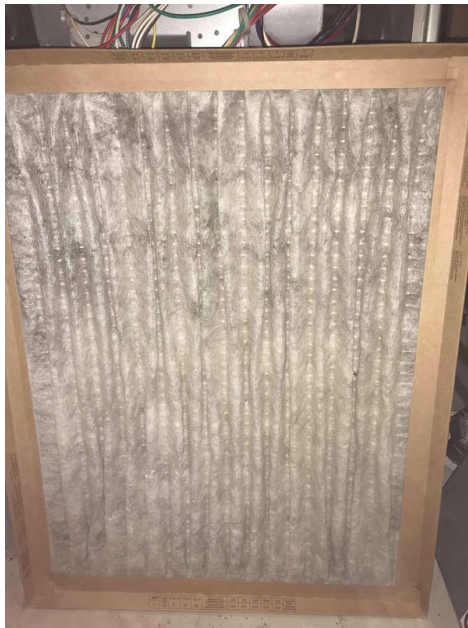
11.1.1 Forced Air Furnace

FURNACE - CLEAN AND SERVICE

The furnace appeared to be in good overall condition, however I recommend having it cleaned and serviced prior to closing, followed by annually.

Contact a qualified HVAC professional.

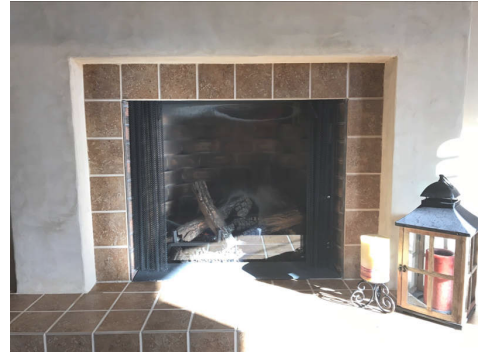
11.2.1 Fireplace & Chimney

DIRECT VENT GAS FIREPLACE - CLEAN AND SERVICE

LIVING ROOM

The gas fireplace appeared to be dirty. I recommend having it cleaned and serviced by a qualified fireplace contractor prior to closing, followed by annually.

Recommendation
Contact a qualified fireplace contractor.

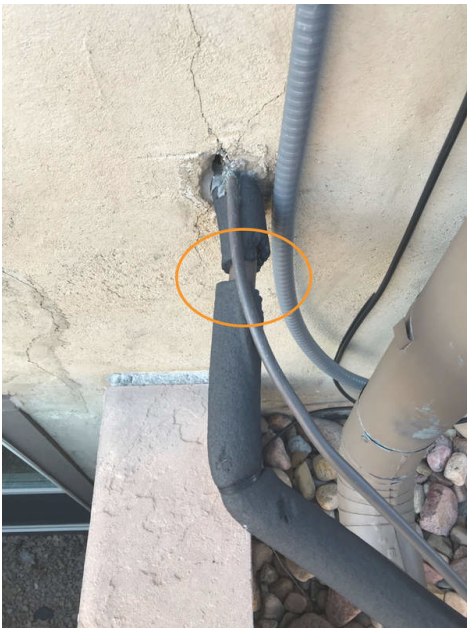
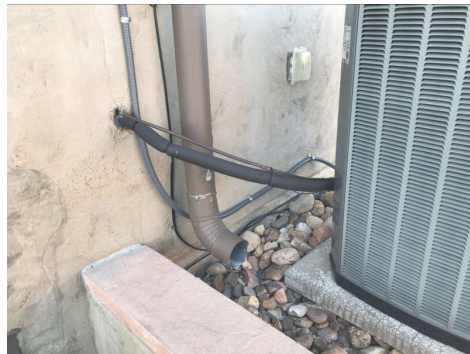
13.1.1 Air Conditioning

AIR CONDITIONING - LINESET INSULATION DAMAGED

The insulation on the suction line for the air conditioning appeared to be in need of repair. Insulating the suction line (larger pipe) is done for two reasons. First, it prevents condensation forming on the pipe. Condensation could drip from the pipe and cause moisture damage to the home. Also, the suction and liquid lines should not touch or come in contact with one another. The warm liquid line would transfer heat to the cooler suction line. The warmer the refrigerant is, the harder the compressor and condenser have to work. Minimizing the temperature of the refrigerant in the suction line, helps the condensing unit work more effectively. I recommend having this evaluated and repaired/replaced as necessary by a licensed and qualified HVAC technician prior to closing.

Recommendation
Contact a qualified HVAC professional.

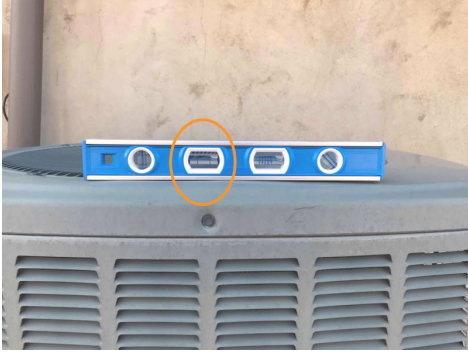
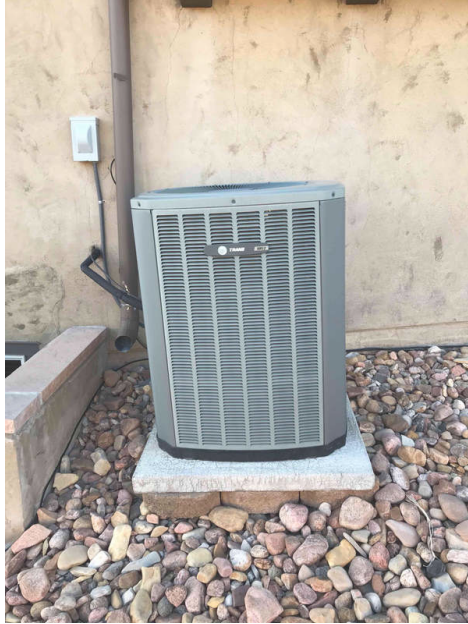
CONDENSER - NOT LEVEL

The concrete pad that supports the condenser does not appear to be level. This can cause the unit to need additional servicing or repairs. I recommend having an HVAC technician level the pad in order to ensure proper function of the unit.

Contact a qualified HVAC professional.
