SUMMARY

1234 Main St. Merrimack NH 03054

Chris Caisse
InterNACHI Certified Professional
Inspector
Platinum Home Inspections
603.897.5495

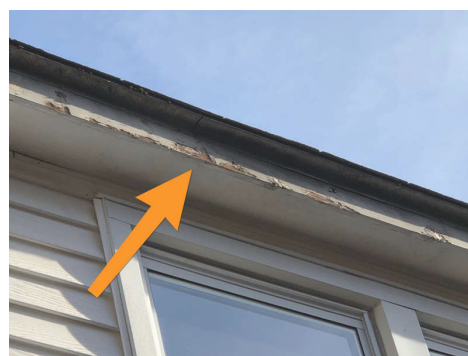
2.4.1 Eaves, Soffits & Fascia

FASCIA - DAMAGED

One or more sections of the fascia are damaged. Recommend qualified roofer evaluate & repair.

Rear

Contact a qualified roofing professional.

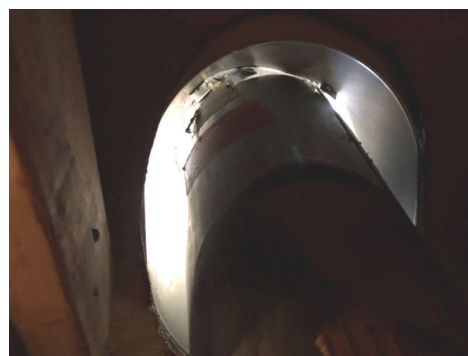
2.5.1 Skylights, Chimneys & Other Roof Penetrations

VENT FLASHING (IMPROPER)

One or more vent penetrations were incorrectly flashing at the time of the inspection. This condition increases the chance of roof leakage at these areas. The Inspector recommends correction by a qualified contractor.

Furnace vent needs exterior flashing

Contact a qualified roofing professional.

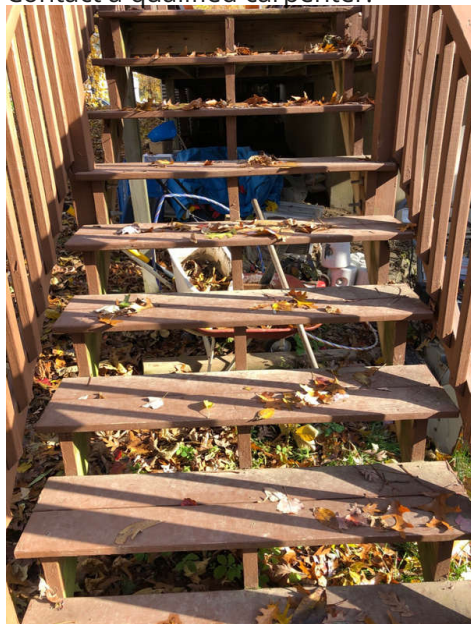
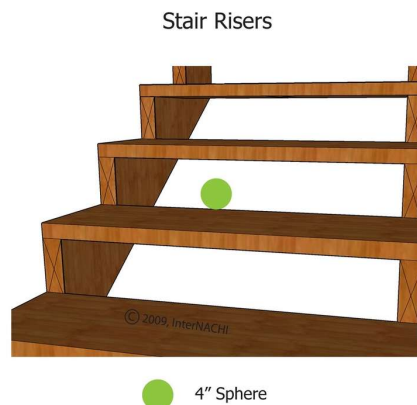
3.3.2 Decks, Balconies, Porches & Steps

OPEN STAIR RISERS

Open risers should not allow the passage of a 4-inch diameter sphere. On stairs with a total rise of 30 inches or less, the size of the open riser is not limited.

Recommendation
Contact a qualified carpenter.

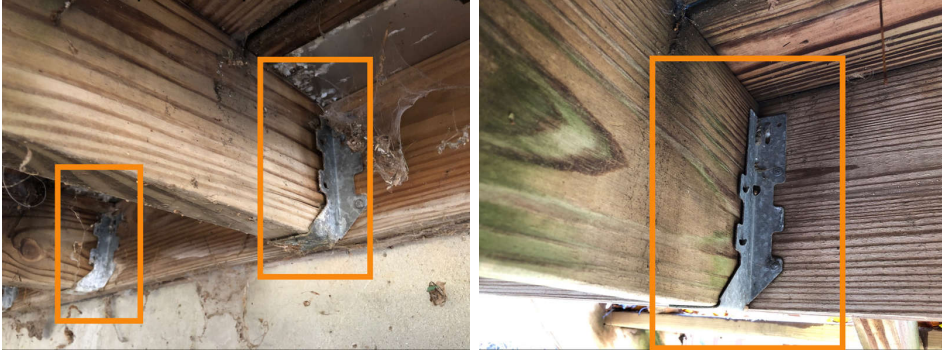
3.3.3 Decks, Balconies, Porches & Steps

CONNECTORS (UNFILLED HOLES)

Most of the metal connectors used in deck framing had unfilled holes. To perform as designed, metal connectors should have all holes filled with the fasteners specified by the hardware manufacturer. The Inspector recommends correction by a qualified contractor.

Recommendation
Contact a qualified professional.

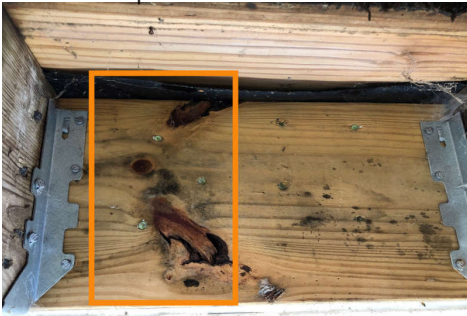
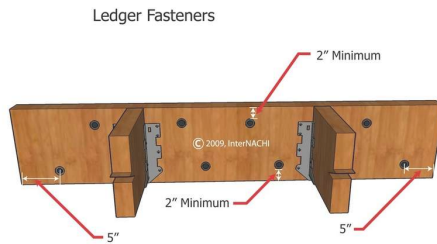
3.3.4 Decks, Balconies, Porches & Steps

LEDGER BOARD - NAILED ON, NO SCREWS OR BOLTS

Ledger boards for one or more decks, balconies or porches appeared to be attached with nails only. This method of attachment is substandard and may result in such structures separating from the main building. This is a potential safety hazard. Modern standards call for ledger boards to be installed with 1/2 inch lag screws or bolts into solid backing, and brackets such as [Simpson Strong Tie DTT2 brackets and threaded rod](#), connecting interior and exterior joists. Recommend that a qualified contractor repair per standard building practices. For more information, visit:

Would prefer to see thru bolts or lag screws

Recommendation
Contact a qualified deck contractor.

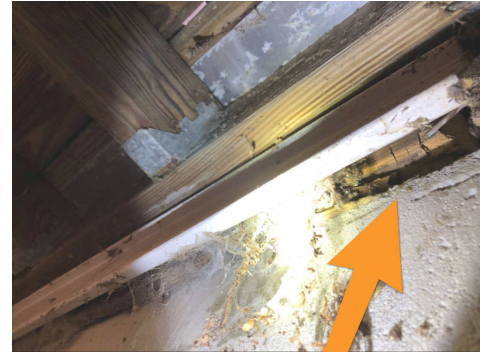
3.3.5 Decks, Balconies, Porches & Steps

LEDGER BOARD ROTTING

Observed sections of the ledger board under the deck (back corner of house) to be rotting. Recommend qualified contractor repair/replace.

Recommendation
Contact a qualified professional.

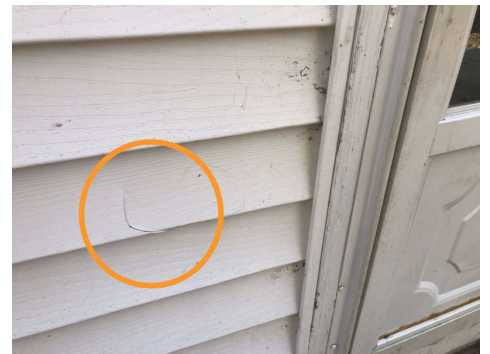
4.1.2 Siding, Flashing & Trim

MINOR DAMAGE

Siding has some typical minor damage. Recommend repair/replace as needed.

Crack

Recommendation
Contact a qualified siding specialist.

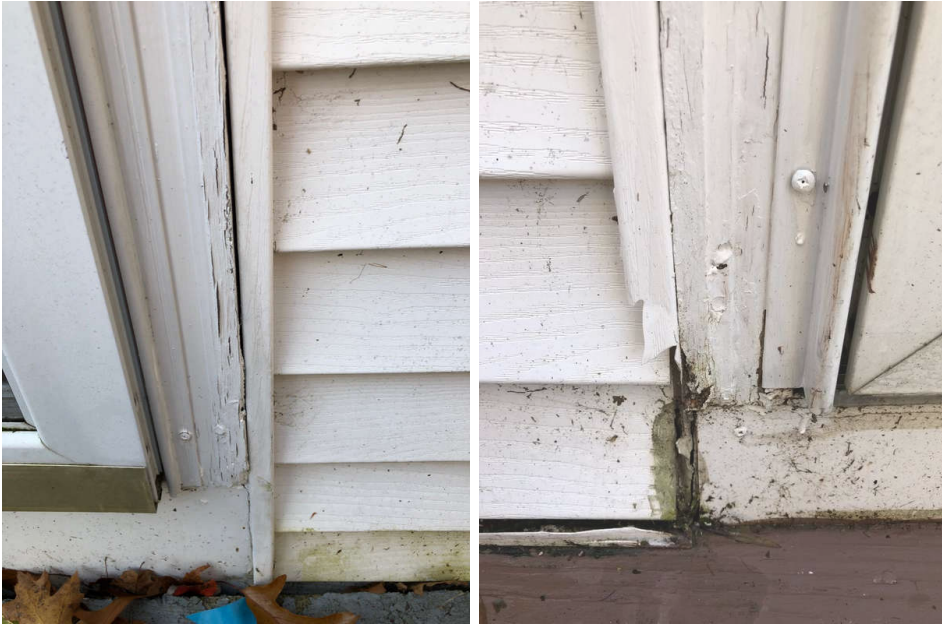
4.3.1 Exterior Doors

DOOR SILL/TRIM

Door sill and/or trim is loose, deteriorated or worn and repair or replacement should be considered.

Front Door

Recommendation
Contact a qualified door repair/installation contractor.

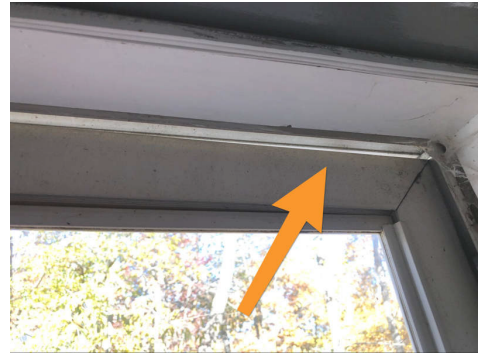
4.3.2 Exterior Doors

WEATHERSTRIPPING NOT PRESENT

Door is missing standard weatherstripping. This can result in significant energy loss and moisture intrusion. Recommend installation of standard weatherstripping.

Contact a qualified door repair/installation contractor.

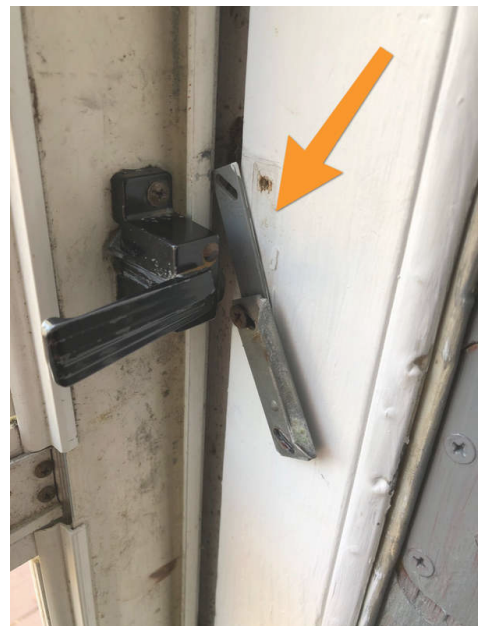
4.3.3 Exterior Doors

SCREEN DOOR DAMAGE

Screen door was observed to have damage which was partially repaired. Recommend repair or replacement as needed

Contact a qualified door repair/installation contractor.

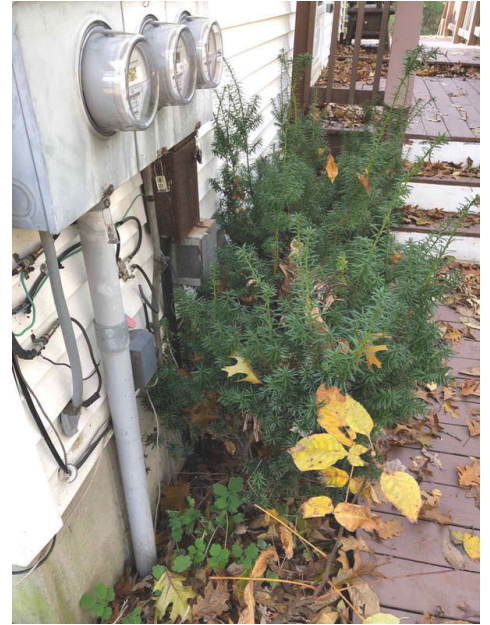
4.4.1 Service Entrance
Conductors

**OBSTRUCTED BY
VEGETATION**

Electrical meter and main electrical disconnect or obstructed by vegetation recommend removal of vegetation for proper access to electrical equipment.

Recommendation
Contact a qualified landscaping contractor

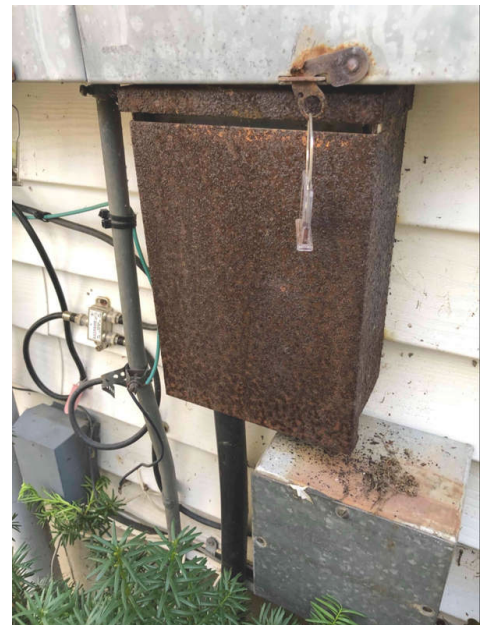
4.4.2 Service Entrance
Conductors

RUSTED ENCLOSURE

Observed exterior electrical box to be rusted inside and out. There where no clear signs as to why this is at the time of inspection. Recommend licensed electrician evaluate further

Recommendation
Contact a qualified professional.

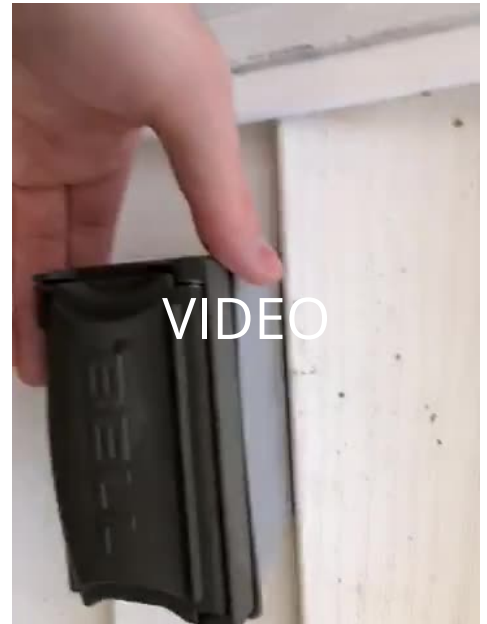
4.5.1 Exterior lighting and
receptacles

**WEATHERPROOF COVER
LOOSE**

One or more exterior receptacles are missing a weatherproof cover. This causes short and shock risk. Recommend installation of proper covers.

Recommendation
Contact a qualified electrical contractor.

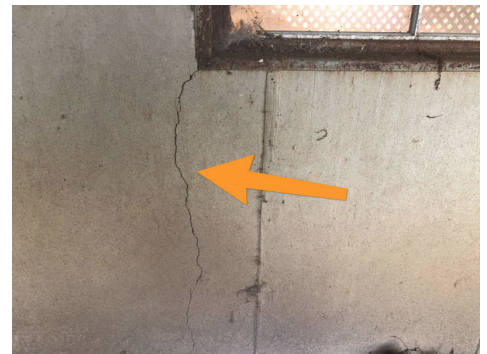
4.7.1 Exterior foundation **TYPICAL CRACKING**

Exterior foundation contains typical cracks due to shrinkage and normal freeze thaw cycle. Recommend patching as needed to prevent moisture intrusion.

Recommendation
Contact a foundation contractor.

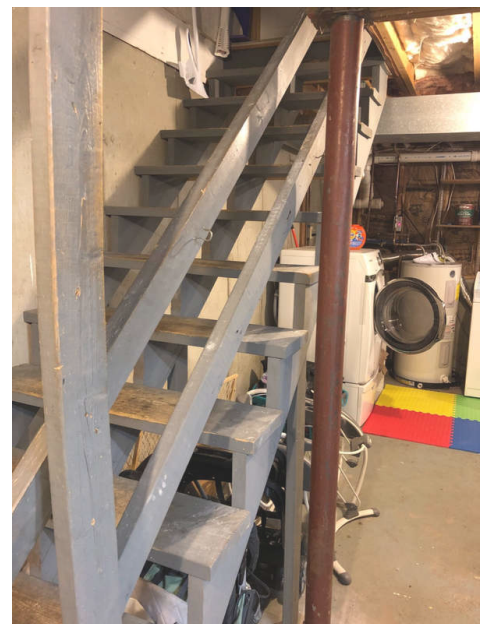
5.1.1 Steps, Stairways & Railings **NO BALUSTERS PRESENT**

The stairway into the basement does not have any balusters present. Balusters should be installed 4 apart for safety.

Recommendation
Contact a qualified professional.

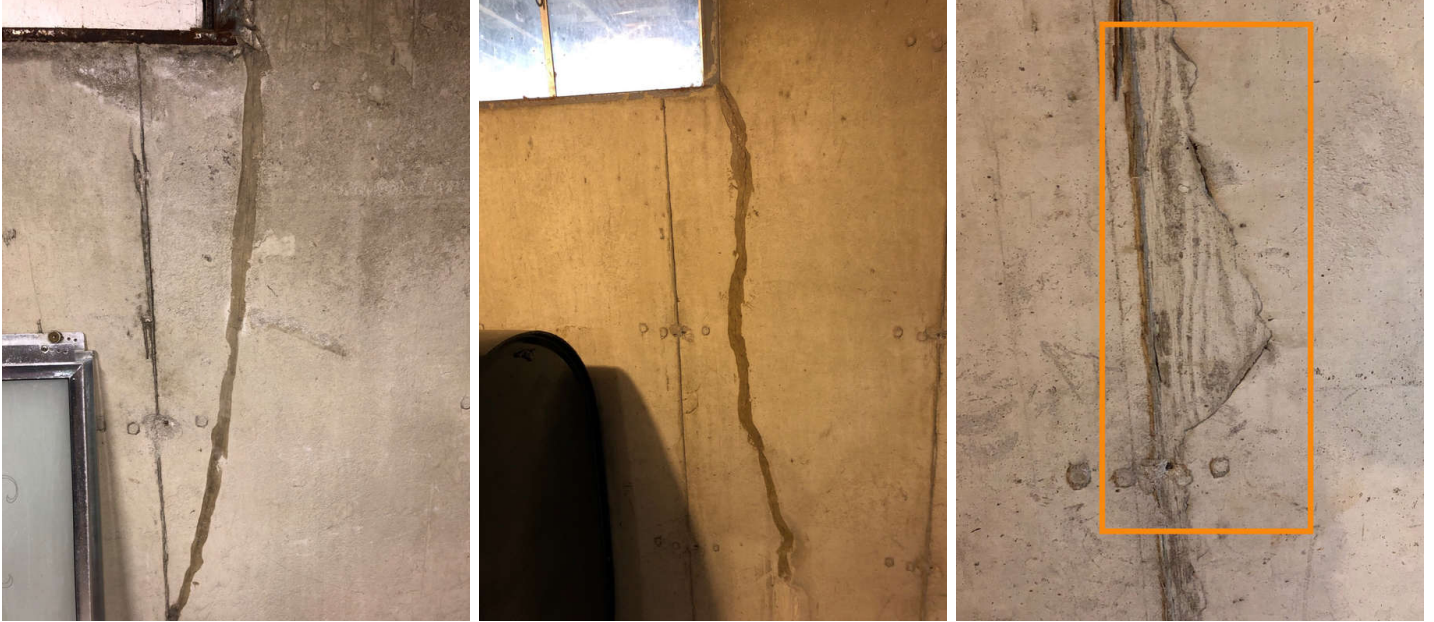
5.2.1 Foundation

FOUNDATION CRACKS - MINOR

Minor cracking was noted at the foundation. This is common as concrete ages and shrinkage surface cracks are normal. Recommend monitoring for more serious shifting/displacement.

Contact a foundation contractor.

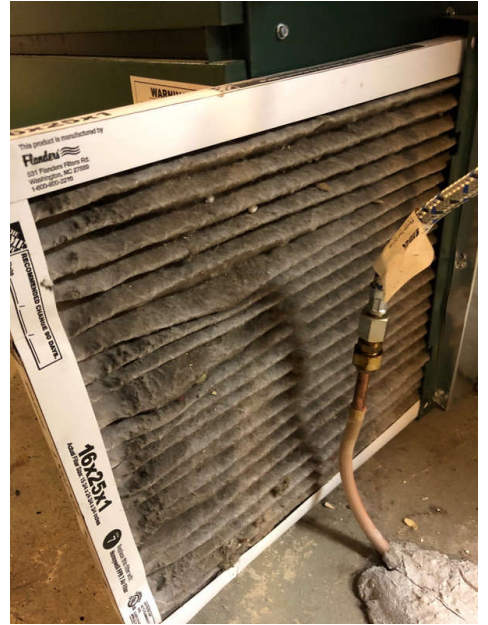
6.1.2 Heating Equipment

FILTER DIRTY

The furnace filter is dirty and should to be replaced every 3-6 months.

Contact a qualified HVAC professional.

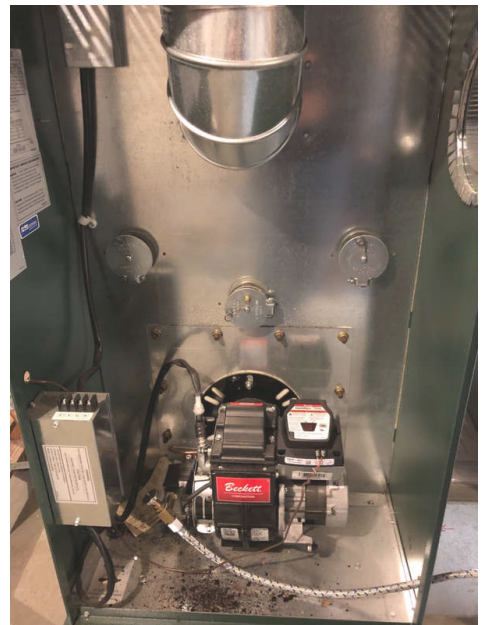
6.1.3 Heating Equipment **SEALED CHAMBER**

The boiler was a high-efficiency system and had a sealed combustion chamber which would require invasive measures which lie beyond the scope of the General Home Inspection to inspect. The combustion chamber was inspected through a sight port only.

Recommendation
Contact a qualified HVAC professional.

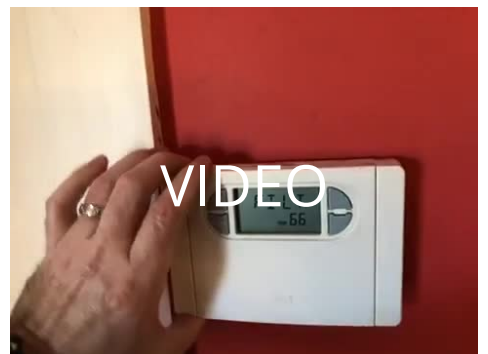
6.2.1 Operating and Safety Controls

LOOSE THERMOSTAT

Thermostat was loose on the wall. Recommend repair or replacement.

Recommendation
Contact a qualified HVAC professional.

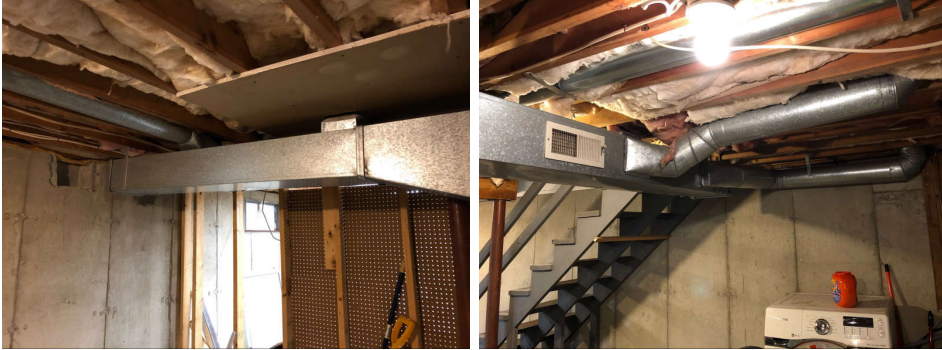
6.3.1 Distribution Systems

DUCT INSULATION MISSING

One or more heating and/or cooling ducts in an unconditioned space (e.g. crawl space, attic or basement) were not insulated. This can result in reduced energy efficiency, moisture inside heating ducts, and/or "sweating" on cooling ducts. Recommend that a qualified person evaluate per standard building practices. For example, by wrapping ducts in insulation with an R-value of R-8.

Recommendation
Contact a qualified HVAC professional.

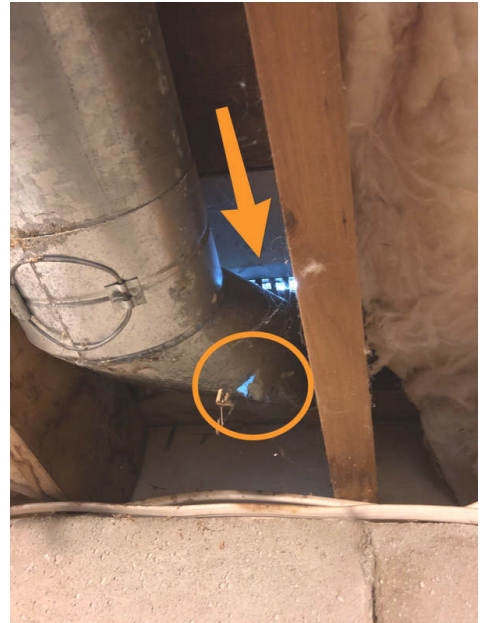
6.3.2 Distribution Systems

DUCT DAMAGED

Air supply duct was damaged and not properly attached to the register above. This is causing the heat to enter the basement and not the room above. Recommend a qualified HVAC contractor repair.

This is for the dining room near slider

Recommendation
Contact a qualified HVAC professional.

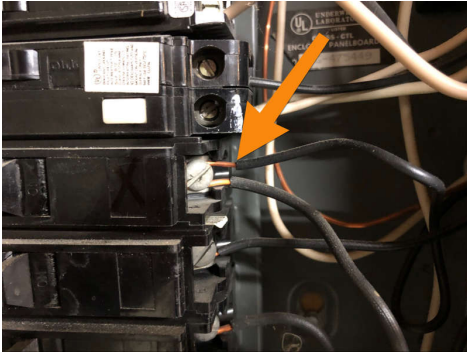
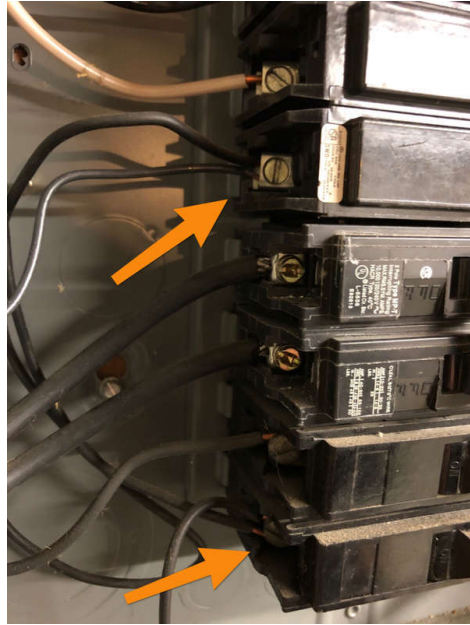
7.1.1 Main & Subpanels, Service & Grounding, Main Overcurrent Device

DOUBLE TAPS

Double taps at the electrical panel should be repaired by a licensed electrician.

Double-Tapped Breakers

Recommendation
Contact a qualified professional.

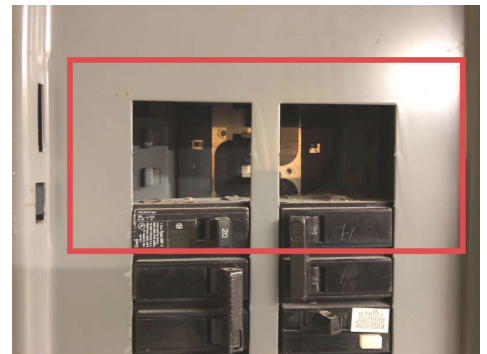
7.1.2 Main & Subpanels, Service & Grounding, Main Overcurrent Device

KNOCKOUTS MISSING

"Knockouts" are missing on the electric panel. This poses a safety hazard and it is recommended that the opening in the panel caused by the missing knockout(s) be properly sealed by a licensed electrician.

Recommendation
Contact a qualified electrical contractor.

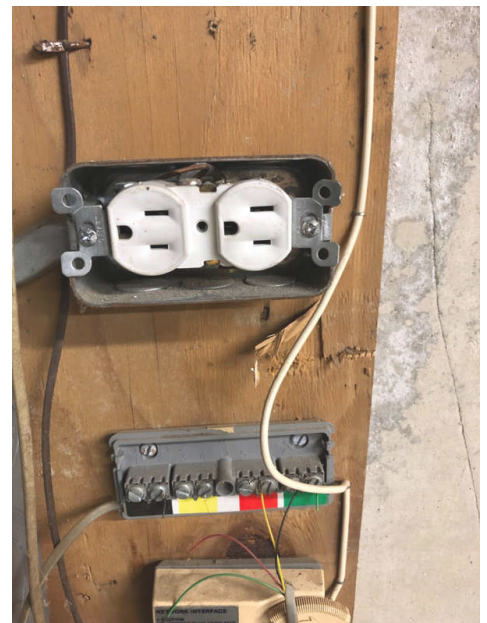
7.3.1 Electrical Fixtures, Switches and Receptacles

COVER PLATES MISSING

One or more receptacles are missing a cover plate. This causes short and shock risk. Recommend installation of plates.

Recommendation
Contact a qualified electrical contractor.

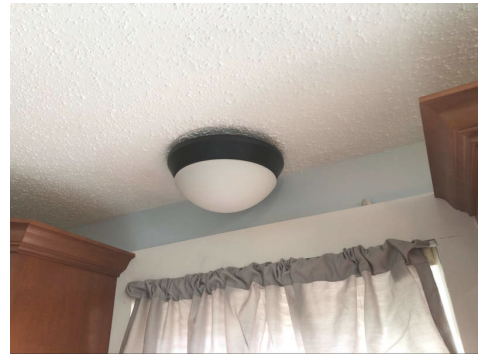
7.3.2 Electrical Fixtures,
Switches and Receptacles

LIGHT INOPERABLE

One or more lights are not operating. New light bulb possibly needed.

Kitchen sink light (also loose)

Contact a qualified electrical contractor.

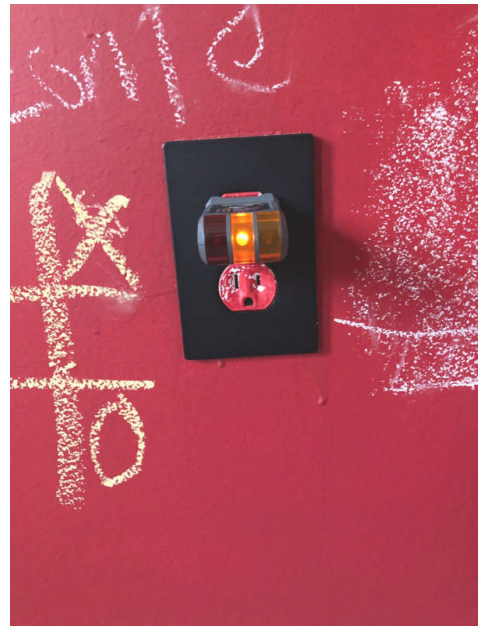
7.3.3 Electrical Fixtures,
Switches and Receptacles

OPEN GROUND

Bedroom

Contact a qualified professional.

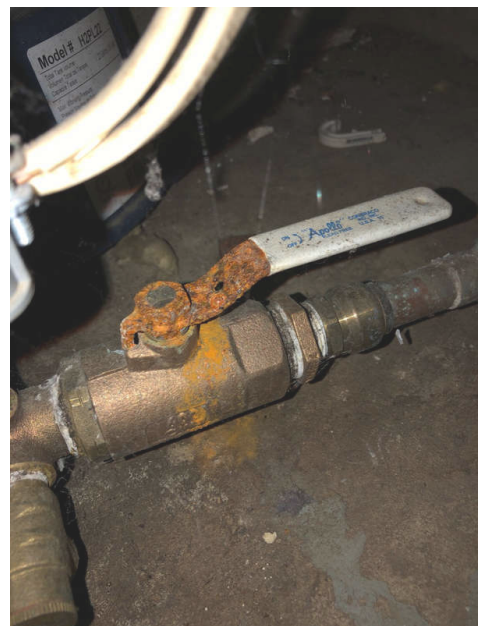
8.2.1 Main Water Shut-off
Device

CORROSION

Water main shut-off shows signs of corrosion. Recommend a qualified plumber evaluate.

Contact a qualified plumbing contractor.

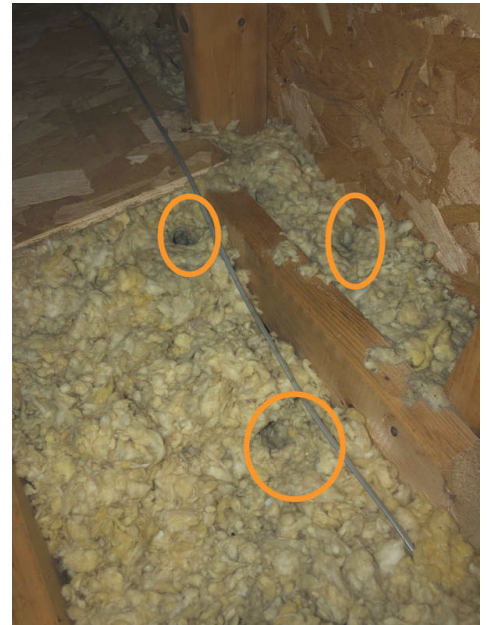
9.1.1 Attic Insulation

DAMAGED (PESTS)

Insulation appears to have holes throughout which is a typical sign of pests borrowing through the insulation. Recommend a qualified insulation contractor or pest pro evaluate and repair.

Contact a qualified insulation contractor.

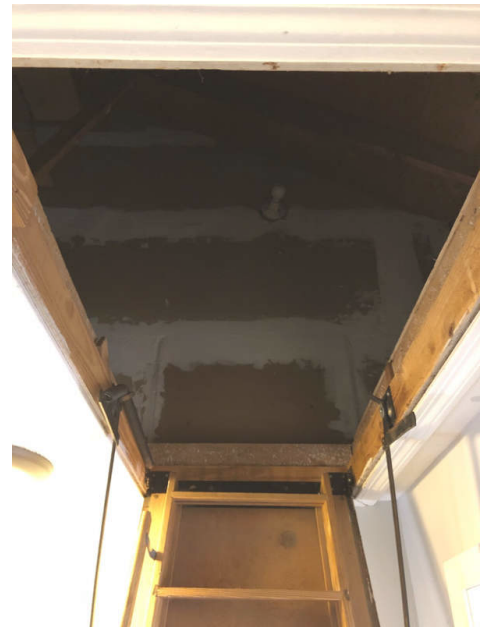
9.1.2 Attic Insulation

INSULATE ACCESS HATCH/ENTRY

The attic access hatch cover was not insulated. The Inspector recommends insulating the attic access hatch cover to reduce unwanted heat loss/gain.

Contact a qualified insulation contractor.

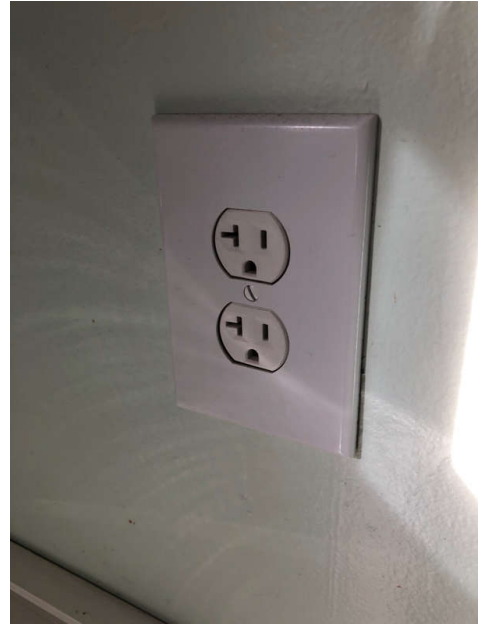
10.1.1 Electrical Components

RECEPTACLE IS LOOSE

Electrical receptacle is not properly secured recommend licensed electrician to repair.

Contact a qualified electrical contractor.

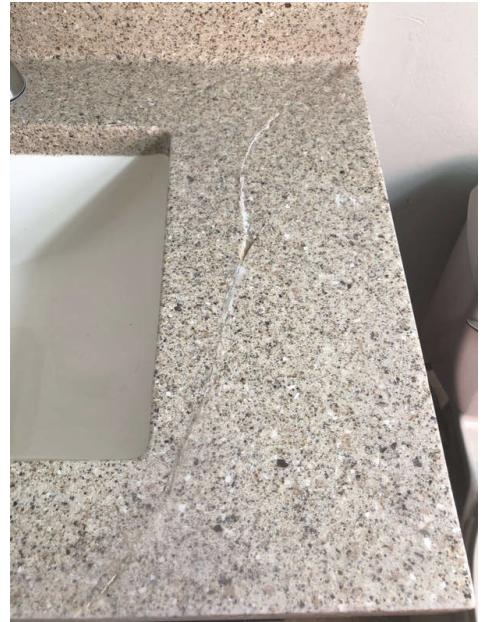
10.3.1 Countertops & Cabinets

COUNTERTOP CRACKED/CHIPPED

Countertop had one or more cracks or chips. Recommend qualified countertop contractor evaluate and repair.

2nd Floor

Contact a qualified countertop contractor.

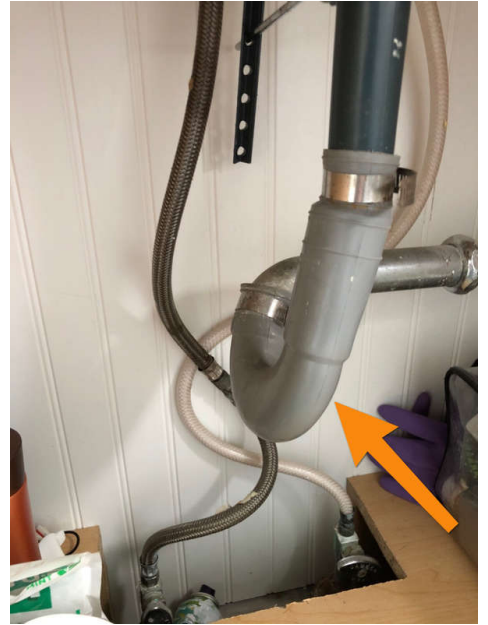
10.4.1 Fixtures Installed

IMPROPER PLUMBING CONNECTIONS

Bathroom sink plumbing connections are improper. 1/2 Bathroom sink drain has a gray rubber piece of hose instead of the required P-Trap. Recommend licensed plumber evaluate and correct.

Contact a qualified plumbing contractor.

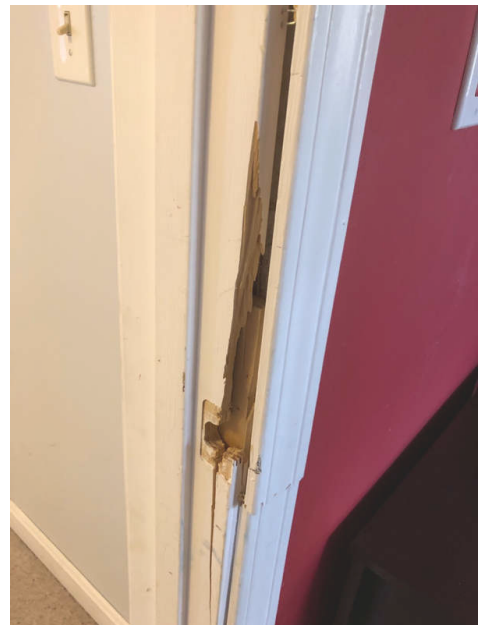
11.4.1 Interior Doors

DAMAGED TRIM

Bedroom door trim is damaged recommend repair

Contact a qualified professional.

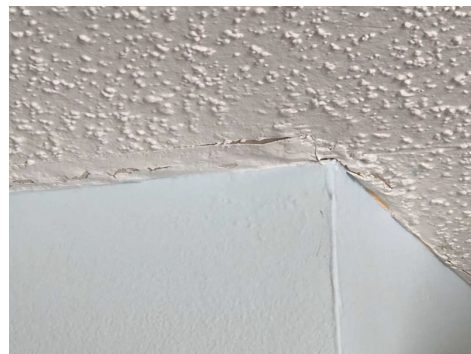
11.5.1 Walls and Ceilings

**TYPICAL CRACKS
OBSERVED**

Typical cracks in drywall/plaster were observed. These cracks may develop due to normal aging of a home, minor settling, as well as moisture/temperature changes. Recommend repair as needed. No evidence of structural defect observed at time of inspection.

Contact a qualified drywall contractor.

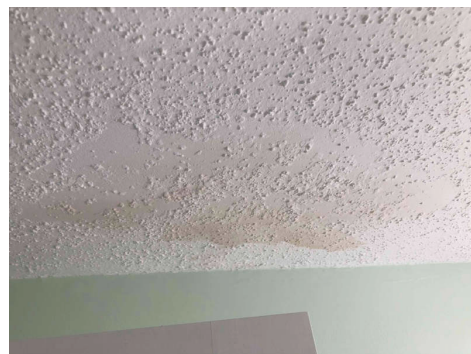
11.5.2 Walls and Ceilings

STAIN(S) ON CEILING

There is a stain on ceiling that requires paint. Inspector tested the area with a moisture meter with 0% moisture registered, therefore this is not a current leak. Source of staining should be determined.

Contact a qualified professional.

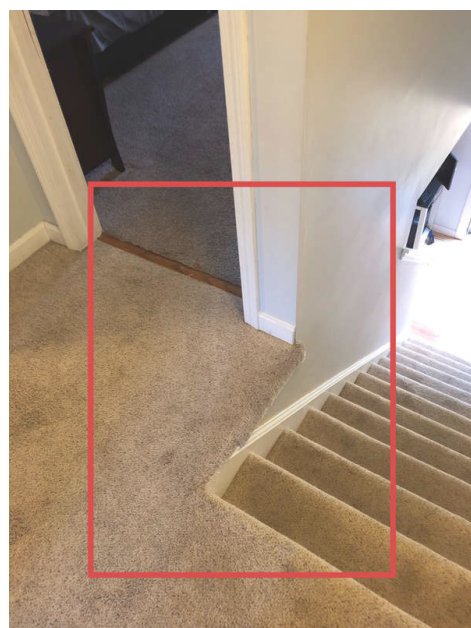
11.6.1 Steps, Stairways & Railings

NO HANDRAIL

Staircase had no handrails. This is a safety hazard. Recommend a qualified handyman install a handrail.

Contact a qualified handyman.

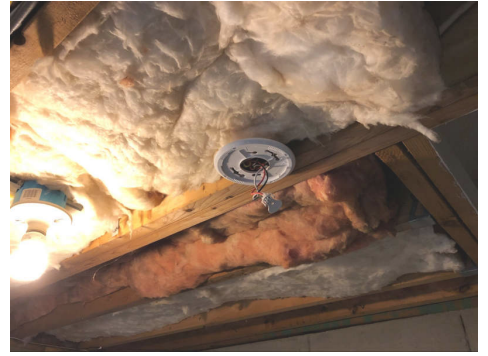
11.7.1 Smoke and CO Detectors

SMOKE/CO DETECTORS ARE NOT INSTALLED PER CURRENT SAFETY STANDARDS

Smoke Detectors are required to be installed in the following locations per current safety standards:

- 1 Per Bedroom
- 1 Per level of home
- Must be sealed Battery type (1JAN2017)

CO Detectors are required to be installed in the following locations per current safety standards:

- 1 Within 15' of sleeping areas
- 1 Per level of home
- Must be sealed Battery type (1JAN2017)

Contact a qualified professional.

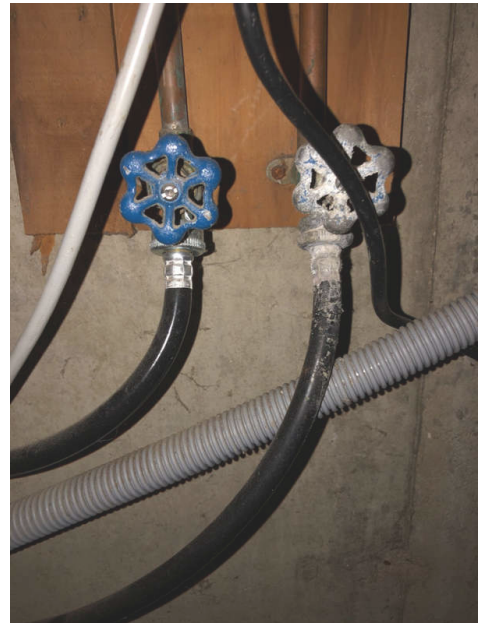
12.1.1 Washer/Dryer

WASHER HOSES IMPROPER

Current hoses are rubber. Recommend replacing with Stainless Steel Braided hoses as rubber can crack and burst.

Contact a qualified professional.

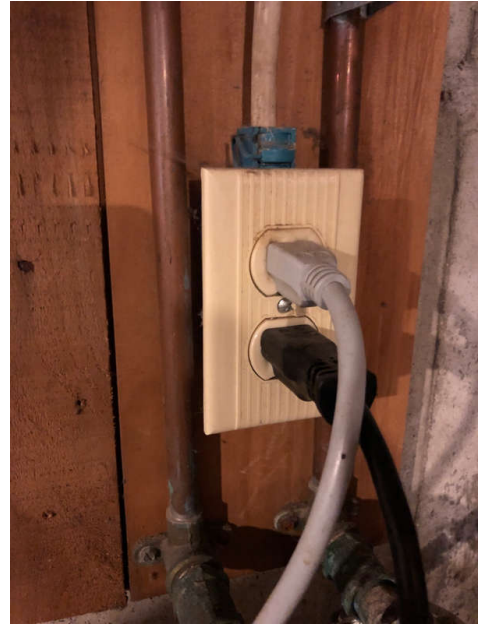
12.2.1 Electrical Components

LAUNDRYROOM ELECTRICAL RECEPTACLES NOT TO CURRENT STANDARDS

Laundry room electrical receptacles do not meet current safety standards, they are currently non-GFCI type. Recommend licensed electrician to repair to current standards to prevent possible injury.

Contact a qualified electrical contractor.

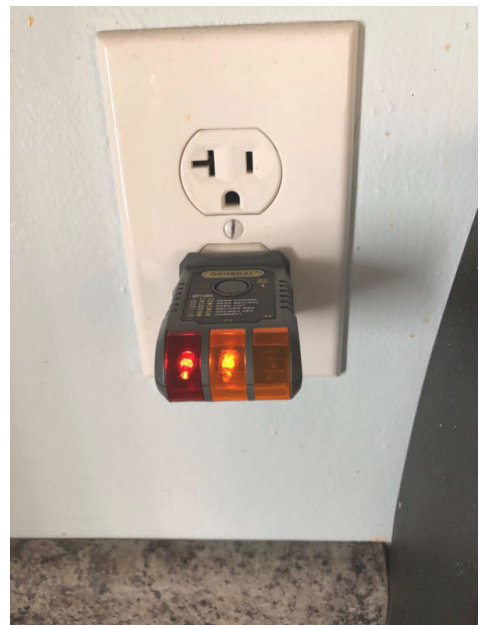
13.3.2 Electrical Components

REVERSE POLARITY

Kitchen receptacles have reverse polarity. This is a potential safety hazard, recommend licensed electrician to repair to current safety standards.

Contact a qualified electrical contractor.

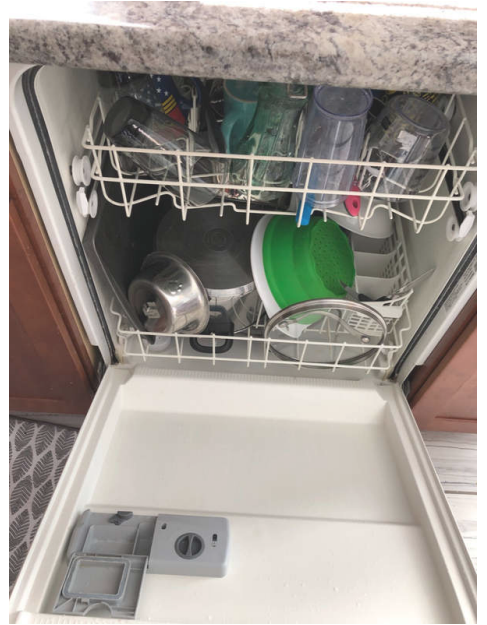
14.3.1 Dishwasher

DISHWASHER NOT ATTACHED PROPERLY

DW not attached to cabinets

Recommendation
Contact a qualified professional.
