SUMMARY
1234 Main St. Lansdale Pennsylvania
19446
Buyer Name
02/08/2019 9:00AM

Donald Nagle
L&L Home Inspections, LLC
(484)-942-7344
ll.homeinspectionsllc@gmail.com

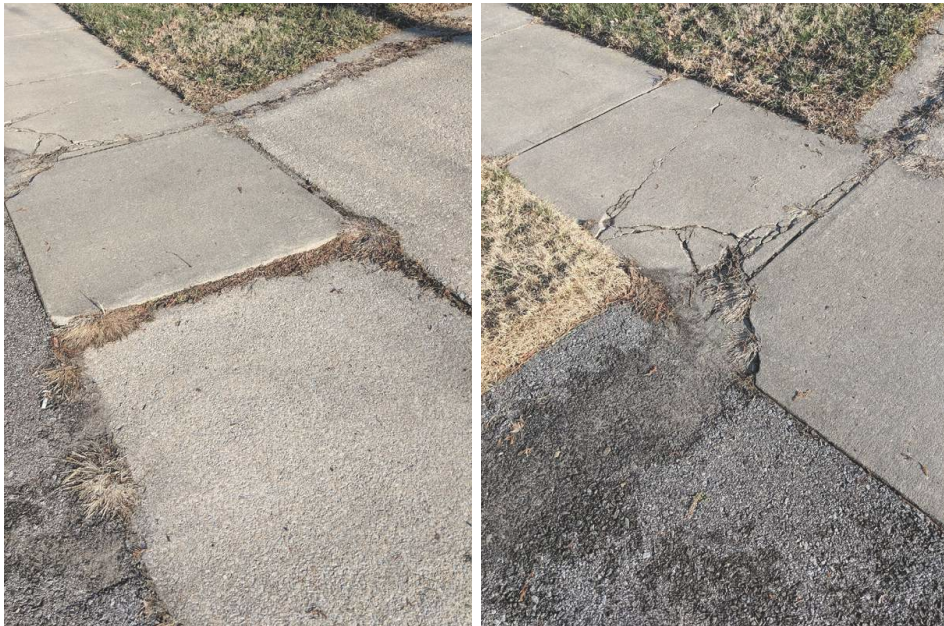
2.2.1 Driveway, Walkway, Patio

TRIP HAZARD-SIDEWALK

Cracks, holes, settlement, heaving and/or deterioration resulting in trip hazards were found in the sidewalks or patios. For safety reasons, recommend that a qualified contractor repair as necessary to eliminate trip hazards.

Recommendation
Contact a qualified professional.

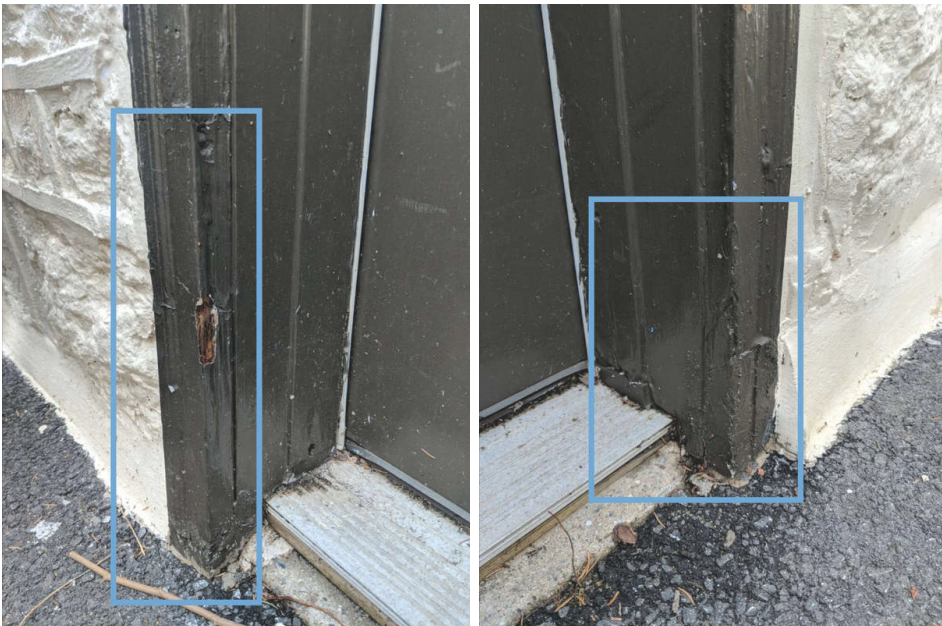
2.5.1 Windows and Door

TRIM ROTTED/DAMAGED

The trim at the base of the door frames damaged. This is a typical area of concern. This area should be sealed on all sides to prevent water wicking and further deterioration. The damaged wood should be repaired or replaced

Contact a qualified professional.

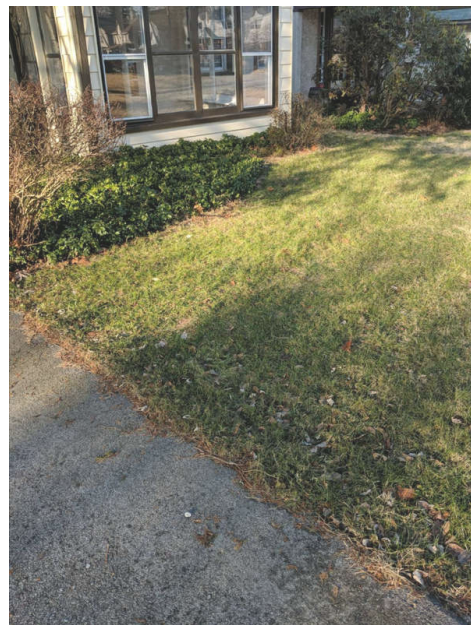
2.8.1 Vegetation and Grading

SURFACE TOWARD BUILDING

Surfaces sloped down towards building perimeters in one or more areas. This may result in water accumulating around building foundations or underneath buildings. Monitor these areas in the future, especially during and after periods of rain. If significant amounts of water are found to accumulate, then recommend that a qualified contractor evaluate and repair as necessary. For example, by installing drain(s) or removing old pavement and installing new.

Contact a qualified professional.

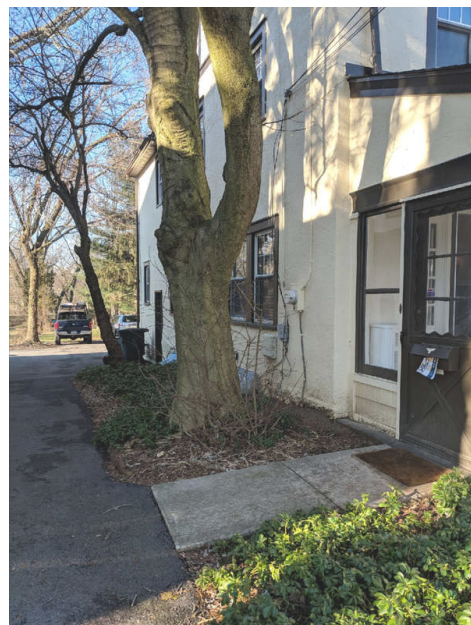
2.8.2 Vegetation and Grading

TREE NEAR FOUNDATION

One or more large trees were very close to the foundation. Tree roots can cause significant structural damage to foundations. Recommend that a qualified tree service contractor or certified arborist remove trees as necessary to prevent damage to foundations.

Contact a qualified tree service company.

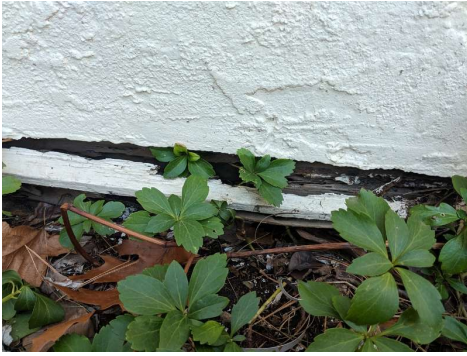
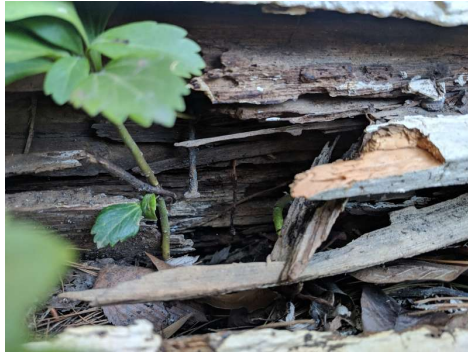
2.12.1 Stucco Walls

TRIM DAMAGED

The trim at the base of the stucco walls are deteriorated. We recommend further investigation into the extent of damage and all damaged trim be replaced

Contact a qualified professional.

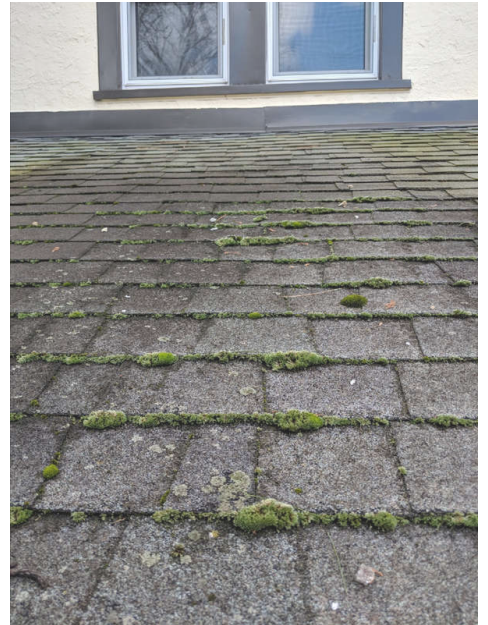
3.3.1 Shingles

MOSS ON SHINGLES

Moss was growing on the roof. As a result, shingles can lift or be damaged. Leaks can result and/or the roof surface can fail prematurely. Efforts should be made to kill the moss during its growing season (wet months). Typically, zinc or phosphate-based chemicals are used for this and must be applied periodically.

Contact a qualified professional.

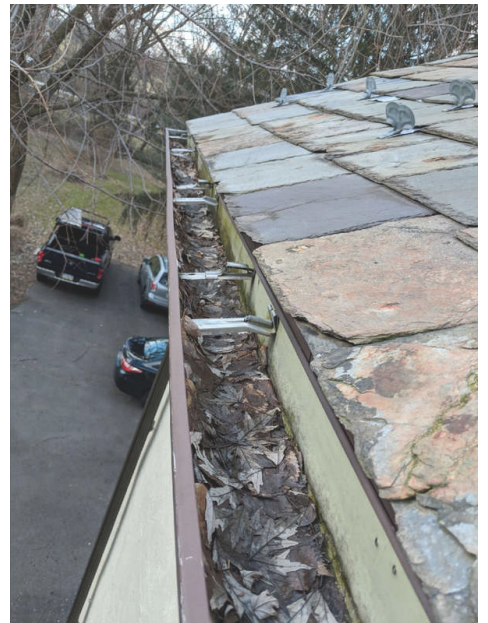
3.5.1 Gutters/drains

CLOGGED GUTTERS/DOWNSPOUTS

Significant amounts of debris have accumulated in one or more gutters or downspouts. Gutters can overflow and cause water to come in contact with the building exterior, or water can accumulate around the foundation. This is a conducive condition for wood-destroying organisms. Recommend cleaning gutters and downspouts now and as necessary in the future.

Recommended DIY Project

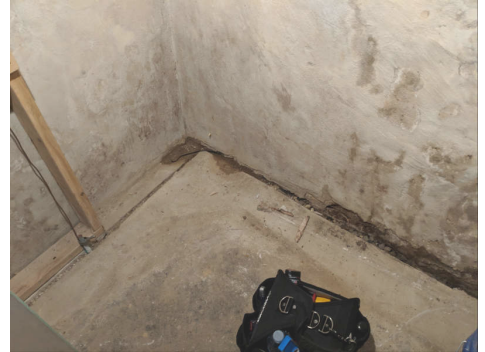
5.2.1 Foundation

MINOR WATER ENTRY

Minor water entry was noted on the basement floor. This is typical in most basements and does not require immediate action.

Contact a qualified professional.

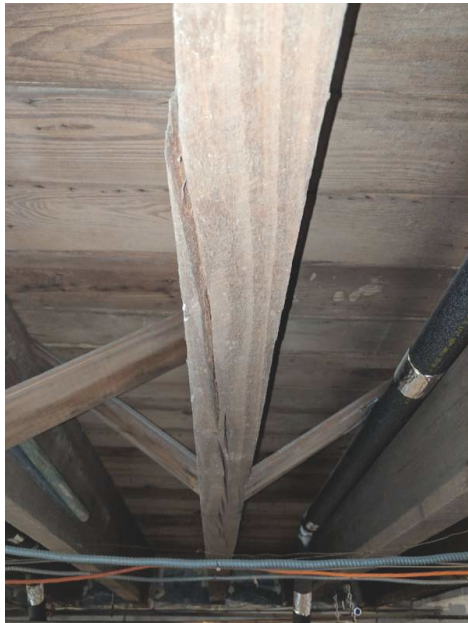
5.3.1 Floor Structure

JOISTS NEED REPAIR

One or more floor joists were damaged or improperly installed. This can cause damage to the structural integrity of the home. Recommend a qualified structural engineer evaluate and advise on how to correct.

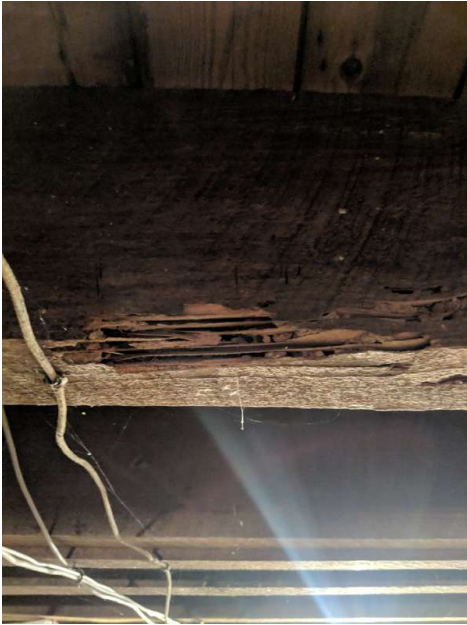
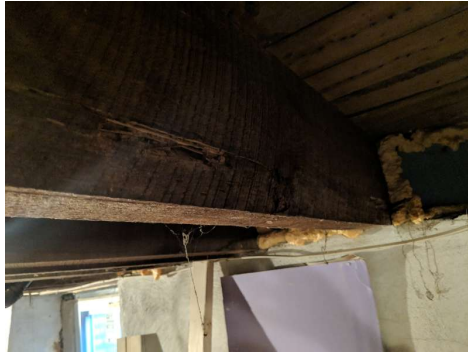
5.3.2 Floor Structure

WDI DAMAGE

Wood destroying insects damage was noted. We recommend an invasive Inspection to determine the extent of damage. A qualified contractor should further evaluate and make necessary repairs

Contact a qualified professional.

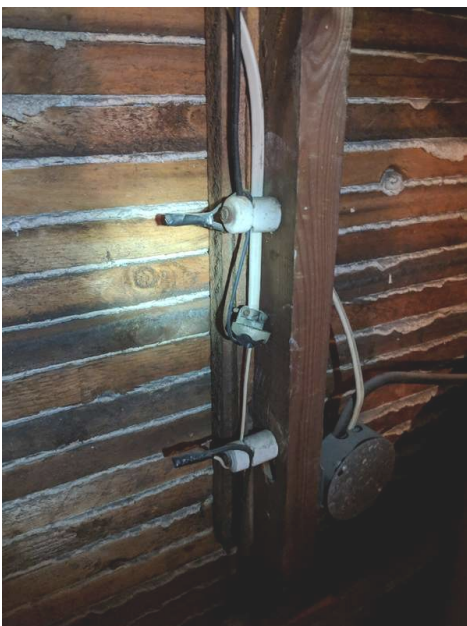
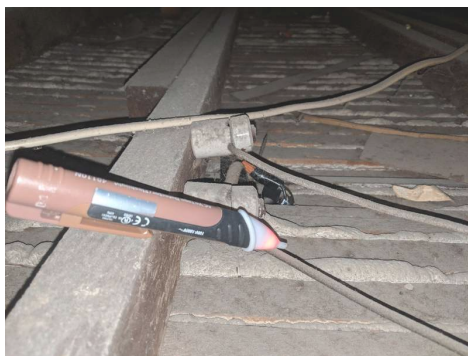
6.2.1 Branch Wiring

KNOB AND TUBE-ENERGIZED

This property has "knob and tube" wiring, which was commonly installed prior to 1950. It is ungrounded, and considered unsafe by today's standards. Over time, the wire's insulation may become brittle and fall apart or wear thin, resulting in exposed conductors and a risk of shock and/or fire. This wiring is also easily damaged by covering it with insulation (a common practice), and incorrectly tapping new wiring into it.

Some energized knob and tube wiring was found during the inspection. It is not within the scope of this inspection to determine what percentage of this property's wiring is of the knob and tube type, or to determine what percentage of the knob and tube wiring is energized vs. abandoned. A qualified electrician should evaluate this wiring and make repairs or replace wiring as necessary.

Contact a qualified electrical contractor.

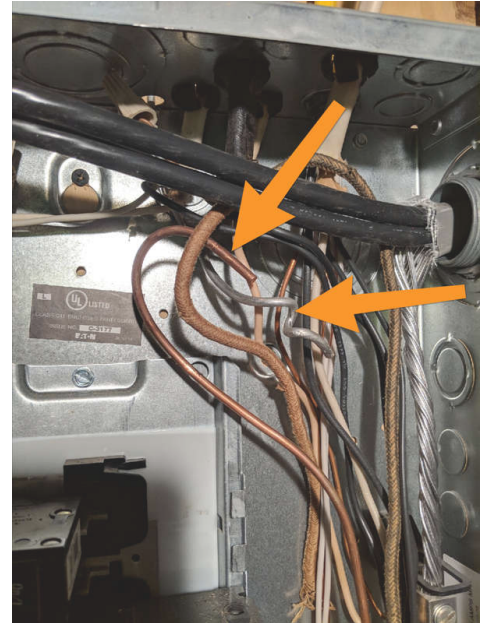
6.3.1 Circuit Breakers

GROUND DISCONNECTED

The system ground has been disconnected inside the electrical panel. We recommend repair by a licensed electrician

Recommendation
Contact a qualified electrical contractor.

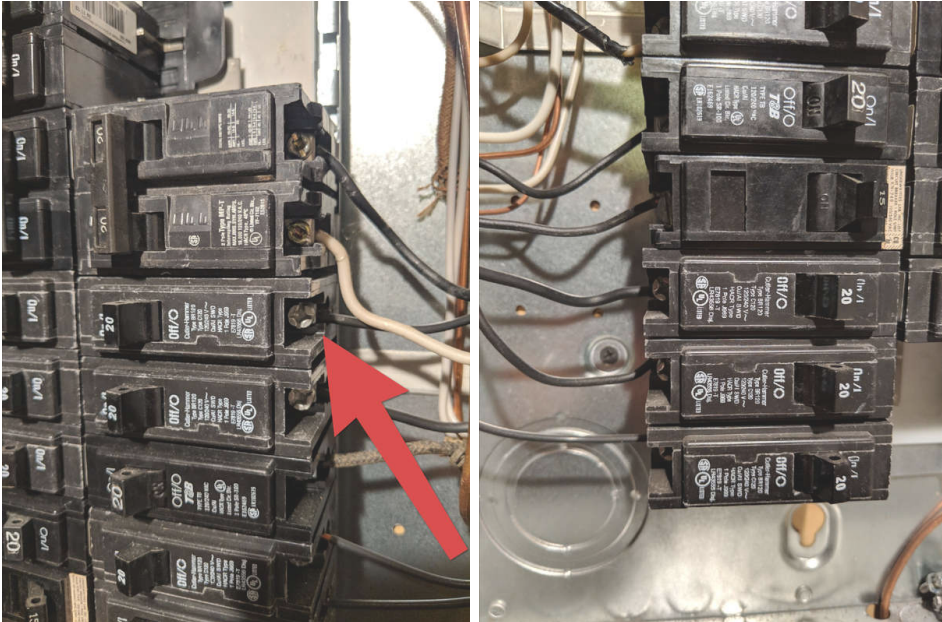
6.3.2 Circuit Breakers

OVER FUSED

We found over-fusing in the main service panel, meaning the fuse or breaker is not rated for the connected wire. This is a potential fire hazard. We recommend the circuit be equipped with an properly rated overcurrent protection device.

Recommendation
Contact a qualified professional.

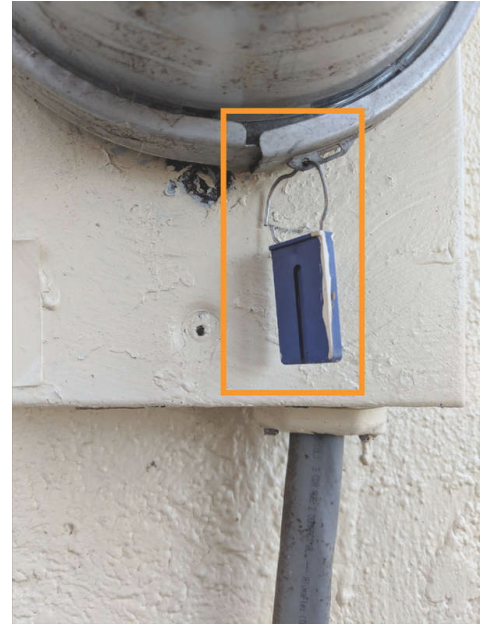
6.4.1 Meter

SEAL MISSING/BROKEN

The seal for the metal ring securing the electric meter to its base is missing or broken. The utility company installs these seals. Recommend consulting with the property owner(s) about this and/or contacting the utility company to have one reinstalled.

Recommendation
Contact your local utility company

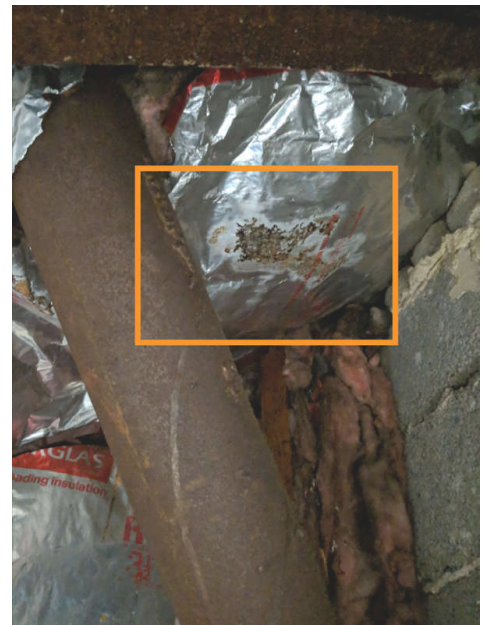
7.1.1 General

WATER STAINS

The area around the plumbing vent had water stains. We indicated no active leaking. It is possible this leak has been addressed. We recommend monitoring during heavy rainfall.

Recommendation
Contact a qualified professional.

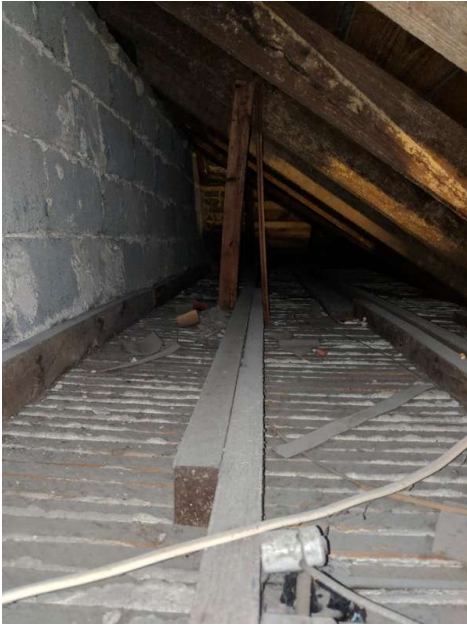
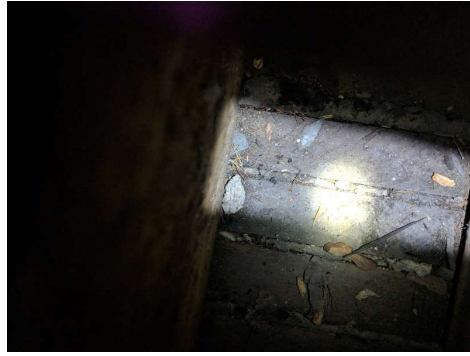
7.4.1 Insulation

MISSING

Ceiling insulation is missing in some areas. Recommend installing insulation where missing for better energy efficiency.

Recommendation
Contact a qualified insulation contractor.

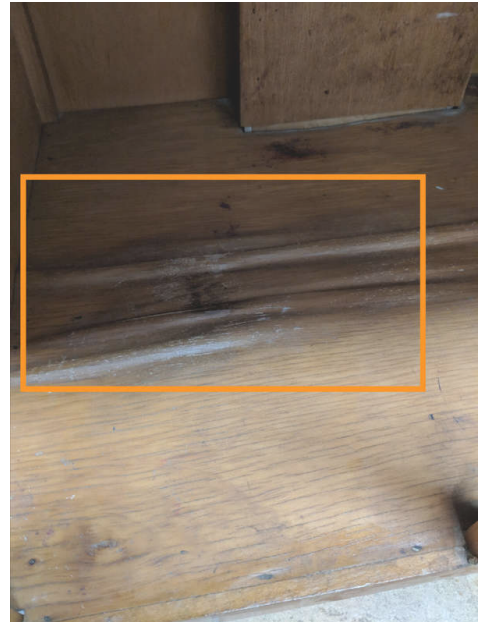
8.1.1 Cabinets

WATER DAMAGE MINOR

Water stains and/or minor water damage was found in the shelving or cabinet components below the sink. The client(s) should evaluate and consider having repairs made.

Contact a qualified cabinet contractor.

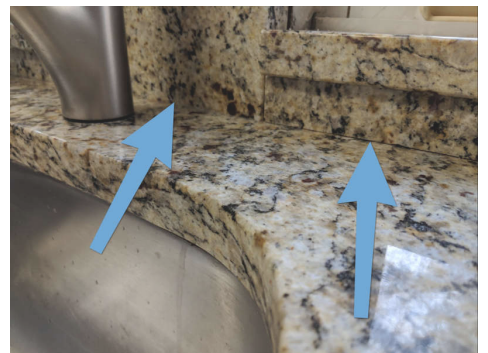
8.2.1 Countertops-Backsplash

CAULKING

One or more areas of the kitchen counter top(s) are recommended to be re-sealed (caulked) to keep any moisture and or water out and prevent future damage.

Recommended DIY Project

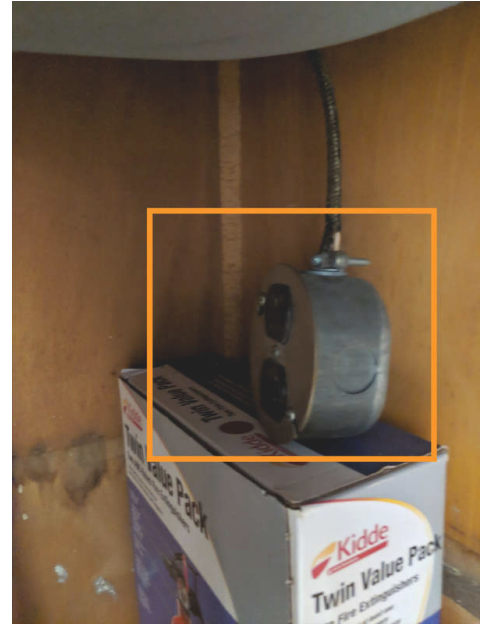
8.3.1 Electrical

RECEPTACLE LOOSE

One or more electric receptacles and/or the boxes they are installed in are loose and/or not securely anchored. Wire conductors may be damaged due to repeated movement and/or tension on wires, or insulation may be damaged. This is a safety hazard due to the risk of shock and fire. A qualified electrician should evaluate and repair as necessary.

Contact a qualified electrical contractor.

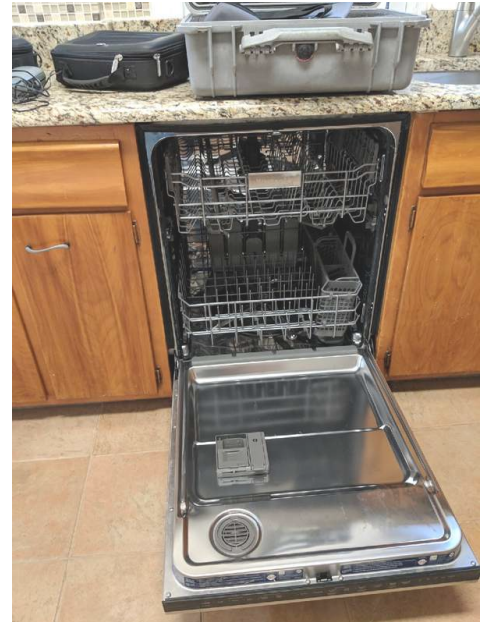
9.2.1 Dishwasher

The bracket that attaches the dishwasher to the underside of the countertop is loose, missing or installed in a substandard way. Repairs should be made as necessary, such as installing or reinstalling the bracket, and by a qualified contractor if necessary.

Contact a qualified appliance repair professional.

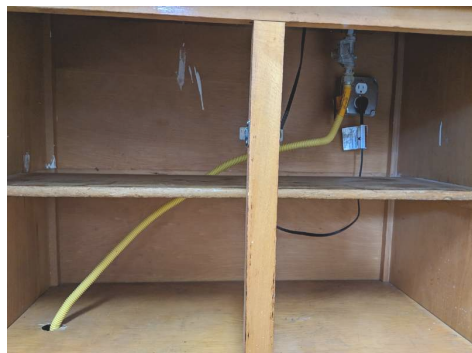
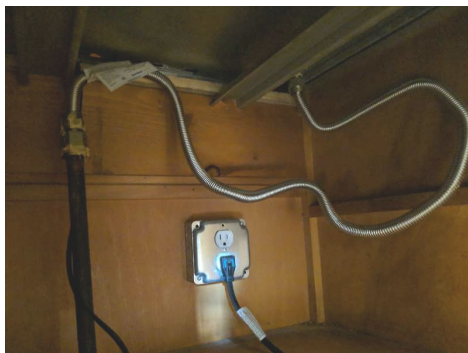
9.6.1 Range-Cooktop-Oven

NO SHUT OFF

There was no shut off present for the gas operated stove/oven/range cooktops. This may have been standard practice when the home was built. We recommend consideration be given to install shut off valve in accordance with current building standards

Contact a qualified professional.

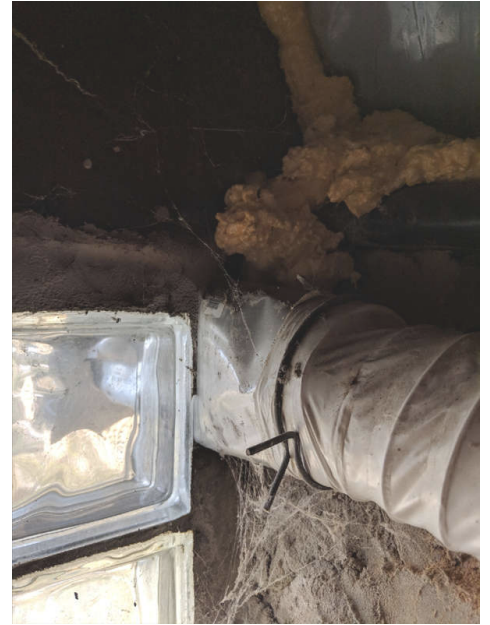
The clothes dryer exhaust duct is kinked, crushed and/or damaged. Air flow is restricted as a result. This is a safety hazard due to the risk of fire. The exhaust duct should be replaced or repaired, and by a qualified contractor if necessary.

Contact a qualified appliance repair professional.

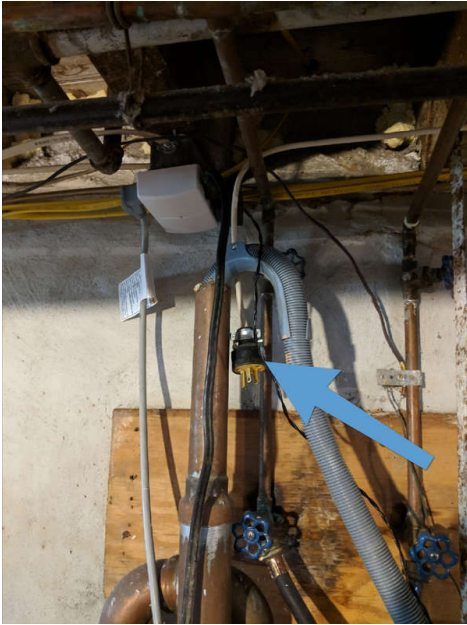
Extension cords were being used as permanent wiring at one or more locations. They should only be used for portable equipment on a temporary basis. Using extension cords as permanent wiring is a potential fire and shock hazard, and indicates that wiring is inadequate and needs updating. Extension cords may be undersized. Connections may not be secure resulting in power fluctuations, damage to equipment, overheating and sparks that could start a fire. Recommend that a qualified electrician repair per standard building practices and eliminate extension cords for permanently installed equipment.

Contact a qualified electrical contractor.

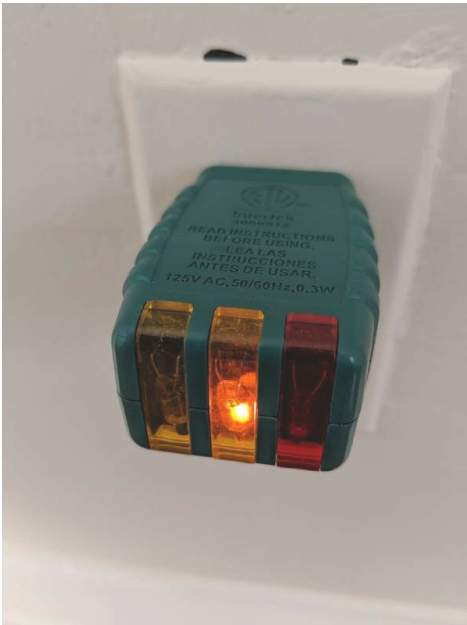
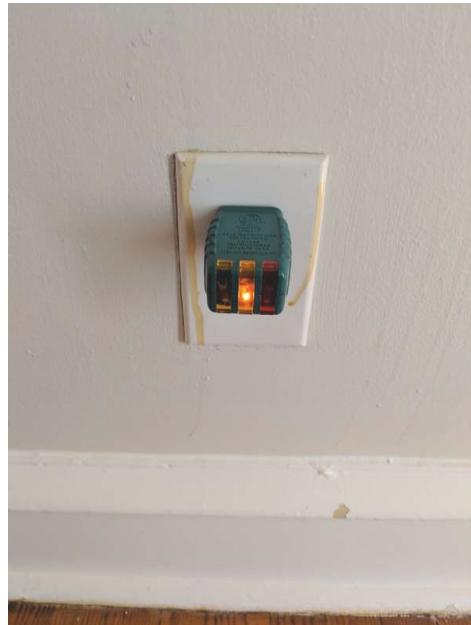
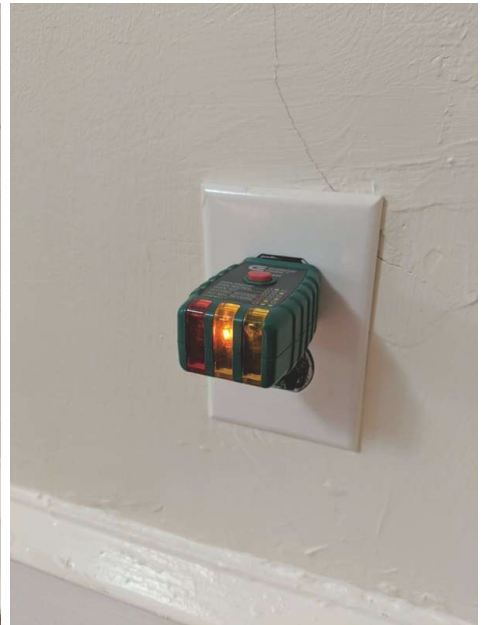
One or more modern, 3-slot electric receptacles were found with an open ground. This is a shock hazard when appliances that require a ground are used with these receptacles. Examples of such appliances include computers and related hardware, refrigerators, freezers, portable air conditioners, clothes washers, aquarium pumps, and electrically operated gardening tools. Recommend that a qualified electrician repair as necessary so all receptacles are grounded per standard building practices.

Contact a qualified electrical contractor.

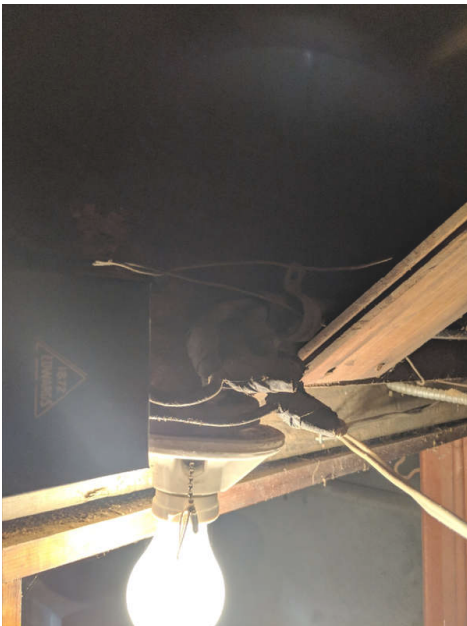
11.1.4 Electrical

Wire splices were exposed and were not contained in a covered junction box. This is a potential shock or fire hazard. Recommend that a qualified electrician repair per standard building practices. For example, by installing permanently mounted junction boxes with cover plates where needed to contain wiring splices.

Contact a qualified electrical contractor.

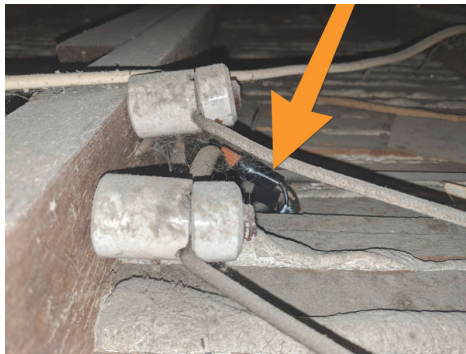
Basement

SPLICES NOT IN BOX

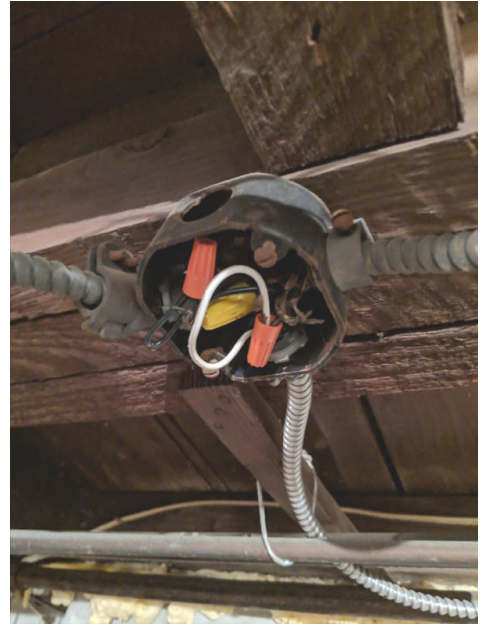
COVER PLATE MISSING

Cover plate(s) are missing from one or more electric boxes, such as for receptacles, switches and/or junction boxes. They are intended to contain fire and prevent electric shock from exposed wires. This is a safety hazard due to the risk of fire and shock. Cover plates should be installed where missing.

Recommendation
Contact a qualified electrical contractor.

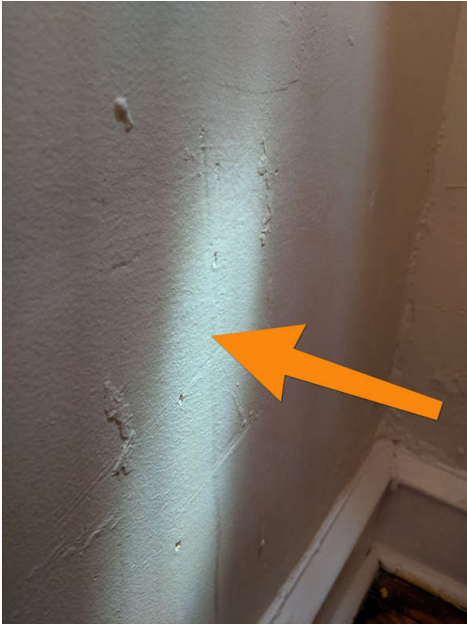
11.2.1 Floors, Walls, Ceilings

CEILING-WET STAIN

Stains and elevated levels of moisture were found in one or more ceiling areas. A qualified contractor should evaluate and repair as necessary.

Recommendation
Contact a qualified professional.

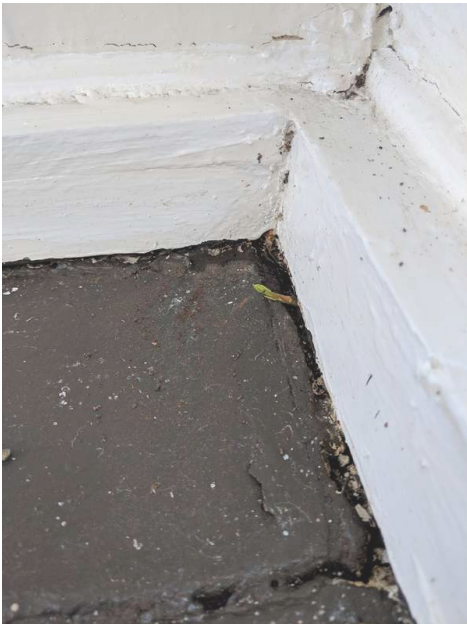
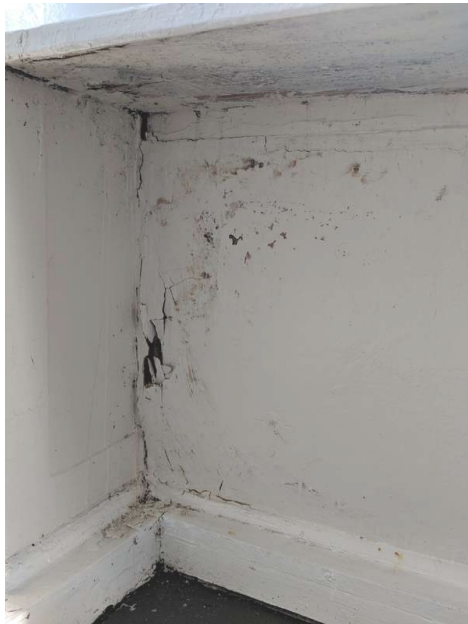
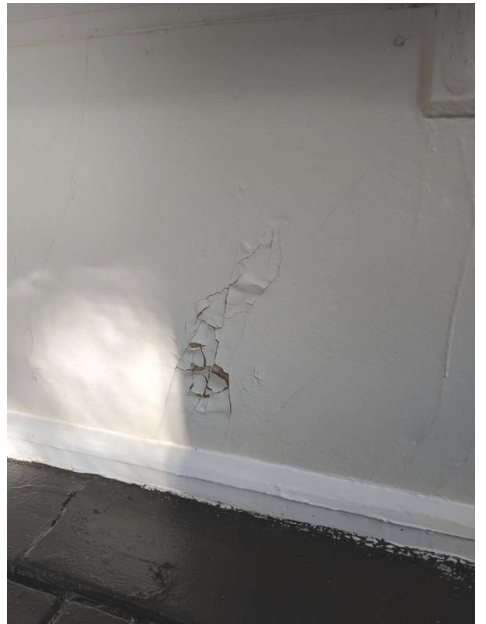
11.2.2 Floors, Walls, Ceilings

WALL- WET STAIN

Stains and elevated levels of moisture were found in one or more wall areas. A qualified contractor should evaluate and repair as necessary. The wall was crumbling. All damaged material should be replaced and the source of the problem be addressed by a qualified contractor

Contact a qualified professional.

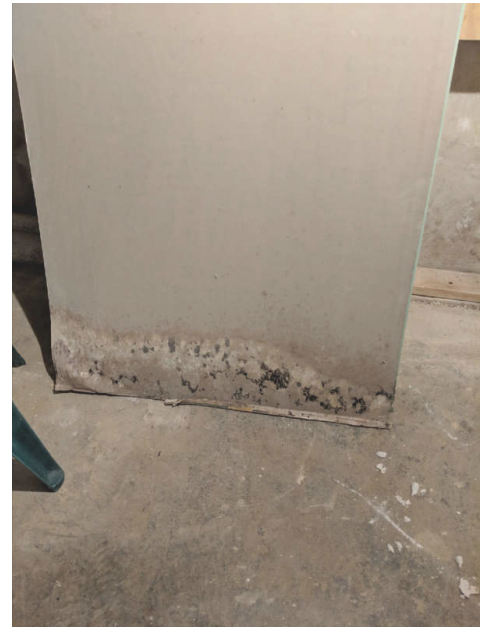
11.2.3 Floors, Walls, Ceilings

ORGANIC GROWTH

Organic growth was noted on drywall in the basement. We recommend all organic growth be removed

Recommendation
Contact a qualified professional.

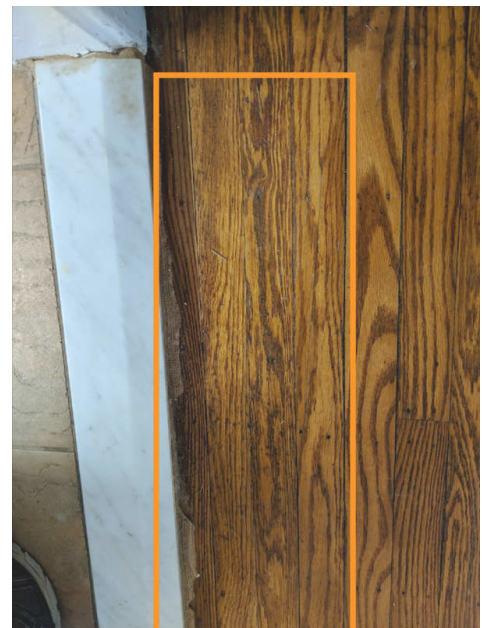
11.2.4 Floors, Walls, Ceilings

FLOOR DAMAGED

The floor was soft in areas. Repair or replacement is considered optional

Recommendation
Contact a qualified professional.

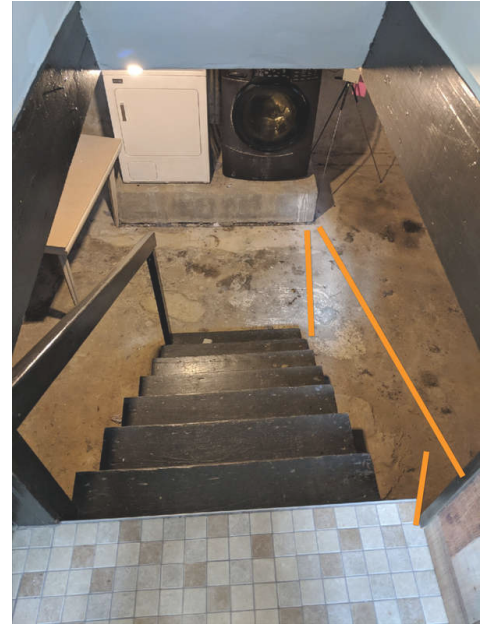
GUARDRAIL MISSING 30"

Guardrails at one or more locations with drop-offs higher than 30 inches were missing. This poses a fall hazard. Guardrails should be installed where walking surfaces are more than 30 inches above the surrounding grade or surfaces below. Recommend that a qualified contractor install guardrails where missing and per standard building practices.

Contact a qualified professional.

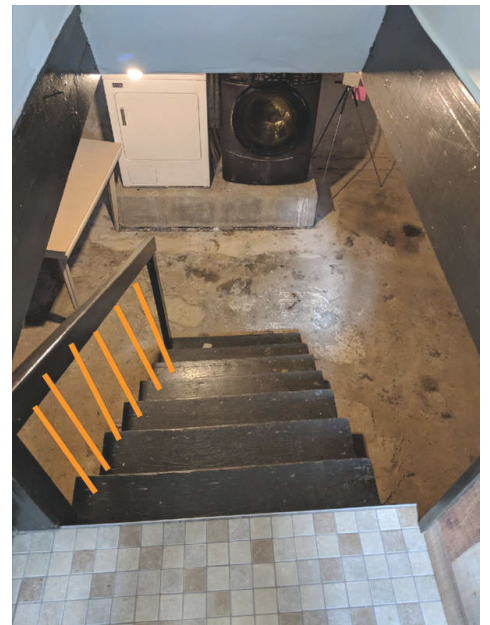
11.4.2 Stairs/Handrails/Guardrails

RISER OPENING GREATER 4"

Openings at stair risers were greater than 4 inches. This is a potential safety hazard for children (e.g. falling through, getting stuck in gaps). Recommend that a qualified contractor repair per standard building practices. For example, by enclosing stair risers.

Contact a qualified professional.

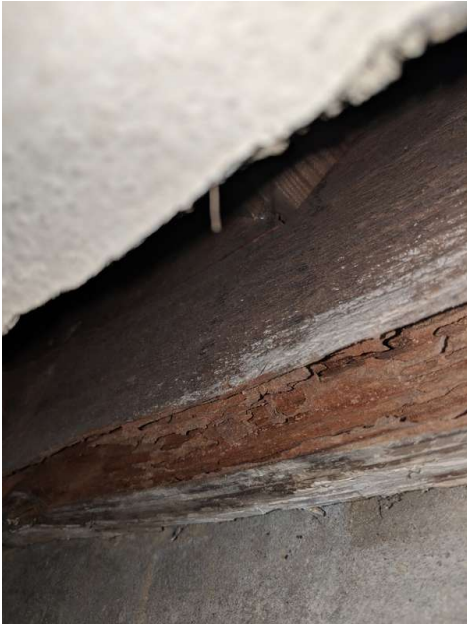
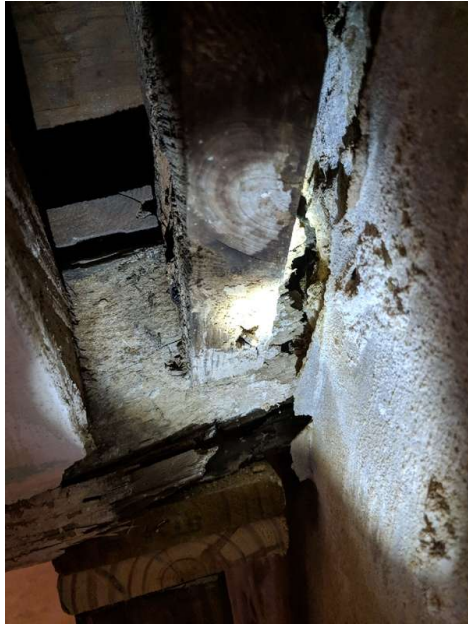
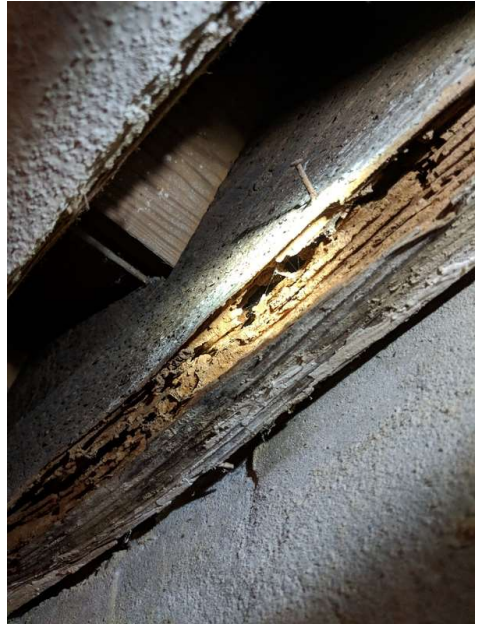
11.4.3 Stairs/Handrails/Guardrails

WDI DAMAGE

Wood destroying insect damage was noted on the stair string/supports. We recommend an invasive inspection by a qualified contractor and all necessary repairs be made.

Contact a qualified professional.

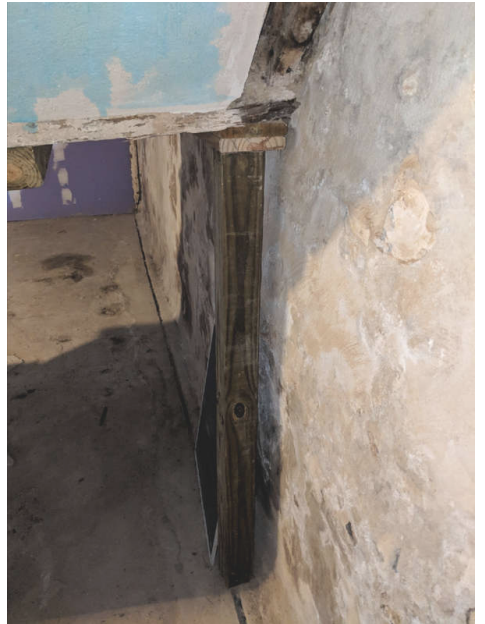
11.4.4 Stairs/Handrails/Guardrails **SUPPORT SUBSTANDARD**

The support most for the stairs was free floating and not properly secured to the landing. We recommend it be fastened to prevent the support from shifting and becoming loose.

Recommendation
Contact a qualified professional.

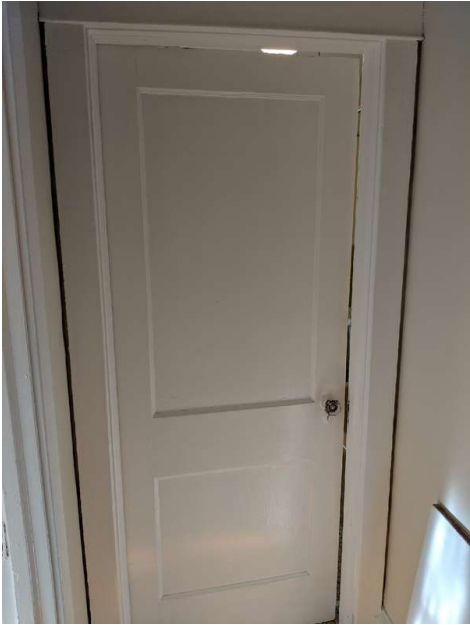
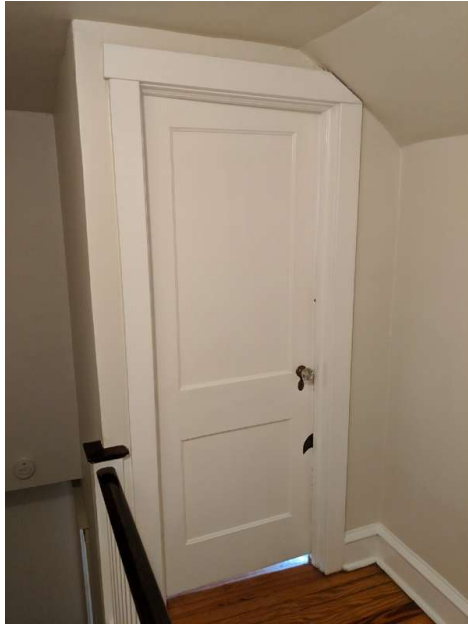
11.5.1 Windows and Door **DOOR RUBS**

One or more doors bind in their jamb, or are difficult to open and close. A qualified contractor should evaluate and repair as necessary. For example, adjusting jambs or trimming doors.

Recommendation
Contact a qualified door repair/installation contractor.

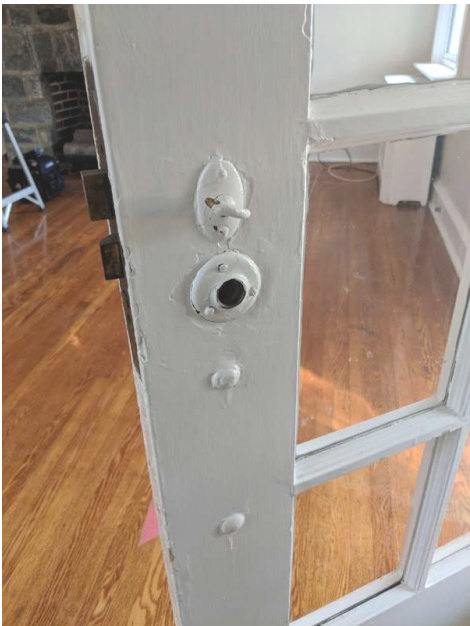
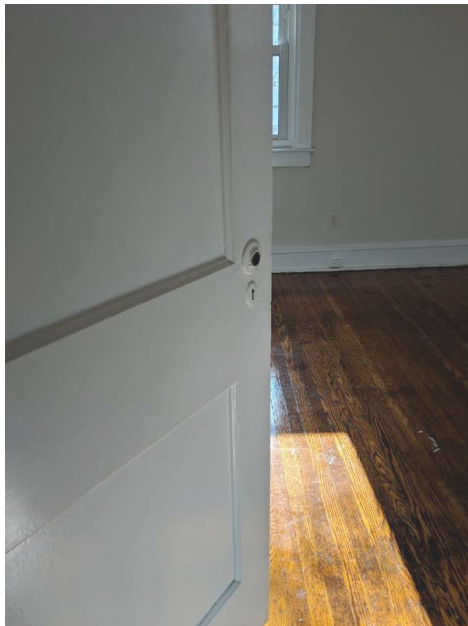
11.5.2 Windows and Door

LOCKSET-DAMAGED

One or more locksets are damaged and/or deteriorated. Locksets should be replaced as necessary.

Contact a qualified handyman.

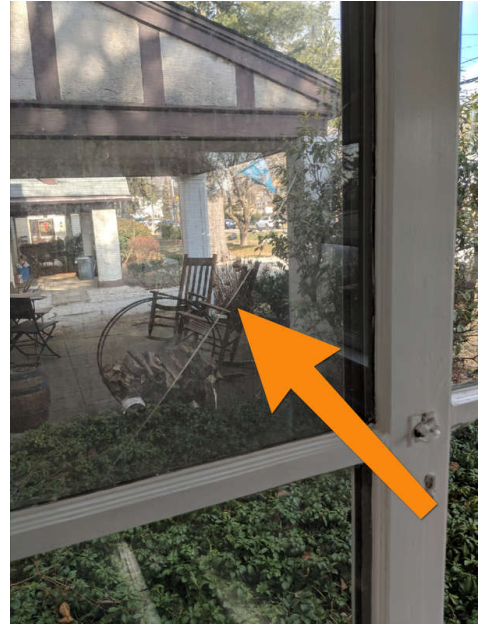
11.5.3 Windows and Door

WINDOW-BROKEN

Glass in one or more windows is broken. A qualified contractor should replace glass where necessary.

Contact a qualified window repair/installation contractor.

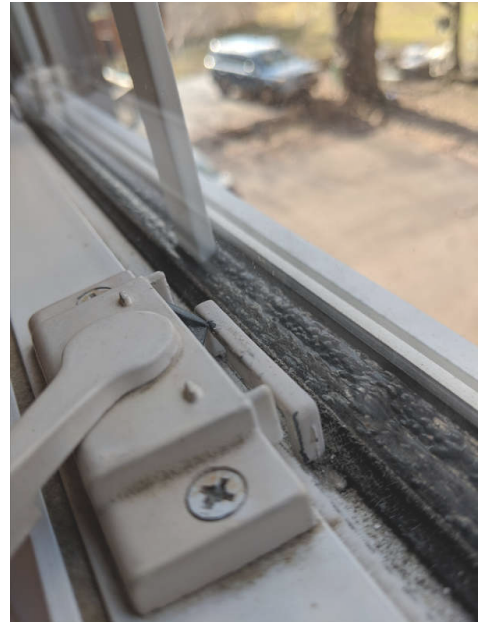
11.5.4 Windows and Door
WINDOW-LOCK ISSUE

Lock mechanisms on one or more windows are missing and/or damaged so that they are inoperable. Repairs should be made by a qualified contractor or service technician so that windows lock and unlock easily.

Recommendation
Contact a qualified window repair/installation contractor.

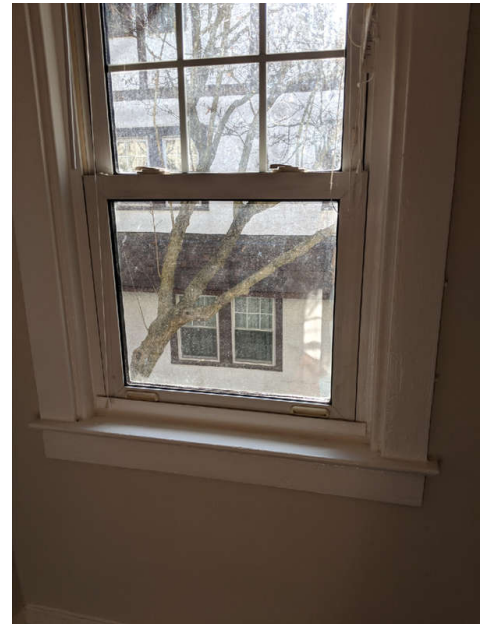
11.5.5 Windows and Door
WINDOW-SCREENS MISSING

Screen(s) in one or more windows are missing. The client(s) should ask the property owner(s) about this. Screens are often removed for window cleaning and they may be stored somewhere. If not, then recommend installing screens where missing.

Recommendation
Contact a qualified window repair/installation contractor.

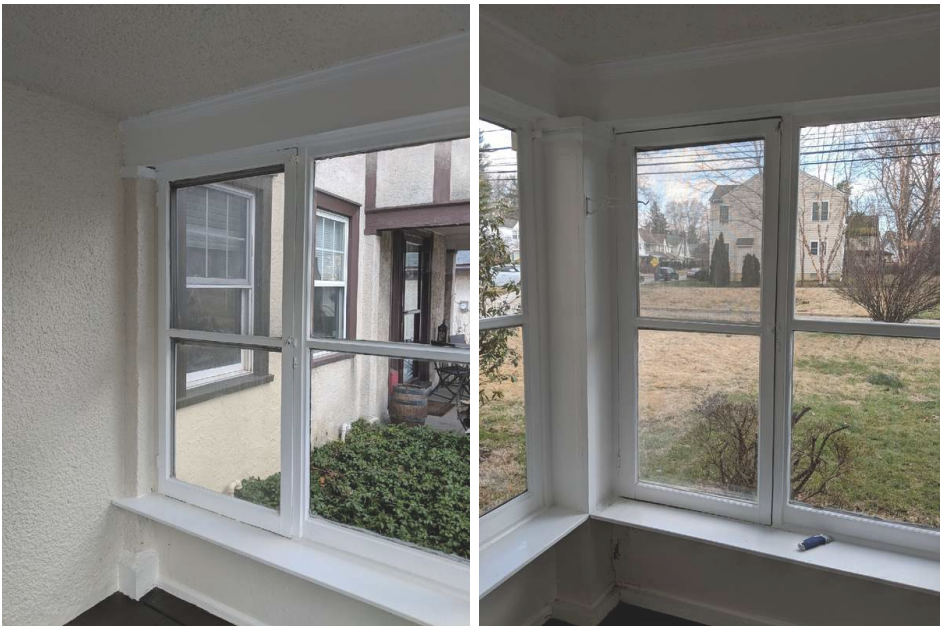
11.5.6 Windows and Door

WINDOW-WON'T OPEN

One or more windows that were built to open, will not open, or open only minimally due to their being painted shut, damaged and/or deteriorated in some way. Repairs should be made as necessary, and by a qualified contractor if necessary so windows open fully, and open and close easily.

Contact a qualified window repair/installation contractor.

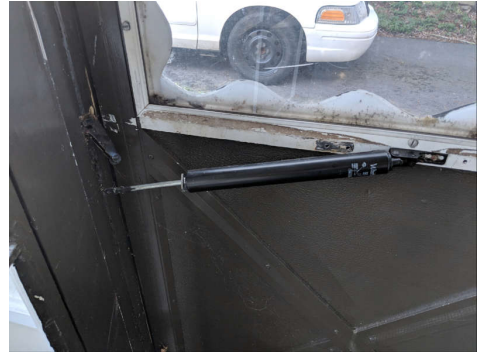
11.5.7 Windows and Door

DOOR CLOSER DAMAGED

The door closer is damaged. We recommend it be repaired or replaced

Contact a qualified professional.

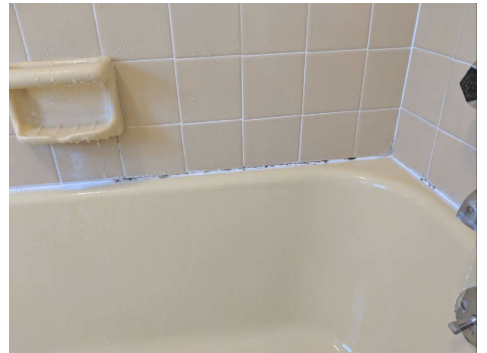
12.1.1 Bathub

CAULKING AT SURROUND

Caulk is missing or deteriorated above one or more bathtubs, where the tub surround meets the tub. It should be replaced where deteriorated and/or applied where missing to prevent water intrusion and damage to the wall structure.

Recommended DIY Project

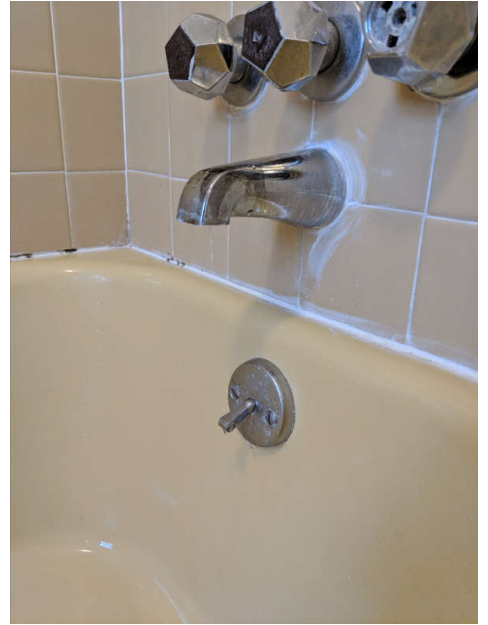
12.1.2 Bathub

FAUCET LEAKS OFF

One or more faucets leak or drip when turned off. A qualified plumber should evaluate and repair as necessary.

Contact a qualified plumbing contractor.

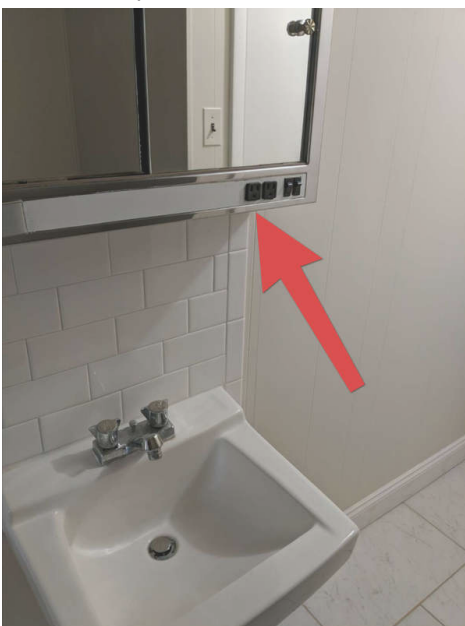
12.3.1 Electrical

GFCI MISSING

One or more electric receptacles at the bathroom(s) had no visible ground fault circuit interrupter (GFCI) protection, or the inspector was unable to determine if GFCI protection was present. If not GFCI-protected, receptacles in wet areas pose a shock hazard. Recommend that a qualified electrician evaluate and install GFCI protection if necessary and per standard building practices. General guidelines for GFCI-protected receptacles include the following locations:

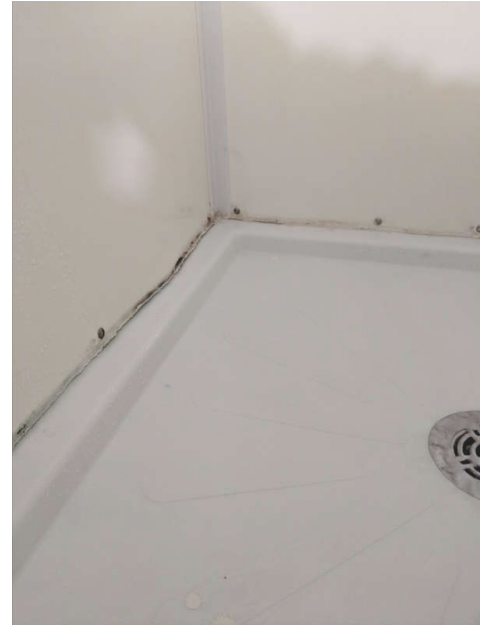
Caulk is missing or deteriorated around the shower surround. It should be replaced where deteriorated and/or applied where missing to prevent water intrusion and damage to the wall structure.

Recommended DIY Project

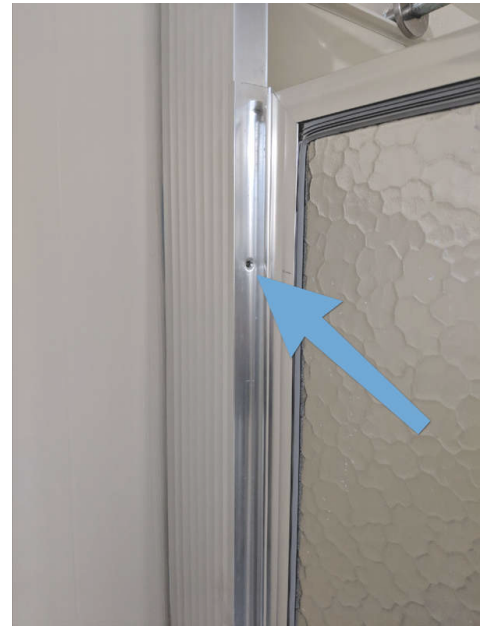
12.6.2 Shower

HARDWARE MISSING

The shower door is very loose and the hardware is missing. This is causing a rough operation. We recommend the door be repaired

Contact a qualified professional.

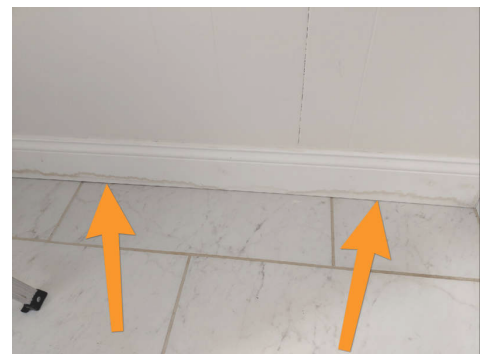
12.6.3 Shower

PAST WATER DAMAGE

Evidence of past water damage was noted on the floor around the shower. We recommend monitoring and repairing if needed

Contact a qualified professional.

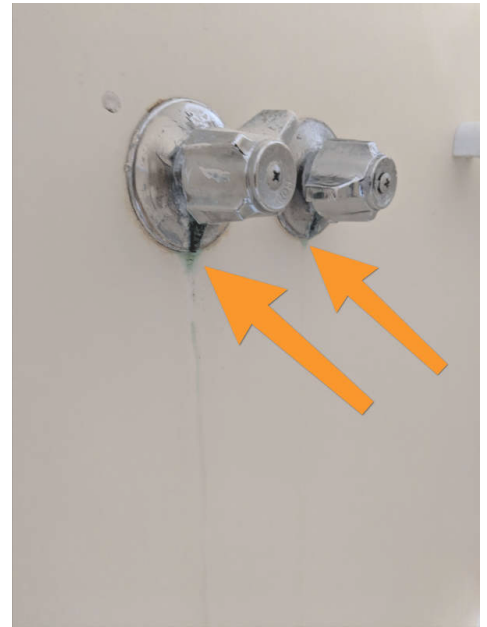
12.7.1 Sink/countertop

FAUCET LEAKS ON

One or more faucets leak by handle(s) or at their base when turned on. A qualified plumber should evaluate and repair as necessary.

Contact a qualified plumbing contractor.

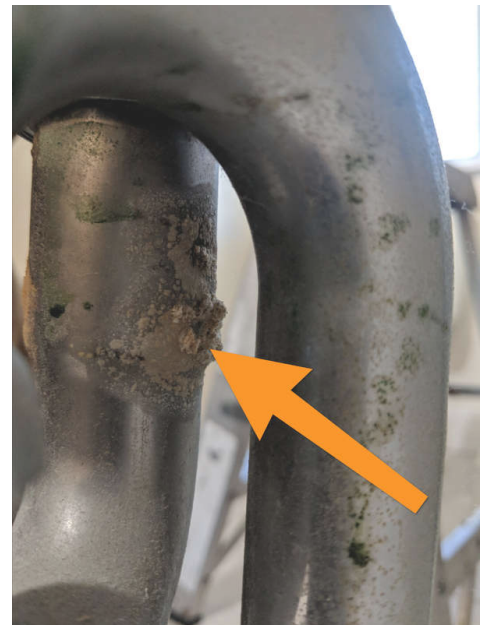
12.7.2 Sink/countertop

SINK DRAIN LEAK

One or more sink drains have an active leak. For example, at pipe fittings and/or junctions between pipe and sink. A qualified plumber should evaluate and repair as necessary.

Contact a qualified plumbing contractor.
