SUMMARY
1234 Main St. Lansdale Pennsylvania
19446
Buyer Name
02/08/2019 9:00AM

Donald Nagle
L&L Home Inspections, LLC
(484)-942-7344
ll.homeinspectionsllc@gmail.com

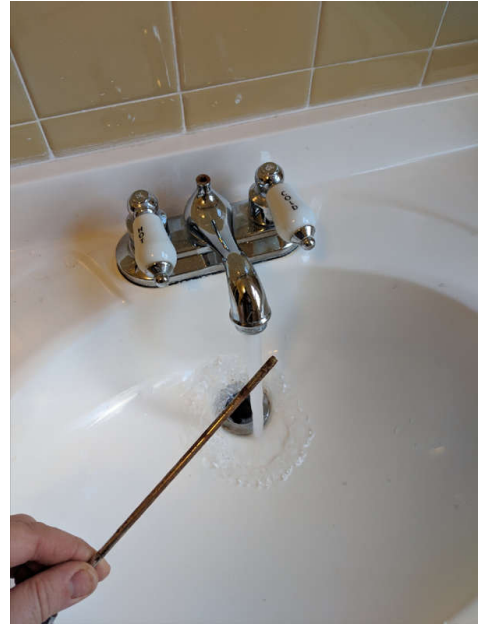
12.7.3 Sink/countertop

STOPPER ISSUE

One or more sink stopper(s) mechanisms are missing, or need adjustment or repair. Stopper mechanisms should be installed where missing and/or repairs should be made so sink stoppers open and close easily.

Contact a qualified plumbing contractor.

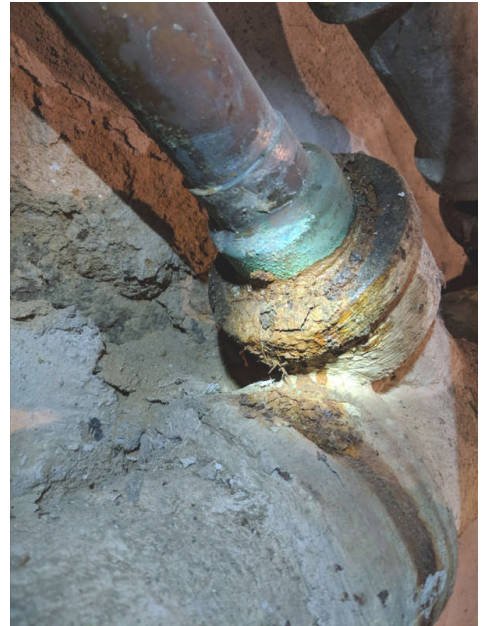
14.3.1 Drain and Waste

PAST LEAKING-NOT OCCUPIED

The home is vacant at the time of our inspection. With a change in occupancy some dormant leaks may become apparent. We noted areas of past leakage. The system should be monitored for active leaks after a change in occupancy

Contact a qualified professional.

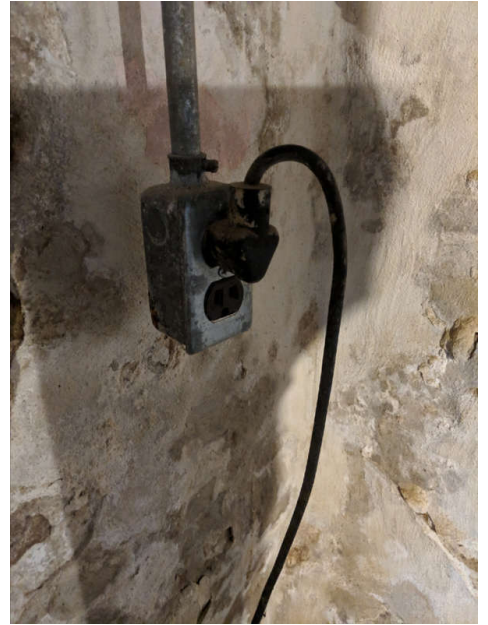
14.5.1 Sump pump

GFCI MISSING

The sump pump electrical connection is not ground fault protected, as would be required today. GFI protection for the sump pump would provide a higher margin of safety and is recommended as an optional upgrade.

The outlet is not properly fastened to the wall. We recommend it be anchored to the wall to prevent damage to the wiring.

Contact a qualified professional.

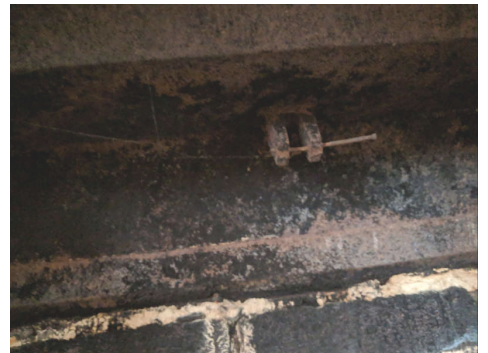
The damper in one or more fireplaces is stuck and cannot be opened or closed. A qualified chimney service contractor should evaluate and make repairs as necessary.

Contact a qualified chimney contractor.

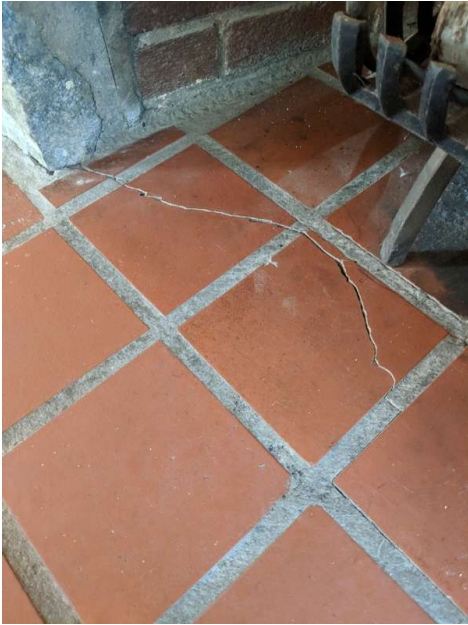
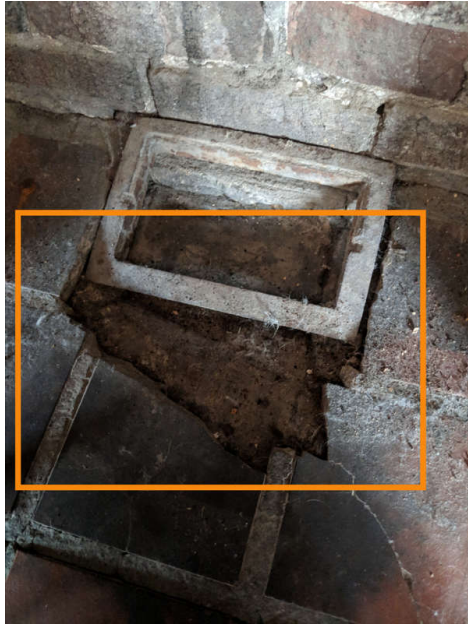
16.3.1 Hearth

DETERIORATED

One or more fireplace and/or woodstove hearths are damaged and/or deteriorated. For example, loose or broken tiles and/or bricks. A qualified contractor should evaluate and make repairs as necessary.

Contact a qualified fireplace contractor.
