## SUMMARY

1234 Main St. Lake Charles LA 70611

Aaron Gott  
LA License # 11034  
AGI: Property Inspections  
337-661-1428  
info@agi-swla.com

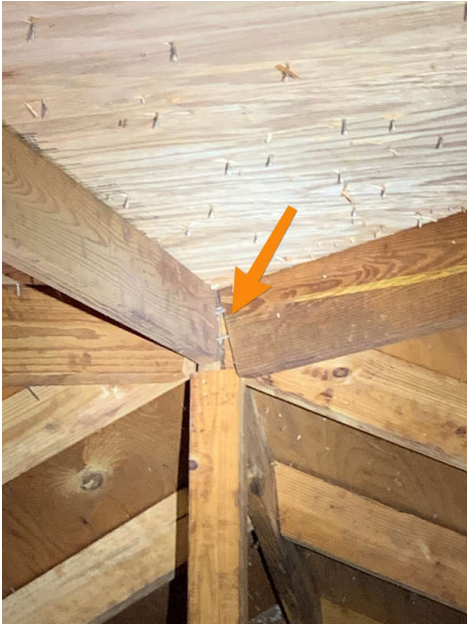
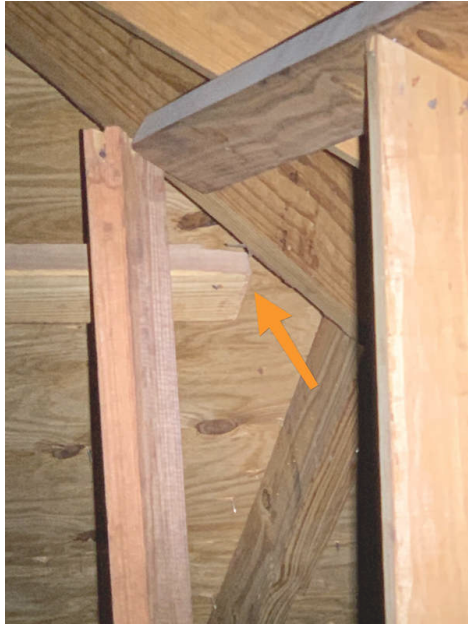
### 3.1.1 Structure

#### **LOOSE/SEPARATED UNIONS**

Moderate Material Defects

One or more areas of roof framing appeared to be pulling apart and loose.

Contact a qualified roofing professional.

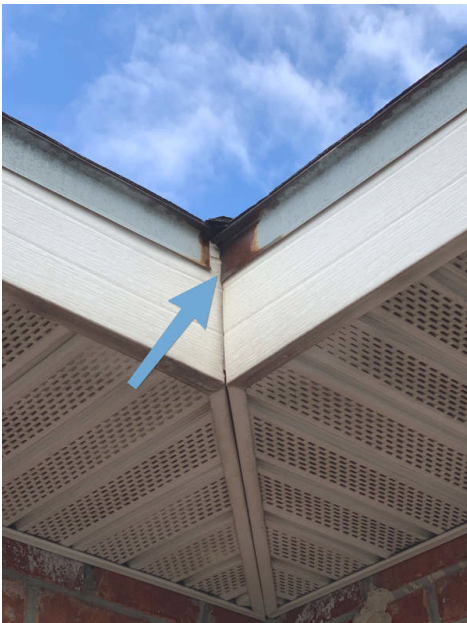
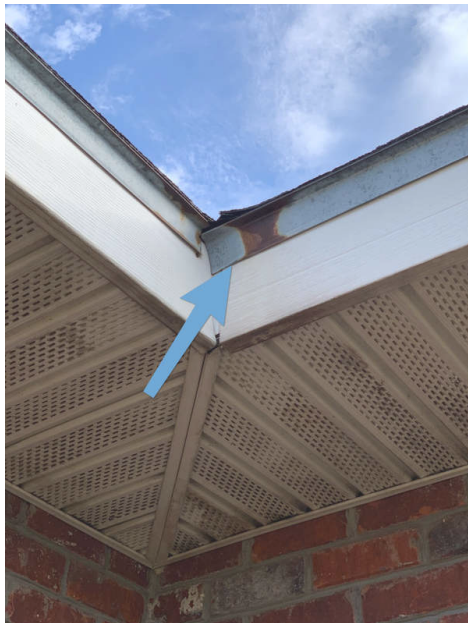
### 3.4.1 Flashings

#### **CORRODED - MINOR**

Maintenance/Minor Items

Roof flashing showed signs of corrosion, but are still in working condition. Flashing should be monitored to prevent severe corrosion leading to moisture intrusion.

Contact a qualified roofing professional.

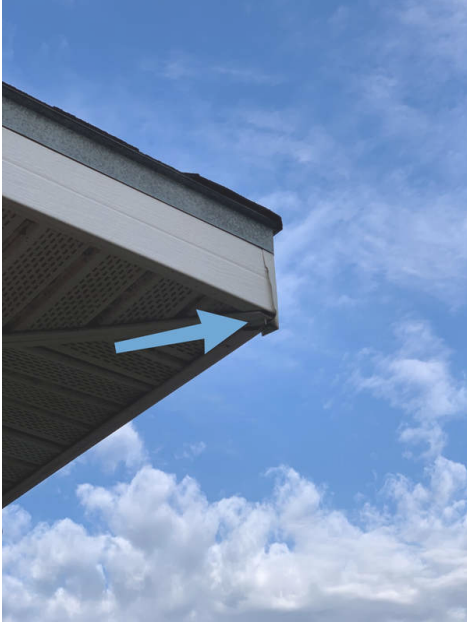
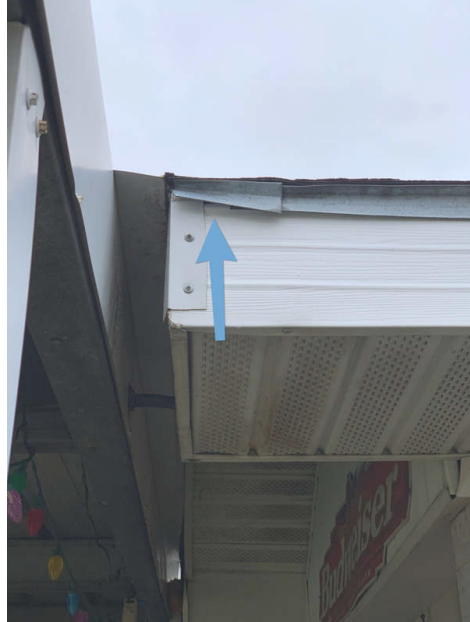
3.4.2 Flashings

**LOOSE/SEPARATED**

Maintenance/Minor Items

Flashings observed to be loose or separated in one or more areas, which can lead to water intrusion and/or mold.

Recommendation  
Contact a qualified roofing professional.

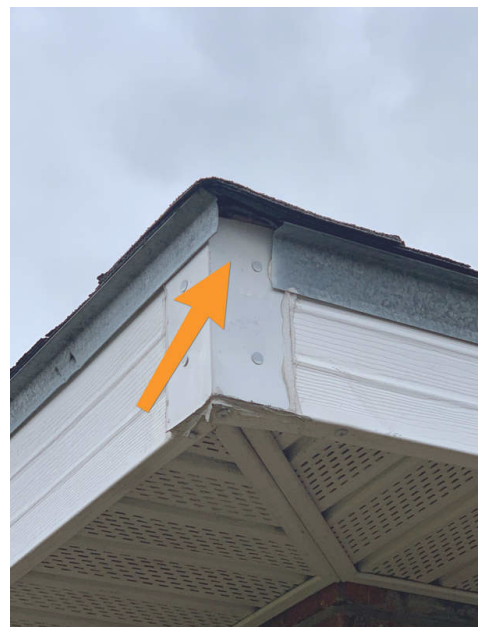
3.4.3 Flashings

**FLASHING- TOO SHORT**

Moderate Material Defects

One or more areas had roof edge flashing that was too short.

Recommendation  
Contact a qualified roofing professional.

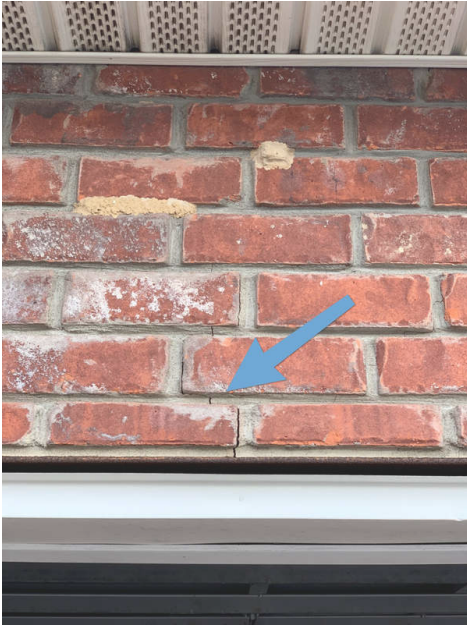
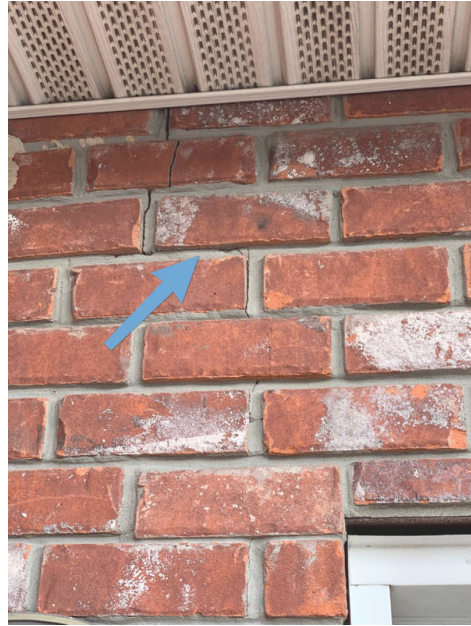
4.1.1 Wall Covering, Trim  
**CRACKING - MINOR**

Maintenance/Minor Items

Siding showed some cracking in one or more places.

Contact a qualified masonry professional.

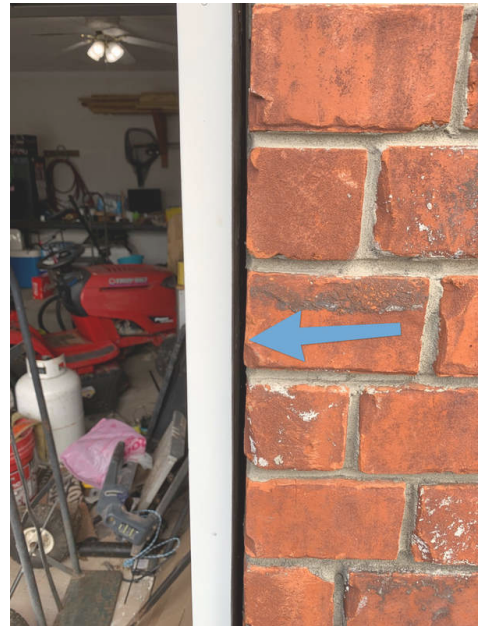
#### 4.1.2 Wall Covering, Trim

### GAP- EXPOSED STRUCTURE

Maintenance/Minor Items

One or more areas of siding had a gap between seems with exposed structure. This should be repeated to prevent damage to the structural components of the home.

Contact a qualified siding specialist.

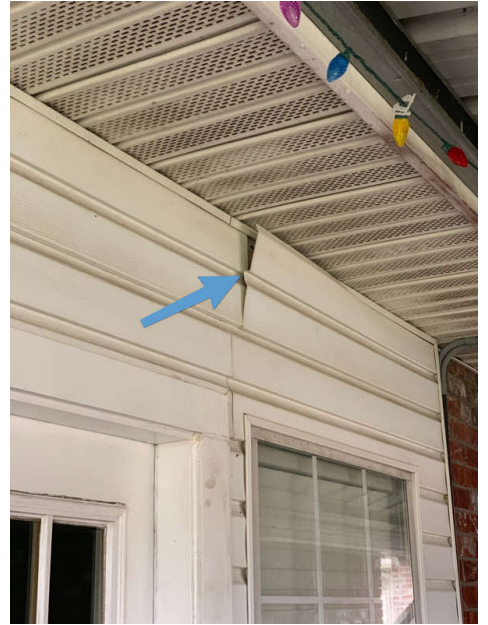
#### 4.1.3 Wall Covering, Trim

### LOOSE SIDING

Maintenance/Minor Items

One or more pieces of siding were loose, which could result in moisture intrusion.

Contact a qualified siding specialist.

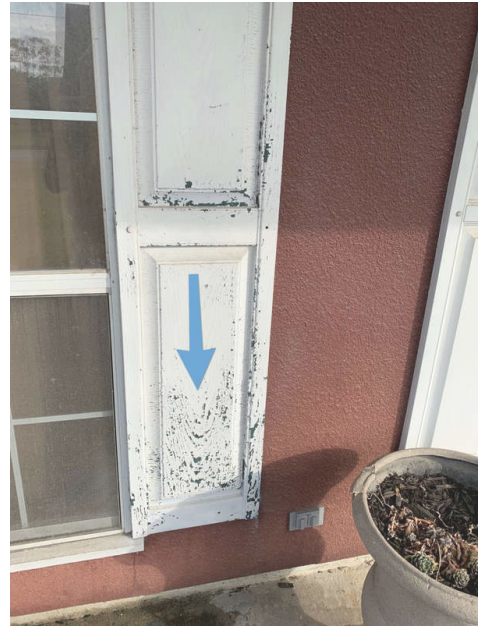
#### 4.1.4 Wall Covering, Trim

### **PAINT- PEELING**

Maintenance/Minor Items

Paint was peeling in one or more areas and should be refinished to prevent premature damage to structural components.

Contact a qualified painter.

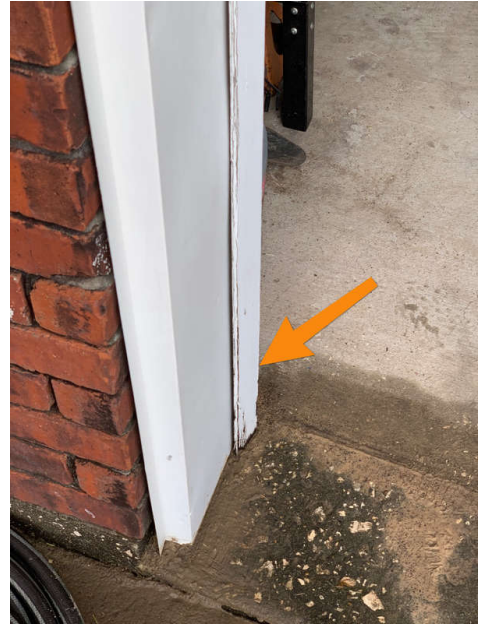
#### 4.1.5 Wall Covering, Trim

### **TRIM- DAMAGED**

Moderate Material Defects

One or more areas of exterior trim was damaged at the time of inspection.

Contact a qualified siding specialist.

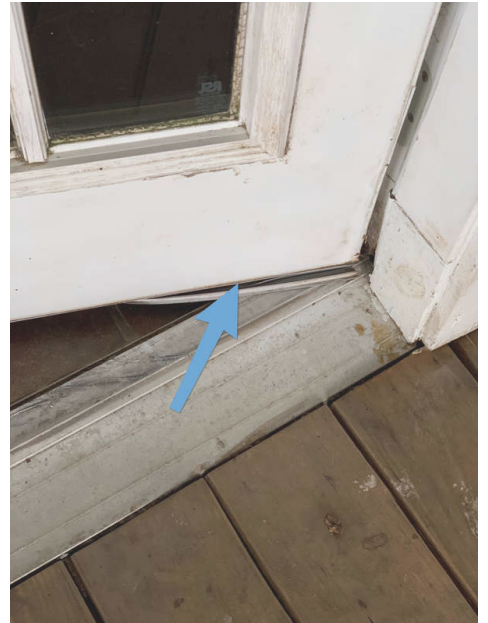
#### 4.3.1 Exterior Doors

### SWEEP- DAMAGED

Maintenance/Minor Items

Sweeps at exterior doors in the home were damaged or deteriorated.

Contact a qualified door repair/installation contractor.

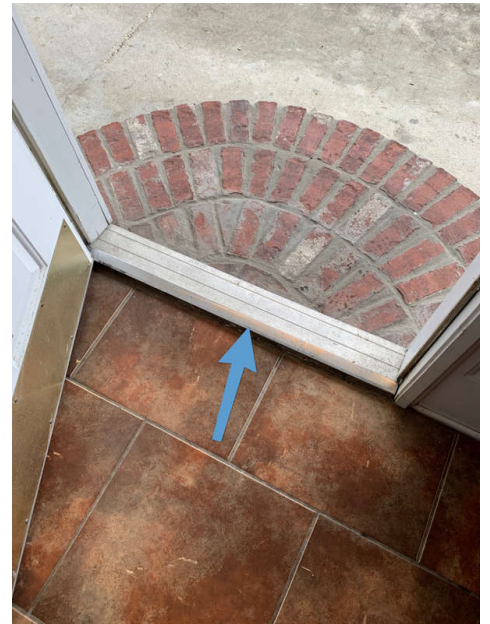
#### 4.3.2 Exterior Doors

### THRESHOLD- DAMAGED

Maintenance/Minor Items

Threshold for exterior door was damaged and should be replaced. This can cause energy loss and allow access for exterior conditions to come inside; weather, moisture, pests.

Contact a handyman or DIY project

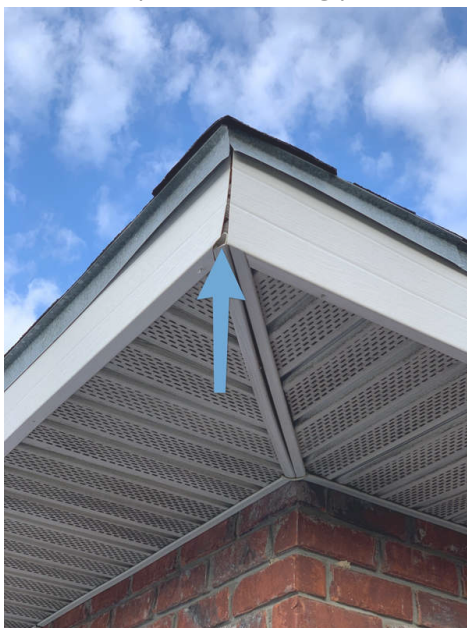
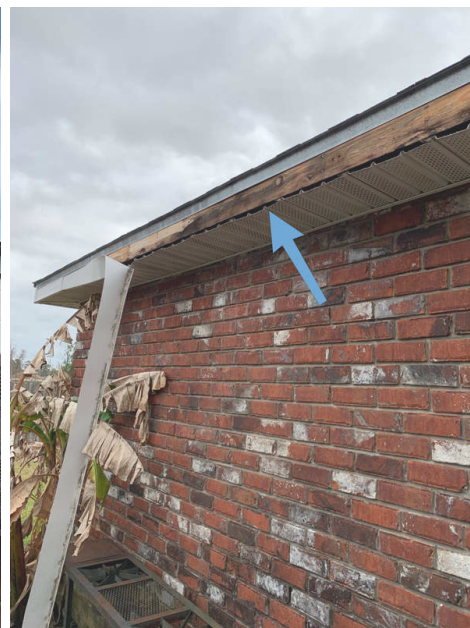
#### 4.5.1 Eaves, Soffits & Fascia

### FASCIA - LOOSE

One or more sections of the fascia are loose and should be repaired to prevent moisture intrusion to the structure.

Contact a qualified roofing professional.

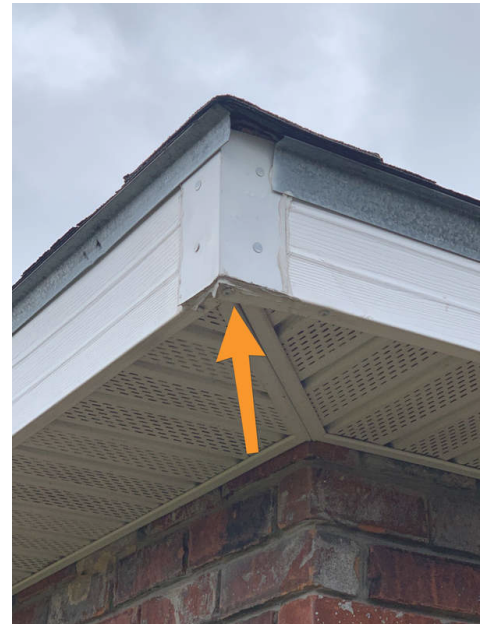
#### 4.5.2 Eaves, Soffits & Fascia

### SEALANT- AFTER INSTALL

When a sealant is applied, after the initial install, it is usually done in an effort to stop or prevent future energy loss or water intrusion. Once applied, it has to be maintained on a regular basis.

Recommendation  
Contact a handyman or DIY project

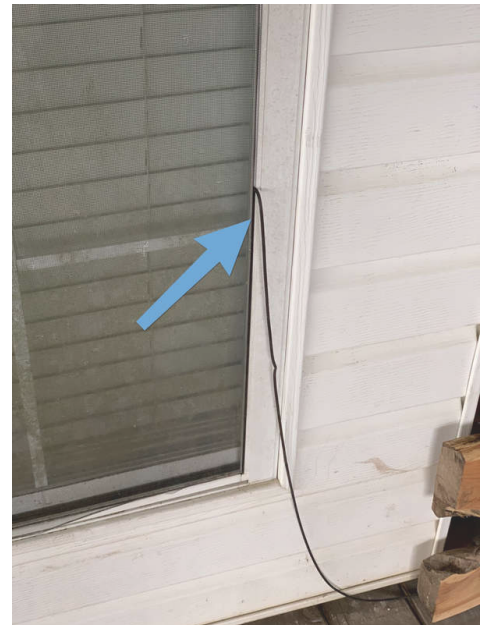
4.7.1 Windows- exterior  
**DAMAGED SCREEN**

Maintenance/Minor Items

One or more screens were damaged. Inspector recommends replacement

Recommendation  
Contact a qualified professional.

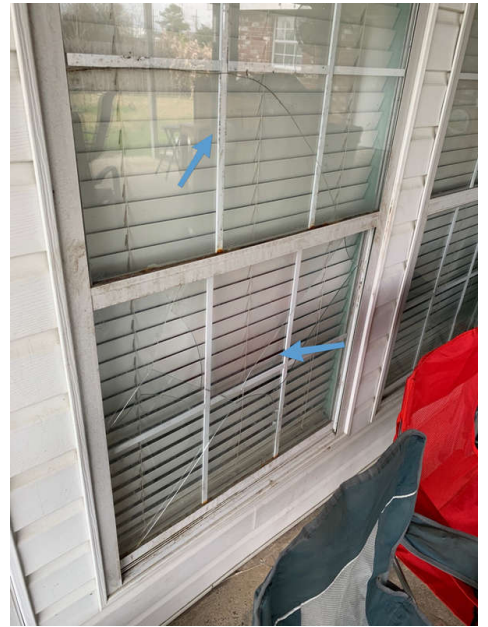
4.7.2 Windows- exterior  
**GLAZING-  
CRACKED/DAMAGED**

Maintenance/Minor Items

One or more glazing (glass panes) were damaged at the time of inspection.

Recommendation  
Contact a qualified window repair/installation contractor.

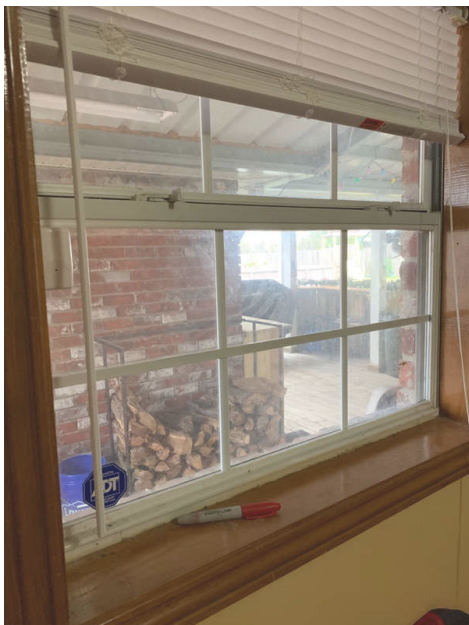
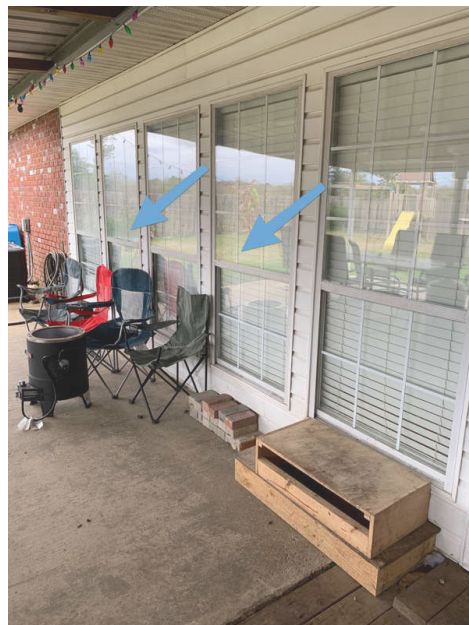
4.7.3 Windows- exterior

**MISSING/DAMAGED SCREEN**

Window had damaged or missing screen.

Maintenance/Minor Items

Contact a qualified window repair/installation contractor.

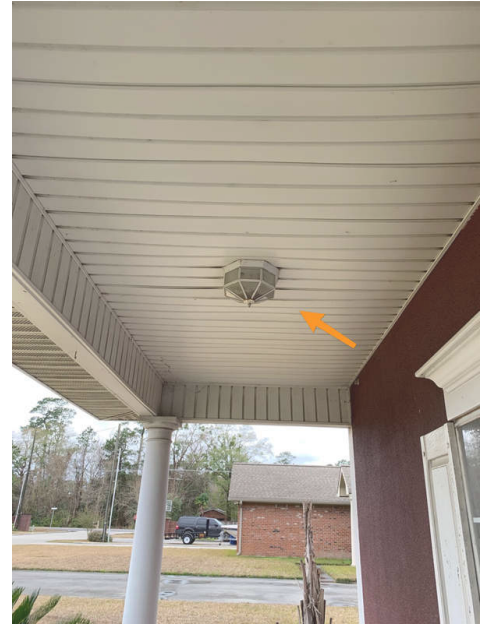
4.8.1 Exterior Lighting

**EXTERIOR LIGHTING-  
INOPERABLE**

Moderate Material Defects

One or more lights were inoperable at the time of the inspection. The bulb may need to be replaced or there may be a problem with the switch, wiring or light fixture.

Recommendation  
Contact a qualified electrical contractor.

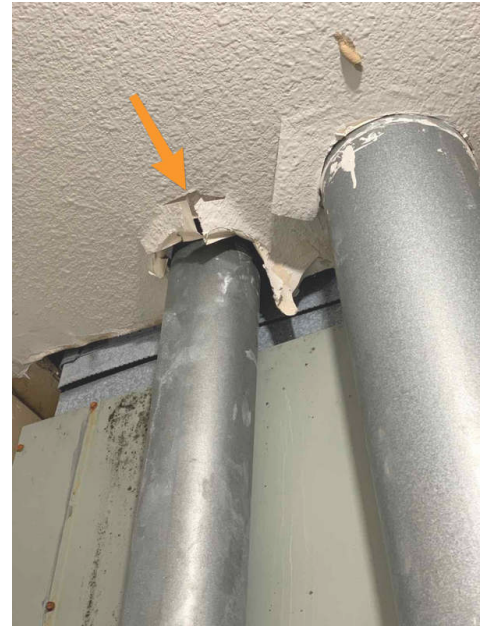
5.4.1 Vents & Flues- gas appliances  
**IMPROPER CLEARANCE**

Moderate Material Defects

For combustion vents, there should be a minimum of 2 inch clearance between the vent stack and any combustible materials.

Recommendation  
Contact a qualified general contractor.

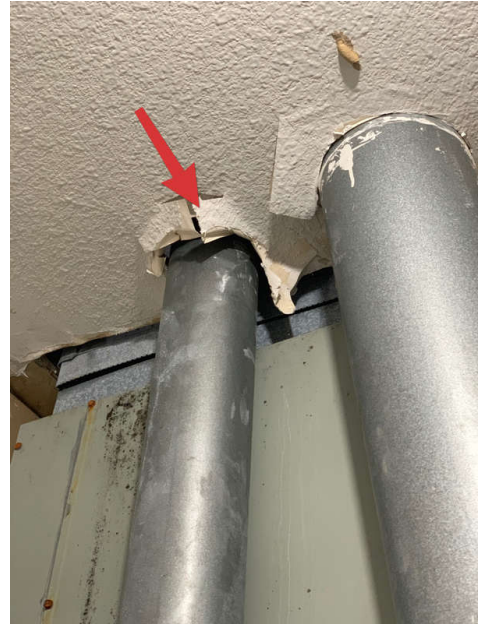
5.4.2 Vents & Flues- gas appliances  
**MISSING FIRE STOP/BLOCKING**

Safety/Major Concerns

The purpose of fire blocking is to slow the spread of fire in concealed vertical spaces, between the top story and the attic, and in long horizontal spaces.

Recommendation  
Contact a handyman or DIY project

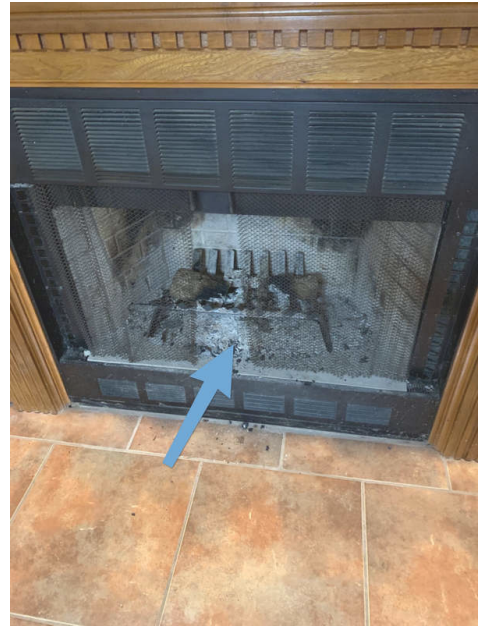
#### 5.5.1 Gas/LP Firelogs & Fireplaces

### DIRTY FIREBOX

Maintenance/Minor Items

The firebox of the wood-burning fireplace in this bedroom needed cleaning at the time of the inspection.

Contact a qualified professional.

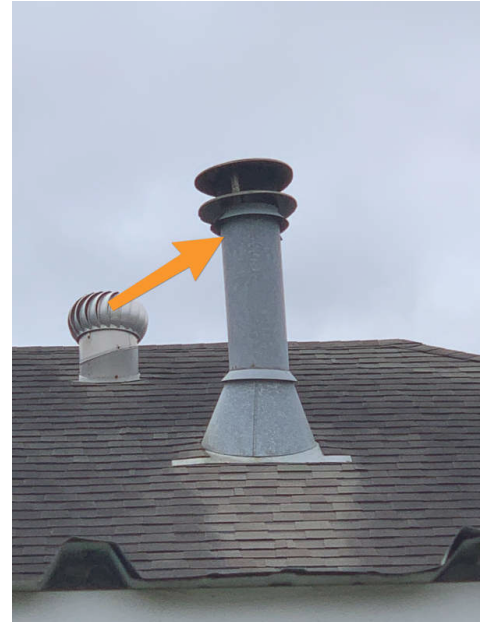
#### 5.5.3 Gas/LP Firelogs & Fireplaces

### CHIMNEY (CAP)- LOOSE

Moderate Material Defects

The chimney cap appeared to be loose from inspection viewpoint.

Contact a qualified chimney contractor.

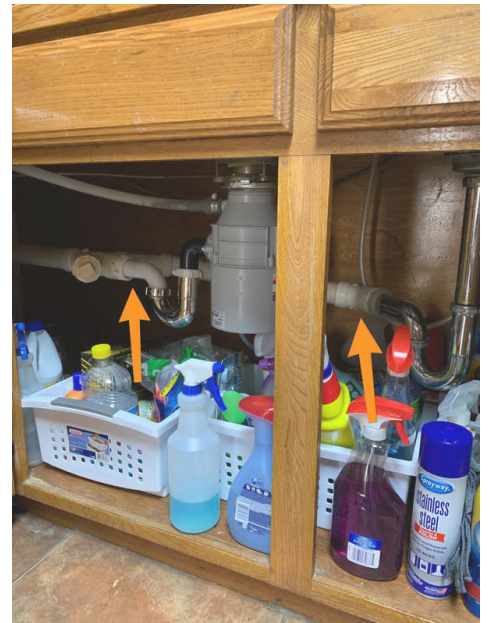
#### 6.4.2 Drain, Waste, & Vent Systems

### IMPROPER SLOPE

One or more areas of plumbing appeared to be improperly sloped.

Moderate Material Defects

Contact a qualified plumbing contractor.

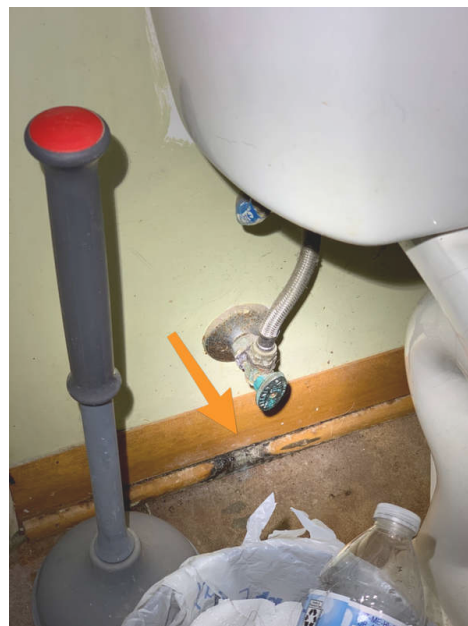
6.6.1 Toilet

### **DISTRIBUTION PIPE LEAKING**

Moderate Material Defects

Distribution pipe was leaking. Recommend a qualified plumber evaluate and repair.

Contact a qualified plumbing contractor.

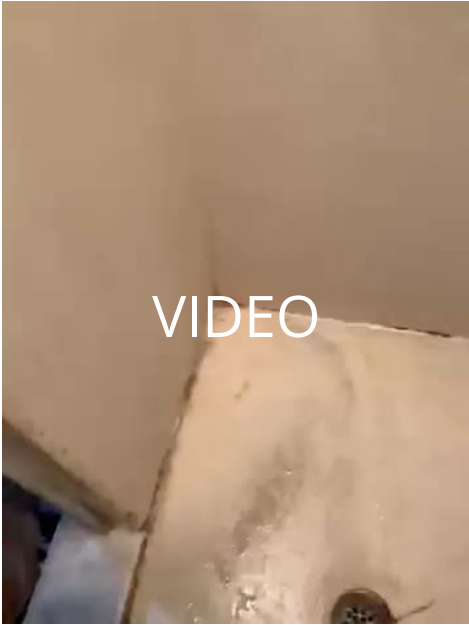
6.7.1 Tub/Shower

### **CAULK LINE FAILED**

Maintenance/Minor Items

Sealant where the tub meets the wall was old and had sections of missing sealant that may allow damage from moisture intrusion to the wall structure.

Recommended DIY Project

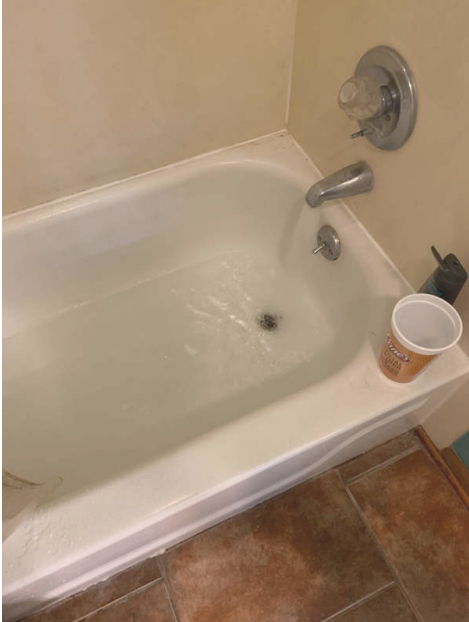
6.7.2 Tub/Shower

**TUB - POOR DRAINAGE**

Tub had slow/poor drainage.

Maintenance/Minor Items

Contact a qualified plumbing contractor.

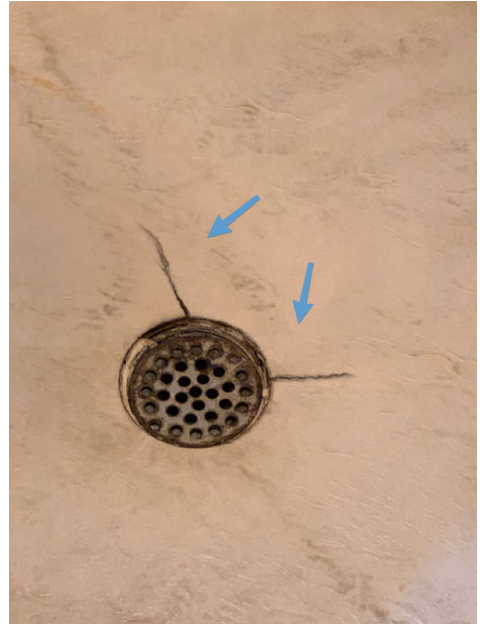
6.7.3 Tub/Shower

**VISIBLE DAMAGE**

One or more tub/shower and tile wall surround in this bathroom had damage visible.

Maintenance/Minor Items

Contact a qualified professional.

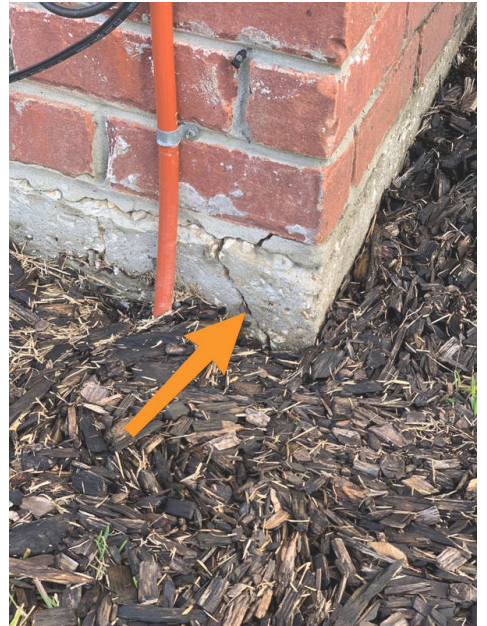
7.1.1 Foundation

**CORNER CRACKS**

Corner cracks are typical of improper workmanship and usually is not a sign of settlement.

Moderate Material Defects

Contact a foundation contractor.

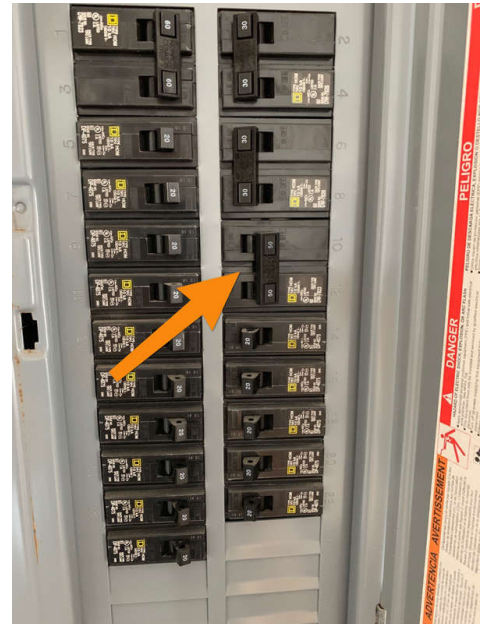
8.2.1 Main & Subpanels

**BREAKERS- SHUT OFF**

One or more breakers in this panel were switched to off at the time of inspection.

Moderate Material Defects

Contact a qualified electrical contractor.

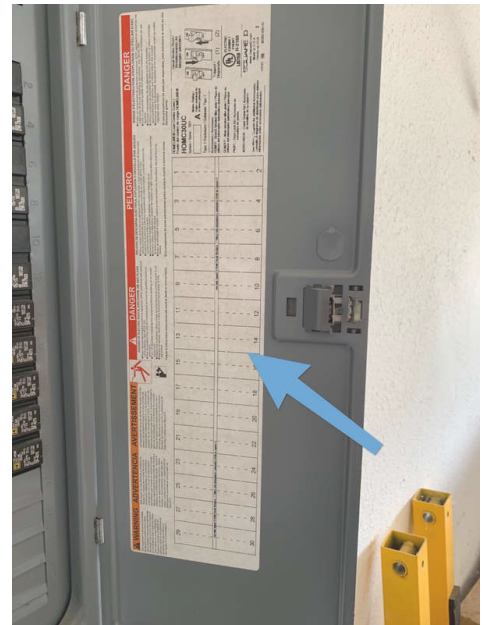
### 8.2.2 Main & Subpanels

#### **LABEL DIRECTORY- MISSING**

Maintenance/Minor Items

The Circuit Directory label identifying individual electrical circuits was missing from the service panel cabinet. The service panel should contain a clearly-marked label identifying individual circuits so that in an emergency, individual circuits can be quickly shut off.

Contact a qualified electrical contractor.

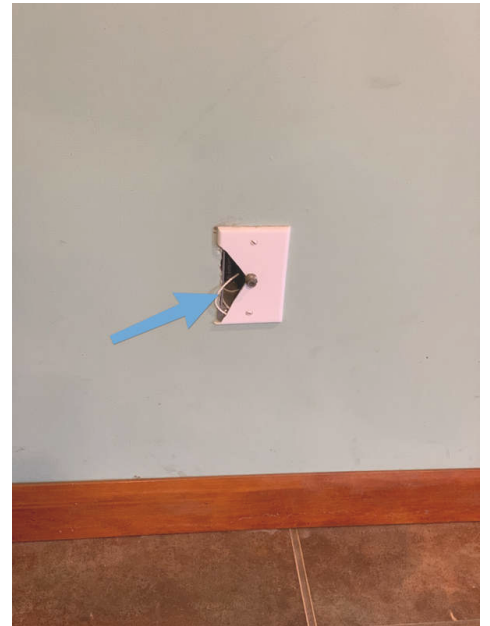
## COVER PLATES DAMAGED

Maintenance/Minor Items

One or more receptacles have a damaged cover plate.

Contact a qualified electrical contractor.

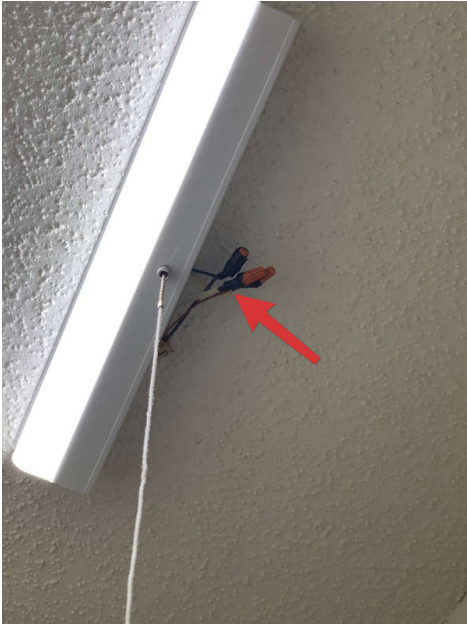
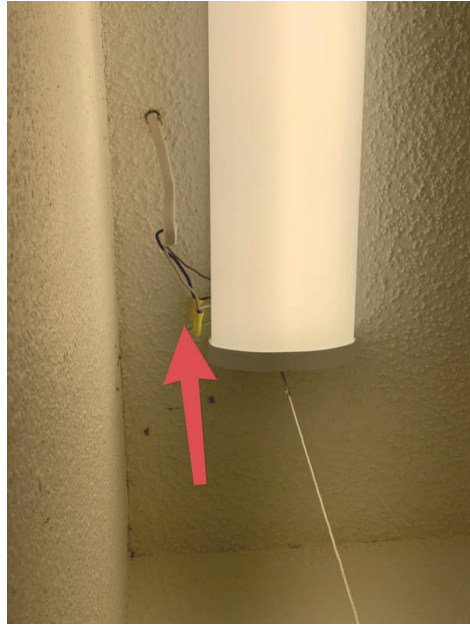
## EXPOSED WIRING

Safety/Major Concerns

A light fixture had energized electrical wires exposed to touch at the time of the inspection. This condition may represent a potential fire or shock/electrocution hazard. The Inspector recommends an examination and any necessary repairs be performed by a qualified electrical contractor.

Contact a qualified electrical contractor.

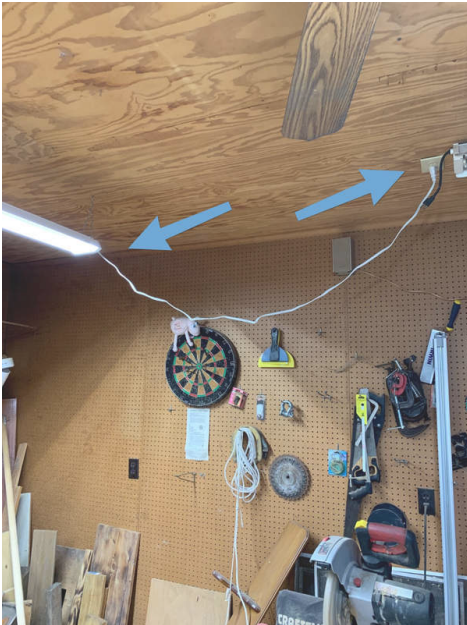
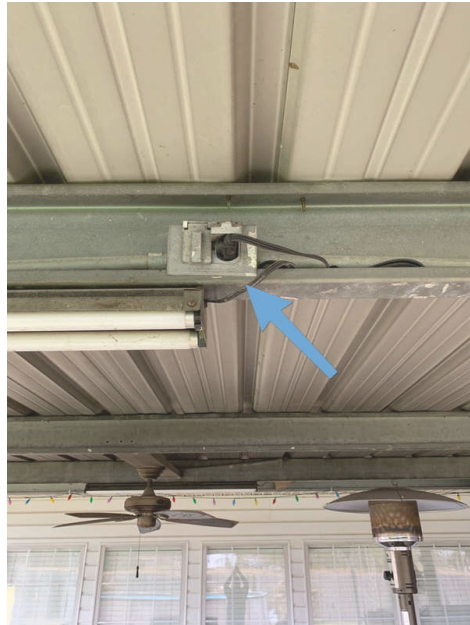
8.4.3 Lighting, Switches & Receptacles

**EXTENSION CORD**

Maintenance/Minor Items

Extension cord used as permanent wiring was visible at the time of inspection. This condition is a potential fire hazard.

Contact a qualified electrical contractor.

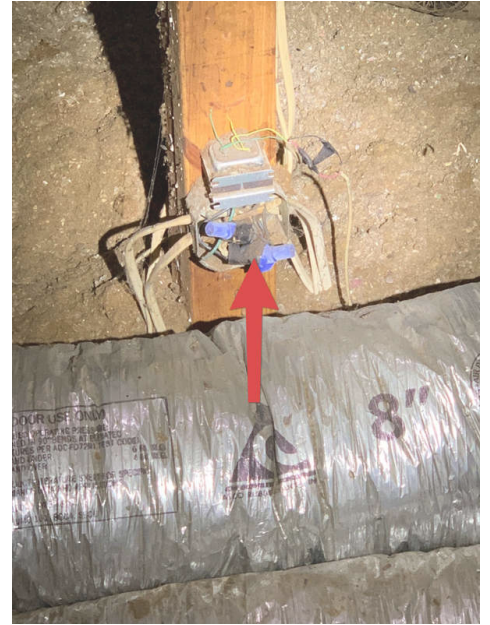
8.4.4 Lighting, Switches & Receptacles

**JUNCTION BOX- OPEN**

Safety/Major Concerns

Junction boxes were missing cover plates and energized electrical components were exposed to touch at the time of the inspection. This condition is a shock/electrocution hazard.

Recommendation  
Contact a qualified electrical contractor.

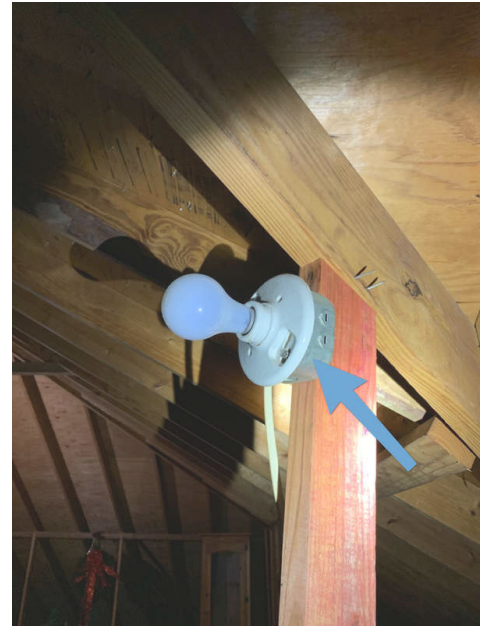
8.4.5 Lighting, Switches & Receptacles  
**LIGHT INOPERABLE**

Maintenance/Minor Items

One or more lights were inoperable at the time of the inspection. The bulb may need to be replaced or there may be a problem with the switch, wiring or light fixture.

Recommendation  
Contact a qualified electrical contractor.

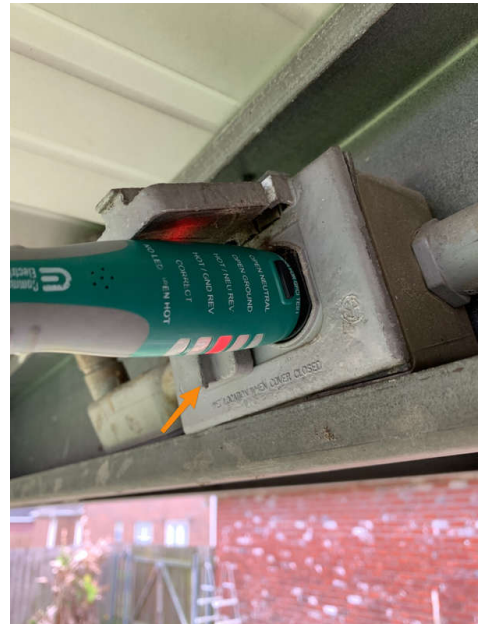
8.4.6 Lighting, Switches & Receptacles  
**RECEPTACLE- IMPROPERLY WIRED**

Moderate Material Defects

One or more electrical receptacle(s) were improperly wired at the time of the inspection.

Recommendation  
Contact a qualified electrical contractor.

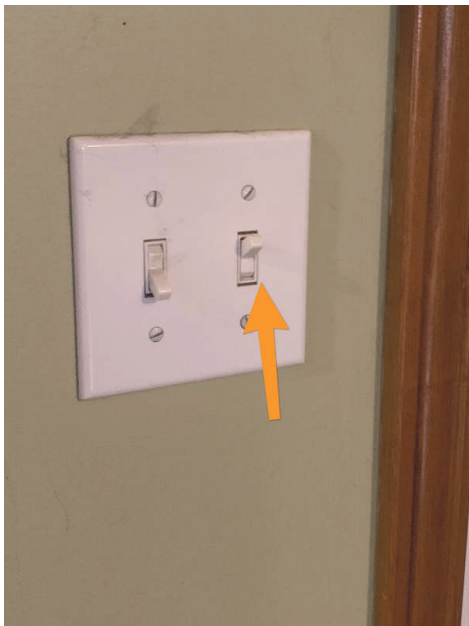
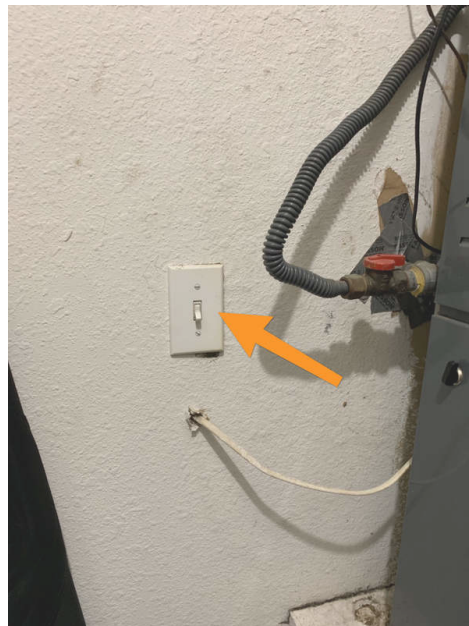
#### 8.4.7 Lighting, Switches & Receptacles

### SWITCH- INOPERABLE

Moderate Material Defects

A light switch in appeared to be inoperable at the time of the inspection. The inspector was unable to determine which device it was intended to control. You should ask the seller about its operation.

Contact a qualified electrical contractor.

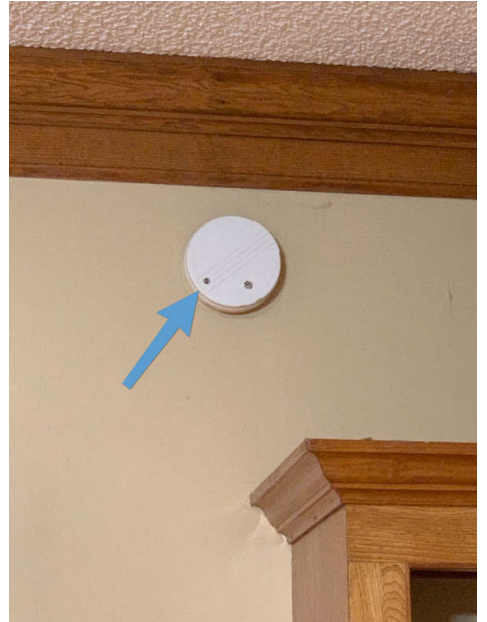
#### 8.5.1 Smoke/CO Detectors

### OLD- NEED UPGRADE

Maintenance/Minor Items

The smoke detectors were older and may not be functional.

Contact a handyman or DIY project

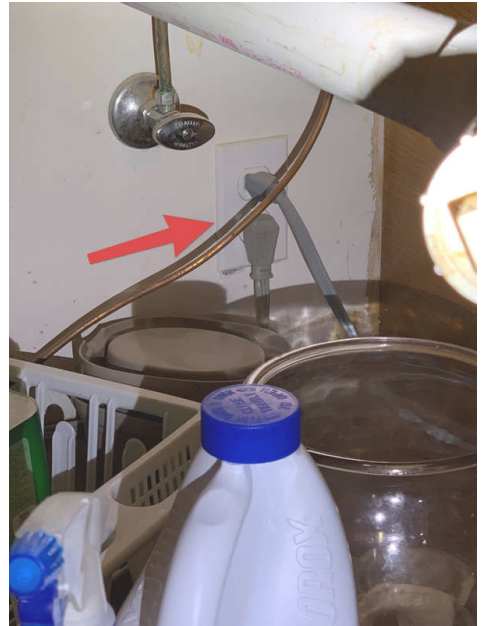
#### 8.6.1 GFCI & AFCI

### GFCI- WITHIN 3 FEET OF WATER SOURCE

Safety/Major Concerns

It is recommended that all receptacles, within 3 feet of a water supply source, are to be GFCI protected. One or more receptacles within that range were not GFCI protected, at the time of inspection, and should be replaced with one to prevent shock hazards or potential damage to the electrical system, via water intrusion.

Contact a qualified electrical contractor.

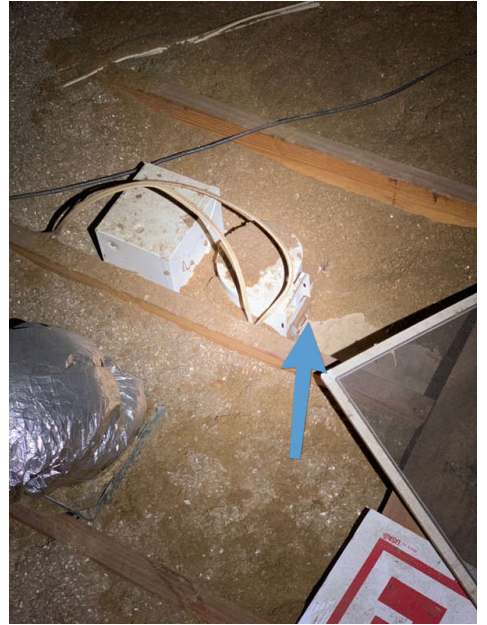
#### 9.4.1 Bathroom Ventilation

### BATHROOM VENTS INTO ATTIC

Maintenance/Minor Items

Bathroom fan vents into the attic, which can cause excess moisture and potential microbial growth.

Contact a qualified HVAC professional.

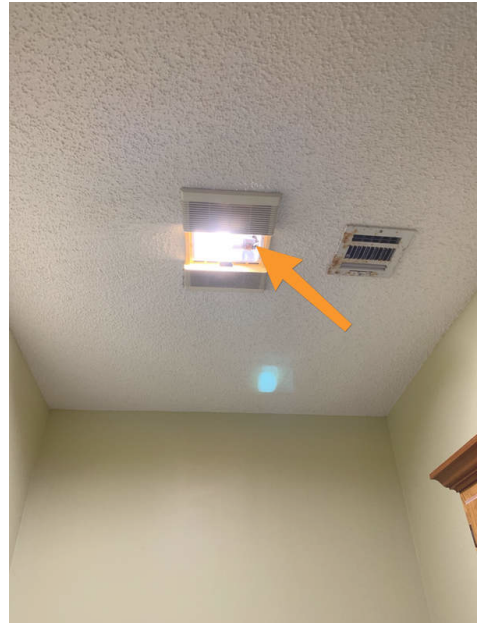
#### 9.4.2 Bathroom Ventilation

### VENT LIGHT COVER- MISSING

Moderate Material Defects

The light cover for the bathroom ventilation was missing.

Contact a handyman or DIY project

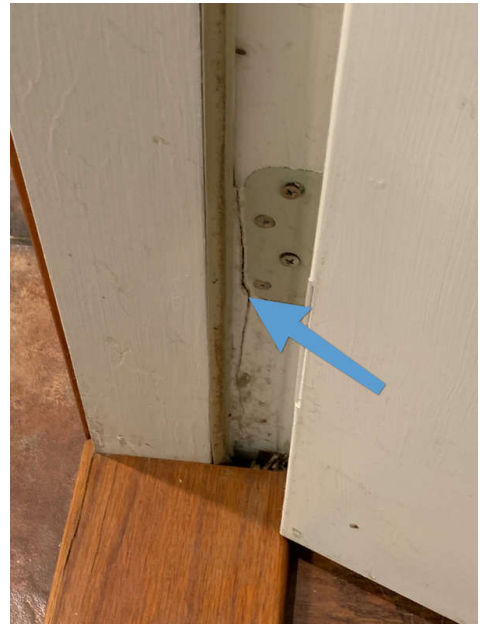
#### 10.1.1 Doors

### DAMAGE- MINOR

Maintenance/Minor Items

One or more interior door(s) exhibited minor damage or deterioration at the time of the inspection.

Contact a qualified door repair/installation contractor.

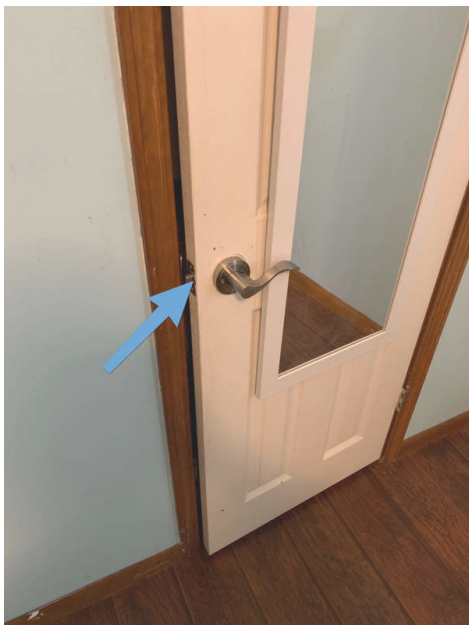
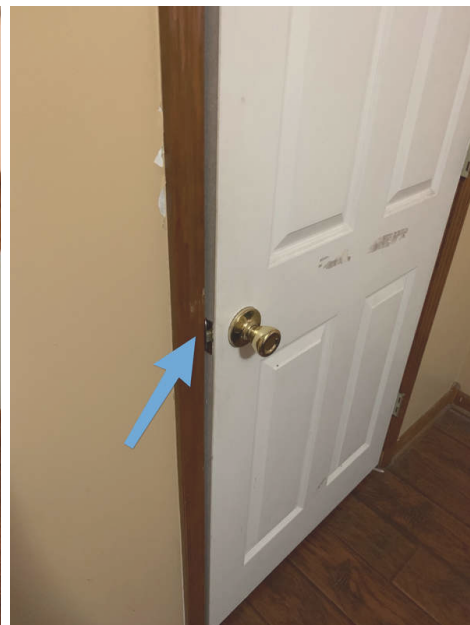
10.1.2 Doors

**DOESN'T LATCH**

Door doesn't latch properly.

Maintenance/Minor Items

Contact a qualified handyman.

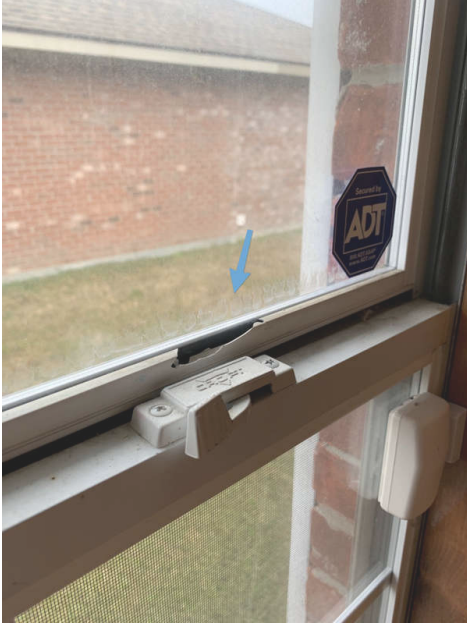
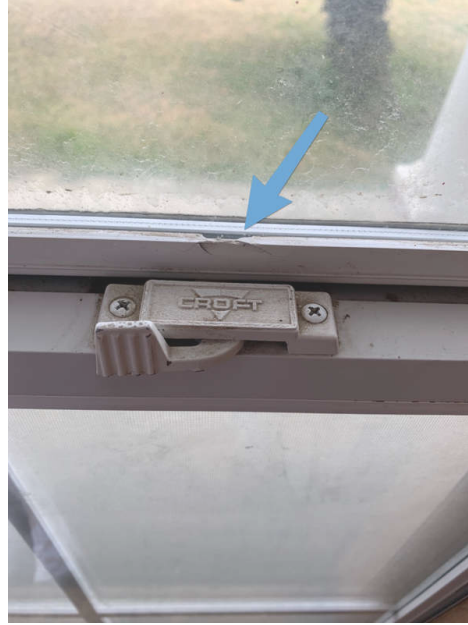
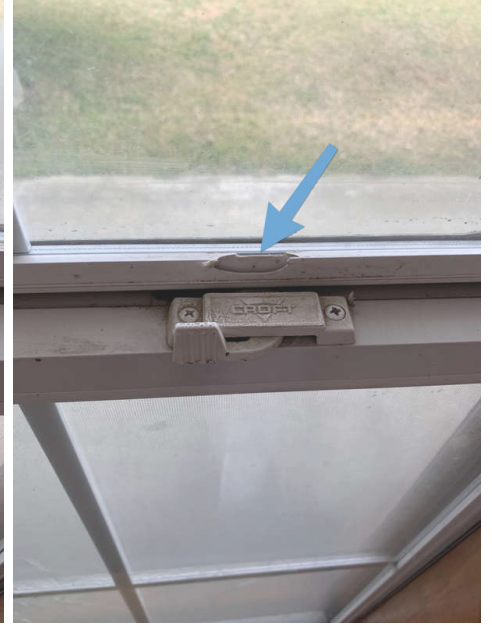
10.2.2 Windows

**SASH DAMAGE**

One or more window sash exhibited minor damage.

Contact a qualified window repair/installation contractor.

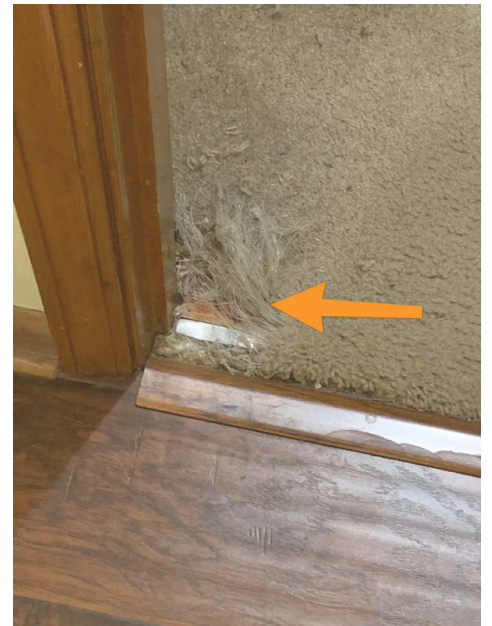
10.3.1 Floors

**DAMAGED**

Moderate Material Defects

One or more areas of the floor were damaged at the time of the inspection.

Contact a qualified flooring contractor

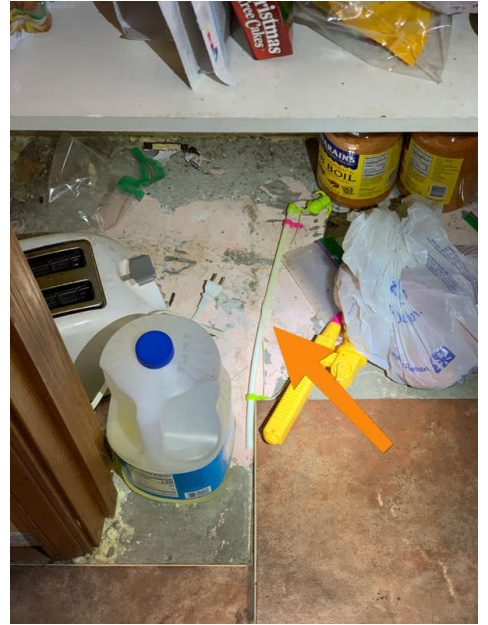
10.3.2 Floors

**TILES- MISSING**

Moderate Material Defects

One or more floor tiles were missing. Recommend installing/replacing missing tiles.

Contact a qualified flooring contractor

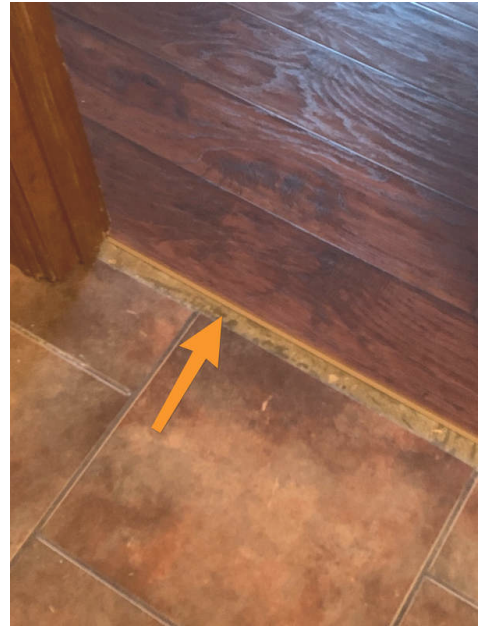
### 10.3.3 Floors

## TRANSITION- MISSING

Moderate Material Defects

There should be a transition strip covering any gaps in flooring between rooms to prevent a trip hazard. One was missing at the time of the inspection and should be properly installed to prevent falling or tripping.

Contact a qualified flooring contractor

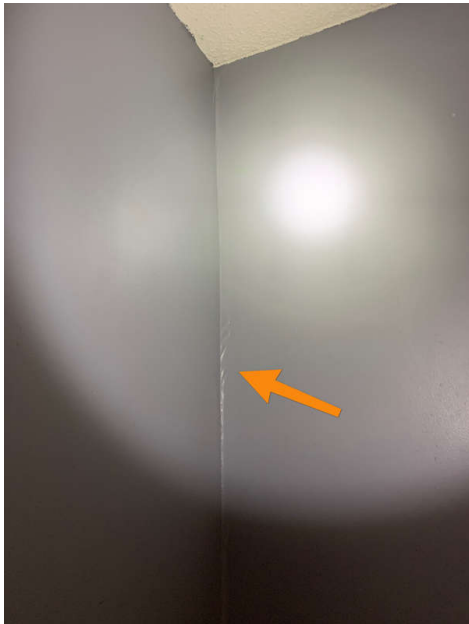
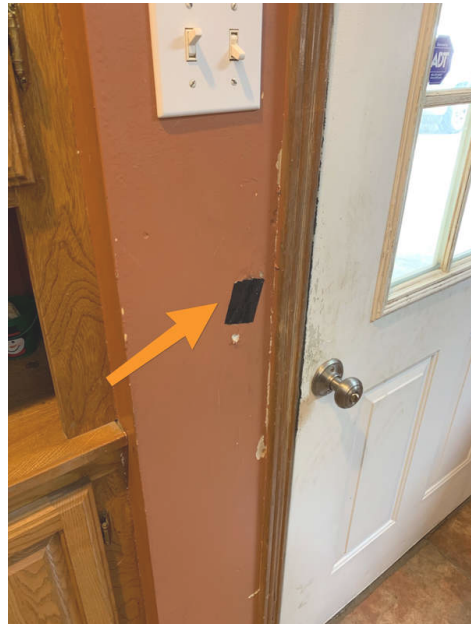
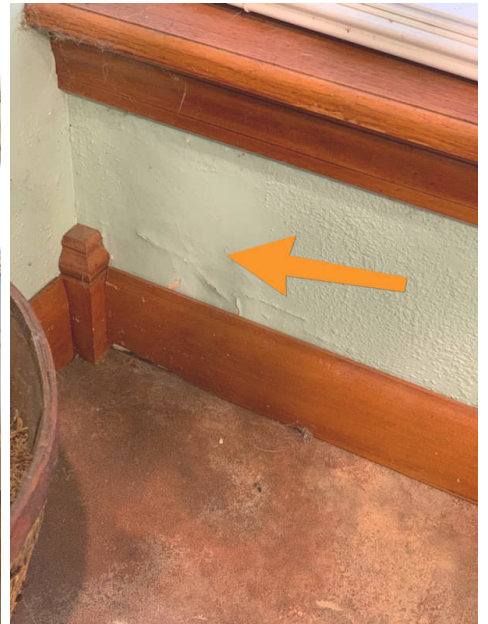
### 10.4.1 Walls

## DAMAGED

Moderate Material Defects

One or more areas of wall were damaged as the time of inspection.

Contact a qualified general contractor.

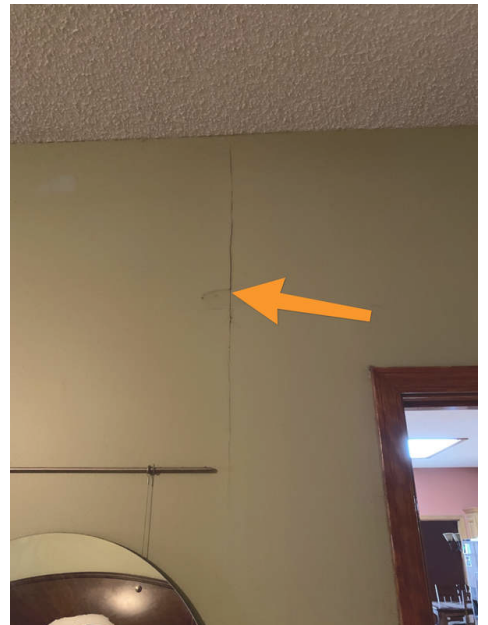
#### 10.4.2 Walls

### MINOR CORNER CRACKS

Moderate Material Defects

Minor cracks at the corners of doors and windows in walls. Appeared to be the result of long-term settling. Some settling is not unusual in a home of this age and these cracks are not necessarily a structural concern.

Contact a qualified drywall contractor.

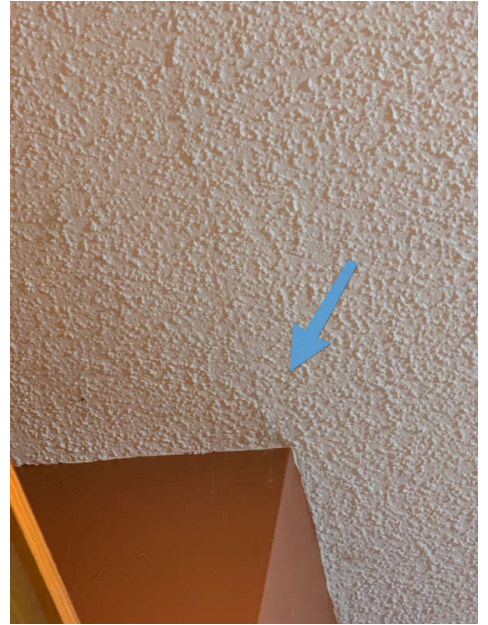
#### 10.5.1 Ceilings

### DAMAGE

Maintenance/Minor Items

Minor damage or deterioration to the ceiling was visible at the time of the inspection.

Contact a qualified drywall contractor.

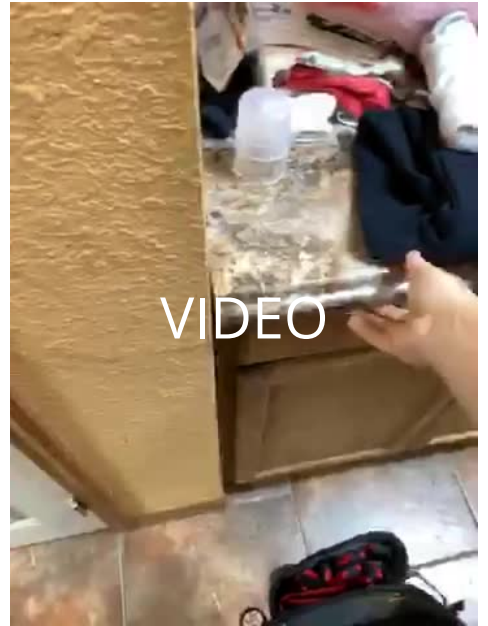
10.6.1 Countertops & Cabinets

**COUNTERTOP- NOT SECURED**

Moderate Material Defects

Kitchen countertop appeared to be improperly secured to base.

Contact a handyman or DIY project

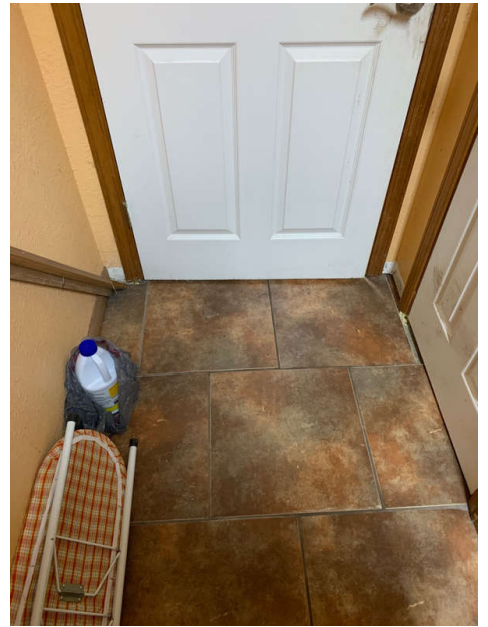
10.7.1 Trim- Door, Window,Crown,  
Base

**MISSING**

Moderate Material Defects

Interior trim was missing in one or more areas.

Contact a qualified general contractor.
