## SUMMARY

1234 Main St. Lake Charles LA 70611

Aaron Gott  
LA License # 11034  
AGI: Property Inspections  
337-661-1428  
info@agi-swla.com

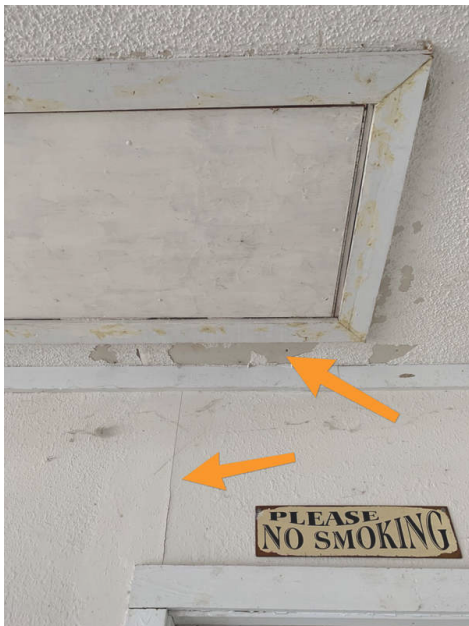
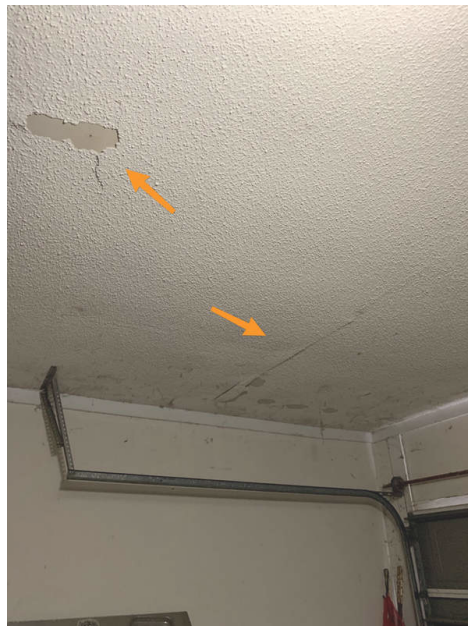
12.1.1 Ceiling  
**DAMAGED**

Moderate Material Defects

Garage ceiling was damaged. Recommend qualified contractor evaluate and repair to prevent moisture intrusion.

Recommendation  
Contact a qualified professional.

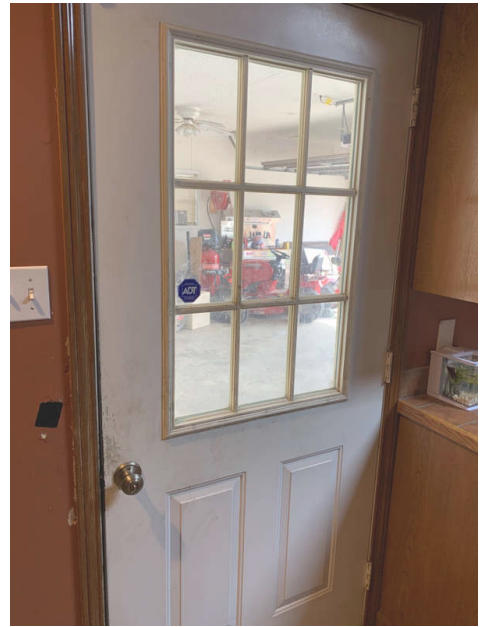
12.6.1 Occupant Door (From garage to inside of home)

Moderate Material Defects

**NON-COMPLIANT DOOR**

Door separating garage and home does not meet safety standards. Doors in firewalls must be at least 1 3/8-inch thick, metal/steel, or a 20-minute fire-rated door.

Recommendation  
Contact a qualified door repair/installation contractor.
