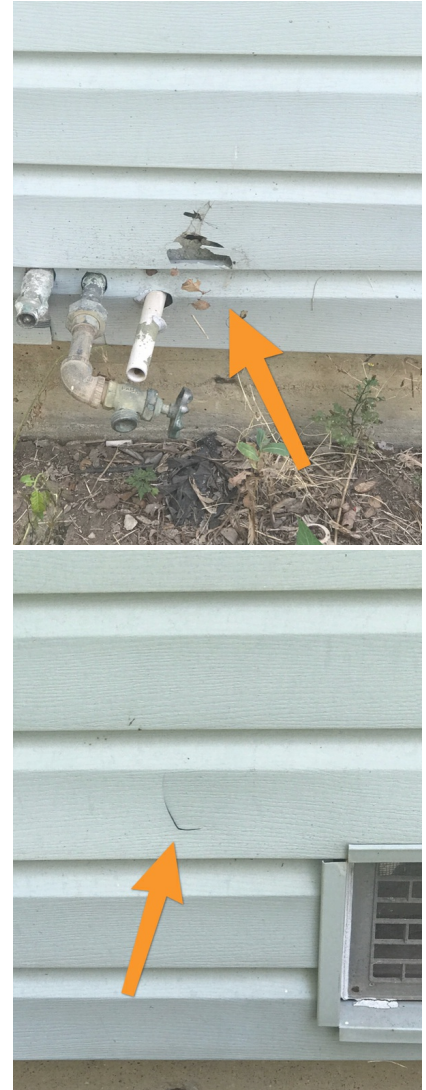
3.1.1 Siding, Flashing & Trim

DAMAGE - MAJOR

Moderate to major damage was observed at one or more points on the exterior. This can be the result of poor original compaction of soil at the time of construction or excess moisture in the underlying soil. Recommend consulting with a structural engineer and/or soil expert.

Recommendation

Contact a qualified siding specialist.

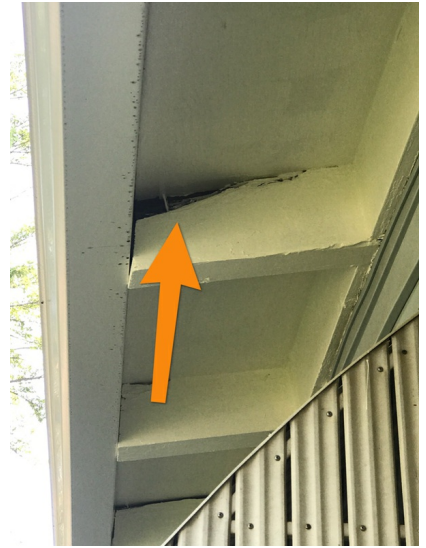
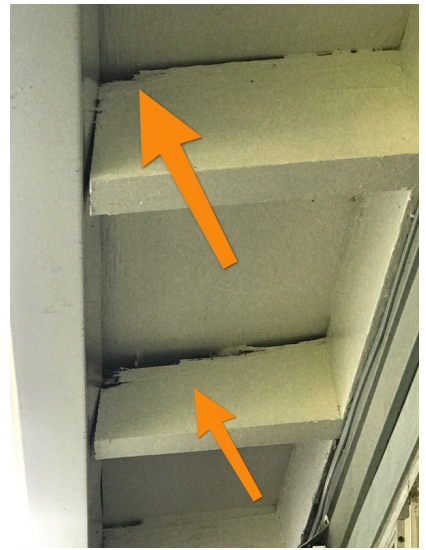
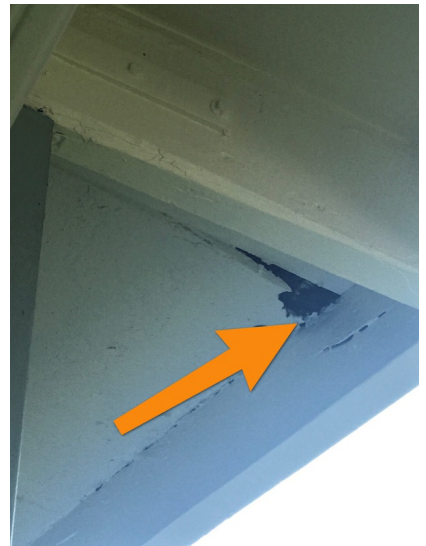
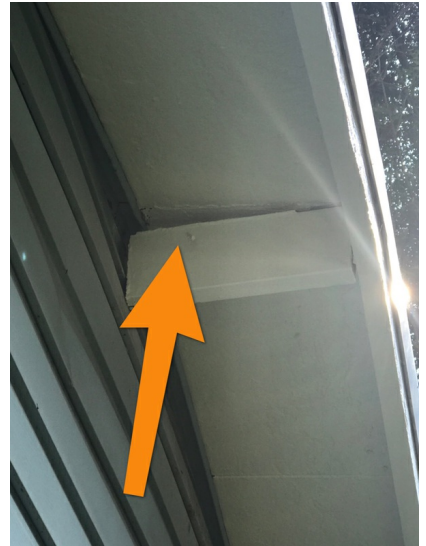
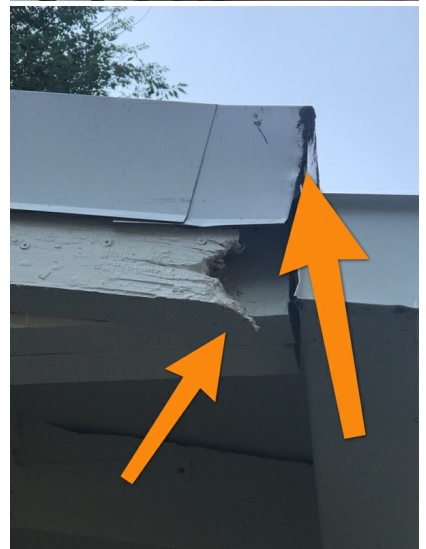
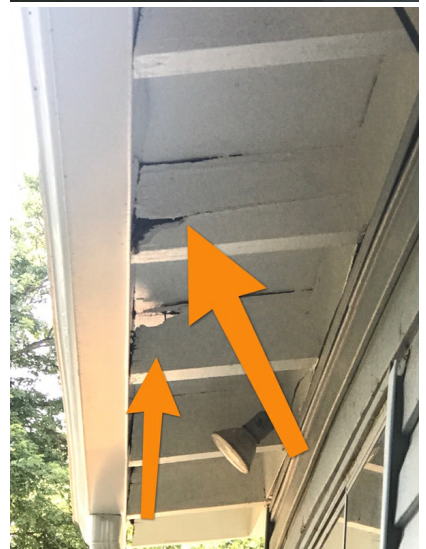
3.4.1 Eaves, Soffits & Fascia

EAVES - DAMAGED

One or more sections of the eaves are damaged. Recommend qualified roofer evaluate & repair.

Recommendation

Contact a qualified roofing professional.

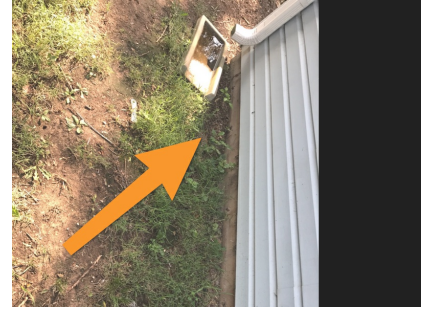
3.5.1 Vegetation, Grading, Drainage & Retaining Walls

NEGATIVE GRADING

Grading is sloping towards the home in some areas. This could lead to water intrusion and foundation issues. Recommend qualified landscaper or foundation contractor regrade so water flows away from home.

Recommendation

Contact a qualified landscaper or gardener.

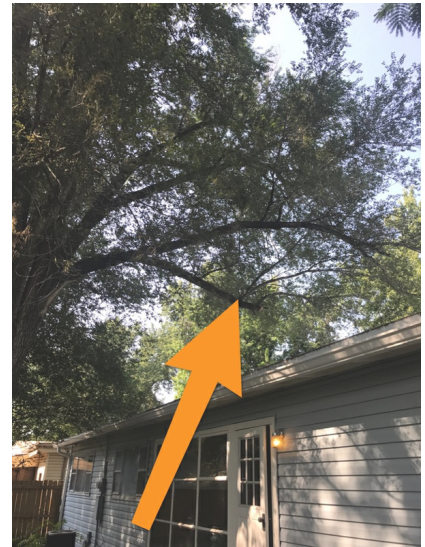
3.5.2 Vegetation, Grading, Drainage & Retaining Walls

TREE OVERHANG

Trees observed overhanging the roof. This can cause damage to the roof and prevent proper drainage. Recommend a qualified tree service trim to allow for proper drainage.

Recommendation

Contact a qualified tree service company.

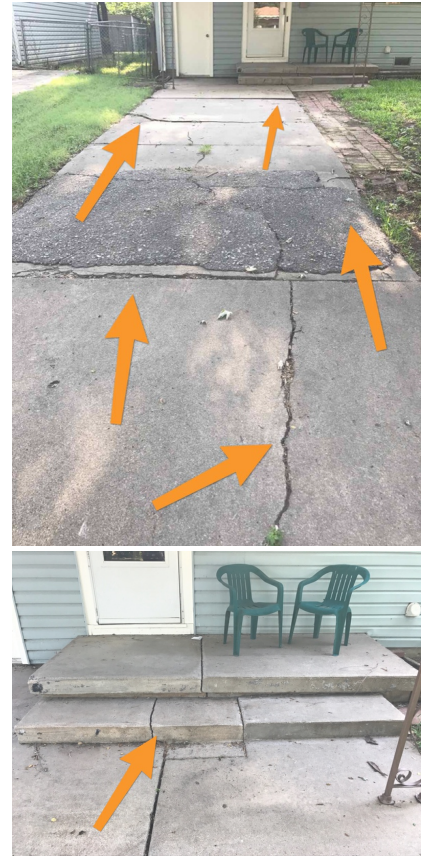
3.6.1 Walkways, Patios & Driveways

DRIVEWAY CRACKING - MAJOR

Major cracks observed. Recommend driveway contractor evaluate and replace.

Recommendation

Contact a qualified driveway contractor.

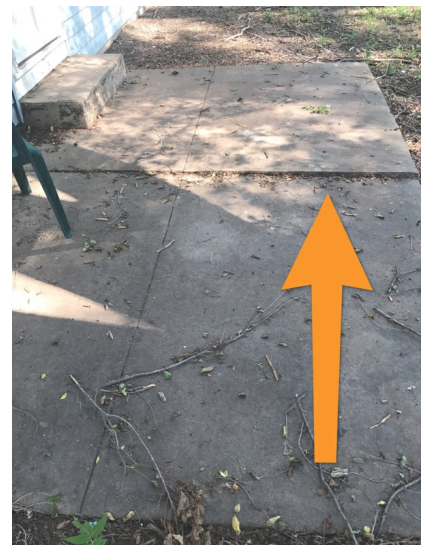
3.6.2 Walkways, Patios & Driveways

PATIO SETTLING - MAJOR

EAST

Significant settling observed. Further deterioration could result. Recommend concrete contractor evaluate & repair.

Recommendation

Contact a qualified concrete contractor.

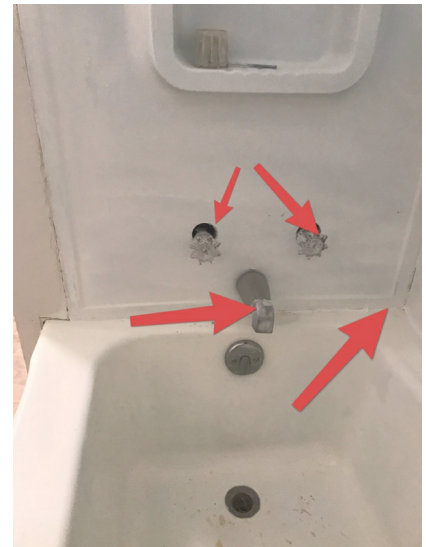
5.1.1 Fixtures / Faucets

IMPROPER INSTALLATION

1ST FLOOR HALL BATHROOM

Fixtures were installed improperly. Recommend a qualified handyman or plumber evaluate and repair.

Recommendation

Contact a quality handyman.

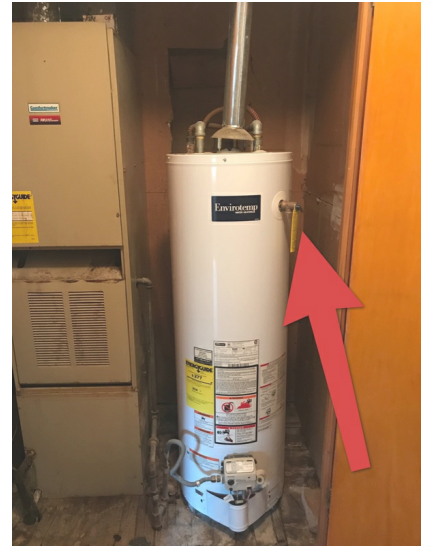
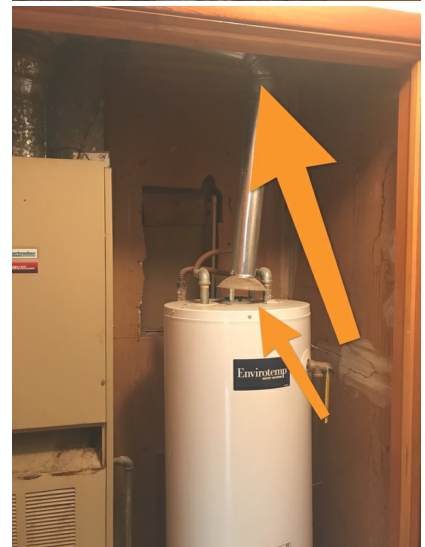
5.3.2 Water Heater

IMPROPER INSTALLATION

⚠ Safety Hazard and/or Requires Immediate Attention

Water heater is improperly installed. Recommend qualified plumber evaluate & repair.

Recommendation
Contact a qualified plumber.

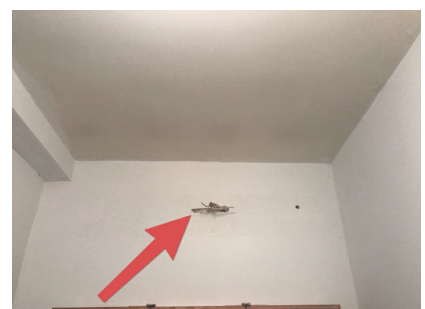
6.4.1 Connected Devices and Fixtures

OPEN JUNCTION BOX

⚠ Safety Hazard and/or Requires Immediate Attention

Open junction box observed. Recommend concealing or replacing.

Recommendation
Recommended DIY Project

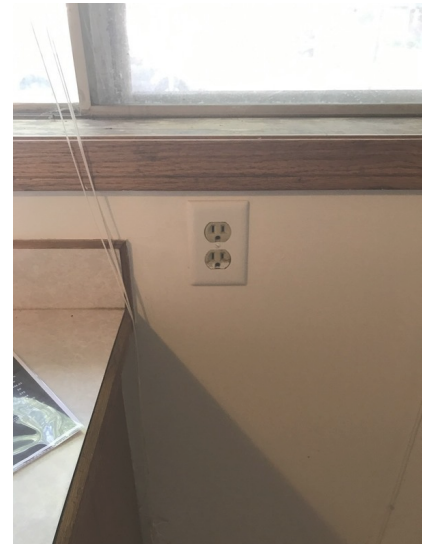
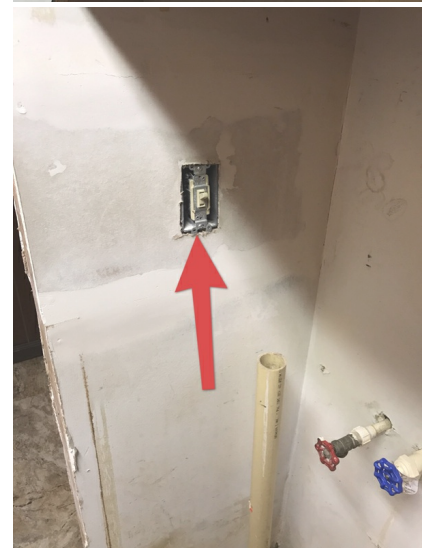
6.5.1 Polarity and Grounding of Receptacles

OUTLET(S) NOT GROUNDED

KITCHEN

⚠ Safety Hazard and/or Requires Immediate Attention

One or more outlets are not grounded. Recommend a qualified electrician replace non-grounded outlets with grounded ones.

Recommendation

Contact a qualified electrician.

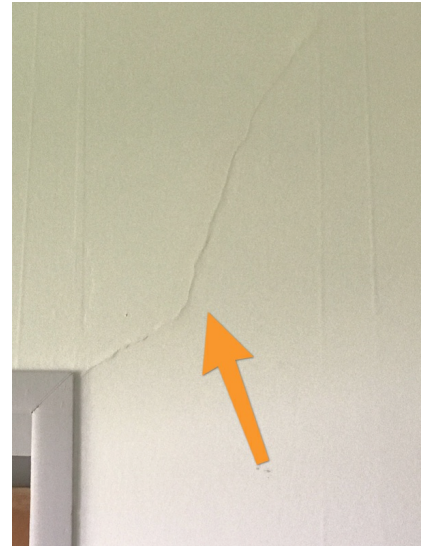
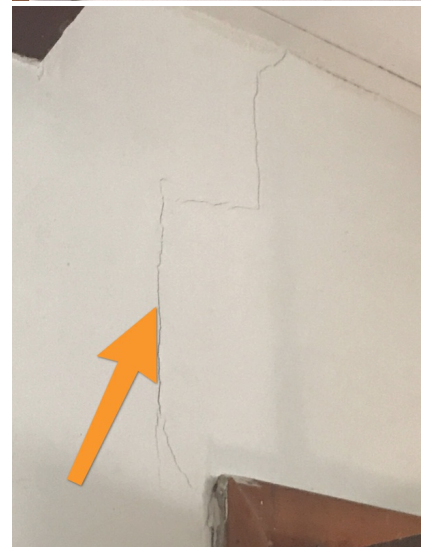
9.1.1 Walls

MINOR CORNER CRACKS

Minor cracks at the corners of doors and windows in walls. Appeared to be the result of long-term settling. Some settling is not unusual in a home of this age and these cracks are not a structural concern.

Recommendation

Contact a qualified structural engineer.

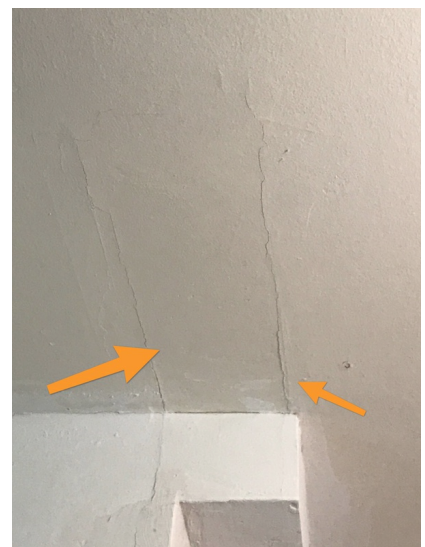
9.2.1 Ceilings

MINOR DAMAGE

Minor damage or deterioration to the ceiling was visible at the time of the inspection.

Recommendation

Contact a qualified professional.

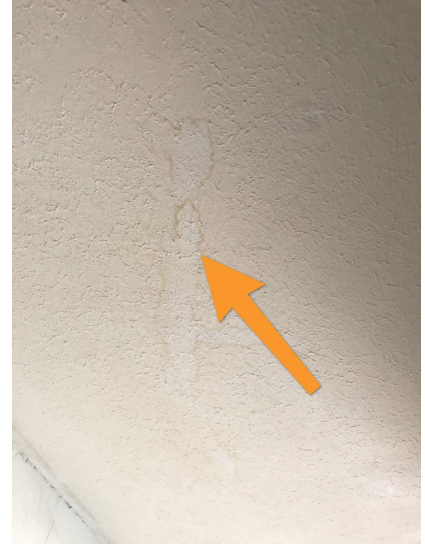
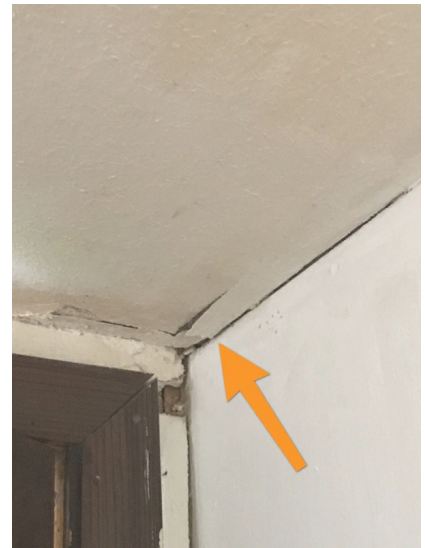
9.2.2 Ceilings

POSSIBLE ROOF LEAK DAMAGE

ABOVE FRONT DOOR

Stains on the ceiling appear to be the result of roof leaks. The source of leakage should be identified and corrected, and the ceiling re-painted.

Recommendation

Contact a qualified professional.

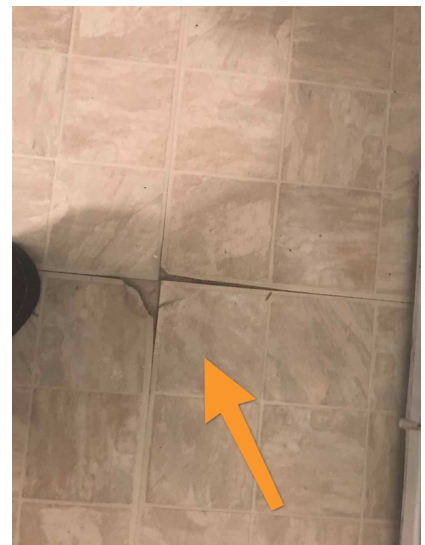
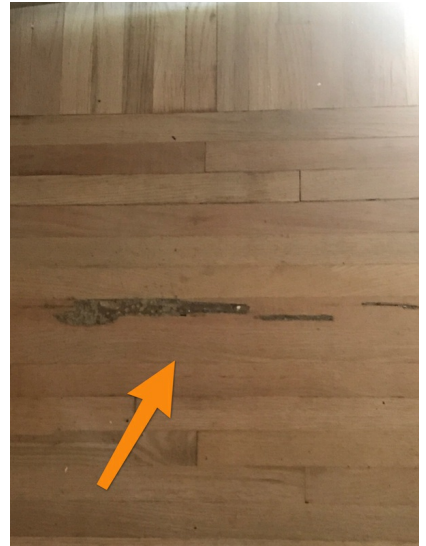
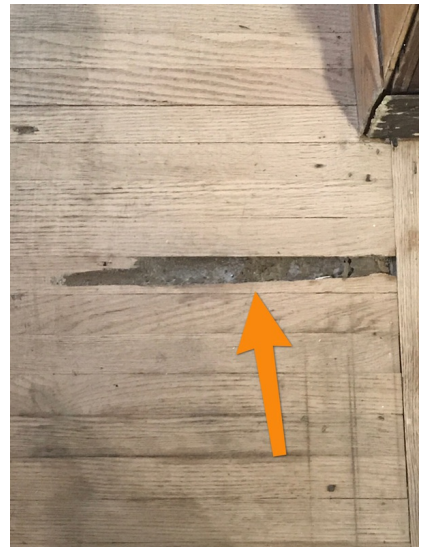
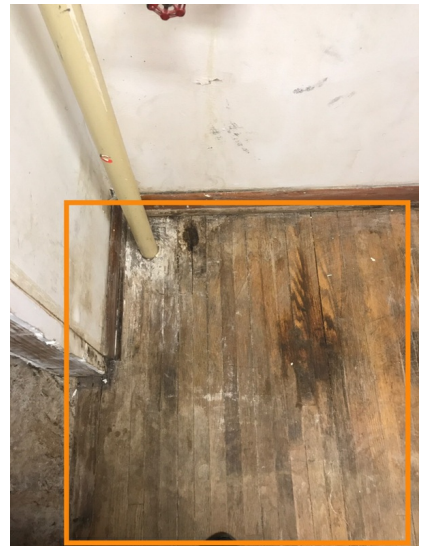
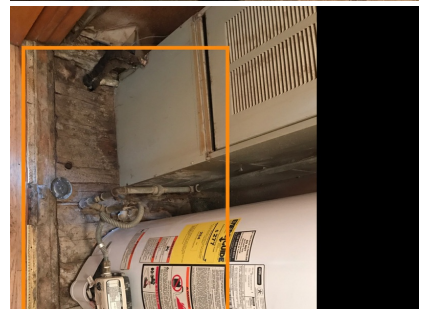
9.3.1 Floors

DAMAGED (GENERAL)

The home flooring had general moderate damage visible at the time of the inspection. Recommend evaluation by a qualified flooring contractor.

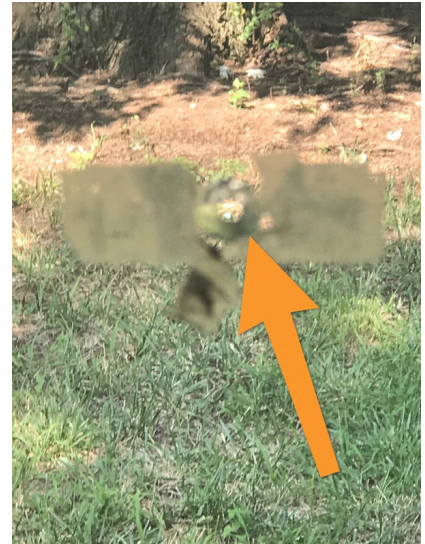
9.7.1 Windows

DAMAGED

One or more windows appears to have general damage, but are operational. Recommend a window professional clean, lubricate, seal & adjust as necessary.

Recommendation

Contact a qualified window repair/installation contractor.

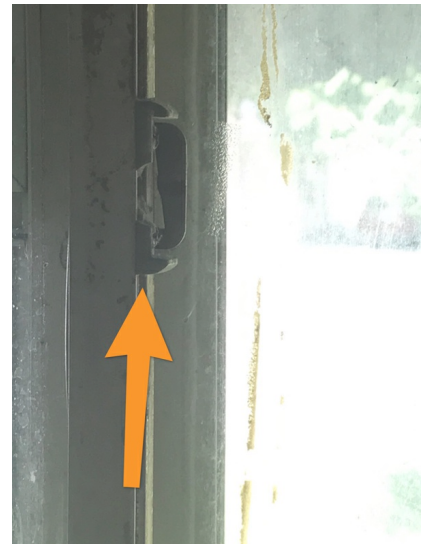
9.7.2 Windows

MISSING HARDWARE

Window missing hardware. Recommend replacement.

Recommendation

Contact a qualified window repair/installation contractor.

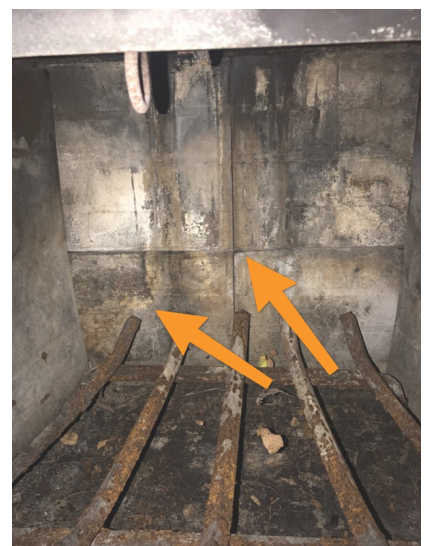
12.1.1 Fireplaces, Stoves & Inserts

FIREWALL CRACKED

⚠ Safety Hazard and/or Requires Immediate Attention

The brick lining of the fireplace was cracked in one or more places, which could lead to chimney damage or toxic fumes entering the home. Recommend a qualified fireplace contractor evaluate and repair.

Recommendation

Contact a qualified fireplace contractor.
