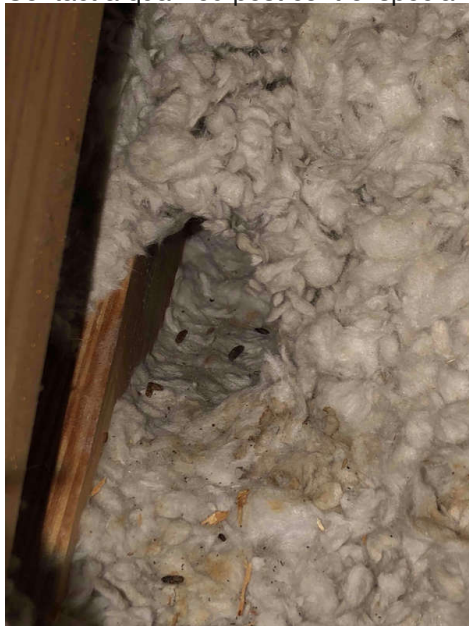
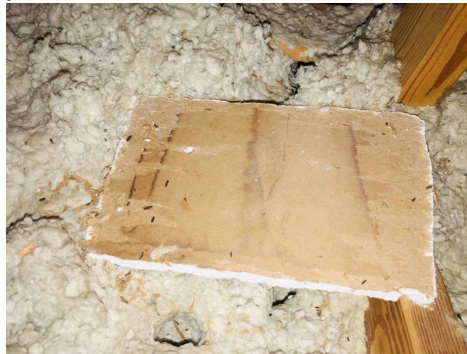
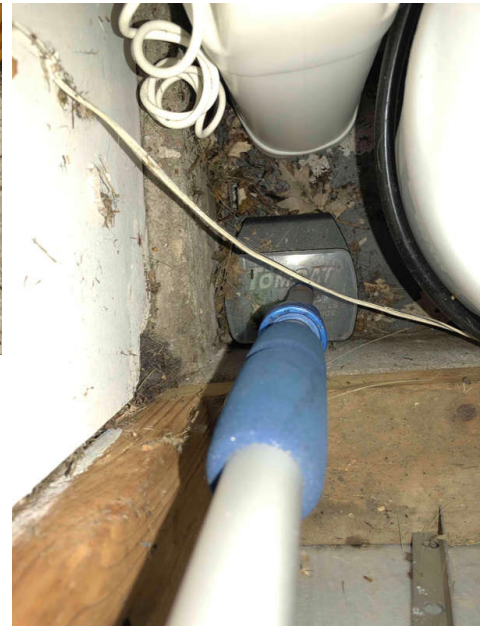
1.1.1 General Concerns
RODENT ACTIVITY

Evidence of rodent activity was observed in and/or around the property. Consult with the property owner about this. A qualified person should make repairs to seal openings in structure, set traps, and clean rodent waste as necessary.

Trap observed in garage.

Recommendation
Contact a qualified pest control specialist.

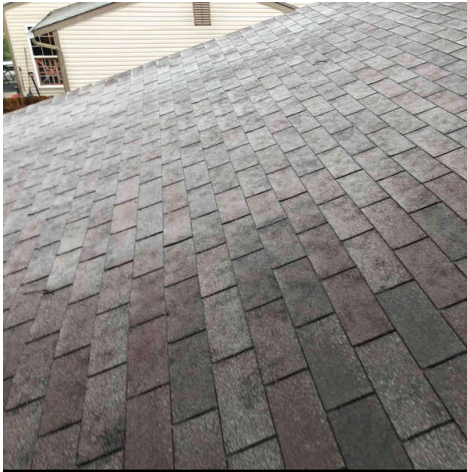
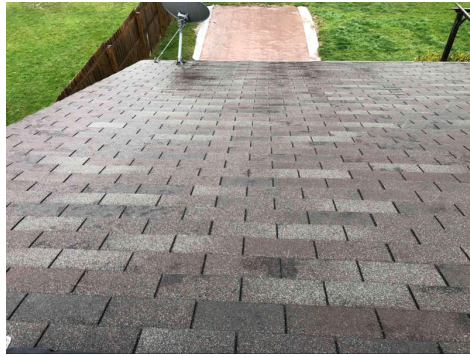
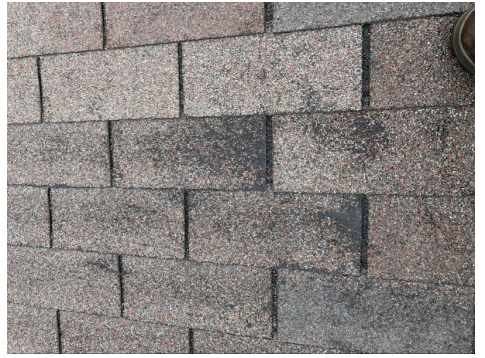
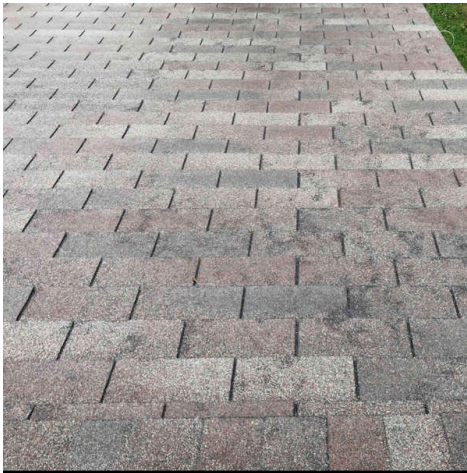
2.1.1 Coverings
GRANULAR DETERIORATION

There was visible erosion of the granular surface of some asphalt shingles. This can accelerate deterioration of the shingles.

Recommendation
Contact a qualified roofing professional.

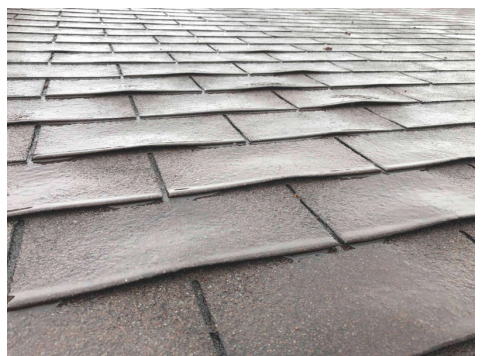
2.1.2 Coverings

LOOSE OR LIFTING

Some shingles were loose or lifting. Leaks can occur as a result. This can be a conducive condition for wood-destroying organisms.

Contact a qualified roofing professional.

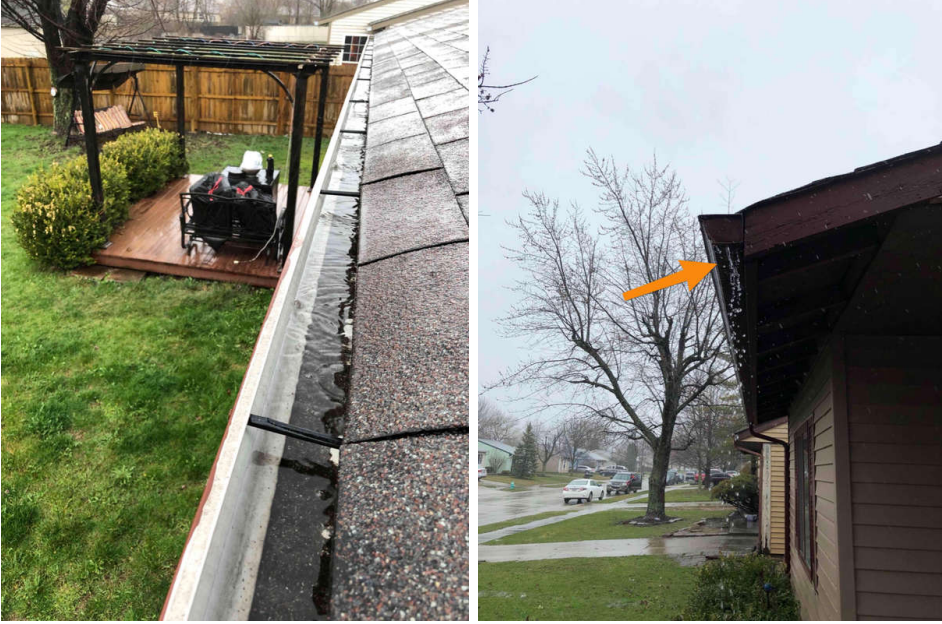
2.2.2 Roof Drainage Systems

GUTTER IMPROPERLY SLOPED

Gutter are improperly sloped in areas, which could result in runoff drainage around the foundation and possible structural shifting. Recommend qualified roofing or gutters contractor repair.

Recommendation
Contact a qualified roofing professional.

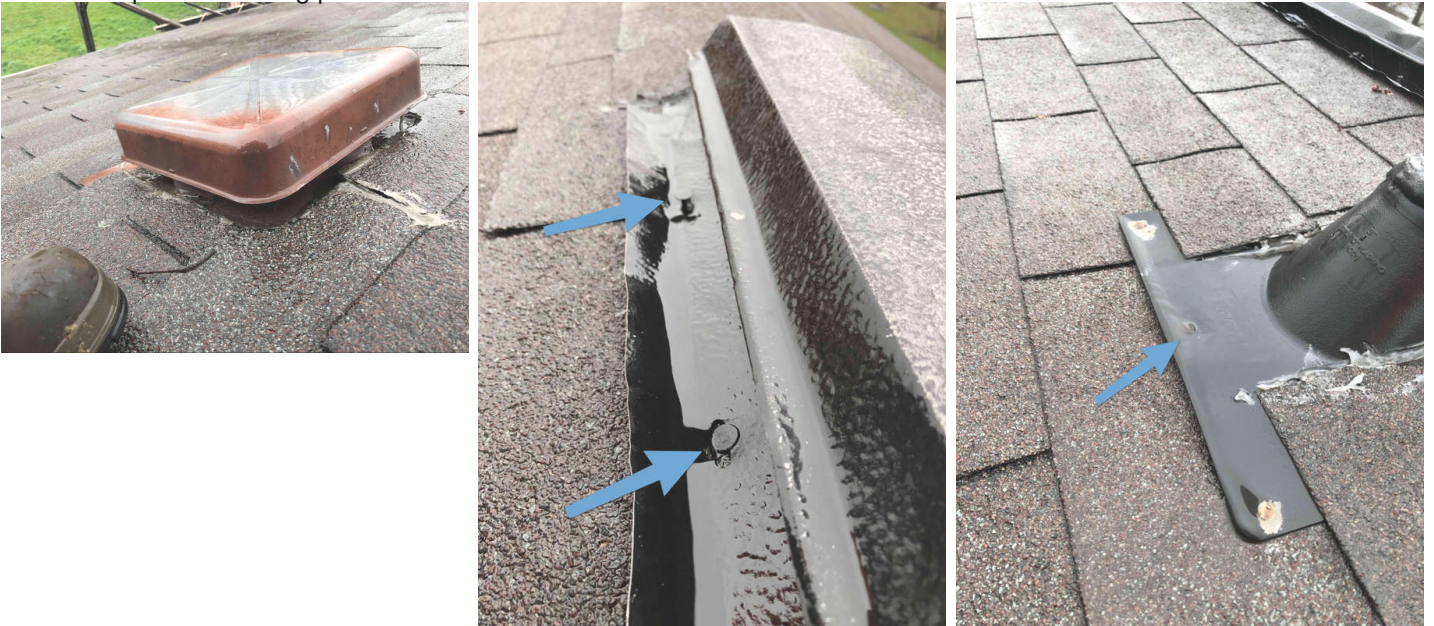
2.3.1 Flashings

SUBSTANDARD INSTALLATION/REPAIRS

Observed substandard installation or repairs at one or more roof flashings. Leaks can occur as a result.

Lifting and exposed fasteners can promote leaking.

Recommendation
Contact a qualified roofing professional.

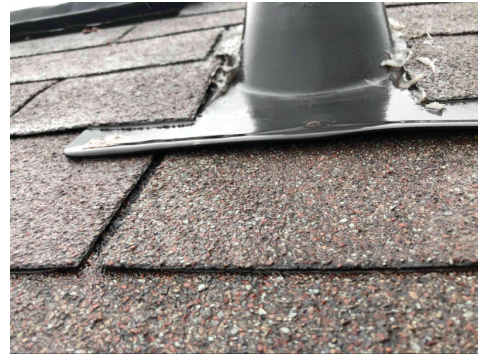
2.3.2 Flashings

LOOSE/SEPARATED

Flashings observed to be loose or separated, which can lead to water intrusion and/or mold. Recommend a qualified roofing contractor repair.

Recommendation
Contact a qualified roofing professional.

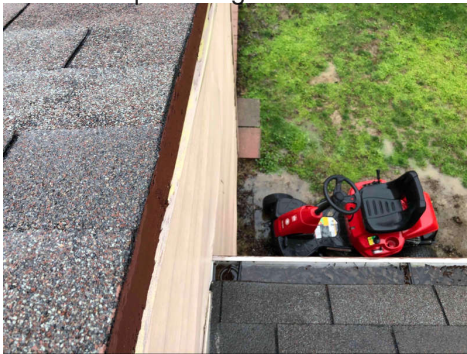
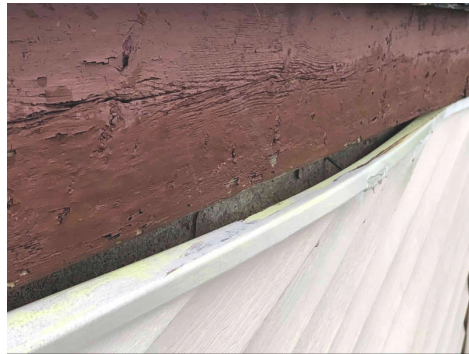
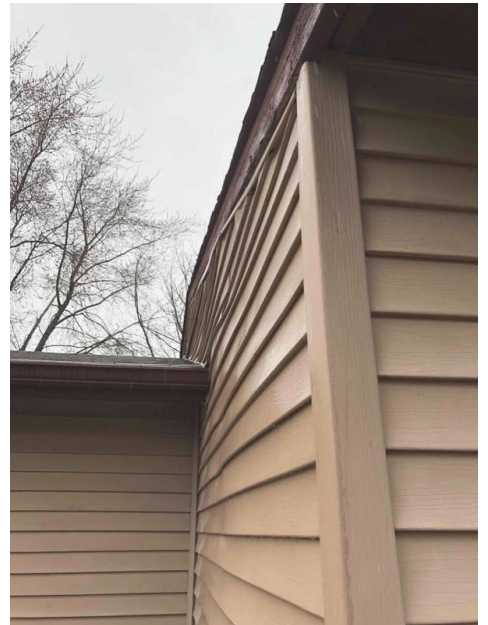
3.1.2 Siding, Flashing & Trim

EVIDENCE OF WATER INTRUSION

Siding showed signs of water intrusion. This could lead to further siding deterioration and/or mold. Recommend a qualified siding contractor evaluate and repair.

Bowing siding may be due to water intrusion.

Contact a qualified general contractor.

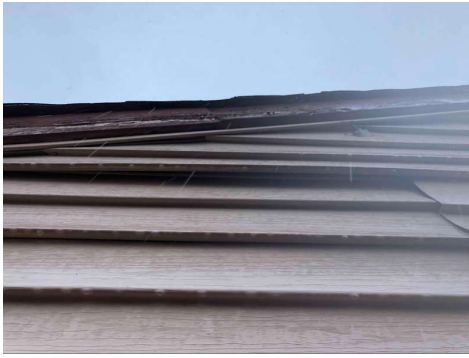
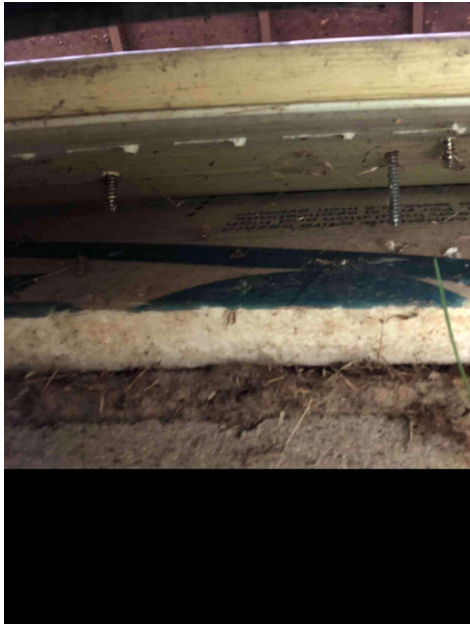
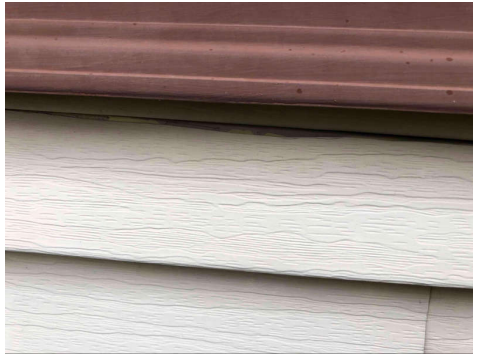
3.1.4 Siding, Flashing & Trim

LOOSE BOARDS

One or more siding boards were loose, which could result in moisture intrusion. Recommend a qualified siding contractor secure and fasten.

Contact a qualified general contractor.

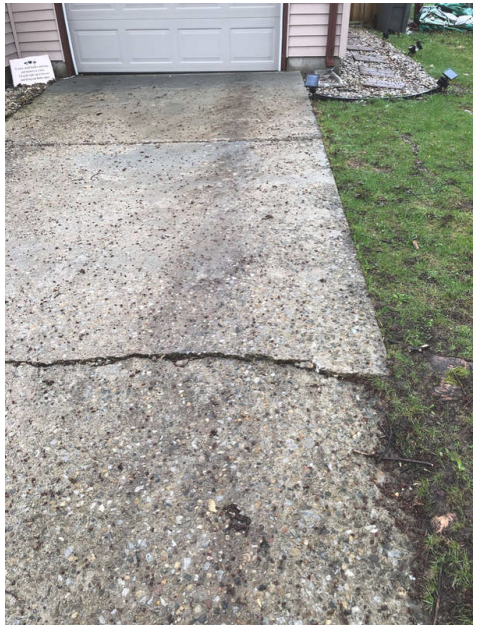
3.3.2 Walkways, Patios & Driveways

DRIVEWAY TRIP HAZARD

Trip hazards observed. Patch or repair recommended.

Contact a qualified professional.

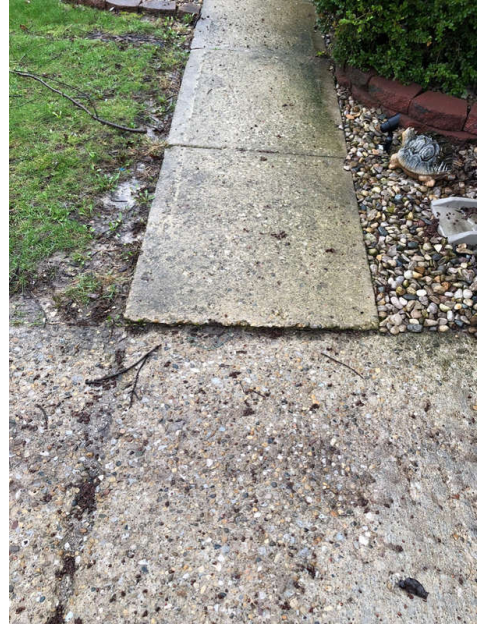
3.3.3 Walkways, Patios & Driveways

WALKWAY CRACKING - MAJOR

Major cracks observed. Recommend concrete contractor evaluate and correct to prevent trip hazard & preserve appearance.

Contact a qualified professional.

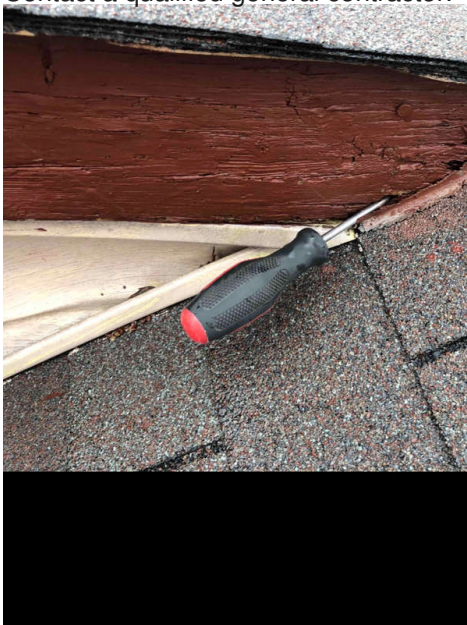
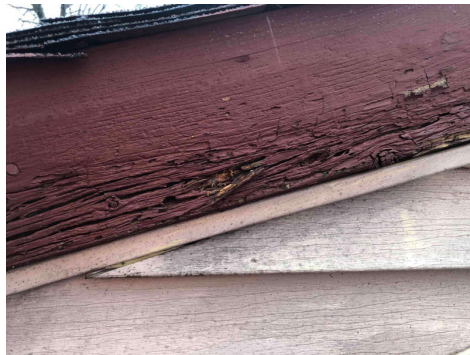
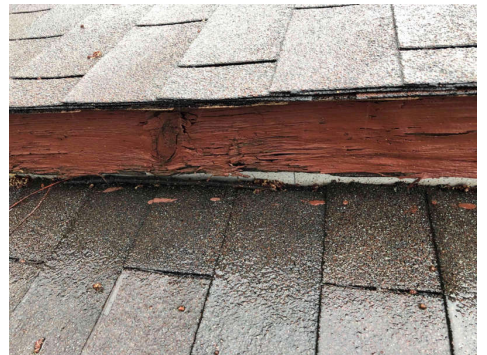
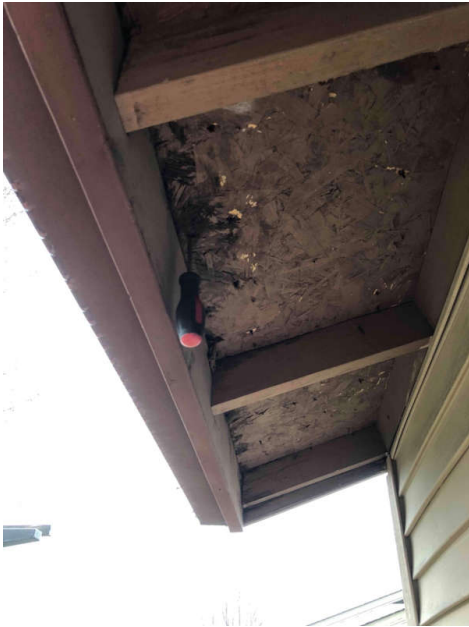
3.5.1 Eaves, Soffits & Fascia

WOOD ROT

Wood rot or significant water damage was observed at one or more sections of the eaves, soffits, fascia boards and/or rake boards. This may be due to a roof or gutter leak (see other comments in "Roof" sections). **All rotten wood should be replaced.**

Contact a qualified general contractor.

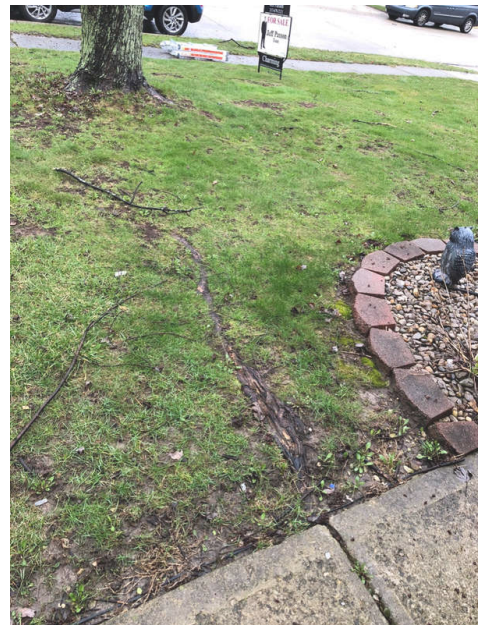
3.6.1 Vegetation, Grading, Drainage & Retaining Walls

TREE ROOTS

One or more large trees were observed close to the home. Tree roots can cause damage to foundations and plumbing. Recommend having a qualified tree service contractor or certified arborist evaluate further.

Contact a qualified professional.

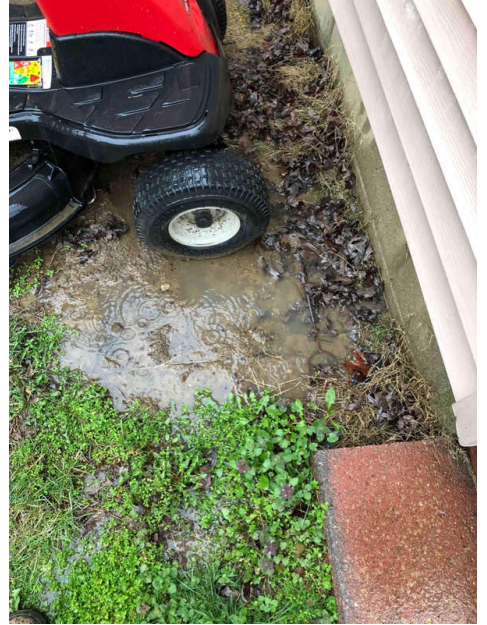
3.6.3 Vegetation, Grading, Drainage & Retaining Walls

STANDING WATER

Standing water observed, which could indicate poor drainage and/or grading. Recommend monitor and/or have landscaper correct.

Contact a qualified landscaping contractor

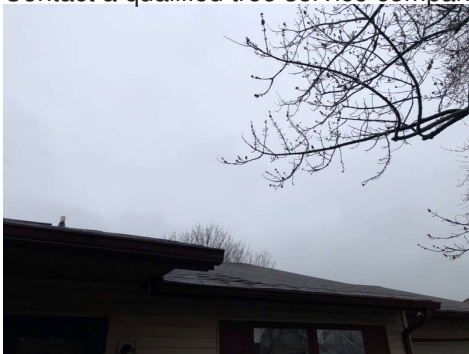
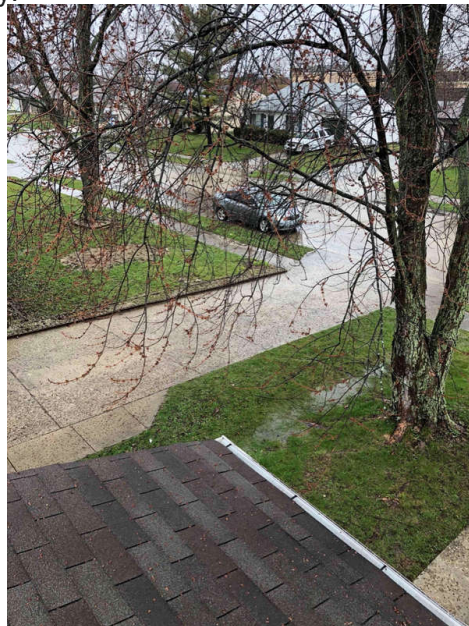
3.6.4 Vegetation, Grading, Drainage & Retaining Walls

TREE OVERHANG

Trees observed overhanging the roof. This can cause damage to the roof and prevent proper drainage. Recommend a qualified tree service trim to allow for proper drainage.

Contact a qualified tree service company.

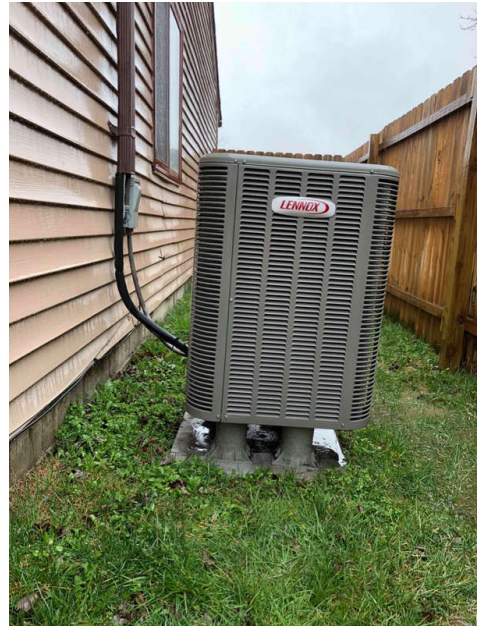
6.1.1 Cooling Equipment

UNIT NOT LEVEL

Pad supporting the outdoor condensing unit is not level. This can cause accelerated deterioration of components. Recommend licensed HVAC contractor level the unit.

Contact a qualified HVAC professional.

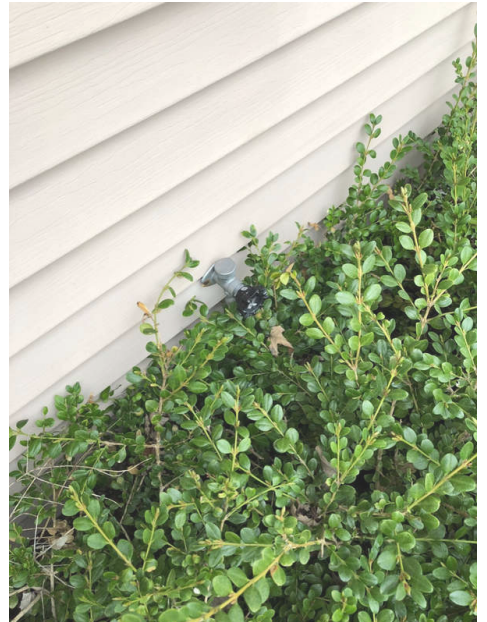
7.3.1 Water Supply, Distribution Systems & Fixtures

EXTERIOR FAUCET

An exterior hose bib was inoperable.

Contact a qualified plumbing contractor.

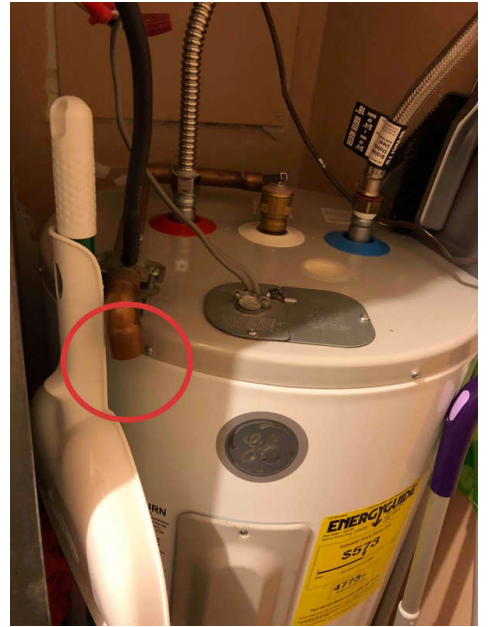
7.4.1 Water Heater

NO DRAIN LINE (TPR)

No drain line was installed for the temperature-pressure relief valve. This is a potential safety hazard due to the risk of scalding if someone is standing next to the water heater when the valve opens.

Contact a qualified plumbing contractor.

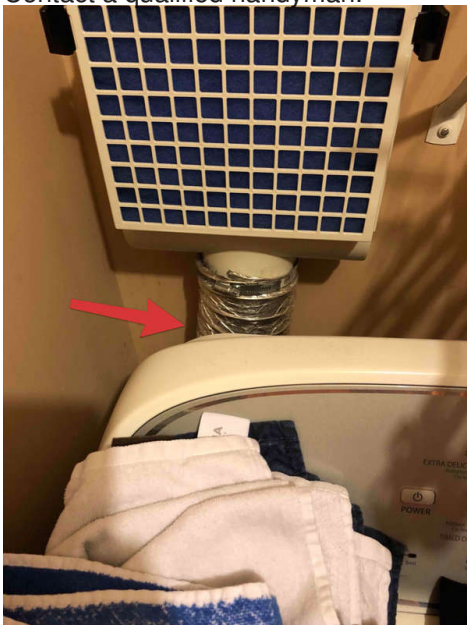
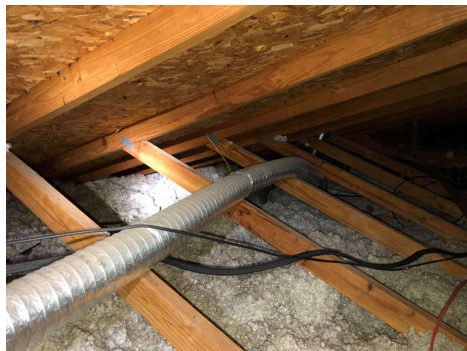
7.8.1 Laundry

VINYL OR MYLAR FLEX-DUCT

The clothes dryer was equipped with a mylar (material) duct. Flexible ducts are acceptable between the dryer and wall, however mylar is flammable. This is a potential fire hazard. Recommend replacing with a rigid or semi-rigid metal duct.

Mylar dryer duct also observed in attic.

Recommendation
Contact a qualified handyman.

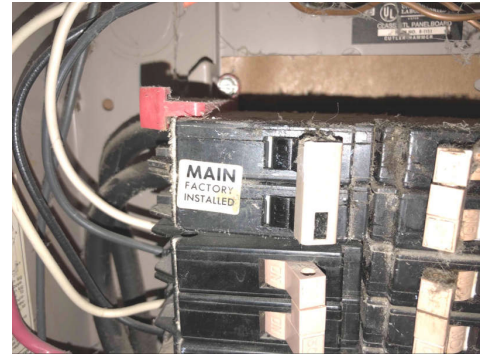
8.1.1 Service

SUB-200 AMP SERVICE

The electric service to this property appeared to be rated less than 200 amps and may be inadequate depending on the client's needs. Recommend consulting with a qualified electrician about upgrading to a 200 amp service.

Recommendation
Contact a qualified electrical contractor.

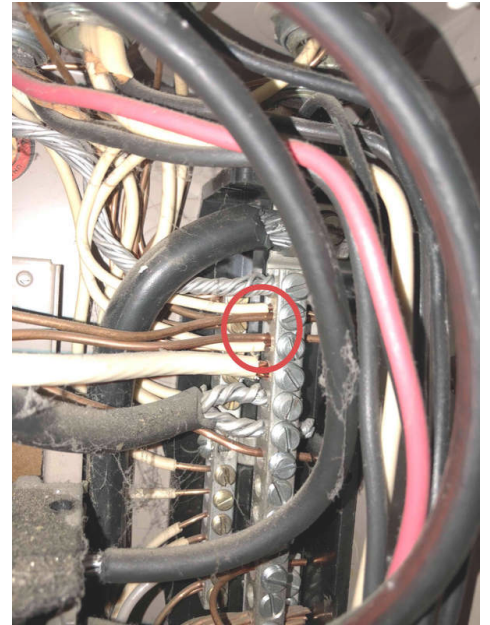
8.2.1 Panels

DOUBLE TAP

Some wires (hot or neutral) were doubled together under the same lug. This can be a fire hazard.

Recommendation
Contact a qualified electrical contractor.

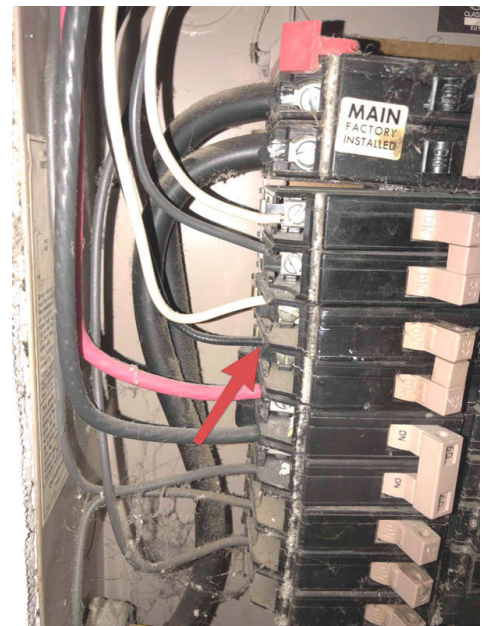
8.2.2 Panels

UNDERSIZED WIRE

One or more branch circuit wires in main service panel appeared to be undersized for their circuit breaker or fuse. This is a potential fire hazard.

Recommendation
Contact a qualified electrical contractor.

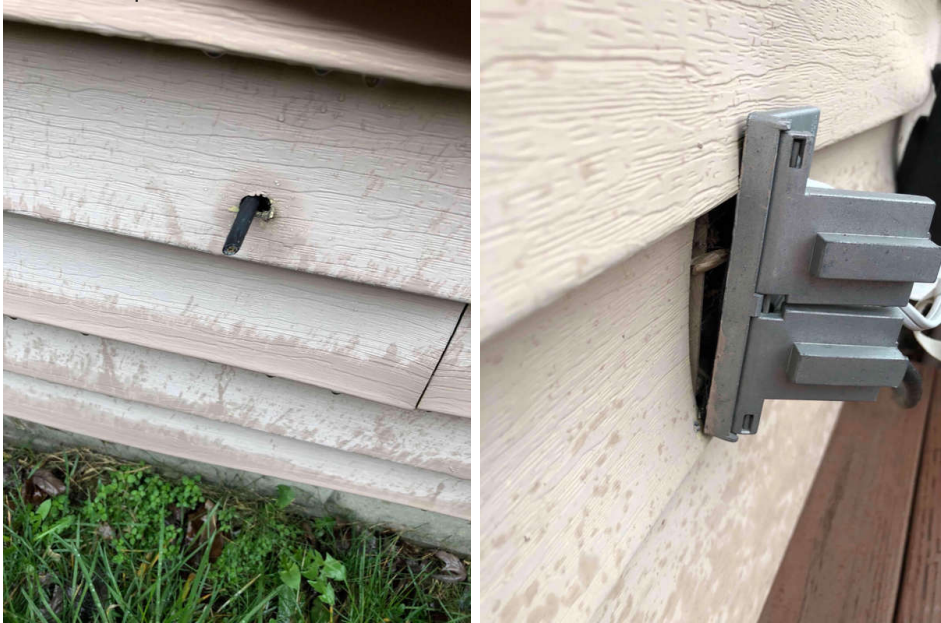
8.3.1 Wiring

EXPOSED WIRING

Exposed wiring was observed at one or more locations or wire ends had a substandard termination. This is a potential shock and/or fire hazard.

Contact a qualified electrical contractor.

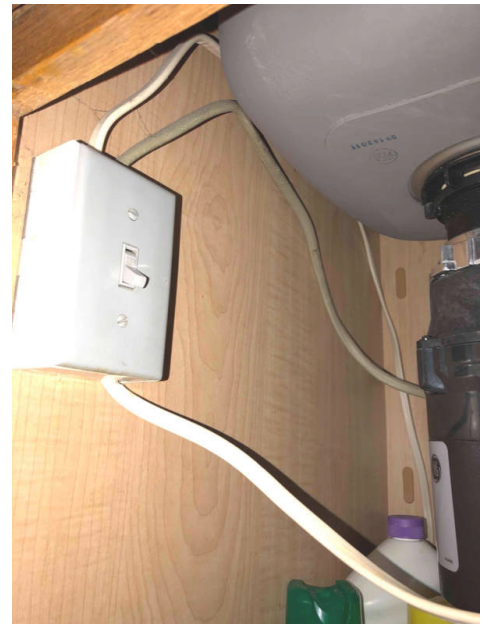
8.3.2 Wiring

NM SHEATHED USED, CONDUIT NEEDED

Non-metallic sheathed wiring was exposed and subject to damage. Wiring can be damaged by repeated bending or contact with sharp objects. This is a potential shock hazard. BX-armored conduit should be installed to protect wiring.

Contact a qualified electrical contractor.

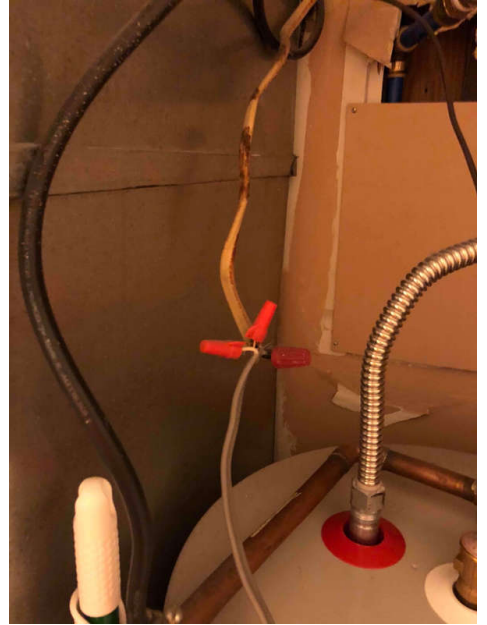
8.3.3 Wiring

SPLICES NOT IN BOX

Wire splices were exposed and were not contained in a covered junction box. This is a potential shock or fire hazard.

Contact a qualified electrical contractor.

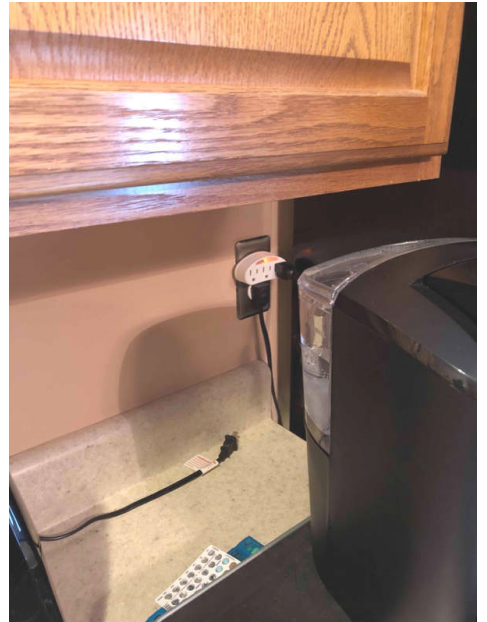
8.4.1 Receptacles
GFCI MISSING

One or more applicable receptacles was missing necessary GFCI protection, or inspector was unable to verify GFCI protection was present. This is a shock hazard.

Recommendation
Contact a qualified electrical contractor.

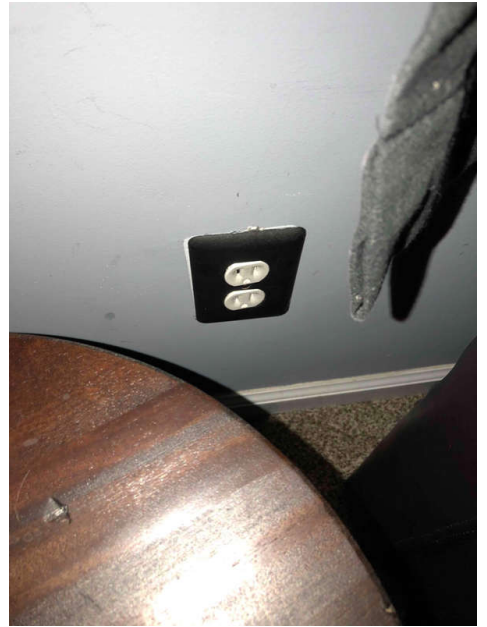
8.4.2 Receptacles
LOOSE

One or more electric receptacles were loose. Wire conductors can be damaged due to repeated movement and/or tension. This is a shock and forensic hazard.

Recommendation
Contact a qualified electrical contractor.

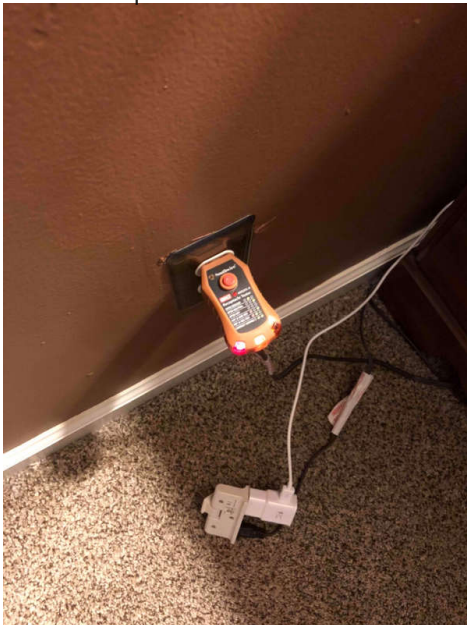
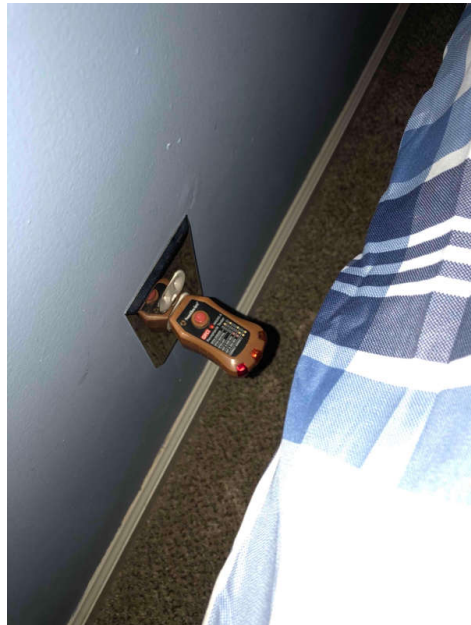
8.4.3 Receptacles

REVERSE POLARITY

One or more receptacles have been wired with reverse polarity. This can create a shock hazard. Recommend licensed electrician evaluate & repair.

Contact a qualified electrical contractor.

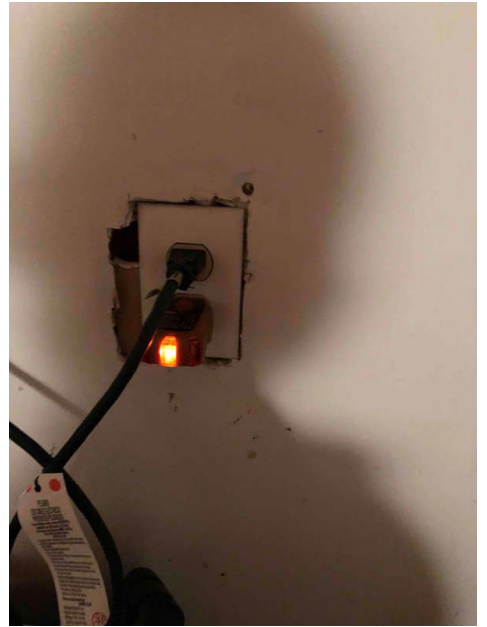
8.4.4 Receptacles

UNGROUND RECEPTACLE

One or more receptacles are ungrounded. To eliminate safety hazards, all receptacles in kitchen, bathrooms, garage & exterior should be grounded.

Contact a qualified electrical contractor.

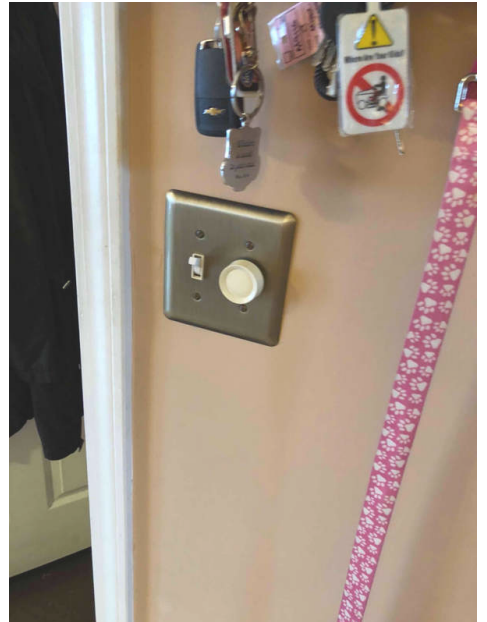
8.8.1 Lighting

DIMMER/NON DIMMABLE LIGHTING

A dimmer switch was wired to what appeared to be a non-dimmable light fixture, or a fixture with non-dimmable bulbs. This can be a fire hazard. Recommend further evaluation.

Contact a qualified electrical contractor.

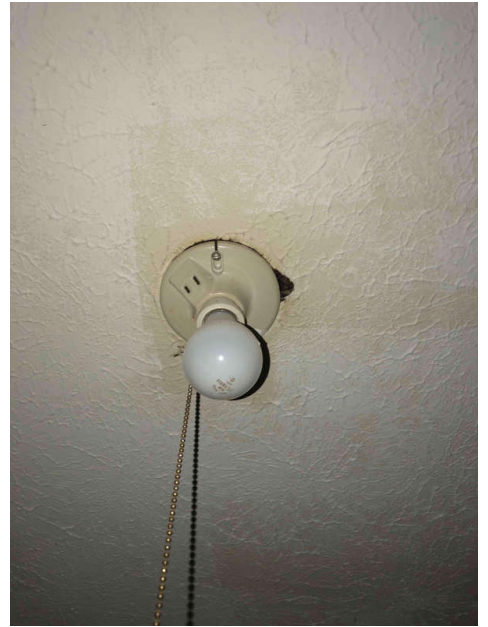
8.8.2 Lighting

EVALUATE LIGHTING

A gap and discoloration was observed at a light fixture in the master bedroom closet. Recommend further evaluation by a qualified electrical contractor.

Contact a qualified electrical contractor.

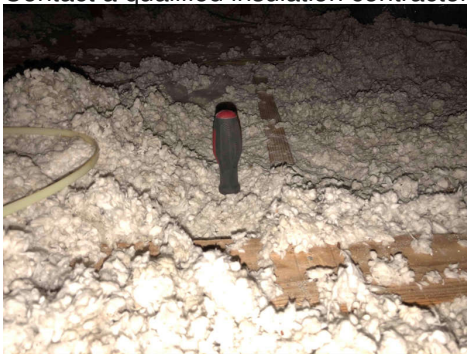
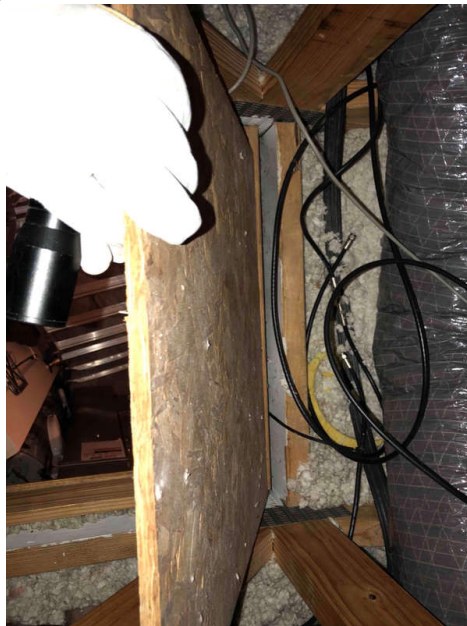
9.1.1 Attic Insulation

INSUFFICIENT INSULATION

Insulation depth was inadequate. Recommend a qualified attic insulation contractor install additional insulation in attic and at hatch to improve energy efficiency of home.

Attic access hatch was uninsulated.

Contact a qualified insulation contractor.

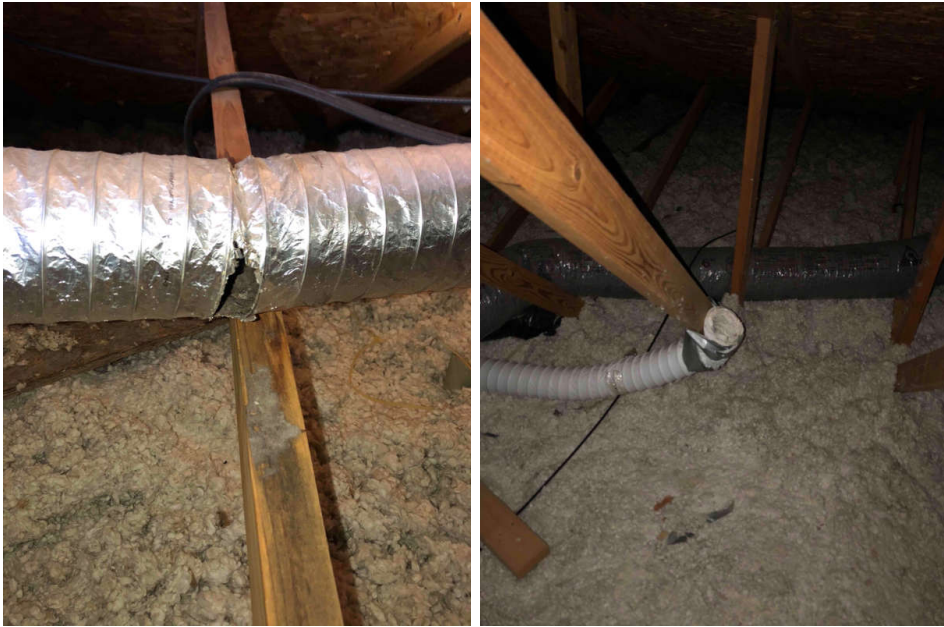
9.4.1 Exhaust Systems

BATHROOM VENTS INTO ATTIC

Bathroom fan vents into the attic. Also observed gaps at dryer exhaust duct in attic. These can cause moisture to accumulate in attic space and result in mold.

Contact a qualified handyman.

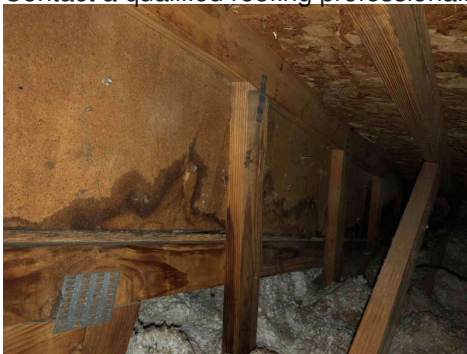
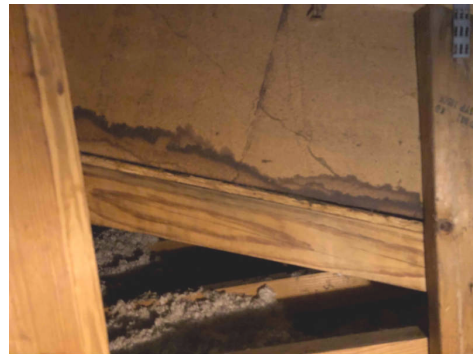
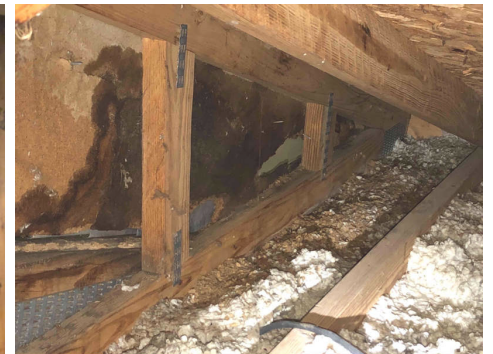
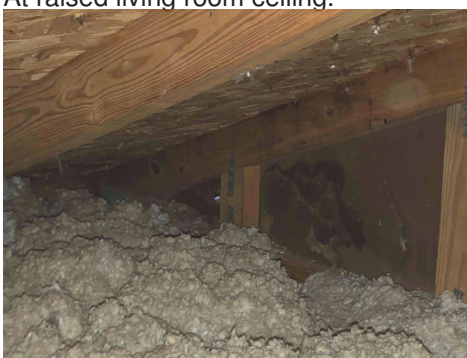
9.5.1 Roof Structure

ROOF LEAK

Inspector observed evidence of active past roof leaking in the attic space. This can cause water damage and/or wood rot, and is a conducive condition for wood-destroying organisms.

At raised living room ceiling.

NE corner of attic.

Contact a qualified roofing professional.

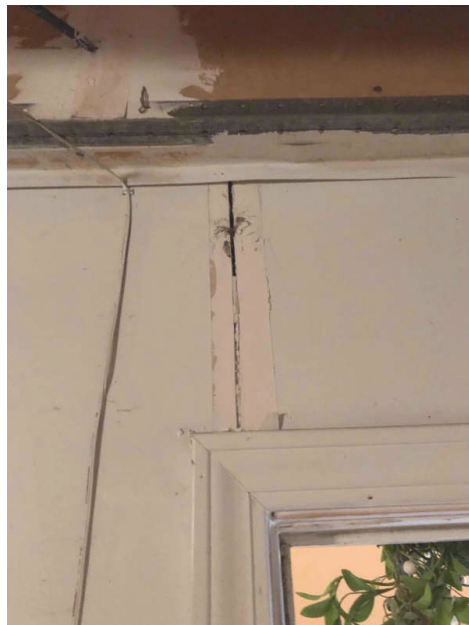
12.3.1 Walls & Firewalls

FIREWALL NOT UP TO CODE

Firewall separating the home and garage is not compliant with modern building standards. Firewalls should be built with materials to prevent the spreading of a fire into the home living space. Recommend a qualified contractor evaluate and bring firewall up to standards.

Contact a qualified handyman.

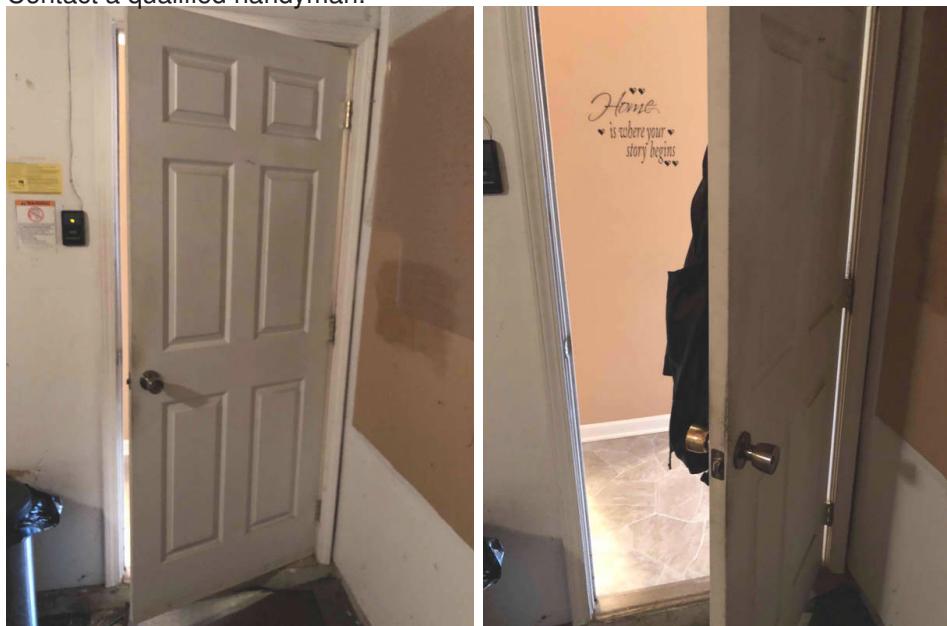
12.6.1 Occupant Door (From garage to inside of home)

DOOR DOES NOT MEET SEPARATION REQUIREMENTS

Door separating garage and home does not meet safety standards. Doors in firewalls must be at least 1 3/8-inch thick, metal/steel, or a 20-minute fire-rated door. This appeared to be an interior door (hollow, wood panel).

Contact a qualified handyman.
