SUMMARY
1234 Main St. Frederick Maryland
21702
Buyer Name
04/19/2019 9:00AM

Colton Beckley
InterNACHI Certified Home Inspector
High Caliber Home Inspections, LLC
2404158502
colton@highcaliberinspect.com

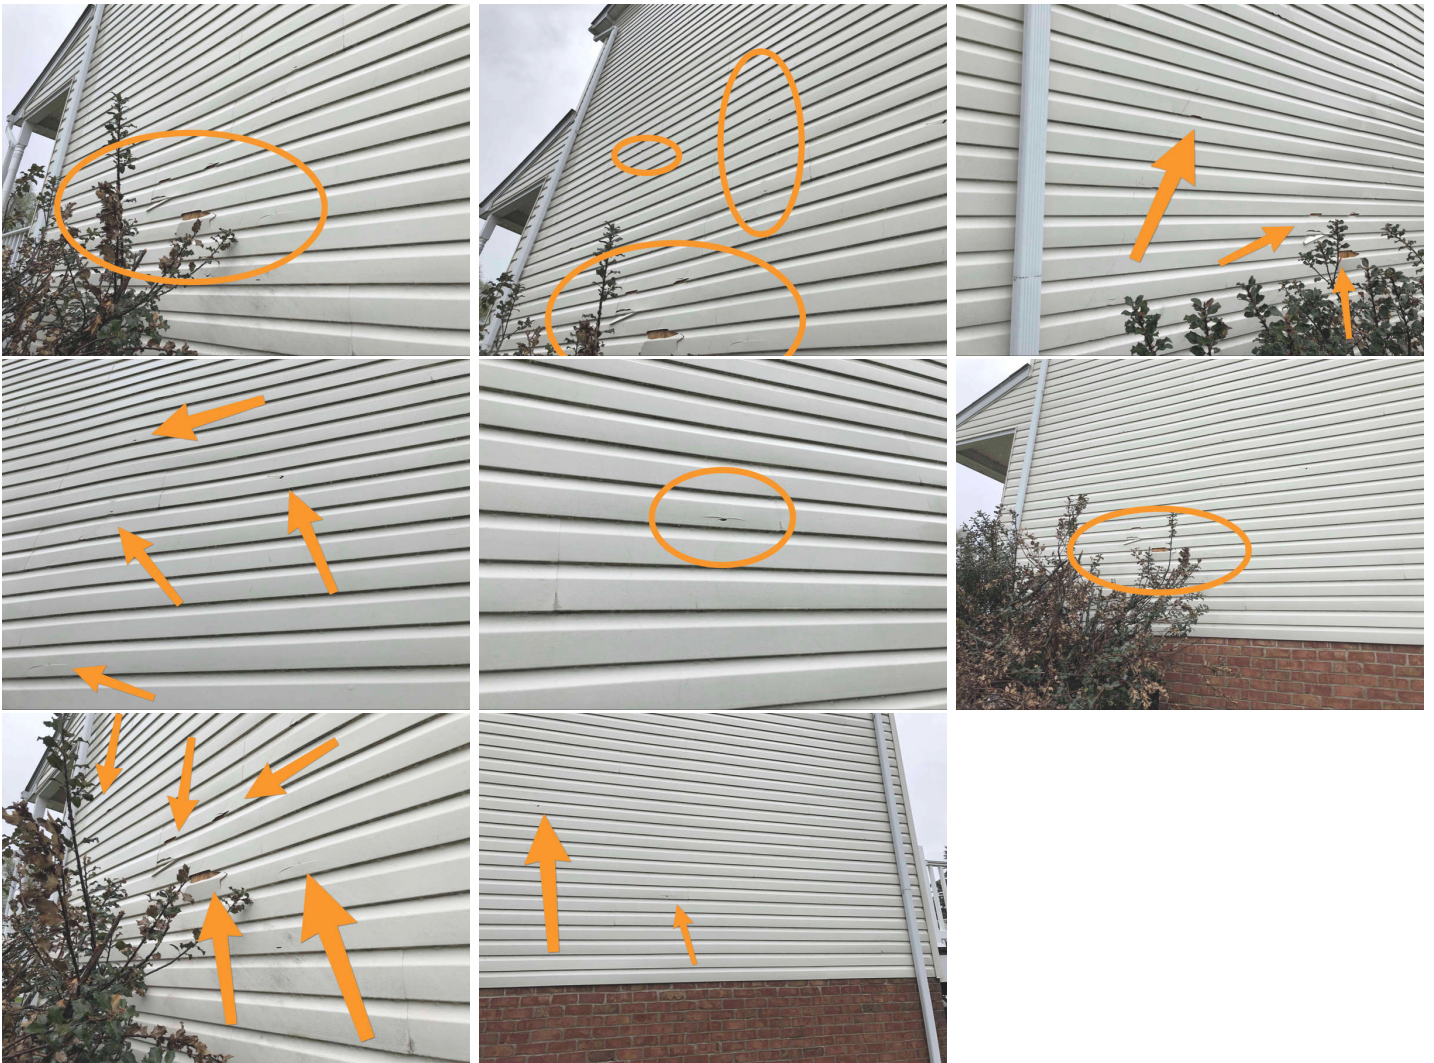
3.1.1 Siding, Flashing & Trim

WIND DAMAGE

RIGHT SIDE

Siding showed signs of wind damage. This could allow moisture in, resulting in structural damage. Recommend a qualified siding contractor evaluate and repair.

Recommendation
Contact a qualified siding specialist.

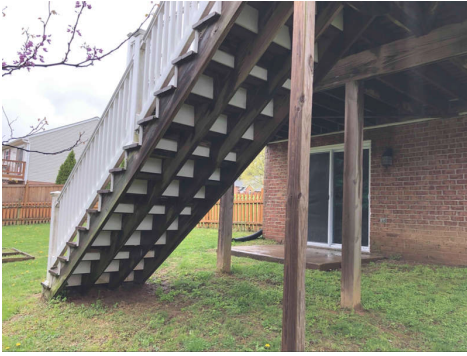
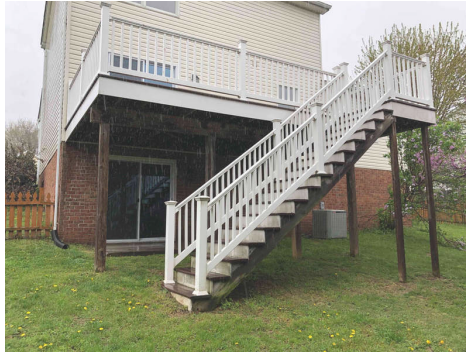
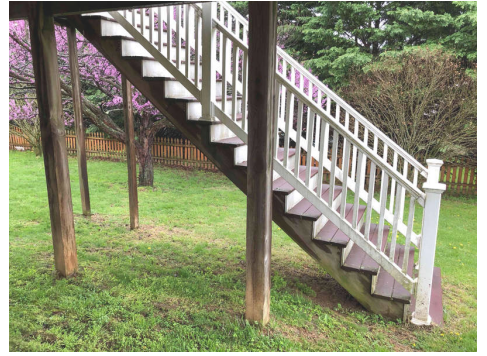
3.4.1 Decks, Balconies, Porches & Steps

DECK STAIRS - UNSTABLE SUPPORT

REAR

Rear deck stairs appears unstable. This could cause a safety hazard and further deterioration of the deck. Recommend qualified deck contractor evaluate and repair by adding more supports for deck stairs.

Recommendation
Contact a qualified deck contractor.

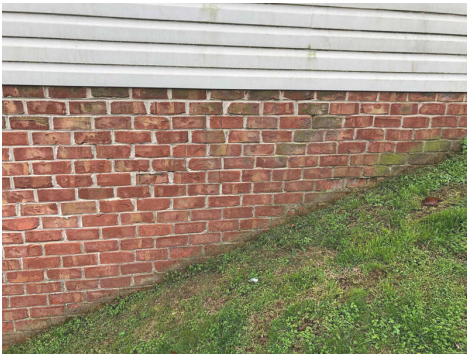
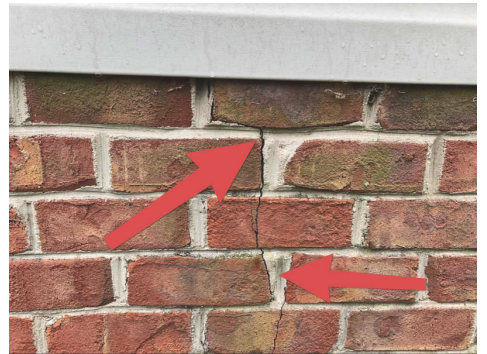
4.1.1 Foundation

FOUNDATION CRACKS

LEFT SIDE

Severe cracking noted at the foundation. This is typically consistent with soil movement and could lead to serious damage to structural components, foundation and/or slabs. Recommend a structural engineer evaluate and provide a report on course of action and remedy.

Contact a qualified structural engineer.

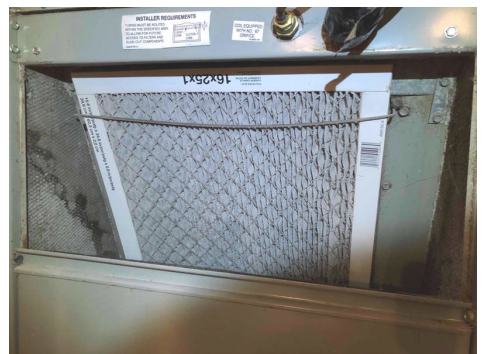
5.1.1 Equipment

FILTER DIRTY

BASEMENT

The furnace filter is dirty and needs to be replaced every 6 months.

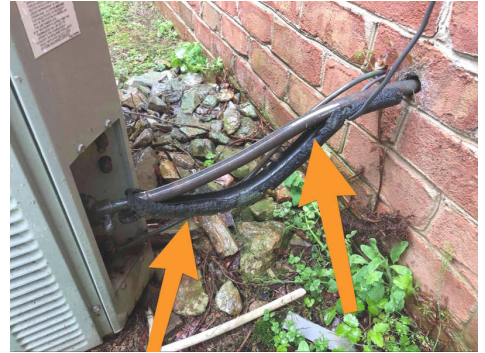
6.1.1 Cooling Equipment

INSULATION MISSING OR DAMAGED

REAR

Missing or damaged insulation on refrigerant line can cause energy loss and condensation.

Contact a qualified HVAC professional.

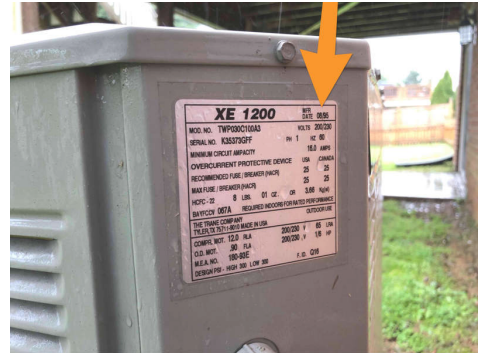
6.1.2 Cooling Equipment

SYSTEM NEARING END OF LIFE EXPECTANCY

REAR

The HVAC system was installed new in 1995. This unit is 24 years old. Systems can last 25+ years with regular maintenance. This unit was functioning properly at time of inspection. Recommend evaluation by qualified HVAC contractor and plan for replacement in the next couple of years.

Contact a qualified HVAC professional.

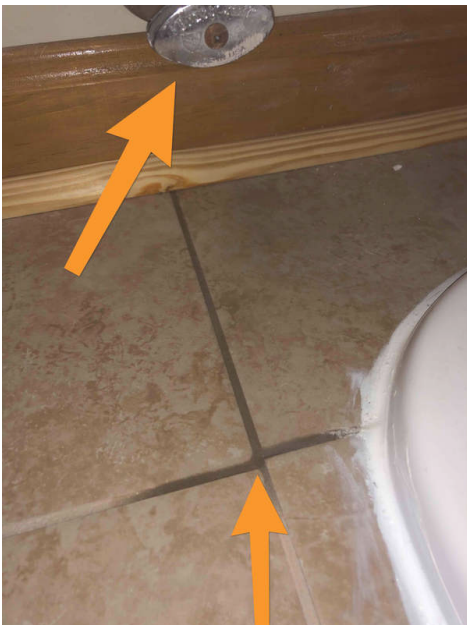
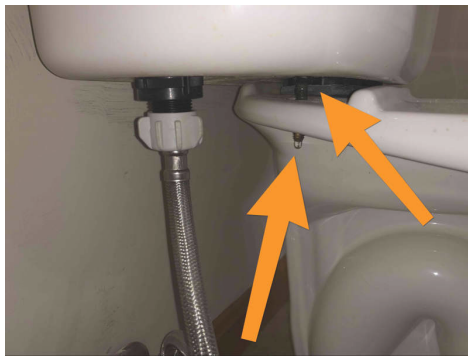
7.3.1 Water Supply, Distribution Systems & Fixtures

TOILET LEAKING

FIRST FLOOR AND UPSTAIRS MASTER

Upstairs toilet is leaking. First floor toilet is leaking at the tank. Recommend a qualified plumber evaluate and repair to prevent further water damage.

Contact a qualified plumbing contractor.

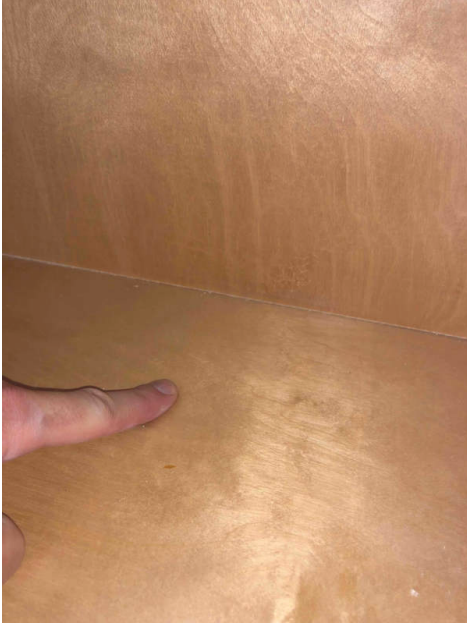
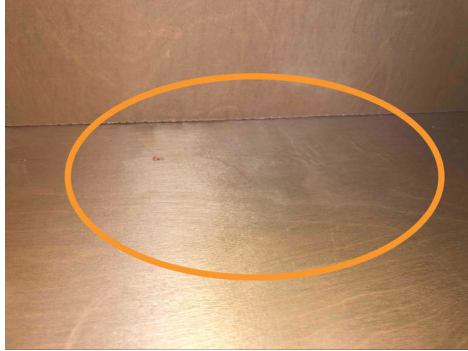
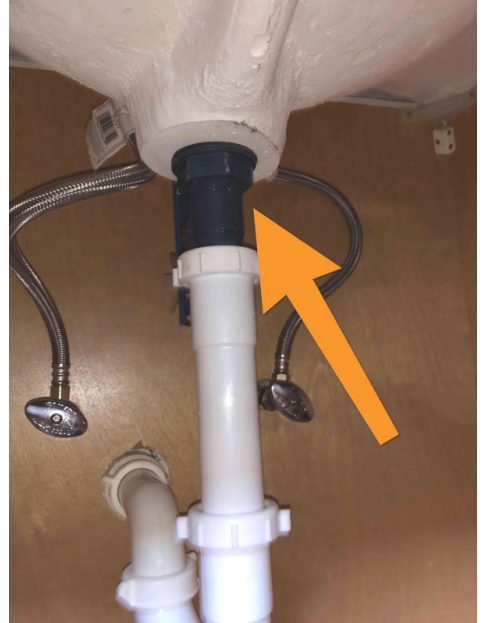
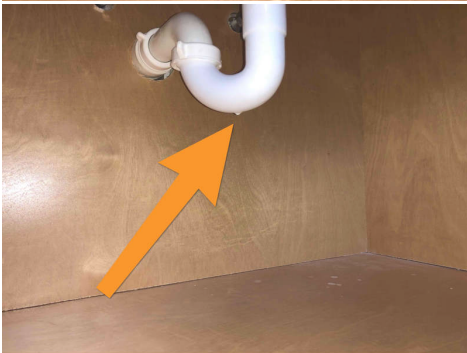
SINK LEAKING

BOTH SECOND FLOOR SINKS

One or more sinks were leaking at time of inspection. Recommend evaluation by qualified plumbing contractor to prevent further water damage.

Contact a qualified plumbing contractor.

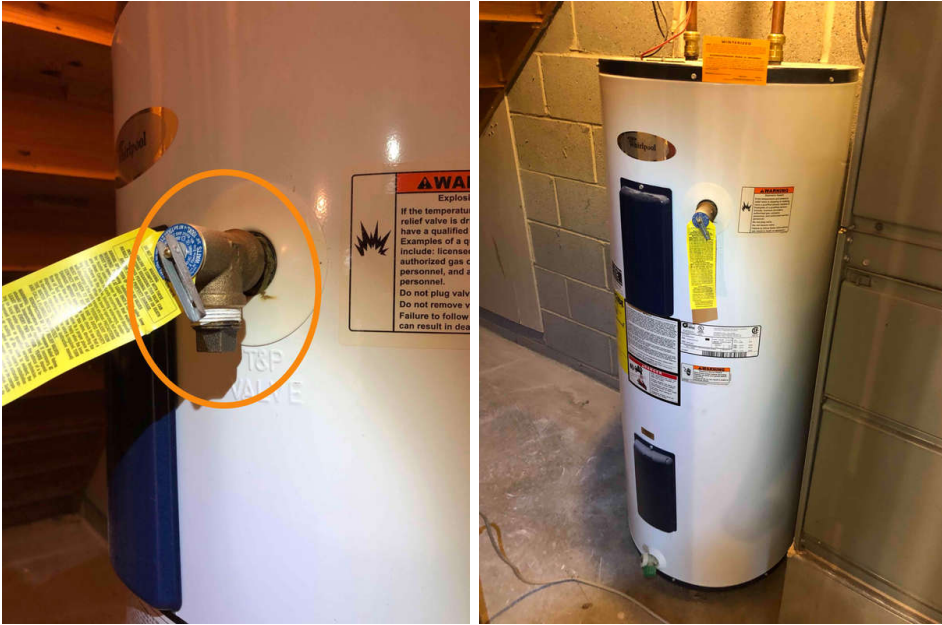
TPR VALVE PLUGGED

BASEMENT

The TPR valve was plugged at time of inspection. This valve should have a pipe that discharges no more than 6 inches from the floor. Recommend repair by qualified plumbing contractor.

Contact a qualified plumbing contractor.

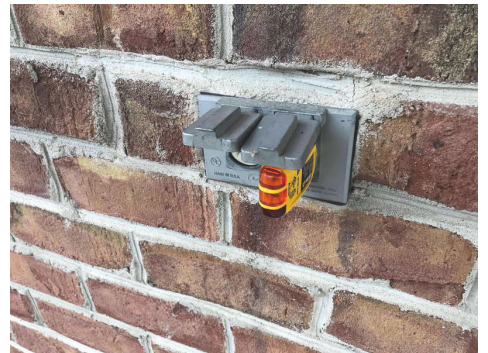
8.4.1 Lighting Fixtures, Switches & Receptacles

RECEPTACLE INOPERABLE

FRONT PORCH

One or more receptacles was inoperable. Recommend evaluation and repair by qualified electrician.

Contact a qualified electrical contractor.

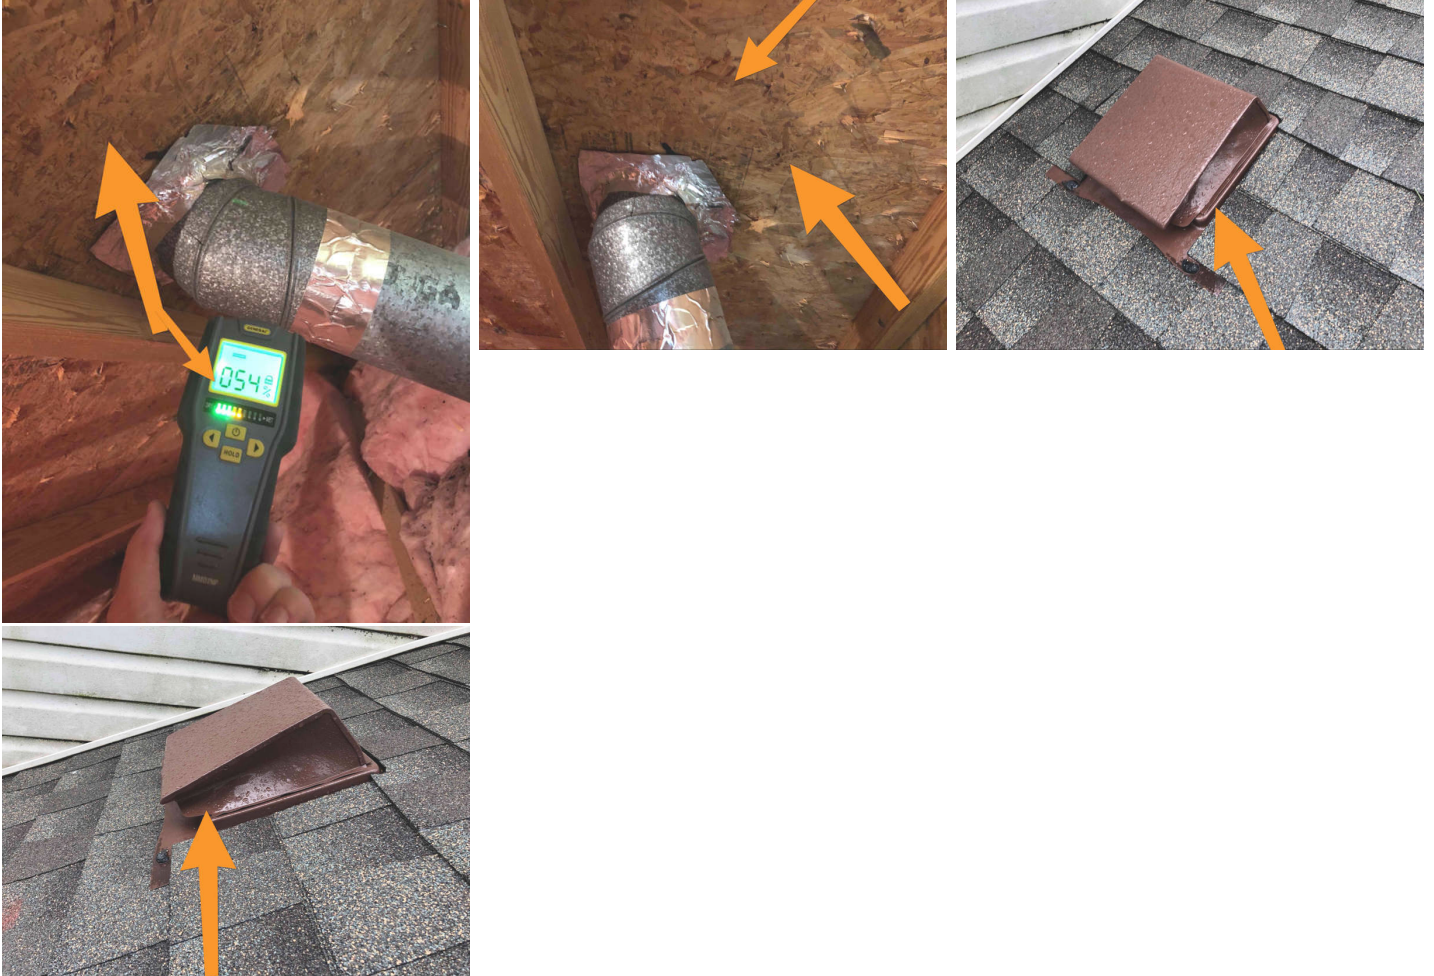
9.4.1 Exhaust Systems

RANGE HOOD VENT LEAKING

ATTIC

The exhaust vent for the range hood was noted to have some moisture in the wood around it. The vent on the roof seems to have been pushed down to try and prevent water intrusion which may have compromised the seals. Recommend repair/evaluation by qualified roofing contractor.

Contact a qualified roofing professional.

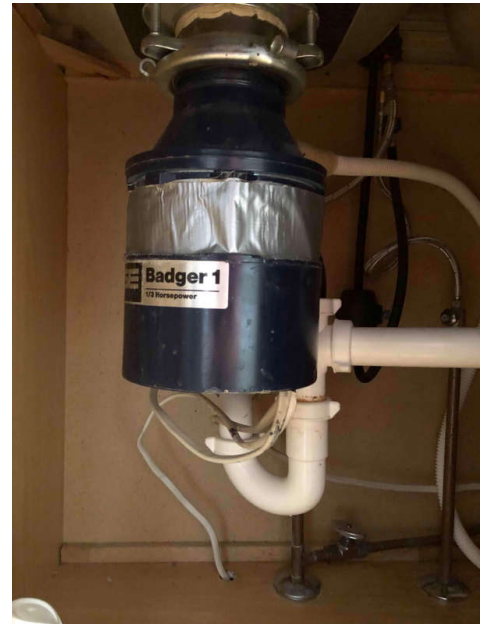
11.4.1 Garbage Disposal

INOPERABLE

KITCHEN

Garbage disposal was inoperable at the time of inspection. Recommend qualified handyman repair.

Contact a qualified appliance repair professional.

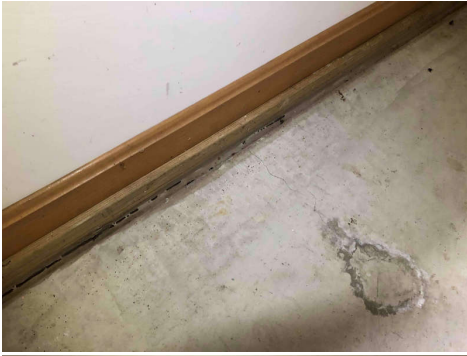
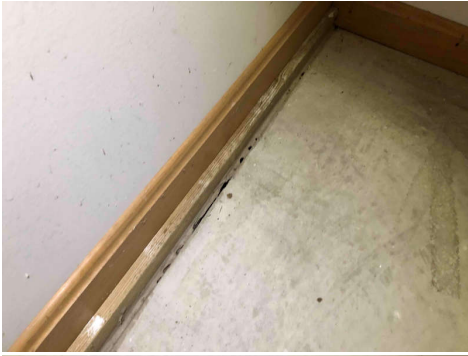
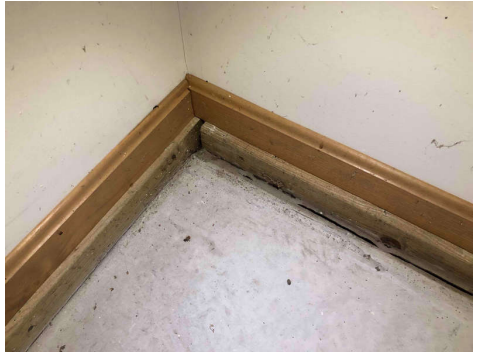
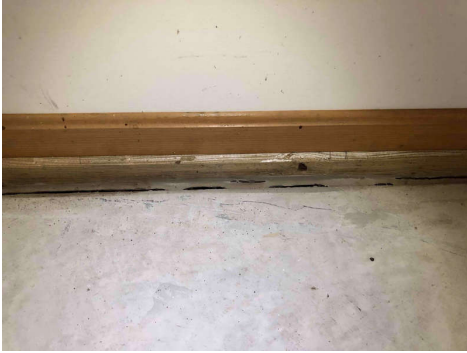
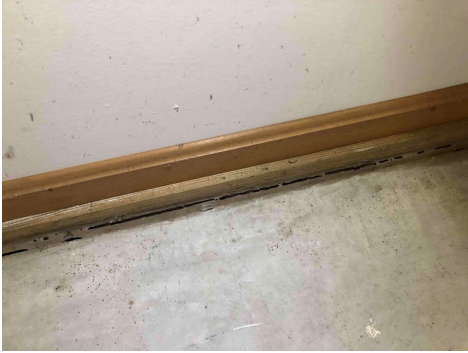
12.2.2 Floor
SETTLING
GARAGE

Garage floor shows signs of settling in the soil beneath the slab. Recommend a structural engineer evaluate for potential repairs.

Recommendation
Contact a qualified structural engineer.
