SUMMARY

1234 Main St. Naches WA 98937

Integrity Inspection Services LLC

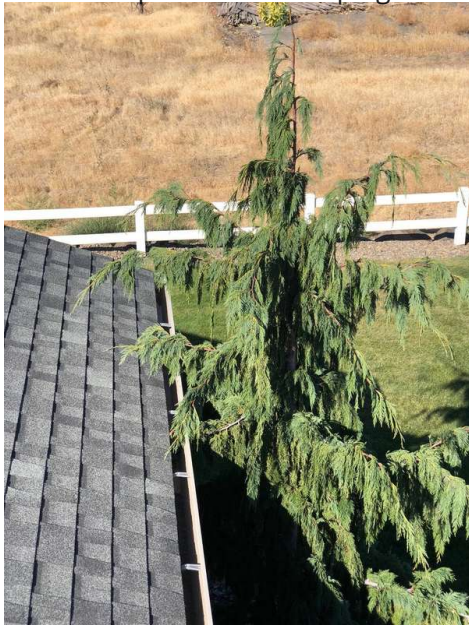
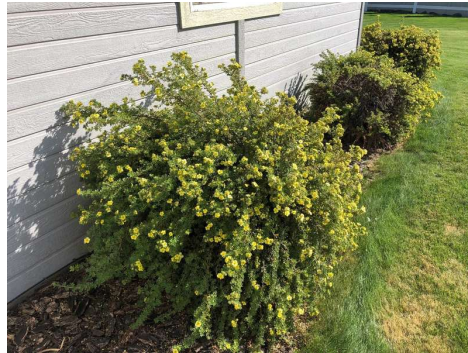
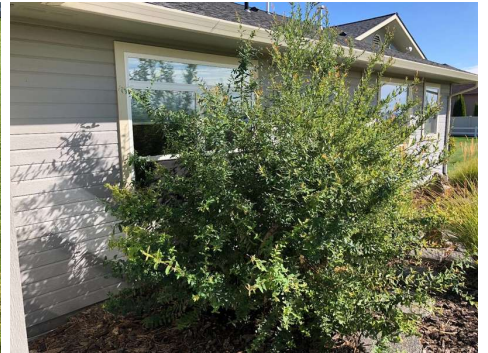
2.1.1 Vegetation & Grading

VEGETATION AGAINST HOME

Trees, shrubs and/or vegetation in contact with home may cause undue wear and trap moisture against home leading to eventual compromise. Recommend all vegetation be maintained with a minimum of 8" clearance from home/ exterior siding.

Contact a qualified landscaping contractor

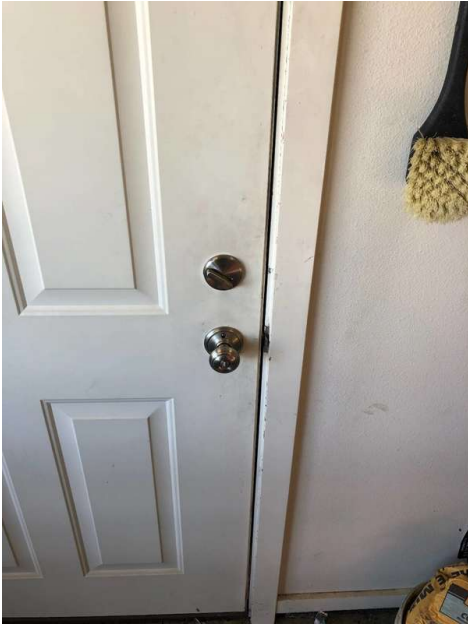
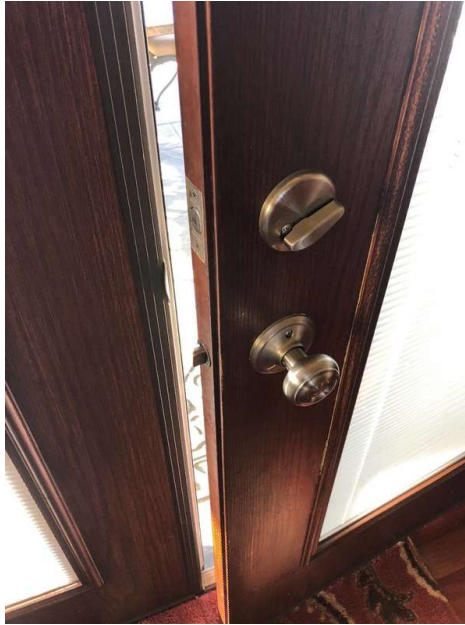
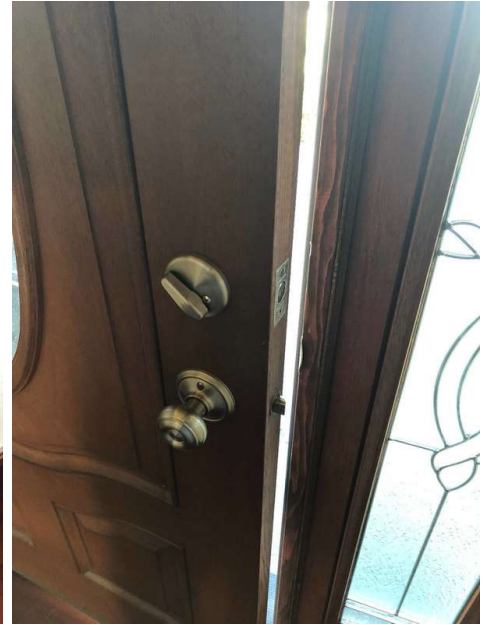
3.2.1 Exterior Doors & Windows

ADJUSTMENT NEEDED

GARAGE ENTRY, FRONT ENTRY, BACK ENTRY

Entry door hardware throughout was not operating smoothly/properly and may be in need of adjustment or repair.

Contact a qualified door repair/installation contractor.

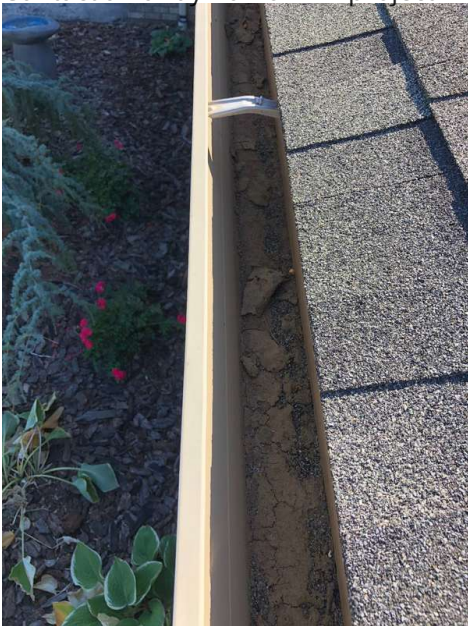
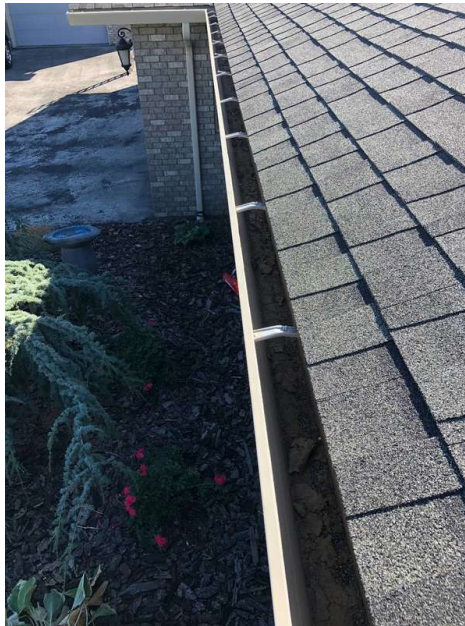
4.2.1 Gutter Systems

CLEAN GUTTERS

Gutters contain dirt or debris that may restrict proper drainage. Full gutters may also add unneeded weight to gutter system leading to potential failure. [Here is a DIY resource](#) for cleaning your gutters.

Recommendation
Contact a handyman or DIY project

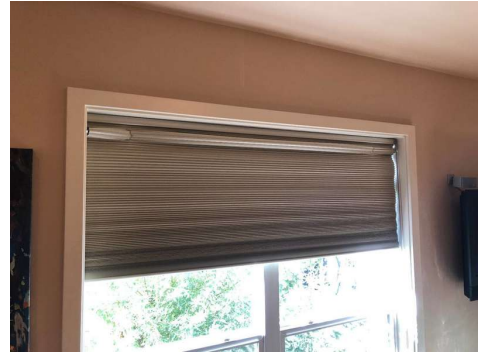
5.5.1 Windows

WINDOW BLINDS DAMAGED

MASTER BEDROOM

Some window blinds were damaged or did not operate properly and may be in need of adjustment or repair.

Recommendation
Contact a qualified handyman.

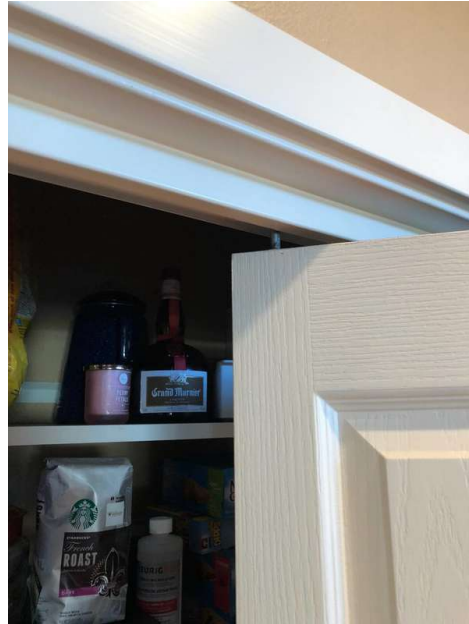
5.6.1 Doors

HARDWARE MISSING

KITCHEN

Some interior closet door hardware was missing or not installed and was not operating smoothly/properly.

Contact a qualified door repair/installation contractor.

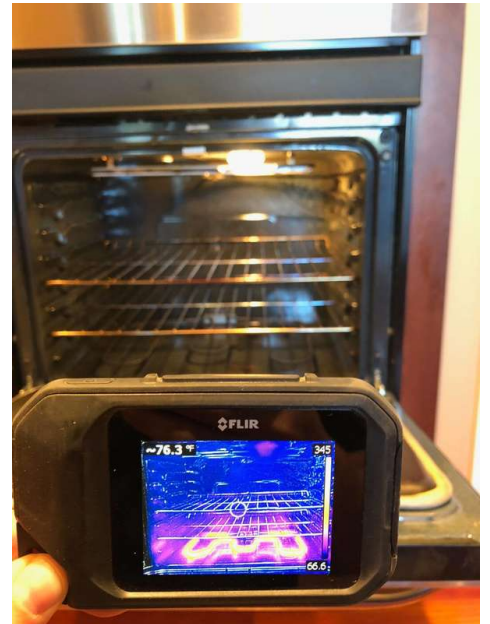
6.11.1 Wall Oven

BURNER NOT OPERATING

Inspector was unable to confirm operation of Broil function at lower oven.

Contact a qualified appliance repair professional.

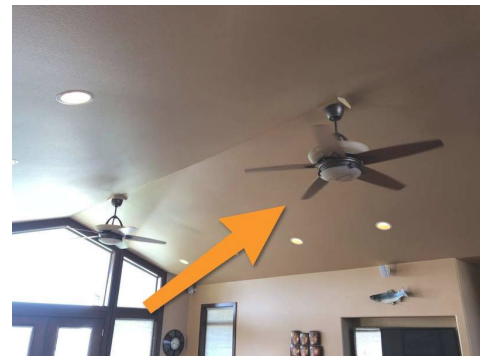
8.4.1 Connected Devices & Fixtures

LIGHT INOPERABLE

LIVING ROOM

Inspector was unable to confirm operation of one or more lights at time of inspection. New light bulb possibly needed. Recommend further evaluation and repair as needed.

Contact a qualified electrical contractor.

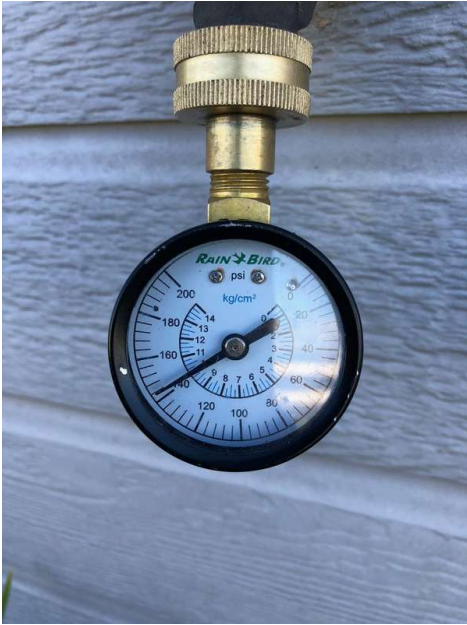
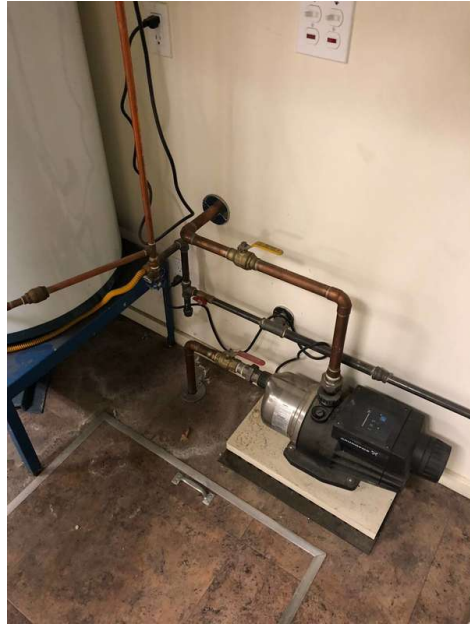
9.1.1 Supply Plumbing

HIGH WATER PRESSURE

High water pressure may put unneeded stress/strain on your plumbing system (pipes and fixtures). The generally recommended safe water pressure for residential application is 60-80 P.S.I. Recommend adjusting water pressure at Booster Pump. Here is a helpful [article](#) on Water Reducing Valves.

Contact a qualified plumbing contractor.

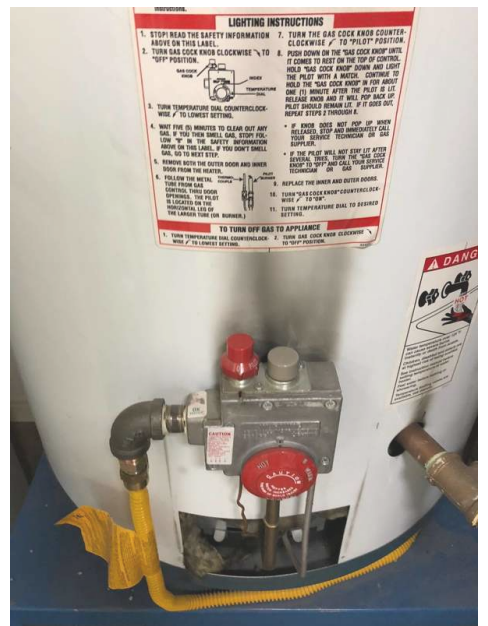
10.1.2 Equipment
FLAME ROLL-OUT

Scorching or evidence of flame roll-out noted at Hot Water Tank. Flame roll-out may be an indication of poor operation or other defects. Recommend further evaluation by a qualified professional and repair or replace as needed.

Recommendation
 Contact a qualified plumbing contractor.

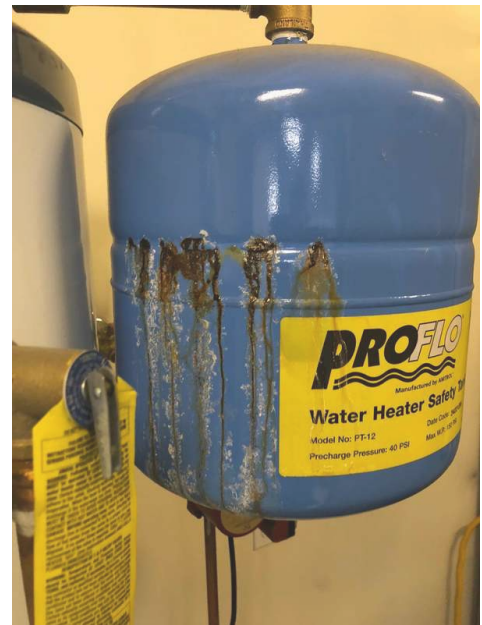
10.1.4 Equipment

EXPANSION TANK LEAKING

Rust or evidence of leaking noted at expansion tank. Recommend repair or replace as needed.

Recommendation
Contact a qualified plumbing contractor.

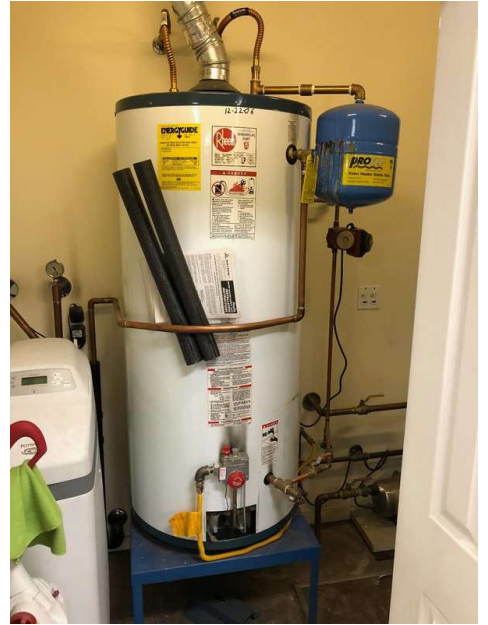
10.3.1 Safety Features

SEISMIC STRAPPING NOT INSTALLED OR IMPROPER

Modern safety standards requires seismic strapping at top and bottom thirds of installed Hot Water Tanks. See this helpful [link](#) for approved strapping and anchoring techniques. Recommend repair.

Recommendation
Contact a qualified appliance repair professional.

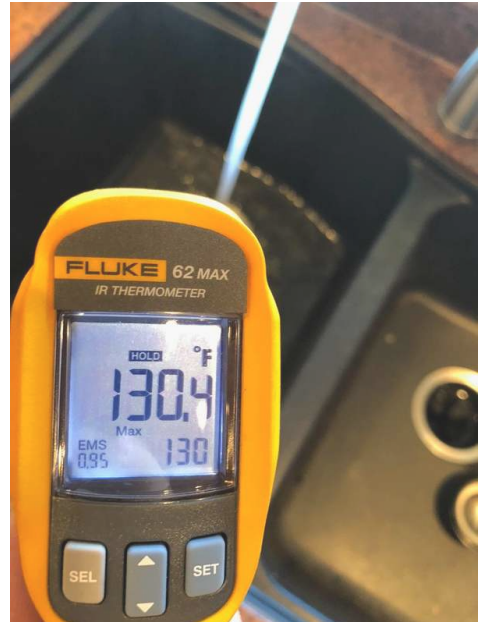
10.3.2 Safety Features

WATER TEMPERATURE HIGH

Water temperature was measured above maximum recommended safe water temperature of 120°F. Recommend adjusting water temperature to no more than 120°F to prevent potential scaling.

Contact a qualified appliance repair professional.

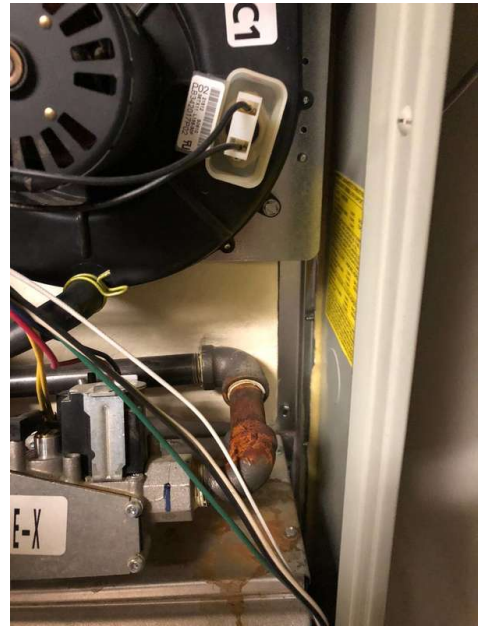
11.1.1 Heating Equipment

CONDENSATE LEAK

Evidence of a condensate leak noted at furnace. Condition conducive to rust/deterioration and potential compromise. Recommend a qualified professional further evaluate and repair.

Contact a qualified HVAC professional.

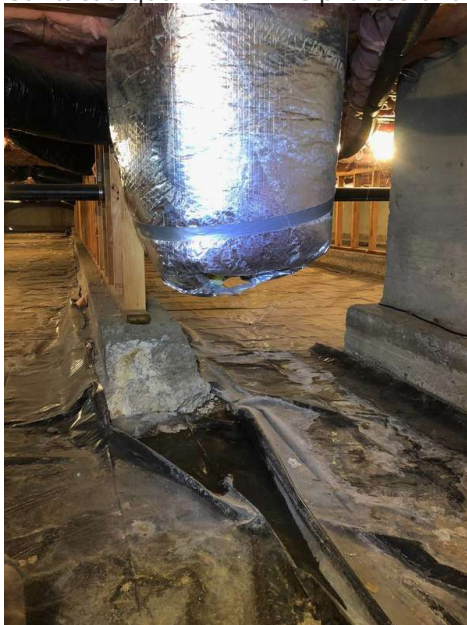
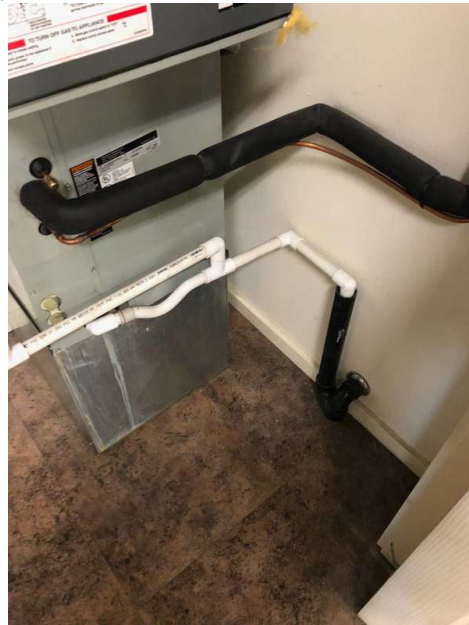
12.2.1 Distribution Systems

CONDENSATE LEAK

CRAWLSPACE

Leaking observed at Furnace Plenum and/or ducting. Probable condensate leak. Condition conducive to eventual deterioration and loss of system efficiency. Recommend a qualified professional further evaluate and repair/remedy as needed.

Contact a qualified HVAC professional.

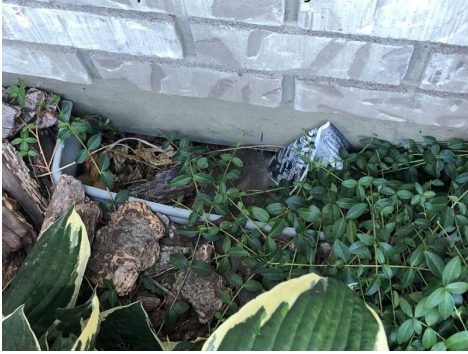
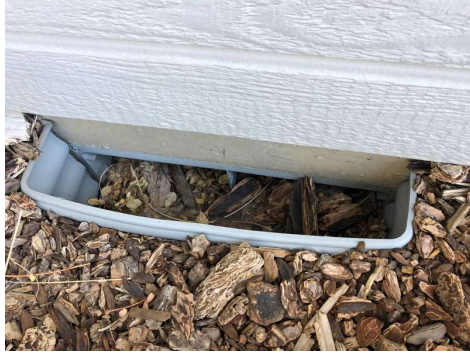
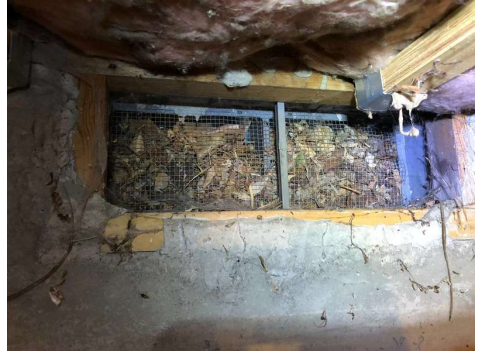
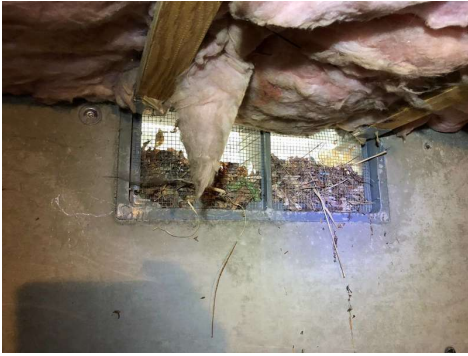
14.3.1 Crawlspace

FOUNDATION VENT/S RESTRICTED

THROUGHOUT EXTERIOR

Some foundation vents throughout are blocked or restricted with landscaping, leaves/debris and/or insulation. Recommend opening/clearing all foundation vents to ensure adequate crawlspace ventilation.

Recommendation
Contact a qualified handyman.

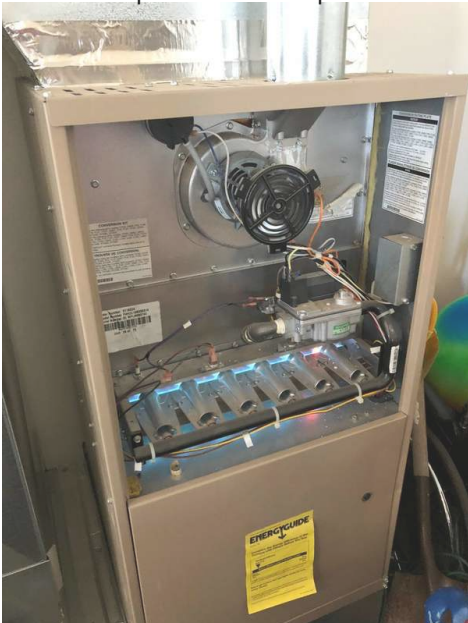
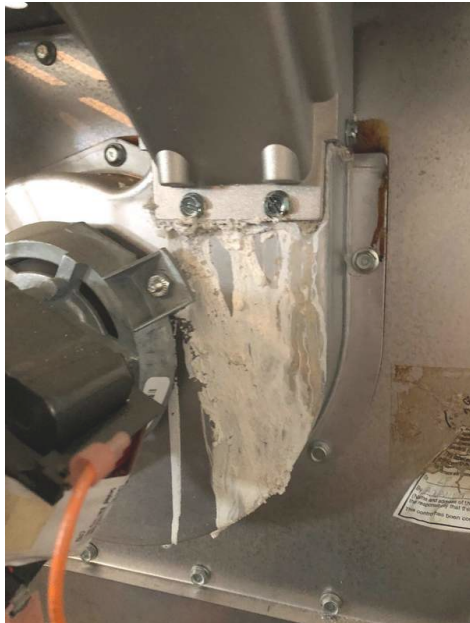
16.1.1 Heat Source

CONDENSATE LEAK

Evidence of condensate leak noted at furnace cabinet. Recommend further evaluation/inquiry and repair as needed.

Recommendation
Contact a qualified HVAC professional.

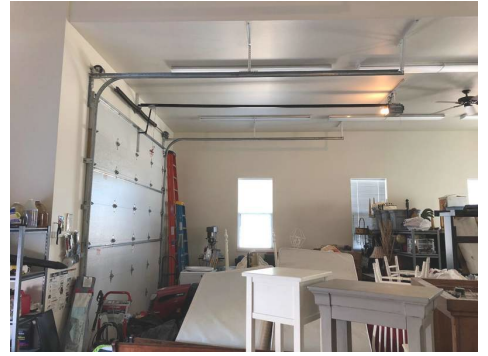
16.4.1 Garage Doors

OPENER NOISY

Garage door opener was noisy when operating and may be at or nearing the end of its useful life. Recommend further evaluation and maintenance or repair.

Contact a qualified garage door contractor.
