SUMMARY
1234 Main St. Jacksonville OR 97530
Buyer Name
11/14/2018 9:00AM

Ian Miller
OCHI# 2214
Rogue Inspection Services LLC
5414992125
ian@rogueinspection.com

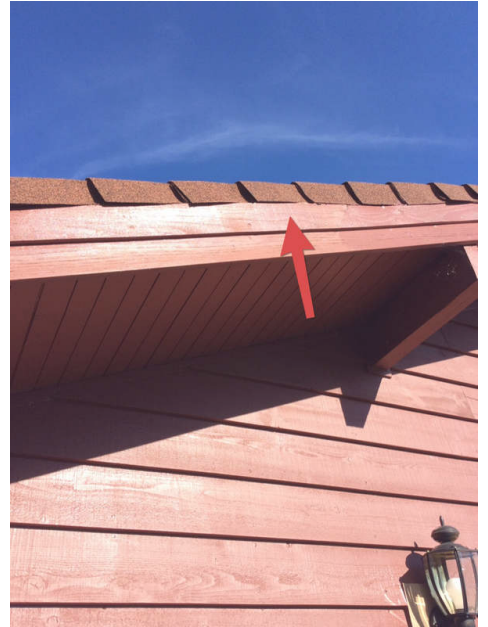
2.1.1 Siding, Flashing & Trim

FLASHING/TRIM IMPROPERLY INSTALLED

GARAGE

Flashing & trim pieces were improperly installed, which could result in moisture intrusion and damaging leaks. Recommend a qualified siding contractor evaluate and install flashing over all horizontal trim.

Contact a qualified siding specialist.

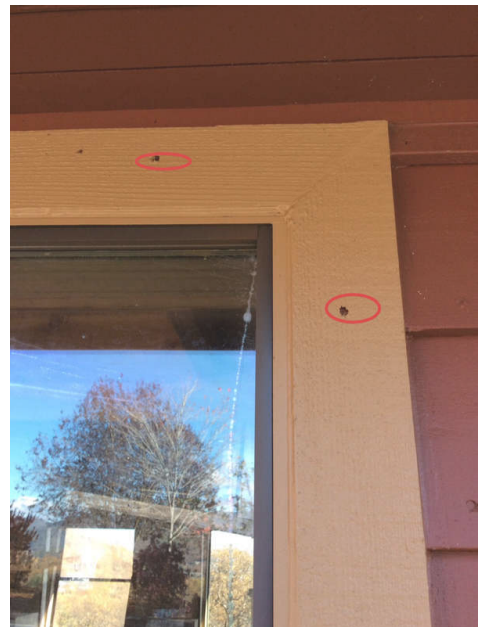
2.1.2 Siding, Flashing & Trim

SEAL PENETRATIONS

GARAGE

There are holes that are exposed on the exterior siding. Recommend sealing to prevent water damage to the siding.

Contact a qualified professional.

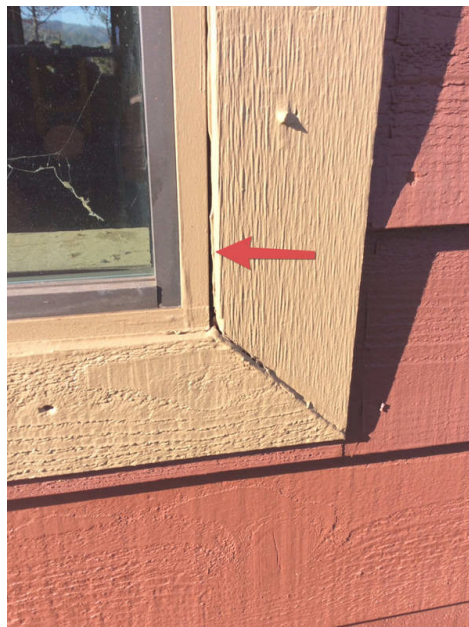
2.1.3 Siding, Flashing & Trim

CRACKED SEALANT AT TRIM JOINTS

GARAGE

The sealant at the trim joints and window trim has deteriorated and cracked. Recommend re-sealing to prevent moisture damage.

Recommendation
Recommended DIY Project

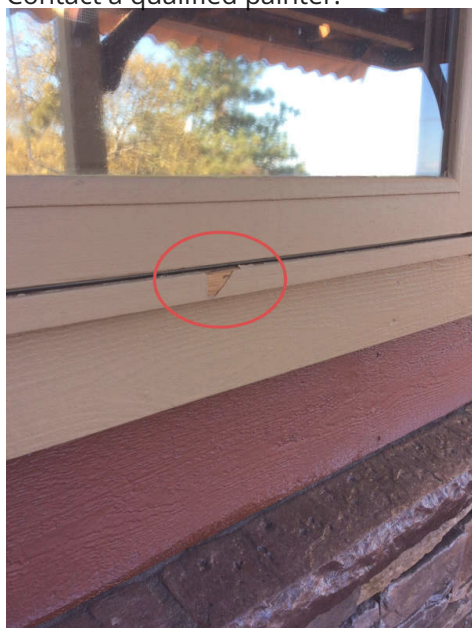
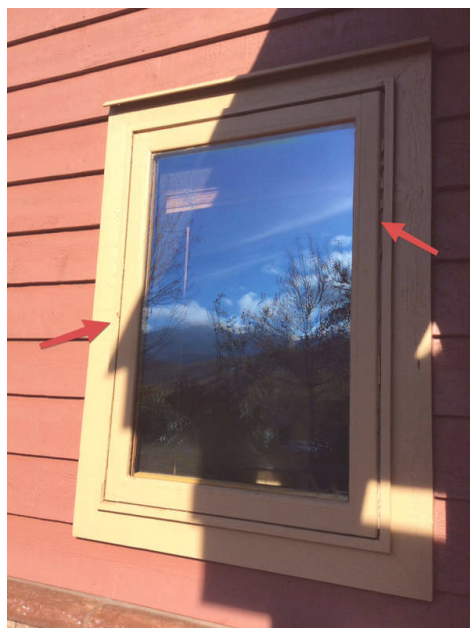
2.1.4 Siding, Flashing & Trim

FAILING PAINT

SOUTH

The paint is failing on various locations around the house and the wood is exposed. Recommend painting to provide a waterproof barrier and to prevent dry Rot.

Recommendation
Contact a qualified painter.

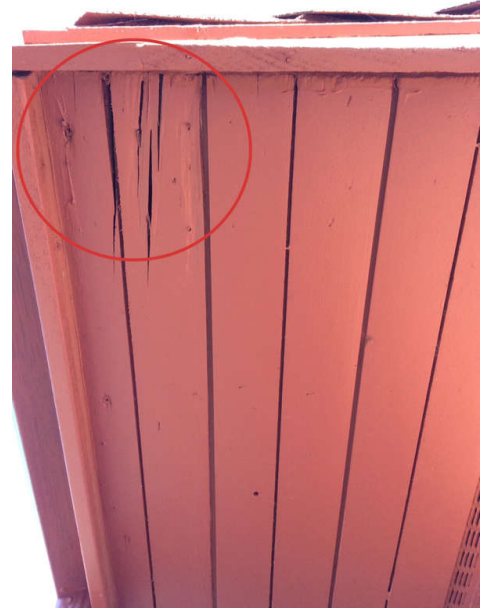
2.1.5 Siding, Flashing & Trim

DRY ROT

GARAGE

There is dry rot present on the exterior trim in some areas. Recommend repair as needed.

Recommendation
Contact a qualified siding specialist.

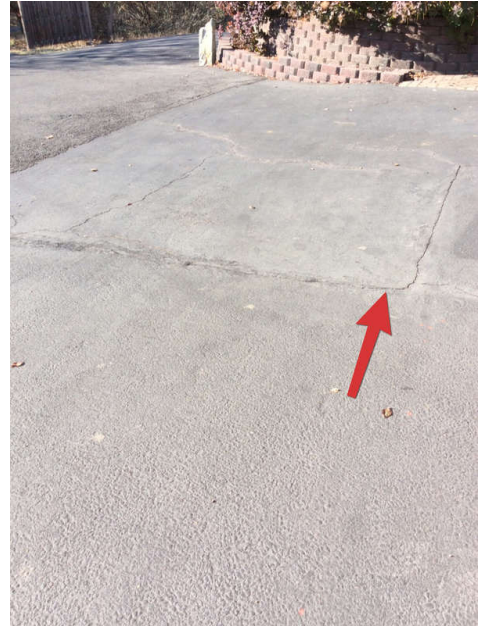
2.3.1 Walkways, Patios & Driveways

DRIVEWAY CRACKING - MINOR

DRIVEWAY

Minor cosmetic cracks observed, which may indicate movement in the soil. Recommend monitor and/or have concrete contractor patch/seal.

Recommend monitoring.

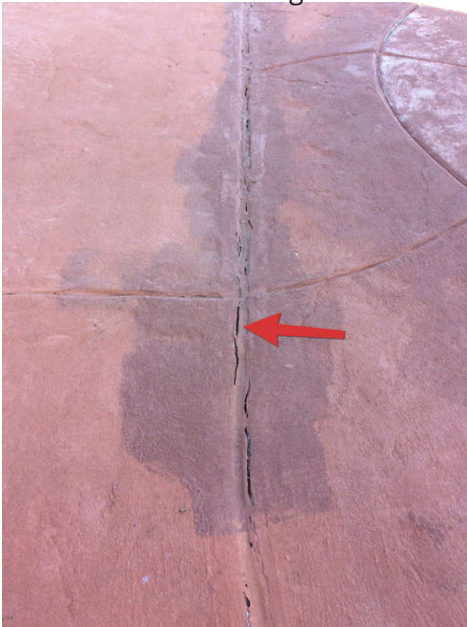
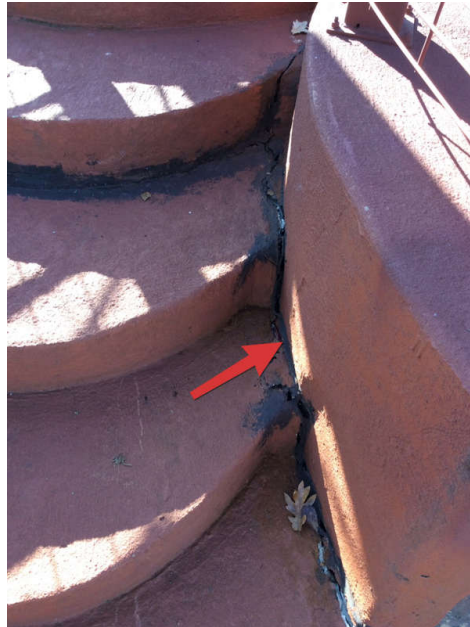
2.3.2 Walkways, Patios & Driveways
PATIO CRACKING - MINOR

PATIO AND STEPS

Normal settling & cracking observed. Recommend monitor and/or patch/seal.

Recommend monitoring.

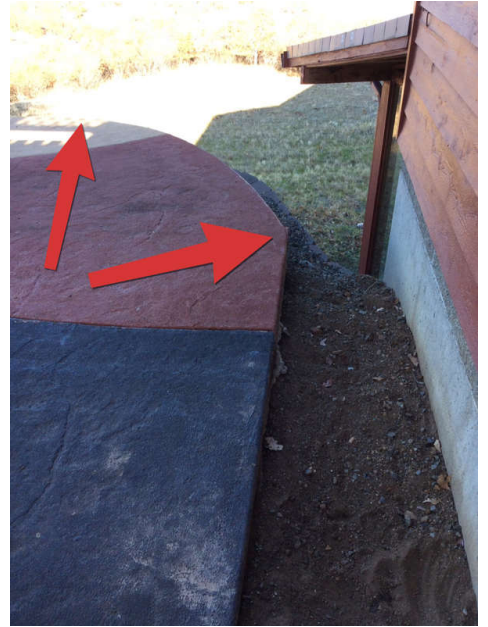
2.4.1 Decks, Balconies, Porches & Steps

MISSING HANDRAIL

WEST

Handrail is missing around the patio on the west side of the house. A handrail should be installed for safety.

Contact a qualified professional.

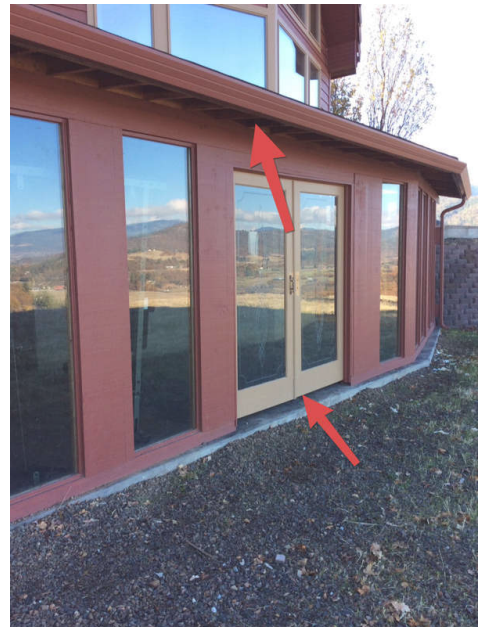
2.4.2 Decks, Balconies, Porches & Steps

UNFINISHED PORCH

BASEMENT

Interior of basement porch is exposed to elements and/or pests due to it being unfinished. Recommend repair/finishing as desired.

Contact a qualified professional.

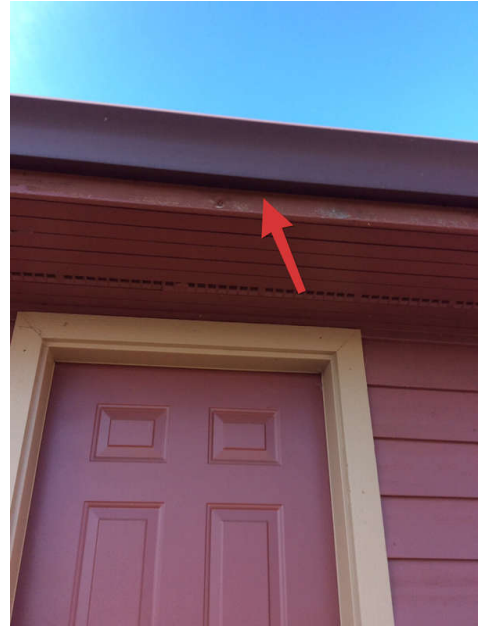
2.5.1 Eaves, Soffits & Fascia

PAINT/FINISH FAILING

GARAGE

The paint or finish is failing on the fascia in one or more locations. I recommend repainting to prevent water damage to the wood.

Contact a qualified painter.

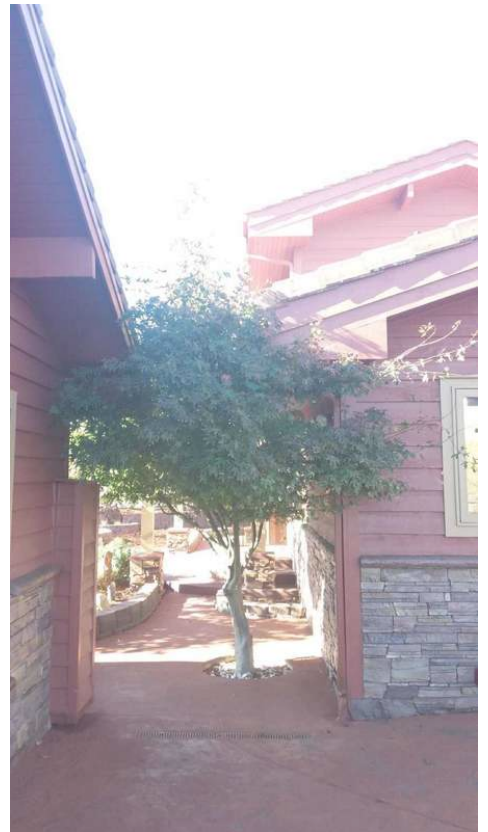
2.6.1 Vegetation, Grading, Drainage & Retaining Walls

TRIM VEGETATION

Keep vegetation trimmed and away from the house. It creates a pathway for insects and rodents and can create prolonged moisture contact with the siding and trim.

Recommendation
Recommended DIY Project

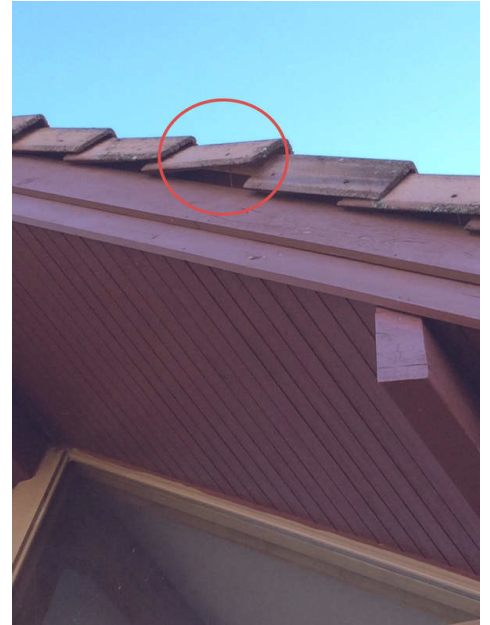
3.1.1 Coverings

UNDER-DRIVEN NAILS

NORTH

Observed one or more under-driven nails/fasteners. Recommend a qualified roofing contractor evaluate and repair. In at least one observed area, the under-driven nail has penetrated the upper layer of shingles.

Recommendation
Contact a qualified roofing professional.

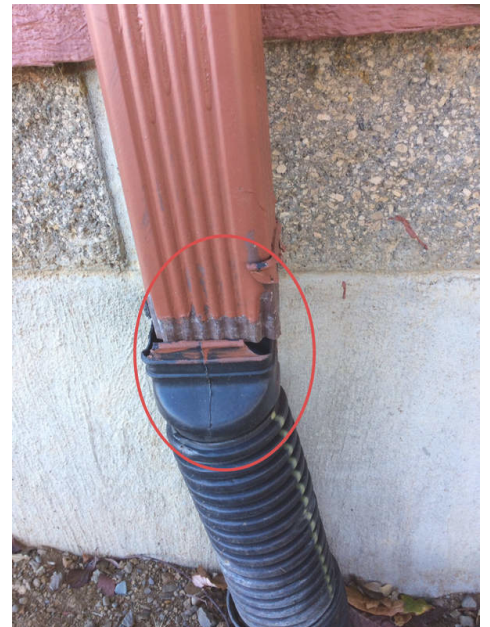
3.2.1 Roof Drainage Systems

DOWNSPOUTS DRAIN NEAR HOUSE

WEST

One or more downspouts drain too close to the home's foundation. This can result in excessive moisture in the soil at the foundation, which can lead to foundation/structural movement. Recommend a qualified contractor adjust downspout extensions to drain at least 6 feet from the foundation.

Recommendation
Recommended DIY Project

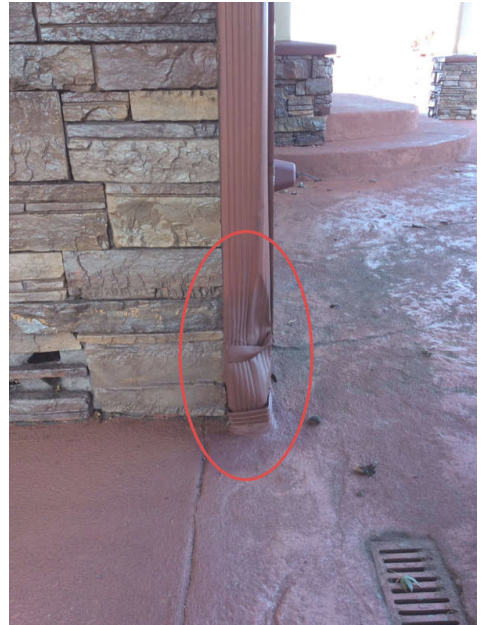
3.2.3 Roof Drainage Systems

DAMAGED DOWNSPOUT

SOUTH

The underground downspout connection is damaged. Recommend repair to prevent water from draining near the foundation.

Contact a qualified professional.

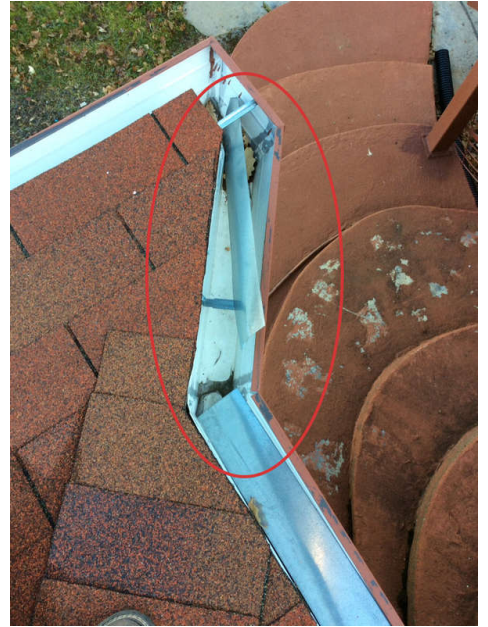
3.2.4 Roof Drainage Systems

GUTTER SCREEN DAMAGED

NORTH

Screen is loose or damaged, recommend replacing with proper gutter screen.

Contact a qualified professional.

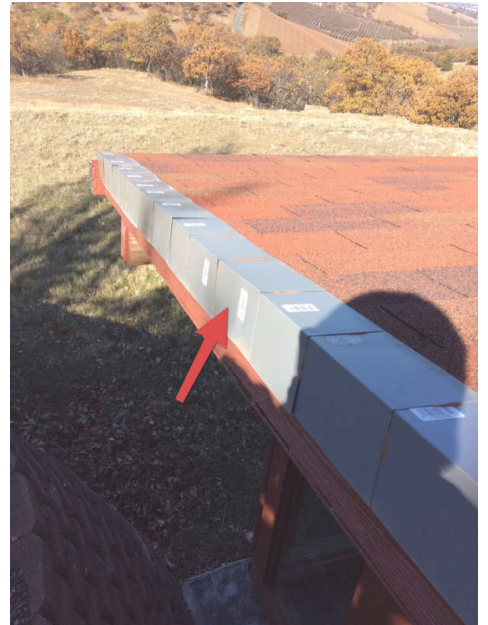
3.3.1 Flashings

STEP FLASHING IMPROPERLY INSTALLED

NORTH

The step flashing on the dormer is improperly installed. Recommend repair and proper installation by a licensed roofing contractor.

Contact a qualified roofing professional.

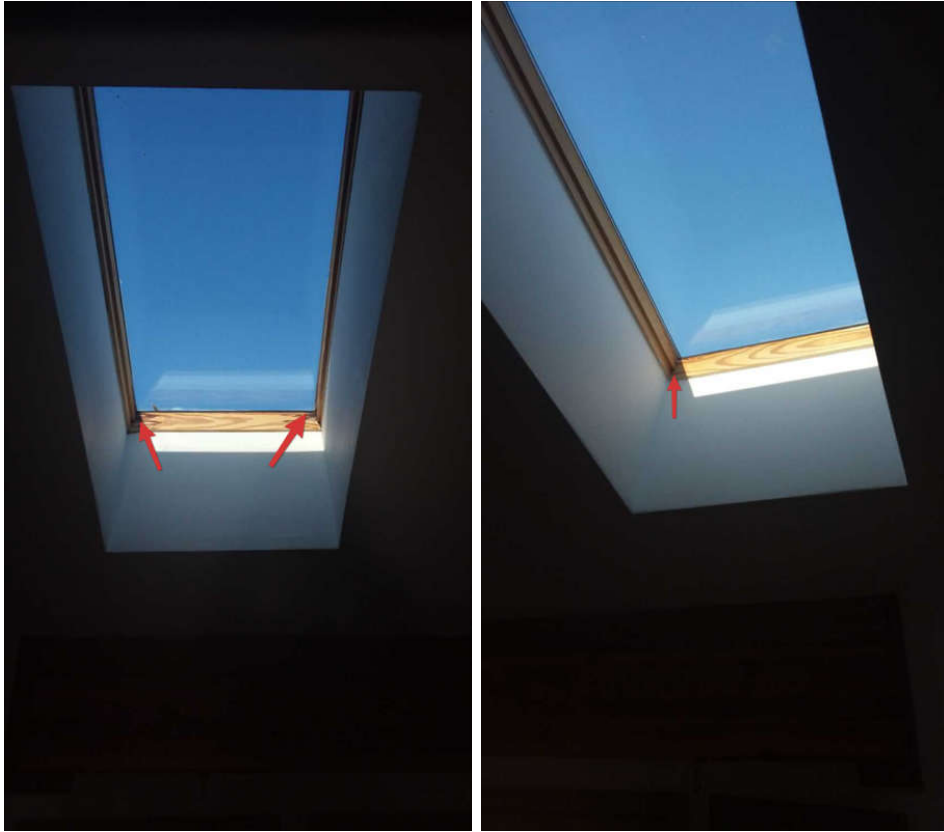
3.4.1 Skylights, Chimneys & Other Roof Penetrations

SKYLIGHT WATER PENETRATION

ROOF

There are signs of possible water penetration at or near the skylight. Skylights, if not properly installed, are prone to leaking. Monitor the condition and if there is sign of leak then have the skylight repaired or replaced.

Proper flashing around the skylight is critical.

Contact a qualified professional.

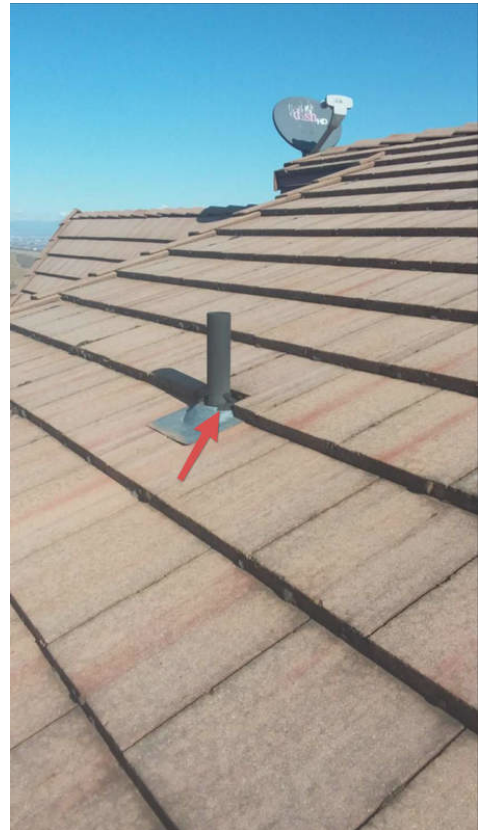
3.4.2 Skylights, Chimneys & Other Roof Penetrations

VENT BOOT CRACKED

WEST

The vent boot is cracked and in need of replacement. Recommend replacing to prevent water from entering the attic.

Contact a qualified roofing professional.

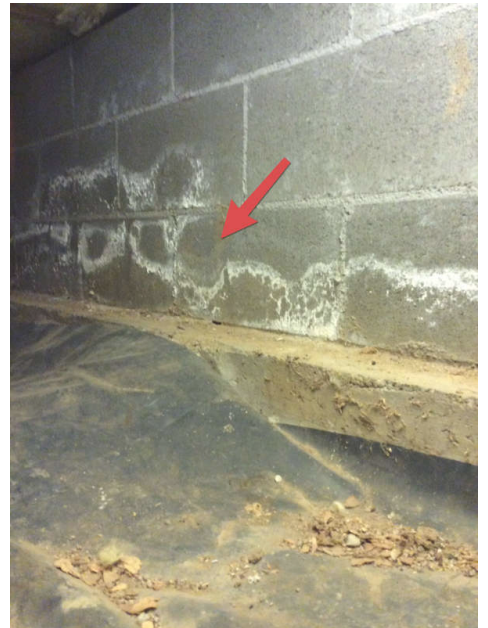
4.1.2 Foundation

EFFLORESCENCE

SEVERAL LOCATIONS

Water staining on foundation indicates that gutters may be clogged and causing moisture to be absorbed into foundation. Recommend maintenance on gutters drainage system to direct water away from home. Also, ensure that the sprinkler system is not hitting the siding/foundation.

Recommend monitoring.

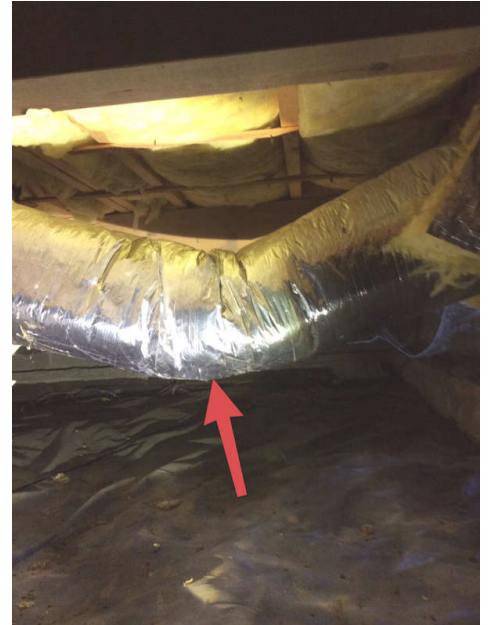
5.3.1 Distribution Systems

DUCT DAMAGED

CRAWLSPACE EAST

Air supply duct has water inside. Recommend a qualified HVAC contractor repair.

Contact a qualified HVAC professional.

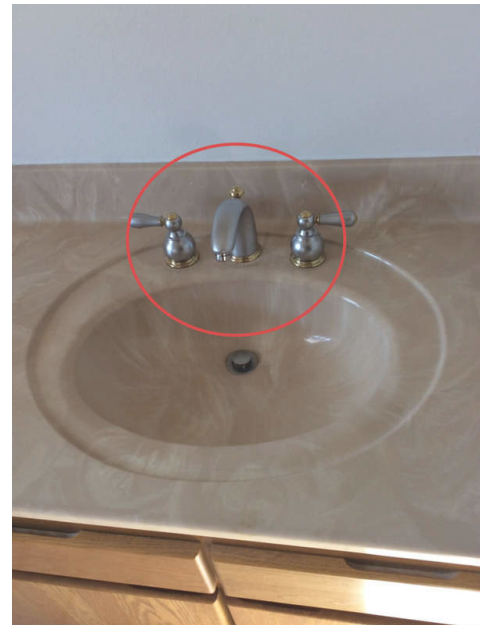
7.3.1 Water Supply, Distribution Systems & Fixtures

HOT AND COLD WATER LINES REVERSED ON BATHROOM SINK

BATHROOM

Recommend repair by licensed plumber

Contact a qualified professional.

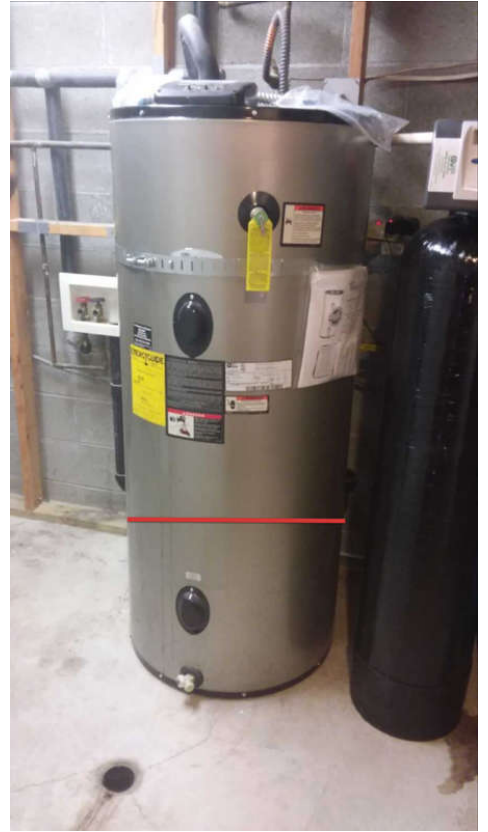
7.4.1 Hot Water Systems, Controls, Flues & Vents

INSUFFICIENT STRAPPING

The water heater is not properly strapped. A strap should be on the upper 1/3 and the lower 1/3, secured to the studs in the wall. Recommend repair.

Contact a qualified professional.

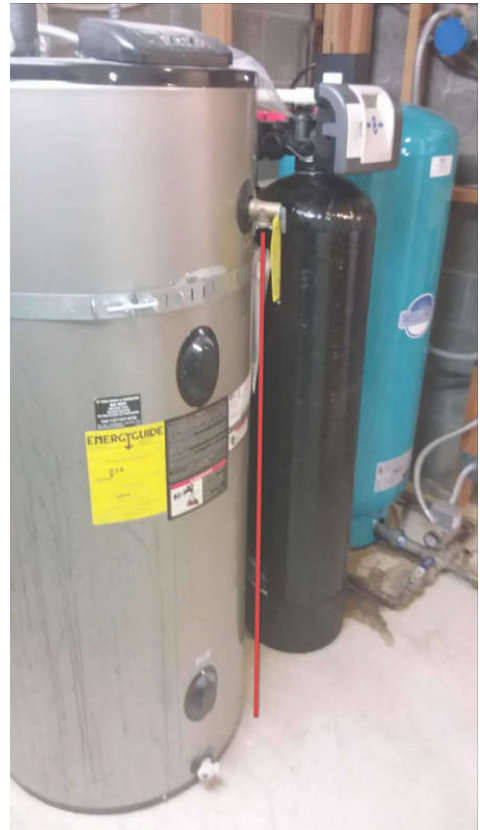
7.4.2 Hot Water Systems, Controls, Flues & Vents

NO TEMPERATURE & PRESSURE RELIEF EXTENSION

An extension should be placed on the T&P valve that extends within 6 inches of the floor. Recommend repair by a licensed plumber.

Contact a qualified plumbing contractor.

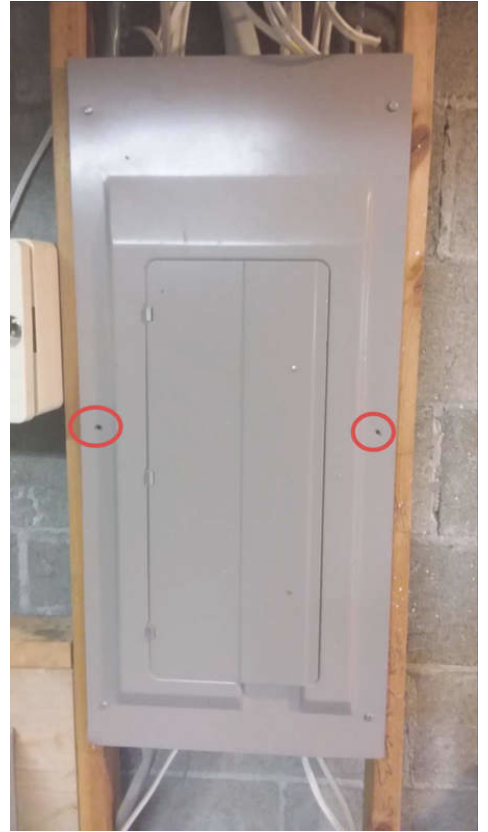
8.2.1 Main & Subpanels, Service & Grounding, Main Overcurrent Device

MISSING PANEL SCREWS

BASEMENT

The main panel is missing screws that hold the cover in place. Recommend replacing with flat head compressed thread screws.

Contact a handyman or DIY project

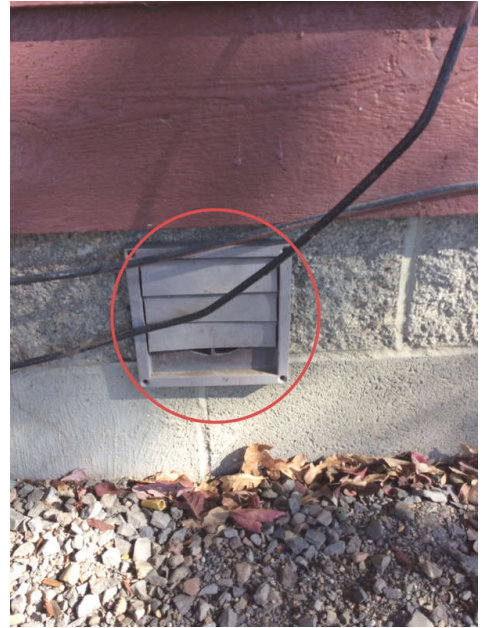
9.5.1 Exhaust Systems

DAMAGED DRYER DAMPER

WEST

The dryer vent on the exterior on the house is damaged and can allow pests to enter the duct. Recommend replacing damper.

Contact a qualified professional.

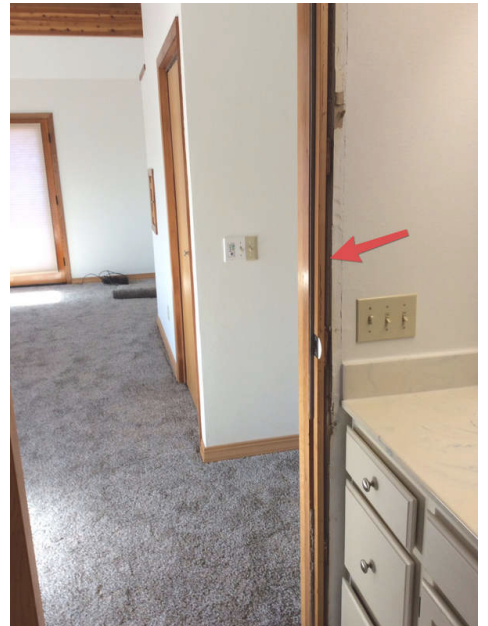
10.1.1 Doors

DOOR TRIM MISSING

MASTER BATH

Recommend installing wood trim on door for finished appearance.

Contact a qualified professional.

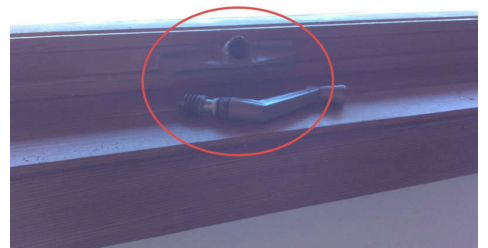
10.2.1 Windows

WINDOW HARDWARE DAMAGED

MASTER BATHROOM

The window on the east side of the house does not lock. Recommend replacement.

Contact a qualified handyman.

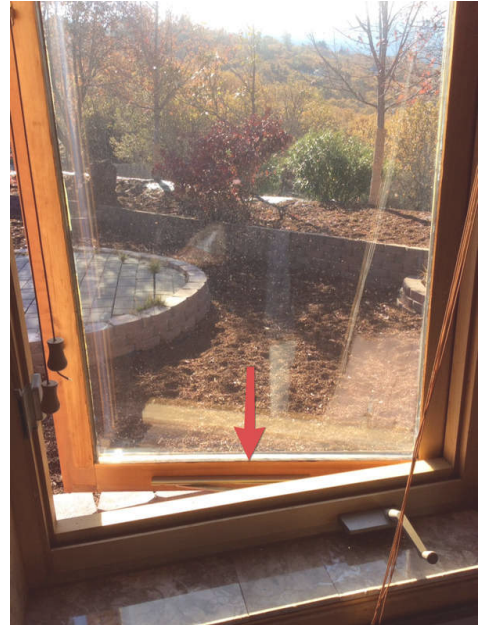
10.2.2 Windows

WATER DAMAGE

WINDOW FRAME

There is water damage at one or more windows. Recommend resealing to prevent further damage.

Contact a qualified handyman.

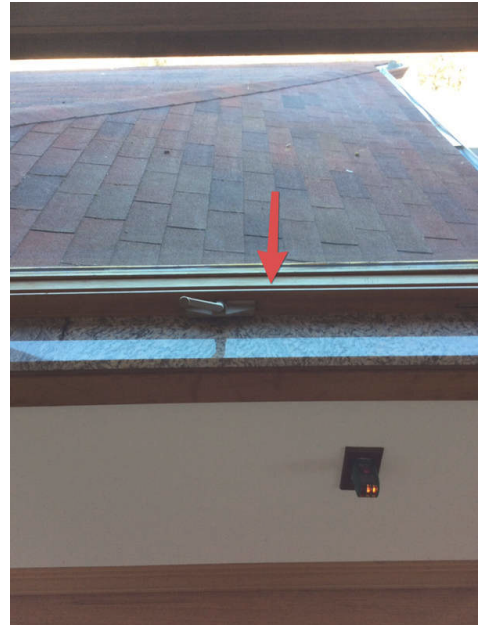
10.2.3 Windows

PAINT FAILING

WINDOW FRAMES

Recommend resealing to prevent further damage to window

Contact a qualified professional.

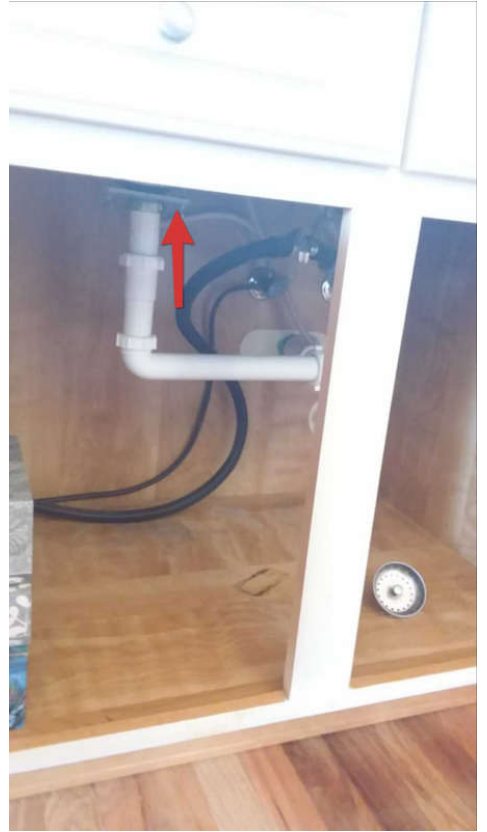
11.1.1 Dishwasher

CREATE HIGH LOOP

Recommend creating a high loop with the dishwasher drain line to prevent backflow from the kitchen sink.

Recommended DIY Project

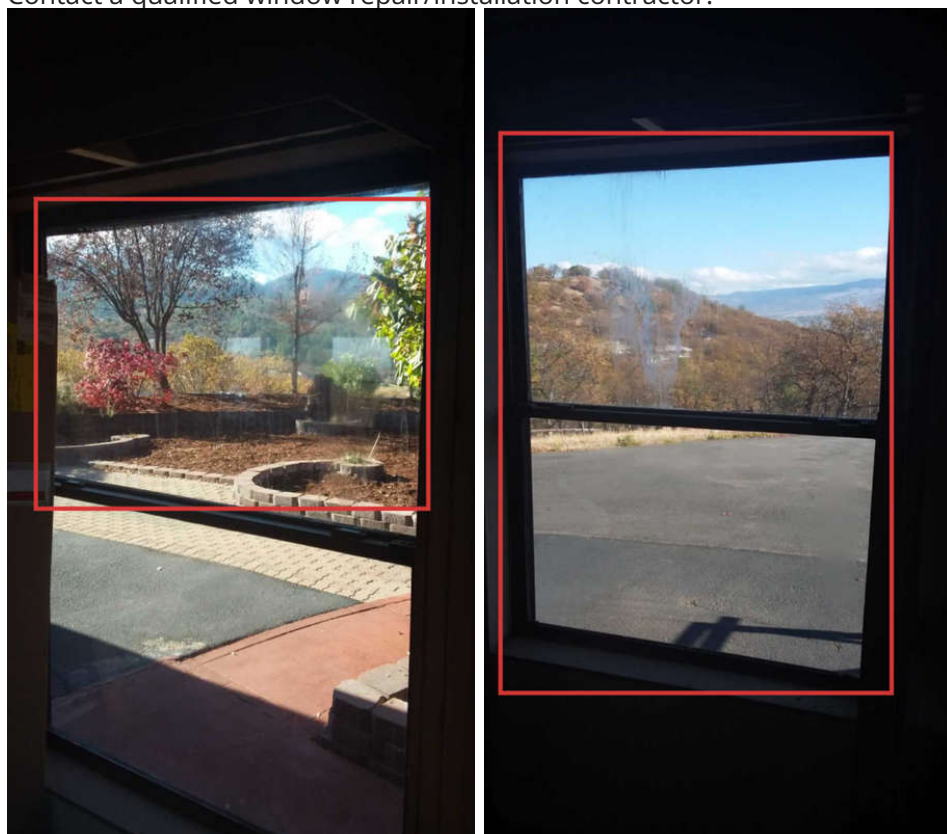
12.7.1 Windows
BROKEN SEAL
GARAGE

Several of the seals on the garage windows are broken, recommend a window contractor to evaluate and replace the window sashes.

Contact a qualified window repair/installation contractor.
