**SUMMARY**  
1234 Main St. Waterford Works New  
Jersey 08089  
Buyer Name  
11/02/2018 9:00AM

Todd Vazquez  
NJ Home Inspector License #  
24GI00167400  
Smart Inspections LLC  
(609) 805-0641  
todd@smart-inspections.com

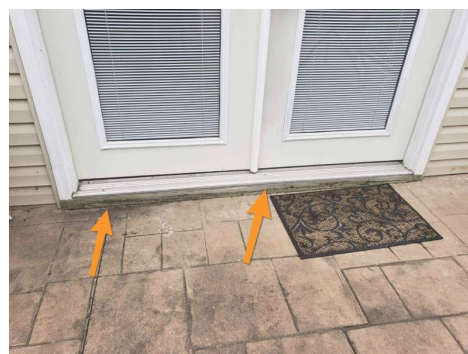
#### 2.6.1 Doors

### DOOR - KICK PLATE DAMAGE

The front door kick plate exhibited signs of wood rot and water damage. This condition, if not repaired, will only cause more moisture intrusion, which may damage surrounding components. The wood rot is likely caused by the excess moisture that the roof drainage system is depositing on the patio. The inspector recommends further evaluation of the entire door and repair of the kick plate by a qualified professional.

Contact a qualified door repair/installation contractor.

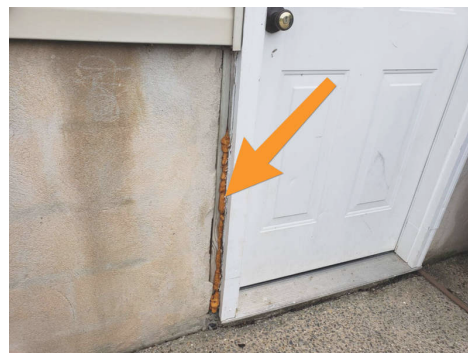
#### 2.6.2 Doors

### DOOR MISSING TRIM

One or more sections of the door trim were missing. This condition may allow moisture intrusion, which may damage surrounding components. The inspector recommends further evaluation and repair by a qualified professional.

Contact a qualified professional.

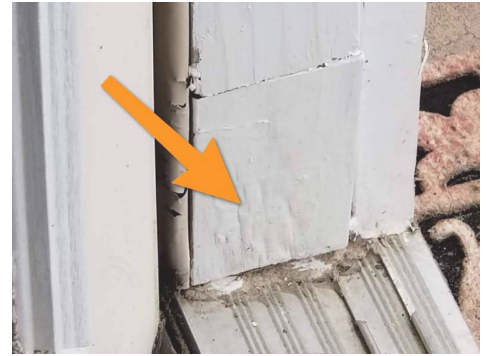
2.6.3 Doors

**DOOR TRIM - WOOD ROT**

One or more door trims exhibited signs of wood rot. This condition will only worsen over time if not repaired. The inspector recommends repair of the door trim by a qualified professional.

Contact a qualified door repair/installation contractor.

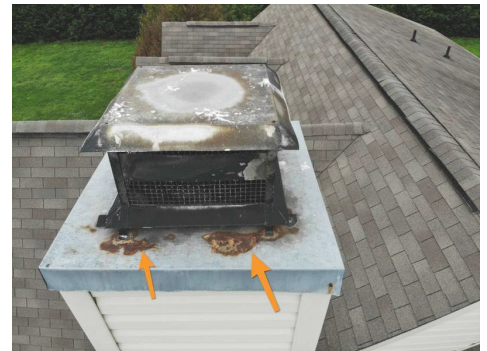
2.8.1 Chimney Exterior

**CHIMNEY CROWN - MINOR CORROSION**

The chimney crown exhibited signs of corrosion. This condition may allow moisture intrusion, which may cause damage to surrounding components. The inspector recommends further evaluation and repair of the chimney crown by a qualified professional.

Contact a qualified chimney contractor.

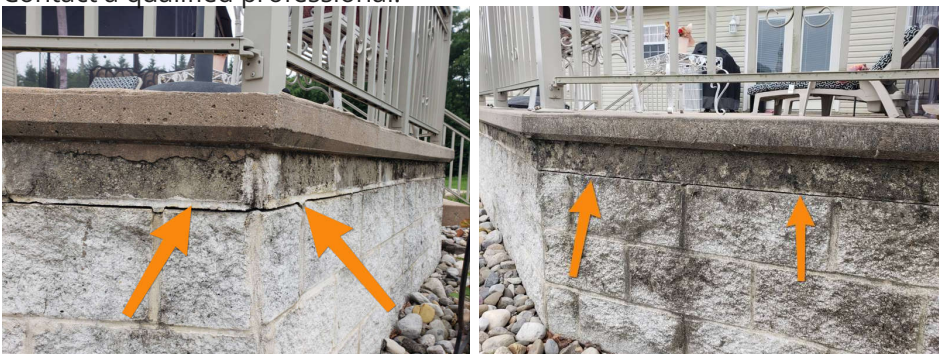
2.9.1 Decks, Patios and Porches

**PATIO - HORIZONTAL CRACK**

One or more portions of the patio exhibited signs of a horizontal crack. This condition is generally caused by lateral pressure on the wall. The inspector recommends further evaluation and repair by a qualified professional.

Contact a qualified professional.

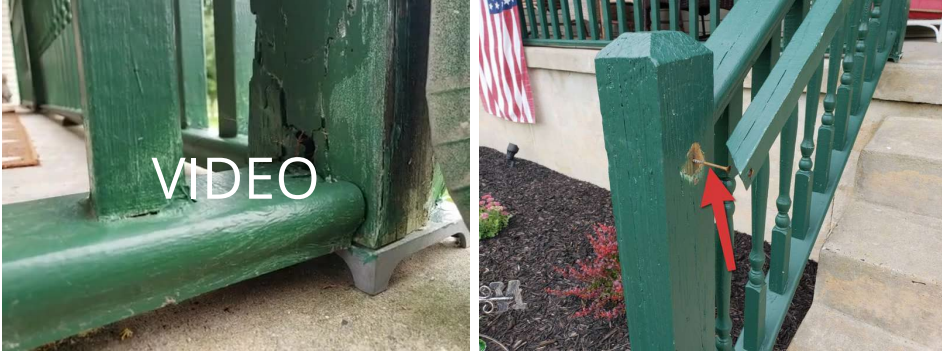
2.10.1 Walkways, Steps and Railings

**RAILING - NOT ATTACHED**

The front stairway railing was not attached to its support post. This condition may cause a safety hazard for anyone who may use the railing for support. The inspector recommends further evaluation and repair by a qualified professional.

Recommendation  
Contact a qualified carpenter.

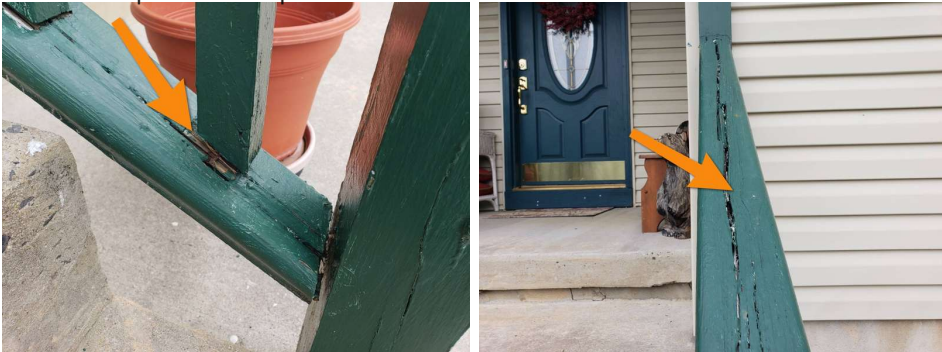
2.10.2 Walkways, Steps and Railings

**RAILING - WOOD ROT**

The front railing exhibited signs of wood rot in one or more locations. This condition may cause structural failure of the railings. The inspector recommends further evaluation and repair by a qualified professional.

Recommendation  
Contact a qualified carpenter.

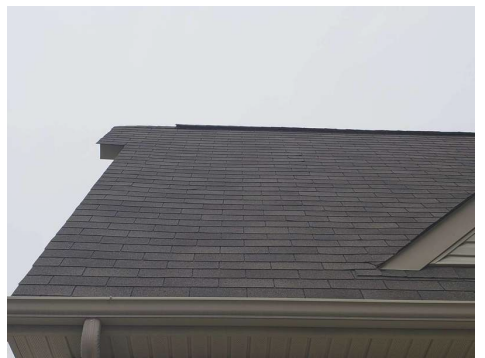
3.1.1 Roof Surface

**AGING ASPHALT SHINGLES**

Although functional, standard three tab roof shingles had widening gaps between tabs and missing granules, which indicate they are near the end of their functional life expectancy. The shingles are likely original to the structure, approx. 17 years old. The life expectancy of three tab shingles is about 20 years. Continued use of the shingles without replacement may lead to moisture penetration into the interior space. The inspector recommends further evaluation of the asphalt shingles by a qualified professional.

Recommendation  
Contact a qualified roofing professional.

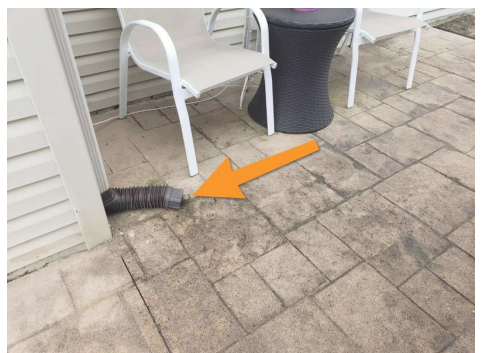
3.2.1 Roof Drainage Systems

**DOWNSPOUT DRAIN NEAR DWELLING**

One or more downspouts drain too close to the home's foundation. This can result in excessive moisture in the soil at the foundation, which can lead to foundation/structural movement. The inspector recommends a qualified contractor adjust downspout extensions to drain at least 6 feet from the foundation.

Recommendation  
Contact a qualified gutter contractor

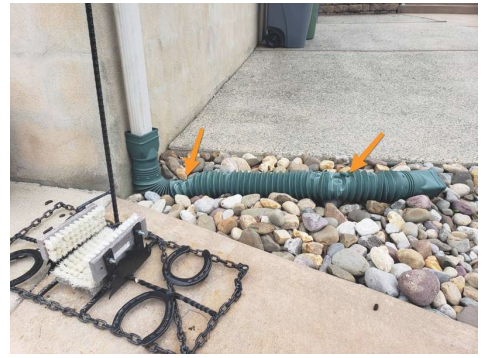
3.2.2 Roof Drainage Systems

**DOWNSPOUT EXTENSION - CRUSHED**

One or more downspout extension pipes were crushed. This condition may cause water to back up, causing the roof drainage system to fail. The inspector recommends further evaluation and repair of the entire roof drainage system by a qualified professional.

Contact a qualified gutter contractor

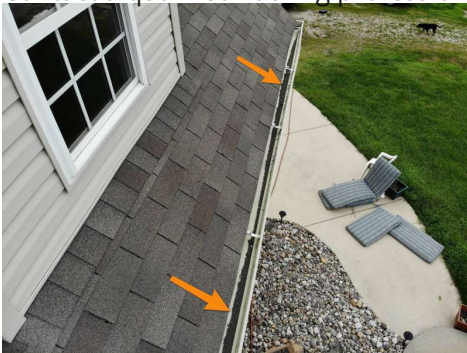
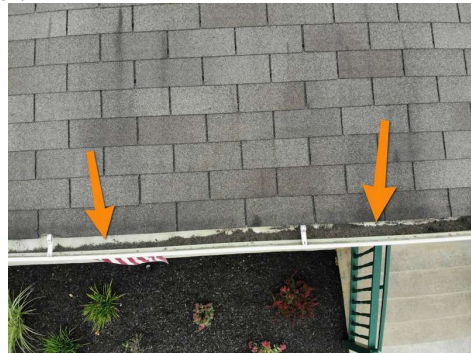
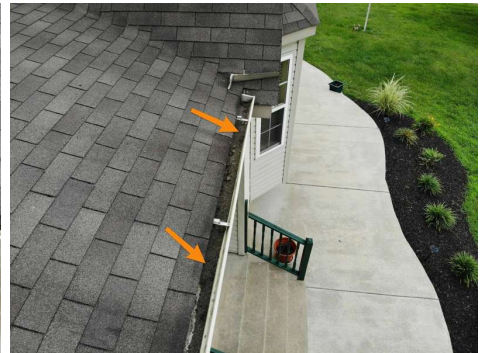
3.2.3 Roof Drainage Systems

**GUTTER - LOOSE GRANULES**

One or more gutters exhibited signs of containing loose shingle granules. This condition is characteristic of an aging roof. The granules should be cleaned from the gutters so they don't impede the flow of water runoff. The inspector recommends further evaluation and repair by a qualified professional.

Contact a qualified roofing professional.

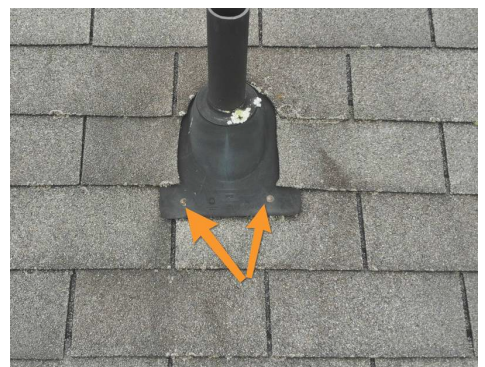
3.3.1 Roof Flashings

**ROOF PENETRATION - EXPOSED FLASHING FASTENERS**

One or more vent flashing fasteners were exposed to environmental elements. This condition may cause fastener corrosion, which could cause moisture intrusion. The inspector recommends evaluation and repair of all of the roof penetration flashings by a qualified professional.

Contact a qualified roofing professional.

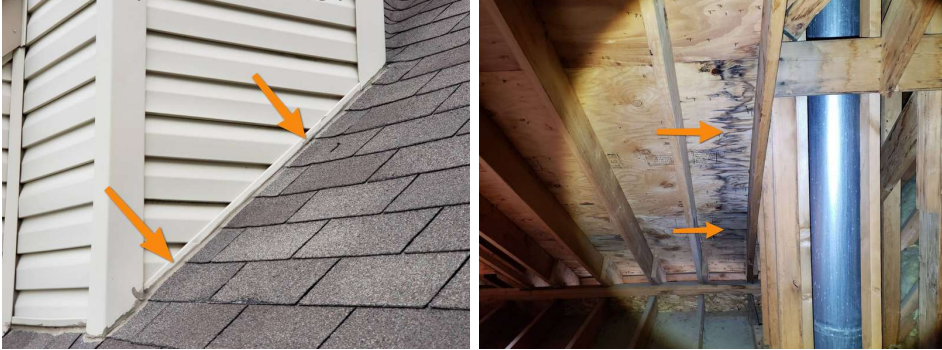
### 3.3.2 Roof Flashings

## CHIMNEY FLASHING - SILICON/COUNTER FLASHING

The joint around the chimney is sealed with silicon. Silicon is not the preferred method for sealing the connection between the siding and chimney. This condition is likely an attempt to stop moisture intrusion that has caused damage to the roof structure over the garage. The inspector recommends further evaluation and repair of the affected areas by a qualified professional.

Contact a qualified roofing professional.

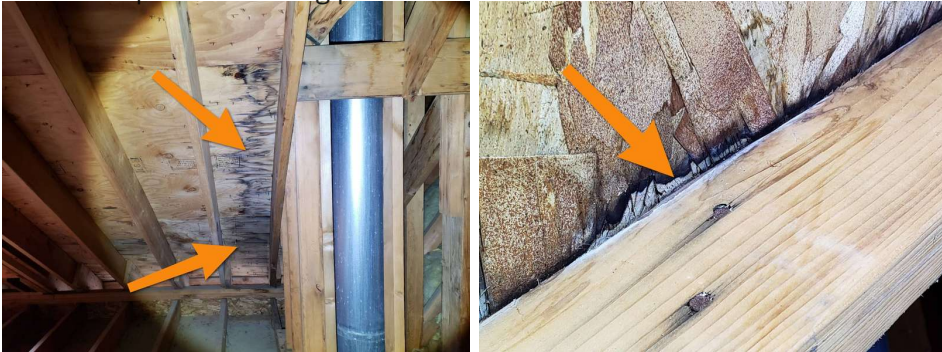
### 4.1.1 Roof Structure

## ROOF SHEATHING - MOISTURE INTRUSION

At the time of the inspection, one or more sections of the roof sheathing exhibited signs of moisture intrusion. This condition, if it has not already been repaired, may lead to the growth of mold and/or water damage to surrounding components. The inspector recommends further evaluation of the roof sheathing by a qualified professional.

Contact a qualified roofing professional.

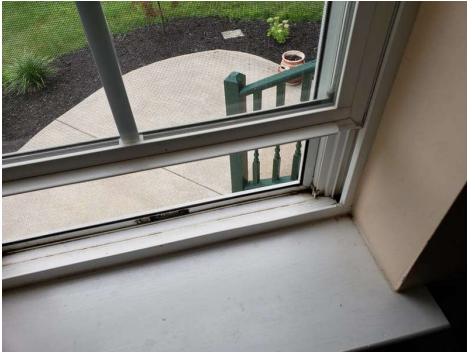
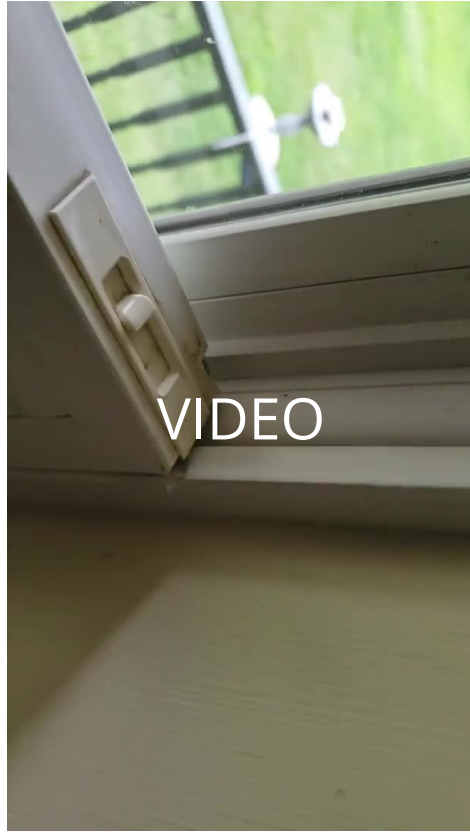
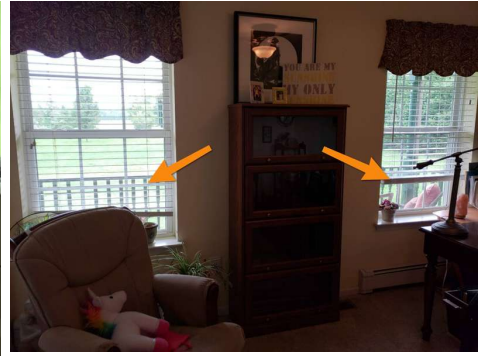
### 5.1.1 Windows

## WINDOW - DAMAGED

One or more windows appear to have general damage, but are functional. This condition may prevent the windows from operating as intended. The inspector recommends further evaluation and repair by a qualified professional.

Contact a qualified window repair/installation contractor.

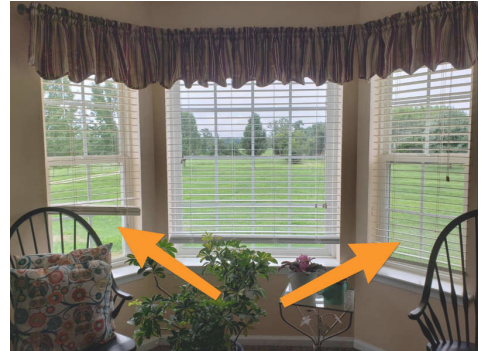
#### 5.1.2 Windows

### **INOPERABLE WINDOW**

One or more of the windows at the time of the inspection were not operational. Inoperable windows may prevent egress during emergency situations. The inspector recommends that all of the windows be evaluated and repaired by a qualified professional.

Contact a qualified window repair/installation contractor.

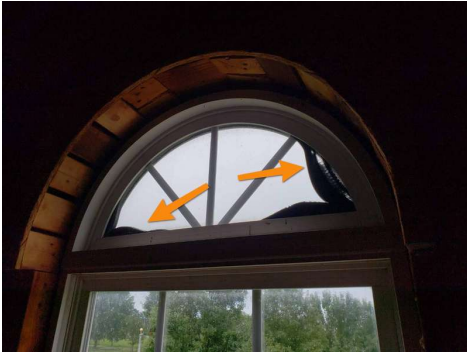
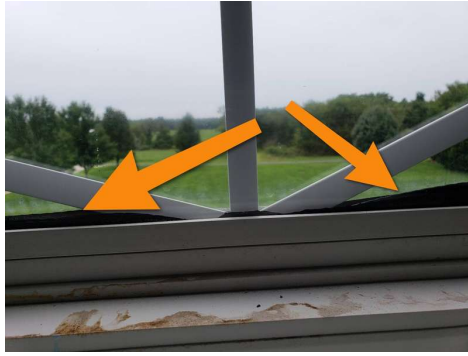
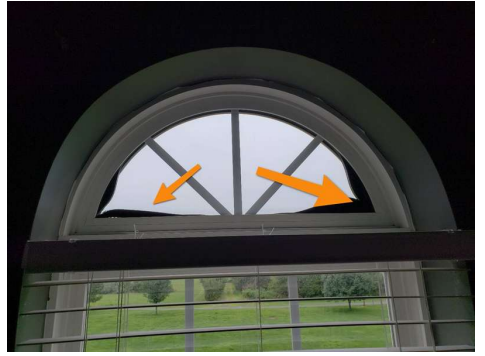
#### 5.1.3 Windows

### **WINDOW - DAMAGED SEALANT**

One or more windows exhibited signs of damaged sealant. This condition may compromise the thermal efficiency of the windows. The inspector recommends further evaluation and repair by a qualified professional.

Contact a qualified window repair/installation contractor.

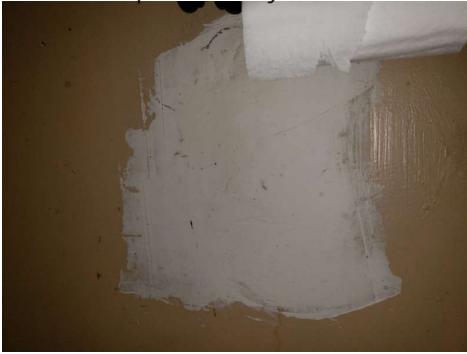
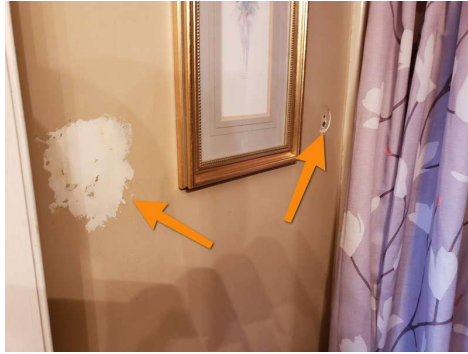
5.5.1 Walls

**DRYWALL - POOR PATCHING**

One or more sections of dry patching was sub-standard. This condition is an indication of poor workmanship, likely not done by a qualified professional. The inspector recommends the drywall be re-patched using proper techniques by a qualified professional.

Contact a qualified drywall contractor.

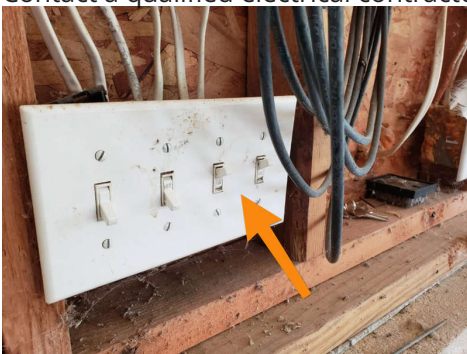
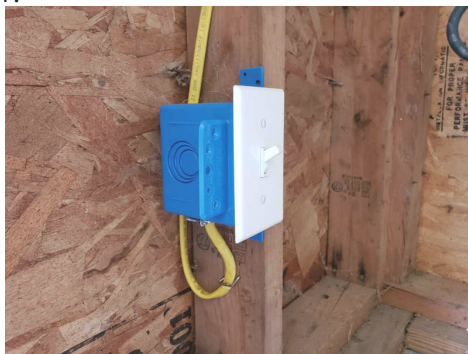
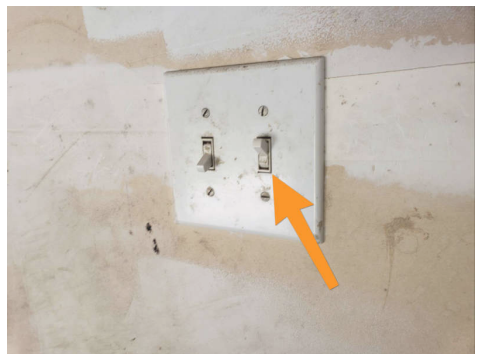
6.6.1 Lighting Fixtures, Switches & Receptacles

**INOPERABLE SWITCHES**

At the time of the inspection, there were several switches that were inoperable. The cause of this condition is unknown. The inspector recommends consultation with the owner to determine which switches work which receptacles and fixtures. If the condition still exists after consultation with the owner, then all the switches should be further evaluated and repaired by a qualified professional.

Contact a qualified electrical contractor.

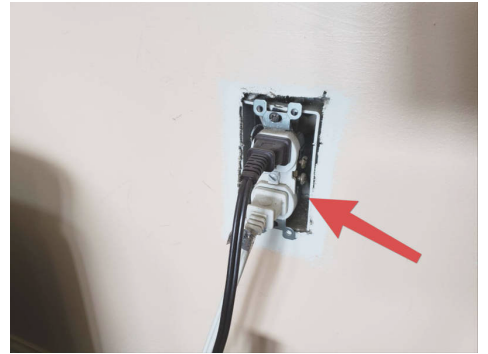
6.6.3 Lighting Fixtures, Switches & Receptacles

**RECEPTACLE - MISSING COVER PLATE**

One or more receptacle cover plates were missing. This condition may cause an electrical short or shock hazard. The inspector recommends evaluation and repair of all cover plates by a qualified professional.

Contact a qualified electrical contractor.

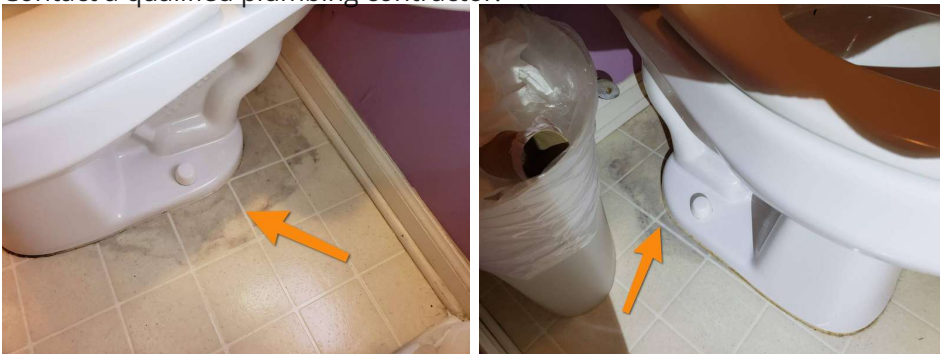
7.4.1 Fixtures and Faucets

**TOILET - FAILING WAX SEAL**

The wax seal on one or more toilets is failing. This condition may allow moisture intrusion which may cause damage to surrounding components. The inspector recommends further evaluation and repair by a qualified professional.

Contact a qualified plumbing contractor.

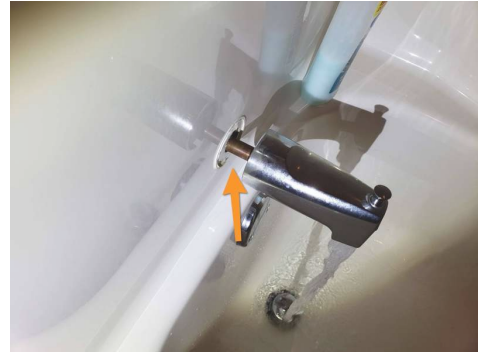
#### 7.4.2 Fixtures and Faucets

### TUB - IMPROPER SPOUT INSTALLATION

The tub spout is not properly installed. This condition may allow moisture intrusion at the wall penetration which may cause damage to surrounding components. The inspector recommends further evaluation and repair by a qualified professional.

Contact a qualified plumbing contractor.

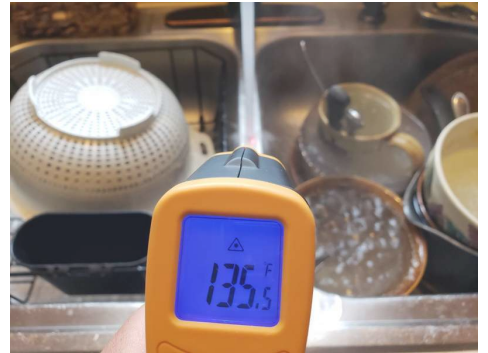
#### 7.5.1 Water Heater

### WATER HEATER - EXCESSIVE TEMPERATURE

At the time of the inspection the temperature of the water in the kitchen was 135 Degrees F. This condition may be a scalding hazard. The inspector recommends further evaluation and repair by a qualified professional.

Contact a qualified plumbing contractor.

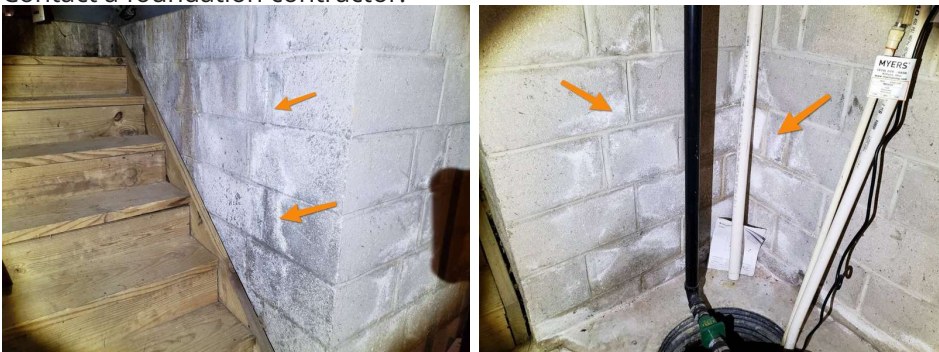
#### 8.1.1 Foundation Walls

### EFFLORESCENCE

One or more foundation walls showed signs of efflorescence. Efflorescence is a white, powdery deposit that is consistent with moisture intrusion. This can compromise the soil's ability to support the home structure and/or lead to mold growth. The inspector recommends the affected walls be evaluated by a qualified contractor to identify the source of moisture and repair.

Contact a foundation contractor.

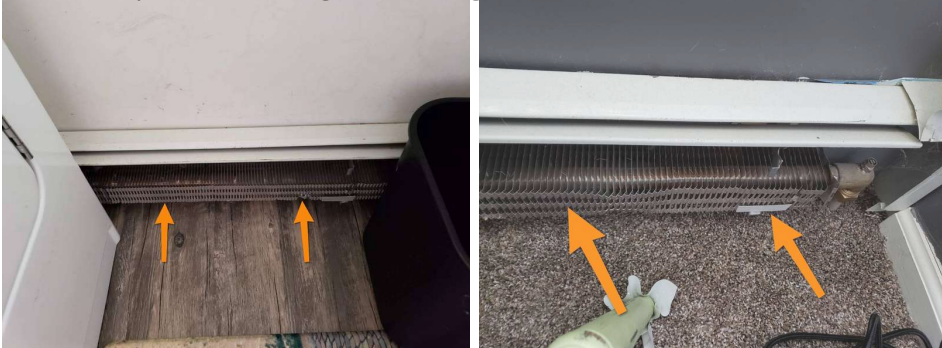
9.4.1 Distribution Systems

**BASEBOARD - NO COVER**

One or more sections of baseboard heating elements were not covered. This condition is a burn hazard especially to small children. The elements are also susceptible to damage if not covered. The inspector recommends further evaluation and repair of all of the baseboard heating elements by a qualified professional.

Recommendation  
Contact a qualified heating and cooling contractor

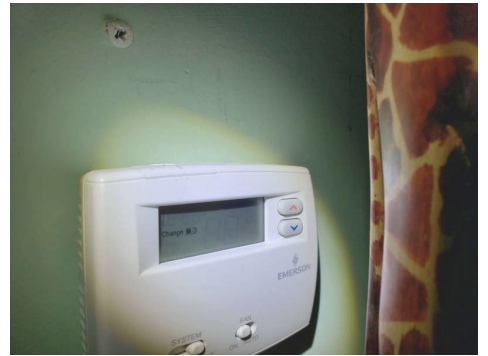
9.5.1 Normal Operating Controls

**THERMOSTAT - INOPERABLE**

One or more thermostats were not functional at the time of the inspection. If the thermostats fail then the corresponding heating element will not turn one. The inspector recommends further evaluation by a qualified professional.

Recommendation  
Contact a qualified HVAC professional.

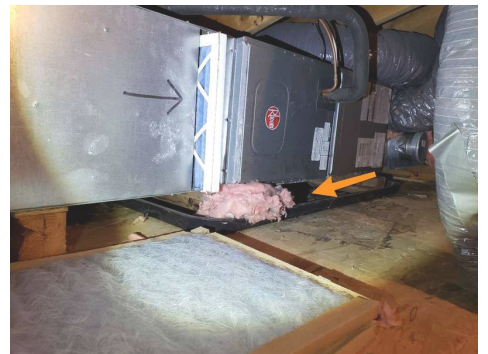
10.2.1 Condensate Tube

**CONDENSATE - OVERFLOW PAN (NO ALARM)**

The air handler does not have an high water alarm on the condensation overflow pan. This condition may allow condensation to overflow the pan without being noticed until damage is done to surrounding components. The inspector recommends further evaluation and repair by a qualified professional.

Recommendation  
Contact a qualified heating and cooling contractor

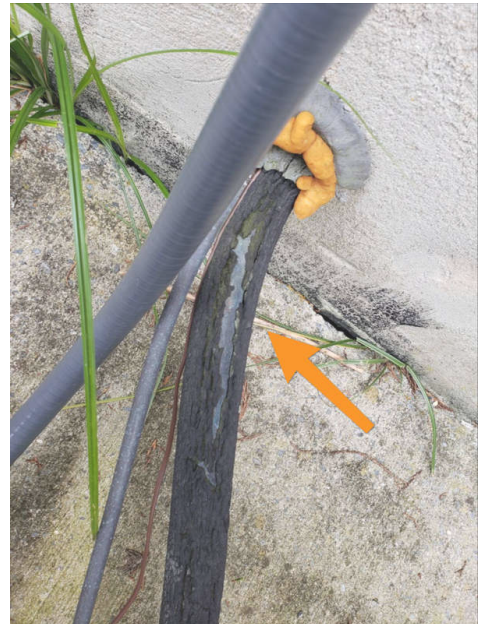
### 10.3.1 Refrigerant Lines

## MISSING SUCTION LINE INSULATION

The suction line insulation is not adequate and is in poor condition. This condition may cause the condensing coil to operate less efficiently. The inspector recommends complete insulation of the refrigerant line by a qualified handyman or contractor.

Contact a handyman or DIY project

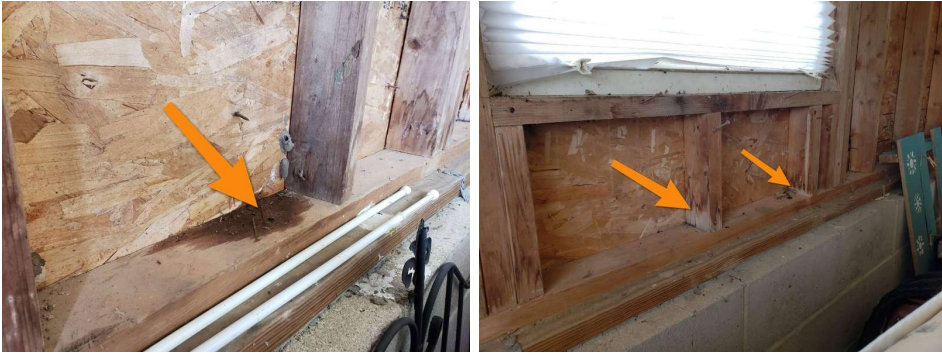
### 12.3.1 Walls & Firewalls

## GARAGE WALL - MOISTURE INTRUSION

One or more sections of the garage wall exhibited signs of moisture intrusion. This condition will only worsen over time if not corrected. Which may cause damage to surrounding components. The inspector recommends further evaluation and repair by a qualified professional.

Contact a qualified carpenter.

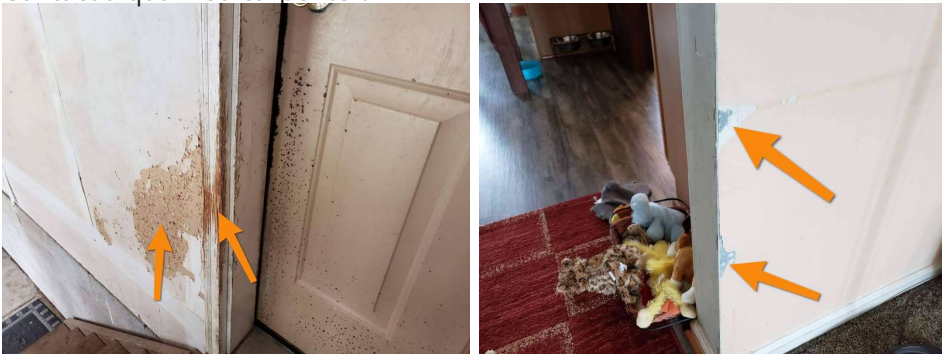
### 12.3.2 Walls & Firewalls

#### INTERIOR WALL - PET DAMAGE

One or more interior walls exhibited signs of pet damage. This is a cosmetic defect to door trim and drywall. The inspector recommends further evaluation and repair by a qualified professional.

Contact a qualified carpenter.

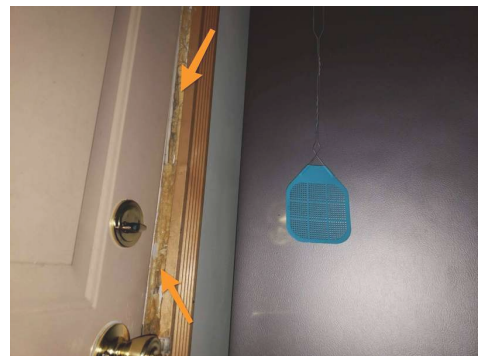
### 12.3.3 Walls & Firewalls

#### GARAGE DOOR - INCOMPLETE INSTALLATION

The kitchen door was not installed properly. This condition causes the door lock bolt to catch on the trim when the door is opened. The inspector recommends further evaluation and repair by a qualified professional.

Contact a qualified door repair/installation contractor.

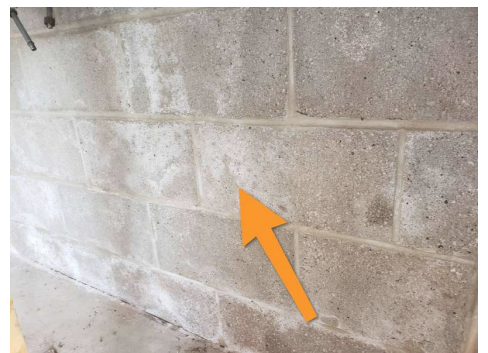
### 12.6.1 Foundation Wall

#### WALL - EFFLORESCENCE

Contact a foundation contractor.
