### YOUR REPORT

Thankyou for choosing HomeXam to inspect your home!**Please read your entire inspection report**. If you have any questions during the closing process, please ask us. We strive to perform every home inspection in accordance with the standards of practice as set forth by InterNachi. (International Association of Certified Home Inspectors)This report is based on a visual inspection of the structure with a focus on safety and function, not on current building codes. Any recommendations made by HomeXam should be addressed prior to closing. We recommend that you and/or your representative carry out a final walk-through inspection immediately before closing to check the condition of the property.

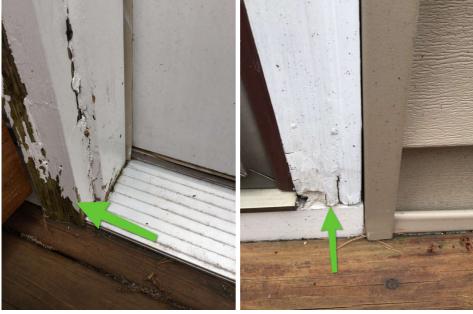
#### 4.3.1 Exterior Doors ROT AT DOOR JAMBS

Rot observed at the bottom of door jams by the back deck.

Recommendation Contact a qualified professional.

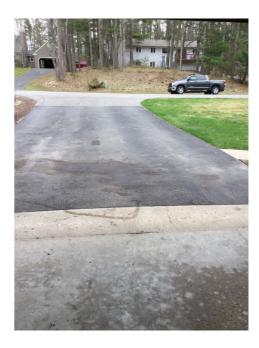
### 4.4.2 Walkways, Patios & Driveways DRIVEWAY DRAINING TOWARDS HOME

The driveway has a negative slope and drains towards the structure. No water intrusion was noted but recommend monitoring for possible future water intrusion.

Recommendation Contact a qualified driveway contractor.

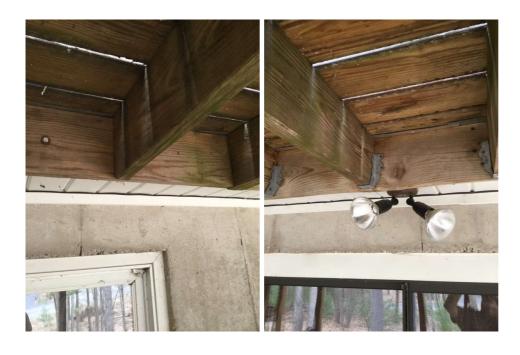
### 4.5.2 Decks, Balconies, Porches & Steps LEDGER BOARD IMPROPERLY INSTALLED

The ledger board is not properly attached to the building. This can cause the deck to pull away from the building and possibly collapse. Recommend that the deck and/or ledger board be properly attached by qualified contractor.

Recommendation Contact a qualified deck contractor.

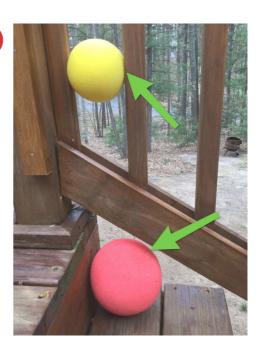
### 4.5.3 Decks, Balconies, Porches & Steps **RAILING UNSAFE**

There is an unsafe opening in the railing. The spacing on the rail should not exceed 4". An opening greater than 4" is a serious safety hazard especially for children as their head or other body part can become trapped.

Recommendation Contact a qualified deck contractor.

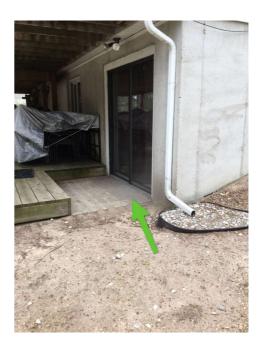
### **NEGATIVE GRADING**

Grading is sloping towards the home in some areas. This could lead to water intrusion and foundation issues. Recommend qualified landscaper or foundation contractor regrade so water flows away from home.

Contact a qualified landscaping contractor

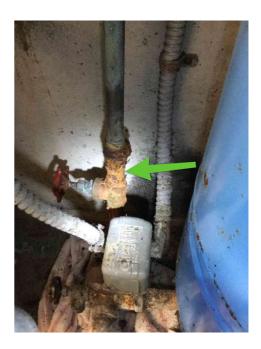
## 8.1.1 Main Water Shut-off Device CORROSION

Water main shut-off shows signs of corrosion. Recommend a qualified plumber evaluate.

Recommendation Contact a qualified plumbing contractor.

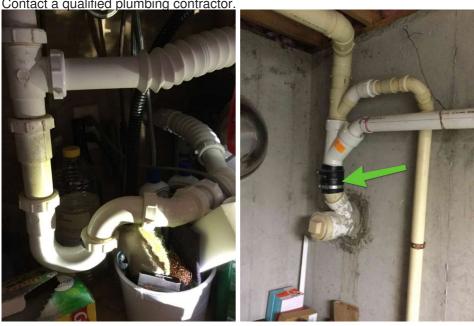
# 8.2.1 Drain, Waste, & Vent Systems IMPROPER CONNECTION

An improper connection was observed at a drain, waste or vent pipe. Recommend a qualified plumber evaluate and repair. (There was electrical tape wrapped around plumbing pipes)

Recommendation Contact a qualified plumbing contractor

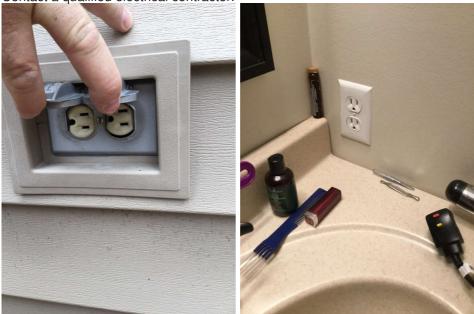
#### 9.5.1 GFCI & AFCI NO GFCI PROTECTION INSTALLED

No GFCI protection present in all locations. Recommend licensed electrician upgrade by installing ground fault receptacles in all locations.

Contact a qualified electrical contractor.

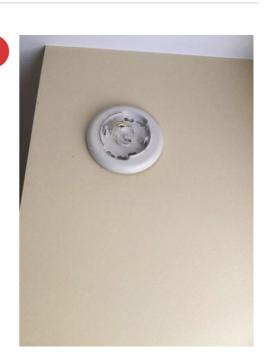
9.6.1 Smoke Detectors INADEQUET SMOKE DETECORS THROUGHOUT HOUSE Recommendation

Safety Hazard / Defect

Contact a qualified professional.

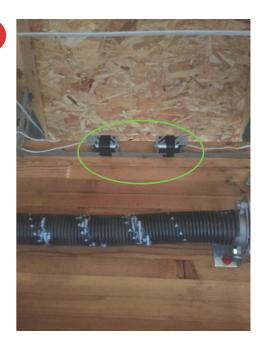
#### 13.5.1 Garage Door Opener GARAGE DOOR SENSOR

Improperly installed garage door sensor. Sensor is wired to bypass this safety feature and could result in serious injury to people or pets caught under a closing door.

Recommendation Contact a qualified garage door contractor.

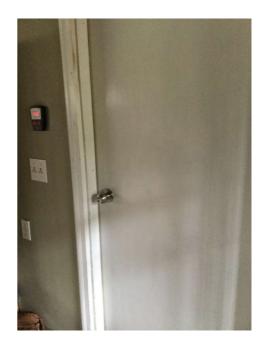
### NOT SELF-CLOSING

Door from garage to home should have self-closing hinges to help prevent spread of a fire to living space. Recommend a qualified contractor install self-closing hinges.

Recommendation Contact a qualified door repair/installation contractor.
