SUMMARY
1234 Main St. Grand Rapids MI 49546
Buyer Name
01/28/2018 9:00AM

Danny Geurink
Certified Home Inspector, Licensed Builder
Ink Home Services
(616) 848-9401
inkhomeservices@gmail.com

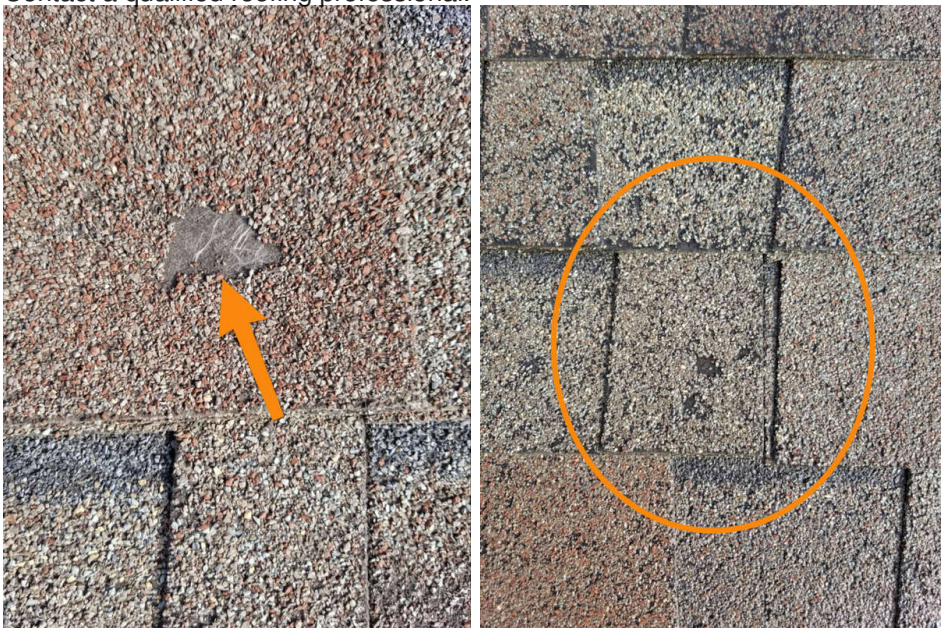
2.1.1 Coverings

GRANUALS MISSING

The inspector noticed that there was one or more areas of shingles with missing granuals. This should not affect the roofs ability to shed water but is an indicator that the roof is nearing the end of its usefulness. Recommend talking to a roofing contractor for options and costs to replace.

Recommendation
Contact a qualified roofing professional.

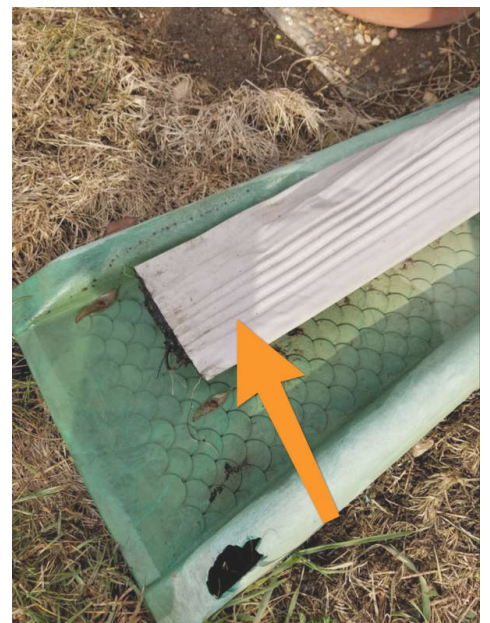
2.2.1 Gutters

DOWNPOUULT EXTENSION DAMAGED

One or more downspout extensions were damaged. Recommend a qualified contractor install downspout extensions that drain at least 6 feet from the foundation.

Recommendation
Contact a qualified professional.

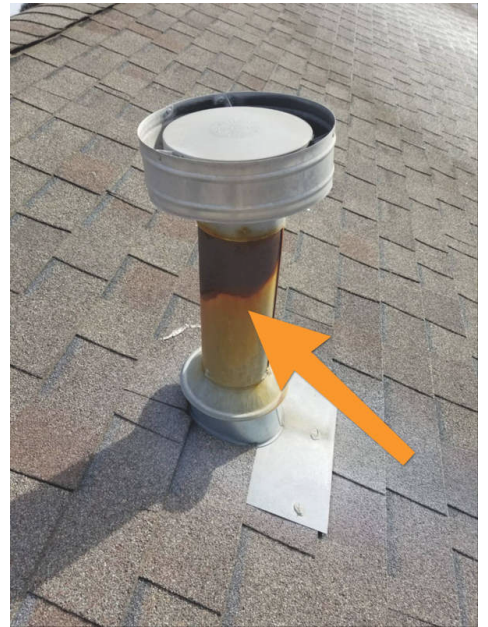
2.4.1 Skylights, Chimneys & Other Roof Penetrations

METAL CHIMNEY RUST

The metal chimney shows evidence of rust and/or rusting. Recommend monitoring the chimney which may have to be replaced at some point.

Contact a qualified repair chimney contractor.

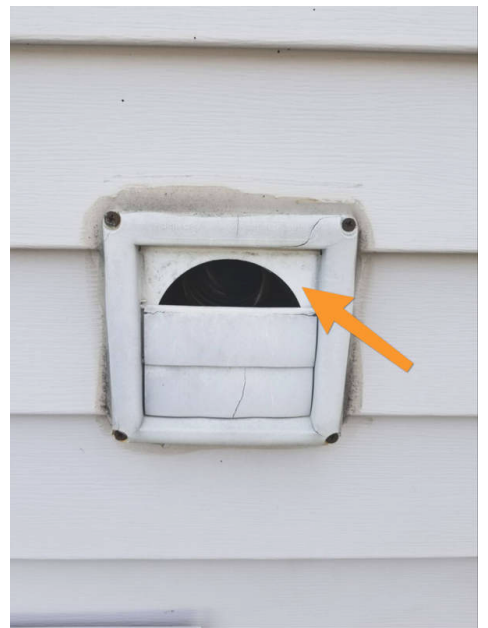
3.1.1 Siding, Flashing & Trim

DRYER VENT

Dryer vent in need of repair or replacement

Contact a qualified professional.

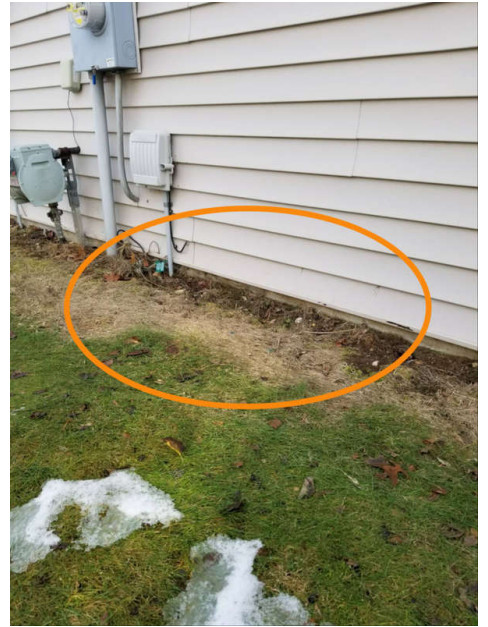
3.1.2 Siding, Flashing & Trim

GROUND CLEARANCE

Inadequate clearance between siding and ground. Recommend a minimum ground clearance between bottom of siding and ground of 4". Siding in contact with the ground or soil is a serious concern because that condition can provide direct access for wood destroying insects.

Contact a qualified siding specialist.

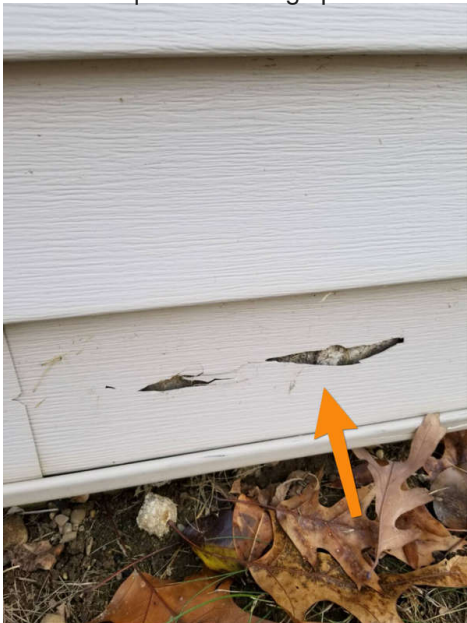
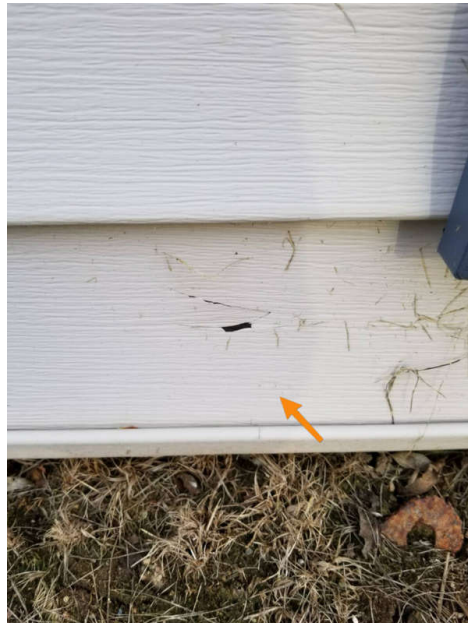
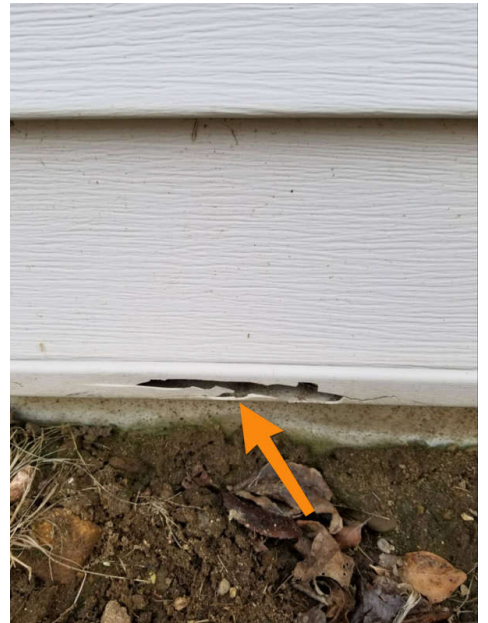
3.1.3 Siding, Flashing & Trim

MINOR DAMAGE

One or more areas showed signs of minor damage. Consult a siding contractor on options and costs to replace.

Contact a qualified siding specialist.

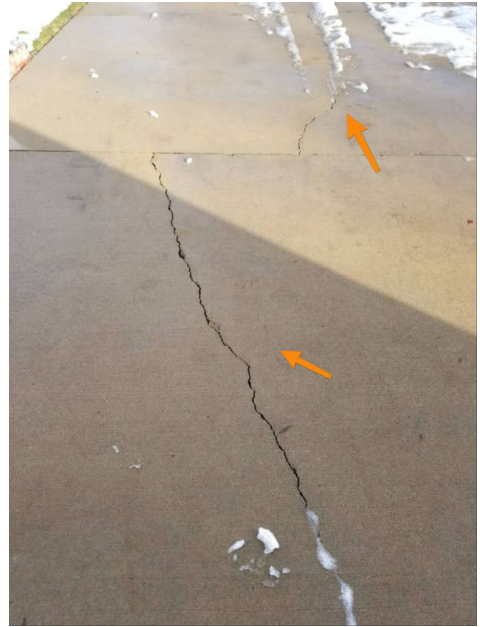
3.3.1 Walkways, Patios & Driveways

DRIVEWAY CRACKING - MINOR

Minor cosmetic cracks observed, which may indicate movement in the soil. Recommend monitor and/or have concrete contractor patch/seal.

Contact a qualified concrete contractor.

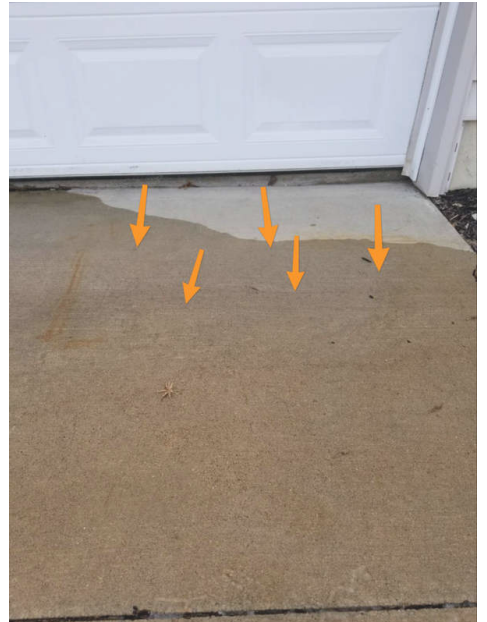
3.3.2 Walkways, Patios & Driveways

DRIVEWAY SETTLING

Inspector noticed one or more areas of the driveway had settled. Recommend talking to a contractor on options and costs to repair or replace.

Recommendation
Contact a qualified professional.

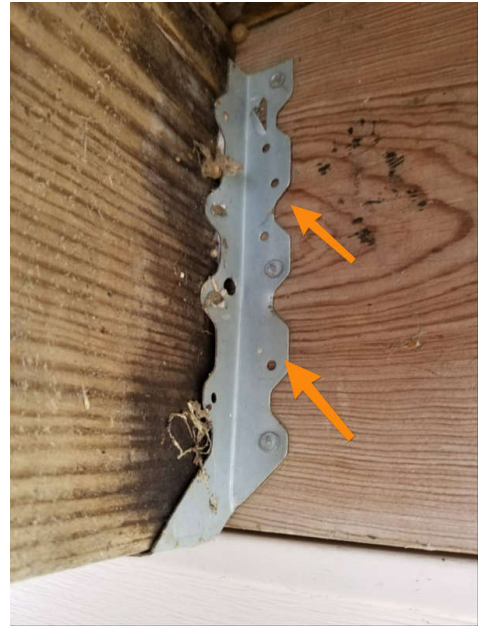
3.4.2 Decks, Balconies, Porches & Steps

JOISTS HANGERS - MISSING NAILS

Inspector noticed one or more hangers missing nails. Recommend installing nails in hanger per the manufacturer guidelines.

Recommendation
Contact a qualified professional.

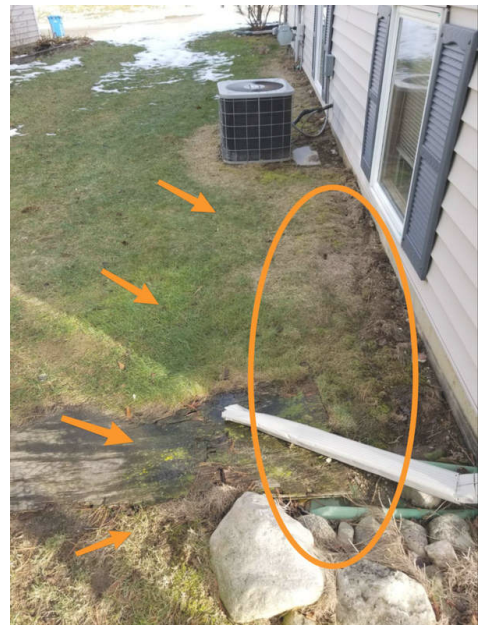
3.6.1 Vegetation, Grading, Drainage & Retaining Walls

NEGATIVE GRADING

Grading is sloping towards the home in some areas. This could lead to water intrusion and foundation issues. Recommend qualified landscaper or foundation contractor regrade so water flows away from home.

Contact a qualified landscaper or gardener.

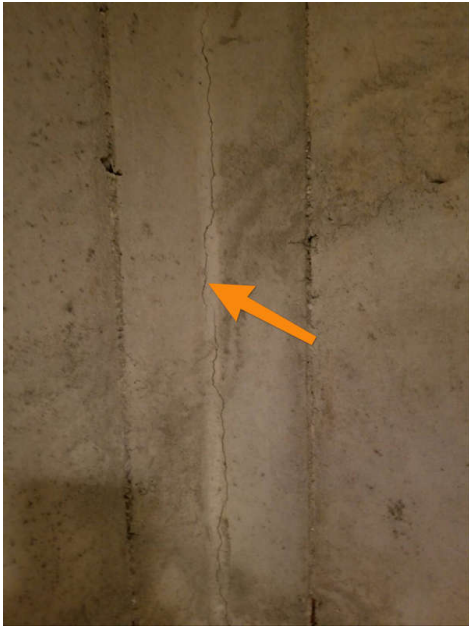
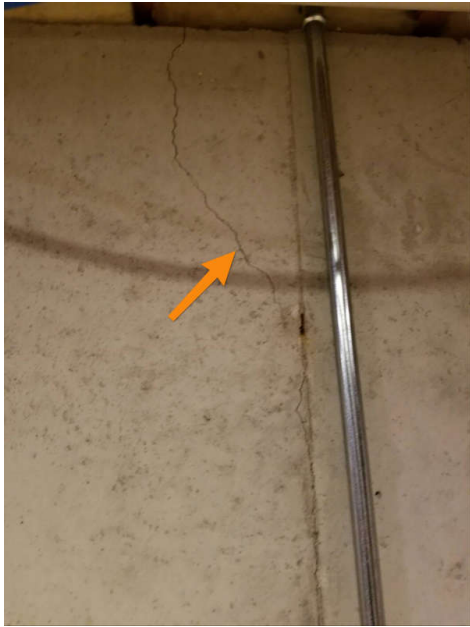
4.1.1 Foundation

FOUNDATION CRACKS - MINOR

Minor cracking was noted at the foundation. This is common as concrete ages and shrinkage surface cracks are normal. Recommend monitoring for more serious shifting/displacement.

Contact a qualified structural engineer.

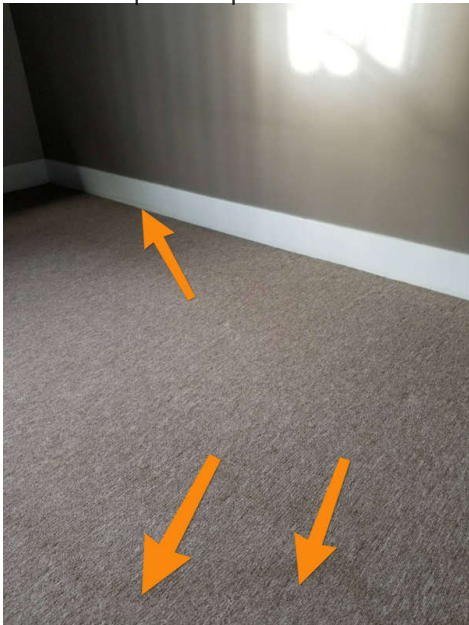
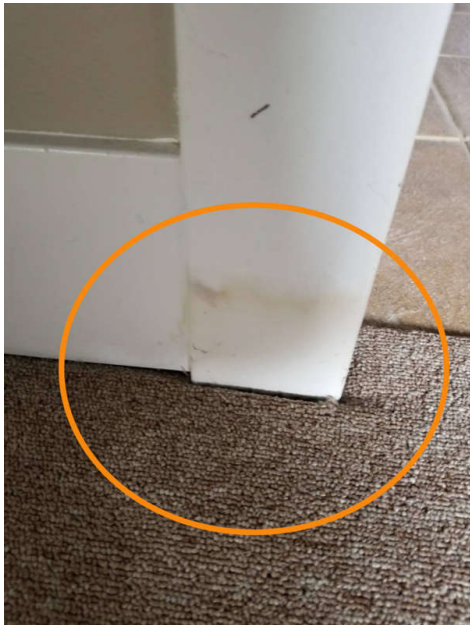
4.2.1 Basements & Crawlspaces

PREVIOUS MOISTURE

Inspector noticed signs of previous moisture intrusion. Recommend talking to a contractor on options and costs to prevent future moisture issues in the basement.

Recommendation
Contact a qualified professional.

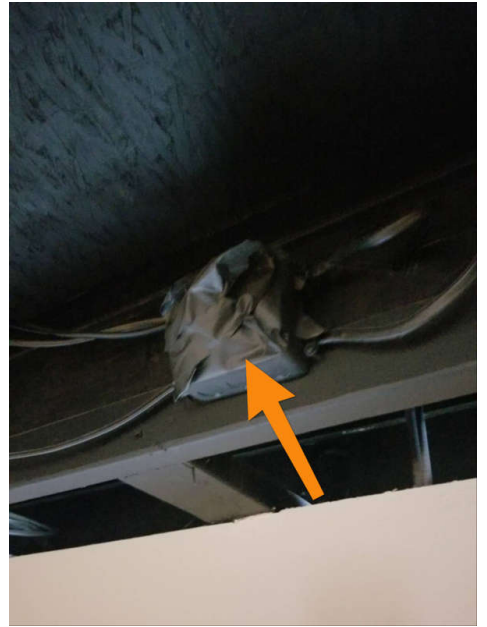
7.4.1 Lighting Fixtures, Switches & Receptacles

COVER PLATES DAMAGED/MISSING

One or more receptacles have a damaged cover plate. Recommend replacement.

Recommendation
Contact a qualified electrical contractor.

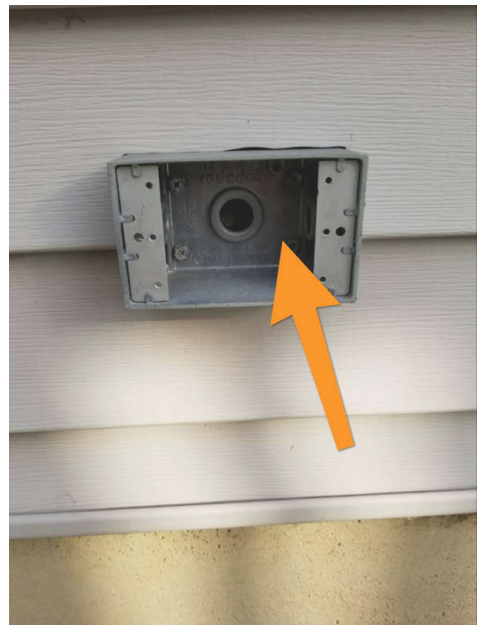
7.4.2 Lighting Fixtures, Switches & Receptacles

COVER PLATES MISSING

One or more receptacles are missing a cover plate. This causes short and shock risk. Recommend installation of plates.

Contact a qualified electrical contractor.

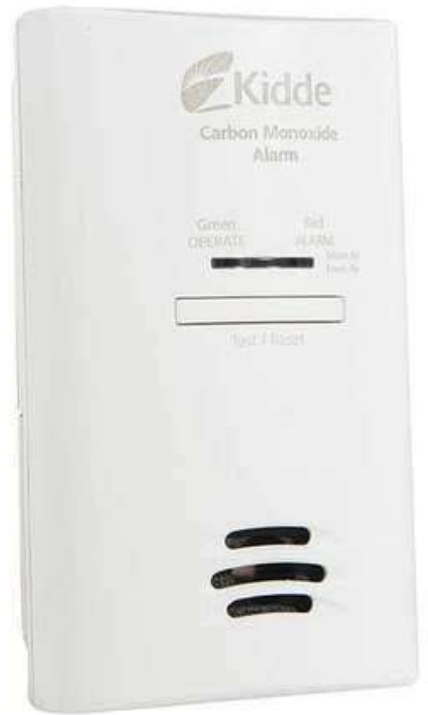
7.7.1 Carbon Monoxide Detectors

MISSING

Inspector noticed that Carbon Monoxide detector was missing from one or more locations. Recommend installation of at least one low level CO monitor per floor.

Contact a qualified professional.

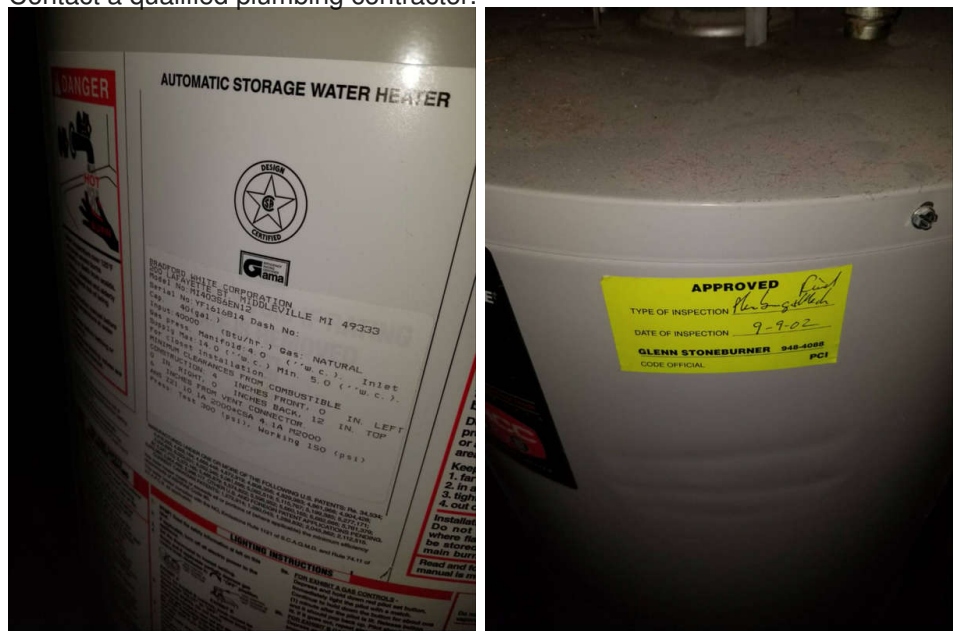
8.4.1 Hot Water Systems, Controls, Flues & Vents
NEARING OR PAST LIFE EXPECTANCY

This water heater is nearing or past the average lifespan of a water heater (10-12 years) Water heater showed normal signs of wear and tear. Recommend monitoring it's effectiveness and replacing in the near future.

Recommendation
 Contact a qualified plumbing contractor.

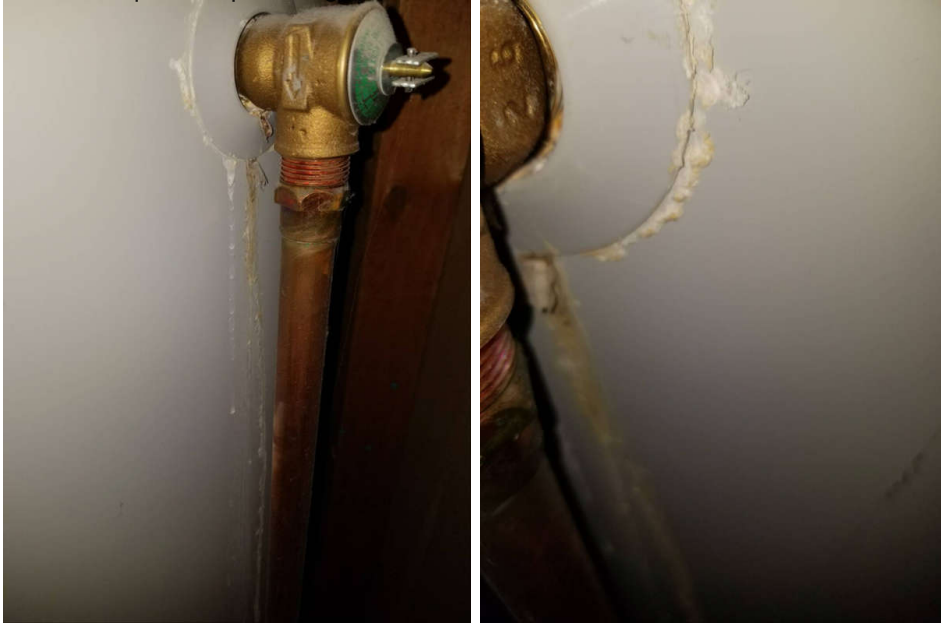
8.4.2 Hot Water Systems, Controls, Flues & Vents
PAST LEAK

Inspector noticed evidence of a past leak. In most cases this is a sign that the water heater is nearing the end of its useful life. You may wish to talk to a licensed plumber on options and costs to replace.

Recommendation
Contact a qualified plumbing contractor.

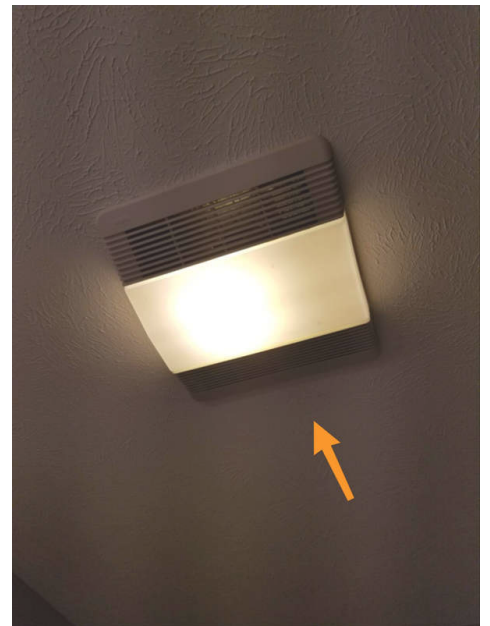
9.3.1 Exhaust Systems

BATH FAN NOISY

Although the bath fan turned on it was very noisy. Bath fan should be cleaned or replaced.

Recommendation
Contact a qualified electrical contractor.

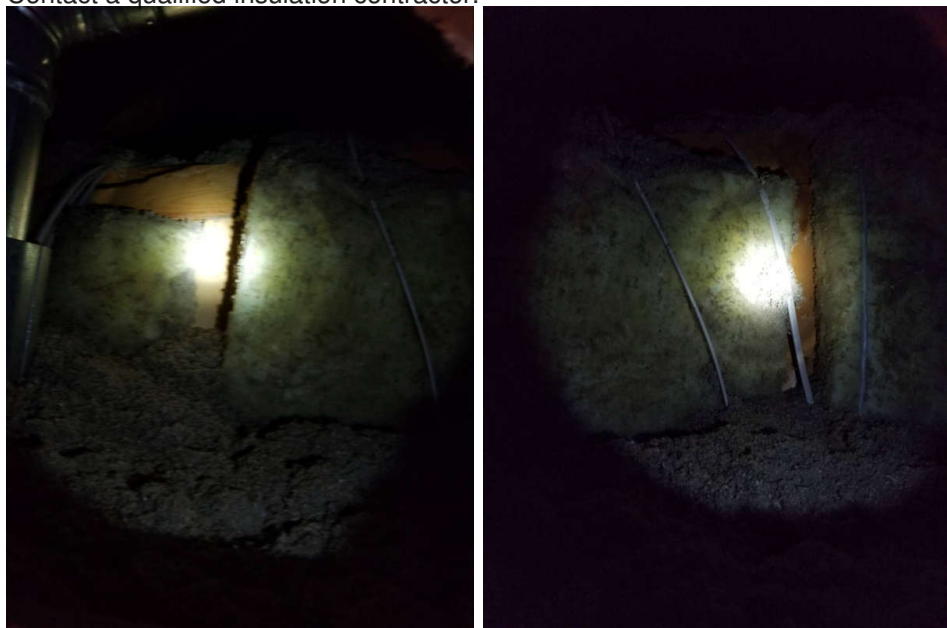
9.4.1 Kneewalls

INADEQUATE INSULATION

One or more kneewalls were poorly insulated. This can lead to ghosting on the cathedral ceiling walls. You may wish to consult with an insulation contractor on options and costs to repair these areas.

Contact a qualified insulation contractor.

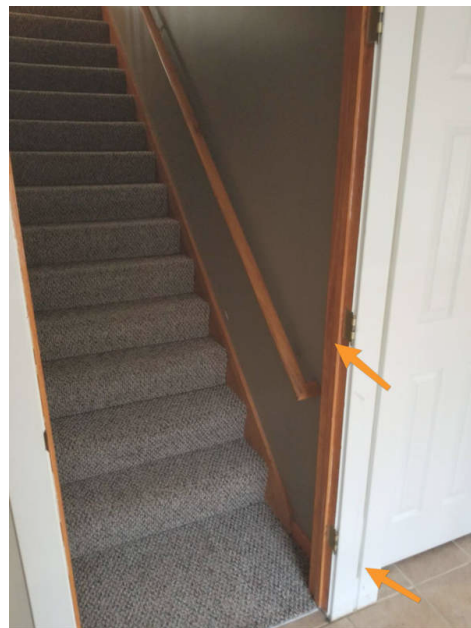
10.1.1 Doors

DOOR MISSING

One or more doors were missing during the inspection.

Contact a qualified carpenter.

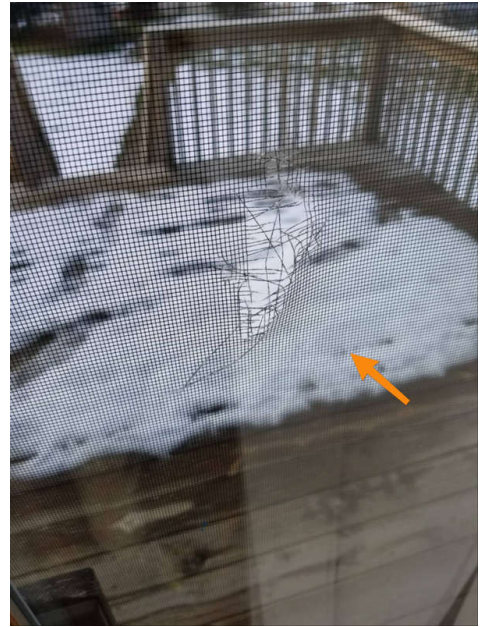
10.2.1 Windows

DAMAGED/MISSING SCREEN

One or more window screens were damaged or missing. Inspector recommends looking at options and costs to repair or replace.

Contact a qualified window repair/installation contractor.

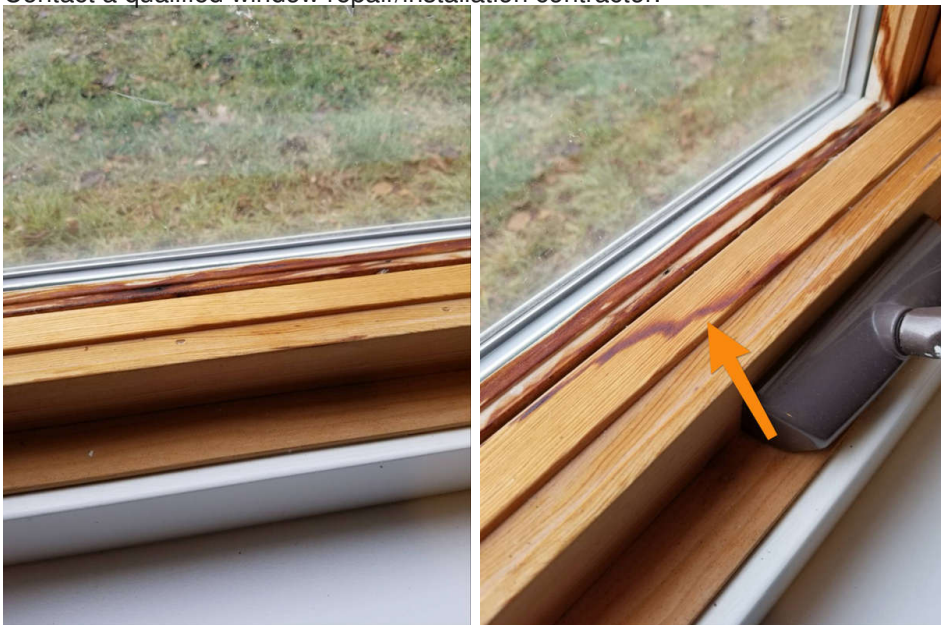
10.2.2 Windows

EVIDENCE OF PREVIOUS MOISTURE

Inspector noticed that some of the windows had signs of previous moisture. This can be due to windows being left open or thermal bridging (wood windows) You may wish to talk to a licensed contractor on options to paint or replace if needed.

Contact a qualified window repair/installation contractor.

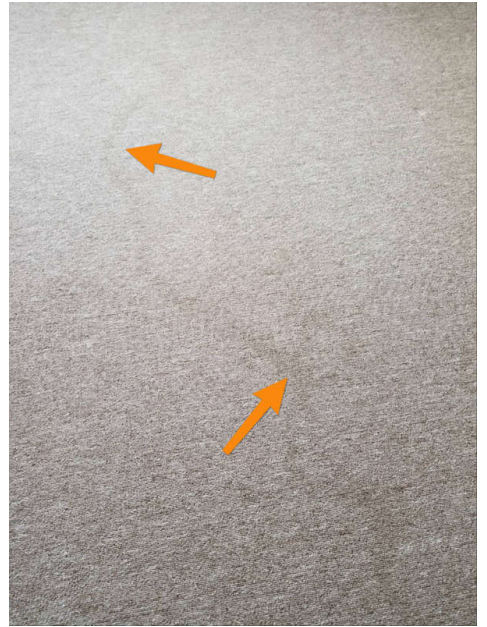
10.3.1 Floors

CARPET STAINS

Carpet had areas of staining or discoloration. Recommend a thorough steam clean by a qualified carpet cleaning company

Contact a qualified cleaning service.

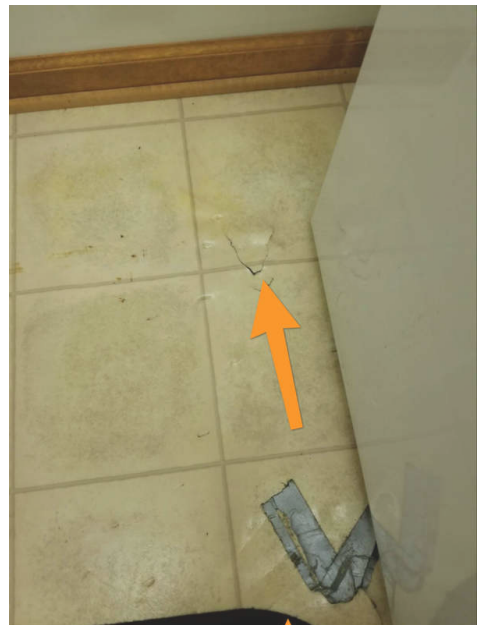
10.3.2 Floors

FLOORING DAMAGE

Inspector noticed one or more areas of flooring had evidence of damage. You may wish to talk to a contractor on options and costs to repair or replace.

Contact a qualified flooring contractor

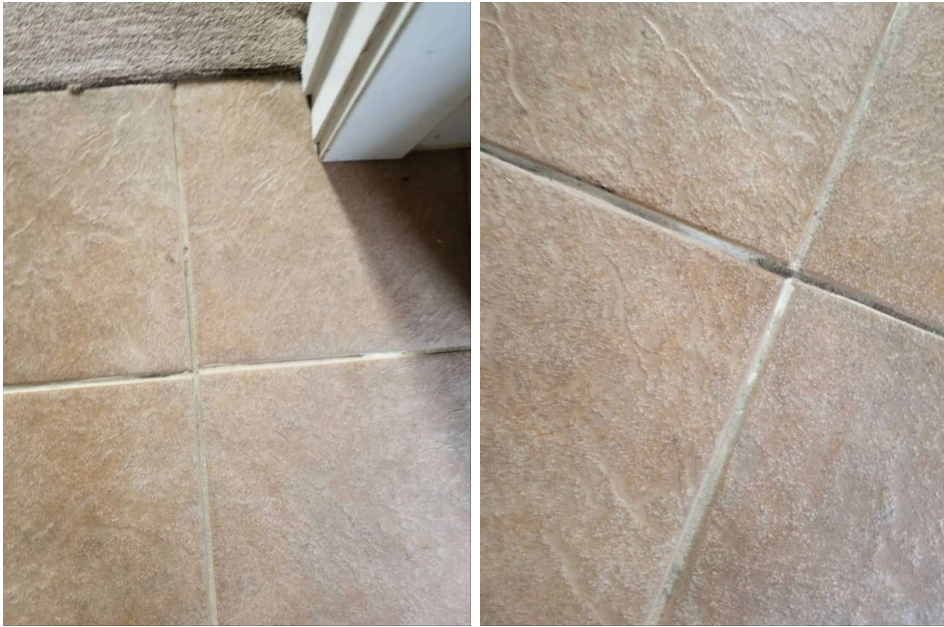
10.3.3 Floors

POOR INSTALL (TILE)

One or more areas of tile was installed poorly. You may wish to talk to a contractor on options and costs to remove tile and replace with new.

Contact a qualified flooring contractor

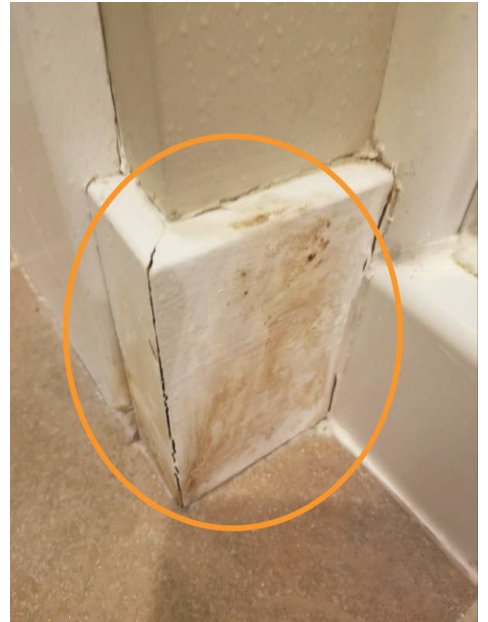
10.4.1 Trim

TRIM MISSING/DAMAGED

Trim was missing in one or more locations. Recommend installing trim by a qualified contractor.

Contact a qualified carpenter.

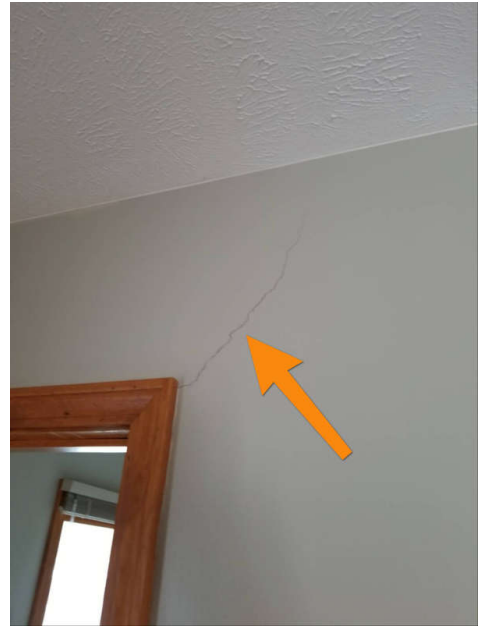
10.5.1 Walls

WALL CRACKS

Minor cracks were apparent in the drywall in one or more locations. Appeared to be the result of long-term settling. Some settling is not unusual in a home of this age however you may wish to have the area evaluated by a structural engineer.

Contact a qualified professional.

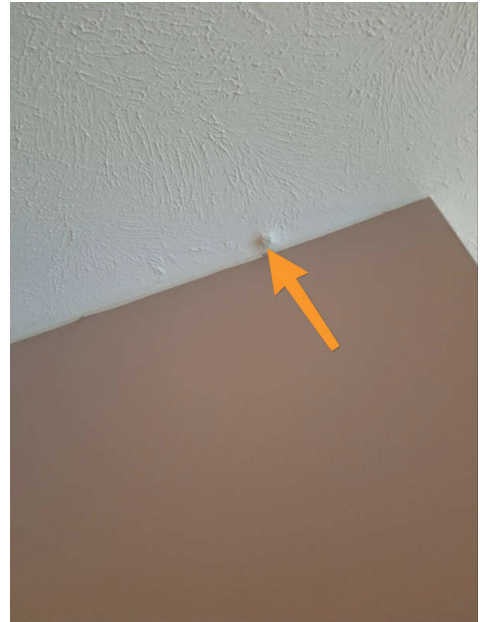
10.5.2 Walls

NAIL POPS

Protruding nail heads visible at the time of the inspection appeared to be the result of contact with moisture. After the source of moisture is located and corrected, protruding nails should be removed, drywall re-fastened and the drywall finished to match the existing wall surfaces. All work should be performed by a qualified drywall or painting contractor.

Contact a qualified drywall contractor.

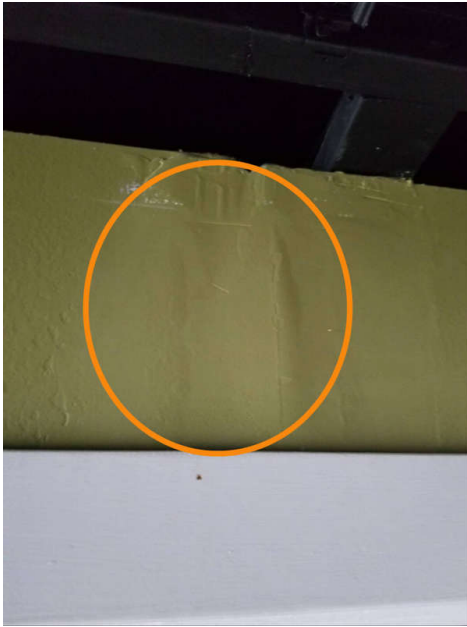
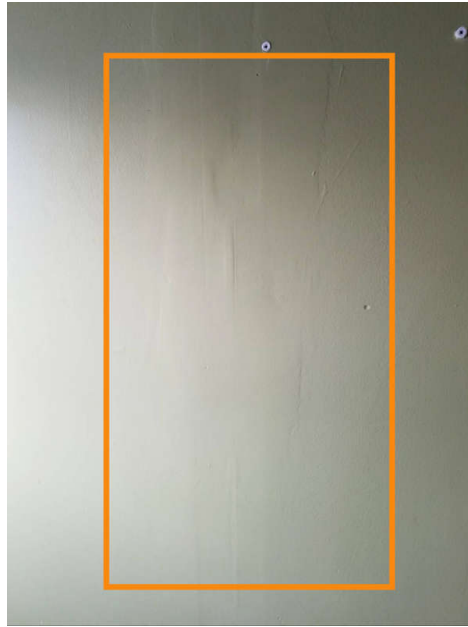
10.5.3 Walls

POOR INSTALL

One or more walls showed evidence of poor Install. Recommend talking to a contractor on options and costs to repair or replace.

Contact a qualified professional.

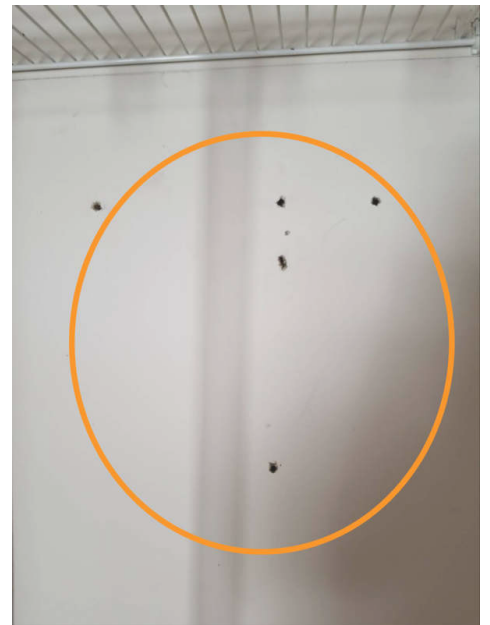
10.5.4 Walls

HOLE

There were one or more holes in the drywall at the time of the inspection. Recommend talking to a licensed contractor on options and costs to patch drywall.

Contact a qualified drywall contractor.

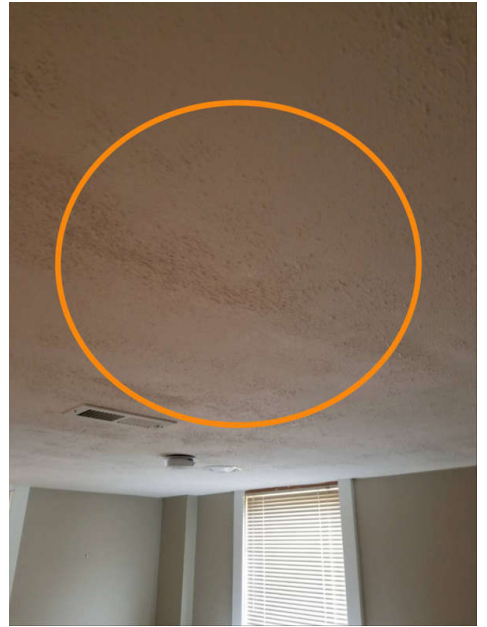
10.6.1 Ceilings

POOR INSTALL

Ceiling showed evidence of poor workmanship. Recommend talking to a qualified contractor on options and costs to repair or replace.

Contact a qualified professional.

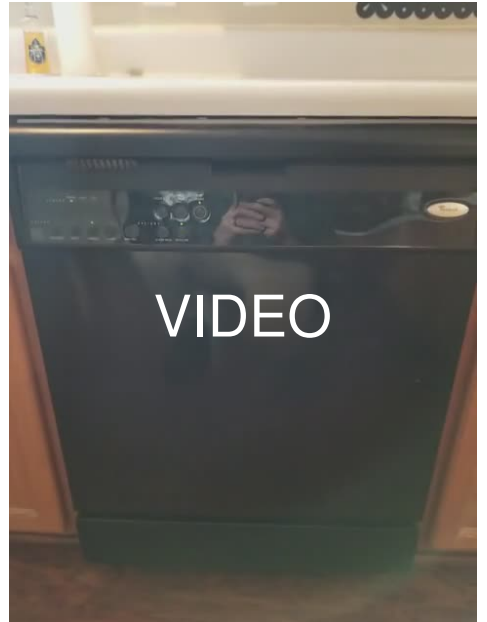
12.1.1 Dishwasher

SERVICE RECOMMENDED

Inspector noticed that the dishwasher did not appear to be working properly. Inspector recommend talking to a appliance repair person on options and costs to repair or replace.

Contact a qualified appliance repair professional.
