SUMMARY
1234 Main St. Ammon ID 83406
Buyer Name
10/10/2018 9:00AM

Adam Smith
InterNACHI Certified Home Inspector
High Mark Home Inspection LLC
2088810782
adam@highmarkhomeinspection.com

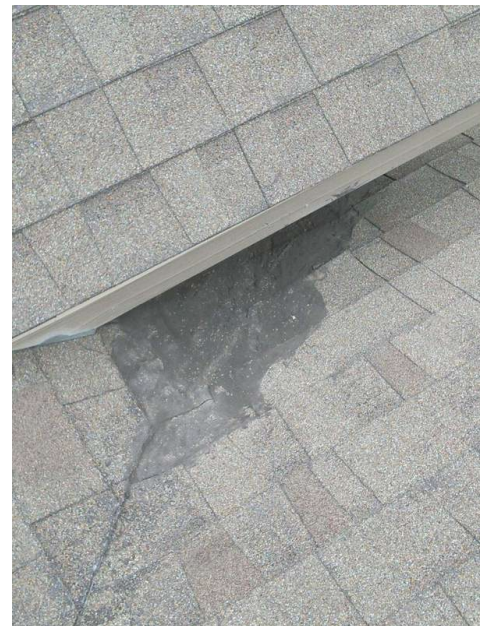
2.1.1 General

HIGH MAINTENANCE

One or more roof surface sections were designed so as to be prone to accumulating debris and/or snow. For example, where *two slopes converged / a slope descended to a vertical wall / a steeper slope met a shallow slope / a slope descends to a flat section of roof*. Accumulated debris in these areas can result in leaks. At a minimum, monitor such areas for accumulated debris in the future and clean as necessary. Consult with a qualified contractor to determine what repairs or modifications may be possible to prevent leaks.

Recommendation
Contact a qualified professional.

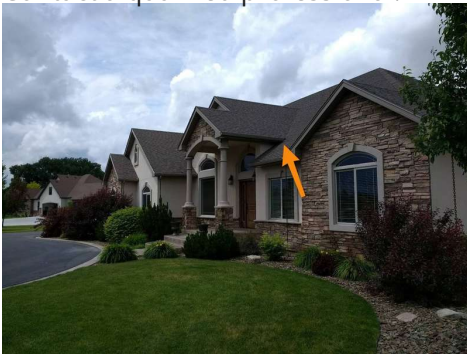
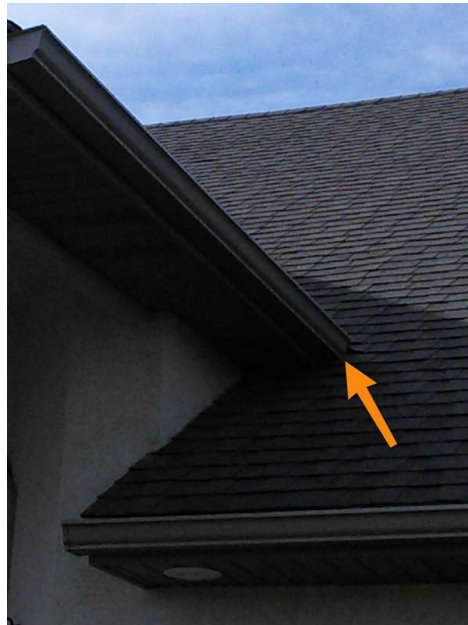
2.2.1 Gutters/drains

OPEN END GUTTER

It is common practice for a builder or rain gutter contractor to install rain gutters that are open at one end and drain directly onto another area of the roof. Installation of this sort causes water to run back onto the the roof and cause the fascia, shingles, tiles or the surface under the covering to deteriorate prematurely and possibly leak. It is recommended to have the end cap installed and a downspout installed to drain into an existing gutter.

Recommendation

Contact a qualified professional.

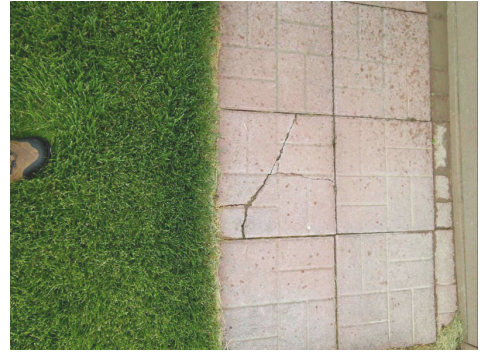
3.2.1 Driveway, Walkway, Patio

CRACKED PAVERS- SIDEWALK/PATIO

One or more of the sidewalk or patio pavers are chipped or cracked. Any paver with a deficiency should be replaced by a certified contractor to help prevent future deterioration.

Recommendation
Contact a qualified professional.

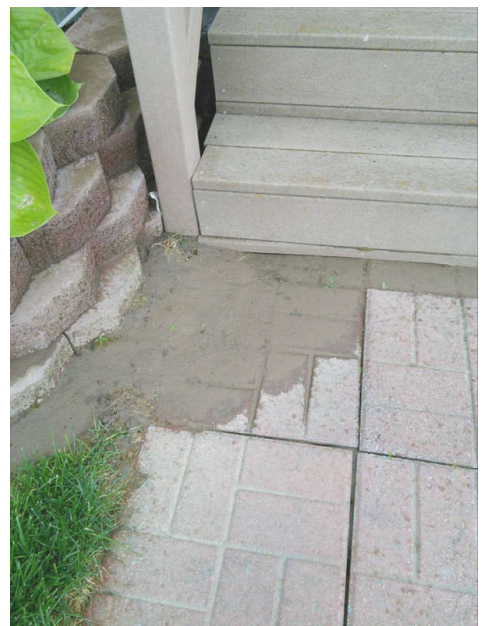
3.2.3 Driveway, Walkway, Patio

PAVER SETTLEMENT-SIDEWALK/PATIO

Recommendation
Contact a qualified professional.

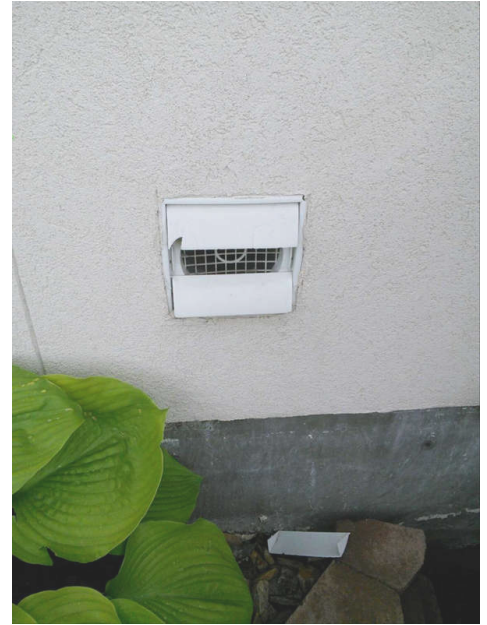
3.3.1 Exterior issues

EXHAUST VENT DAMAGE

One or more exhaust duct end caps were *missing / loose / damaged / deteriorated*. Their purpose is to prevent unconditioned air from entering the building, and keep out birds, rodents and bugs. Blocked ducts can cause fan motors and/or clothes dryers to overheat and can pose a fire hazard. Recommend that a qualified person repair or replace covers as necessary.

Recommendation

Contact a qualified professional.

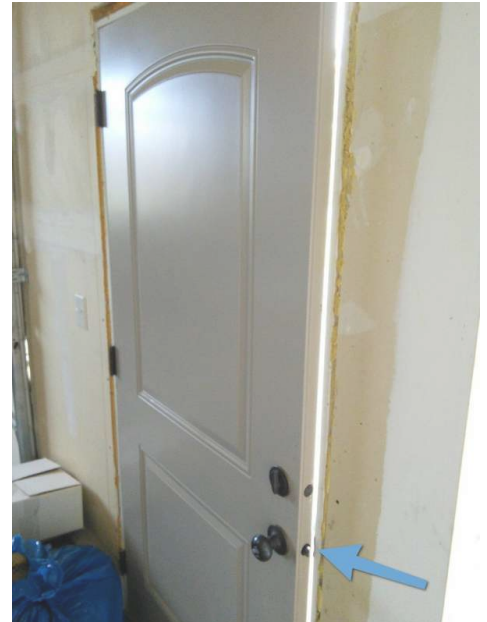
3.3.2 Exterior issues

DOOR- BINDS IN JAMB

GARAGE MAN DOOR TO EXTERIOR FROM GARAGE.

One or more doors bind in their jamb and cannot be closed and latched, or are difficult to open and close. A qualified contractor should evaluate and repair as necessary. For example, adjusting jambs or trimming doors.

Recommendation

Contact a handyman or DIY project

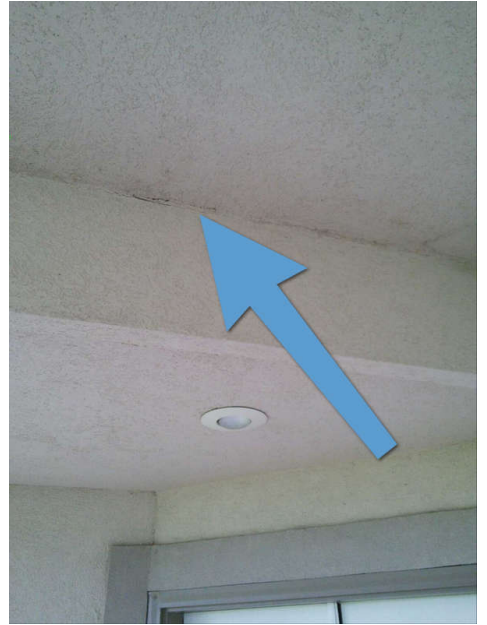
3.3.3 Exterior issues

MINOR CEILING CRACK

DECK CEILING

Minor cracks were found in ceilings in one or more areas. They do not appear to be a structural concern, but the client(s) may wish to repair these for aesthetic reasons.

Recommendation

Contact a qualified painter.

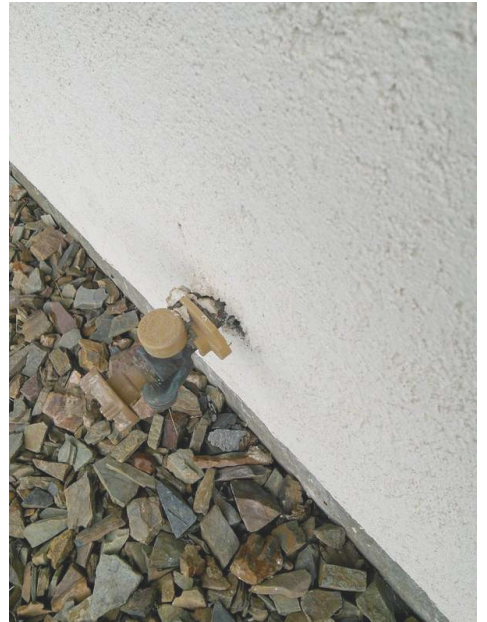
3.3.4 Exterior issues

LOOSE HOSE BIBB

One or more hose bibs weren't anchored securely to the structure's exterior. Water supply pipes can be stressed when hose bibs are turned on and off and when hoses are pulled. Leaks may occur as a result. Recommend that a qualified person install fasteners per standard building practices.

Recommendation

Contact a qualified professional.

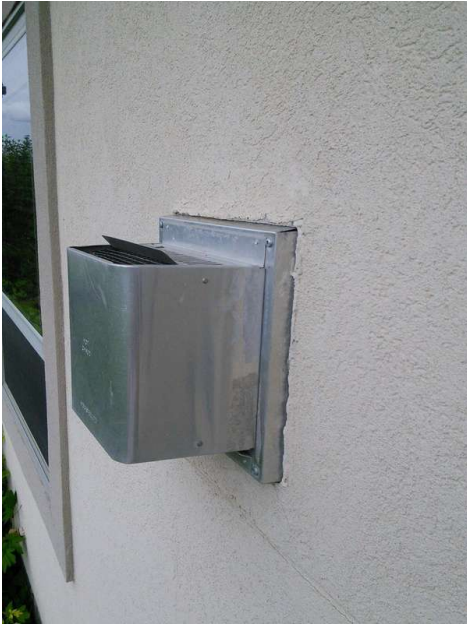
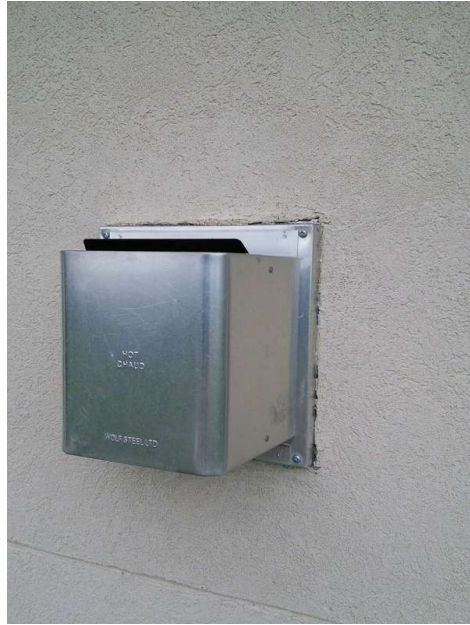
3.3.5 Exterior issues

SEALANT DETERIORATED AROUND EXTERIOR FIXTURES

BACK DECK/ALL LOCATIONS SHOULD BE CHECKED

Sealant is deteriorated around exterior fixtures where they exit the wall (i.e. Hose faucets, conduit, lights, wires). These areas should be properly sealed to help prevent moisture intrusion.

Recommendation

Contact a handyman or DIY project

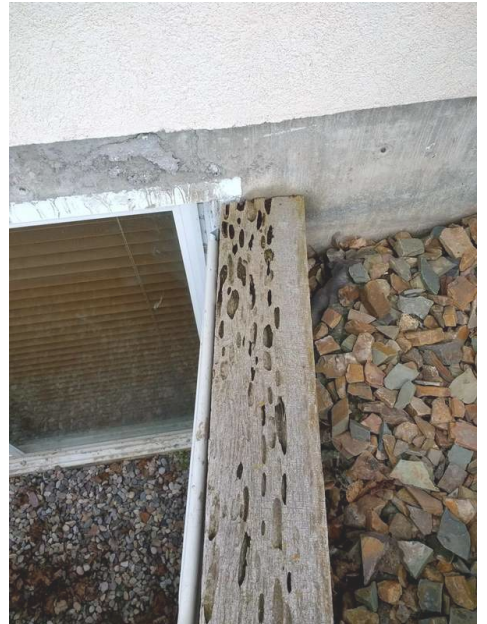
3.3.6 Exterior issues

WOOD DESTROYING ORGANISM EVIDENCE

At various locations of the exterior of the home there are areas that show past wood destroying organism damage. It is unknown if this activity is current, as High mark Home Inspection is not a pest control company. These areas should be evaluated and treated and repaired as necessary.

Recommendation
Contact a qualified professional.

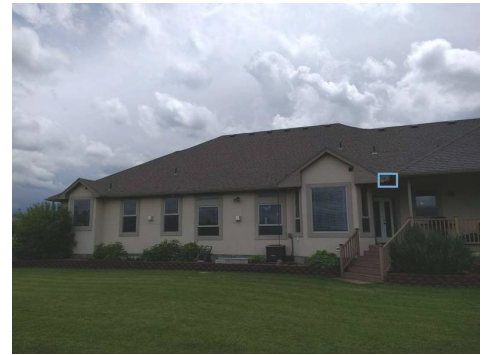
3.7.1 Gutters and Flashing

LEAKING GUTTER

BACKYARD DECK BY THE STAIRS

One or more gutters were leaking. Rainwater may come in contact with the building exterior or accumulate around the foundation as a result. Recommend that a qualified person repair as necessary.

Recommendation

Contact a qualified professional.

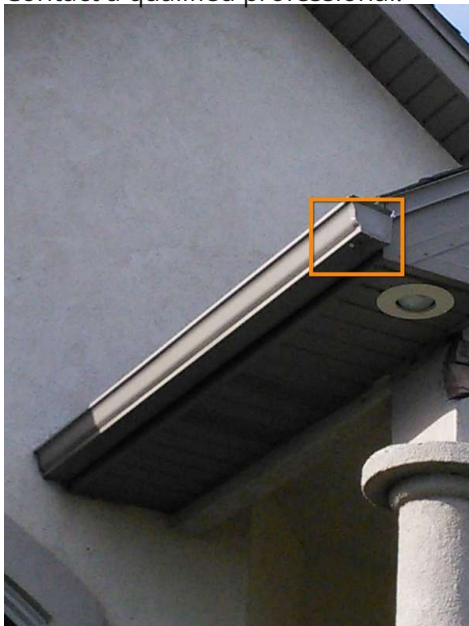
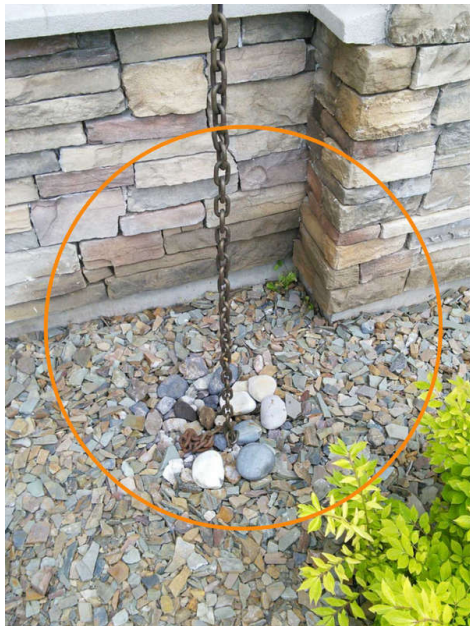
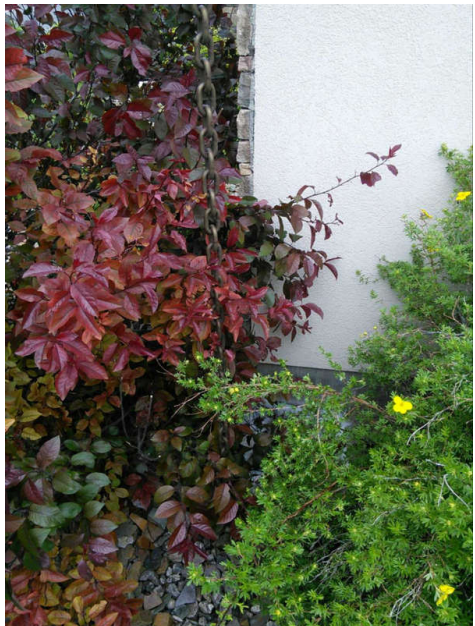
3.7.2 Gutters and Flashing

NO DOWNSPOUT

There is no downspout installed at the gutter system (In multiple locations). This can cause water to accumulate around the homes foundation and cause soil a erosion. Also standing water could occur as well as low spots around the home. Downspouts should be installed as needed. There are currently chains in the place of downspouts, however to get the water away from the home an actual downspout system would need to be installed. No underground drain system was observed where the chains meet the ground.

Recommendation

Contact a qualified professional.

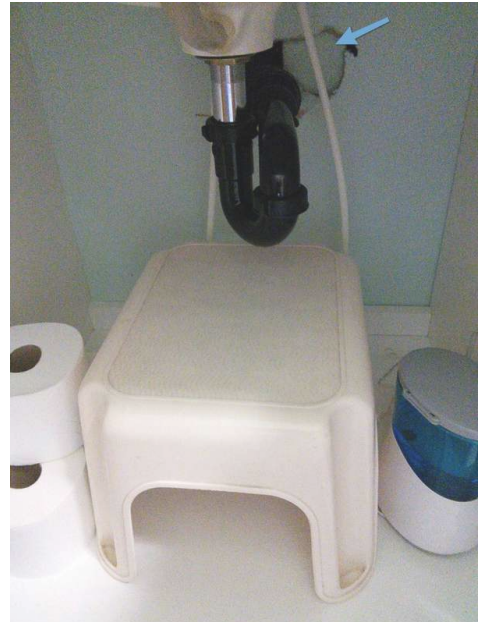
4.2.2 Floors, Walls, Ceilings

WALL DAMAGE

There is damage to the drywall under a vanity. It's recommended to have this evaluated and repaired by a certified contractor or handyman.

Recommendation

Contact a qualified drywall contractor.

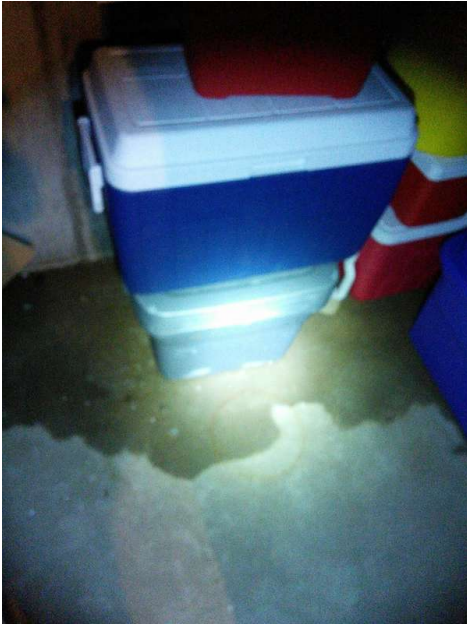
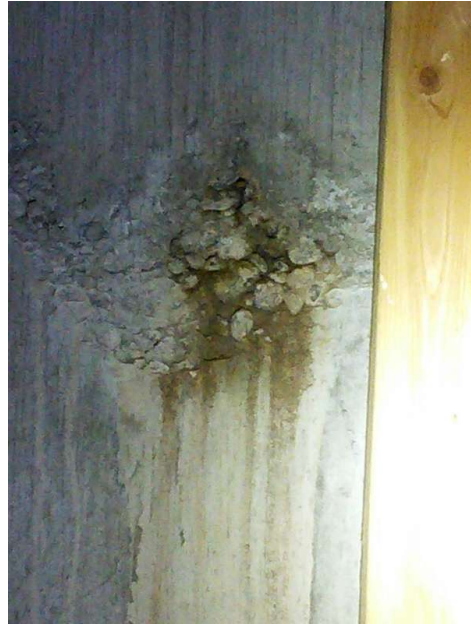
4.2.3 Floors, Walls, Ceilings

FLOOR - STANDING WATER

BASEMENT ROOM UNDER FRONT PATIO

One or more areas show evidence of standing water. The cause could be a variant of things, however it appears to be coming from the bottom up. It is possible that there is too much moisture being deposited too close to the house. Recommend a qualified professional evaluate and take the necessary steps to correct.

Recommendation

Contact a qualified professional.

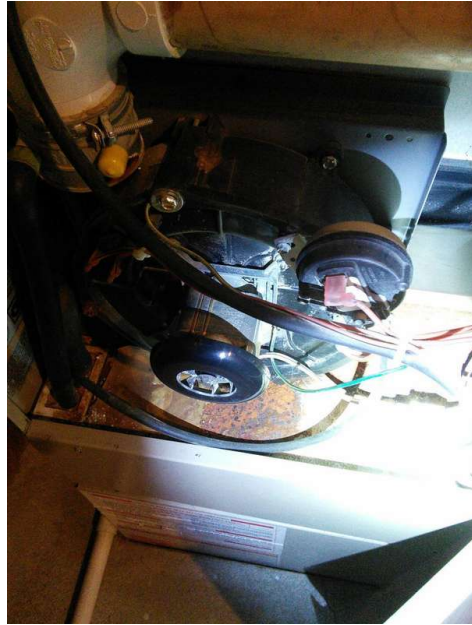
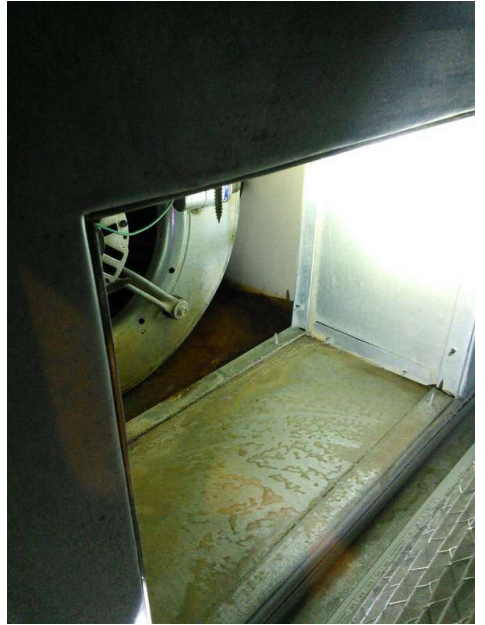
8.3.1 Air Handler

STAINS BELOW MAIN CONDENSATE DRAIN LINE

There were stains below the air handler units main condensate drain line. This would indicate there is a leak somewhere in the system.

Recommendation

Contact a qualified professional.

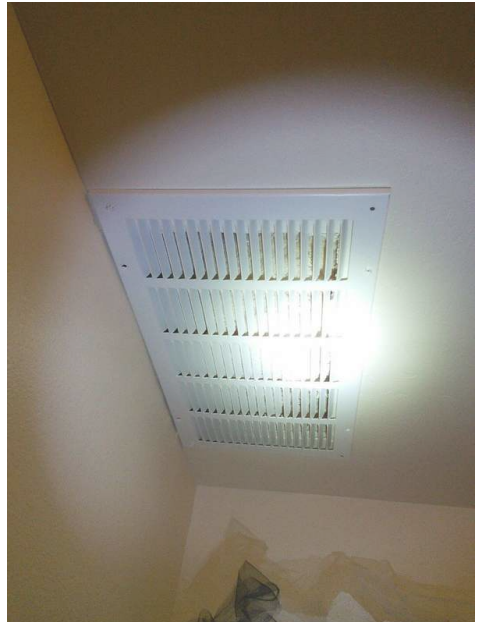
8.4.1 Duct Work

RETURN AIR IMPEDANCE

BASEMENT BEDROOM CLOSET

Return air grill has some type of blockage present. Recommend blockage be removed by a qualified professional or handy man.

Recommendation

Contact a qualified professional.

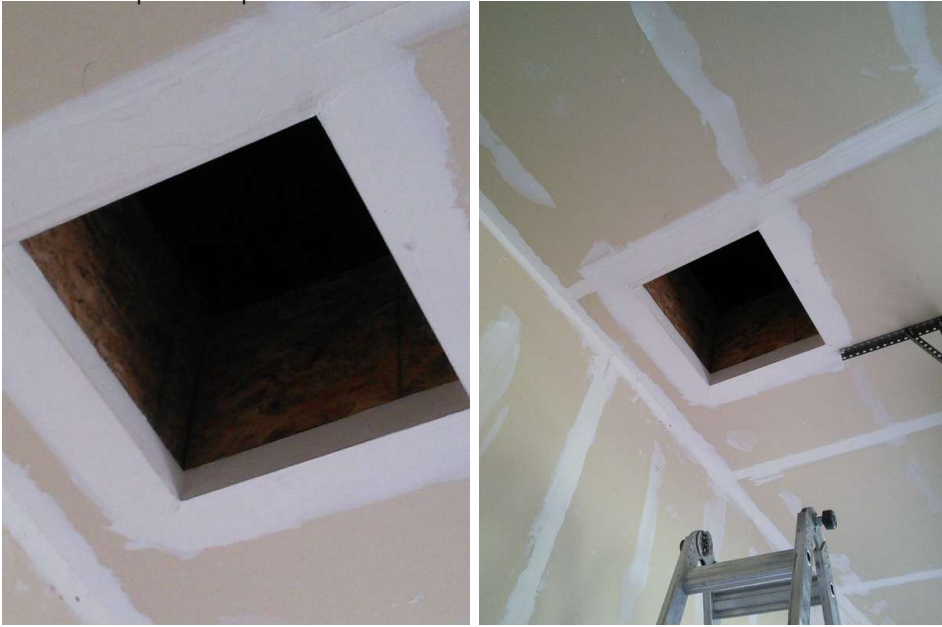
12.2.2 Attic Hatch

NO ACCESS COVER

Safety/Immediate Attention

There is no attic access cover installed at the attic access opening. The proper cover should be installed at the attic access opening. This could also pose a fire hazard because there is no firewall between the garage and the living space of the house in the attic space.

Recommendation

Contact a qualified professional.
