SUMMARY

1234 Main St. Lake Charles LA 70611

Aaron Gott
LA License # 11034
AGI: Property Inspections
337-661-1428
agottges@gmail.com

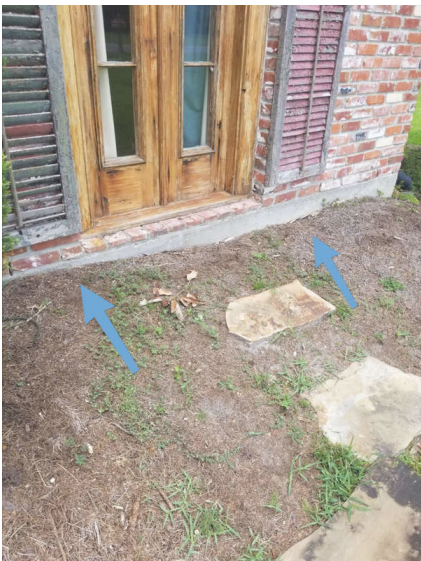
Front of House

PLANTING BEDS- TOO CLOSE TO FOUNDATION

Planting beds have been constructed near the exterior walls, without proper separation from foundation.

Contact a qualified landscaping contractor

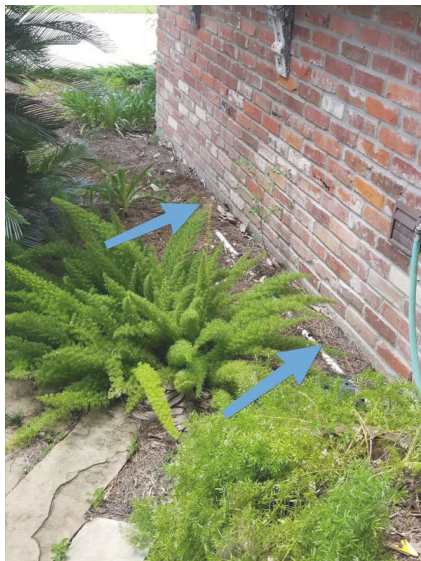
Front of House

Vines growing on the exterior walls may introduce insects, pests and/or accelerate deterioration of the exterior wall covering by retaining moisture. Over time, vine tendrils may damage wall covering materials. Watering this vegetation will introduce moisture to the soil which may eventually reach the foundation. Moisture in soil supporting the foundation can affect the ability of the foundation to support the weight of the structure above and can cause damage from soil heaving or settling, depending on soil composition and other conditions.

Recommendation
Contact a qualified professional.

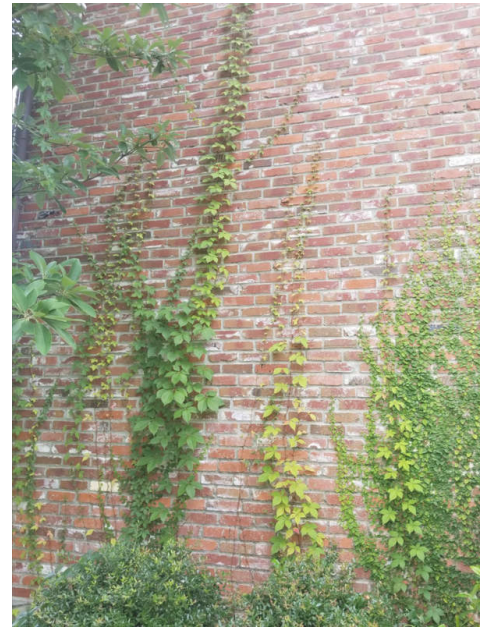
Right Side- facing the house

VINES ON WALL

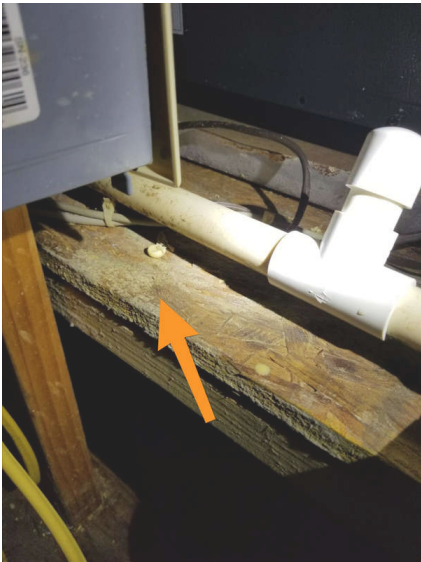
Attic

MICROBIAL GROWTH- ATTIC

Inspector noted one or more areas that looked like potential microbial growth.

Recommendation
Contact a qualified professional.

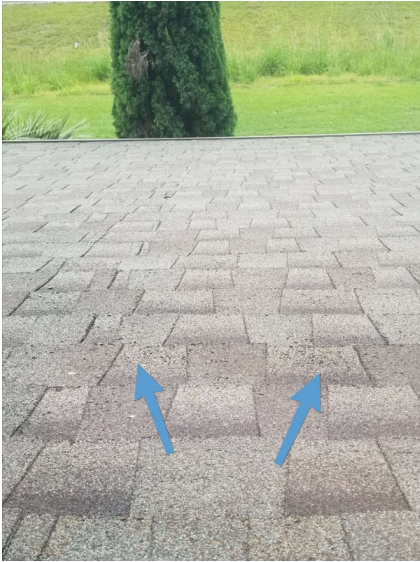
Left Side- facing the house

GRANULE LOSS

There were areas with significant granule loss of the roofing shingles. Long-term, uniform granule loss is considered part of the natural aging process.

Recommendation
Contact a qualified roofing professional.

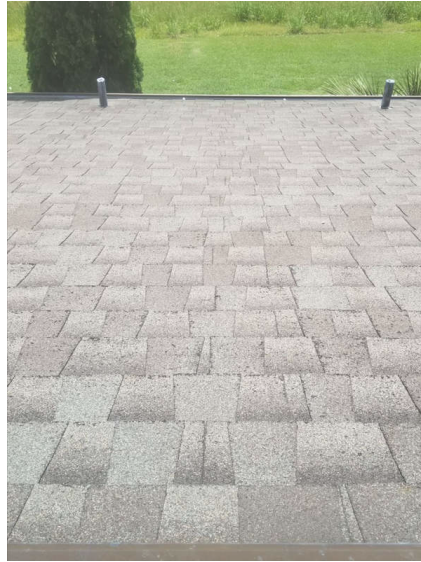
Left Side- facing the house

The shingles were old, appeared to be well past the mid point of their long-term service life and may need to be replaced soon. They appeared to be adequately protecting the roof at the time of the inspection.

Recommendation

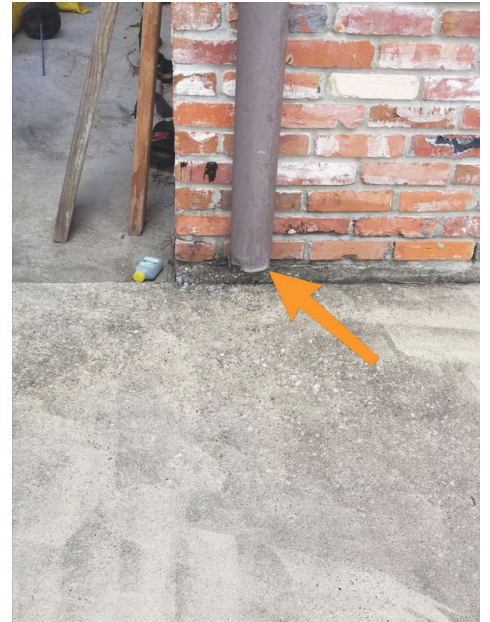
Rear of House

ELBOW MISSING

Home was missing elbow(s) in one or more areas. This can result in excessive moisture in the soil at the foundation, which can lead to foundation/structural movement and soil erosion.

Contact a qualified roofing professional.

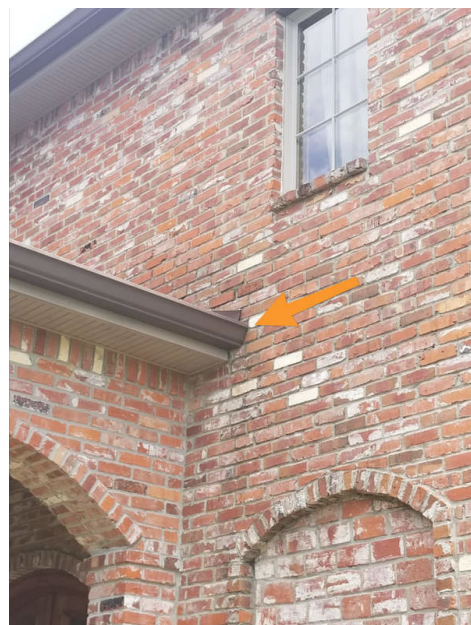
Front of House

KICKOUT FLASHING- MISSING

The home had no kick-out flashing installed where walls extended past roof edges. Kick-out flashing is designed and installed to divert water from behind the exterior wall covering at areas of the home where a sidewall extends out past a connecting roof eave.

Contact a qualified gutter contractor

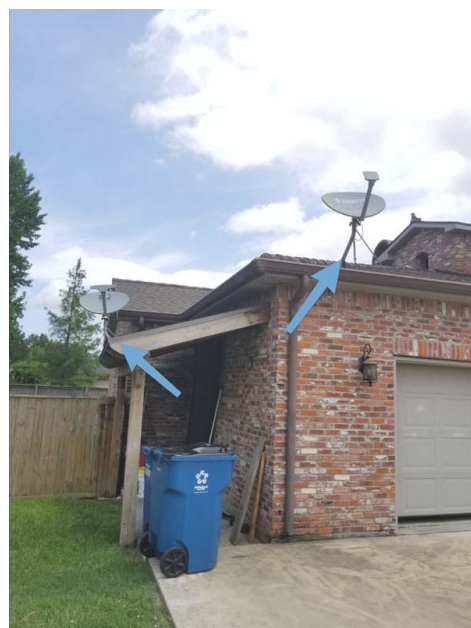
Rear of House

SATELLITE- ROOF INSTALLATION

The satellite roof install can cause damage to shingles and roofing materials and should be installed in a different location.

Contact a qualified professional.

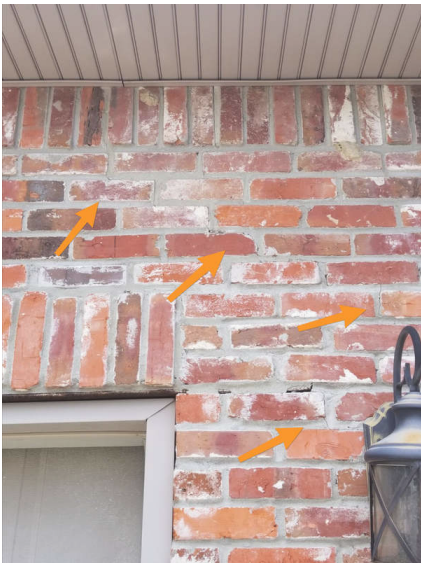
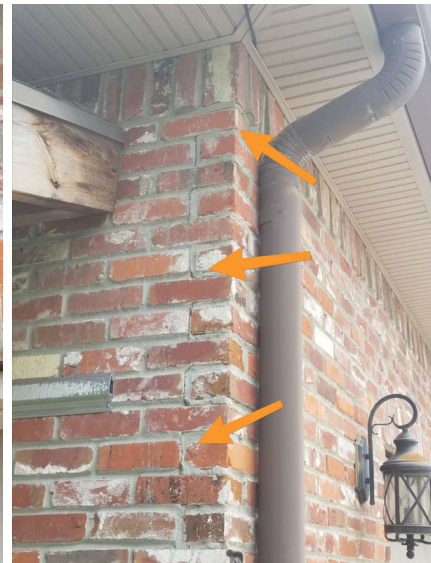
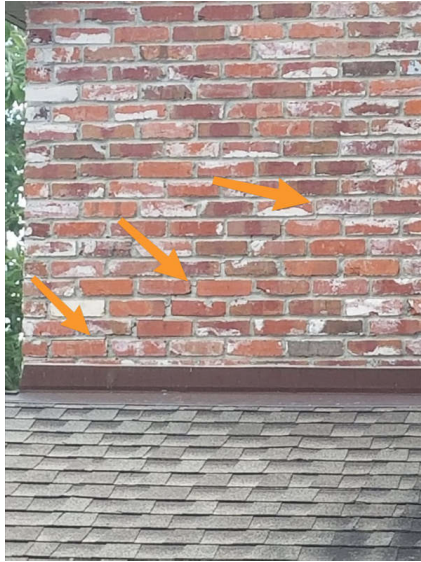
The exterior wall covering had areas cracked or broken which should be replaced or repaired to prevent potential damage from moisture intrusion to the home materials. These areas could be a structural concern and can have a variety of causes.

Recommendation
Contact a foundation contractor.

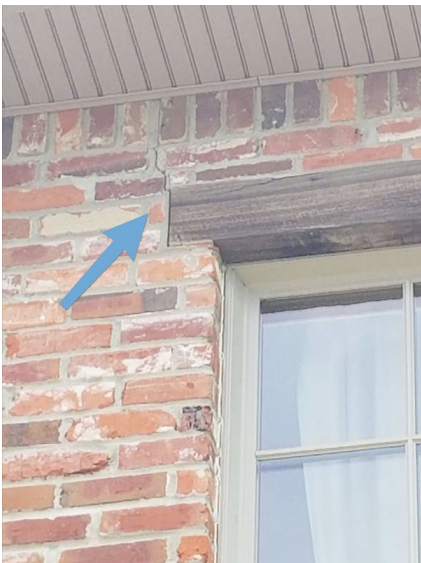
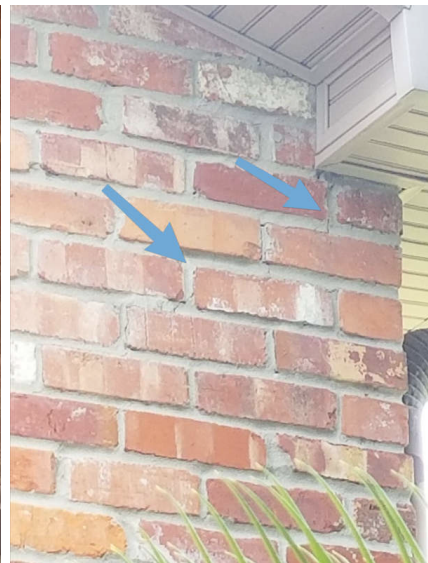
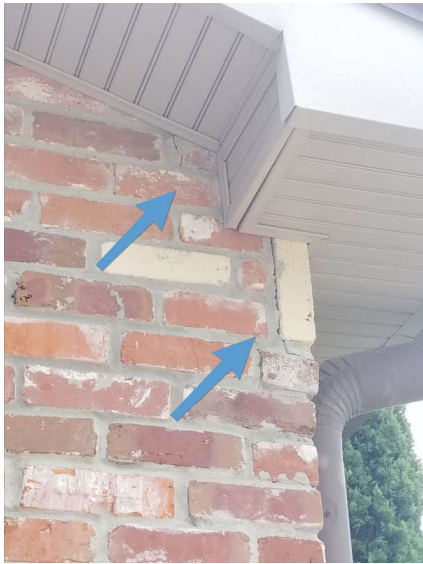
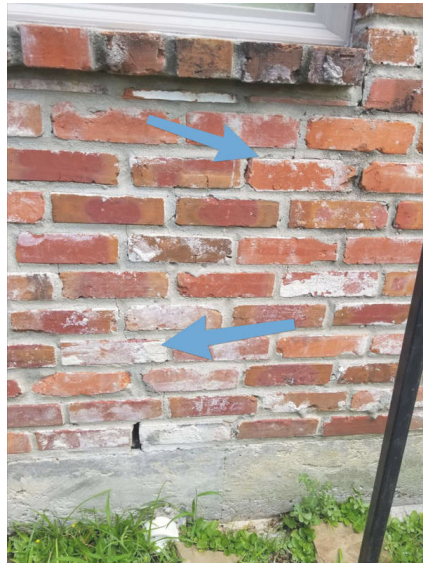
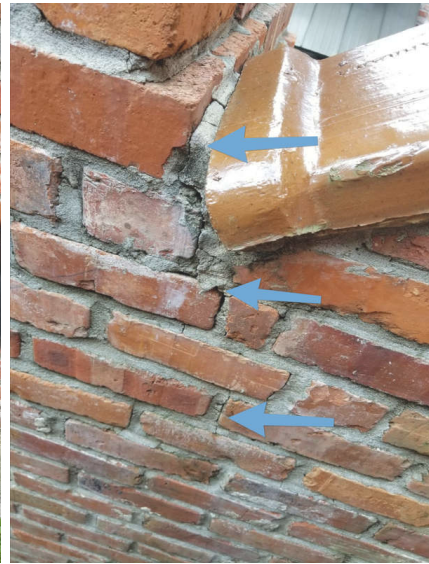
4.1.3 Wall Covering, Trim **CRACKING - MINOR**

Siding showed some cracking in one or more places.

Recommendation
Contact a qualified masonry professional.

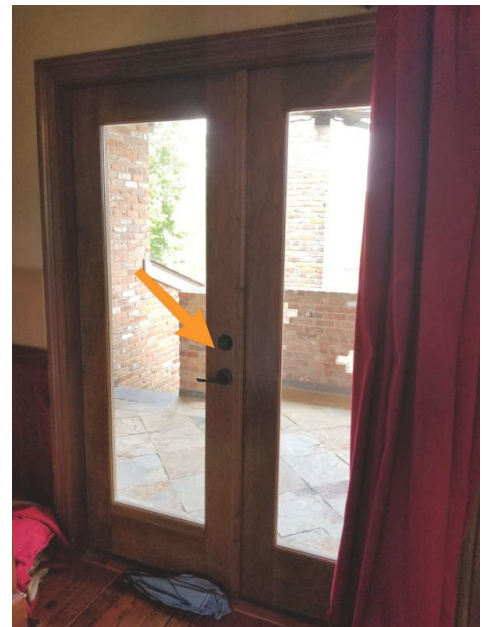
DEADBOLT- KEYED BOTH SIDES

Multiple doors to the home exterior had deadbolts that required a key for operation from the inside. This condition is unsafe as it may slow or prevent exit during an emergency.

Contact a handyman or DIY project

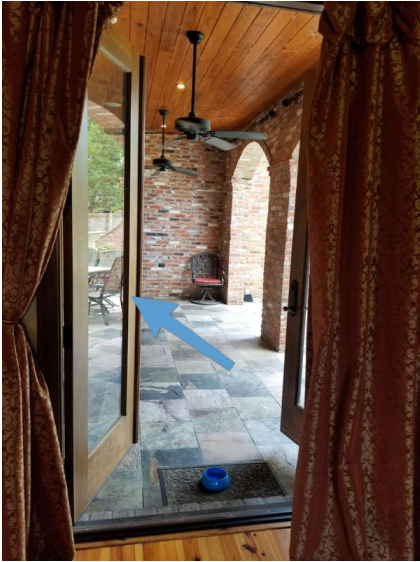
Rear of House

OPEN OUTWARD

One or more exterior entry doors opened outwards and didn't appear to have security hinges and/or an anti pry plate over the lockset area. Doors that open outwards have hinges oriented so the pins are exposed outside and can easily be removed also strikers and/or deadbolts can be pried open. Without security hinges, the door can also be removed allowing someone to gain entry.

Contact a qualified door repair/installation contractor.

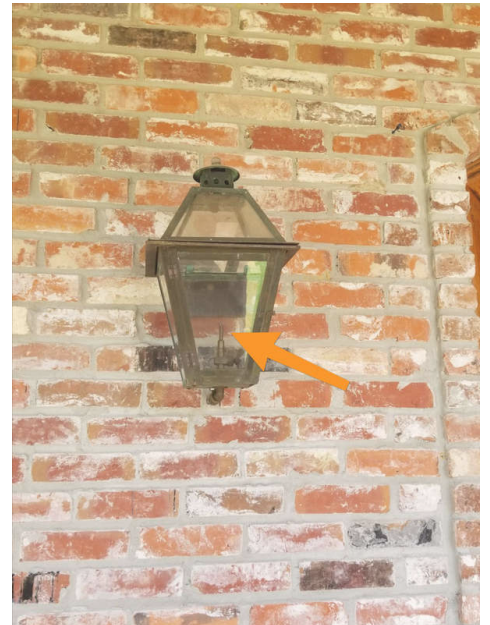
Front of House

EXTERIOR LIGHTING- INOPERABLE

One or more lights were inoperable at the time of the inspection.

Contact a qualified electrical contractor.

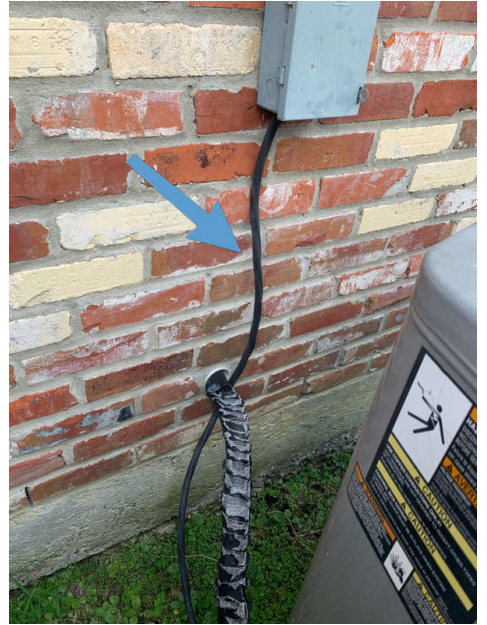
Rear of House

CONDUIT- MISSING

Exterior wiring was noted at the time of the inspection. It was not protected and should be ran in conduit to prevent damage or electric shock.

Contact a qualified professional.

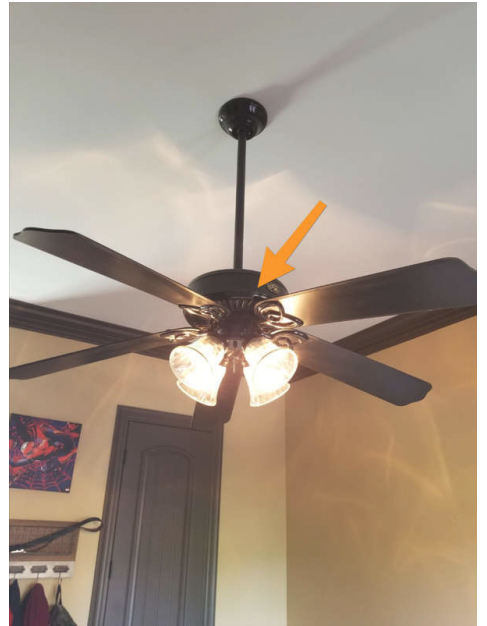
Bedroom 2

CEILING FAN- INOPERABLE

The ceiling fan in this bedroom was inoperable.

Contact a qualified electrical contractor.

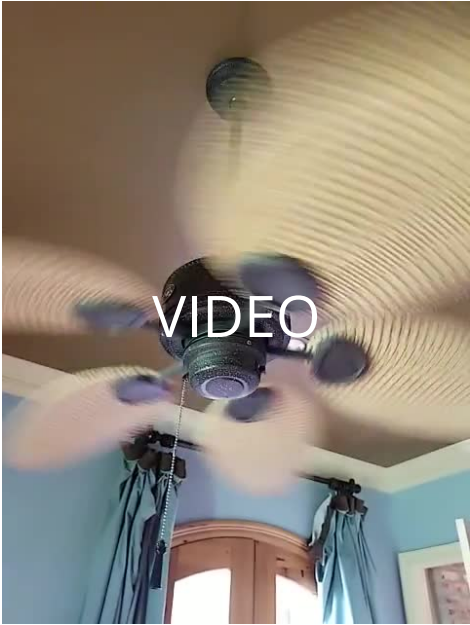
CEILING FAN- NOISY

The ceiling fan in this bedroom was noisy during operation. This condition is typical of deteriorated fan components.

Contact a handyman or DIY project

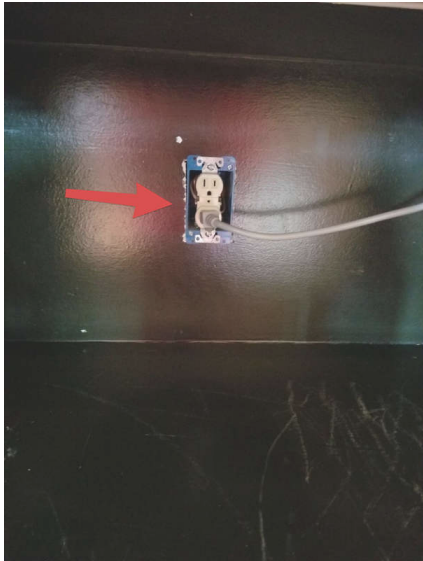
Upstairs cabinets

COVER PLATES MISSING

One or more receptacles are missing a cover plate. This causes short and shock risk.

Recommendation
Contact a qualified electrical contractor.

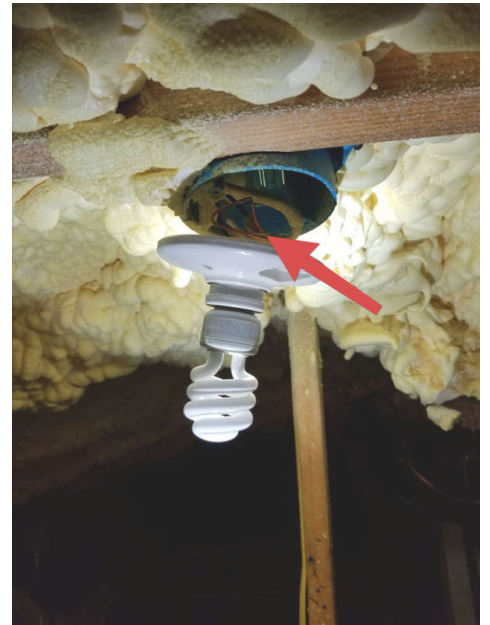
Attic

EXPOSED WIRING

An electrical fixture had energized electrical wires exposed to touch at the time of the inspection. This condition may represent a potential fire or shock/electrocution hazard.

Contact a qualified electrical contractor.

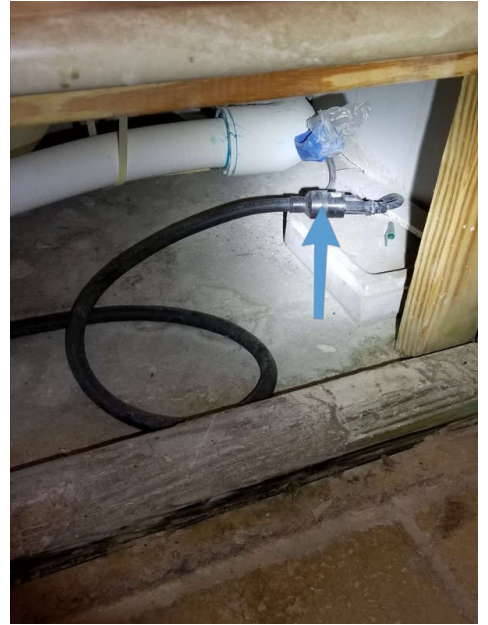
Master Bath

EXTENSION CORD

Extension cord used as permanent wiring was visible at the time of inspection. This condition is a potential fire hazard.

Contact a qualified electrical contractor.

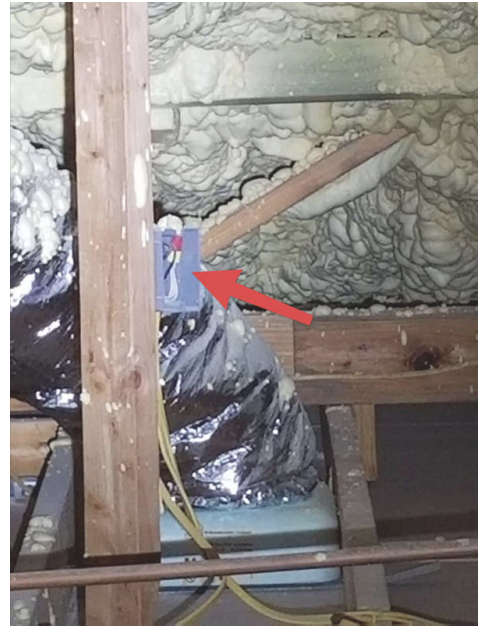
Attic

JUNCTION BOX- OPEN

Junction boxes were missing cover plates and energized electrical components were exposed to touch at the time of the inspection. This condition is a shock/electrocution hazard.

Contact a qualified electrical contractor.

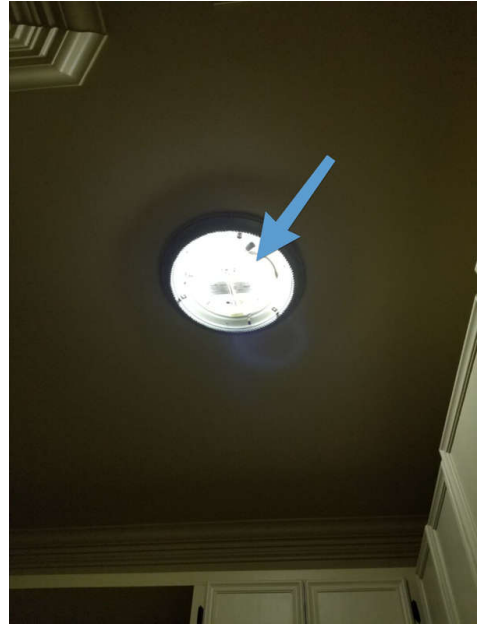
Master Closet

LIGHT COVER- MISSING

One or more plastic covers for the light fixture was missing at the time of inspection.

Contact a handyman or DIY project

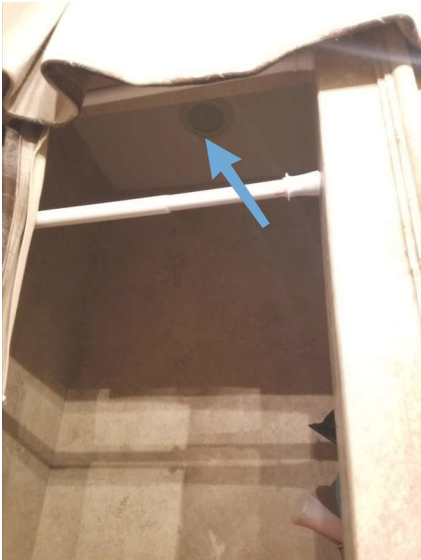
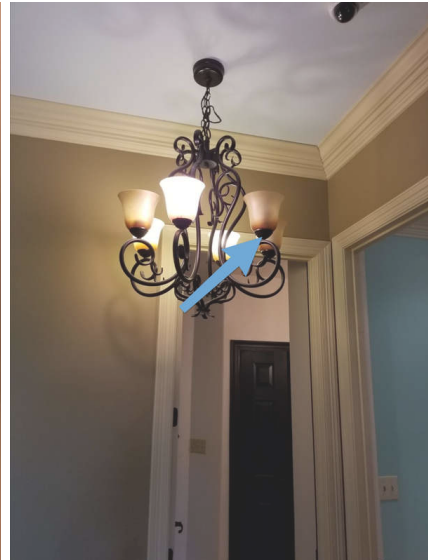
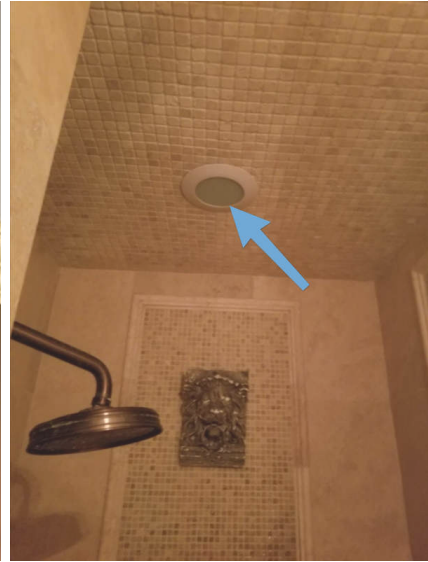
LIGHT INOPERABLE

One or more lights were inoperable at the time of the inspection. The bulb may need to be replaced or there may be a problem with the switch, wiring or light fixture.

Contact a qualified electrical contractor.

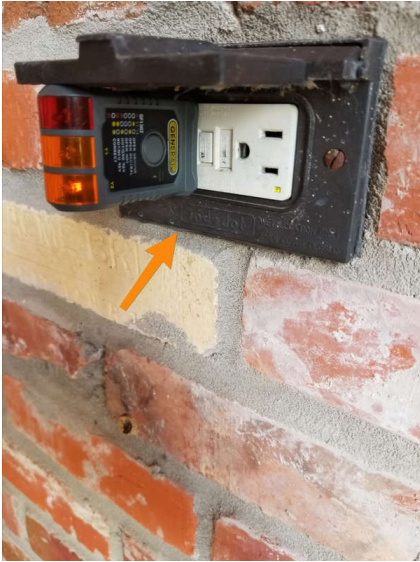
Back patio

RECEPTACLE- IMPROPERLY WIRED

One or more electrical receptacle(s) were improperly wired at the time of the inspection.

Contact a qualified electrical contractor.

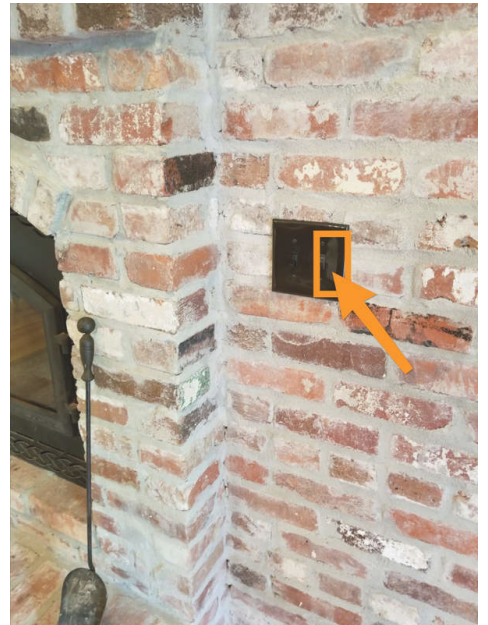
Living Room

SWITCH- INOPERABLE

A light switch in appeared to be inoperable at the time of the inspection. The inspector was unable to determine which device it was intended to control. You should ask the seller about its operation.

Recommendation
Contact a qualified electrical contractor.

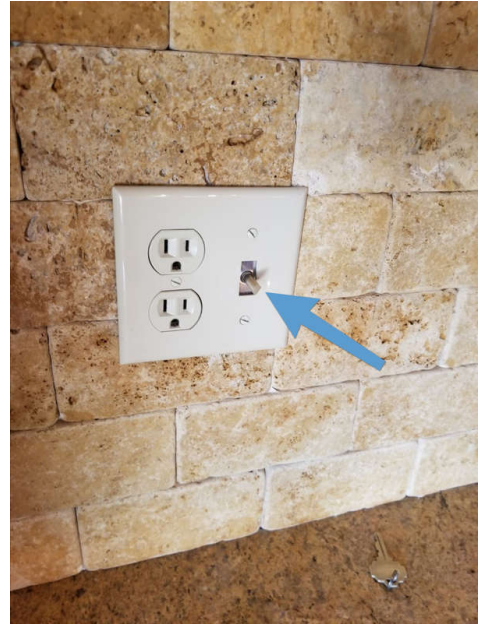
Kitchen

SWITCH- DAMAGED

Switch was damaged but was operational.

Recommendation
Contact a qualified professional.

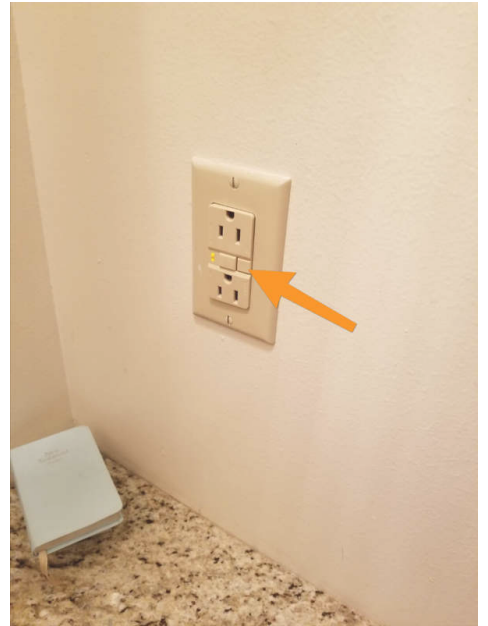
Upstairs Bathroom stairs

GFCI- NOT WORKING PROPERLY

A ground fault circuit interrupter (GFCI) electrical receptacle did not operate as intended when tested.

Contact a qualified electrical contractor.

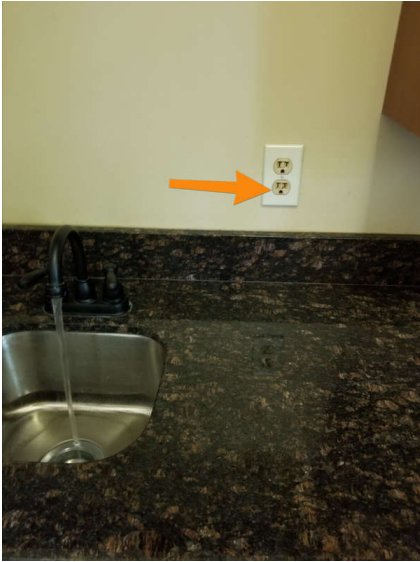
Laundry

GFCI- WITHIN 5 FEET OF WATER SOURCE

It is recommended that all receptacles, within 5 feet of a water supply source, are to be GFCI protected. One or more receptacles within that range were not GFCI protected, at the time of inspection.

Contact a qualified electrical contractor.

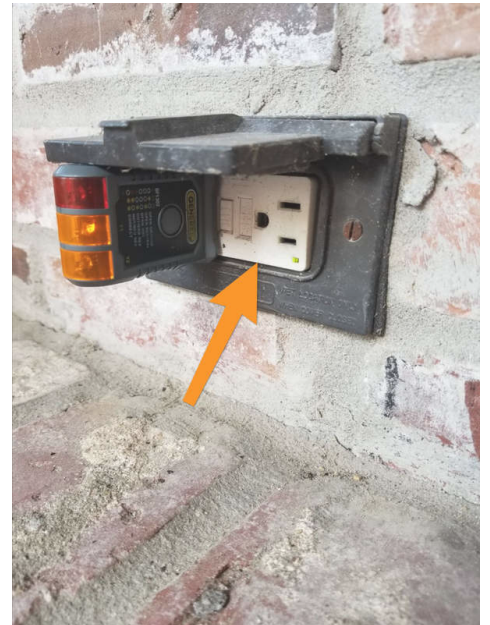
Back kitchen area

5.5.3 GFCI & AFCI
OPEN GROUND

One or more receptacles, at the time of inspection, had GFCI protection but were not functioning properly.

Recommendation
Contact a qualified professional.

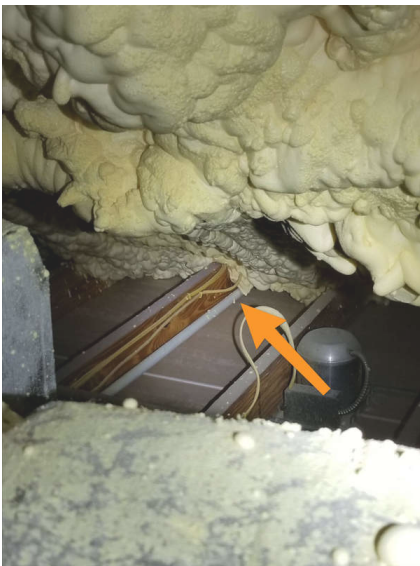
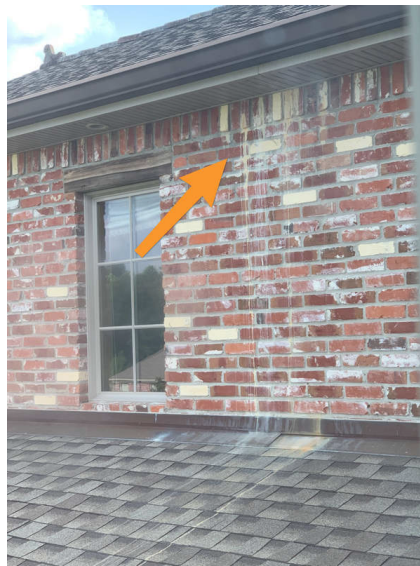
CONDENSATE LINE- IMPROPER INSTALLATION

The condensate line was running into the soffit vent. This can cause moisture damage to the interior of the home.

Contact a qualified HVAC professional.

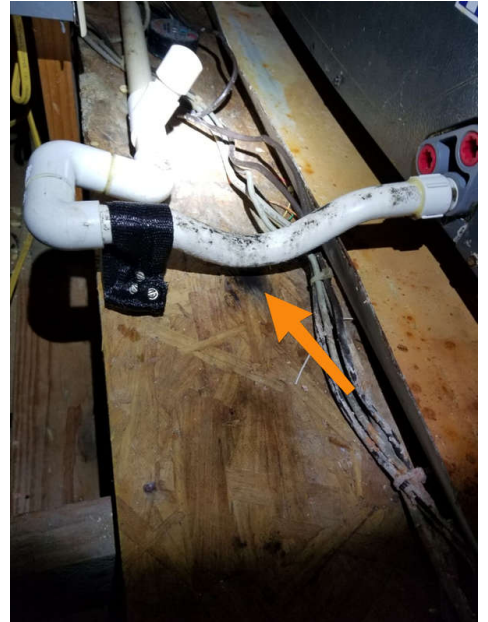
Attic

DRAIN LINE- CONDENSING OUTSIDE DRAIN PAN

Condensation line was leaking/draining outside the drip pan.

Contact a qualified HVAC professional.

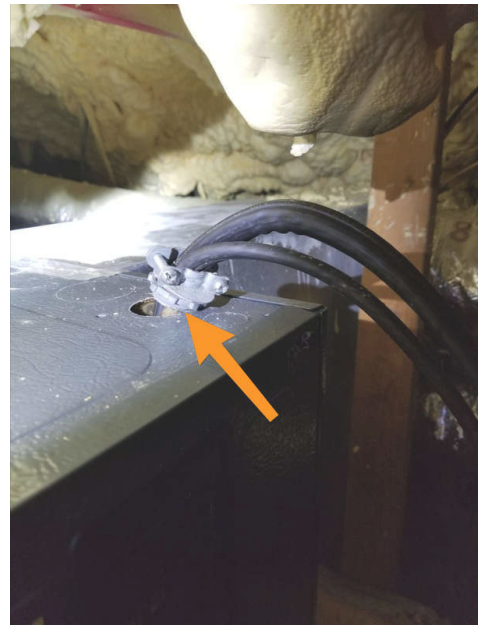
Attic

ELECTRICAL- IMPROPERLY SECURED

The hvac electrical supply was improperly secured.

Contact a qualified electrical contractor.

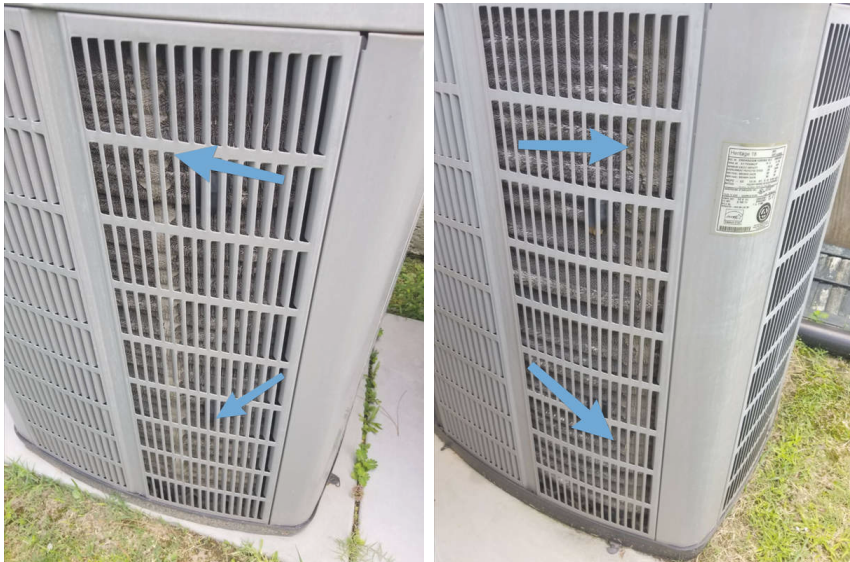
Rear of House

NEEDS SERVICING/CLEANING

HVAC system should be cleaned and serviced annually.

Contact a qualified HVAC professional.

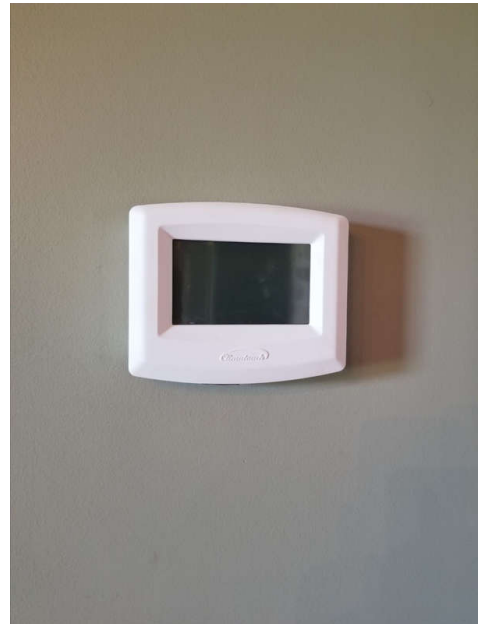
Dining

THERMOSTAT INOPERABLE

Thermostat did not working using normal operating procedures.

Contact a qualified HVAC professional.

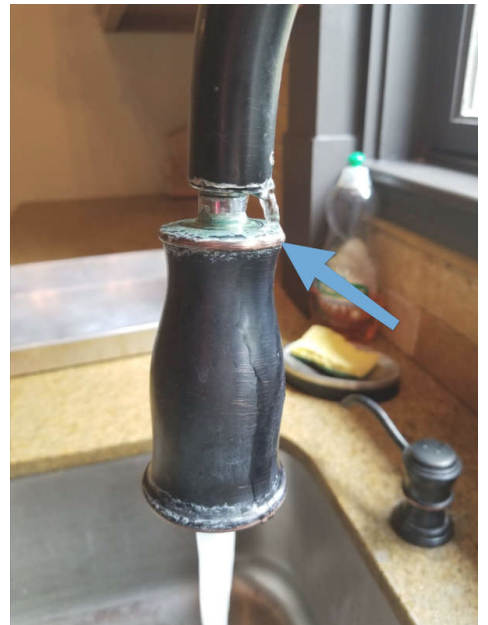
Kitchen

8.4.1 Sink
FAUCET- LEAK

The sink faucet was loose and leaked during operation.

Recommendation
Contact a qualified plumbing contractor.

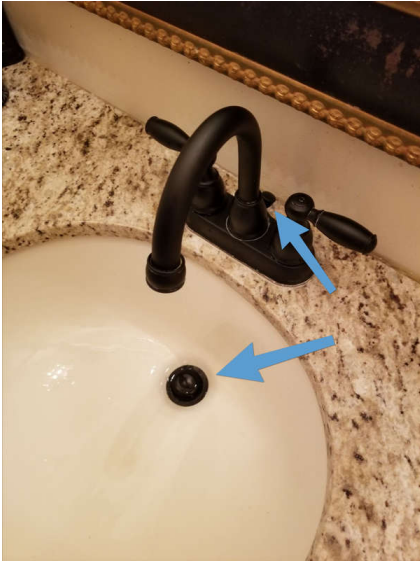
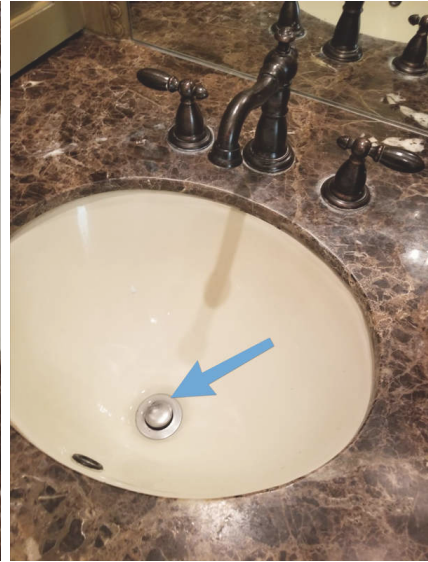
8.4.2 Sink
INOPERABLE STOPPER

One or more sink(s) in this bathroom had an inoperable stopper.

Recommendation
Contact a qualified plumbing contractor.

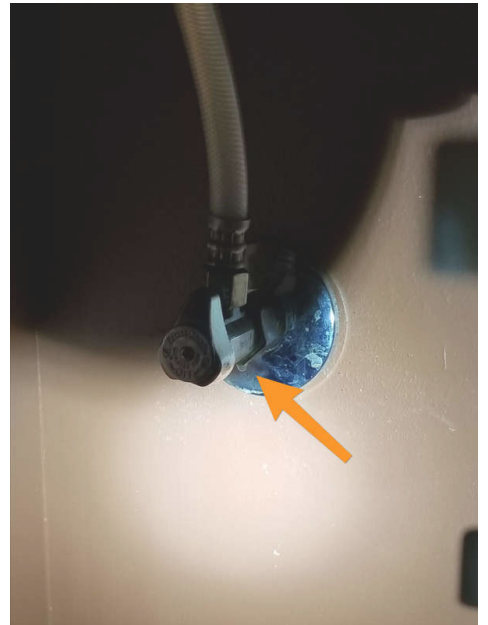
Upstairs Bathroom

8.4.3 Sink **LEAKING**

Sink leaked during operation.

Contact a qualified plumbing contractor.

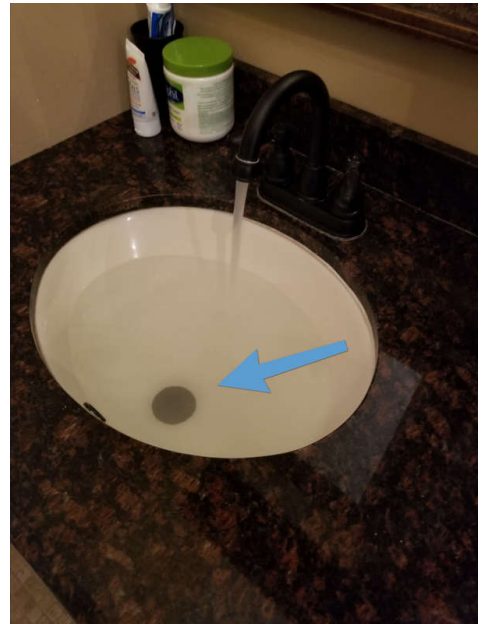
Upstairs Bathroom

8.4.4 Sink **SINK - POOR DRAINAGE**

Sink had slow/poor drainage.

Contact a qualified plumbing contractor.

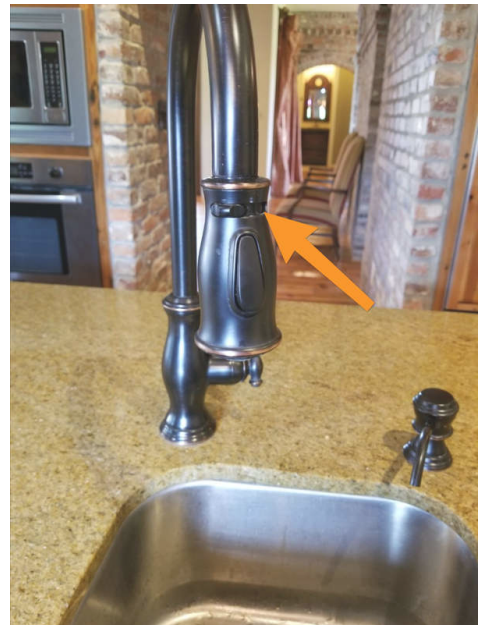
Kitchen

FAUCET- NOT FUNCTIONING PROPERLY

One or more sink faucets had multiple functions and was not operating as intended.

Contact a qualified plumbing contractor.

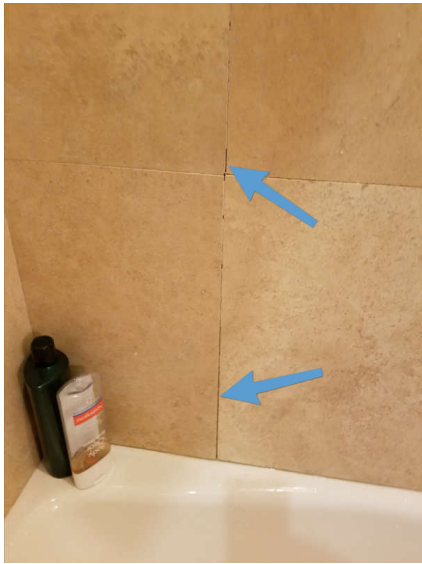
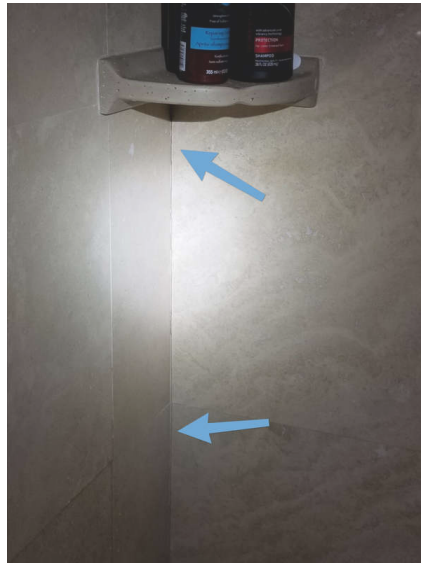
CAULK/GROUT LINE FAILED

Sealant where the tub meets the wall was old and had sections of missing sealant that may allow damage from moisture intrusion to the wall structure.

Contact a handyman or DIY project

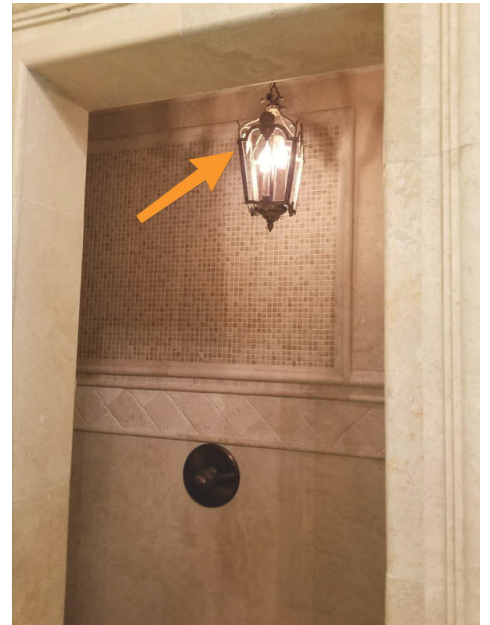
Master Bath

HANGING LIGHT FIXTURE-SHOWER

This is a potential safety/shock hazard.

Contact a qualified plumbing contractor.

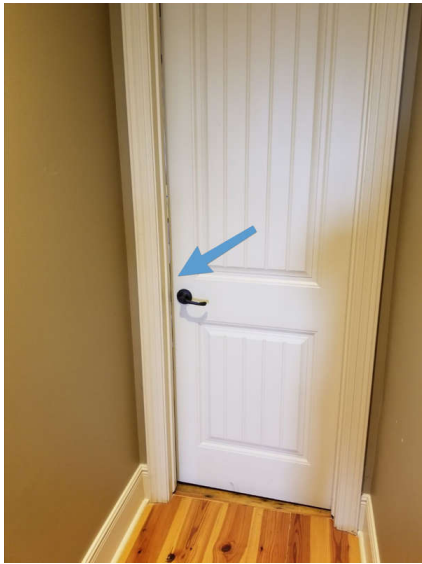
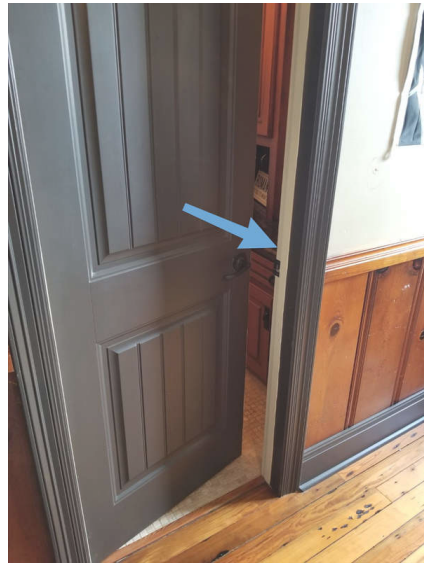
DOESN'T LATCH

Door doesn't latch properly.

Contact a qualified handyman.

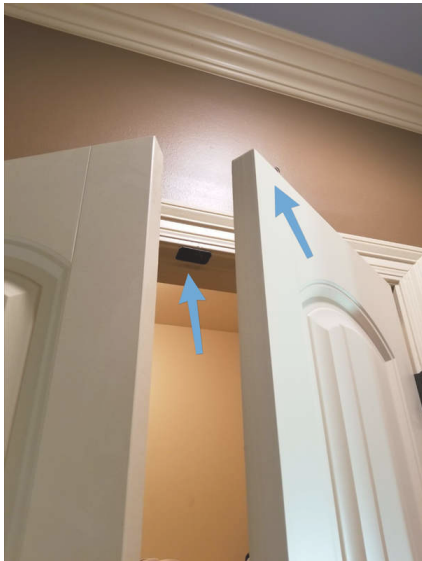
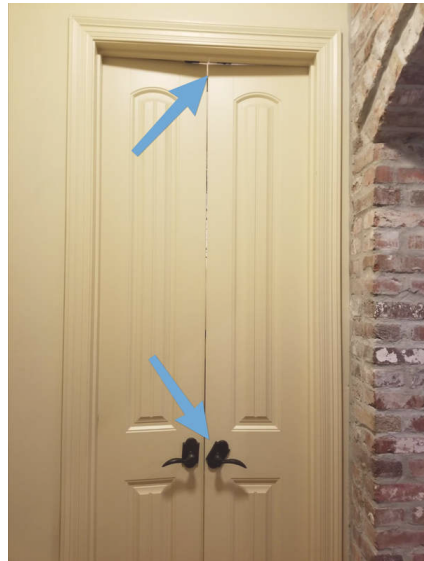
LOOSE/DAMAGED HARDWARE

An interior door had loose/damaged hardware.

Contact a qualified door repair/installation contractor.

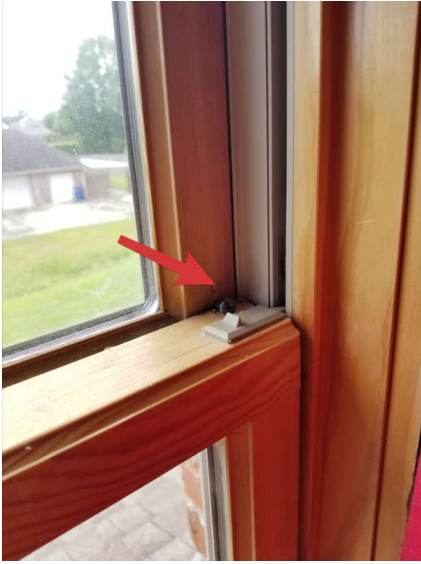
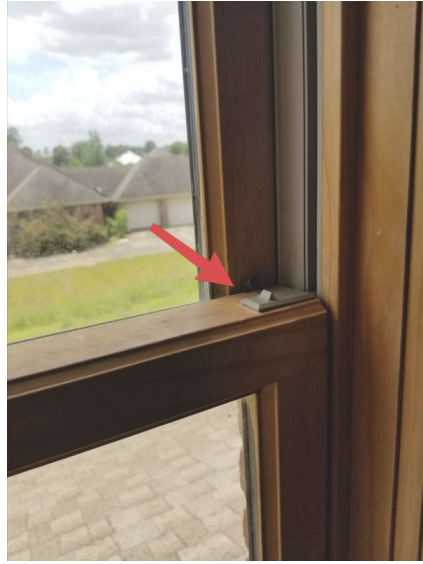
INOPERABLE WINDOW

One or more windows were inoperable at the time of the inspection. They had a screw in them.

Contact a qualified professional.

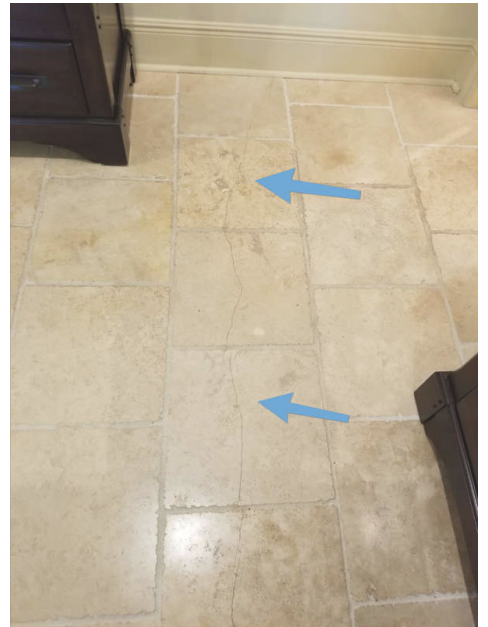
Master

TILES- CRACKED

Loose/cracked tiles were present at time of inspection.

Contact a qualified flooring contractor

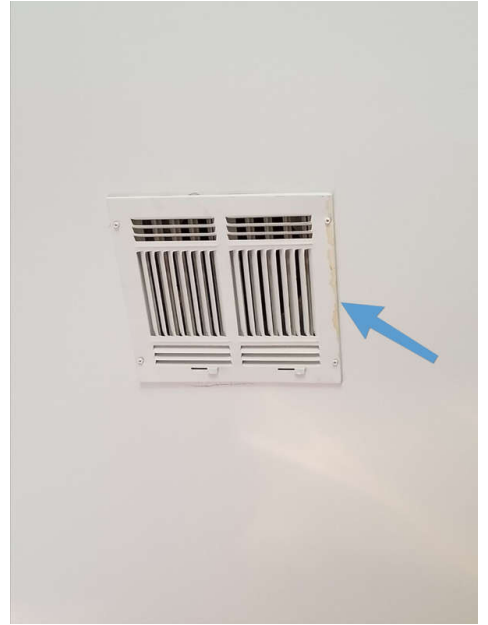
Bedroom 2

MOISTURE INTRUSION

One or more areas appeared to have moisture damage. These areas may or may not be wet from active leaks.

Contact a qualified professional.

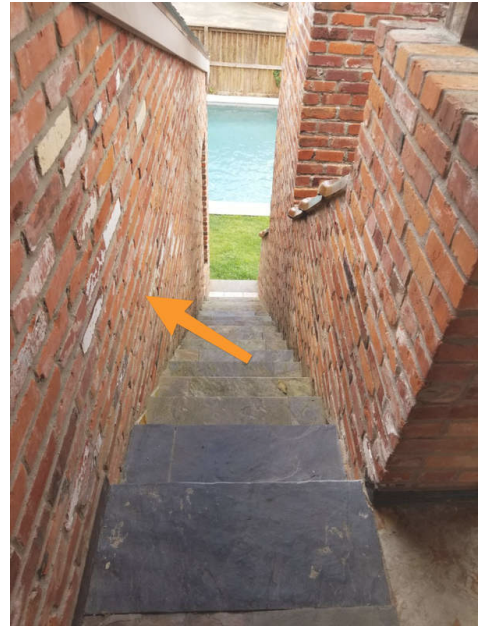
Rear of House

HANDRAIL- MISSING

Staircase had no handrails. This is a safety hazard.

Recommendation
Contact a qualified handyman.

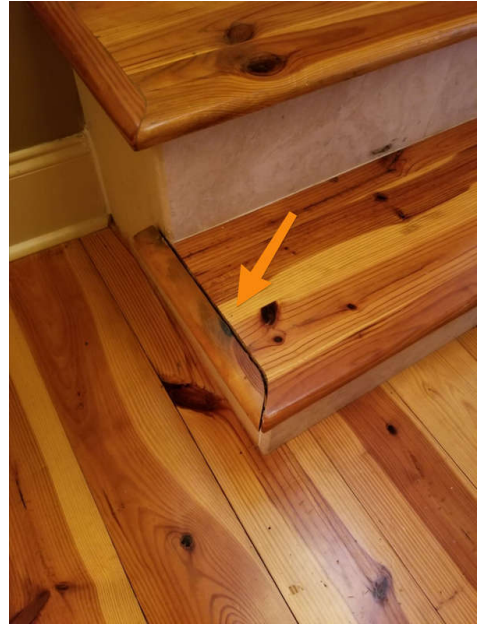
Stairs

STEP- DAMAGED

One or more steps were damaged and could be a trip hazard.

Recommendation
Contact a qualified professional.

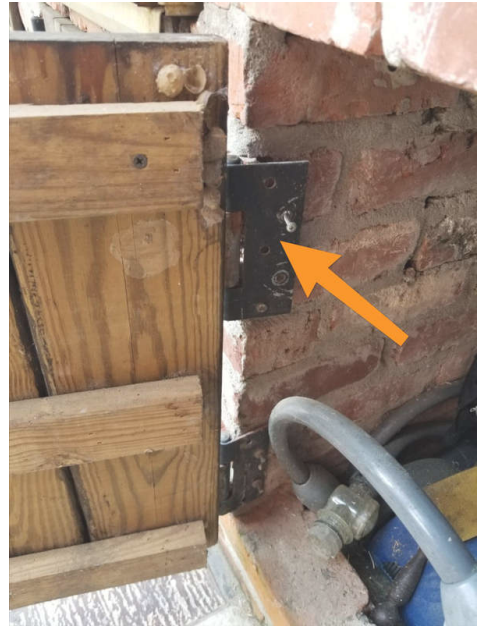
Back kitchen area

CABINET DOOR HARDWARE-DAMAGED

Cabinet door did not operate properly due to damaged hardware.

Contact a qualified cabinet contractor.

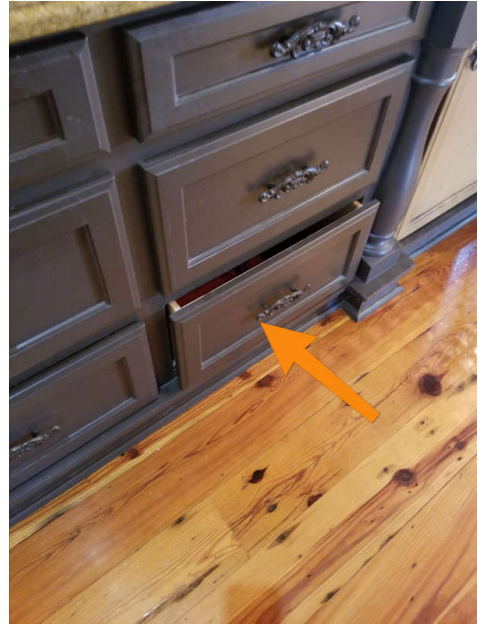
Kitchen

DRAWER- DOESN'T CLOSE PROPERLY

One or more drawers did not line up and close properly.

Contact a handyman or DIY project

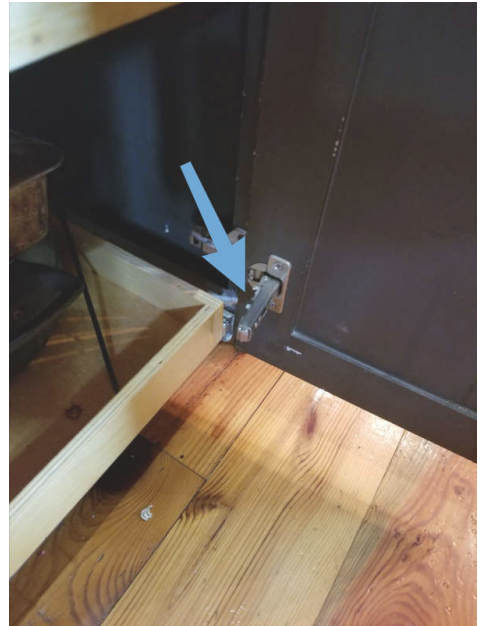
Kitchen

11.7.3 Countertops & Cabinets
HINGE- DAMAGED/LOOSE

One or more cabinet hinges were damaged/loose.

Recommendation
Contact a qualified cabinet contractor.

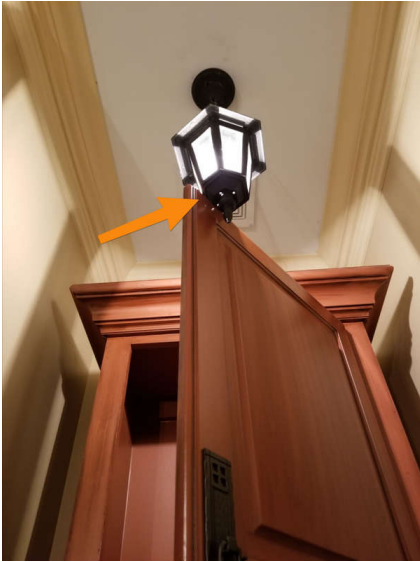
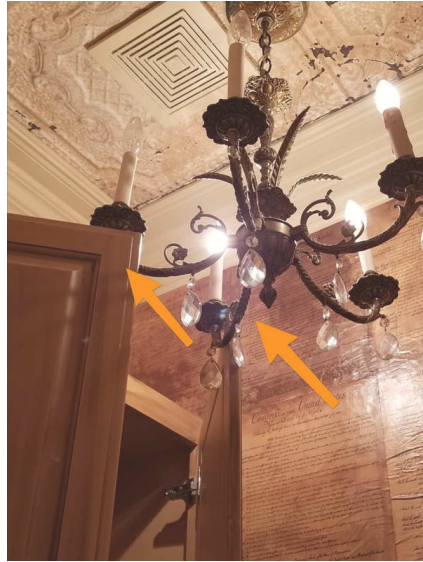
11.7.4 Countertops & Cabinets
IMPROPER DESIGN

The cabinet door hit the light when opened.

Recommendation
Contact a qualified general contractor.

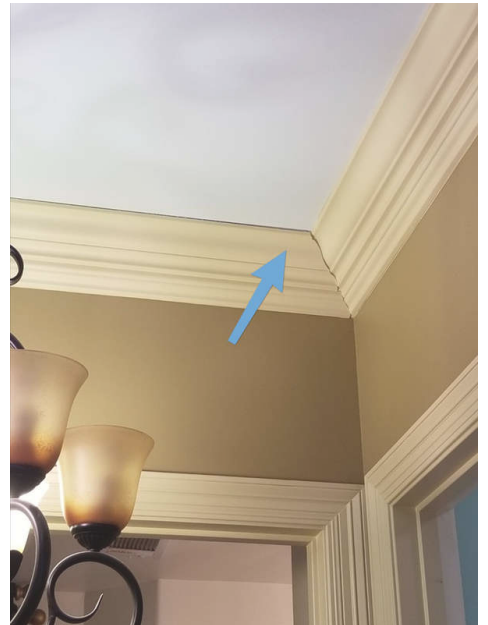
Upstairs

TRIM- SEPERATING

One or more areas of trim were seperating from the wall.

Contact a handyman or DIY project

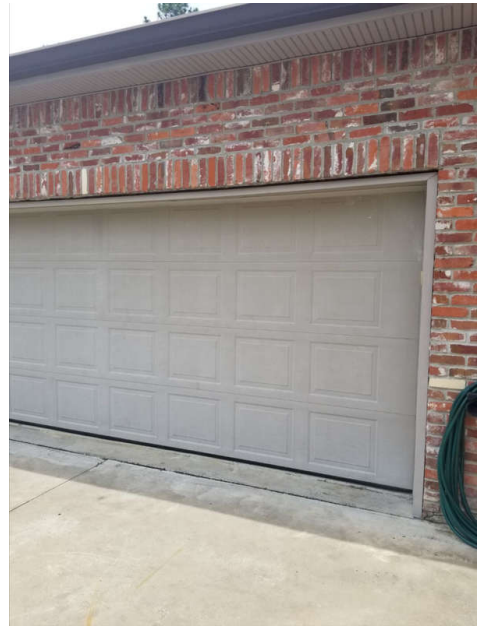
INOPERABLE

The garage door was inoperable, at the time of inspection.

Contact a qualified professional.
