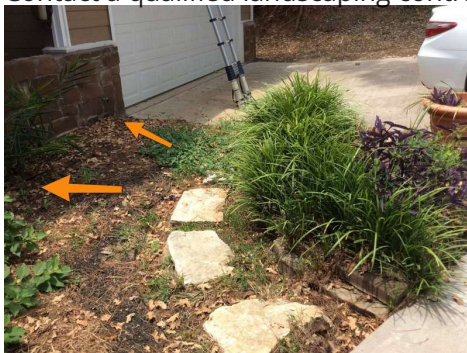
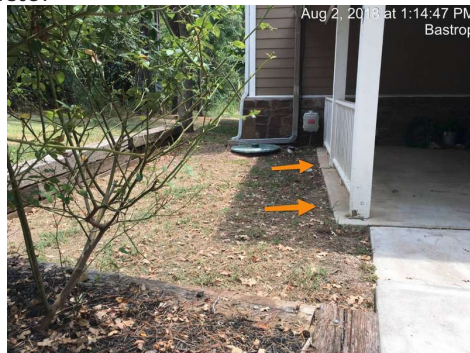
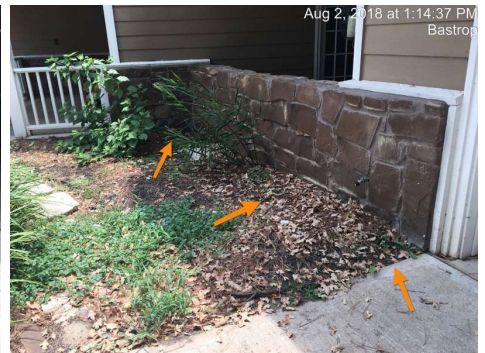
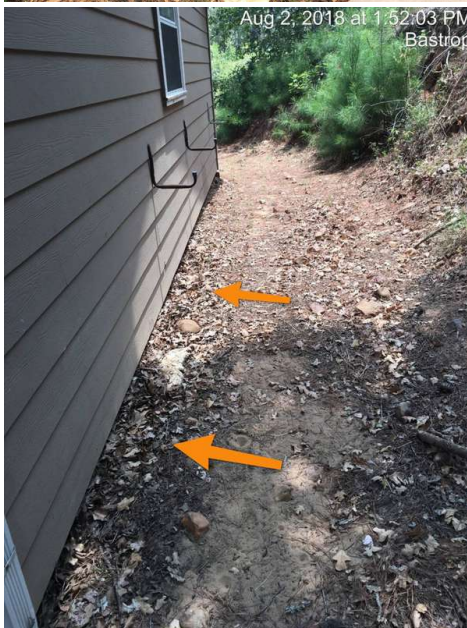
2.2.1 B. Grading and Drainage
NEGATIVE GRADE

Deficient: Front and right side of home has negative grade towards the home. Industry standards call for a minimum of 6" inch slope away from the foundation in the first 10 feet. Recommend having a landscaping specialist provide further evaluation and establish guidelines for achieving positive drainage in these areas.

Recommendation
Contact a qualified landscaping contractor

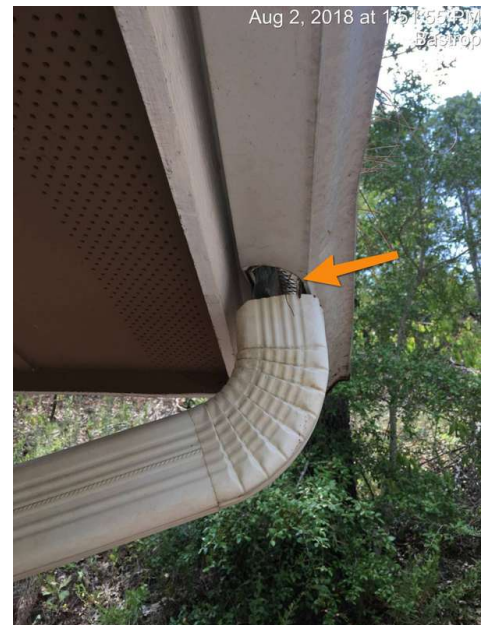
2.2.2 B. Grading and Drainage
**GUTTER DOWNSPOUT
DISCONNECTED**

Deficient: Down spout disconnected at bottom of gutter to the right of garage. Have a gutter specialist perform needed repairs.

Recommendation
Contact a qualified gutter contractor

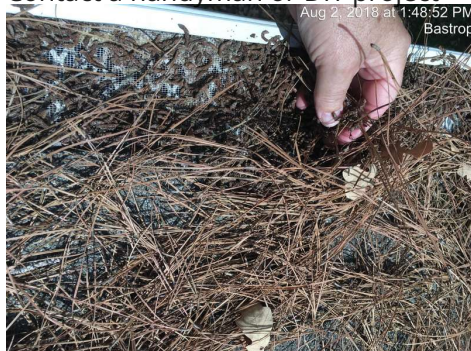
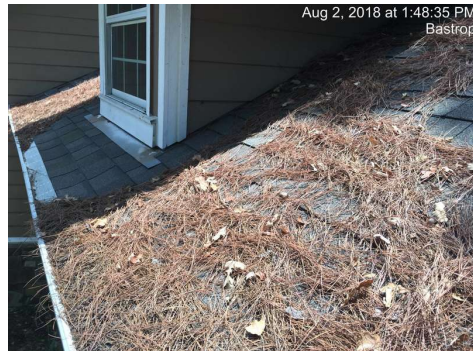
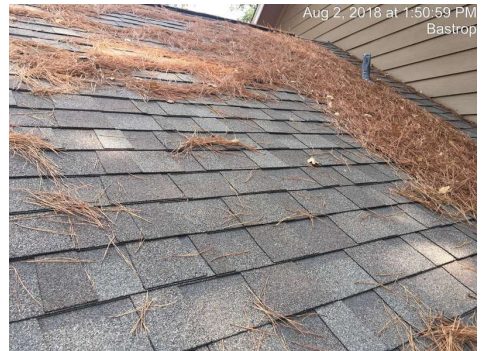
EXCESSIVE DEBRIS

Deficient: Roof covering has excessive amount of debris such as pine needles collecting on the surface. Gutters are being clogged and this can cause rain water to back wash onto fascia and into soffit cavities causing rot and deterioration in these locations. Recommend regular cleaning to prevent water damage from occurring.

Contact a handyman or DIY project

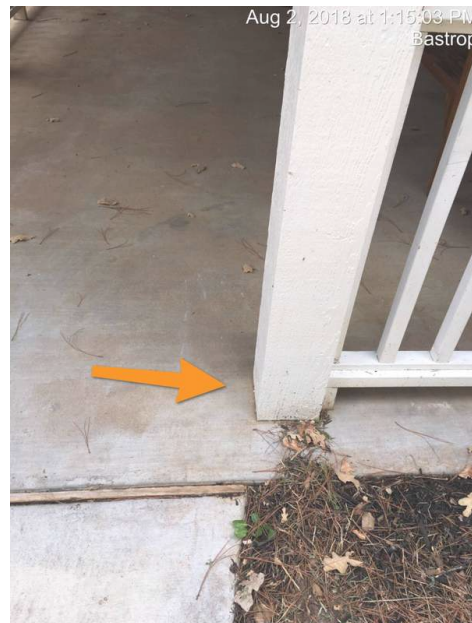
SUPPORT POST BASES:

Deficient: Support post on front porch should have metal post bases installed to prevent deterioration and rot from occurring from wood to concrete contact. Recommend having a carpentry specialist perform needed repairs.

Recommendation
Contact a qualified carpenter.

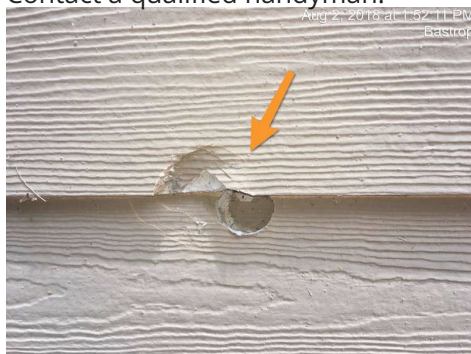
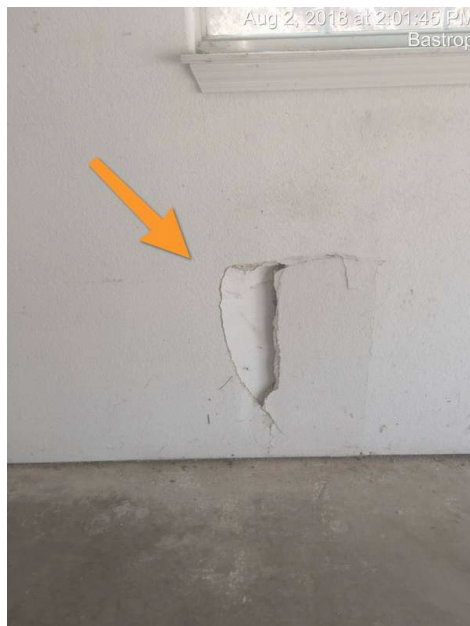
WALL DAMAGES

Deficient: Exterior siding has one minor area with damage on the right side of the garage, and the interior wall of the garage has some sheet rock damage. Have a handyman provide needed repairs.

Recommendation
Contact a qualified handyman.

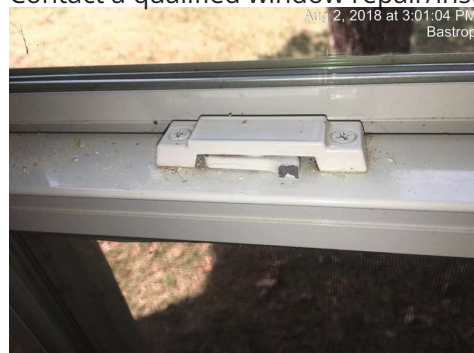
WINDOW ISSUES:

Deficient: The following issues were discovered with windows:

Latches are broken on downstairs front bedroom window.

Upstairs master bedroom window has a broken glass.

Have a window & glass specialist perform needed repairs.

Contact a qualified window repair/installation contractor.

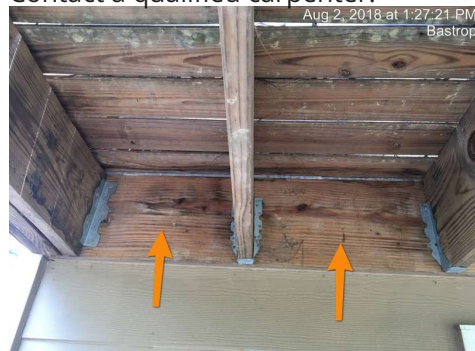
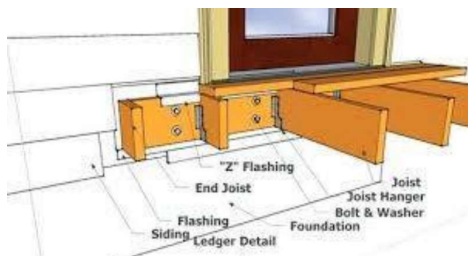
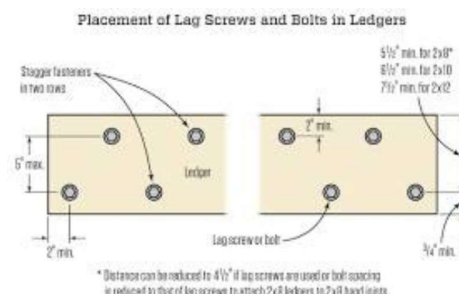
LEDGER BOARD

Deficient: Ledger board supporting back balcony deck is required to have specific fasteners installed in a specific pattern. (see attached diagram) Recommend adding wood supports under the outside band joist to add additional stability.

Contact a qualified carpenter.

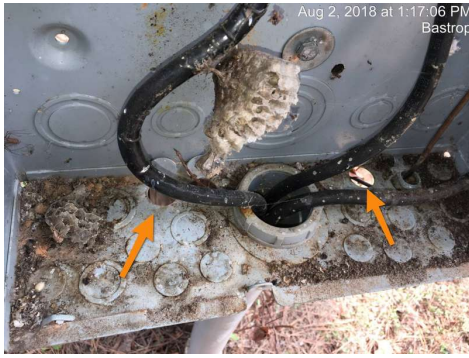
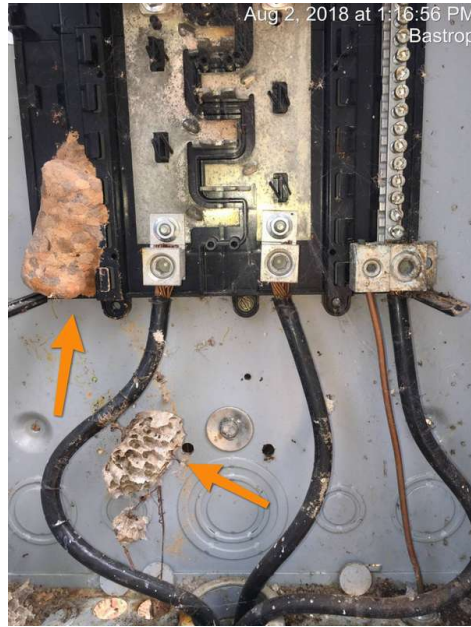
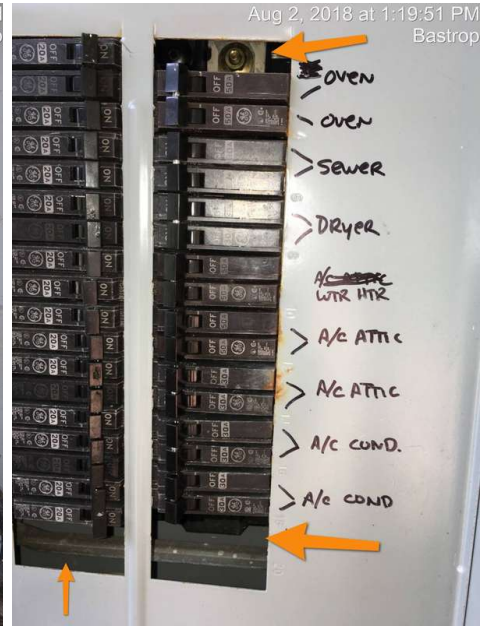
SERVICE PANEL ISSUES:

Deficient: The following deficiencies were discovered with the service panels:

Panel located right below meter with the main disconnect is not sealed. There are openings in the bottom of the panel allowing insects such as wasp to build nest inside the panel. This can very easily cause a short and can be very dangerous. Recommend having an electrical specialist perform needed repairs.

Sub-panel located on exterior of wall does not have the required space in front of the panel to allow for a safe environment when working on the panel. Industry standards call for a minimum of 36" inches in front of the panel with 30" inches free space on either side of the panel. Recommend cutting tree that is obstructing this space back to allow for proper access.

Sub-panel has knock-out covers missing on panel cover to protect live wiring on the inside of the panel. Have an electrical specialist perform needed repairs.

Contact a qualified electrical contractor.

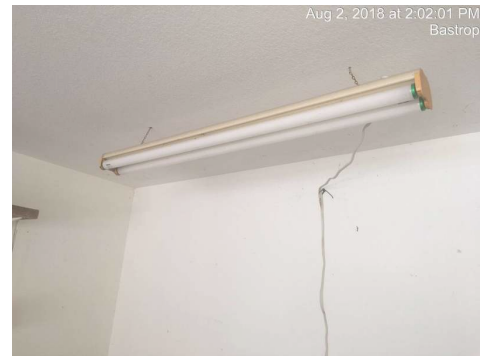
EXPOSED LIGHT BULBS:

Deficient: All exposed light bulbs are required to have a shatterproof globe as protection. Have a handyman provide needed repairs.

Recommendation
Contact a qualified handyman.

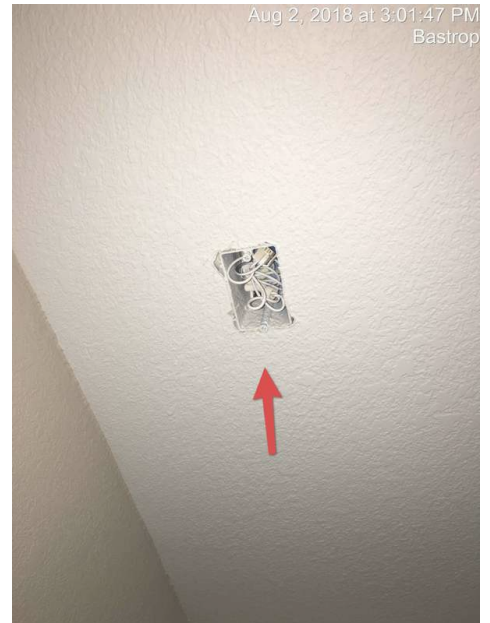
MISSING SMOKE DETECTORS

Deficient: Two bedrooms have missing smoke detectors, hallway outside of bedrooms does not have a smoke detector as required. Have an electrician install all new combination smoke /carbon monoxide detectors as now required.

Recommendation
Contact a qualified electrical contractor.

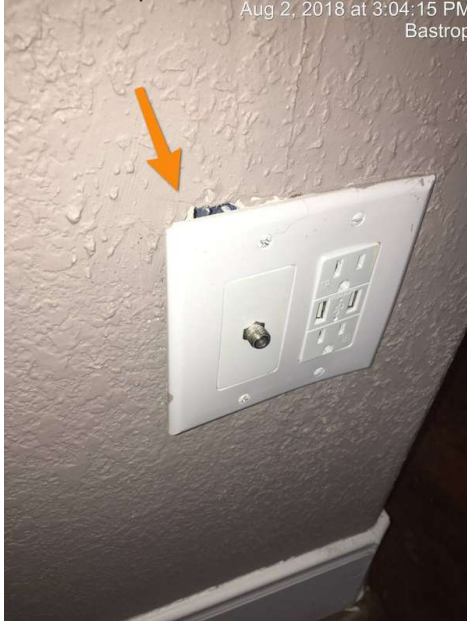
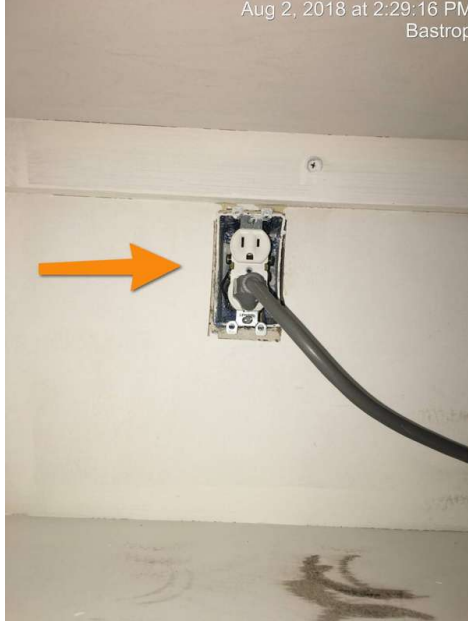
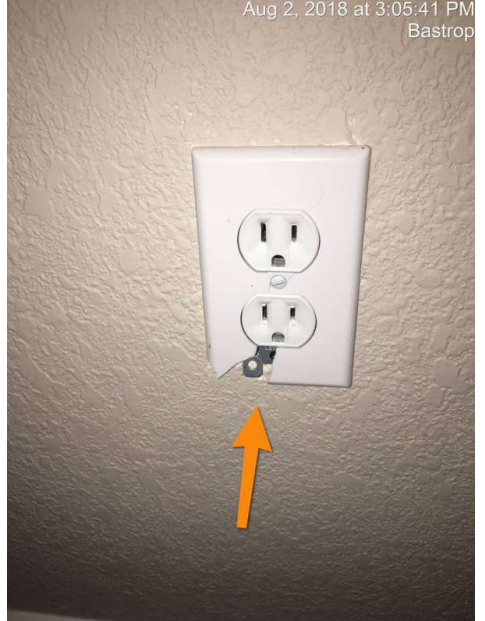
RECEPTACLE ISSUES:

Deficient: The following receptacle issues were discovered:

Receptacle in dining room is not fitting tight to the wall as required.

Receptacle in upstairs front bedroom has no power to top plug.

Receptacle cover damaged in upstairs bedroom.

Receptacle cover missing in cabinet above microwave.

Contact a qualified electrical contractor.

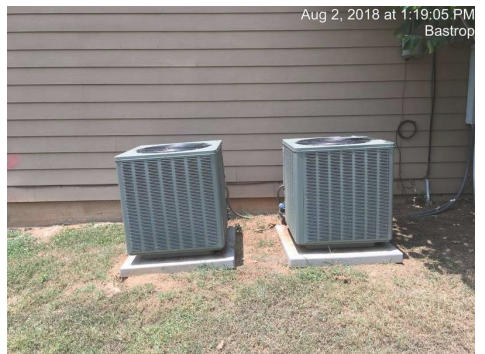
UNIT NOT LEVEL

Deficient: Concrete pad supporting one of the outdoor condensing units is not level. This can cause accelerated deterioration of components. Recommend licensed HVAC contractor level the unit.

Contact a qualified HVAC professional.

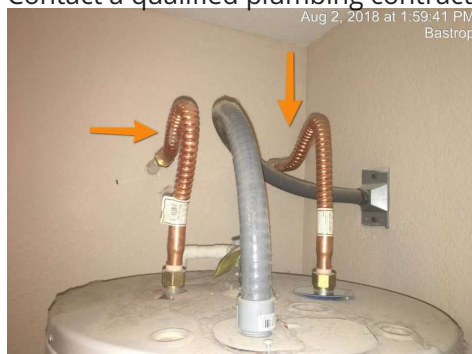
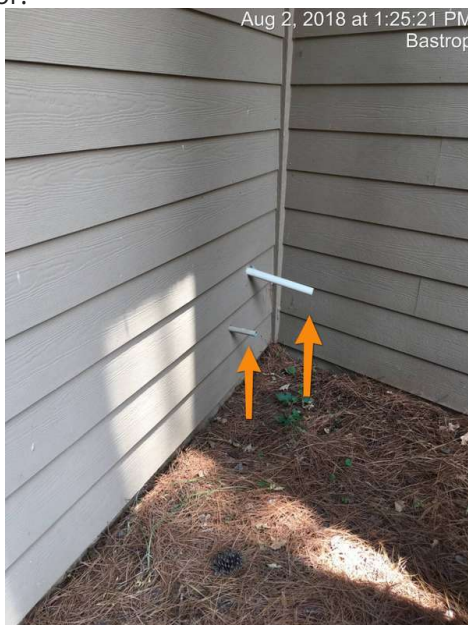
NO CUT-OFF VALVE

Deficient: Cold water supply line for the water heater does not have a cut-off valve at the entrance to the tank as required. Cold water line into water heater should have a cut-off valve to allow water supply to be turned off for service or in an emergency event.

Deficient: Drain line terminations should have a 90 degree turn-down installed that terminated approx. six inches above grade.

Note: It is also recommended that hot water line be insulated.

Have a plumbing specialist perform needed repairs.

Contact a qualified plumbing contractor.

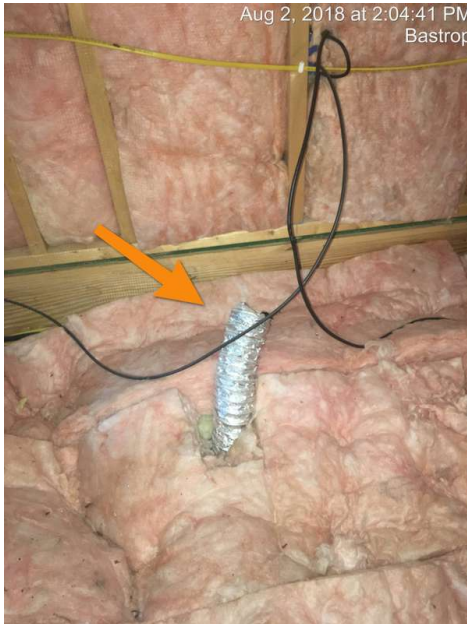
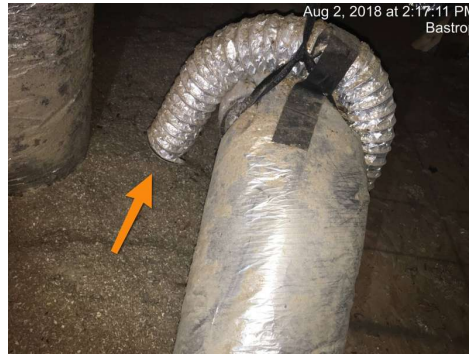
IMPROPER VENTING

Deficient: Improper venting practices were noted. All bathroom exhaust fans are terminated into attic space and are required to vented to the exterior of the home. Have a plumbing specialist provide needed repairs.

Contact a qualified plumbing contractor.

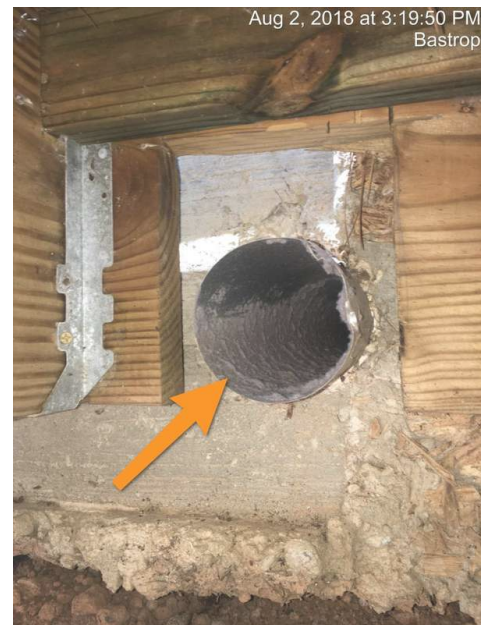
6.8.1 H. Dryer Exhaust Systems DRYER VENT EXHAUST DIRTY

Deficient: Dryer vent exhaust pipe is clogged with lint and will need to be cleaned by a professional. Annual cleaning is recommended to prevent build-up of lint.

Recommendation
Contact a qualified professional.
