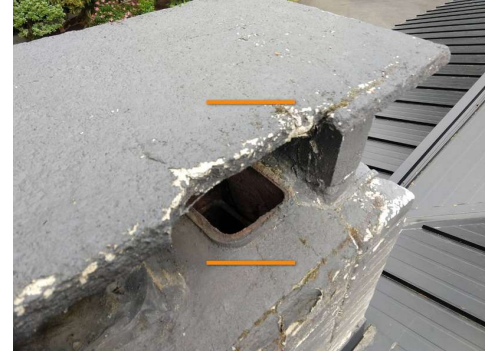
## 3.5.1 Chimney

**DETERIORATED CONCRETE CAP**

The top concrete chimney cap has a chunk missing out of it and is showing early signs of deterioration. I recommend replacing this at some point in the near future before it becomes a bigger issue.

Contact a qualified chimney contractor.

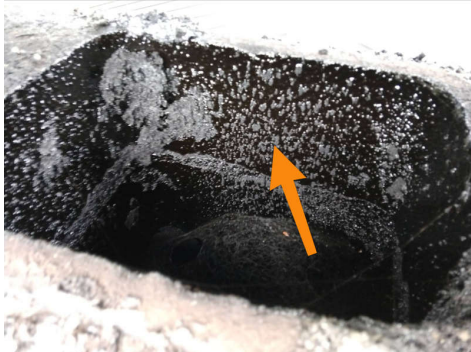
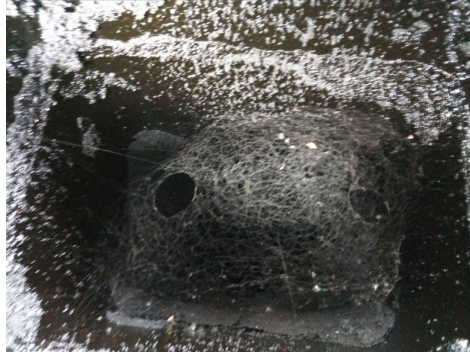
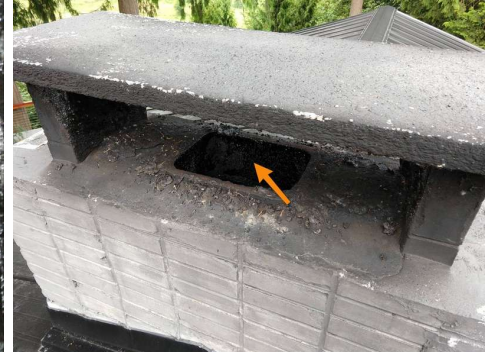
## 3.5.2 Chimney

**CLEANING**

The chimney flues are dirty and is in need of cleaning. I recommend the chimney is cleaned and certified before use by a chimney cleaning contractor.

Contact a qualified professional.

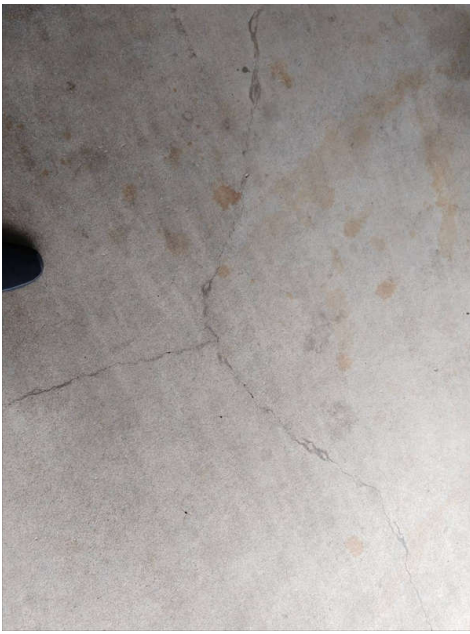
## 4.2.1 Driveway, Walkway, Patio

**MINOR DRIVEWAY DAMAGE**

Minor deterioration (e.g. cracks, holes, settlement, heaving) was found in the driveway, but no trip hazards were found. The client may wish to have repairs made for cosmetic reasons.

Contact a qualified professional.

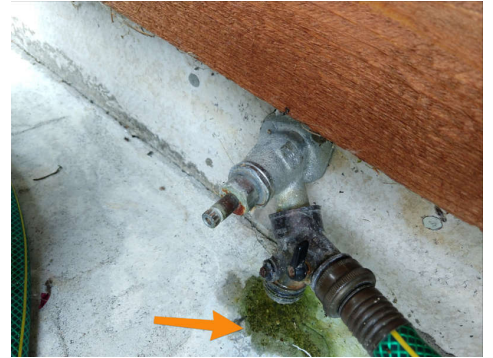
4.3.1 Exterior issues

**HOSE BIBB LEAK**

One or more hose bibs leaked *when tested / while off*. When hose bibs leak while turned off, it's often caused by a worn valve seat or a loose bonnet. When hose bibs leak while turned on, it may be due to worn "packing" around the stem or a defective backflow prevention device. Recommend that a qualified plumber repair as necessary.

Contact a qualified plumbing contractor.

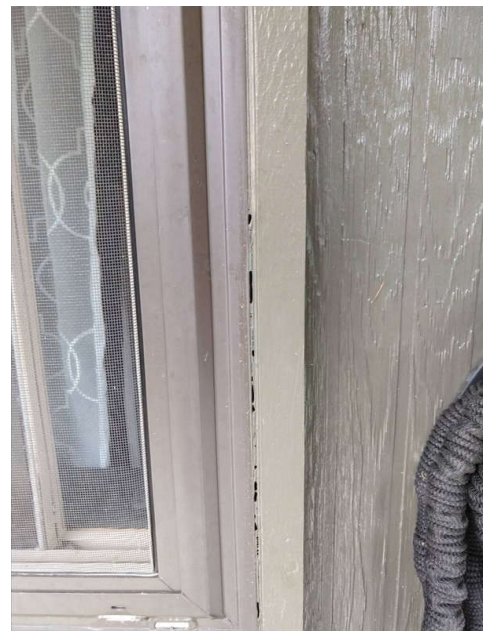
4.3.2 Exterior issues

**CAULKING/TRIM**

Some of the caulking on the exterior trim boards, siding seams, windows, doors, fascia boards, was cracking. This can cause potential water intrusion areas, that will lead to accelerated deterioration. Caulking around trim boards, windows, fascia, and exterior fixtures should be inspected and repaired as needed on an annual basis.

Contact a qualified professional.

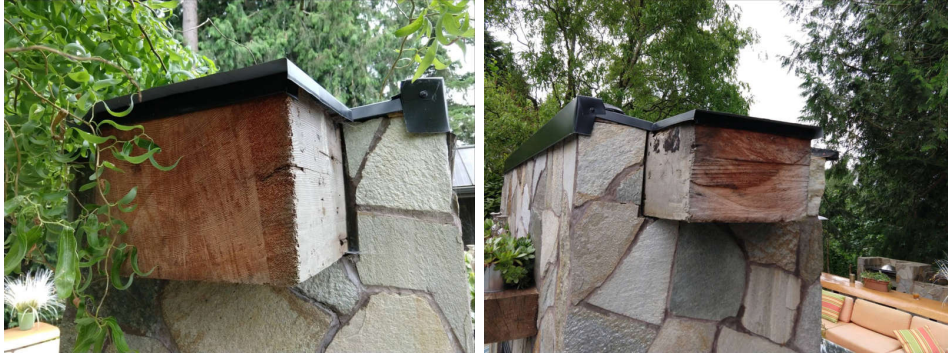
4.3.3 Exterior issues

**EXPOSED BEAM NEEDS SEALING.**

The beam over the exterior fireplace is bare wood. I recommend sealing/staining this to prevent the beam from deterioration and water damage.

Recommendation  
Contact a qualified professional.

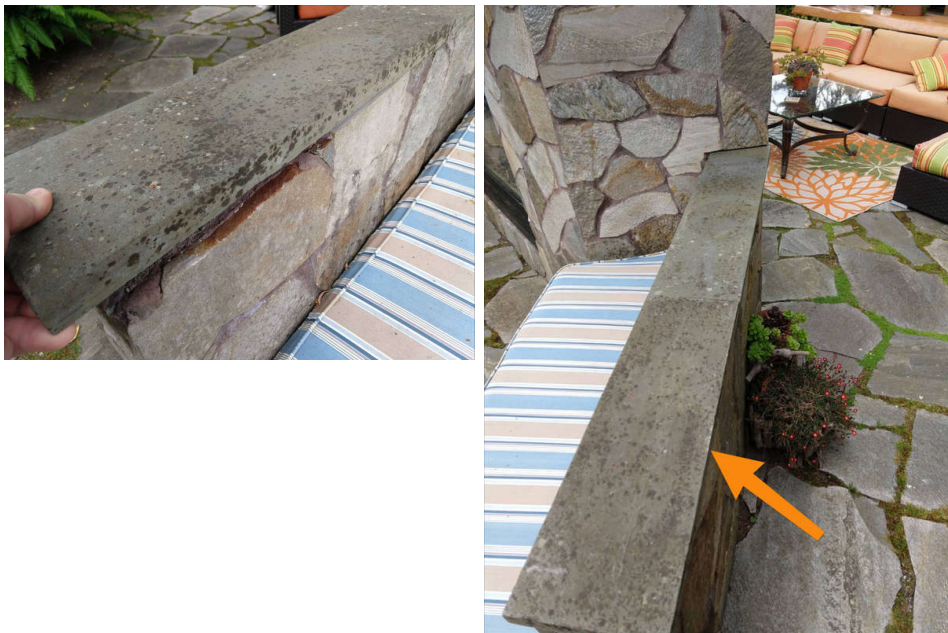
#### 4.3.4 Exterior issues

### CONCRETE BLOCKS LOOSE

The stone cap around the exterior fireplace is just sitting in place and is loose. I recommend mortaring these in place to prevent them from fall off and breaking or hurting someone. This would be a easy fix for A licensed masonry contractor.

Recommendation  
Contact a qualified professional.

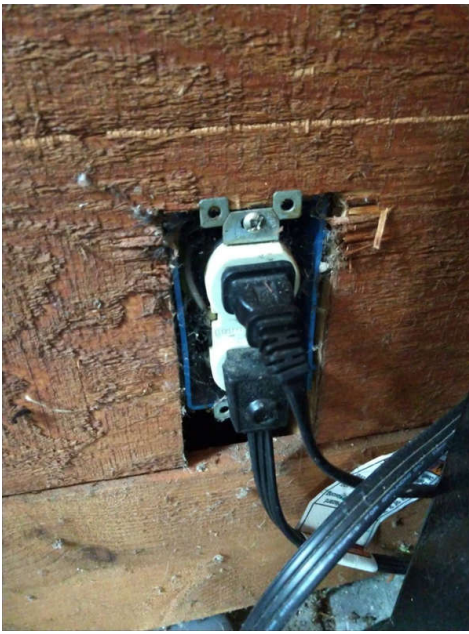
#### 4.4.1 Electrical

### COVER PLATE ISSUES

One or more *cover plates / light fixtures / electric boxes / conduits or conduit fittings / water proof covers* installed outside were *loose / damaged / deteriorated / corroded / substandard / missing components / missing*. This is a potential shock and/or fire hazard. Recommend that a qualified electrician repair as necessary.

Recommendation  
Contact a qualified electrical contractor.

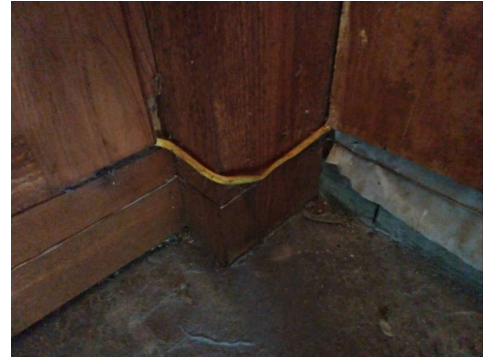
#### 4.4.2 Electrical

### EXPOSED WIRES

One or more sections of outdoor wiring were exposed and *not rated for exterior use / subject to damage*. This is a potential shock hazard. Recommend that a qualified electrician repair per standard building practices. For example, by installing conduit, re-routing wires or replacing wiring.

Contact a qualified electrical contractor.

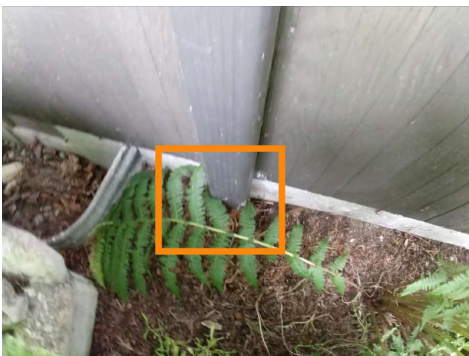
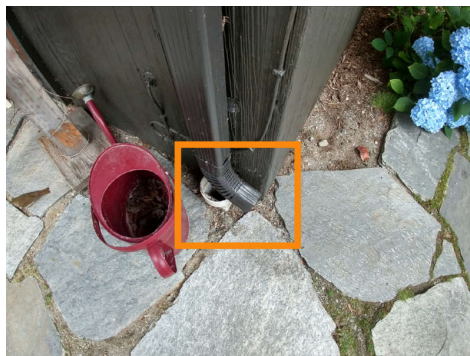
#### 4.7.1 Gutters and Flashing

### DOWNSPOUT EXTENSIONS

Extensions such as splash blocks or drain pipes for one or more downspouts were *missing / poorly sloped / misaligned / clogged / substandard / damaged*. Water can accumulate around the building foundation or inside crawl spaces or basements as a result. Recommend that a qualified person install, replace or repair extensions as necessary so rainwater drains away from the structure.

Contact a qualified professional.

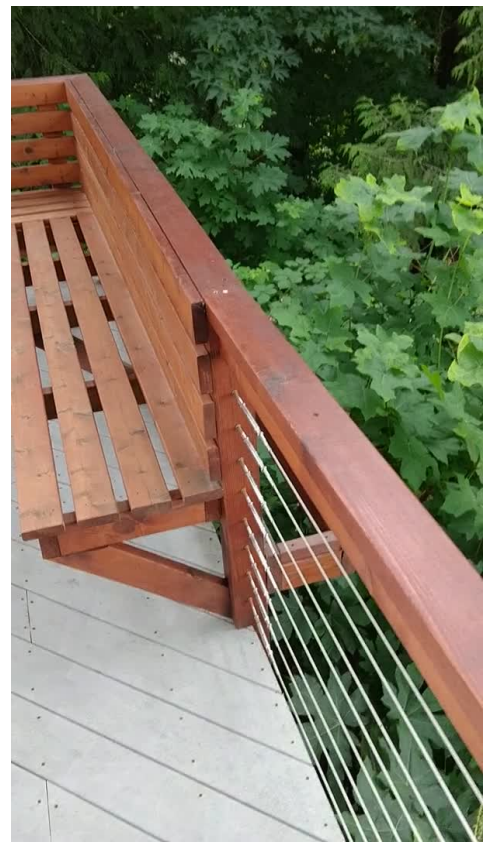
#### 4.11.1 Deck

### GUARDRAIL LOOSE

Guardrails at one or more locations with drop-offs higher than 30 inches were *loose / wobbly / damaged / deteriorated / missing components*, and pose a fall hazard. Recommend that a qualified person repair guardrails as necessary.

Contact a qualified professional.

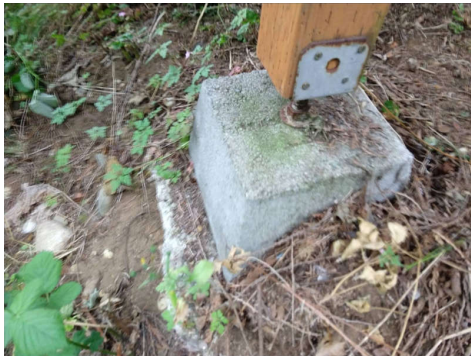
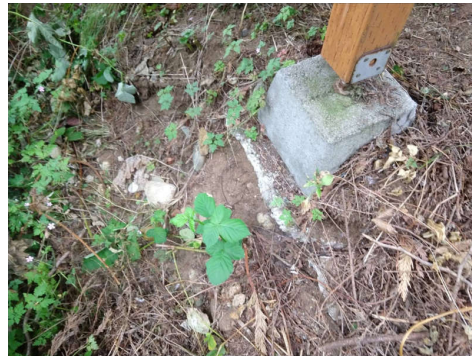
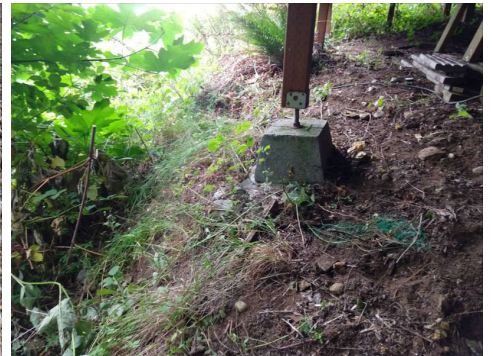
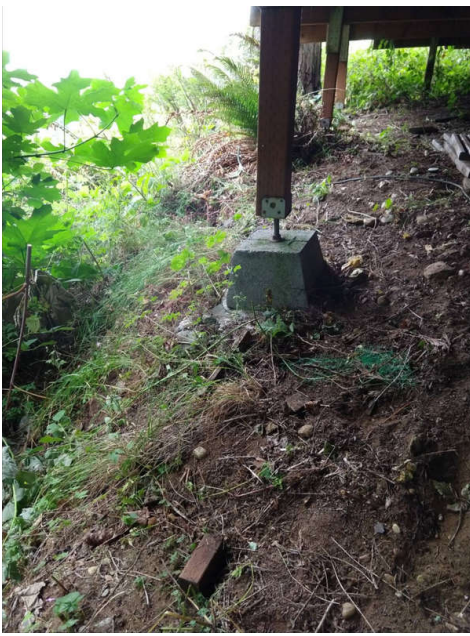
#### 4.11.2 Deck

### DECK POST EROSION

The ground around the deck support posts seems to be slowly eroding away. This could cause the deck to fail if the ground gave out. Maybe a retaining wall can be built out of landscape blocks. I recommend consulting with a landscape contractor about the best way to shore this up.

Contact a qualified professional.

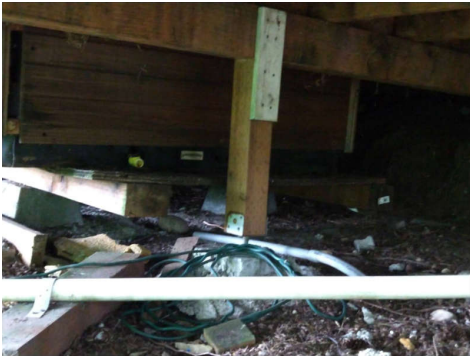
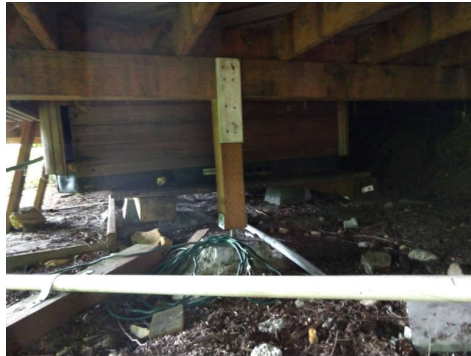
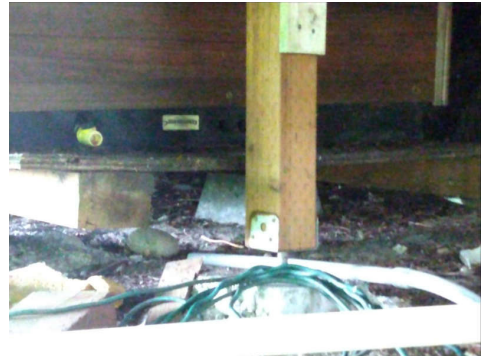
#### 4.11.3 Deck

### HOT TUB SUPPORTS

The support beams and plywood for the hot tub are beginning to deteriorate and warp under the weight of the hot tub. These supports should be shored up or replaced to ensure the hot tub does not fail. I recommend having this repaired by a licensed contractor.

Contact a qualified professional.

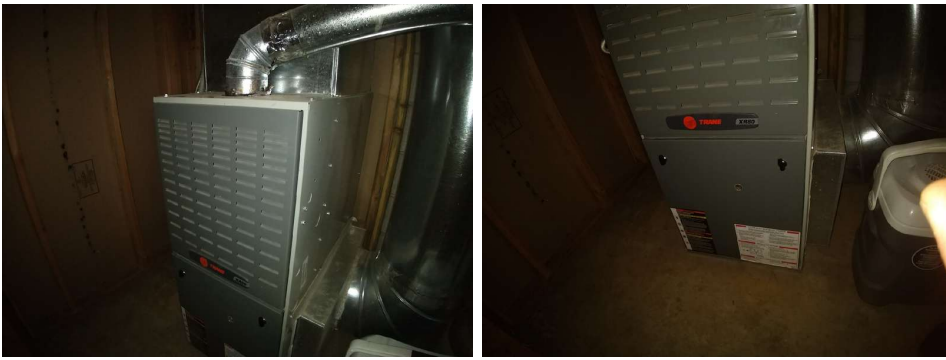
#### 6.1.1 General comments

### SERVICE HEATING SYSTEM

The last service date of the forced air heating system appeared to be more than 1 year ago, or the inspector was unable to determine the last service date. Ask the property owner when it was last serviced. If unable to determine the last service date, or if this system was serviced more than 1 year ago, recommend that a qualified HVAC contractor service this system and make repairs if necessary. This servicing should be performed annually in the future. Any needed repairs noted in this report should be brought to the attention of the contractor when it is serviced.

Contact a qualified HVAC professional.

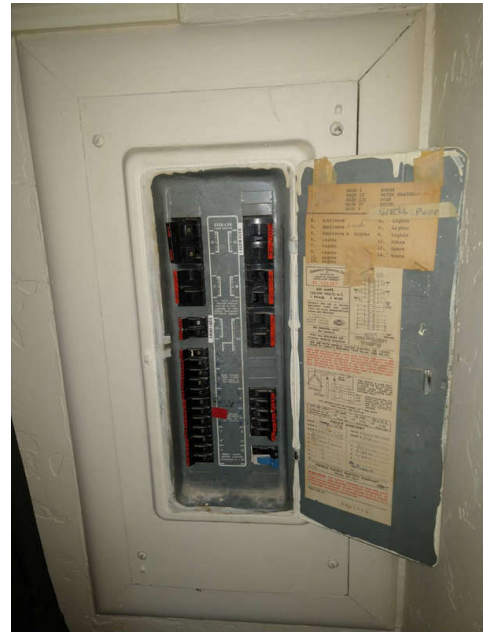
7.1.1 Electric Panel  
**FPE STABLOCK**

An electric panel was manufactured by the Federal Pacific Electric/Challenger company and used "Stab-Lok" circuit breakers. There is significant evidence that both double and single pole versions of these circuit breakers fail by not tripping when they are supposed to. I recommend that a qualified electrician carefully evaluate all Federal Pacific panels and upgrade them to a new panel. Federal Pacific/Stab-Loc Panels have been discontinued and are known fire hazards. Consider replacing Federal Pacific panels with modern panels that offer more flexibility for new, safer protective technologies like ground fault circuit interrupters (GFCIs) and arc fault circuit interrupters (AFCIs).

Recommendation  
 Contact a qualified electrical contractor.

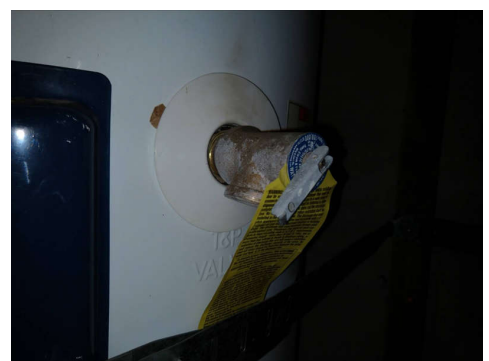
8.1.1 Water Heater  
**TPR DRAIN MISSING**

No drain line is installed for the temperature-pressure relief valve. This is a potential safety hazard due to the risk of scalding if someone is standing next to the water heater when the valve opens. A qualified plumber should install a drain line as per standard building practices. For example, extending to 6 inches from the floor, or routed so as to drain outside.

Recommendation  
 Contact a qualified plumbing contractor.

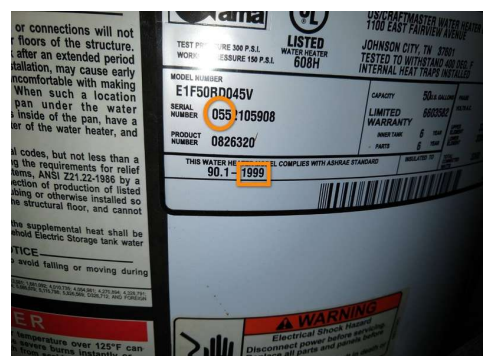
8.1.2 Water Heater  
**EXCEEDS LIFE EXPECTANCY**

The estimated useful life for most water heaters is 8 to 12 years. This water heater appears to be at this age or older and may need replacing at any time. Recommend budgeting for a replacement in the near future. The first 2 digits of the serial number indicate it was manufactured in 2005 making it approximately 14 years old. It meets the plumbing code of 1999 standards.

Recommendation  
Contact a qualified plumbing contractor.

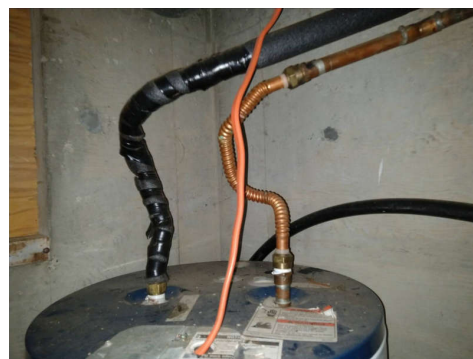
### 8.1.3 Water Heater

#### **EXPOSED WIRING**

Wiring for the water heater's power supply was exposed and subject to damage. Standard building practices call for non-metallic sheathed wiring to be protected with BX armored conduit to prevent damage. This is a potential safety hazard for shock. Recommend that a qualified contractor repair per standard building practices.

Recommendation  
Contact a qualified electrical contractor.

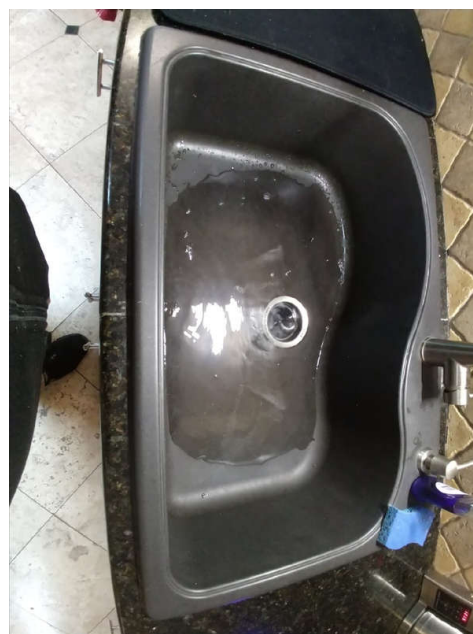
### 10.1.1 Kitchen Sink

#### **SLOW DRAIN**

The drain in the kitchen sink was slow. I recommend cleaning the drain and the P-trap. If this does not clear out the drain, then I recommend having a licensed plumber make needed repairs.

Recommendation  
Contact a qualified professional.

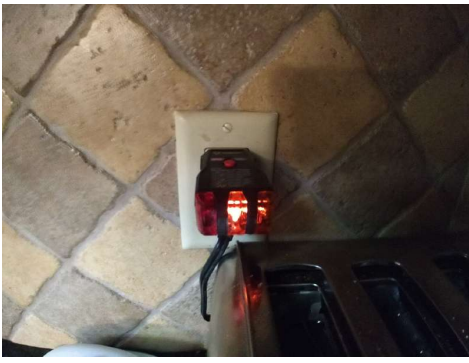
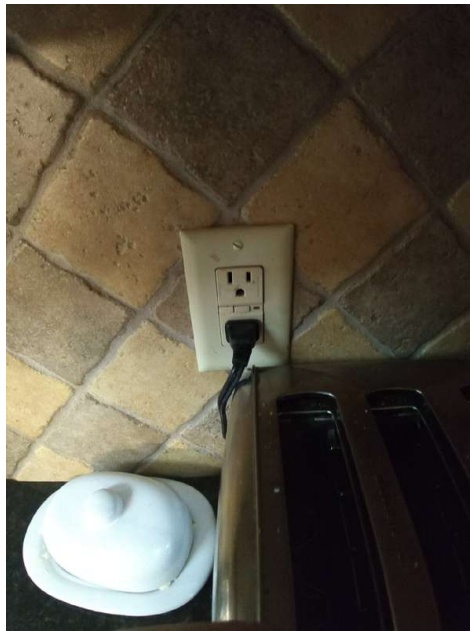
### 10.3.1 GFCI

#### **GFCI WOULDN'T RESET**

The tested GFCI would not trip with my tester. This is to the right of the kitchen sink. It is recommended that all GFCI's are in operational condition. I recommend having an electrician check the wiring, and/or replace the GFCI if it is necessary.

Recommendation  
Contact a qualified electrical contractor.

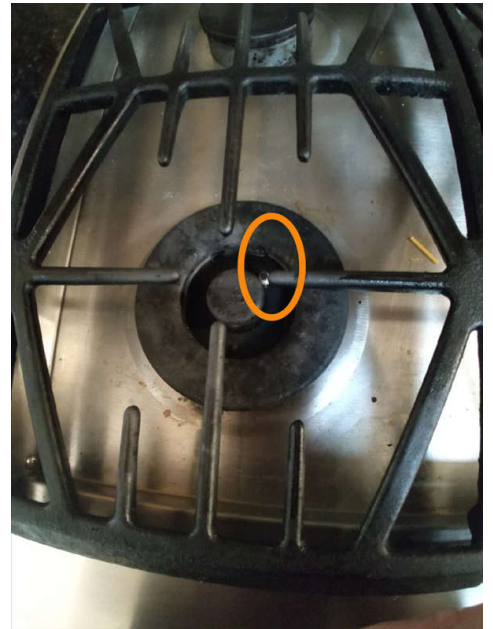
### 10.6.1 Range/Oven/Cooktop

## IGNITER CONTINUES AFTER IGNITION

When lighting the stove top and testing the burners. I found the lower left hand side burner would keep trying to ignite even after the stove top was lit. None of the other burners did this. I recommend having this repaired by a licensed appliance service technician.

Contact a qualified professional.

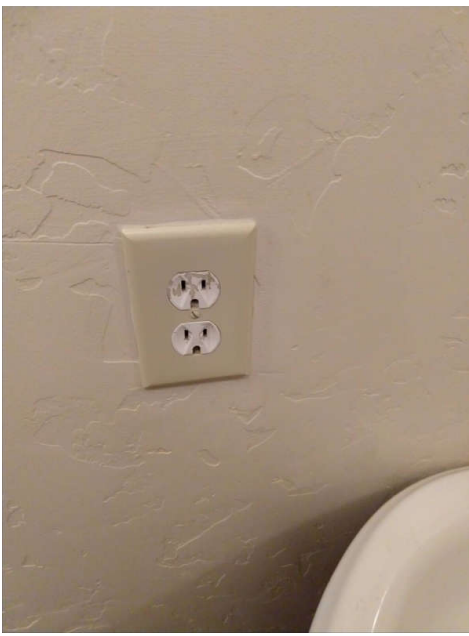
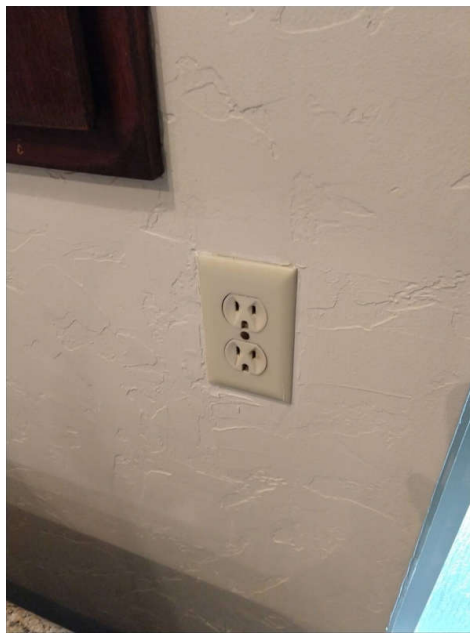
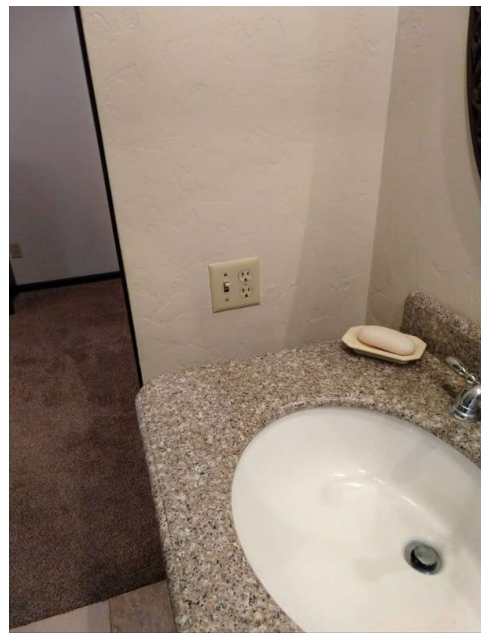
### 11.3.1 Electrical

## GFCI MISSING

One or more electric receptacles at the bathroom(s) had no visible ground fault circuit interrupter (GFCI) protection, or the inspector was unable to determine if GFCI protection was present. If not GFCI-protected, receptacles in wet areas pose a shock hazard. Recommend that a qualified electrician evaluate and install GFCI protection if necessary and per standard building practices. General guidelines for GFCI-protected receptacles include the following locations:

Contact a qualified electrical contractor.

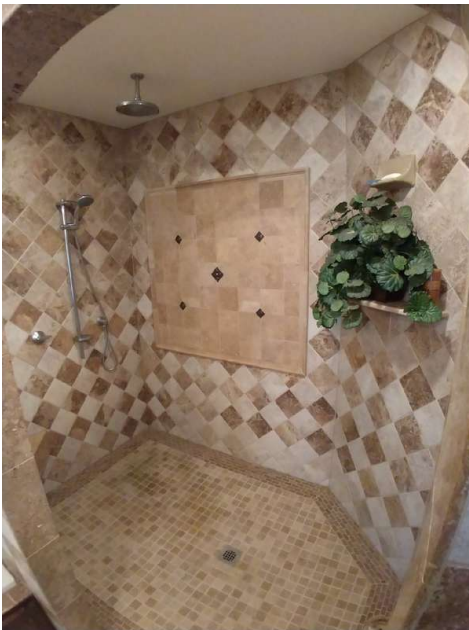
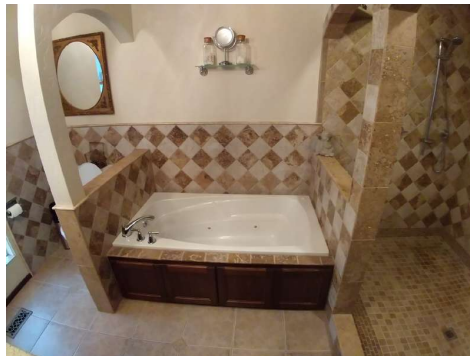
### 11.6.1 Shower

## GROUT SEAL TILE SHOWER

Sealing the grout on an annual basis is a very important part of maintaining your tile shower. I recommend using a high quality grout sealer as part of your waterproofing regimen for the shower.

Contact a qualified professional.

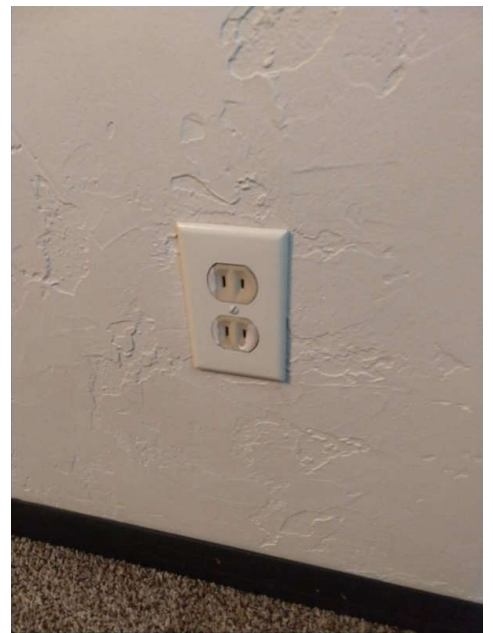
### 12.1.1 Electrical

## 2 SLOT

2-slot receptacles rather than 3-slot, grounded receptacles were installed in one or more areas. These do not have an equipment ground and are considered unsafe by today's standards. Appliances that require a ground should not be used with 2-slot receptacles. Examples of such appliances include computers and related hardware, refrigerators, freezers, portable air conditioners, clothes washers, aquarium pumps, and electrically operated gardening tools. The client should be aware of this limitation when planning use for various rooms, such as an office. Upgrading to grounded receptacles typically requires installing new wiring from the main service panel or sub-panel to the receptacle(s), in addition to replacing the receptacle(s). Consult with a qualified electrician about upgrading to 3-wire, grounded circuits.

Contact a qualified electrical contractor.

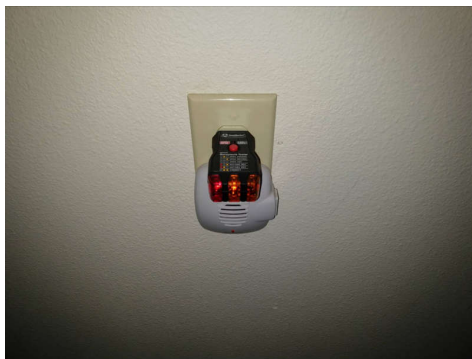
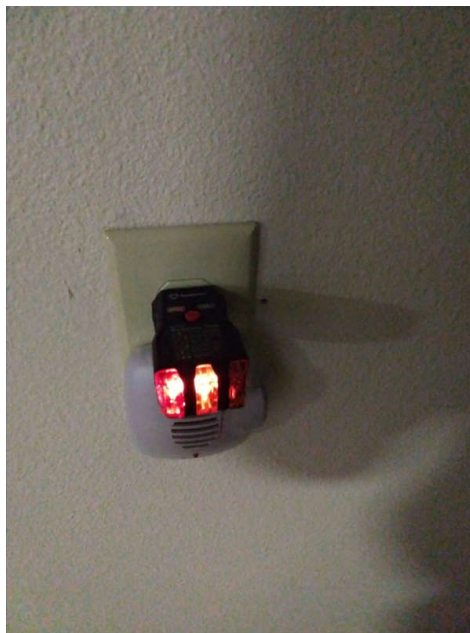
### 12.1.2 Electrical

#### **HOT-NEUTRAL REVERSE**

One or more electric receptacles had reverse-polarity wiring, where the hot and neutral wires were reversed. This is a shock hazard. Recommend that a qualified electrician repair as necessary.

Contact a qualified electrical contractor.

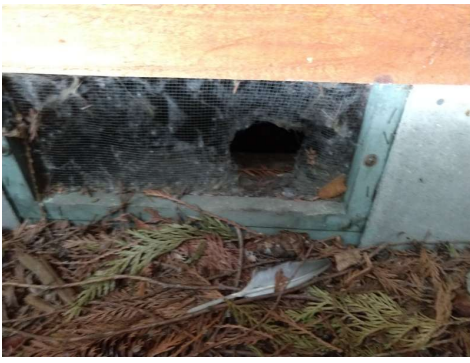
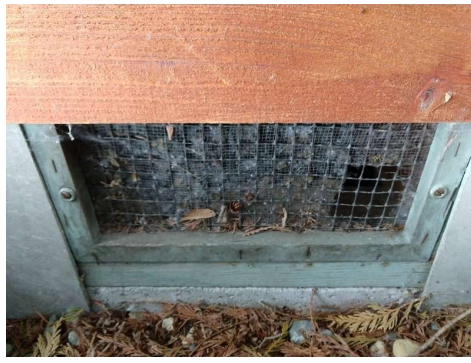
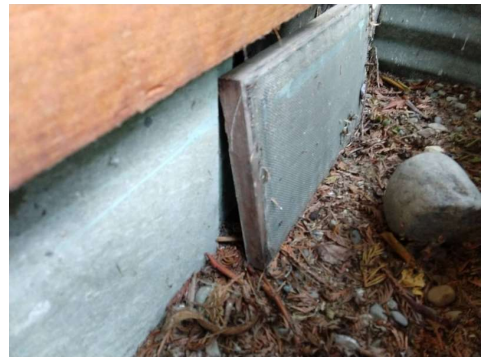
### 15.4.1 Ventilation-Insulation

#### **DAMAGED SCREEN**

The screens for one or more crawl space vents were damaged. Vermin or pets can enter the crawl space and nest, die and/or leave feces and urine. Vermin often damage under-floor insulation too. Recommend that a qualified person install or replace screens where necessary using 1/8-inch to 1/4-inch wire mesh.

Contact a qualified handyman.

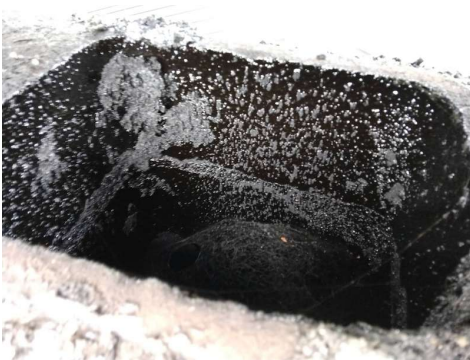
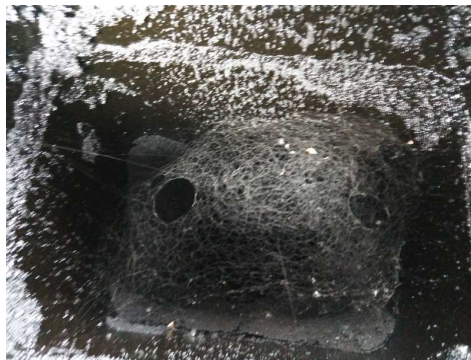
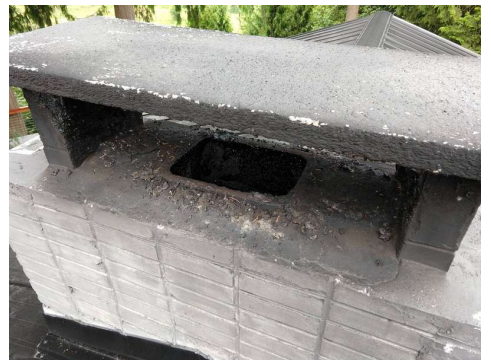
17.2.1 Flue and damper  
**CREOSOTE VISIBLE**

A significant amount of creosote (1/8 inch or more) is visible in the flue. A qualified chimney service contractor should inspect, clean, and repair if necessary now and annually in the future.

Recommendation  
Contact a qualified fireplace contractor.
