**SUMMARY**  
 1234 Main St. Winchester California  
 92596  
 Buyer Name  
 07/19/2018 9:00AM

Dan Happe  
 InterNACHI Certified Professional  
 Inspector  
 Fundamental Home Inspection  
 951-215-9658  
[danhappe13@gmail.com](mailto:danhappe13@gmail.com)

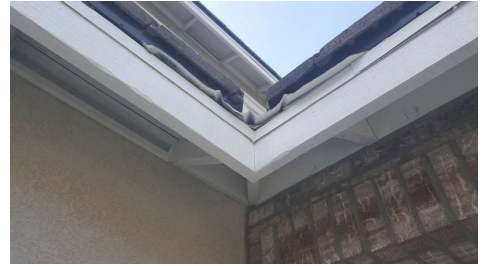
2.1.1 General  
**VALLEY**

Recommendation / Improvement

The 'W' valley has a jagged cut not a good look for the front entry area

Recommendation  
 Contact a qualified roofing professional.

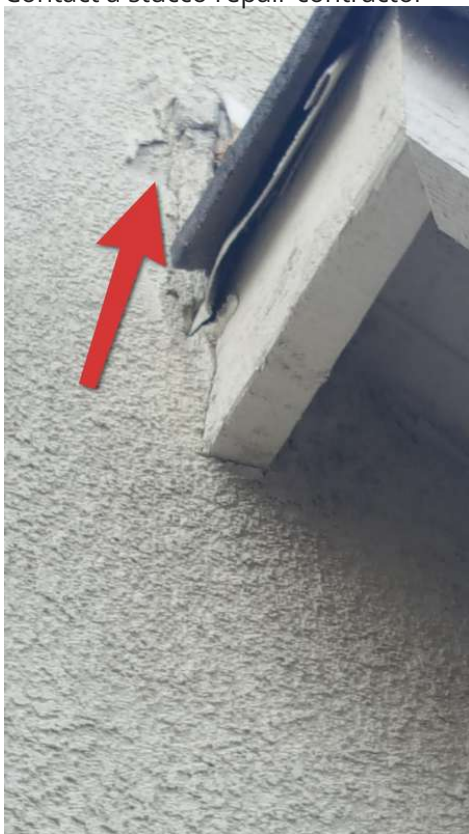
LEFT FRONT Garage

3.2.1 Siding, Flashing & Trim  
**DAMAGED SIDING**

Major Concern / Safety Hazard

Some areas of the siding were damaged. Recommend repair.  
 Recommendation  
 Contact a stucco repair contractor

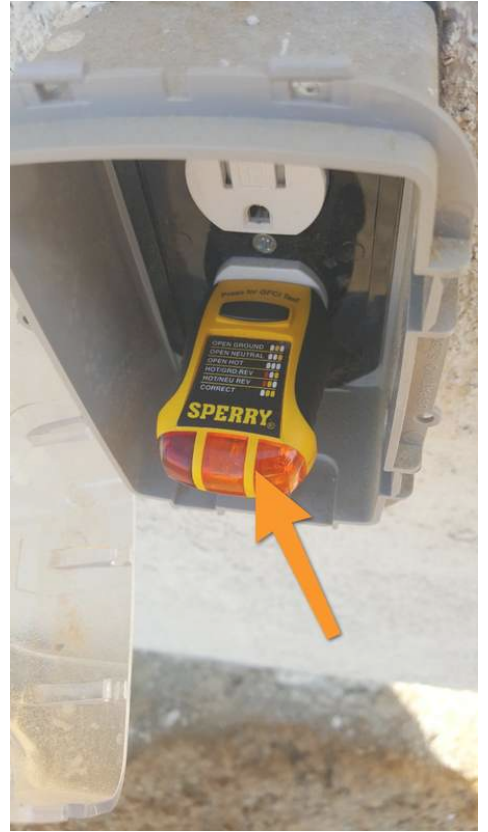
back of house

3.10.1 Exterior Outlets  
**\*\*\*OUTLET\*\*\***

Recommendation / Improvement

BACK OF HOUSE  
 Not working

Recommendation  
Contact a qualified electrical contractor.

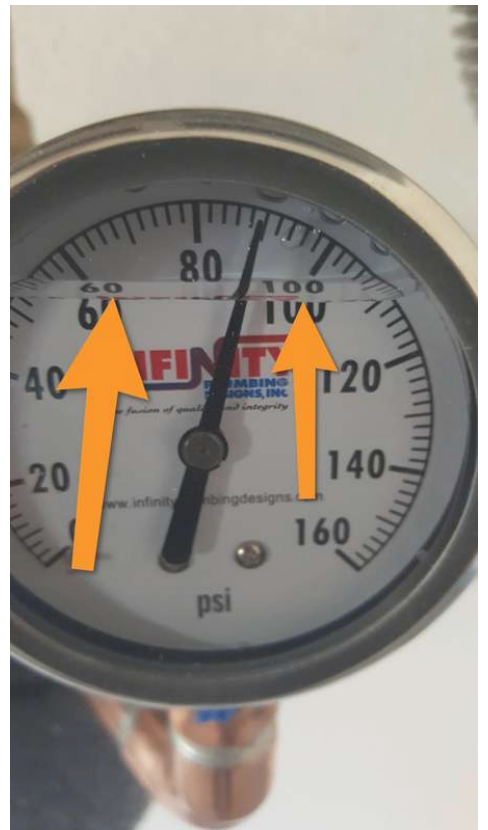
8.5.1 Hot Water Systems,  
Controls, Flues & Vents

**GAUGE**

There is water in the psi gauge

Recommendation  
Contact a qualified plumbing contractor.

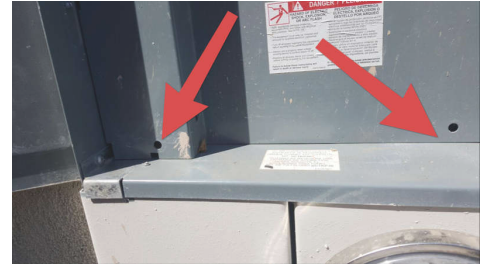
9.2.1 Service Entrance Conductors  
**PANEL NOT SECURED**

Major Concern / Safety Hazard

Screws missing

Recommendation

Contact a qualified electrical contractor.

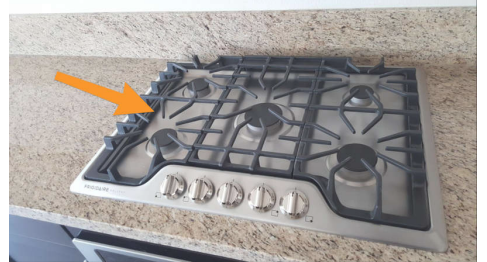
15.6.1 Range/Oven/Cooktop

**BURNER NOT LIGHTING**

Major Concern / Safety Hazard

One or more heating elements did not heat up when turned on. Recommend qualified professional evaluate & repair. Here is a DIY resource on possible solutions.

Recommendation

Contact a qualified appliance repair professional.
