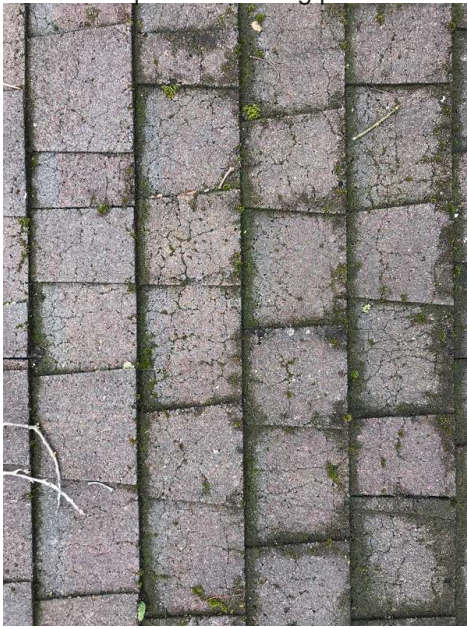
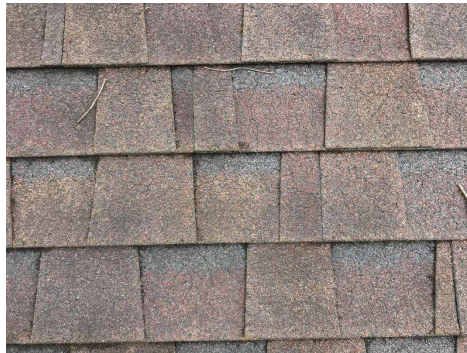
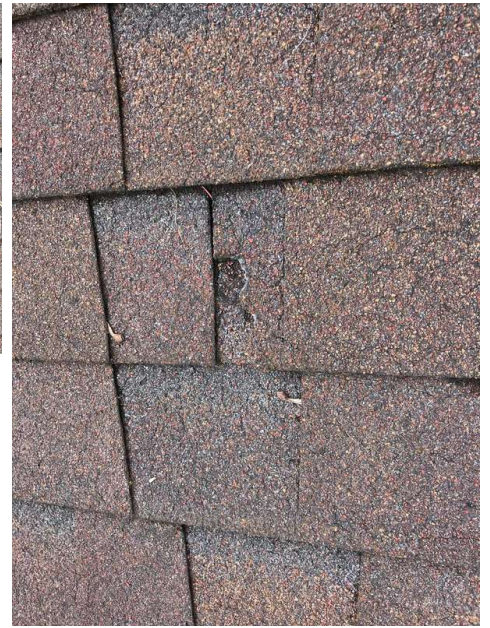
### 2.1.1 Main Roof Coverings

#### **DAMAGED COVERINGS**

Roof coverings exhibited general damage that could affect performance. Recommend a qualified roofer evaluate and repair.

Contact a qualified roofing professional.

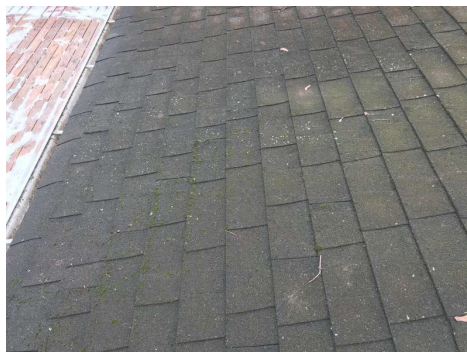
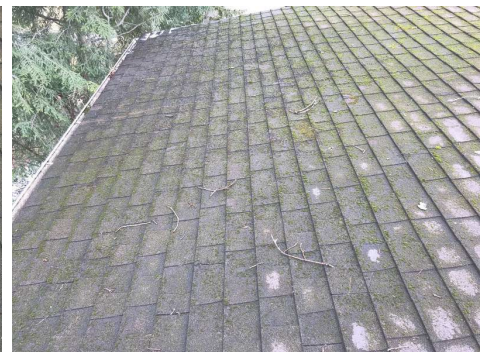
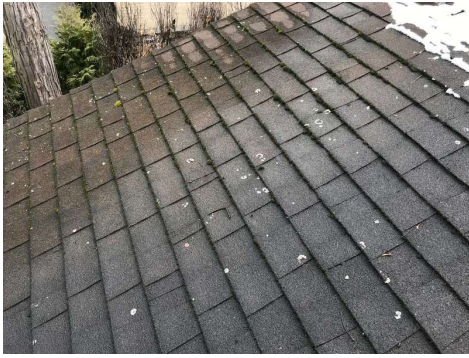
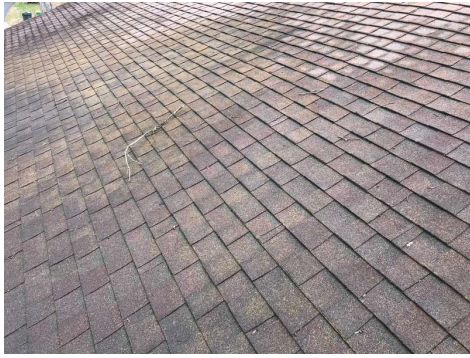
### 2.1.2 Main Roof Coverings

#### **DISCOLORATION**

**INFORMATION** - Roof shingles were discolored, which can be caused by moisture, rust or soot. Recommend a qualified roofing contractor evaluate and remedy with a roof cleaning or repair.

Contact a qualified roofing professional.

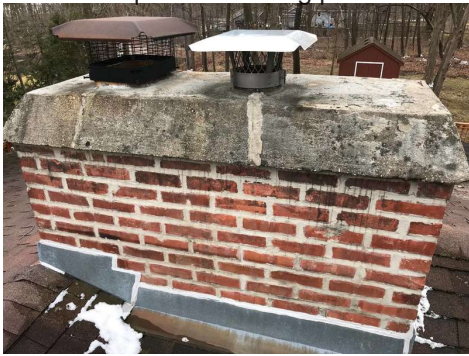
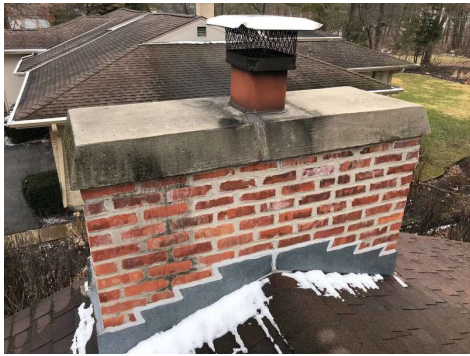
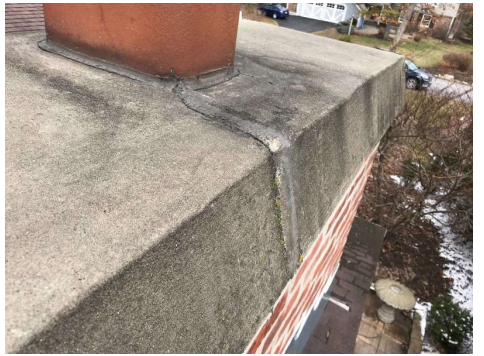
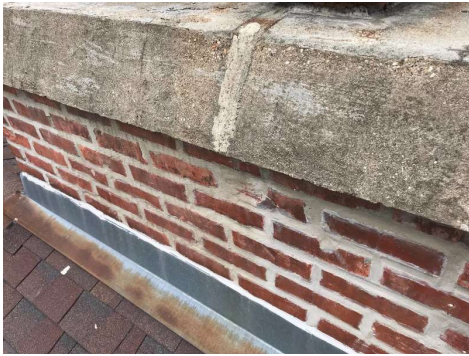
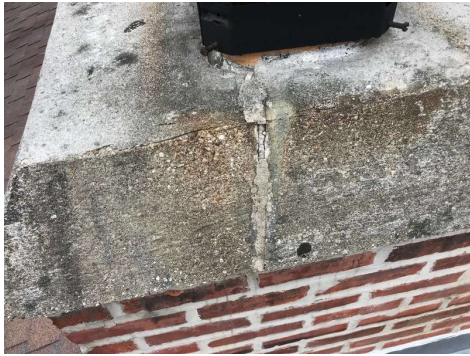
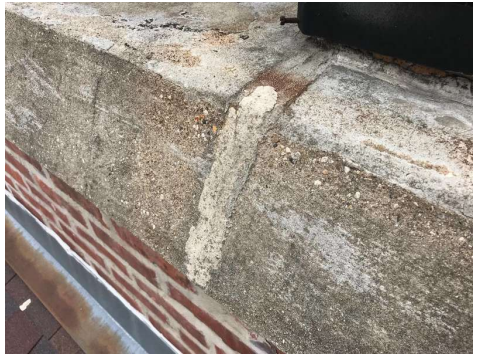
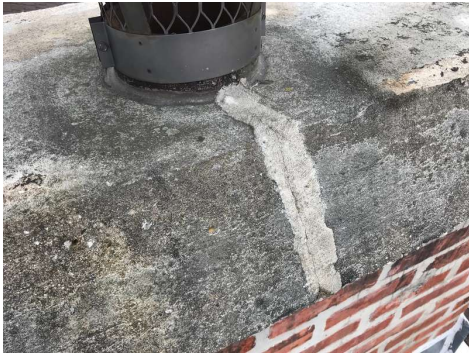
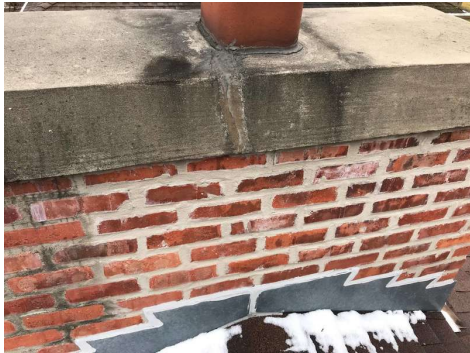
### 2.3.1 Skylights, Chimneys & Roof Penetrations

#### **CHIMNEY CROWN CRACKED**

The chimney crown had one or more cracks, which can lead to further damage to the chimney structure. Recommend a qualified contractor repair.

Contact a qualified roofing professional.

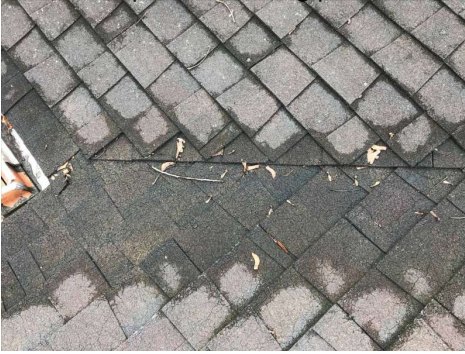
#### **WORN**

Flashings showed signs of wear and tear. This is normal for a roof of this age. Recommend monitoring.

The valley flashing is cracked and worn.

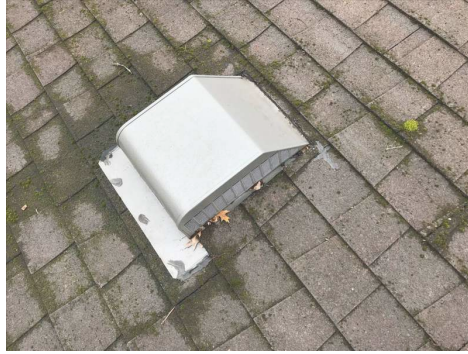
Patching around the vent needs to be checked annually.

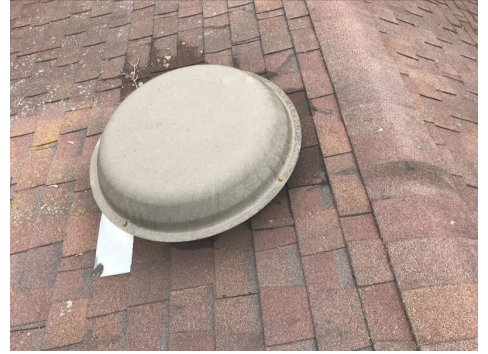
Patching on the attic fan needs to be inspected once a year.

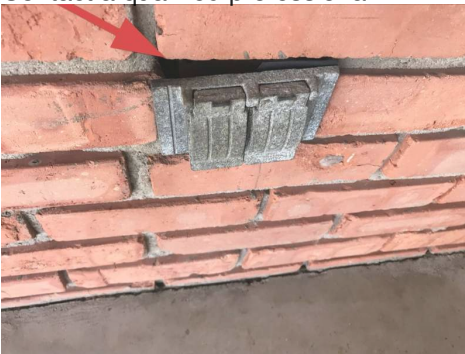
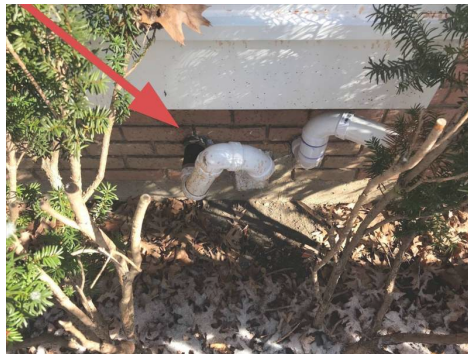
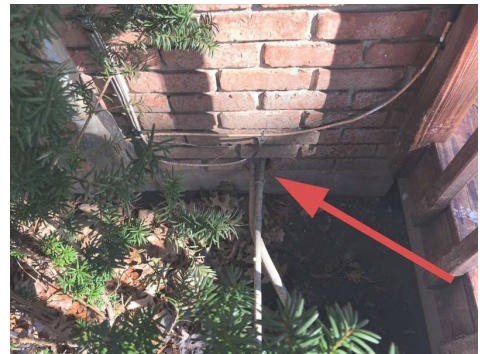
### 3.1.1 Siding, Flashing & Trim

#### **IMPROPER CONSTRUCTION PRACTICES**

Siding appears to be installed improperly and not up to standards. This could lead to moisture damage or deterioration of the home structure. These openings need to be sealed.

Recommendation  
Contact a qualified professional.

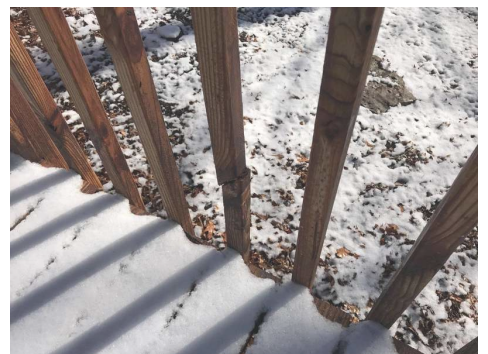
### 3.3.1 Decks, Balconies, Porches & Steps

#### **RAILINGS ARE DAMAGED**

Broken railings are present and should be repaired.

Recommendation  
Contact a handyman or DIY project

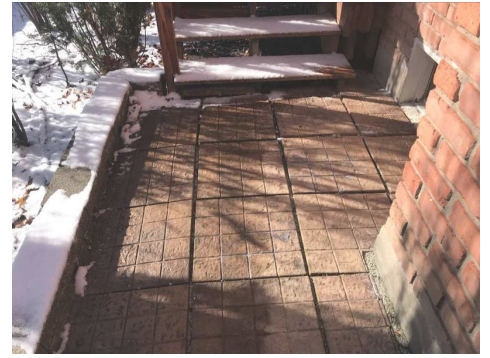
### 3.6.1 Walkways, Patios & Driveways

#### **PATIO CRACKING - MINOR**

Normal settling & cracking observed. Recommend monitor and/or patch/seal.

The patio settled on the left side.

Recommendation  
Recommended DIY Project

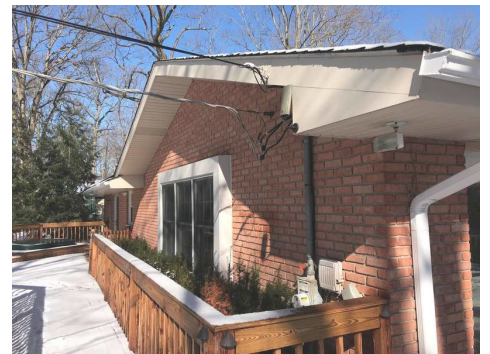
#### 5.1.1 Service Entrance Conductors

### **NOT ENOUGH CLEARANCE**

Safety Hazard

Service drop overhead wires are too low, not giving enough clearance above roof. Recommend contacting your local electric utility company or qualified electrician to see if they can correct.

Recommendation  
Contact a qualified electrical contractor.

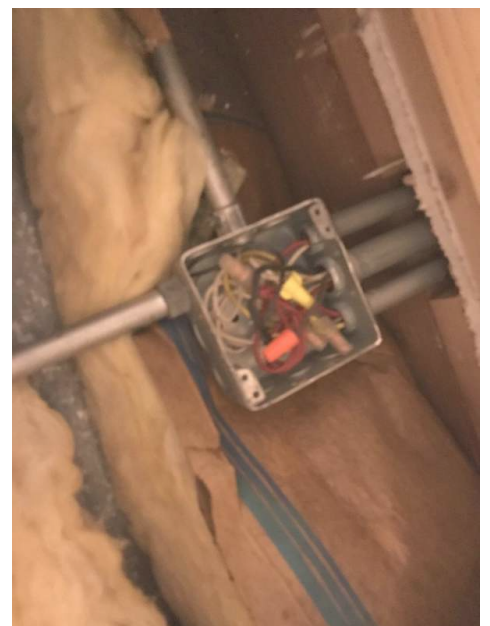
#### 5.3.1 Branch Circuit Conductors, Overcurrent Devices and Compatibility of Their Amperage & Voltage

### **EXPOSED ENDS & SPLICES**

Safety Hazard

All wire connections & charged wires with exposed ends and splices should be covered in junction boxes for safety. Recommend a qualified electrician correct.

Recommendation  
Contact a qualified electrical contractor.

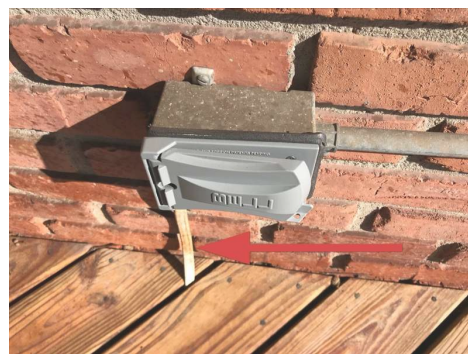
5.3.2 Branch Circuit Conductors, Overcurrent Devices and Compatibility of Their Amperage & Voltage

**IMPROPER WIRING**

Improper wiring was observed at the time of inspection. Recommend a licensed electrician evaluate and repair.

NMC is not designed to be installed like this. This type of wiring is not accepted by the local authority.

Contact a qualified electrical contractor.

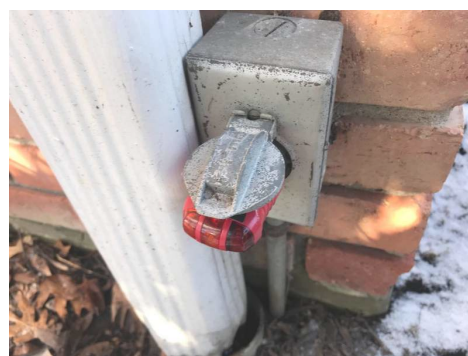
5.4.1 Outlets, Switches, Lights, and Ceiling Fans

**NO GFCI PROTECTION INSTALLED**

THE OUTDOOR AND BASEMENT OUTLETS

No GFCI protection present in all locations. Recommend licensed electrician upgrade by installing ground fault receptacles in all locations.

Contact a qualified electrical contractor.

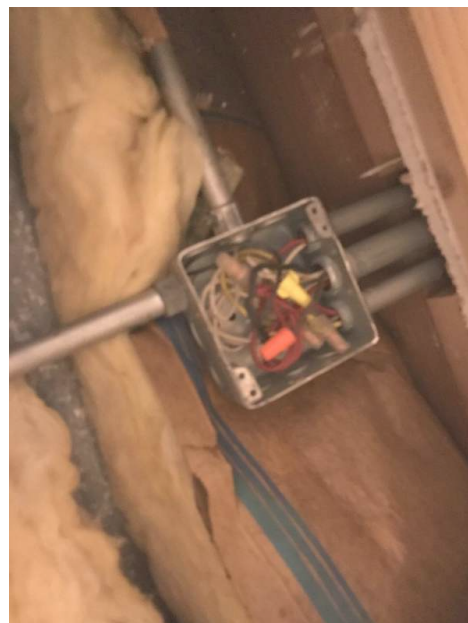
5.4.2 Outlets, Switches, Lights, and Ceiling Fans

**OPEN JUNCTION BOX**

Open junction box observed. Recommend concealing or replacing.

Recommended DIY Project

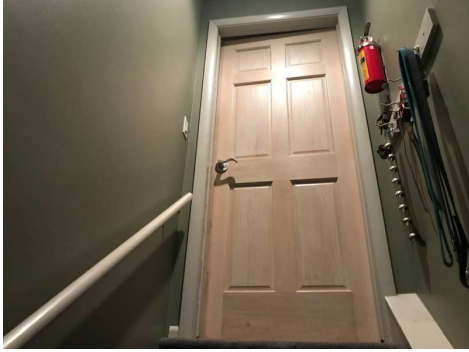
There is no 3-way switch to the basement

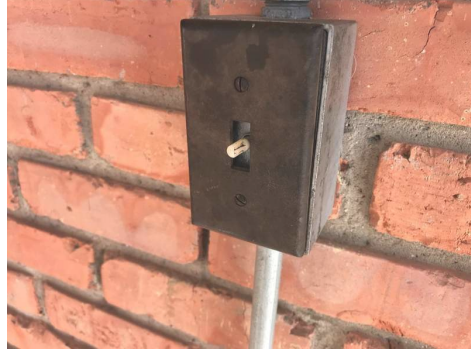
The outdoor dimmer switch is missing a knob

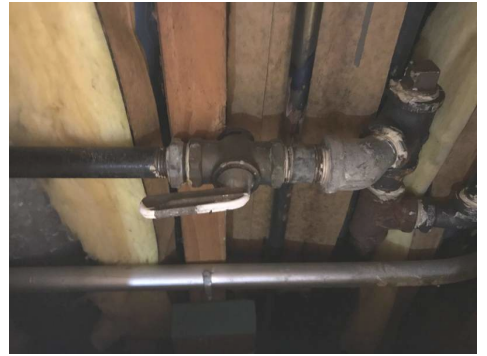
#### 6.4.1 Fuel Storage & Distribution Systems

### LEAKING GAS LINE

A gas line was observed to be leaking at time of inspection. Recommend a qualified plumber or local utility company evaluate and repair.

Recommendation  
Contact a qualified plumbing contractor.

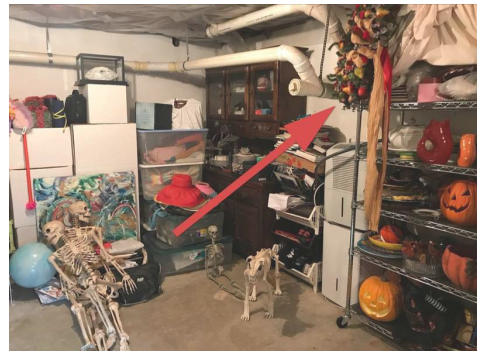
#### 8.3.1 Drain, Waste, & Vent Systems

### IMPROPER CONNECTIONS OR IMPROPER REPAIR

The waste lines have poor connections or the repair present is not trustworthy.

Duct tape is used on the connection where the pipe leaves the building.

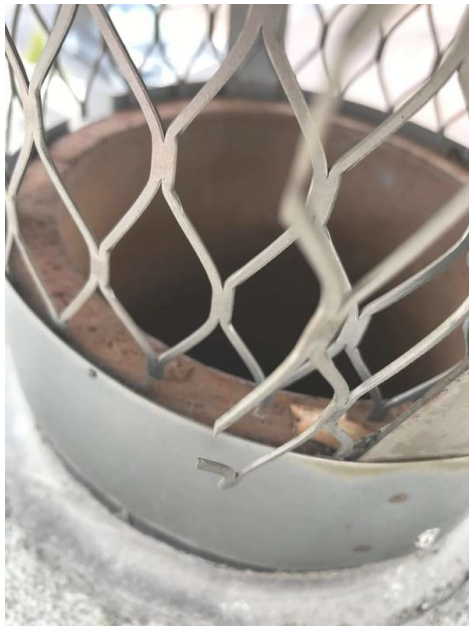
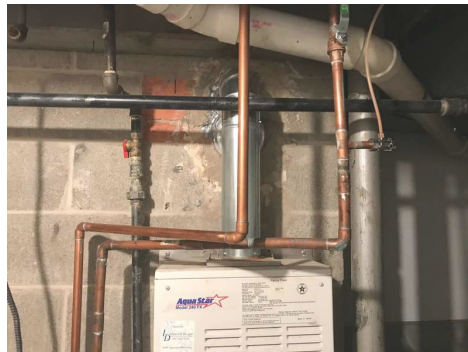
#### 8.4.3 Water Heater

### **THE WATER HEATER VENTS INTO THE CHIMNEY**

The water heater terminates into the chimney. This appliance needs to have a flue liner that carries the exhaust gasses all the way through, up, and out of the chimney. Lack of this liner causes deterioration of the chimney.

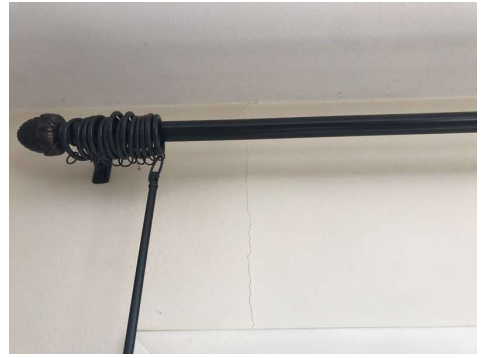
#### 9.1.1 Walls

### **MINOR CRACKS**

Minor cracks, nail pops, and other damage were noted on the walls. This is not unusual in a home of this age and these cracks are not a structural concern.

Contact a qualified structural engineer.

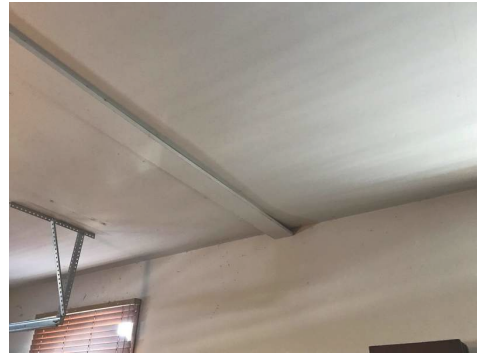
### 9.2.1 Ceilings

#### **MINOR DAMAGE**

Minor damage or deterioration to the ceiling was visible at the time of the inspection.

Recommendation  
Contact a qualified professional.

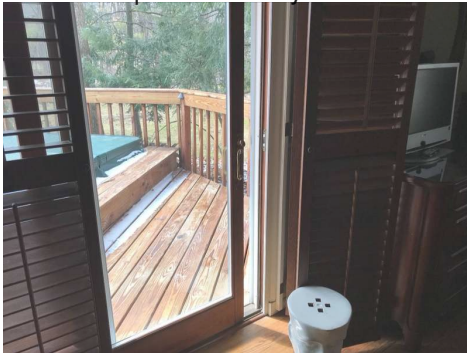
Bedroom door does not lock

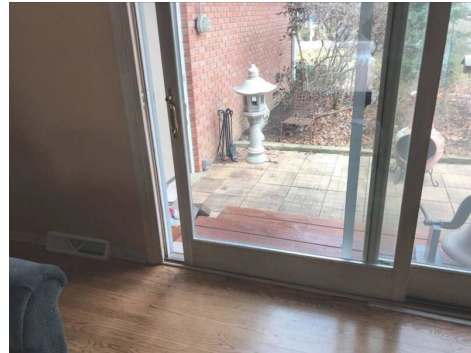
Family room door does not lock

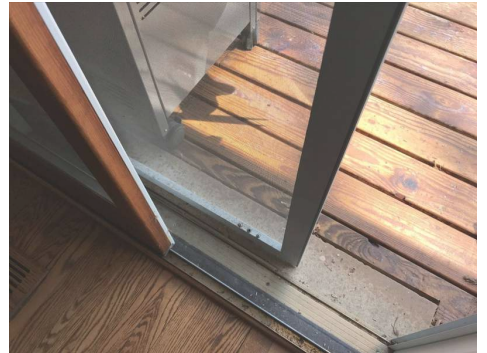
The screen is off the track

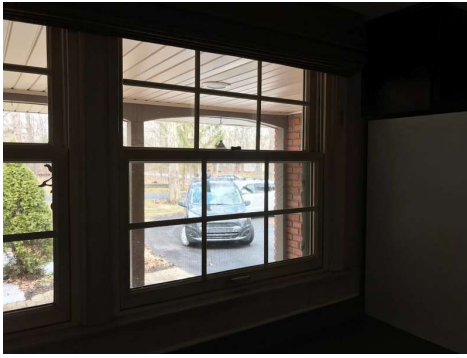
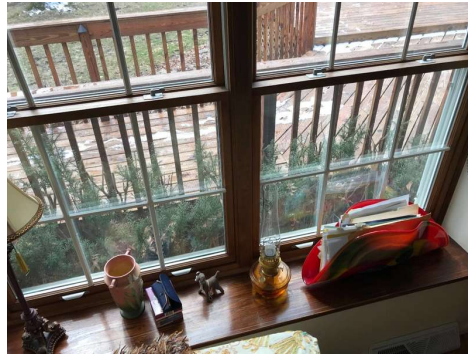
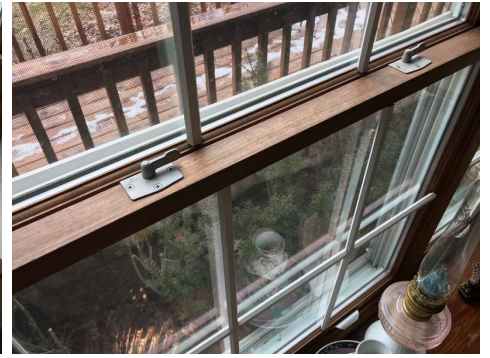
### 9.5.1 Windows

#### **DIFFICULT TO OPERATE**

Some of the windows were difficult to open, close, or tilt inwards for cleaning. The windows were also drafty and separated when the locks were engaged.

Recommendation  
Contact a handyman or DIY project

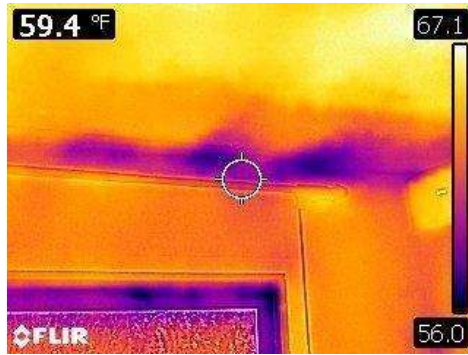
### 10.1.1 Attic Insulation

## INSUFFICIENT INSULATION

Insulation depth was inadequate. Recommend a qualified attic insulation contractor install additional insulation.

Contact a qualified insulation contractor.

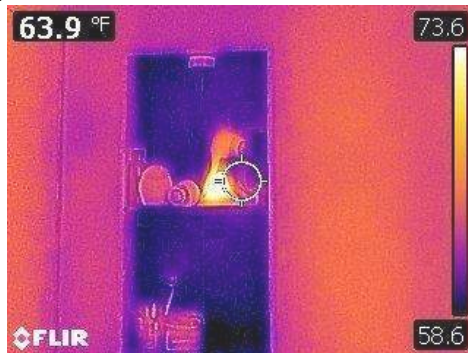
### 10.2.1 Wall Insulation

## INSUFFICIENT INSULATION

Insulation depth was inadequate. Recommend a qualified attic insulation contractor install additional insulation.

Contact a qualified insulation contractor.

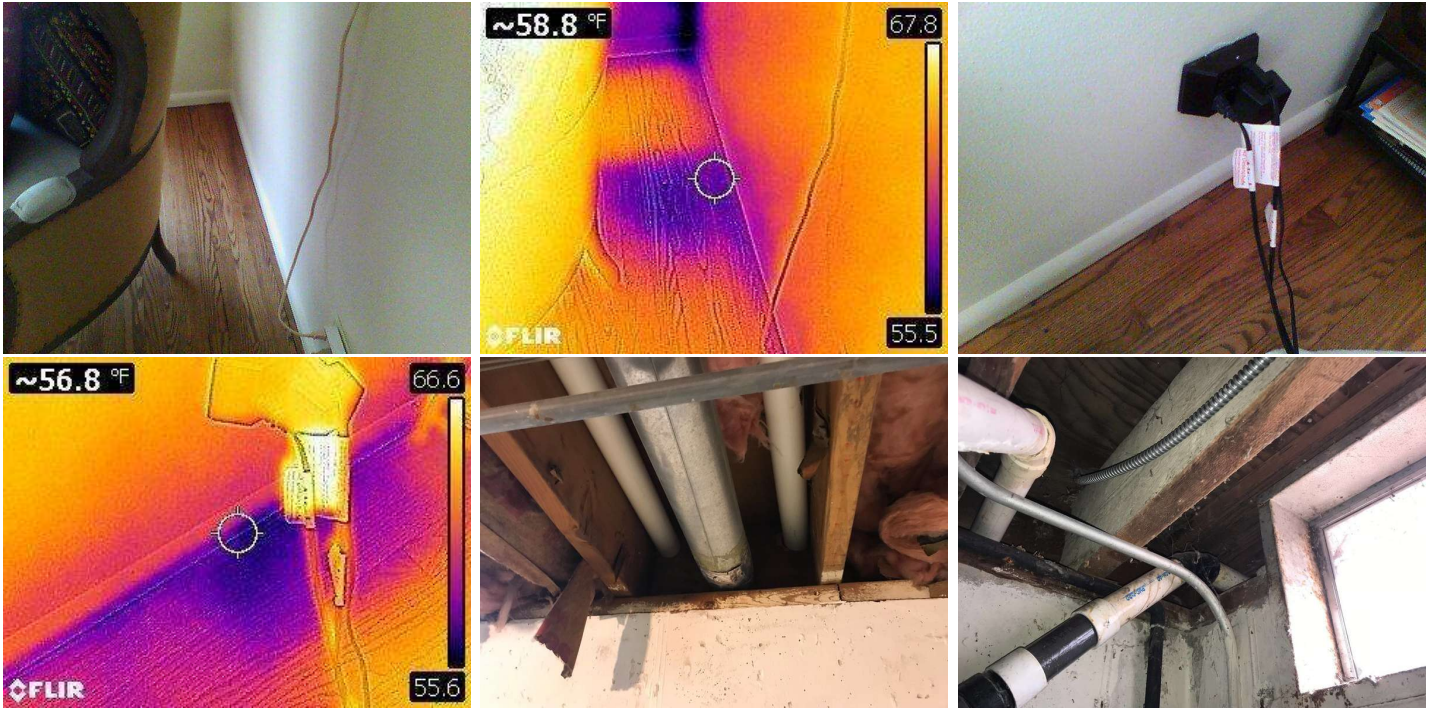
### 10.3.1 Under Floor and Rim Joist Insulation

## INSUFFICIENT INSULATION

Insulation depth was inadequate. Recommend a qualified attic insulation contractor install additional insulation.

Contact a qualified insulation contractor.

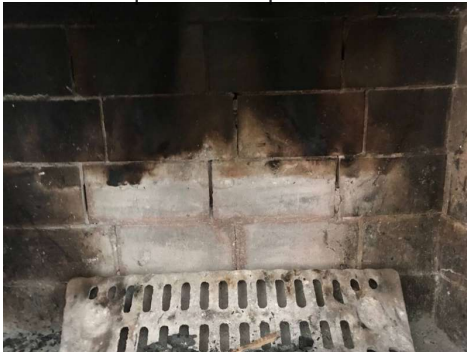
#### **FIREWALL CRACKED**

The brick lining of the fireplace was cracked in one or more places, which could lead to chimney damage or toxic fumes entering the home. Recommend a qualified fireplace contractor evaluate and repair.

The fireplace in the family room has cracks in the firebox. This is unsafe to use until a level 2 inspection is performed by a chimney sweep.

A level 2 chimney inspection needs to be performed on both fireplaces and chimneys.

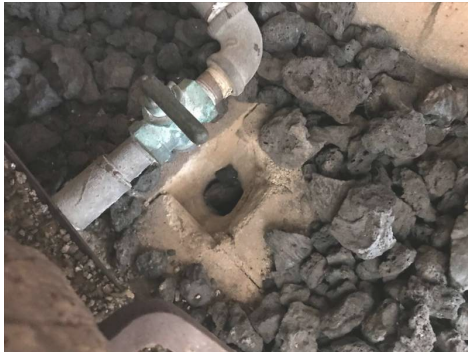
This is the fireplace in the piano room. There is a hole in the floor of the firebox. The isolation valve is inside the firebox.

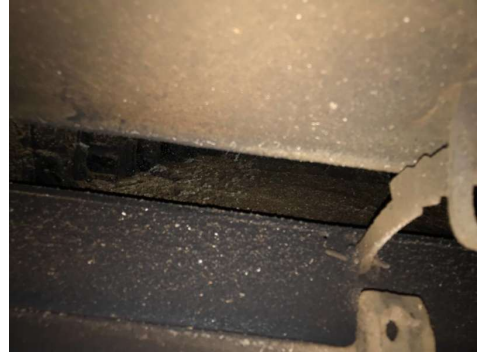
### 11.3.1 Chimney & Vent Systems

#### **CHIMNEY LINER DIRTY**

Chimney liner had layer of creosote dust, so underlying structure couldn't be inspected for cracks. Recommend qualified chimney sweep company inspect and/or clean.

Contact a qualified chimney contractor.

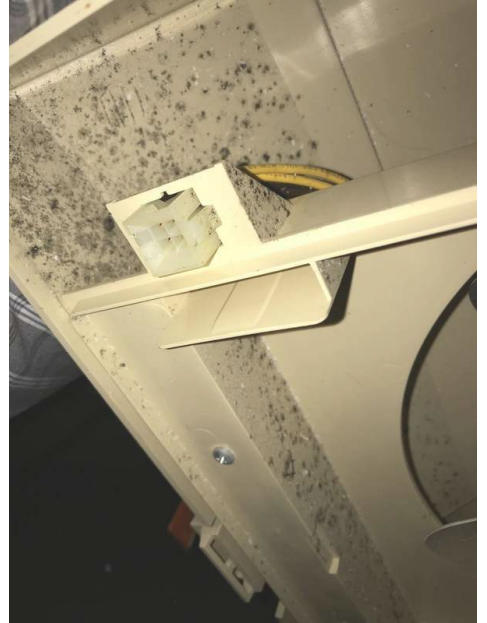
12.5.1 Humidifier

**MOLD**

Safety Hazard

The humidifier has mold growing in it. I consider this unhealthy and it should be cleaned.

Contact a qualified HVAC professional.
