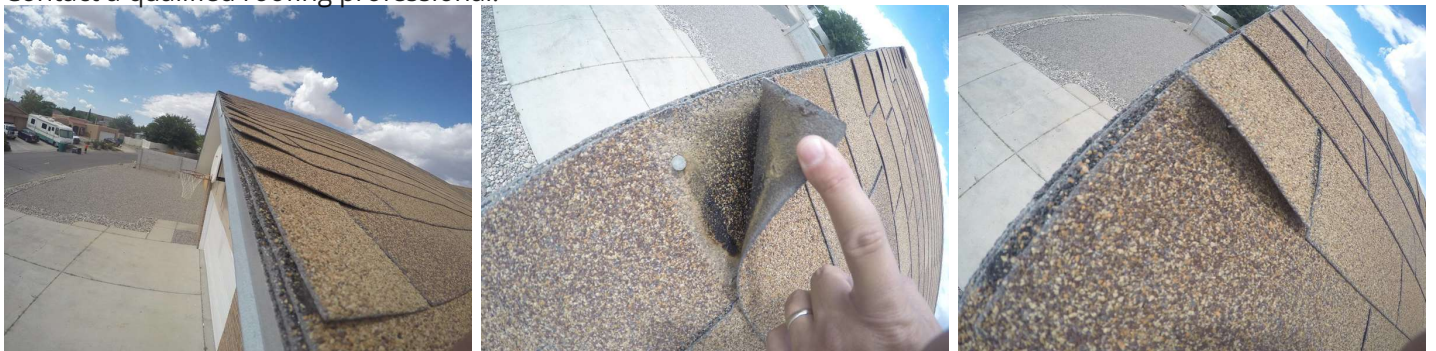
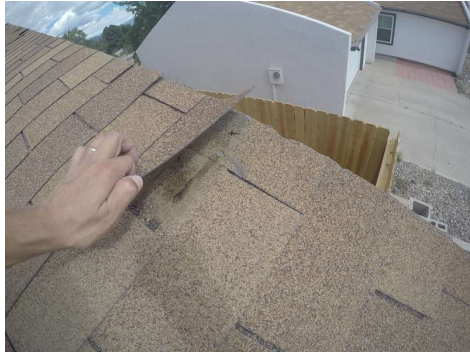
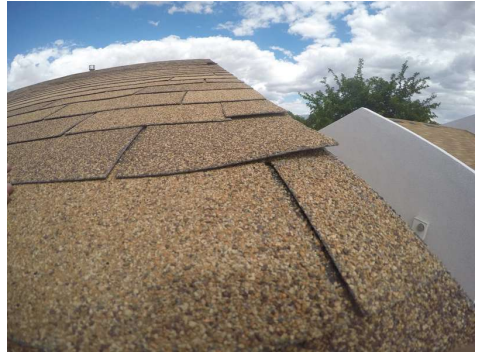
2.2.2 Coverings

UNSEALED/LIFTED SHINGLES

Observed a large number of tabs that were unsealed. This may be a result of under-driven nails, debris, wind-driven damage or other factors. Recommend a qualified roofing professional evaluate and make recommendations.

Recommendation
Contact a qualified roofing professional.

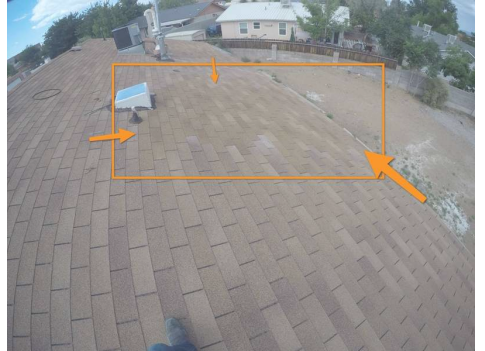
2.2.3 Coverings

PREVIOUS REPAIR

Evidence of previous repair to shingles was apparent. Recommend asking seller if repair work was performed and why.

Recommendation
Recommend monitoring.

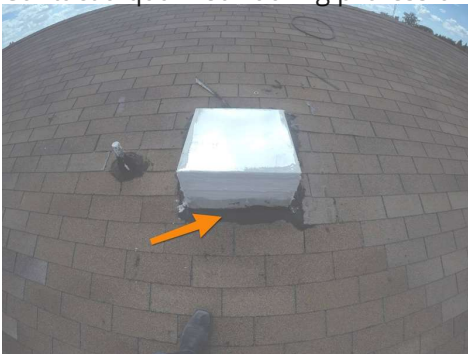
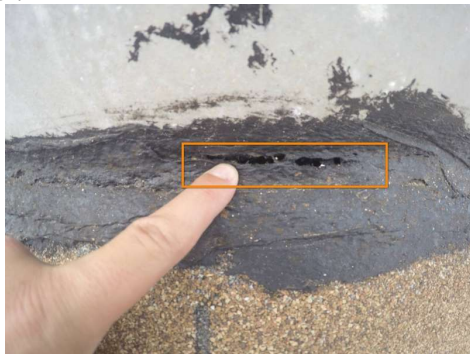
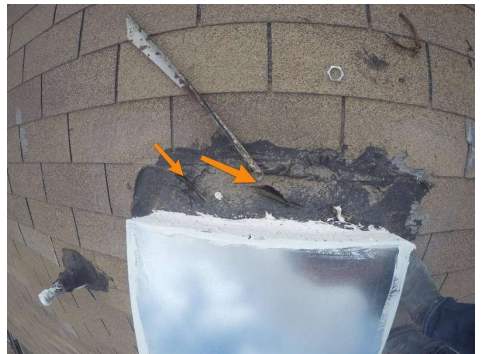
2.4.1 Flashings

LOOSE/SEPARATED

Flashings observed to be loose or separated, which can lead to water intrusion and/or mold. Recommend a qualified roofing contractor repair.

Recommendation
Contact a qualified roofing professional.

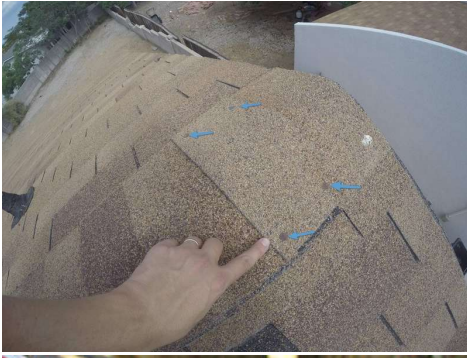
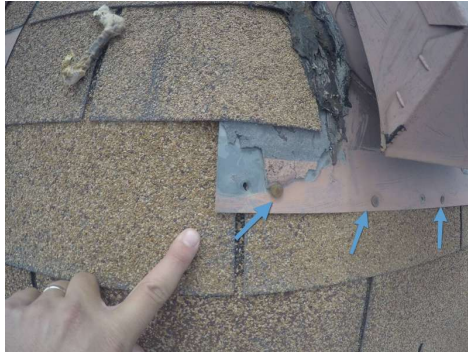
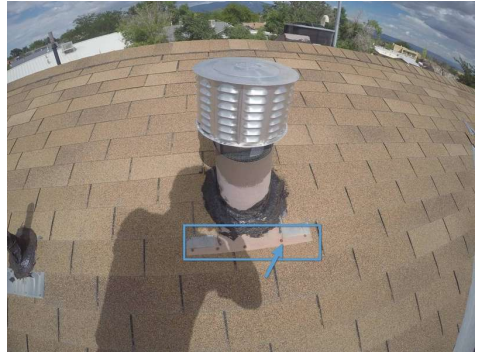
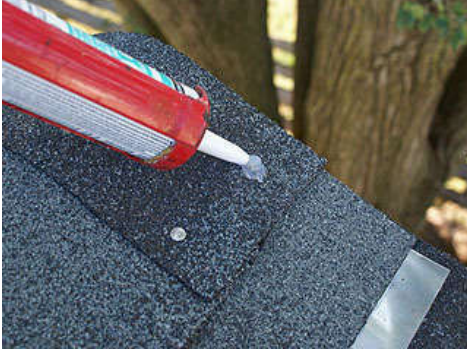
2.4.2 Flashings

CAULK NAIL HEADS

As part of ongoing home maintenance, recommend caulking/sealing nail heads.

Recommendation
Contact a qualified professional.

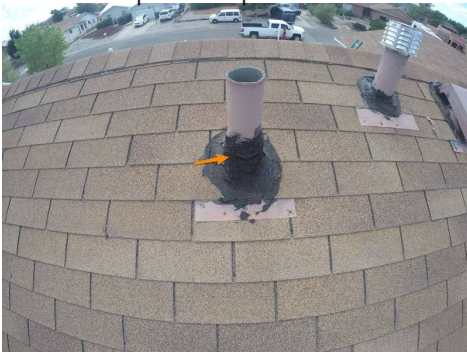
2.4.3 Flashings

PIPE FLASHING BOOT

Pipe flashing rubber boot was damaged which could allow moisture into the home, recommend repair.

Recommendation
Contact a qualified professional.

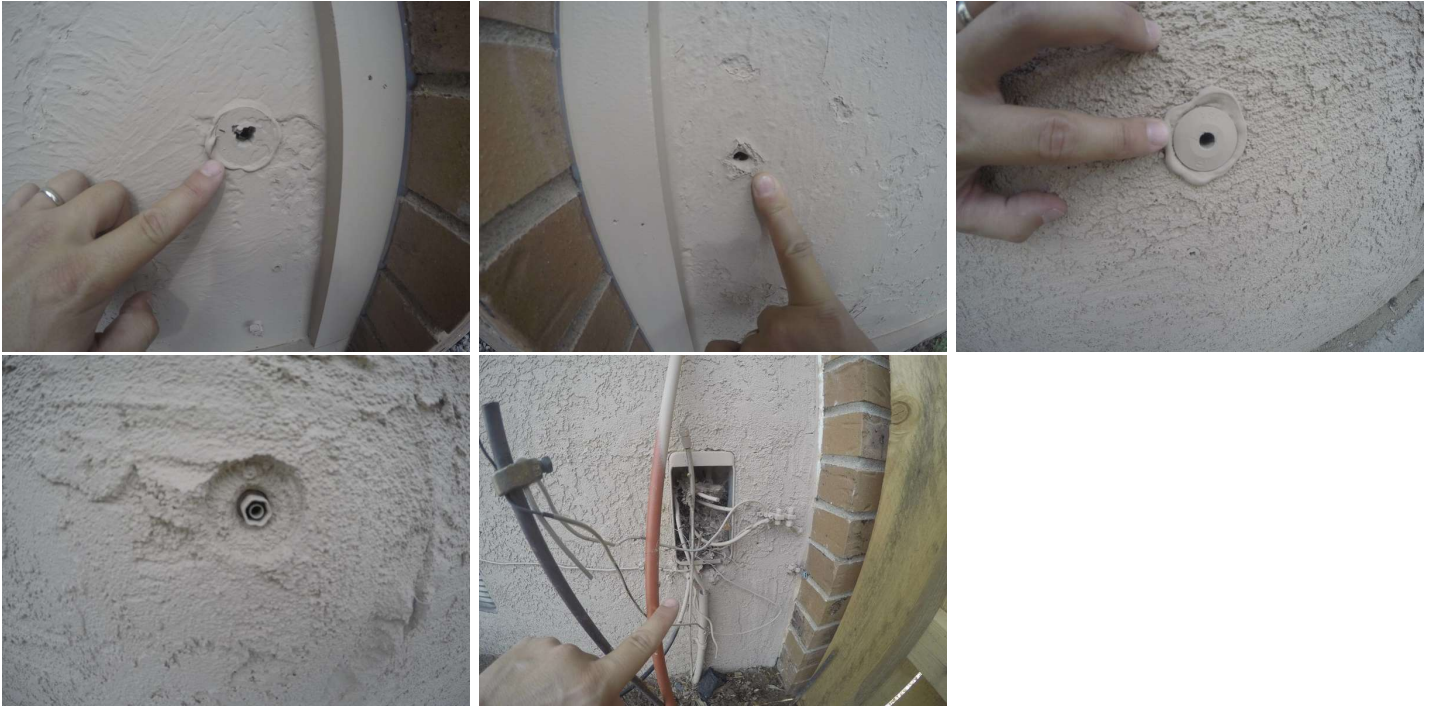
3.1.1 Siding, Flashing & Trim

SIDING - GAP/OPENING

There is opening, gap or hole in siding which should be repaired. This can allow water intrusion and rodent infestation as well as deterioration of the surrounding material.

Recommendation
Contact a qualified professional.

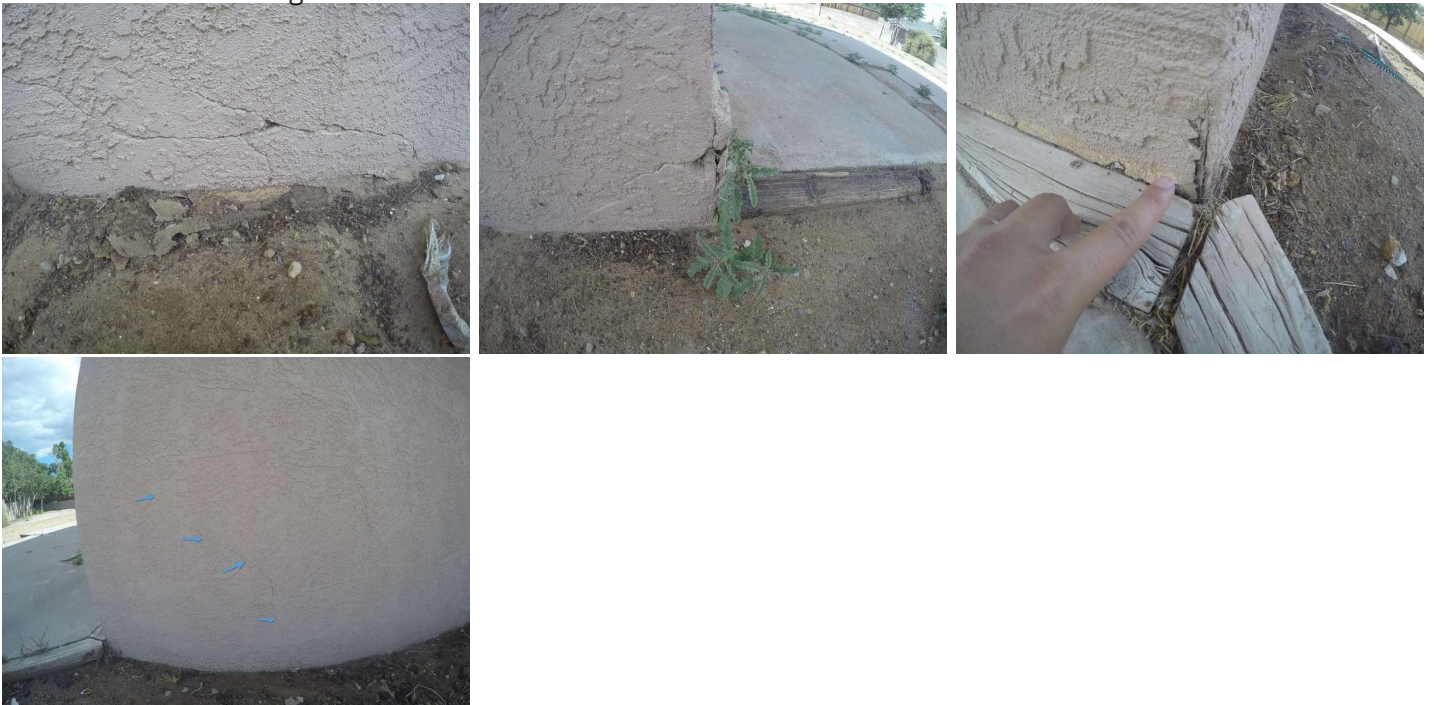
3.1.2 Siding, Flashing & Trim

STUCCO CRACKING - MINOR

Siding showed cracking in one or more places. This can be a result of temperature changes, and typical as homes with stucco age. Recommend monitoring.

Recommendation
Recommend monitoring.

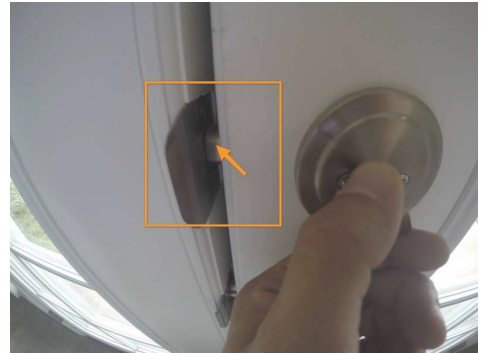
3.2.1 Exterior Doors
DOOR DOES NOT CLOSE OR LATCH

Door does not close or latch properly. Recommend qualified handyman adjust strike plate and/or lock. Here is a DIY troubleshooting article on fixing door issues.

Recommendation
Contact a qualified door repair/installation contractor.

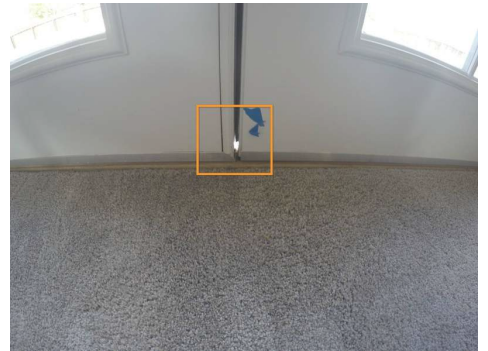
3.2.2 Exterior Doors
WEATHERSTRIPPING NEEDS REPAIR

Door weatherstripping is in need of repair/replace. This can result in significant energy loss and moisture intrusion. Recommend repair/replacement of standard weatherstripping. Here is a DIY guide on weatherstripping.

Recommendation
Contact a handyman or DIY project

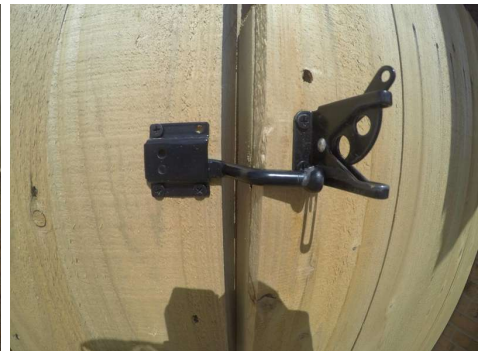
3.2.3 Exterior Doors
GATE DOES NOT LATCH

The gate to the side yard does not latch. Recommend repairing to ensure access is secured.

Recommendation
Contact a handyman or DIY project

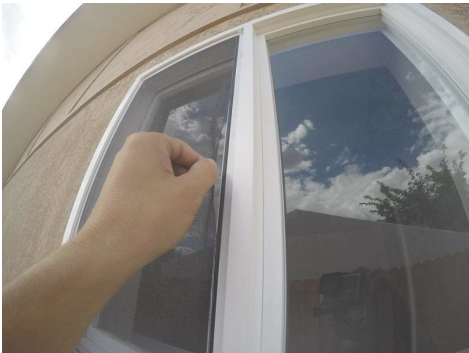
3.3.1 Windows

SCREEN DAMAGED.

Window screen damaged. Recommend repairing screen to keep insects and pests out of house.

Contact a handyman or DIY project

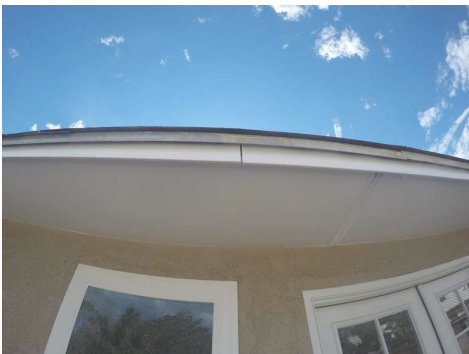
3.6.1 Eaves, Soffits & Fascia

GAP

There is opening, gap or hole in fascia / soffit which should be repaired. This can allow water intrusion and rodent infestation as well as deterioration of the surrounding material.

Contact a handyman or DIY project

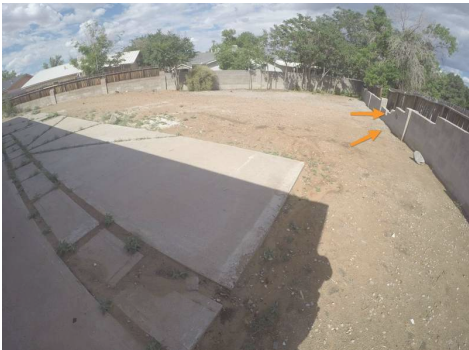
3.7.1 Vegetation, Grading, Drainage & Retaining Walls

BLOCK WALL NOT SECURED PROPERLY

Block wall was not securely fastened. Loose blocks can fall and cause injury.

Recommend repair by qualified contractor.

Contact a qualified professional.

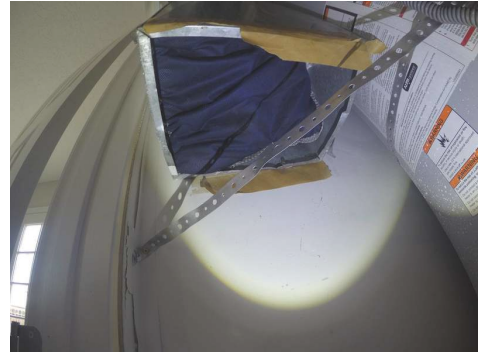
5.4.1 Vents, Flues & Chimneys

FRESH AIR DUCT BLOCKED

Fresh air duct for furnace/ water heater blocked by pillow.

Recommend asking Seller why the pillow was placed in the duct and have removed before closing.

Recommendation
Contact a qualified professional.

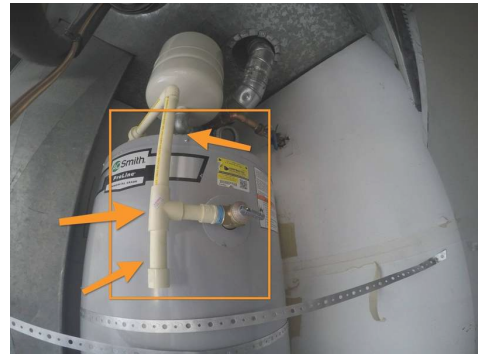
7.5.2 Hot Water Systems, Controls, Flues & Vents

DISCHARGE PIPE

Water heater TPR discharge pipe should be installed as to allow gravity to drain water from pipe. Discharge pipe should not have a "T" or a trap.

Recommend a plumbing professional repair or replace.

Recommendation
Contact a qualified professional.

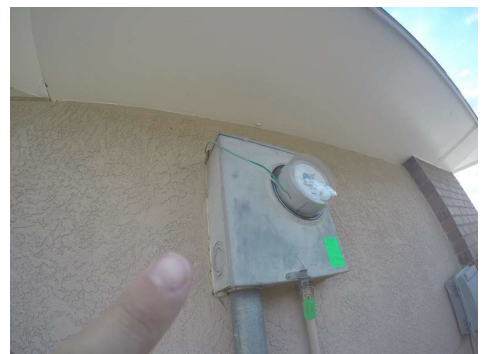
8.2.1 Service Entrance Conductors

GROUND WIRE STICKING OUT OF METER

Ungrounded ground wire sticking out from meter.

Recommend a qualified professional to investigate and repair.

Recommendation
Contact a qualified professional.

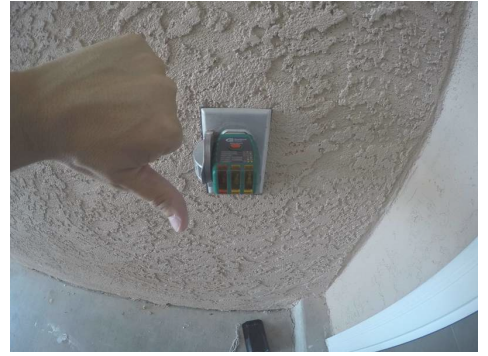
8.5.1 Lighting Fixtures, Switches & Receptacles

**RECEPTACLE
INOPERABLE**

Receptacle was not working at the time of inspection, recommend repair.

Recommendation
Contact a qualified professional.

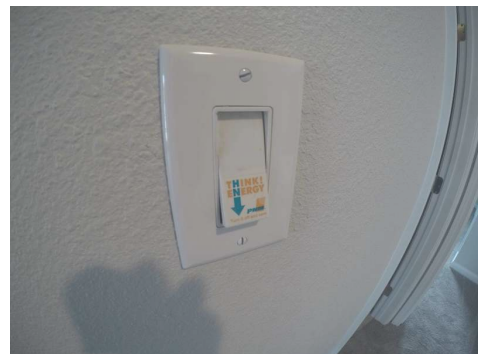
8.5.3 Lighting Fixtures, Switches & Receptacles

SWITCH BROKEN

Broken light switch, recommend repair.

Recommendation
Contact a qualified professional.

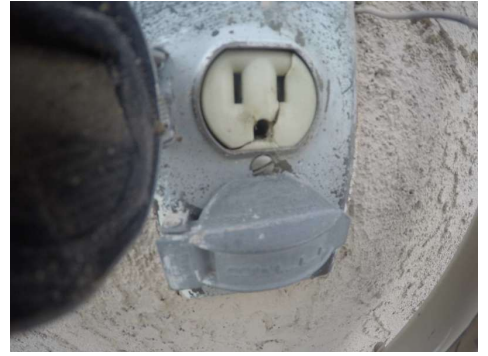
8.5.4 Lighting Fixtures, Switches & Receptacles

RECEPTACLE DAMAGED

Receptacle damaged. Recommend replacement by qualified professional.

Recommendation
Contact a qualified professional.

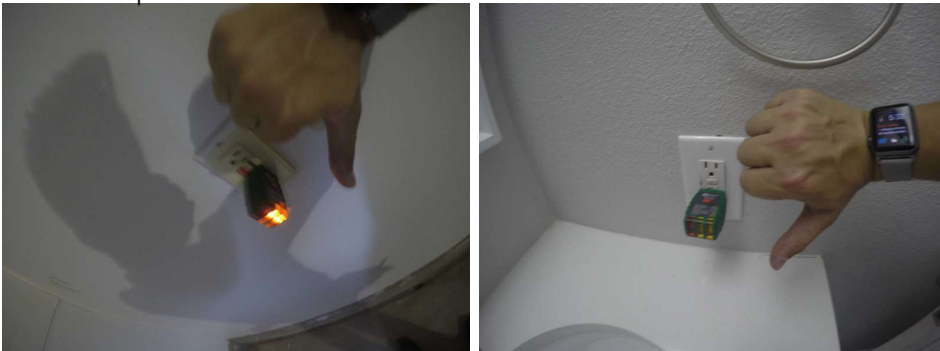
8.6.2 GFCI & AFCI

GFCI NOT OPERABLE

GFCI Receptacle was not responding to the test/reset button when pressed. Recommend qualified professional review and repair as necessary.

Contact a qualified electrical contractor.

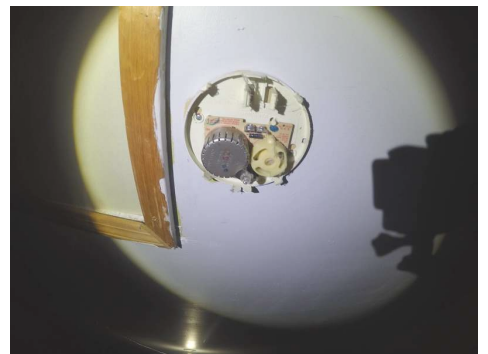
8.7.1 Smoke Detectors

NEEDS REPLACED

Recommend smoke detector that is older than 10 years of age or if age is unknown, replace with new smoke detector.

Contact a handyman or DIY project

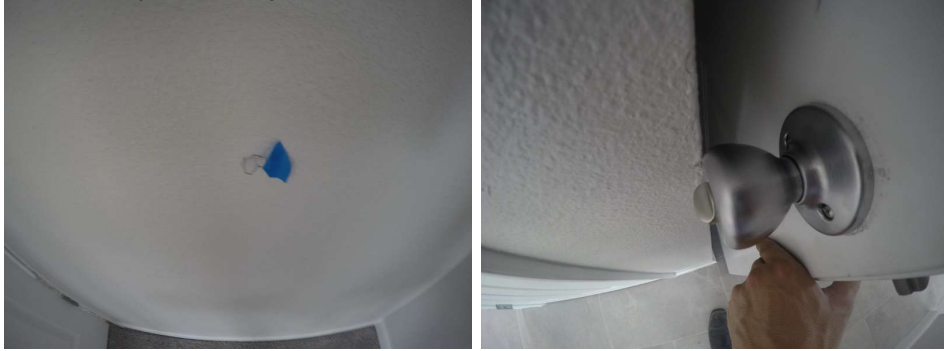
10.3.1 Walls

DOORKNOB HOLE

Wall had damage from doorknob. Recommend a qualified handyman or drywall contractor repair.

Contact a qualified drywall contractor.

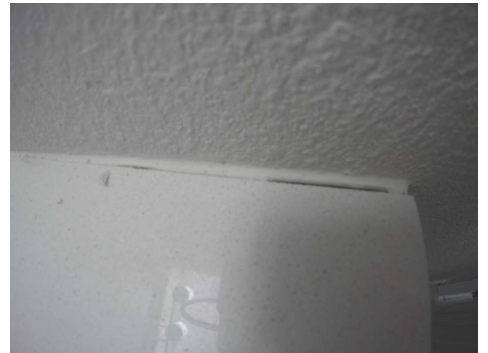
10.5.1 Countertops & Cabinets

POOR/MISSING CAULK

Bathroom countertop was missing sufficient caulk/sealant at the wall. This can lead to water damage. Recommend adding sealant at sides and corners where counters touch walls.

Recommended DIY Project

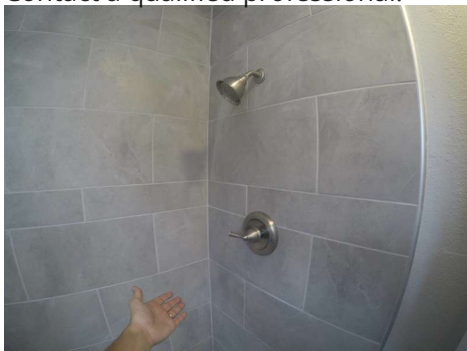
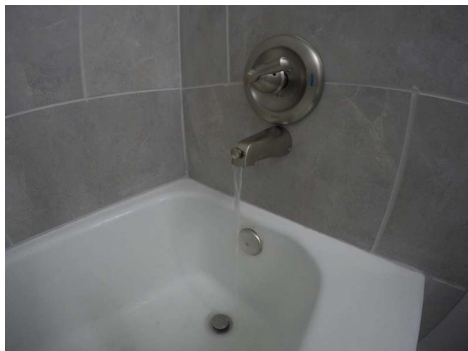
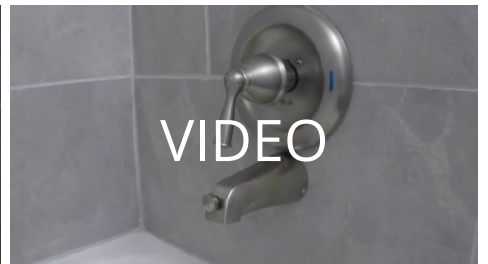
11.2.1 Plumbing & Fixtures

LOW / NO WATER PRESSURE AT SHOWER/ TUB

Low to No water pressure at Shower and tub facilities.

Recommend a qualified professional investigate and repair the problem.

Contact a qualified professional.

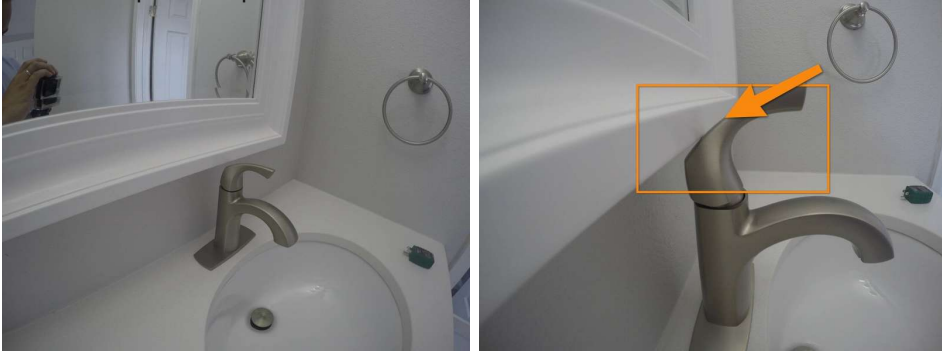
11.2.2 Plumbing & Fixtures

FAUCET HANDLE NOT OPERABLE

Faucet handle at master bath sink was not able to be operated.

Handle comes in contact with frame of mirror.

Contact a qualified professional.

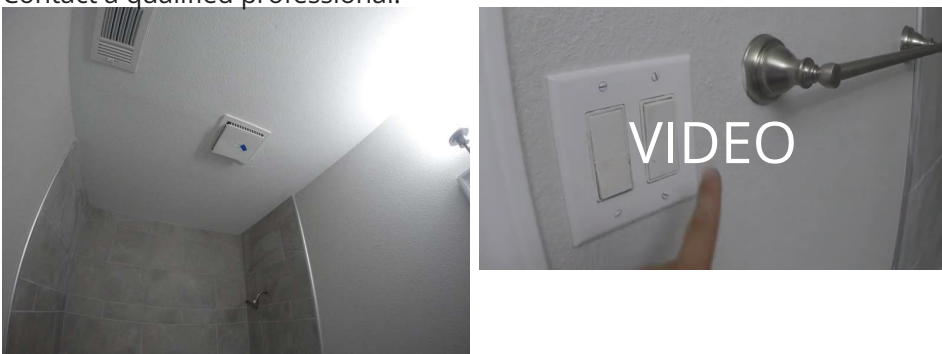
11.3.2 Electrical & Other

BATHROOM VENT MALFUNCTION

Hall Bathroom exhaust vent emits screech when operated by switch.

Recommend repair or replacement by qualified professional.

Contact a qualified professional.

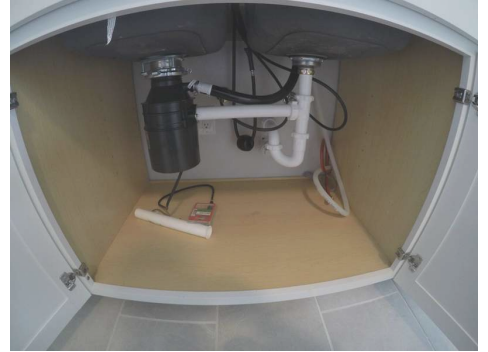
12.3.1 Electrical & Other

GARBAGE DISPOSAL WIRING

The electrical cable for the garbage disposal at the kitchen should be protected in a flexible metal conduit. This will help prevent damage to the wire from items being moved under the kitchen sink.

Recommendation
Contact a qualified professional.

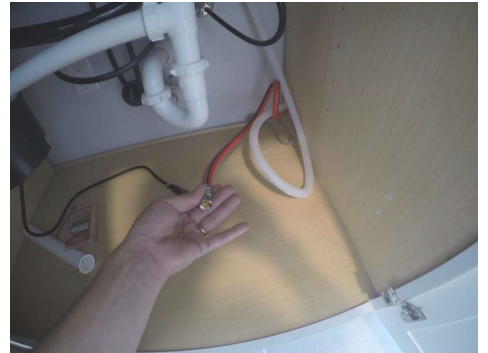
12.4.1 Dishwasher

IMPROPER INSTALLATION

Dishwasher installation not completed.

Recommendation
Contact a qualified professional.

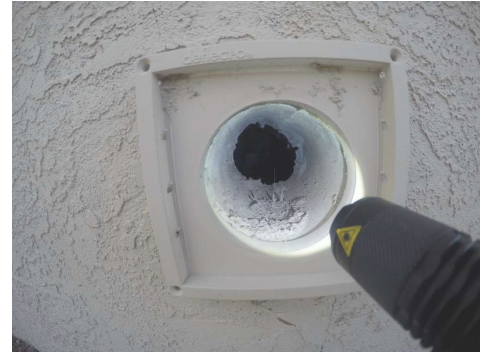
13.4.1 Washer/Dryer

EXTERIOR DRYER VENT HOOD

Recommend that a dryer vent louvered hood be installed outside. This can prevent rodents and other pests from entering the dryer vent and causing damage.

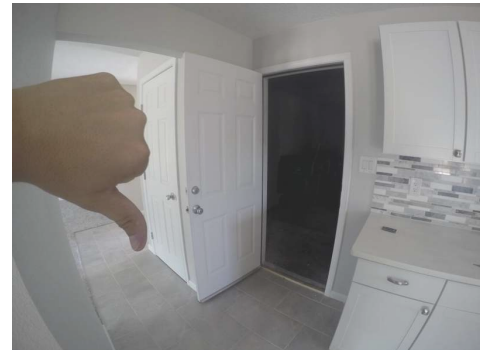
14.11.1 Occupant Door (From garage to inside of home)

NOT SELF-CLOSING

Door from garage to home should have self-closing hinges to help prevent spread of a fire to living space. Recommend a qualified contractor install self-closing hinges.

Contact a qualified door repair/installation contractor.
