SUMMARY

1234 Main St. Jefferson GA 30549

Kurt Puterbaugh
ASHI #260782

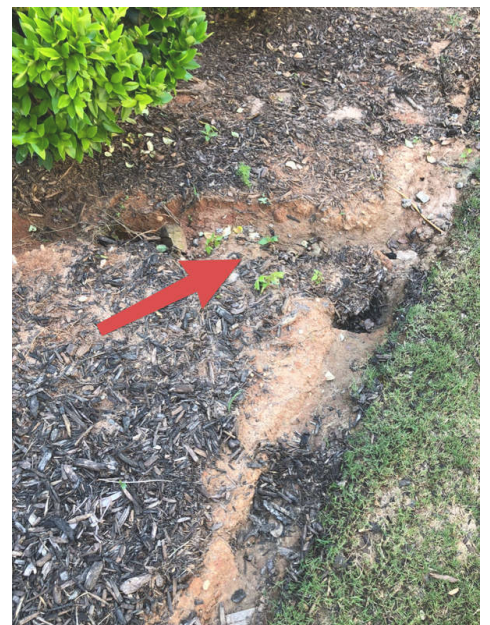
Right

4.1.1 Grading

EROSION

SERVICE / REPAIR: Erosion noted at time of inspection. Have ground area restored and make efforts to control rain water runoff to prevent reoccurrence. Some local and state municipalities can invoke fines on property owners for storm water silt runoff responsible for filling streams.

Contact a qualified professional.

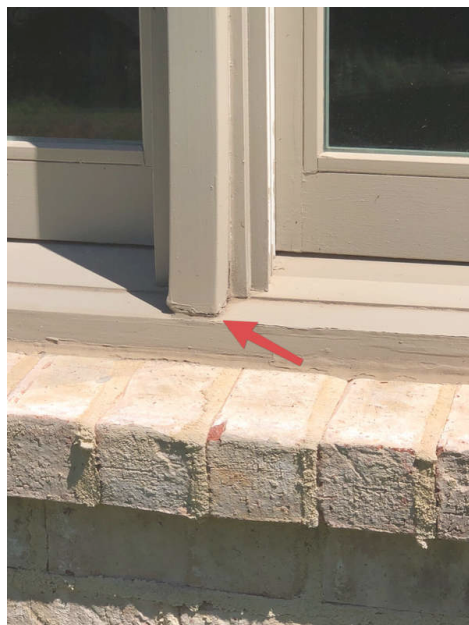
Rear

4.5.1 Windows

DAMAGED TRIM

SERVICE / REPAIR: Damaged trim found at window. Replace as needed.

Recommendation
Contact a qualified professional.

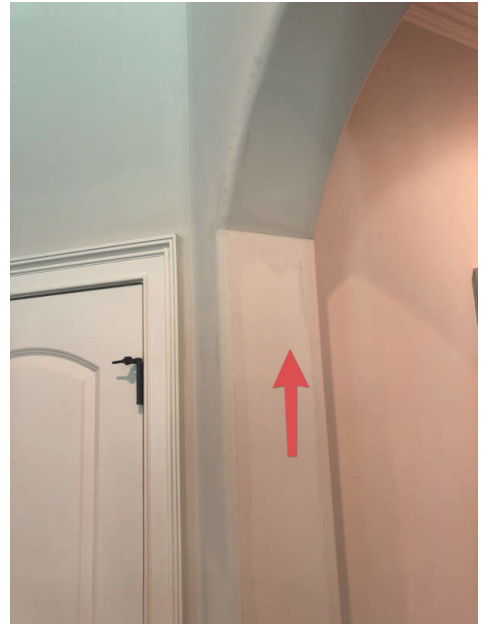
Basement

8.1.1 Walls | Ceilings

IR - DRY

GENERAL NOTE: The ceiling is water damaged. Infrared scan indicated no moisture above the ceiling and moisture meter indicates low moisture content(dry) at the time of this inspection.

Recommendation
Contact a qualified professional.

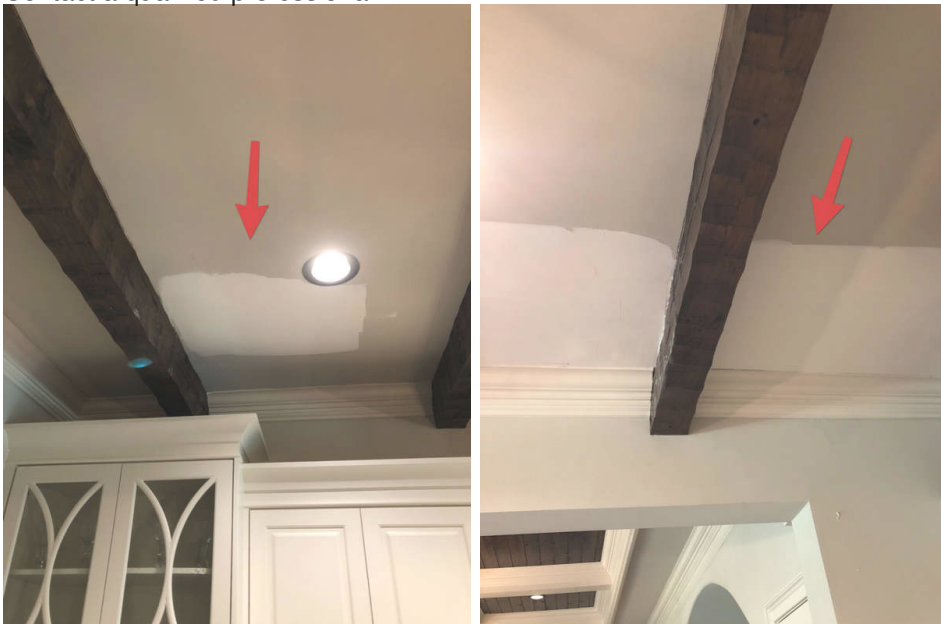
Kitchen

8.1.2 Walls | Ceilings

CEILING REPAIRS

GENERAL NOTE: Touch ups and repairs noted in ceiling(s) during inspection. Seller to disclose the source of problem, including extent of repairs made. This information may be needed for buyer's future reference. Usually requires full area painting to reduce obvious conditions.

Recommendation
Contact a qualified professional.

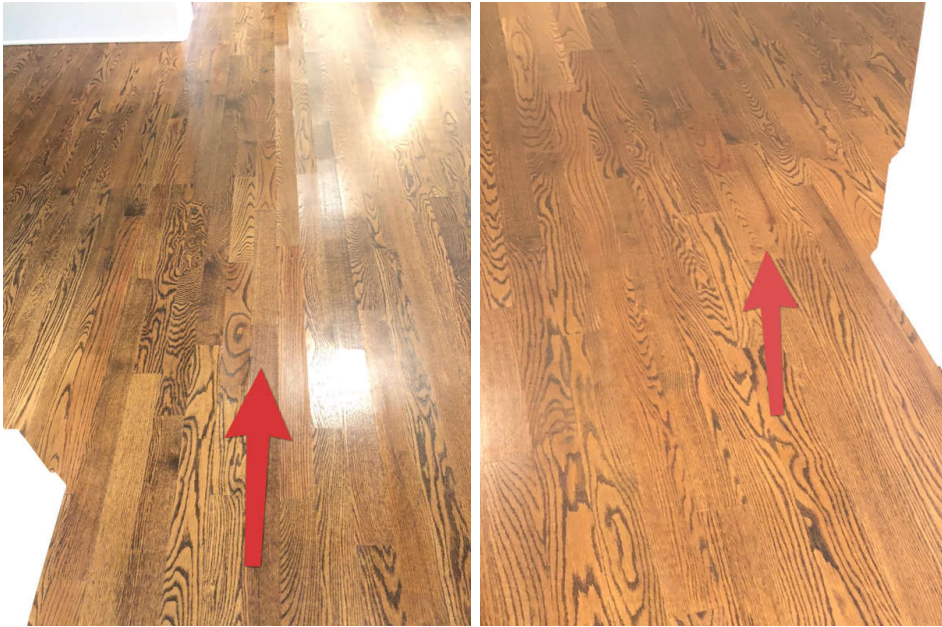
Family Room

8.2.1 Floors

DAMAGED

SERVICE / REPAIR: Damaged areas of flooring observed. Have a professional flooring contractor evaluate and repair or replace the flooring as needed.

Recommendation
Contact a qualified professional.

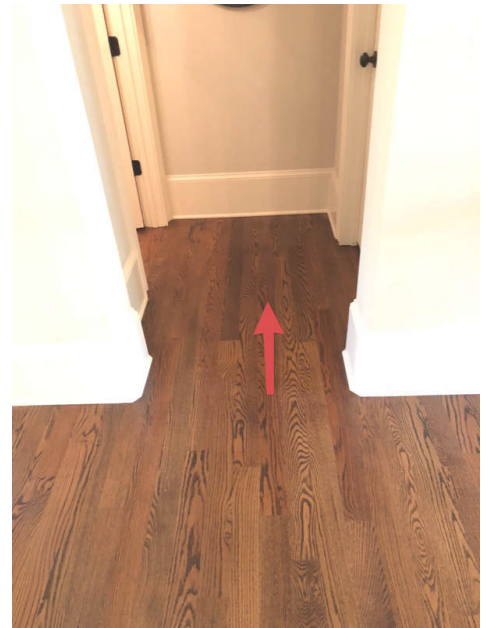
Foyer

8.2.2 Floors

WOOD - NOT LEVEL

SERVICE / REPAIR: No point on the surface of a wood floor should be more than 1/2 inch higher or lower than any other point on the surface within 20 feet, or proportional multiples. NAHB 3-8

Contact a qualified professional.

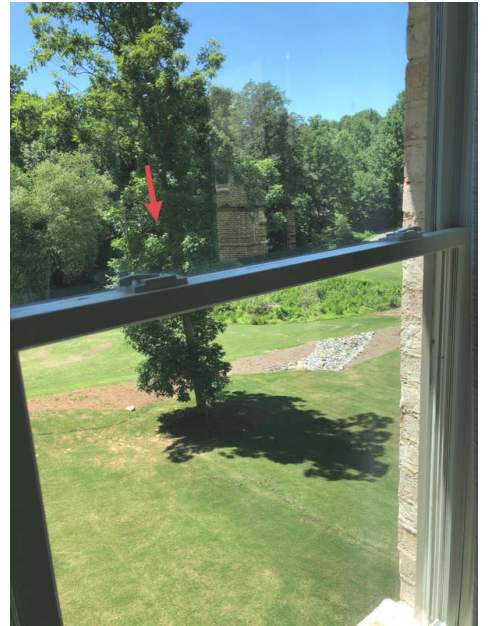
Master Bedroom

8.4.1 Windows

WINDOWS STUCK

SERVICE / REPAIR: A number of windows are painted shut. Have contractor repair as needed to ensure proper egress.

Recommendation
Contact a qualified professional.

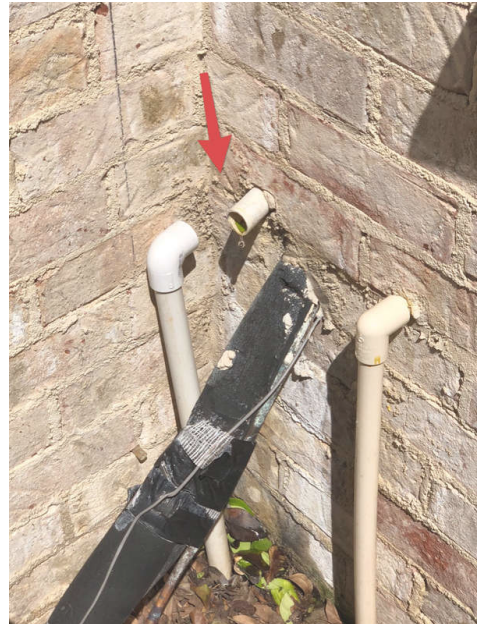
Rear

12.1.1 Air Conditioner

CONDENSATE DRAIN

SERVICE / REPAIR: The drain line is disconnected. Have a qualified contractor repair as needed.

Contact a qualified professional.
