## SUMMARY

1234 Main St. Vancouver WA 98663

Northbank Home Inspection

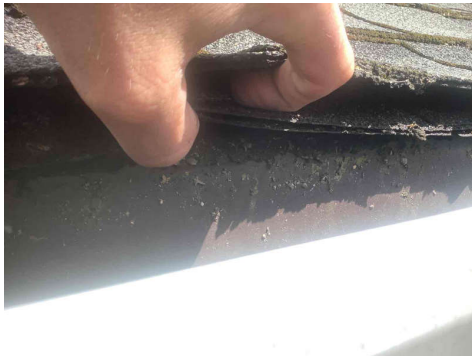
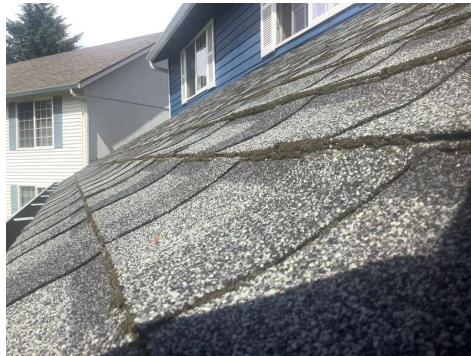
### 2.1.1 Coverings

## MULTIPLE LAYERS OF SHINGLES

More than one layer of asphalt shingles was observed. This new layer of shingles may not last as long as single, new layer and it could void any warranty that came with the new shingles. Additionally, the original underlayment may fail before the latest layer. Recommend monitoring.

Contact a qualified roofing professional.

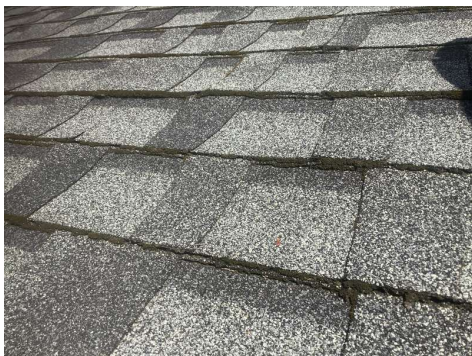
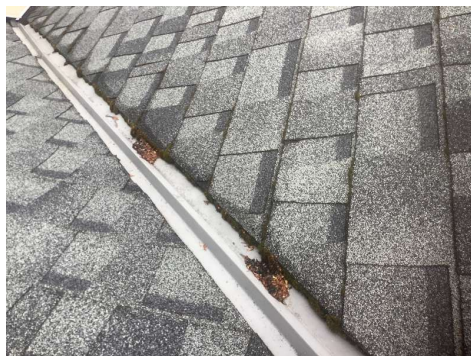
### 2.1.2 Coverings

## MOSS

Moss was observed growing on portions of the roof. Moss can accelerate the deterioration of roof covering materials, lift shingles and lead to moisture intrusion. Leaks may result. Additionally, moss is a conducive condition for wood-destroying organisms. Recommend removal with a product such as, Moss Out, applied seasonally. Do not remove with a pressure washer, as this will dramatically shorten the life expectancy of the roof.

Contact a qualified professional.

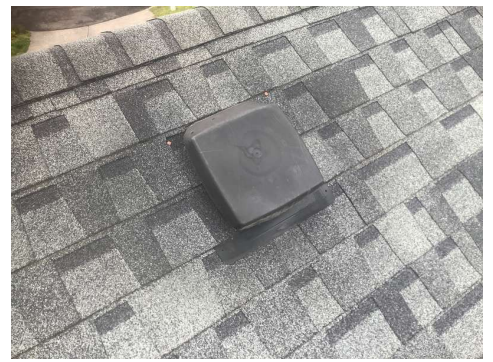
Roof covering showed signs of darkening around roof vents. This is cosmetic and typically the result of excessive attic heat. Attic heat is largely driven by the color of the roof coverings - darker absorbs heat; lighter reflects heat. Recommend monitoring and evaluation by a qualified roofing contractor, if necessary.

Recommend monitoring.

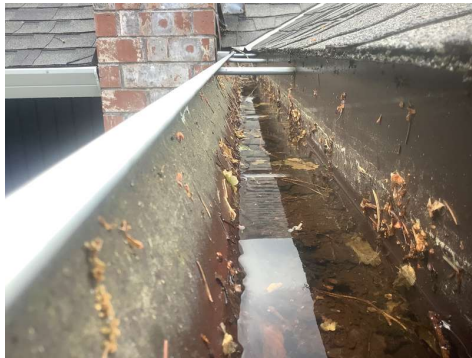
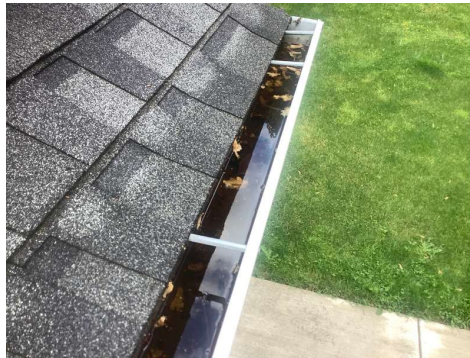
Debris has accumulated in the gutters. Clogged gutters can overflow and cause water to drain near the foundation, increasing the chance of siding and foundation damage. Recommend cleaning to facilitate water flow.

Contact a qualified roofing professional.

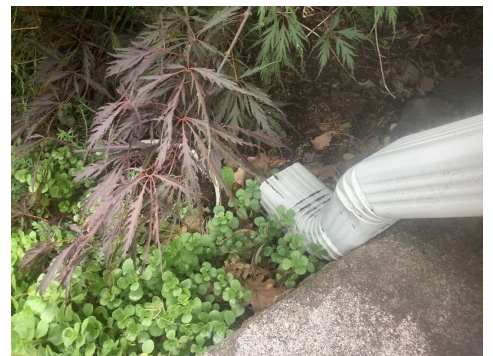
One or more downspouts drain too close to the home's foundation. This can result in excessive moisture in the soil at the foundation, which can lead to foundation/structural damage from soil movement. Recommend a qualified professional adjust downspout extensions to drain at least 6 feet from the foundation.

Contact a qualified roofing professional.

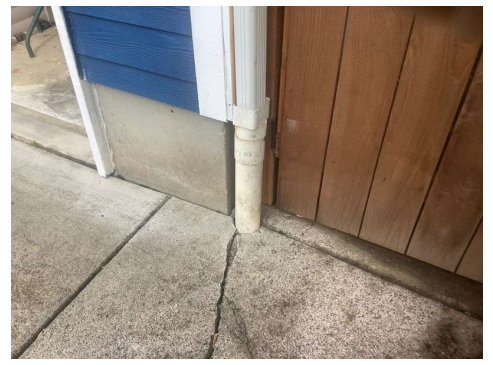
### 2.2.3 Roof Drainage Systems

## UNDERGROUND STORM DRAINS

The roof drainage systems are connected to drains underground and I cannot verify if the discharge is an appropriate distance away from the foundation or if the drain lines are compromised. The minimum distance water should be diverted away from the foundation is 6 feet. Recommend monitoring.

Recommendation  
Contact a qualified general contractor.

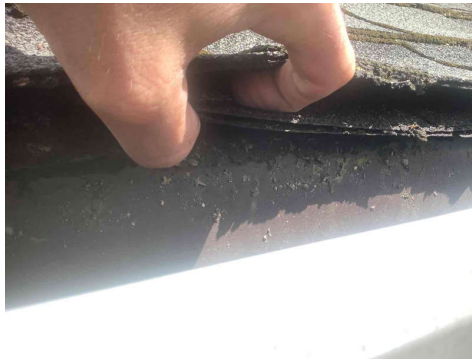
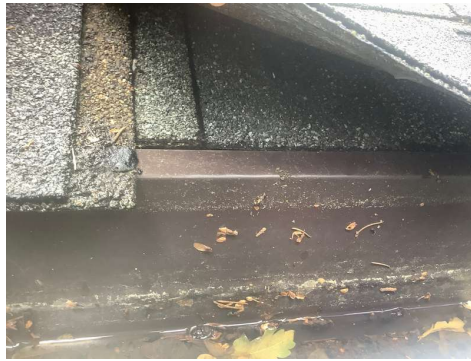
## MISSING DRIP AND RAKE EDGE FLASHING

Adequate drip and rake edge flashings were not installed at the time of inspection. These flashings help shed water and protect fascia and trim from water damage. Recommend a qualified roofing professional repair.

Recommendation  
Contact a qualified roofing professional.

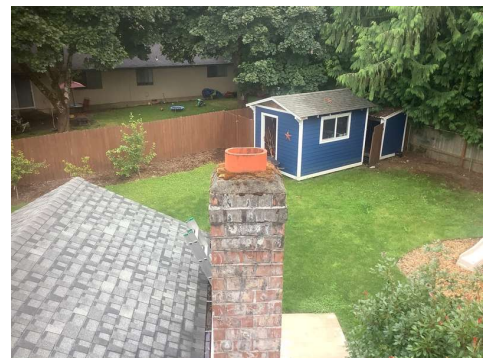
### 2.4.1 Chimneys, Skylights, & Other Roof Penetrations

## CHIMNEY CAP MISSING

No chimney cap was observed. This is important to protect from moisture intrusion, pests, and protect the chimney. Additionally, the chimney should be equipped with a spark arrestor, which protects against errant fireplace embers that may start fires after drifting out of the chimney. Recommend a qualified roofer or chimney expert install.

Recommendation  
Contact a qualified roofing professional.

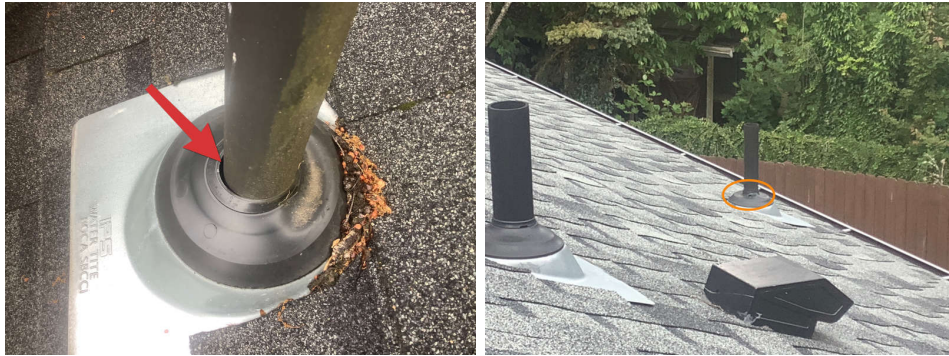
Plumbing vent and boot is installed in a substandard manner -- the gasket is compressed. This could create gaps that can allow moisture to enter or lead to gasket damage. Recommend a qualified contractor repair.

Contact a qualified roofing professional.

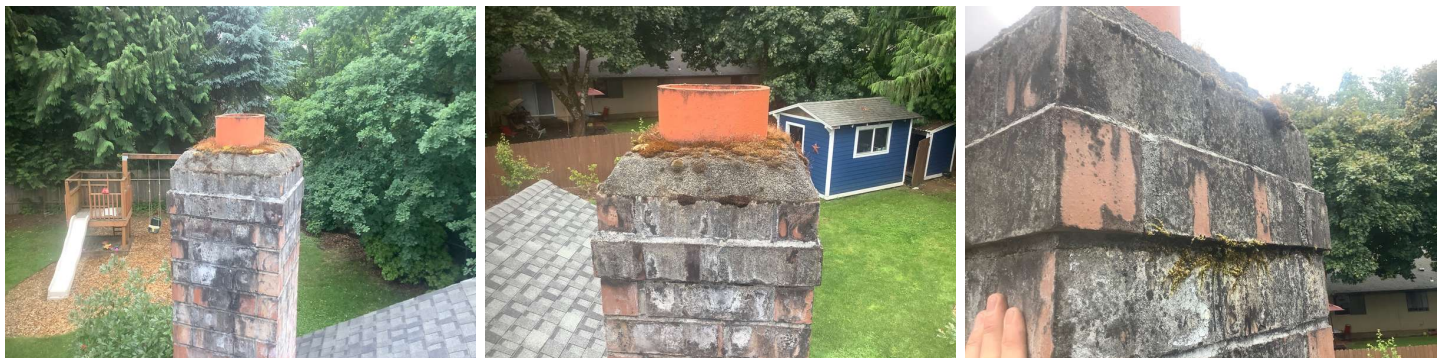
**CHIMNEY NEEDS MAINTENANCE**

The chimney is in need of maintenance -- moss and cracks were observed. If not maintained, additional deterioration may result, which could lead to leaks. Recommend a qualified contractor repaired.

Contact a qualified chimney contractor.

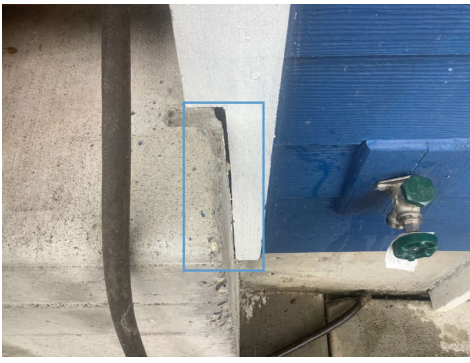
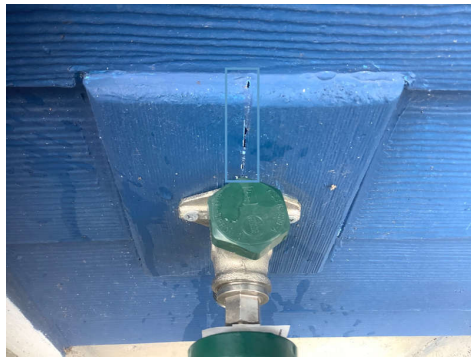
**SEALANT DETERIORATED**

The siding sealant is deteriorated in one or more areas. This can allow water intrusion, which could lead to underlying wall component damage. Recommend a qualified contractor repair sealant or install flashing in these areas.

Contact a qualified siding specialist.

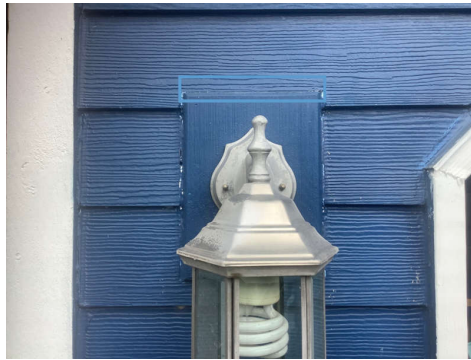
## MISSING FLASHING

Flashing is not installed where its needed. This can allow water to damage the siding, windows, fixtures, or other components, and lead to multiple issues, including rot of wooden components. Appropriate flashings can help extend the life of building components. Recommend a qualified contractor install flashing where needed.

Contact a qualified siding specialist.

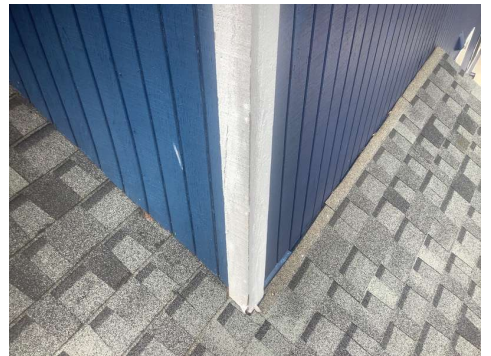
### 3.1.3 Siding, Flashing & Trim

## TRIM NEEDS PAINTING

Trim around the home has deteriorated paint. This can expose it to water damage, which can lead to rot. Recommend a qualified painter paint trim around the home.

Contact a qualified painting contractor.

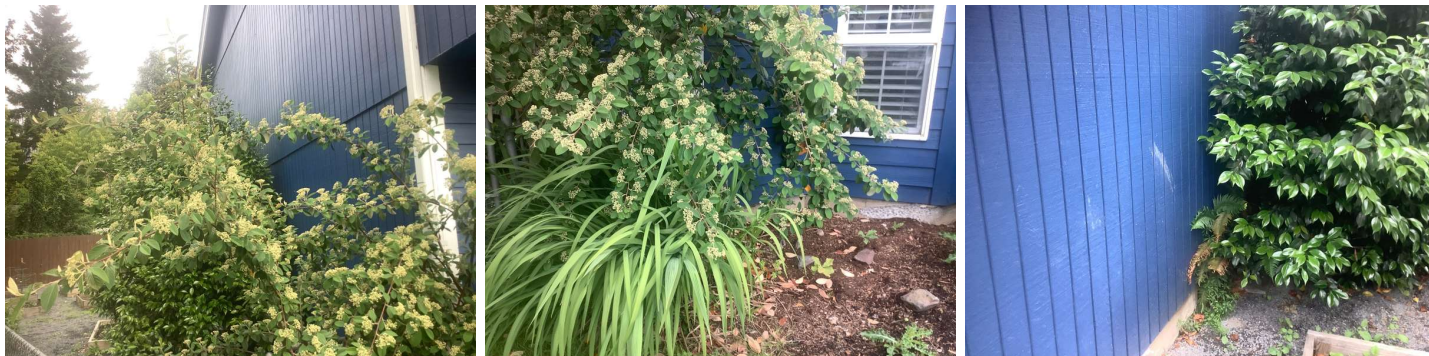
### 3.1.4 Siding, Flashing & Trim

## VEGETATION

Vegetation was in contact with the exterior siding. This condition allows moisture to wick into wooden components or beneath siding, which may lead to moisture damage to structural members behind the siding in time. Additionally, it also provides an avenue into the home for wood-destroying organisms. Recommend trimming or removing vegetation in contact with the siding by a qualified and licensed landscaper.

Recommendation  
Contact a qualified landscaping contractor

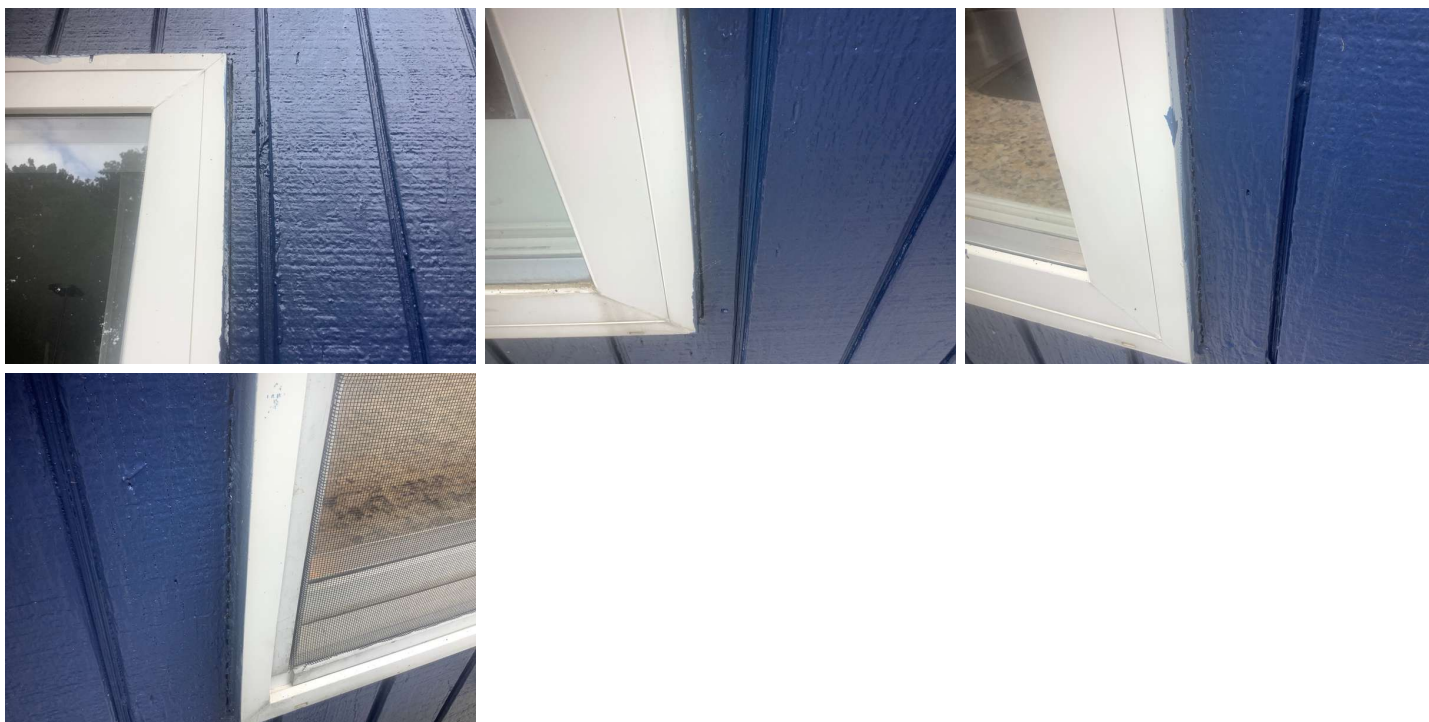
## **WINDOW EXTERIOR SEAL CRACK**

The sealant around the windows in one or more areas is cracked or deteriorated. This can lead to moisture intrusion. Recommend a qualified contractor repair.

Recommendation  
Contact a qualified handyman.

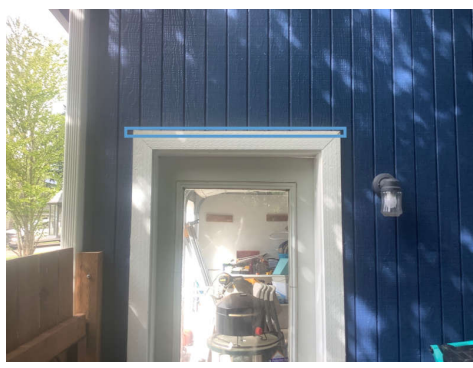
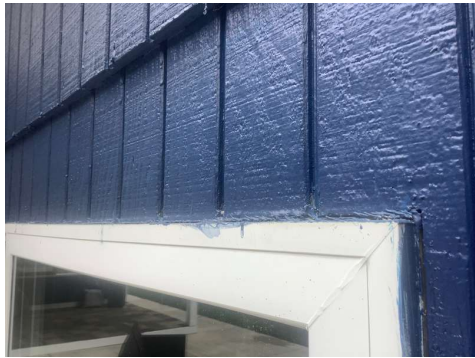
### 3.1.6 Siding, Flashing & Trim

## **WINDOW/DOOR HEAD FLASHING**

Windows and/or doors in one or more areas are missing flashing. This can lead to water intrusion and damage if exterior seals fail. Windows and doors should have flashing installed above them to help shed water. This is a modern building standard. Recommend monitoring and maintaining sealant or installation of flashing by a qualified contractor if needed.

Recommendation  
Contact a qualified siding specialist.

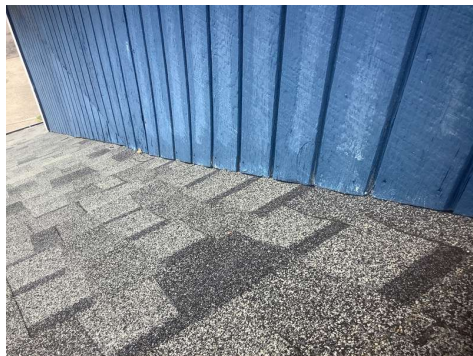
### 3.1.7 Siding, Flashing & Trim **SIDING ROOF CLEARANCE**

Siding is near or touching roof coverings. Without a larger clearance, rain water can wick up into siding and cause damage. This may lead to siding deterioration and rot. Recommend a qualified contractor repair.

Recommendation  
Contact a qualified siding specialist.

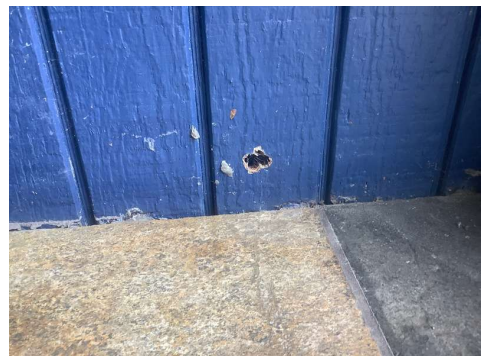
Gaps in the siding and trim were observed. This can allow moisture and pest intrusion. Gaps should be sealed appropriately with sealant or flashing. Recommend a qualified contractor repair.

Recommendation  
Contact a qualified handyman.

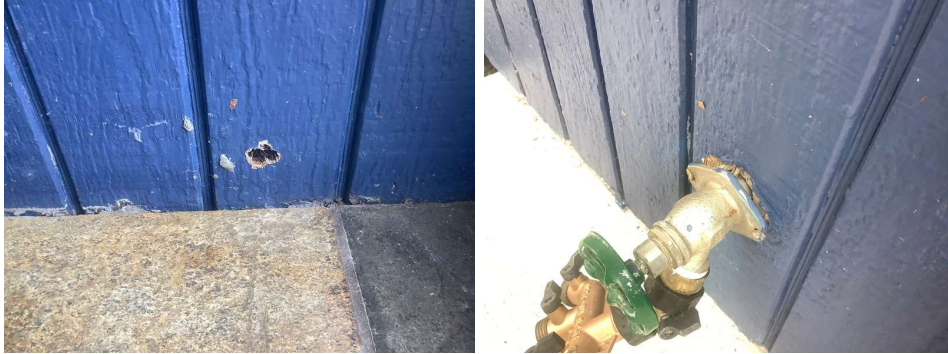
3.1.9 Siding, Flashing & Trim

**SIDING PENETRATION NOT SEALED**

Siding penetrations are not sealed or flashed properly in one or more areas. This can lead to water intrusion, which can potentially cause damage, including rot, of siding and framing components. Recommend a qualified contractor repair with appropriate sealant and/or flashing.

Contact a qualified siding specialist.

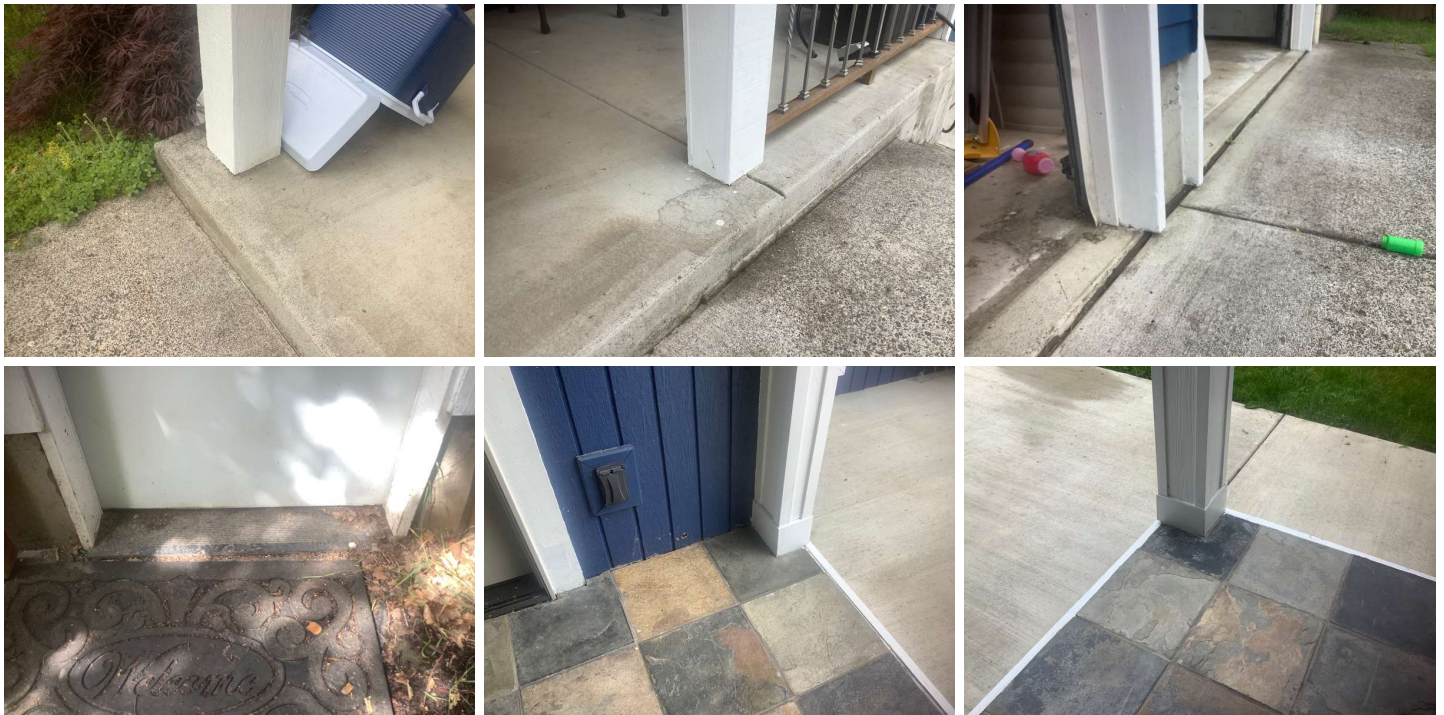
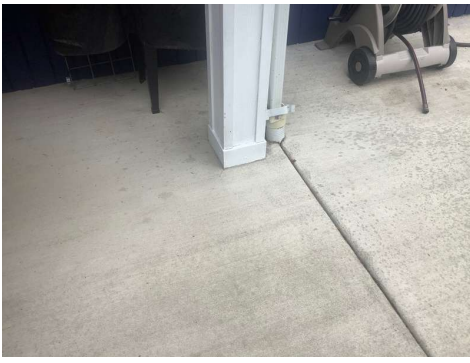
3.1.10 Siding, Flashing & Trim

**TRIM GROUND CLEARANCE**

Trim in one or more areas does not have enough clearance from the ground. Trim should be a minimum of 1-2 inches above hardscape, ie concrete, or 6-8 inches above soil to prevent water wicking up into the trim and causing damaged. Recommend a qualified contractor repair.

Contact a qualified handyman.

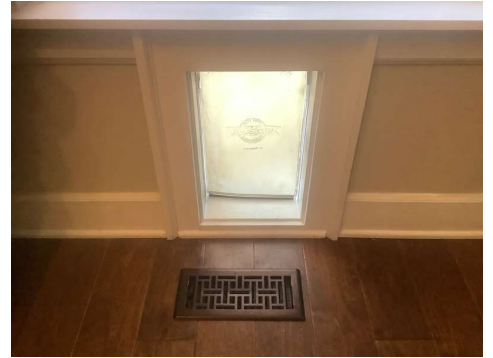
**PET DOOR INADEQUATE**

The pet door does not appear to be equipped with a weather door. This can be a significant source of energy loss. Recommend a qualified contractor evaluate and repair.

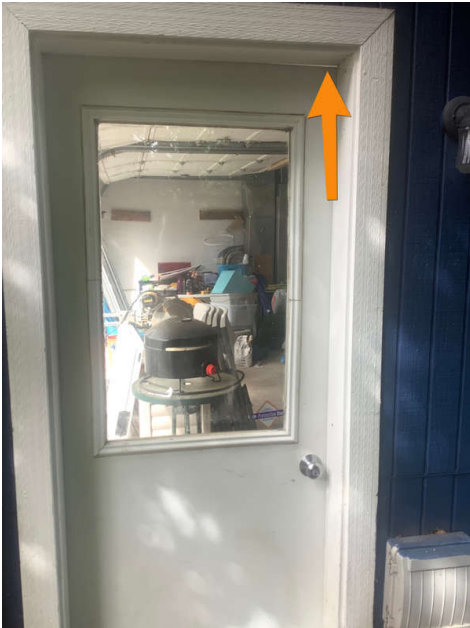
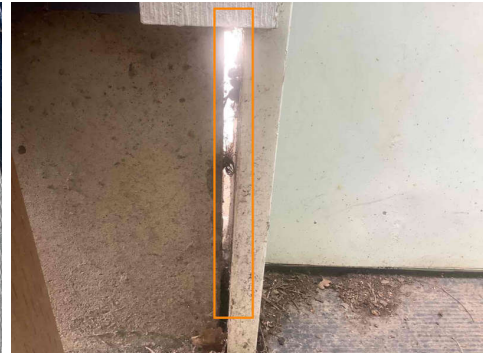
An exterior door and trim are not properly aligned and need adjustment - the door does not close and gaps near the trim are present. Recommend a qualified millworks contractor repair.

Contact a qualified door repair/installation contractor.

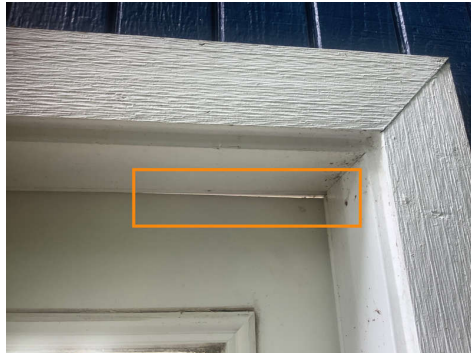
3.2.2 Exterior Doors

**DOOR NEEDS ADJUSTMENT**

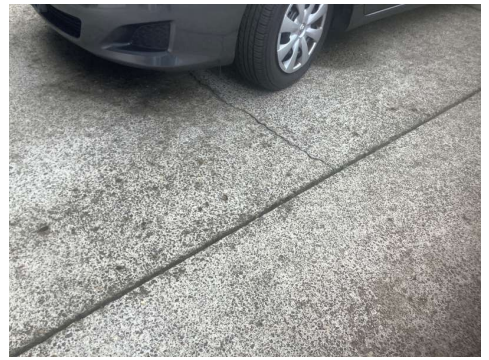
3.3.1 Walkways, Patios & Driveways

**DRIVEWAY CRACKING**

Cracks were observed in the driveway. These cracks are typical of settling concrete of this age. Recommend monitoring for widening cracks this -- could indicate more serious soil movement -- and patch or seal, if needed, by a qualified contractor.

Contact a qualified concrete contractor.

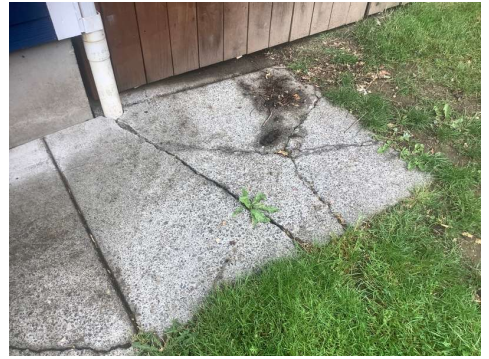
3.3.2 Walkways, Patios & Driveways

**WALKWAY CRACKING - LARGE**

Large cracks and damage were observed on portions of the exterior walkways. These cracks could be related to inadequate site drainage in this area, which can lead to settling and damage. Recommend concrete contractor evaluate and correct to prevent trip hazard and preserve appearance.

Contact a qualified concrete contractor.

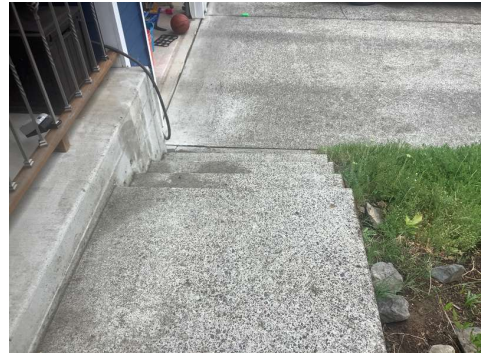
3.4.1 Decks, Balconies, Porches & Steps

One or more exterior stairways do not have a graspable handrail. Stairways having four or more risers or rising more than 30 inches (76 cm), whichever is less, should be equipped with a graspable handrail, according to Washington state guidelines. Recommend installation of appropriate railing by a qualified contractor. Consider your own needs and safety requirements when deciding whether upgrading to these modern standards is necessary for your family.

Contact a qualified general contractor.

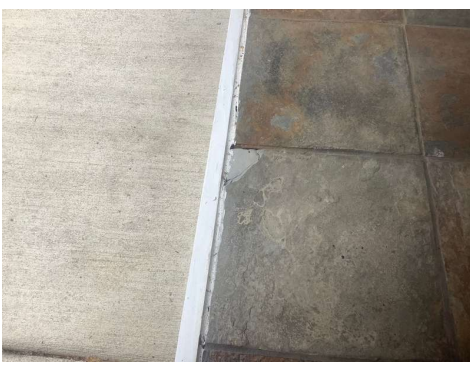
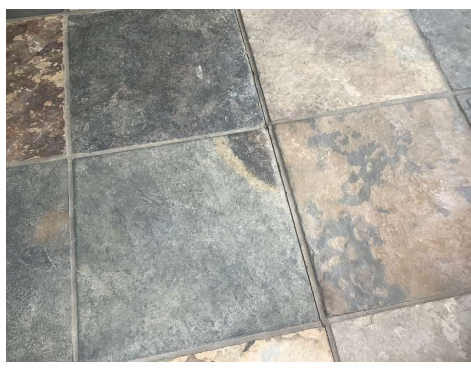
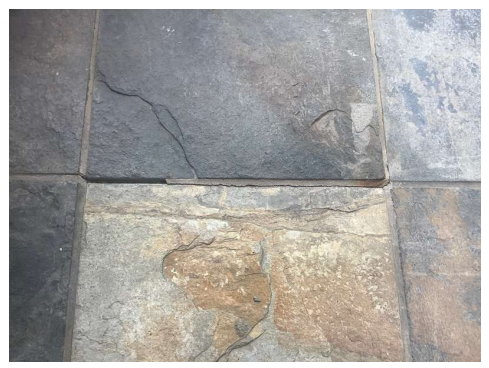
3.4.2 Decks, Balconies, Porches & Steps

Exterior tile and grout is damaged and in need of repair. Deteriorated grout and cracked tiles can allow moisture beneath the tile, which can lead to further damage. Recommend a qualified tile contractor evaluate and repair.

Contact a qualified tile contractor

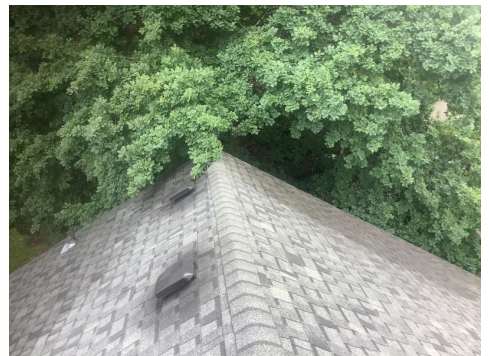
Trees observed overhanging the roof. This can cause damage to the roof and prevent proper drainage from clogged gutters. Additionally, tree overhang can allow access to the roof for pests. Recommend a qualified tree service trim as needed.

Contact a qualified tree service company.

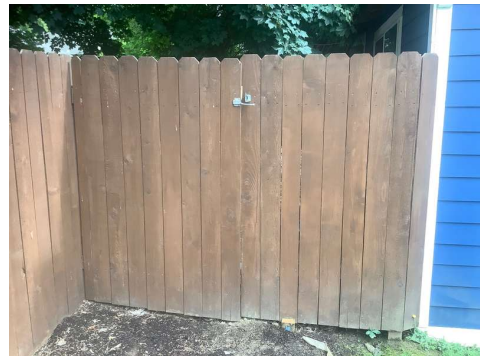
### GATE SAGGING

Gate is sagging. This can affect its function. Recommend a qualified contractor install tension device to repair.

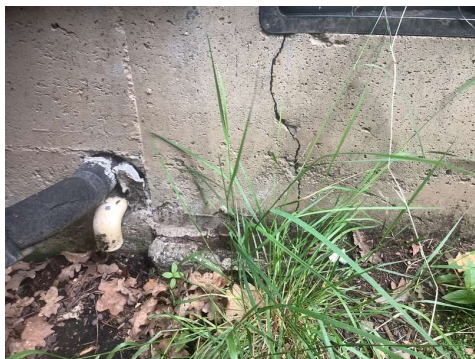
### FOUNDATION CRACKS - MINOR

Minor cracking was noted at the foundation. This is common as concrete ages -- shrinkage surface cracks are normal. Cracks should not exceed more than 1/4 inch in width, which may indicate more significant settling. Recommend monitoring for more serious shifting/displacement and having a qualified contractor seal cracks to prevent moisture intrusion.

Recommend monitoring.

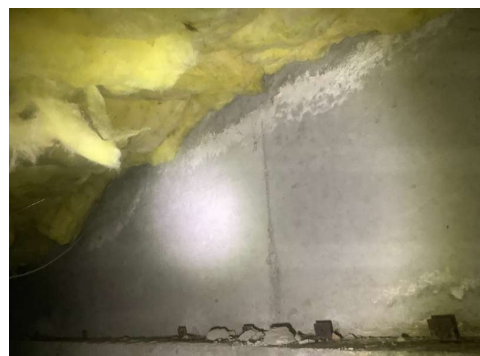
### EFFLORESCENCE

Efflorescence (white salt staining) on concrete wall indicates moisture is in contact with the foundation, which is typically caused by poor site drainage. Recommend ensuring the gutters and the downspout drain lines are functioning properly and the grading slopes away from the home appropriately. Efflorescence should alert you to the possibility that future steps may be needed. Recommend monitoring and having a qualified contractor repair drainage or grading issues.

Contact a qualified general contractor.

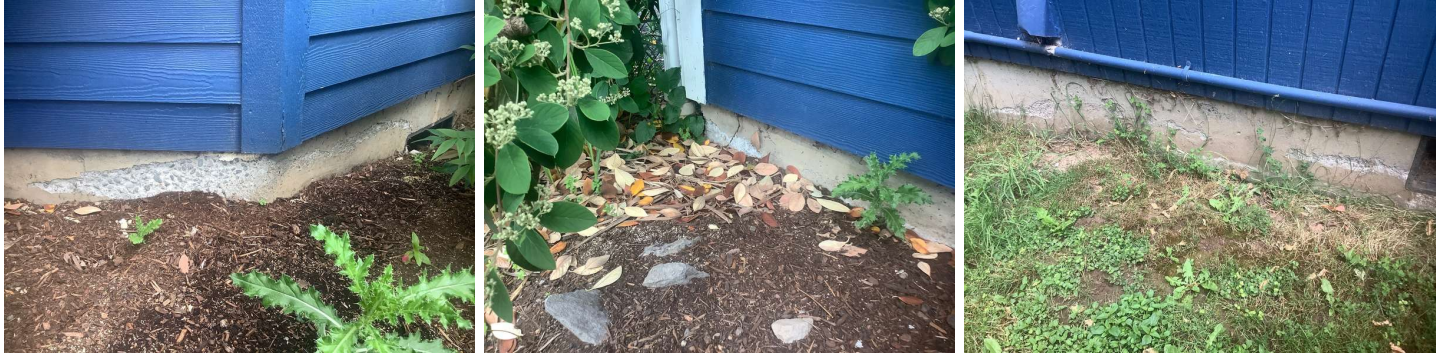
#### 4.1.3 Foundation

### CHIPPING (SPALLING)

Chipping, or spalling, of the foundation was observed in areas around the home. Spalling can be caused by multiple effects, but water near the foundation is typically the most common source. This can be caused by inadequate site drainage that may allow water saturate the soil around the foundation, wick up the foundation, and freeze, leading to spalling. This underscores the importance of directing water away from the foundation. This can also be related to the concrete mixture when it was poured. Recommend monitoring and correcting drainage issues if needed.

Contact a qualified general contractor.

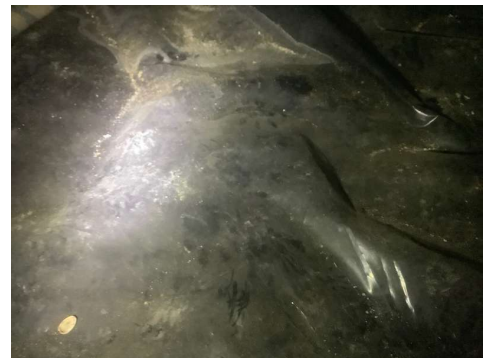
#### 4.2.1 Basements & Crawlspaces

### PESTS

Evidence of pests was observed in the crawlspace. Recommend removal of debris and evaluation, if necessary, by a qualified pest control professional.

Paw prints

Contact a qualified pest control specialist.

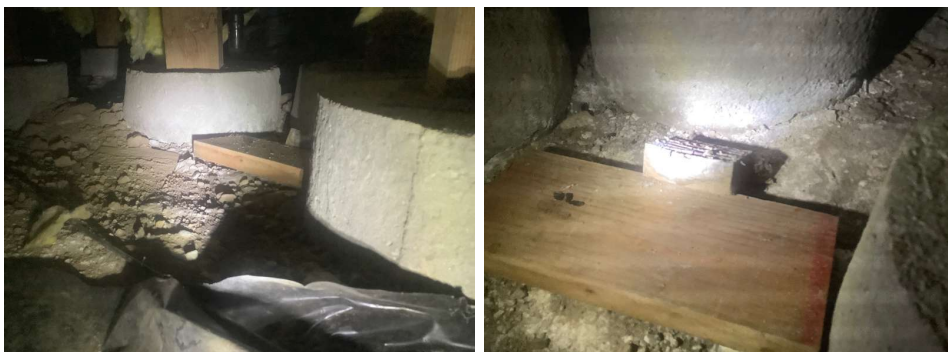
#### 4.2.2 Basements & Crawlspaces

Various debris was observed on the floor of the crawlspace, some of which could be a source of nutrients for wood-destroying organisms. Recommend removal of debris from crawlspace by a qualified professional.

Contact a qualified handyman.

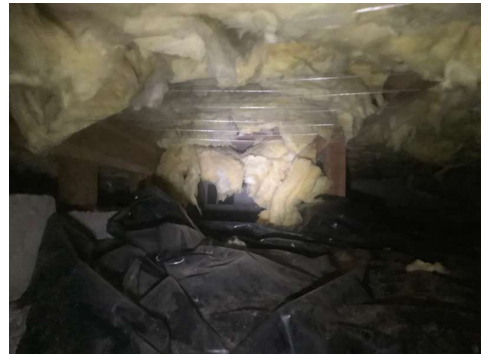
#### 4.2.3 Basements & Crawlspaces

### **DAMAGED INSULATION**

Insulation is damaged in the crawlspace. This can lead to energy loss. Recommend a qualified insulation contractor repair.

Contact a qualified insulation contractor.

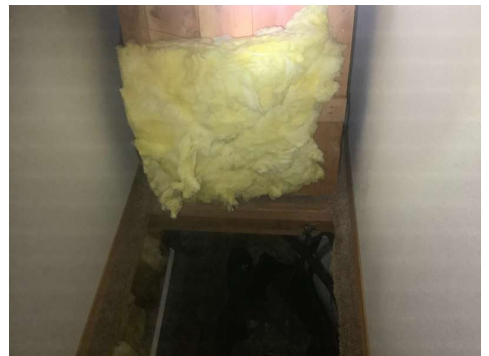
#### 4.2.4 Basements & Crawlspaces

### **WEATHERSTRIPPING - CRAWLSPACE HATCH INADEQUATE**

The crawlspace hatch has missing or damaged weatherstripping. Weatherstripping helps improve energy efficiency. Recommend installation or repair of weatherstripping by a qualified contractor.

Contact a handyman or DIY project

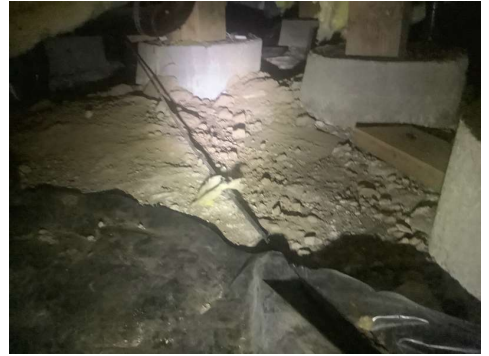
#### 4.3.1 Vapor Retarders (Crawlspace or Basement)

### **VAPOR BARRIER DAMAGED/MISSING**

The vapor barrier is damaged or missing in one or more areas. This can lead to moisture issues in the crawlspace and create conducive conditions for wood-destroying organisms. Additionally, a properly installed vapor barrier provides some protection from radon, a radioactive gas released from the soil that is common in many areas of the northwest. In elevated levels over extended periods of time, radon exposure can lead to lung cancer. I recommend a qualified contractor repair or replace vapor barrier.

Recommendation  
Contact a qualified insulation contractor.

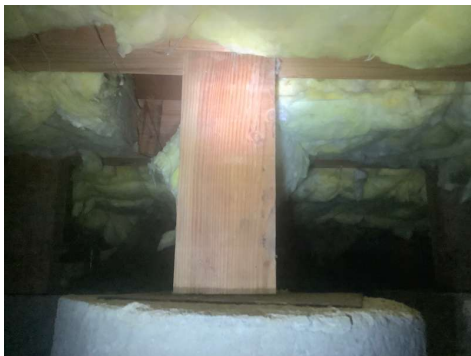
#### 4.4.1 Floor Structure

### INADEQUATE FOOTER, POST, AND BEAM CONNECTIONS

Posts and beams in one or more areas do not have adequate connections. All post and beam connections should have positive connections using appropriate fasteners. These connections help bolster structural integrity and are especially important in seismically active areas. Recommend further evaluation and repair by qualified contractor.

Recommendation  
Contact a qualified general contractor.

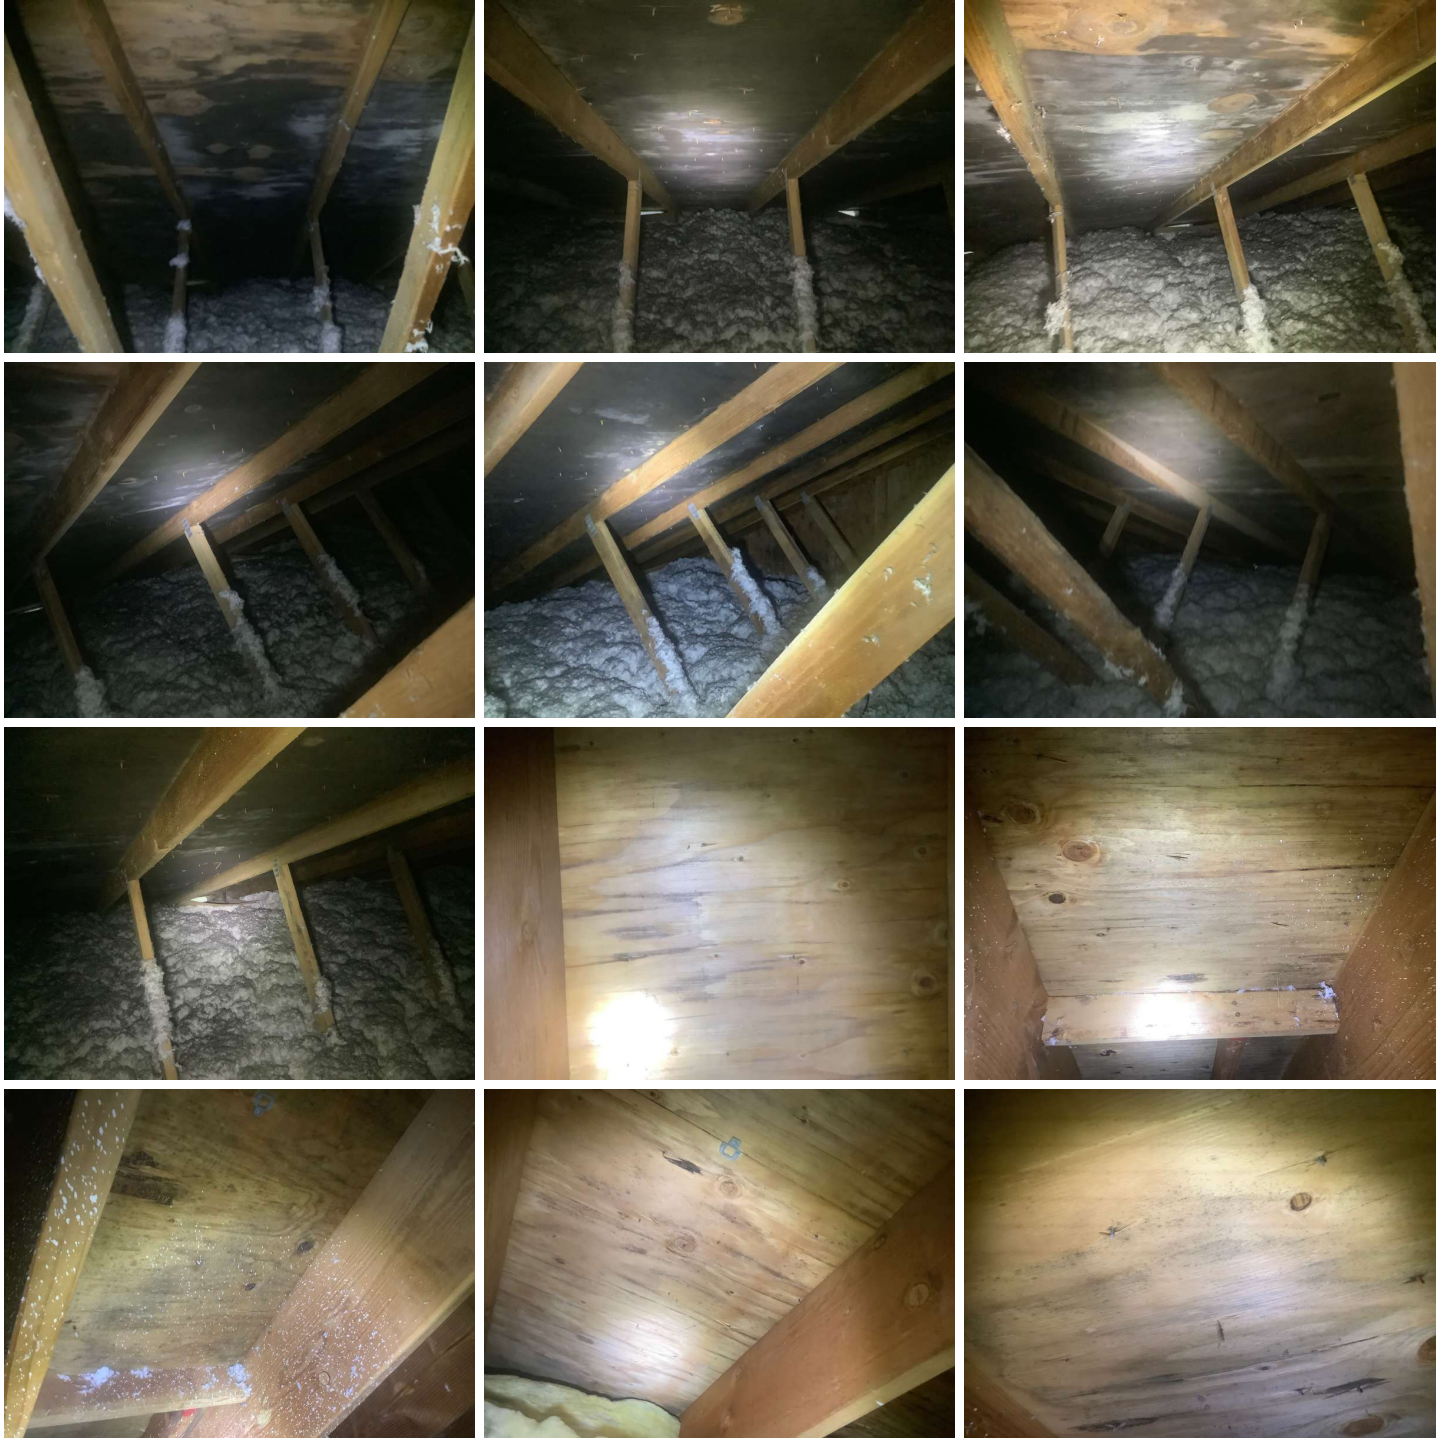
Discoloration - possible mold - was observed in the attic. This is typically caused by inadequate exhaust systems, ventilation issues, or moisture intrusion. Recommend a qualified contractor: clean and remove growth from affected areas to prevent spread and damage to home or health; find source of moisture, and ensure appropriate exhaust, ventilation, and moisture prevention practices.

Contact a qualified environmental contractor

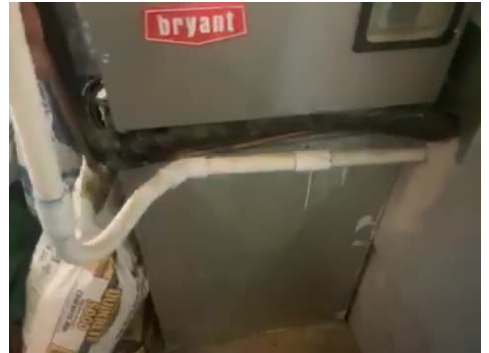
5.1.1 Heating Equipment

The furnace condensation line is not secure. This could lead to improper drainage of condensate and potentially make the pipe prone to damage. Recommend a qualified contractor repair.

Contact a handyman or DIY project

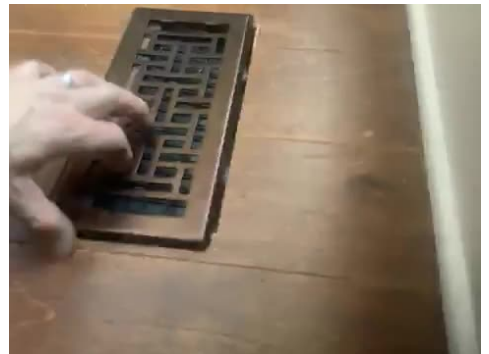
5.4.1 Distribution Systems

**REGISTER LOOSE**

Register is loose. Recommend a qualified contractor secure.

Contact a handyman or DIY project

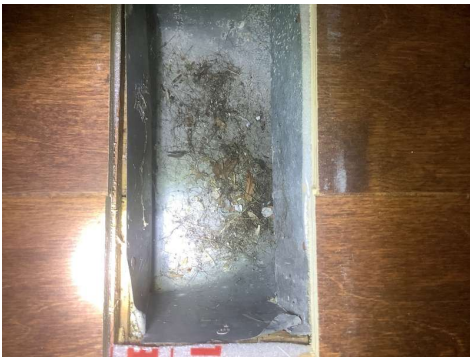
5.4.2 Distribution Systems

**DUCTS NEED CLEANING**

Debris was observed in ducts around the home. This can impact air quality and the efficiency of the HVAC system. Recommend a qualified professional clean duct system at least annually.

Contact a qualified HVAC professional.

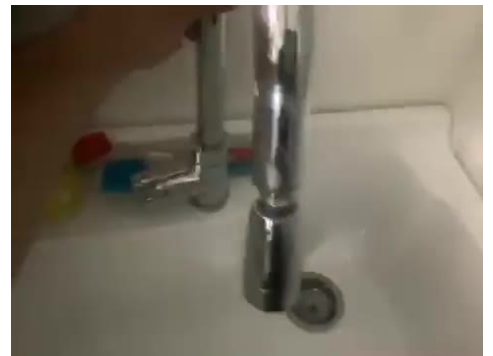
## **LOOSE FAUCET**

One or more faucets are loose. This can cause damage to the fixture. Recommend a qualified contractor repair.

Contact a qualified professional.

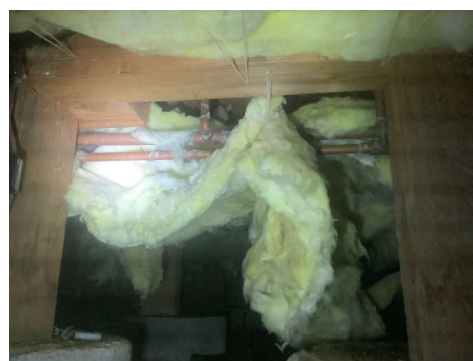
The water distribution pipes are not insulated in portions of the home. This can be a significant source of energy loss. Additionally, cold temperatures can freeze the water in pipes in unconditioned spaces, expand, and cause the pipes to burst, typically at joints. Recommend a qualified contractor insulate all water supply plumbing.

**Recommendation**  
Contact a qualified plumbing contractor.

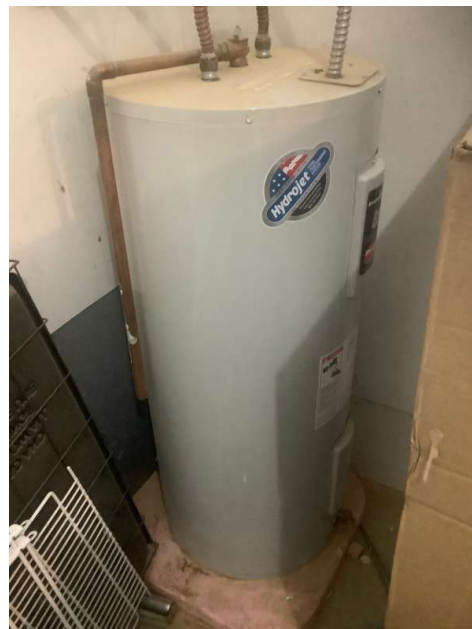
### INADEQUATE SEISMIC STRAPS

The water heater is not equipped with adequate seismic straps. Seismic straps, which help prevent tipping of the water heater in the event of an earthquake, should be installed on the upper and lower thirds of the tank. Recommend a qualified professional install seismic straps.

Contact a qualified handyman.

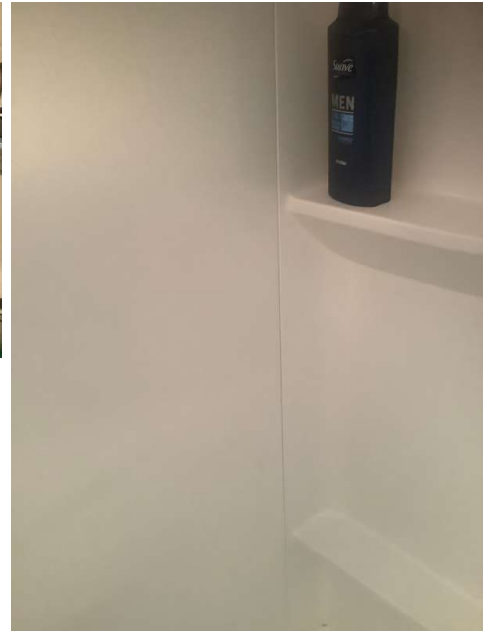
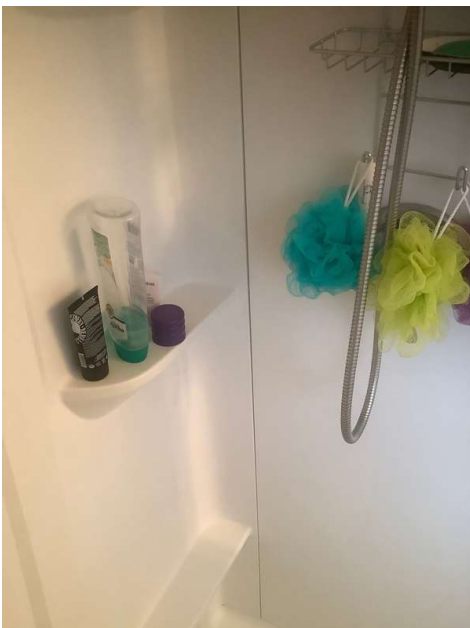
## CAULK IN NEED OF REPAIR

Shower/tub has missing or deteriorated caulk. This can lead to water damage behind the surround. Recommend a qualified contractor repair.

Contact a handyman or DIY project

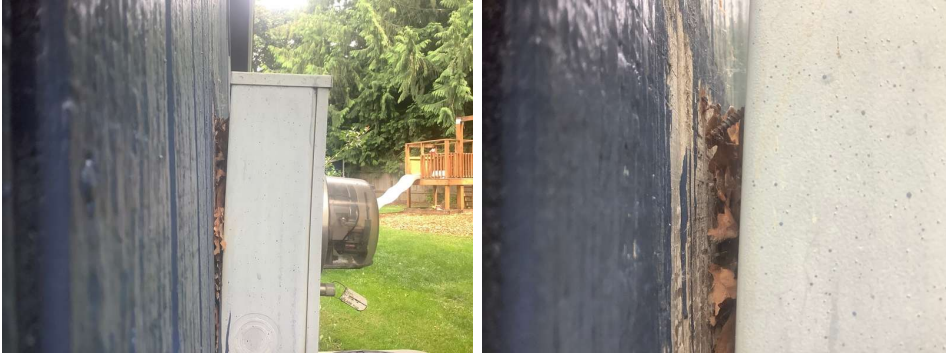
**NOT SECURED**

The electrical service meter box is not secure. This can lead to damage to the meter box and moisture intrusion in the box, panel, and underlying siding components. Recommend a qualified electrical contractor repair.

Contact a qualified electrical contractor.

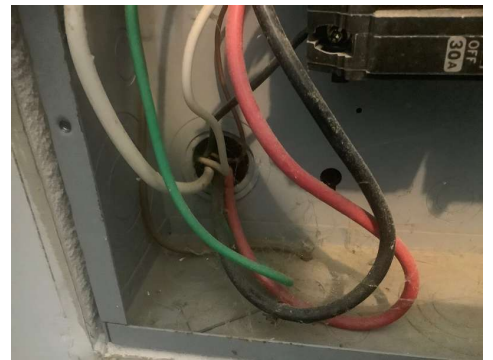
**MISSING, LOOSE BUSHING(S)**

One or more bushings are missing, loose, or open in an electrical panel box. Bushings help protect wires from becoming damaged by the sharp edges of knockouts. Additionally, bushings help prevent rodents from entering the panel box. Recommend a qualified contractor repair.

## Recommendation

Contact a qualified electrical contractor.

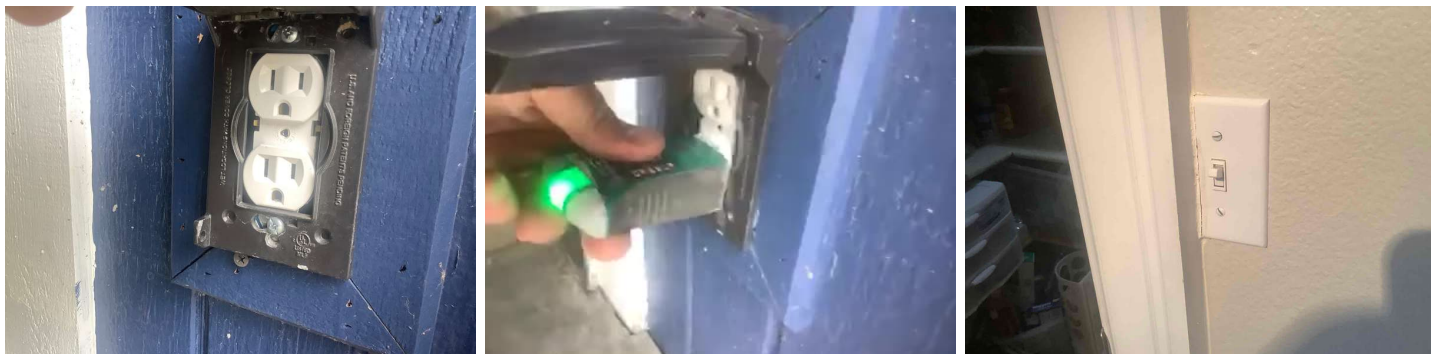
**IMPROPER INSTALLATION**

Electrical receptacles, lights, or switches in one or more areas are installed improperly. This can be a short or shock hazard. Recommend a qualified contractor repair.

Contact a qualified electrical contractor.

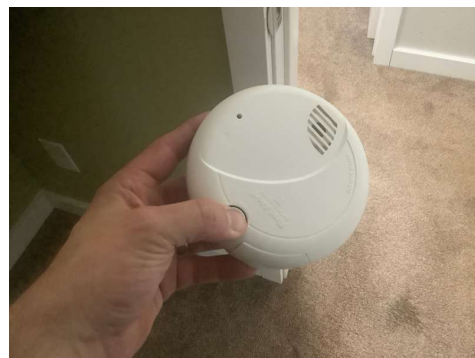
**DEFECTIVE**

One or more smoke detectors are not functioning properly - this could be caused by dead batteries. Smoke alarms throughout the home should ideally be interconnected -- if one is triggered, all alarms should sound. Recommend replacing smoke alarm and evaluation by a qualified electrical contractor.

Recommendation

Contact a qualified electrical contractor.

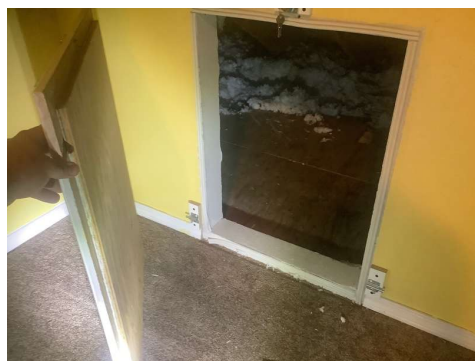
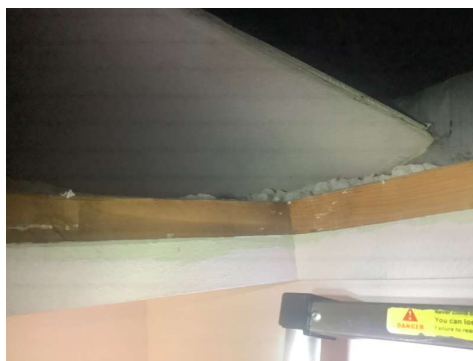
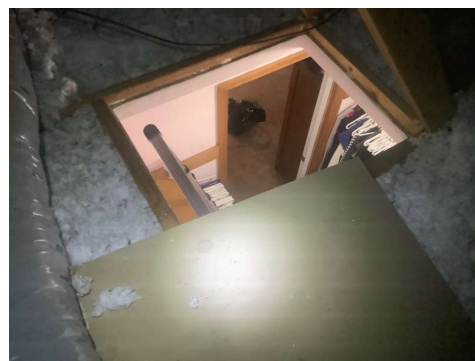
## ATTIC HATCH -- INADEQUATE INSULATION

The attic hatch has inadequate insulation. This area can be a significant source of energy loss. Additionally, improperly sealed attic hatches can allow energy (hot/cold air) to leak into the attic. Recommend a qualified contractor properly secure insulation to the hatch and repair weatherstripping, if needed.

Recommendation

Contact a qualified insulation contractor.

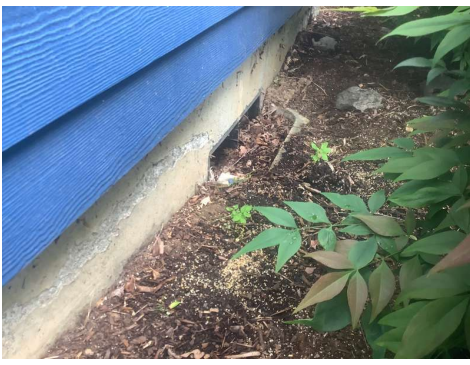
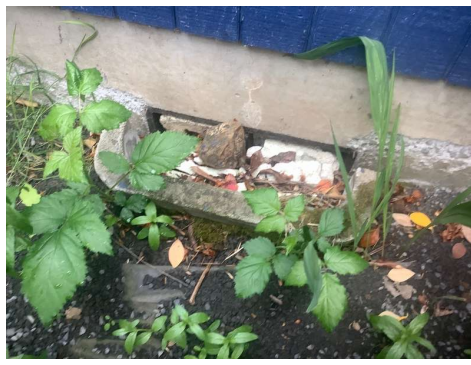
## FOUNDATION VENT BELOW GRADE

One or more foundation vents are below grade. This can allow water to enter the crawlspace. Recommend installation of foundation vent wells by a qualified professional.

Recommendation

Contact a qualified handyman.

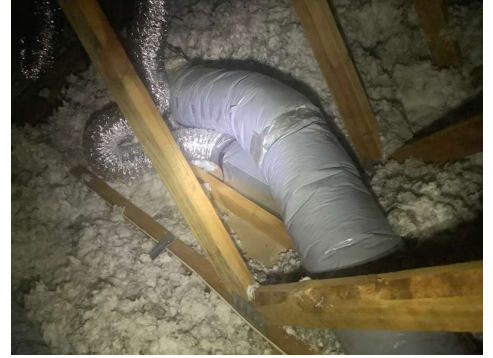
## DUCT-TAPED DUCTS

Exhaust ducts in the home are connected or sealed with duct tape. Counter-intuitively, duct tape as a duct sealer fails quickly, and often, quite catastrophically. This can promote moisture in the areas through which the ducting runs and create an environment conducive to mold, wood-destroying insects, and fungi. I recommend a qualified contractor properly seal or connect ducts with a product like mastic.

Recommendation

Contact a qualified handyman.
