## SUMMARY

1234 Main St. Vancouver WA 98663

Northbank Home Inspection

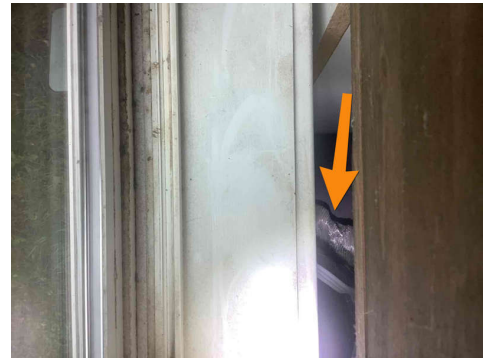
## DRYER DUCT DAMAGED

The dryer duct is damaged. This could allow lint to become trapped and start a fire. Recommend a qualified professional repair or replace.

Recommendation

Contact a handyman or DIY project

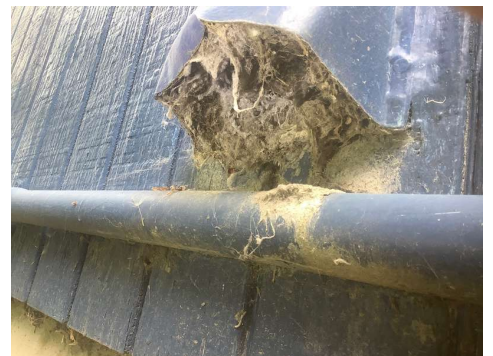
## DRYER VENT NEEDS CLEANING

The dryer vent is obstructed with lint and does not close. Excessive lint can be a fire hazard and allow pest access. Recommend a qualified person clean.

Recommendation

Contact a handyman or DIY project

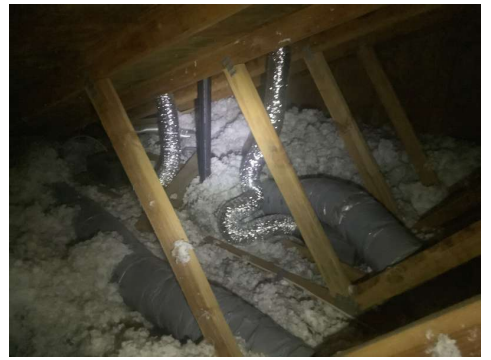
## DUCTS NOT INSULATED

Exhaust ducts are not insulated. Insulation around these ducts helps minimize the condensation that will otherwise occur as typically warm, moist exhaust air passes through the ductwork. Recommend a qualified contractor insulate ducts.

#### Recommendation

Contact a qualified HVAC professional.

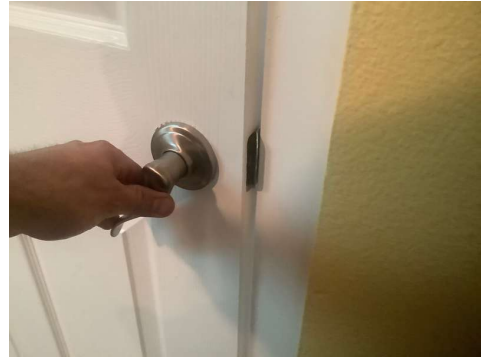
## DOOR STICKS

One or more doors stick and are difficult to use. Recommend a qualified contractor repair.

#### Recommendation

Contact a qualified handyman.

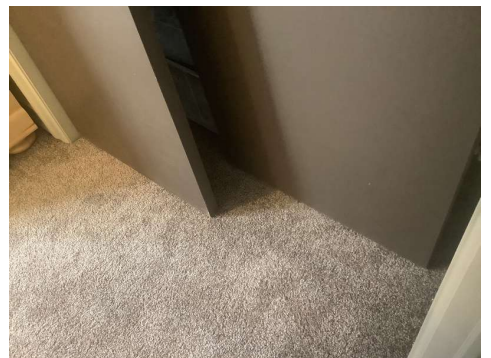
## CLOSET DOOR GUIDE DAMAGED/MISSING

Closet door guide is damaged or missing. This can lead to damage to the door from improper movement. Recommend installation of a guide by a qualified person.

#### Recommendation

Contact a handyman or DIY project

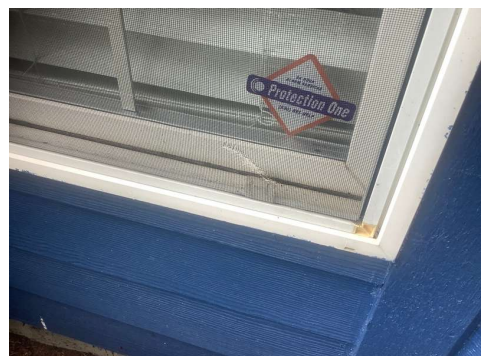
## DAMAGED SCREEN

Screen(s) in one or more windows are torn or have damaged frames. Screens should be replaced where necessary.

#### Recommendation

Contact a qualified window repair/installation contractor.

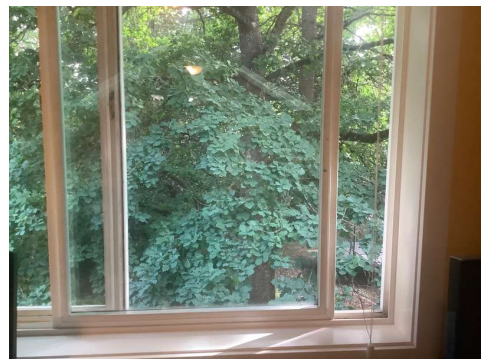
## MISSING SCREEN(S)

One or more windows are missing screens. Recommend replacement.

Recommendation

Contact a qualified window repair/installation contractor.

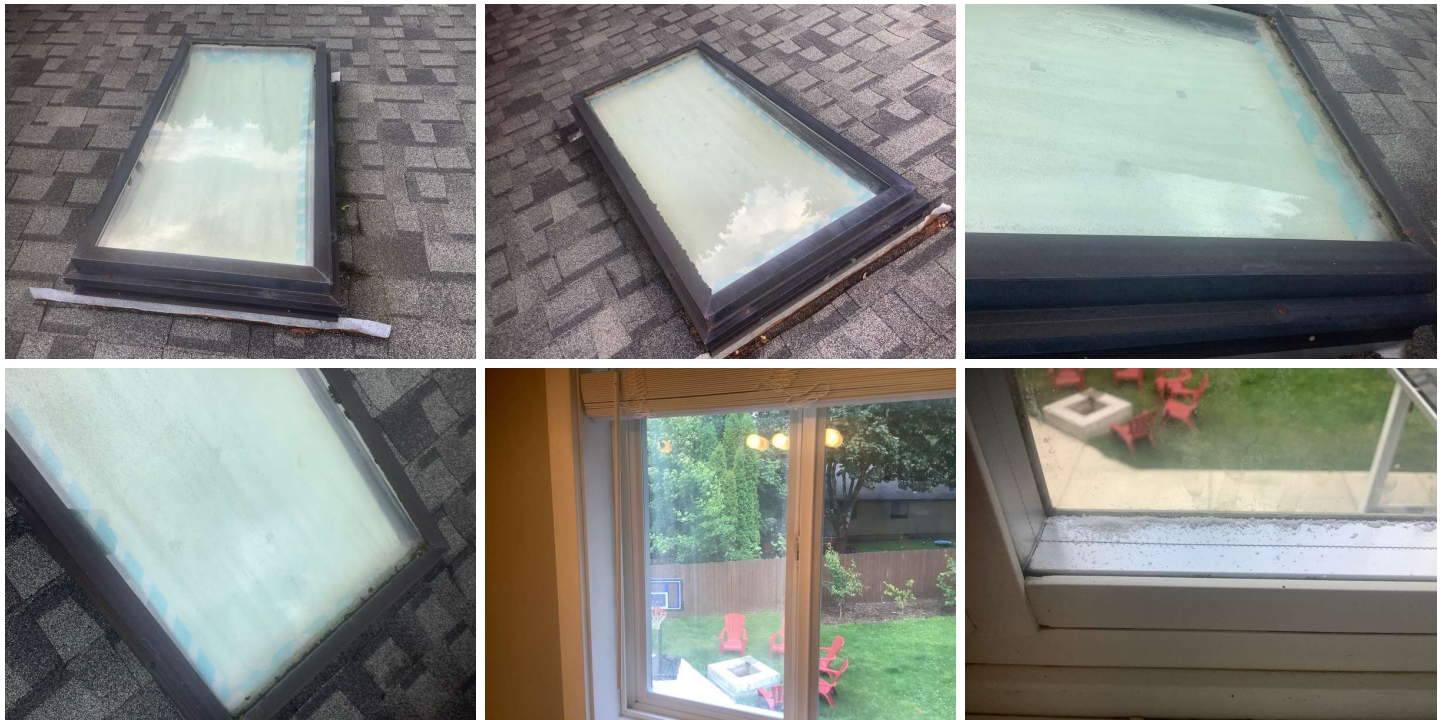
#### **POSSIBLE FAILED SEAL**

Observed evidence condensation is or has been between the window panes, which indicates a failed seal. Failed seals can promote mold growth and decrease energy efficiency. Recommend qualified window contractor evaluate & replace.

Be aware that evidence of broken seals may be more or less visible from one day to the next depending on the temperature, humidity, sunlight, etc. Windows or glass doors other than those that I identified may also have failed seals and need glass replaced, too.

Recommendation

Contact a qualified window repair/installation contractor.

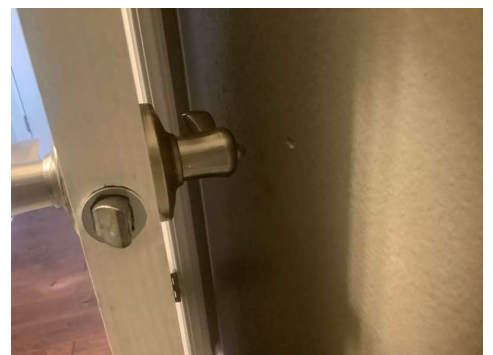
9.4.1 Walls

**DOORKNOB DAMAGE**

Wall appears to be damaged from doorknob. Recommend a qualified handyman or drywall contractor repair.

Recommendation  
Contact a qualified drywall contractor.

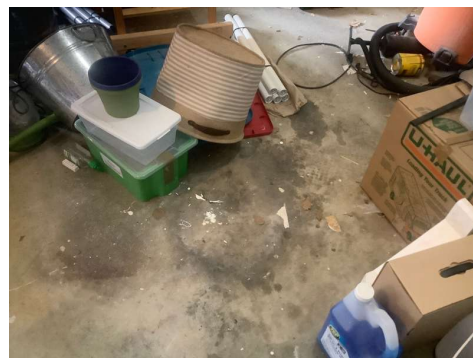
## STAINING

Garage floor shows visible staining from oil/grease. Recommend scrubbing with a degreaser or cleaning solution.

[Here is a DIY resource to help.](#)

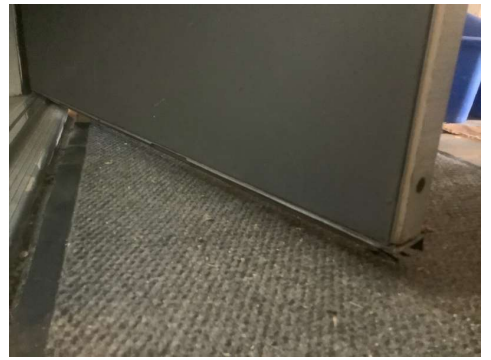
## WEATHERSTRIPPING

The door into the home from the garage has inadequate and/or damaged weatherstripping. This can allow carbon monoxide produced by vehicles in the garage to enter the home and is a safety hazard. Additionally, this door should be sealed to prevent air from the garage, which often contains fumes from oil and other chemicals, from entering the house. Recommend repair or replacement of weatherstripping by a qualified contractor.
