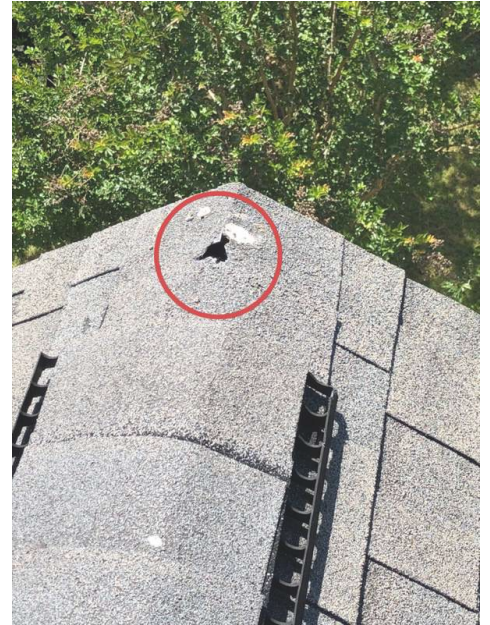
4.1.1 Coverings

DAMAGED COVERINGS

There is a small hole in the coverings at both ends of the ridge cap. There is not a sign of this causing a leak inside the house, but it should be replaced to prevent a future leak. These holes are over the eave.

Contact a qualified roofing professional.

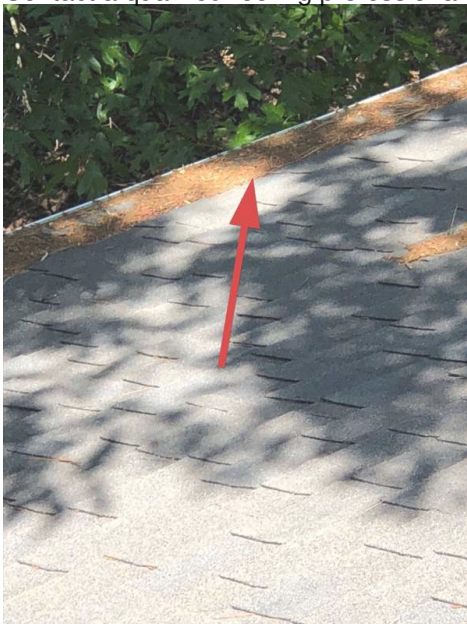
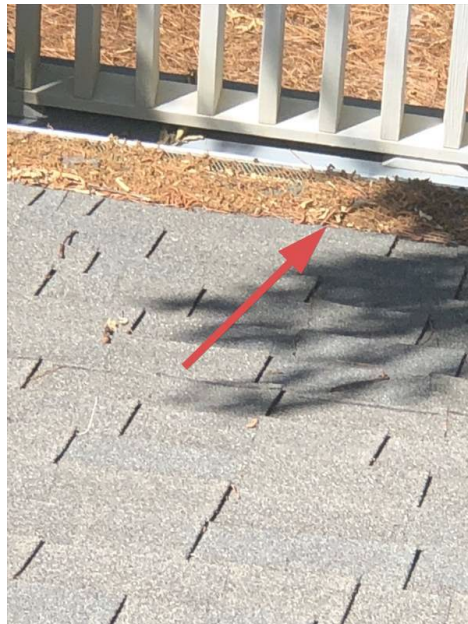
4.2.1 Roof Drainage Systems

DEBRIS

Debris has accumulated in the gutters. Recommend cleaning to facilitate water flow.

[Here is a DIY resource](#) for cleaning your gutters.

Contact a qualified roofing professional.

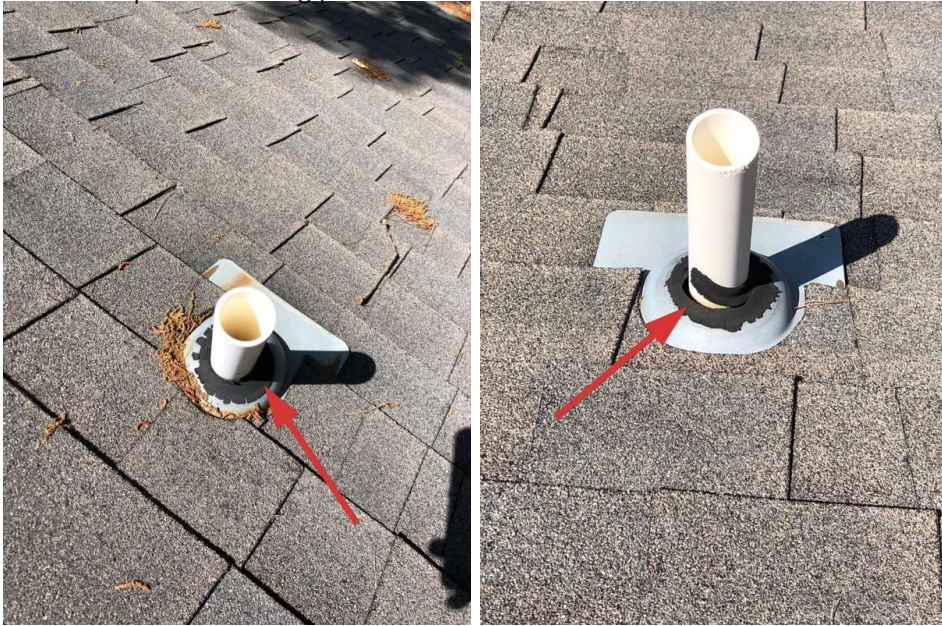
4.3.1 Flashings

CORRODED - SEVERE

Roof flashing showed signs of severe corrosion, which can lead to moisture intrusion. Recommend a qualified roofing contractor evaluate and repair. All three of the flashings need to be replaced. This is common for flashings of this age and material.

Contact a qualified roofing professional.

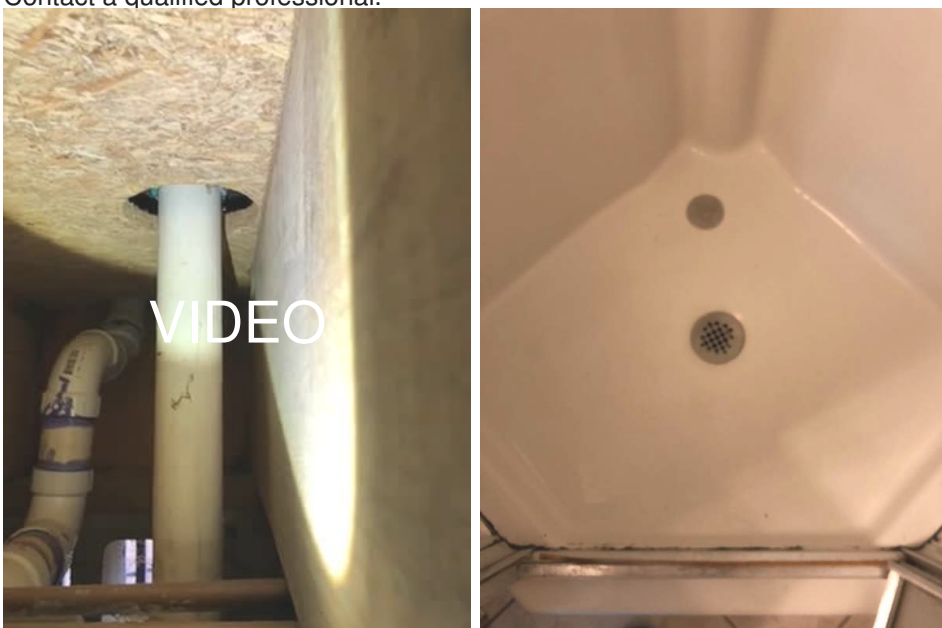
5.1.1 Fixtures / Faucets

SHOWER DRAIN LEAKING

The drain in the master bathroom shower is leaking. It has not caused any damage, it is dripping into the crawlspace. Recommend tightening the drain or replacing the rubber grommet that secures the drain to the drain pipe.

Contact a qualified professional.

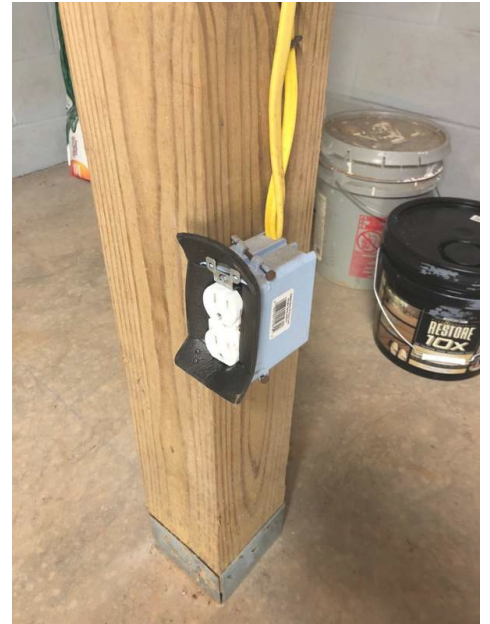
6.4.1 Connected Devices and Fixtures

COVER PLATES MISSING

One receptacle in the basement is missing its cover plate. The rubber/foam gasket that goes behind the cover plate is still present. Recommend installing a new cover plate.

Contact a qualified electrical contractor.

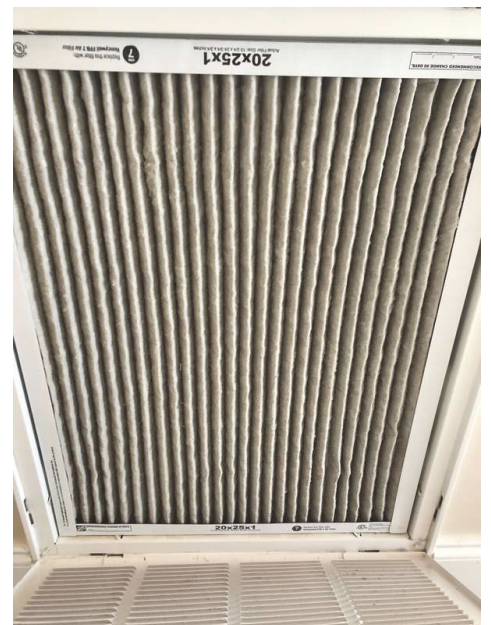
7.1.1 Heating Equipment

FILTER REQUIRES REPLACEMENT

The furnace filter appears to be beyond its expected lifespan. Recommend replacement.

Contact a qualified HVAC professional.

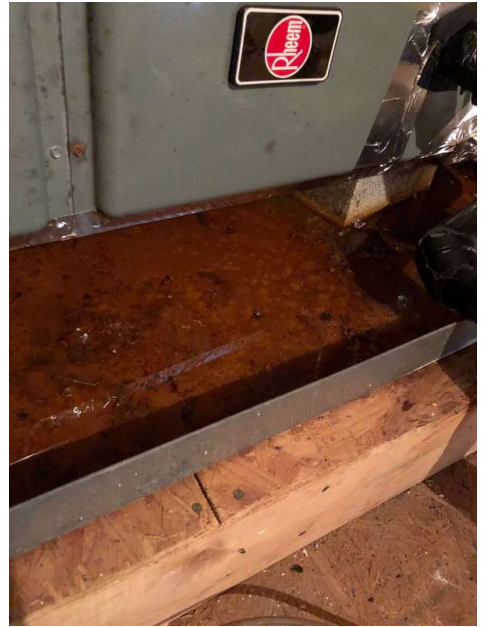
7.1.2 Heating Equipment

NEEDS SERVICING/CLEANING

Furnace should be cleaned and serviced. The upstairs HVAC unit has standing water in the condensate overflow pan. This can lead to a leak. I would also recommend installing an automatic cut off switch to turn the unit off in the event the condensate line stopped up again.

Contact a qualified HVAC professional.

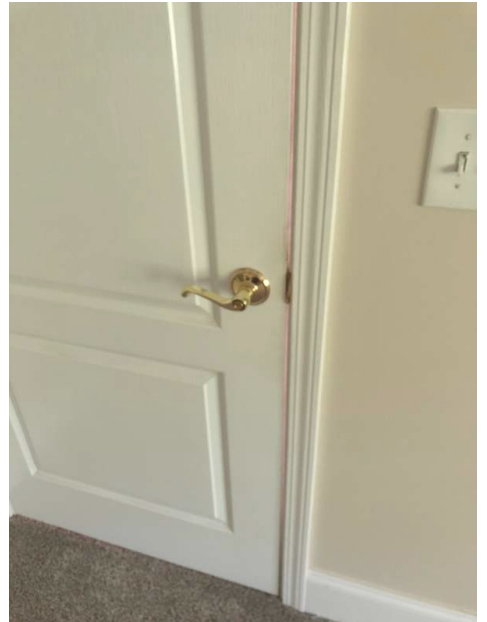
9.6.1 Doors

DOOR DOESN'T LATCH

Door doesn't latch properly. Recommend handyman repair latch and/or strike plate.

Master bedroom door.

Contact a qualified handyman.

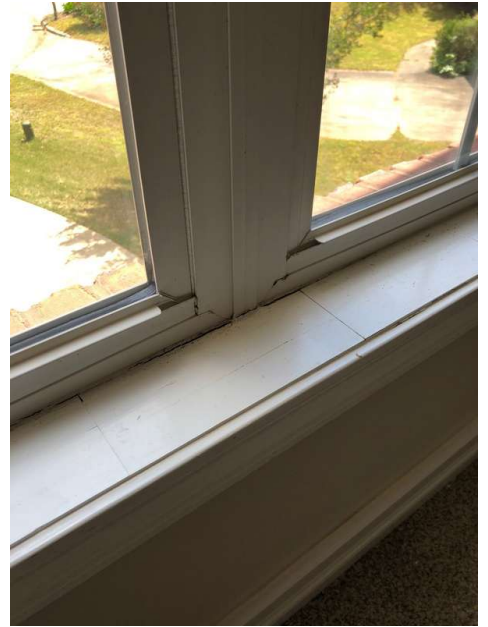
9.7.1 Windows

SOFT WINDOW SILL

The window sill in the upstairs southeast bedroom is soft. It has experienced moisture intrusion at some point in the past. The sealant around this window appeared to be intact and in good condition. There was a small area of shingles above this area that have been replaced. So this damage is most likely from the apparent past leak. There is no evidence of a current leak and I did not see any other damage in this area.

Contact a qualified professional.

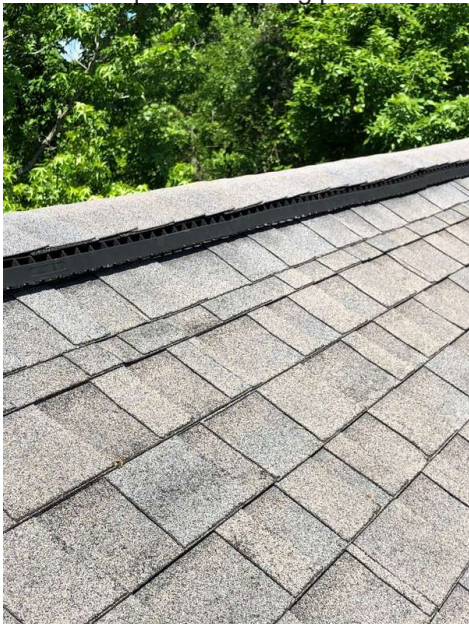
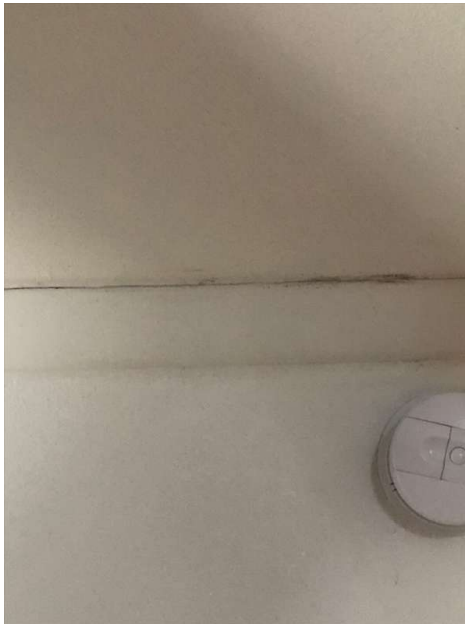
11.3.1 Ventilation

SUGGESTED RIDGE VENT REPLACEMENT

The ridge vent is allowing the drywall in the inside peak of the roof to absorb some moisture. The drywall in the peak is slightly discolored from being so close to exterior moisture and humidity. I would recommend removing the existing ridge vent and replacing it with A different type of ridge vent (Foam/rubber, versa-vent, etc.) . This would help prevent any further absorption of moisture from the outside. Then primer and paint would restore the inside.

The replacement of the ridge vent and the shingles over it, is just a suggestion, and should take a professional roofer about two hours to complete. The materials for this project should cost about \$250.00

Contact a qualified roofing professional.
