## 2.1.1 Foundation, Basement &amp; Crawlspaces

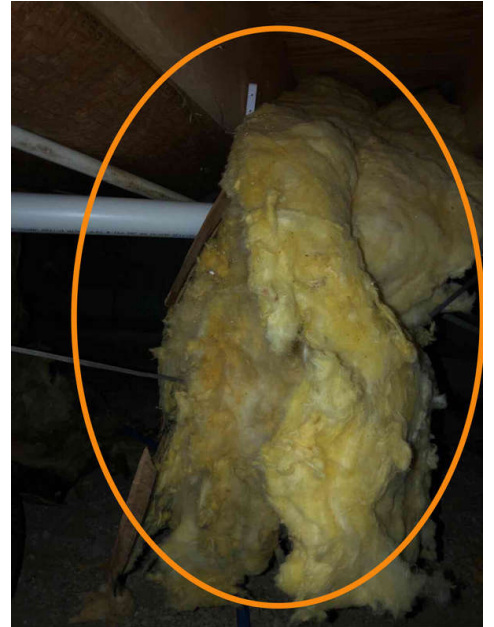
Crawlspace

Recommendation**INSULATION-LOOSE**

The flooring insulation is displaced in several locations. This leads to poor efficiency and allows moisture to the sub-floor. Recommend qualified professional to return insulation to proper uniformity.

Recommendation  
Contact a qualified professional.

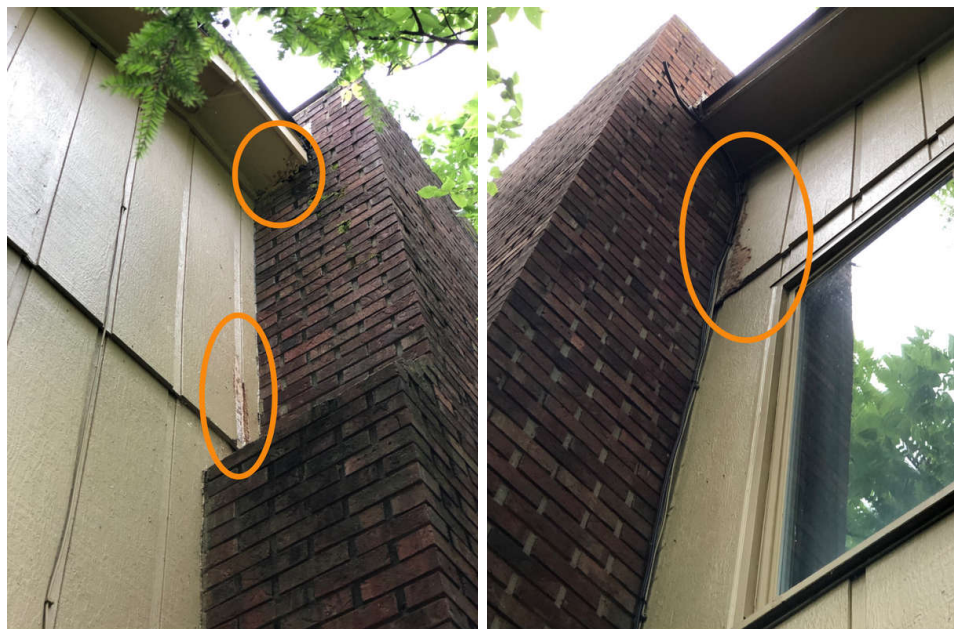
West

Recommendation**DAMAGE**

Damage to the siding was noted. This could lead to the siding falling off or allowing water to penetrate behind the material. Recommend qualified professional for repair.

Recommendation  
Contact a qualified professional.

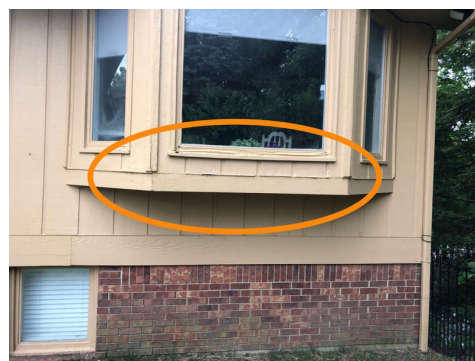
Bay window

## WOOD SIDING- DAMAGE/WOOD ROT

The wood siding on the house showed signs of wood rot and damage. Recommend qualified siding professional to evaluate and repair or replace the siding where needed.

Contact a qualified siding specialist.

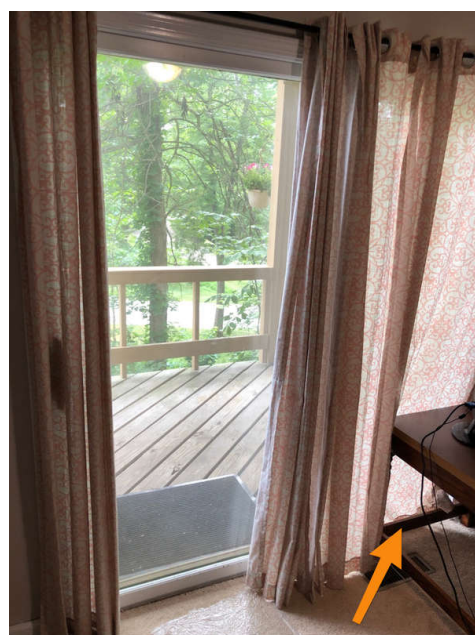
## SLIDING DOOR OPERATION

The sliding door did not operate properly. Recommend qualified professional for service and repair or adjustments.

Hard to fully open- East

Contact a qualified professional.

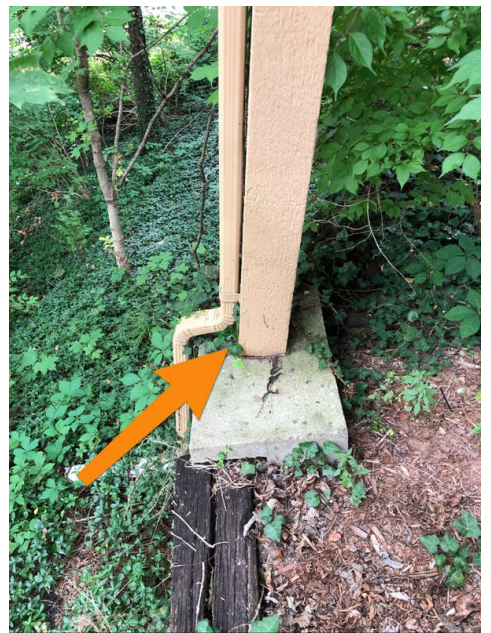
Southwest

**COLUMN-WOOD ROT**

One or more columns showed signs of wood rot. Recommend qualified professional to make necessary repairs.

Contact a qualified professional.

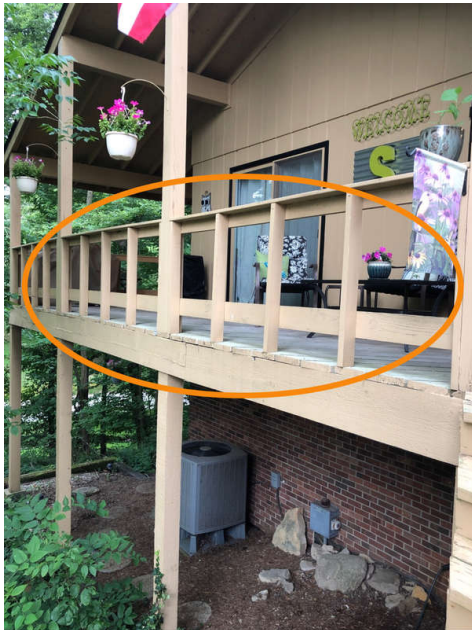
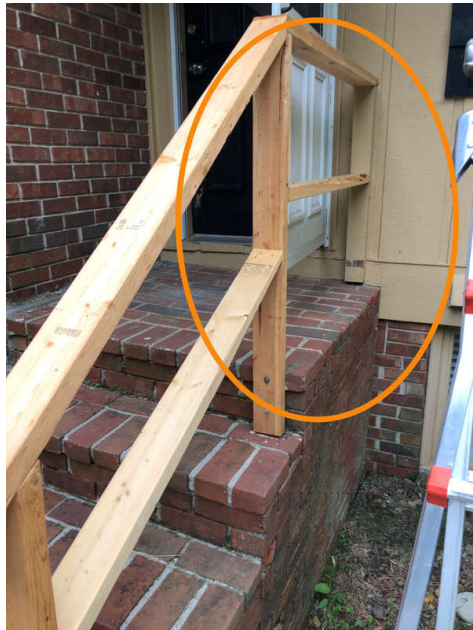
**BALUSTER SPACE TOO WIDE**

The spacing between the balusters is too wide and does not meet current safety standards. Recommend qualified handyman for repair.

Contact a qualified handyman.

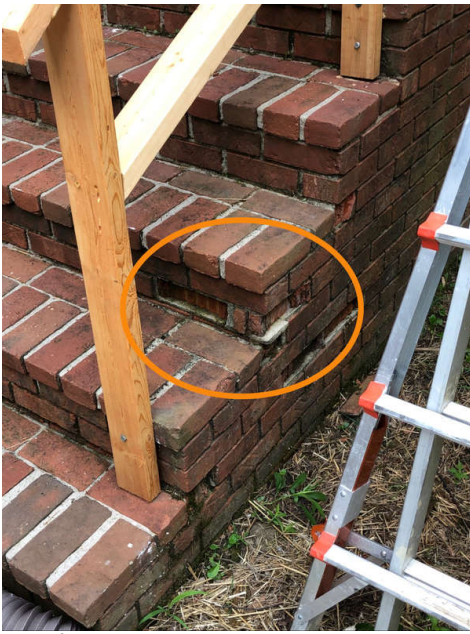
North

**BRICK-DAMAGED**

Some of the brick on the steps was damaged/deteriorated. This could lead to a trip or fall hazard. Recommend qualified masonry professional for repair.

Contact a qualified masonry professional.

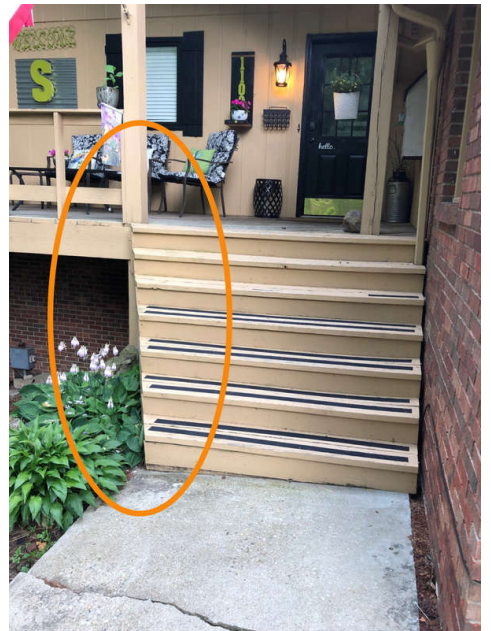
Main entry

**RAILING**

A railing and handrail is needed for the steps. The height can be a safety hazard. Recommend qualified professional to install railing and handrail.

Contact a qualified professional.

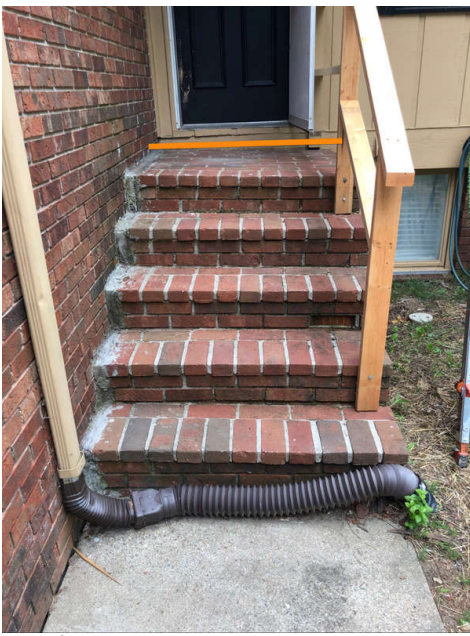
North

**PORCH-SETTLING**

The porch has settled and is showing signs of deterioration. Recommend qualified professional for evaluation and repair.

Contact a qualified professional.

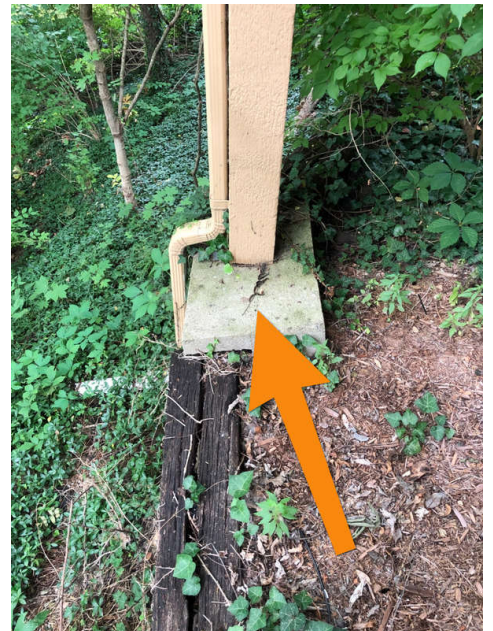
Southwest

#### **COLUMN FOOTER-SETTLEMENT**

The footer for the column has settled which could eventually effect the integrity of the column and the structure above. Recommend qualified professional for repair.

Contact a qualified professional.

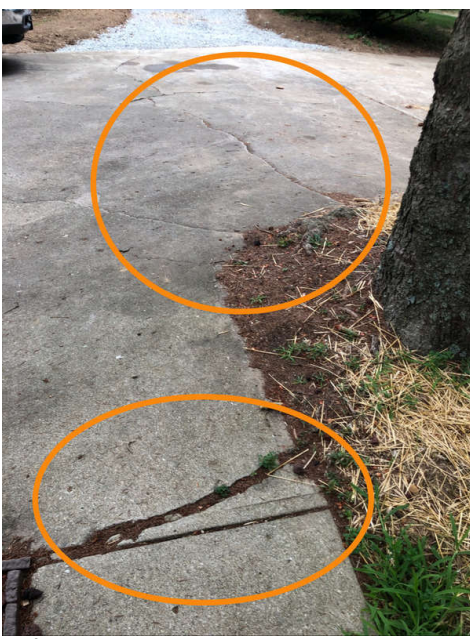
Driveway

#### **DRIVEWAY CRACKING - MAJOR**

Major cracks observed. Recommend driveway contractor evaluate and make necessary repairs.

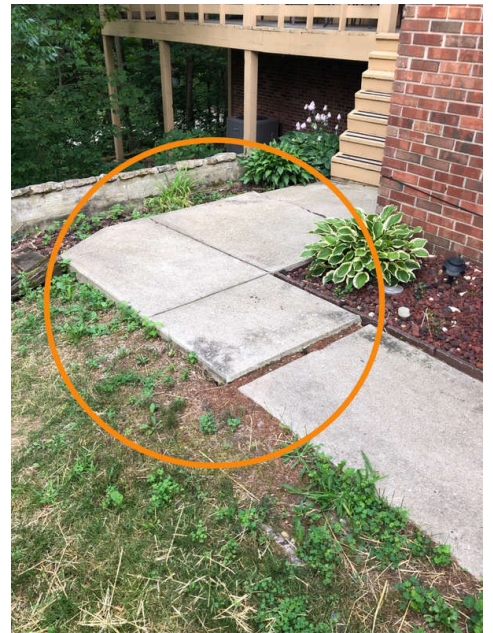
East

#### **WALKWAY TRIP HAZARD**

The walkway has settled which has caused a trip hazard. Recommend qualified professional for repair.

Contact a qualified professional.

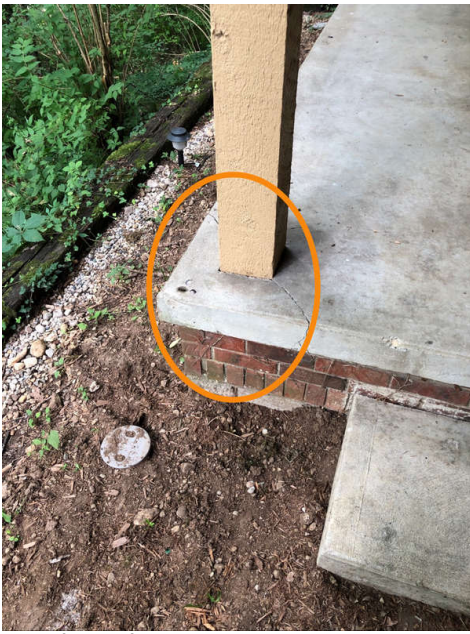
South-patio

#### **PATIO-LOOSE CONCRETE**

Concrete was observed to be loose at the time of inspection. This has the potential to be a trip and fall hazard. Recommend qualified professional for evaluation and possible repair.

Contact a qualified professional.

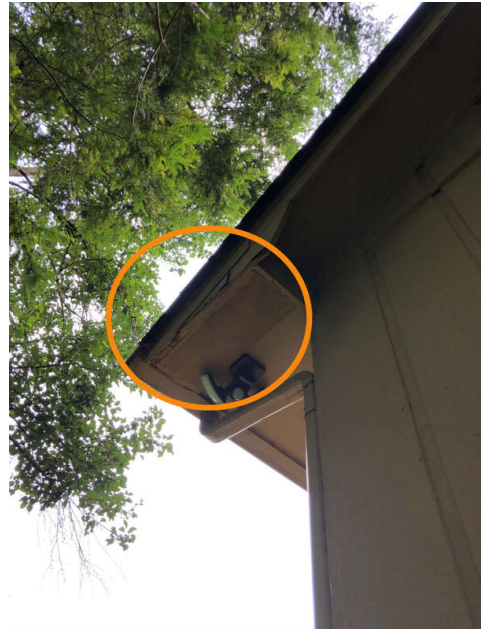
Northwest

#### **EAVES-WOOD ROT**

The eave was showing signs of wood rot. Recommend qualified professional for repair.

Contact a qualified professional.

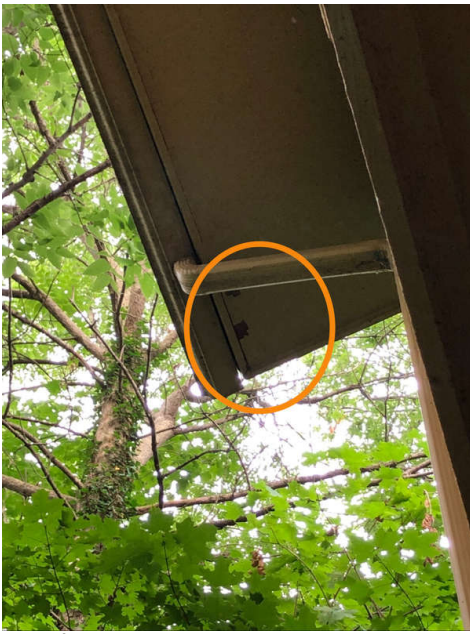
Southwest

#### **SOFFIT-DAMAGE**

The soffit was damaged. This will allow pests to enter. Recommend qualified professional for repair.

Contact a qualified professional.

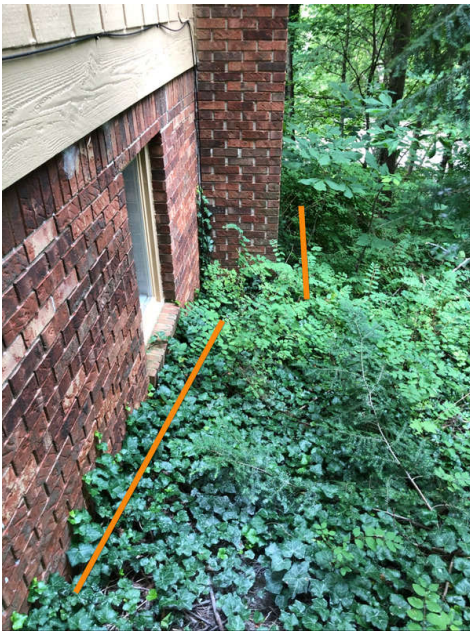
West

**VEGETATION NEEDS TRIMMED**

Vegetation should be trimmed back approximately 12 inches from the house to allow proper drying and air flow.

Recommendation  
Contact a qualified professional.

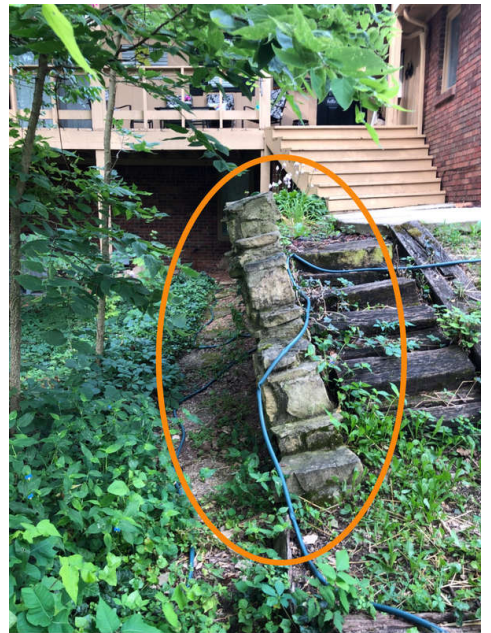
East

**RETAINING WALL-LEANING**

The retaining wall is leaning and May be in need of repair. Recommend qualified professional for further evaluation and possible repair.

Recommendation  
Contact a qualified professional.

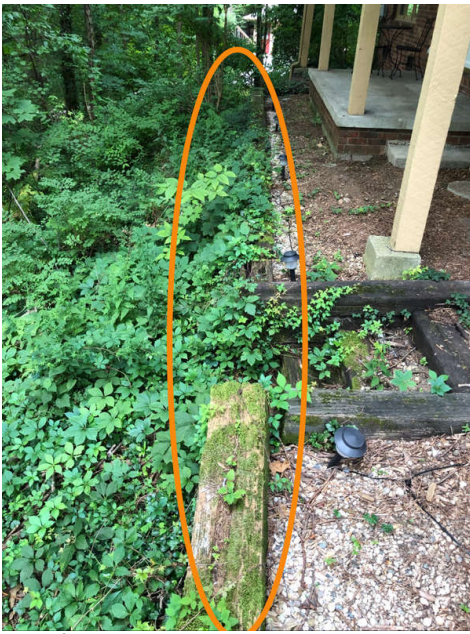
South

**RETAINING WALL-WOOD ROT**

Wood rot was present on the retaining wall. Recommend qualified professional to replace affected pieces.

Recommendation  
Contact a qualified professional.

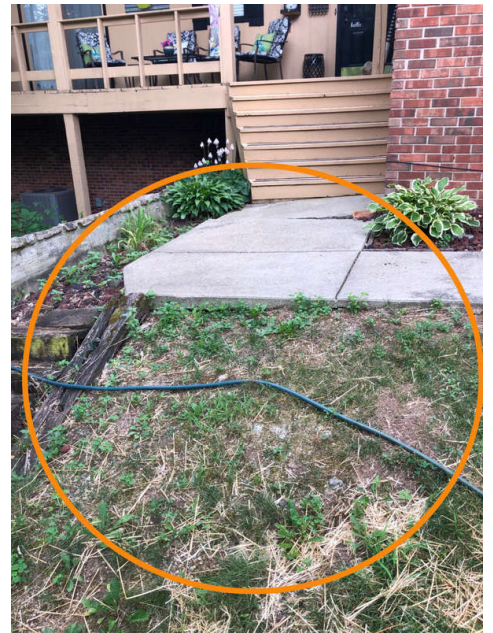
East

**SOIL LOSS/SETTLING**

Significant settlement/movement was noted. This can lead to further damage and movement in this area. Recommend qualified professional for evaluation and repair.

Contact a qualified professional.

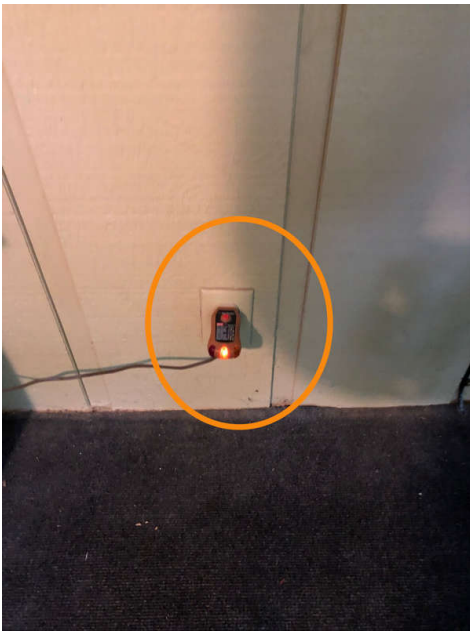
South porch

#### **UNGROUNDING OUTLET**

Exterior outlet is ungrounded. Depending on the age of the house, grounding the outlet may not be a required upgrade. Grounding and GFCI protecting the outlet is an upgrade that should be considered.

Contact a qualified professional.

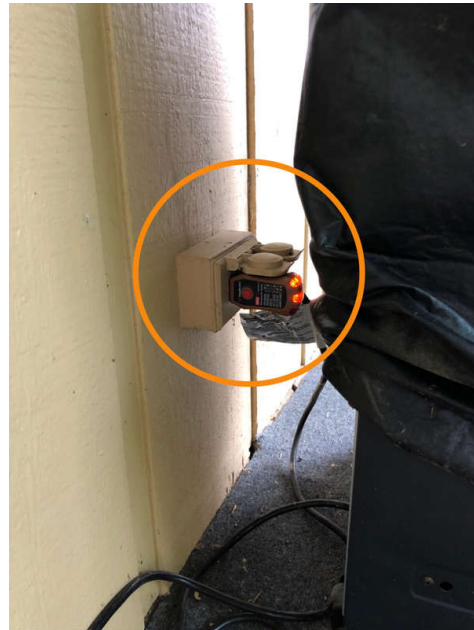
**NO GFCI PROTECTION**

Exterior outlet(s) were not GFCI protected. All exterior outlets should be GFCI protected for safety. Recommend qualified electrician for repair.

Recommendation  
Contact a qualified electrical contractor.

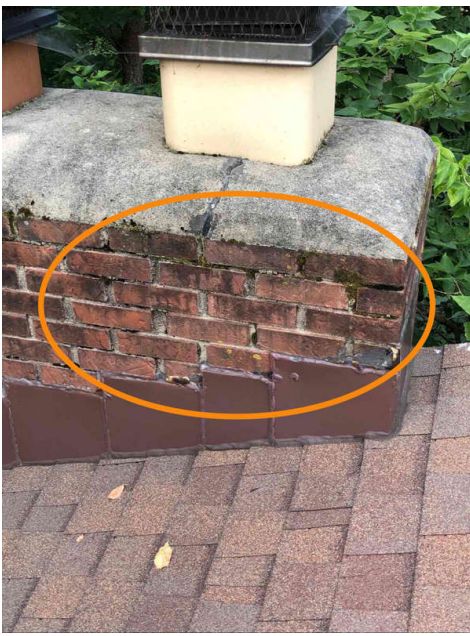
**VEGETATION GROWTH**

Vegetation growth was noted on the chimney. This growth can lead to deterioration of the mortar. Recommend qualified handyman to clean the chimney.

Recommendation  
Contact a qualified professional.

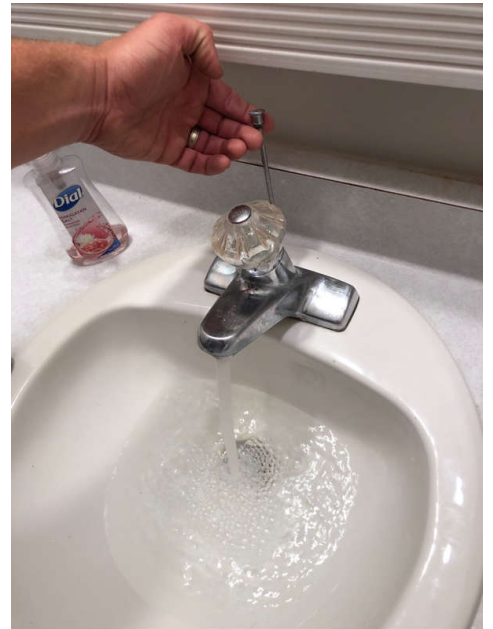
Master Bathroom

## **SINK DRAIN STOPPER**

The sink drain stopper does not properly operate. Recommend qualified handyman for adjustments.

Contact a qualified handyman.

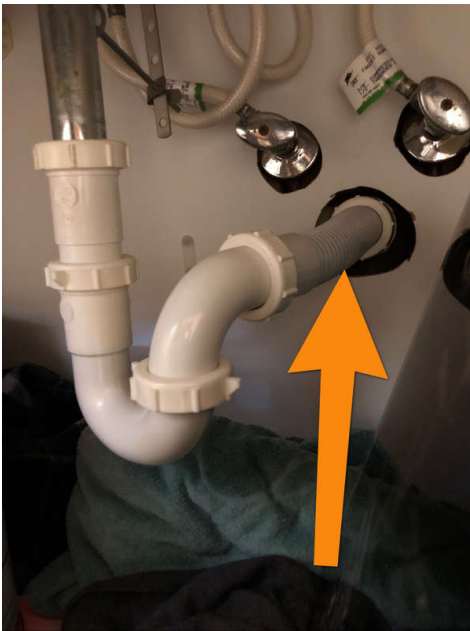
Hall Bathroom sink

## **NEGATIVE SLOPE**

A negative slope was noted on a drain pipe. This will cause slow drainage and a higher chance of a clog. Recommend qualified plumber to create the proper slope.

Contact a qualified professional.

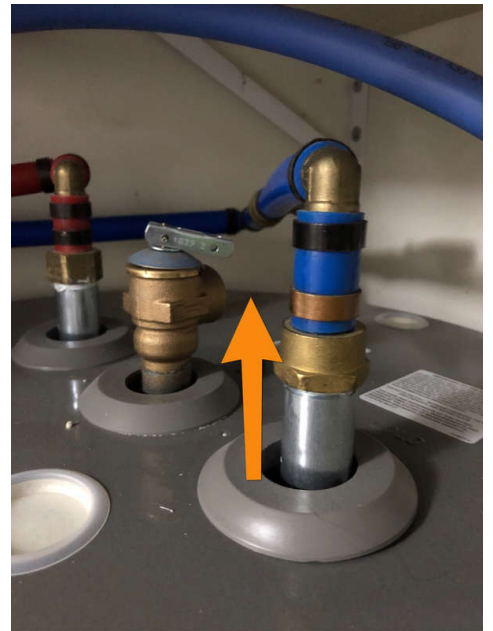
#### **MISSING T&P EXTENSION PIPE**

The t&p extension pipe has not been installed. Recommend qualified plumber for installation.

Contact a qualified professional.

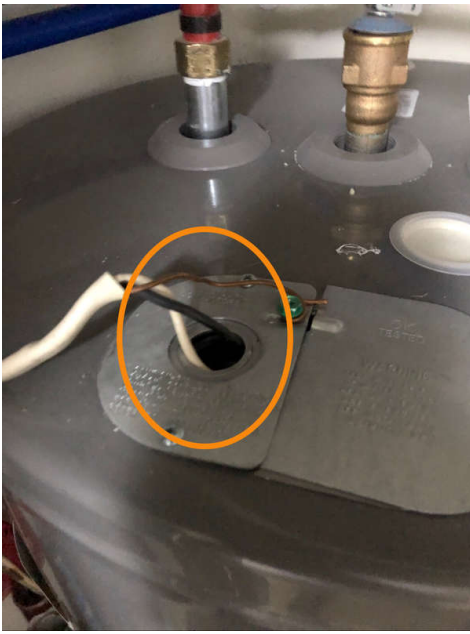
#### **GROMMET NEEDED**

A grommet is needed at the electrical entrance to protect the wire. Recommend qualified professional for installation.

Contact a qualified professional.

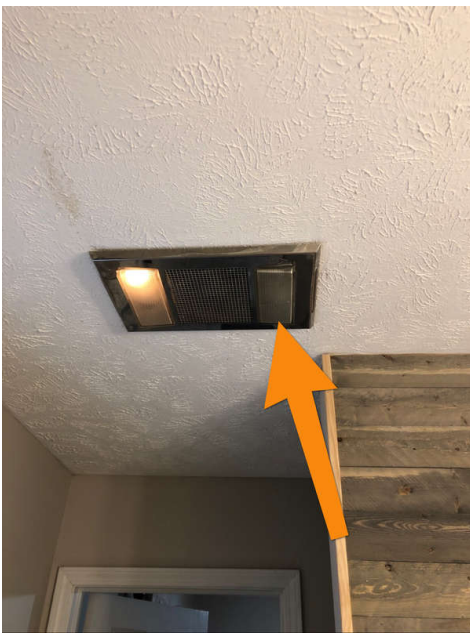
Hall Bathroom

#### **LIGHT INOPERABLE**

One or more lights are not operating. New light bulb possibly needed.

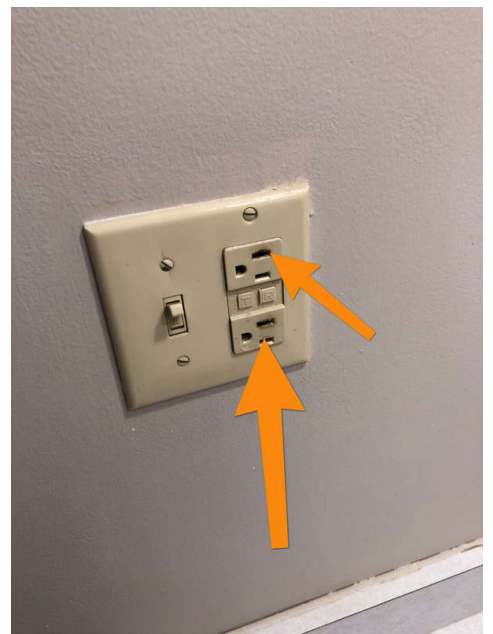
Master Bathroom

#### **OUTLET-MELTED**

The outlet was melted. This is an indication that overheating occurred and could have caused damage to the outlet. Recommend qualified electrician for replacement.

Contact a qualified electrical contractor.

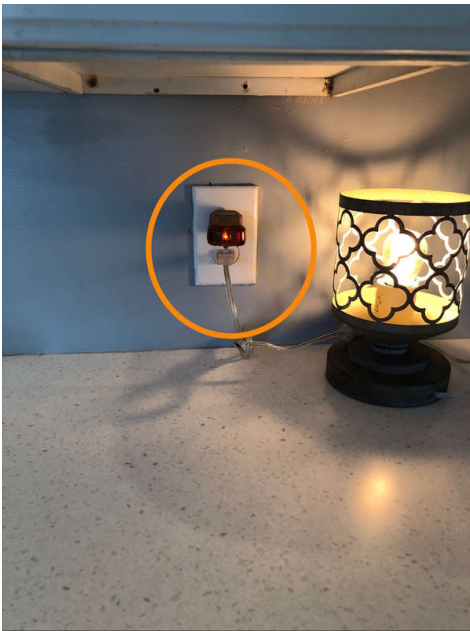
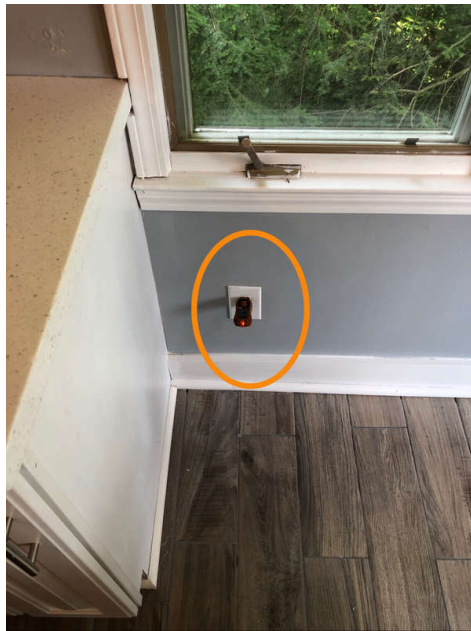
#### **OUTLET(S) NOT GROUNDED**

One or more outlets are not grounded. Grounding of outlets may not be a requirement depending on the age of the house. For the well being of electronics and people, grounding the outlets is an upgrade to consider.

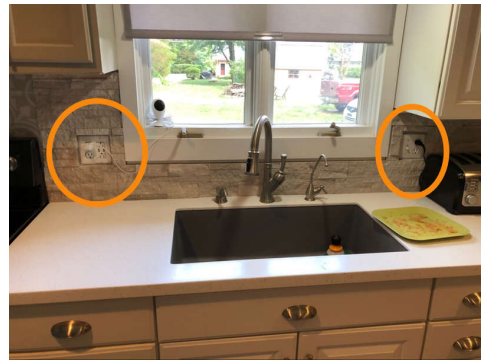
Kitchen

**KITCHEN GFCI**

Outlets within 6 feet of a water source need to be GFCI protected. Recommend qualified electrician for repair.

Contact a qualified professional.

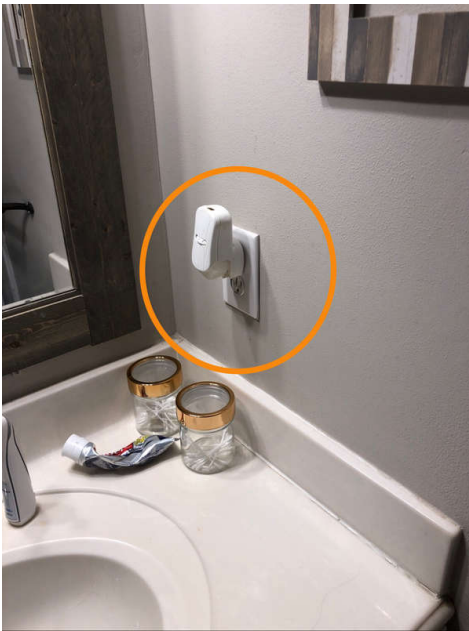
**BATHROOM GFCI**

Outlet(s) were not GFCI protected. Recommend qualified electrician for repair.

Contact a qualified professional.

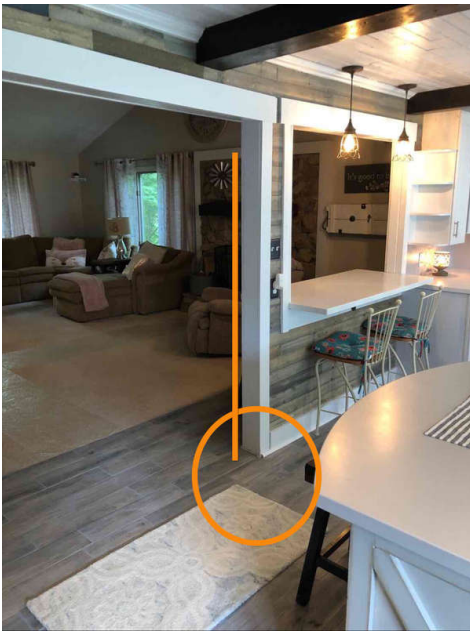
#### **SLOPED-SETTLEMENT**

The floor was sloped and some settling has occurred. This can be an indication of foundation settling or other issues. Recommend qualified foundation professional for further evaluation.

Contact a foundation contractor.

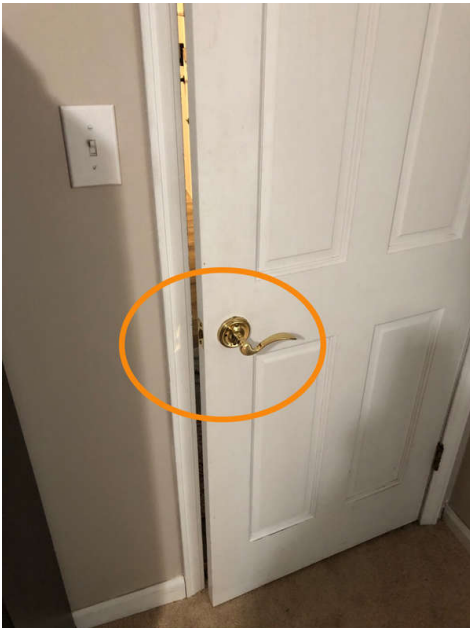
**DOOR DOESN'T LATCH**

Door doesn't latch properly. Recommend handyman repair latch and/or strike plate.

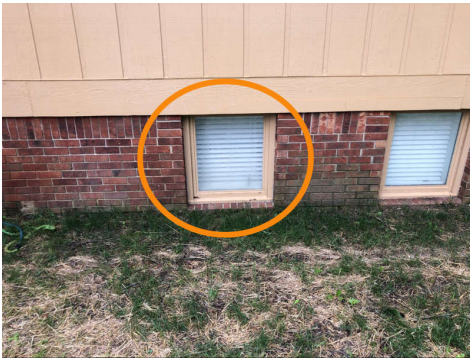
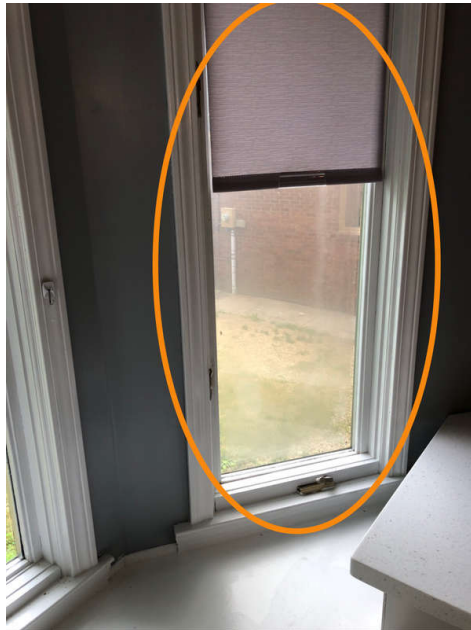
Bay window- Dining Room

#### **FAILED SEAL**

Observed condensation between the window panes, which indicates a failed seal. Recommend qualified window contractor evaluate & replace.

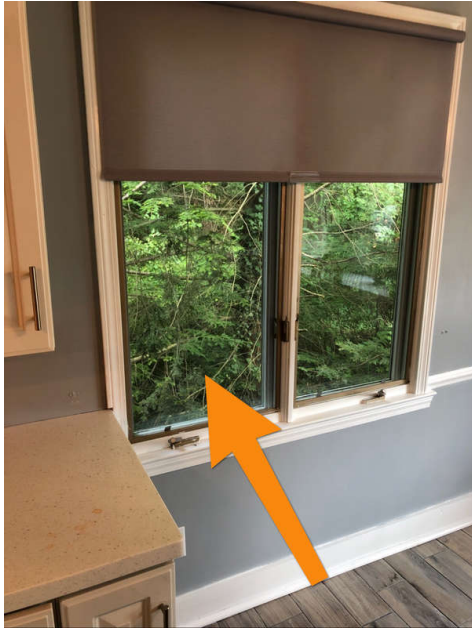
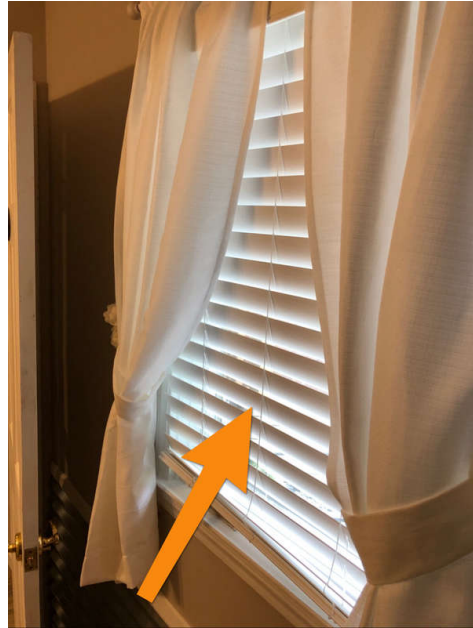
#### **DIFFICULT TO OPERATE**

Some windows were difficult to operate. This could be because of their age and/or swelling. Recommend working them loose and maintaining workability or calling a window professional for further evaluation and make all necessary repairs.

Recommendation  
Contact a qualified window repair/installation contractor.

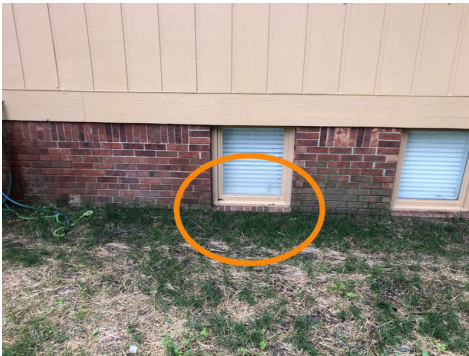
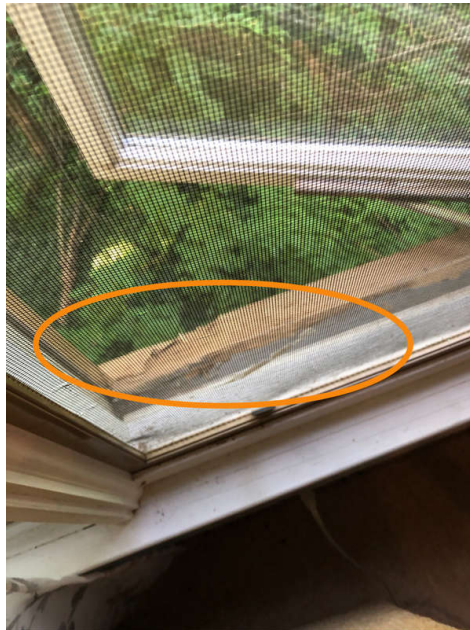
#### 8.7.4 Windows **WOOD ROT**

Wood rot was noted on the exterior trim. Recommend contacting window professional for repairing and replacing all affected materials.

Recommendation  
Contact a qualified professional.

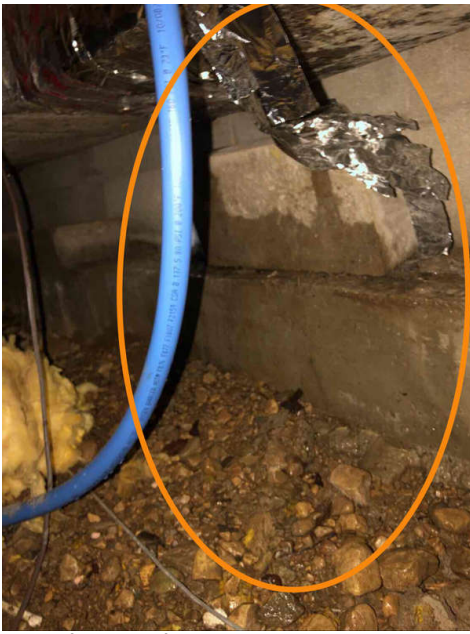
Crawlspace-by access

#### 9.1.1 Cooling Equipment **CONDENSATE-LEAK**

There appears to be a condensation leak. Recommend qualified professional to evaluate and properly drain condensate water.

Recommendation  
Contact a qualified professional.

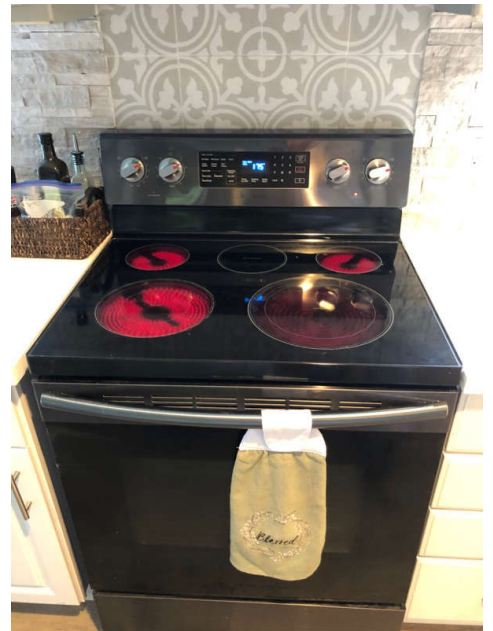
10.3.1 Range/Oven/Cooktop  
**RANGE NOT FASTENED**

Range was not fastened to the floor. This poses a safety hazard to children. Recommend a qualified contractor secure range so it can't tip.

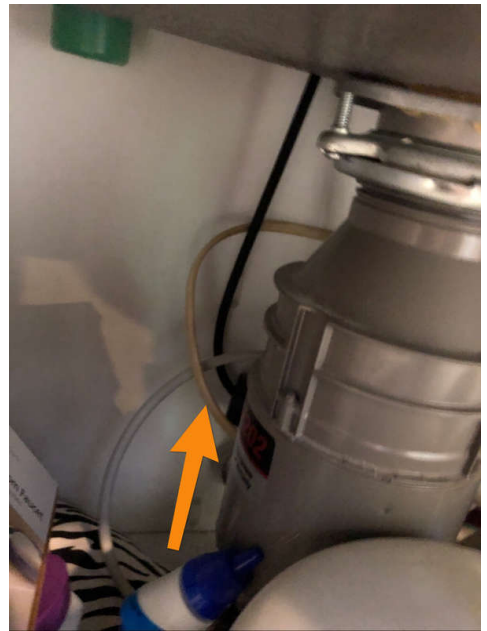
Disposal wire

### CONDUIT

Current standards state that the exposed wiring should be in electrical conduit for safety. However, depending on when disposal was installed, it may not have been required at that time. Recommend qualified electrician for installing conduit.

Contact a qualified electrical contractor.

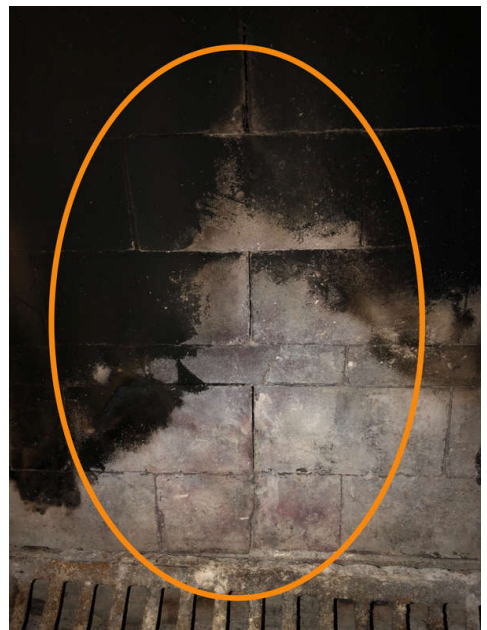
Fire brick

### DAMAGED FIREBRICK

The fire brick was damaged in places. Recommend qualified fire place professional for repair.

Contact a qualified professional.

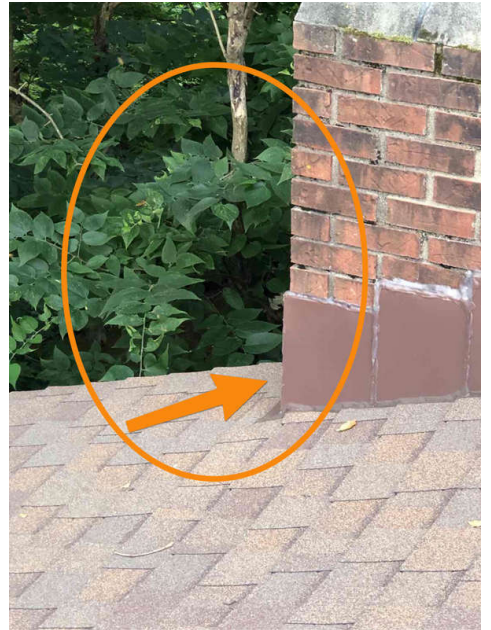
West

**SWARMING**

Bees were swarming at the time of inspection. Recommend qualified professional for treatment.

Contact a qualified professional.

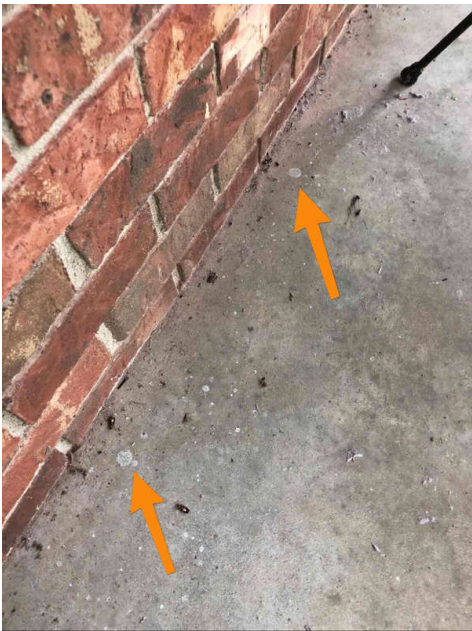
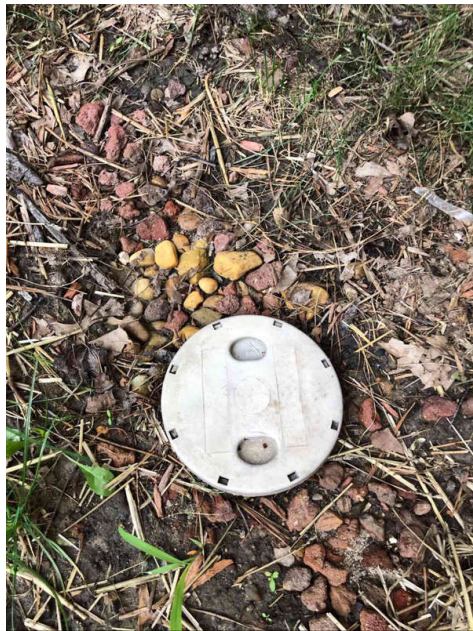
**EVIDENCE OF PREVIOUS/CURRENT TREATMENT**

There was evidence of previous termite treatment. It is unknown if it is a recent treatment or not. Recommend asking current owner when treatment was done.

Drill holes- South patio

Bait station-around entire house

Contact a qualified professional.
