**SUMMARY**

1234 Main St. Long Beach CA 90808

Buyer Name
03/20/2018 9:00AMLochard Bell
InterNACHI CPI
Highlander Inspections
9094850428
nspctrloch@gmail.com

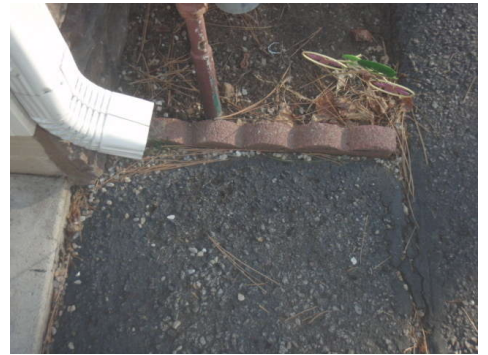
2.2.2 Roof Drainage Systems

DOWNSPOUTS DRAIN NEAR HOUSE

One or more downspouts drain too close to the home's foundation. This can result in excessive moisture in the soil at the foundation, which can lead to foundation/structural movement. Recommend a qualified contractor adjust downspout extensions to drain at least 6 feet from the foundation.

Recommendation
Recommended DIY Project

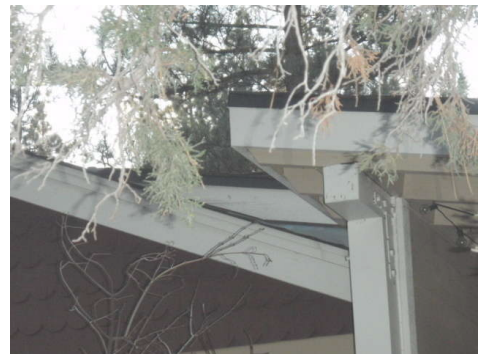
2.3.1 Flashings

MISSING

KICK OUT FLASHINGS ON BOTH SIDES OF DECK ROOF TIE IN.

Flashings were missing at time of inspection. Flashings provide protection against moisture intrusion. Recommend a qualified roofing contractor evaluate and remedy.

Recommendation
Contact a qualified roofing professional.

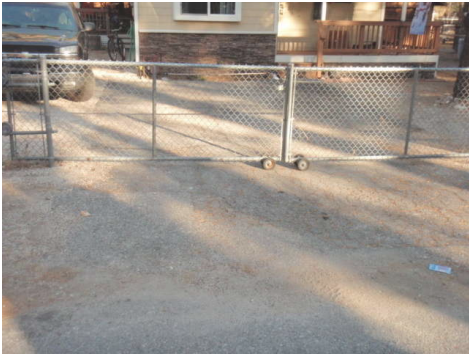
3.3.1 Walkways, Patios & Driveways

DRIVEWAY CRACKING - MINOR

Minor cosmetic cracks observed, which may indicate movement in the soil. Recommend monitor and/or have asphalt contractor patch/seal.

Contact a qualified driveway contractor.

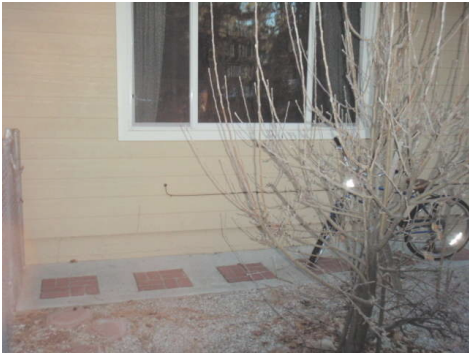
3.3.2 Walkways, Patios & Driveways

WALKWAY CRACKING - MINOR

Minor cosmetic cracks observed. Recommend monitor and/or patch/seal.

Contact a qualified concrete contractor.

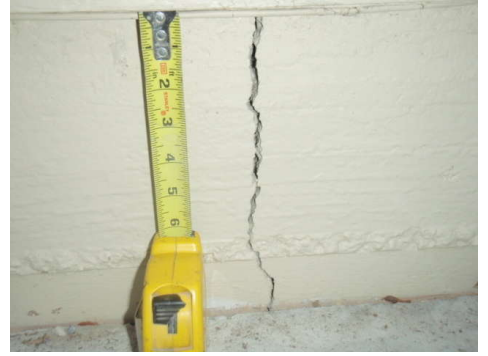
4.1.1 Foundation

FOUNDATION CRACKS - MINOR

NORTH AND SOUTH SIDE OF HOUSE

Minor cracking was noted at the foundation. This is common as concrete ages and shrinkage surface cracks are normal. Recommend monitoring for more serious shifting/displacement.

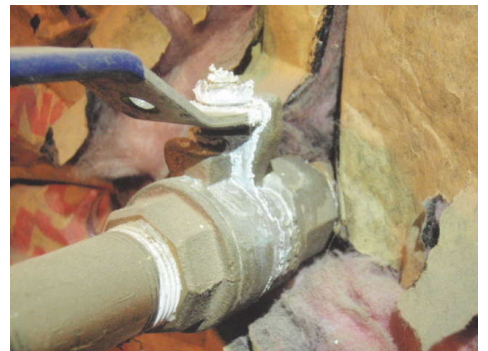
6.4.1 Hot Water Systems, Controls, Flues & Vents

WATER STAINS - LEAKAGE

Water stains were observed at water heater supply valve, indicating a past or present leak. Recommend further evaluation and repair by a qualified plumber.

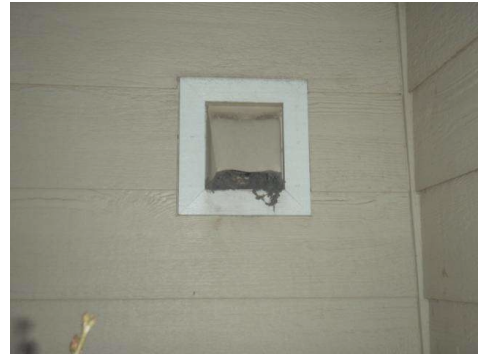
8.3.1 Exhaust Systems

DRYER EXHAUST

Dryer exhaust hood damper is prevented from operating properly due to lint buildup. Needs regular cleaning.

Recommendation
Recommended DIY Project
