SUMMARY

1234 Main St. Salt Lake City UTAH

Brent Limb
SouthPaw Home Inspections
801-680-6495
bhinspector17@gmail.com

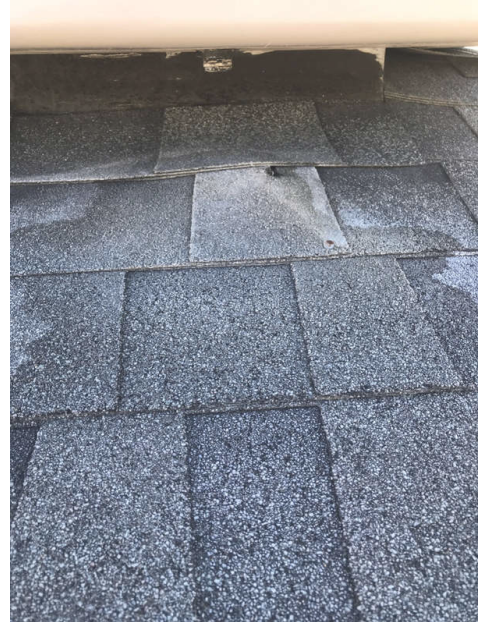
2.1.1 Coverings

SHINGLES SHOW SIGNS OF WARPING/BUCKLING

Shingles show signs of warping/buckling. Recommend further evaluation by a certified roofing contractor.

Recommendation

Contact a qualified professional.

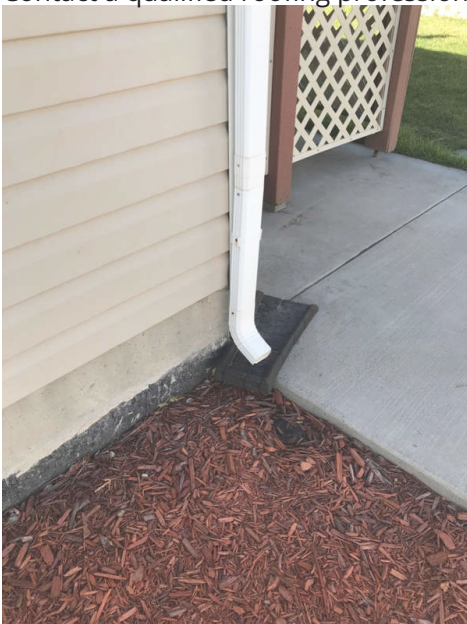
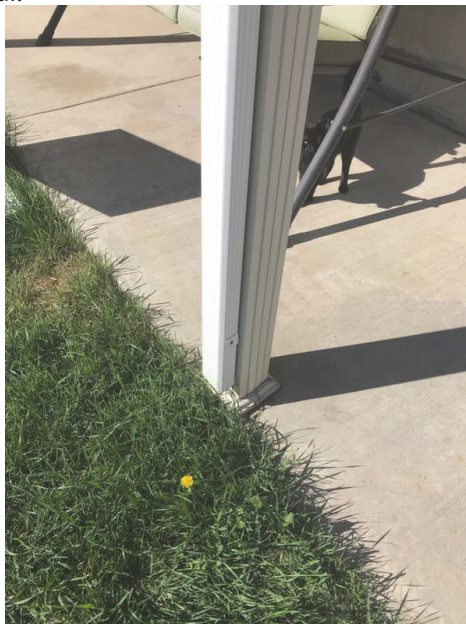
2.2.1 Roof Drainage Systems

DOWNSPOUTS DRAIN NEAR HOUSE

One or more downspouts drain too close to the home's foundation. This can result in excessive moisture in the soil at the foundation, which can lead to foundation/structural movement. Recommend a qualified contractor adjust downspout extensions to drain at least 6 feet from the foundation.

Recommendation

Contact a qualified roofing professional.

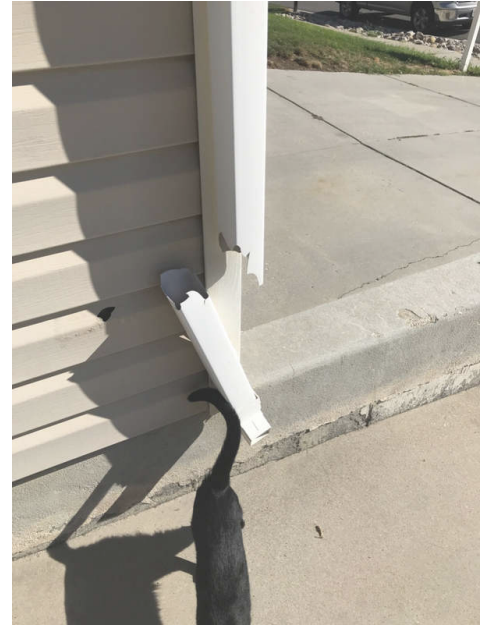
2.2.2 Roof Drainage Systems

DOWNSPOUTS MISSING/DAMAGED

Home was missing downspouts in one or more areas. This can result in excessive moisture in the soil at the foundation, which can lead to foundation/structural movement. Recommend a qualified contractor install downspout extensions that drain at least 6 feet from the foundation.

Recommendation

Contact a qualified roofing professional.

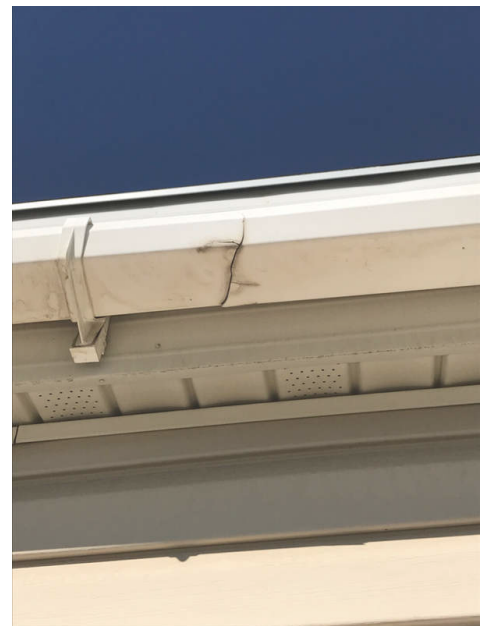
2.2.3 Roof Drainage Systems

GUTTER DAMAGED

Gutters were damaged. This can result in excessive moisture in the soil at the foundation, which can lead to foundation/structural movement. Recommend a qualified contractor evaluate and repair.

Recommendation

Contact a qualified roofing professional.

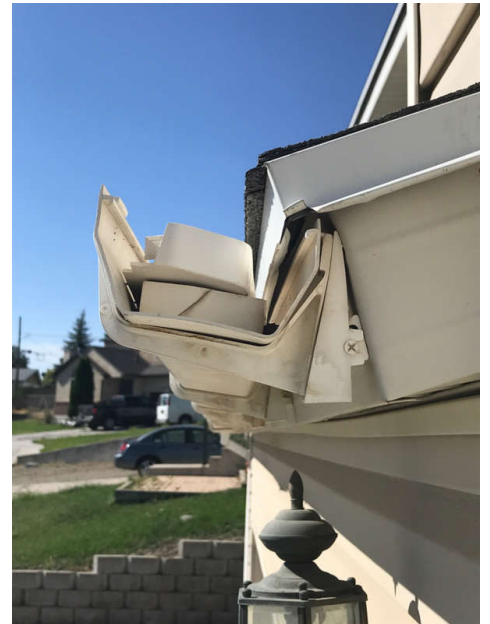
2.2.4 Roof Drainage Systems

MISSING END CAPS

Recommendation

Contact a qualified professional.

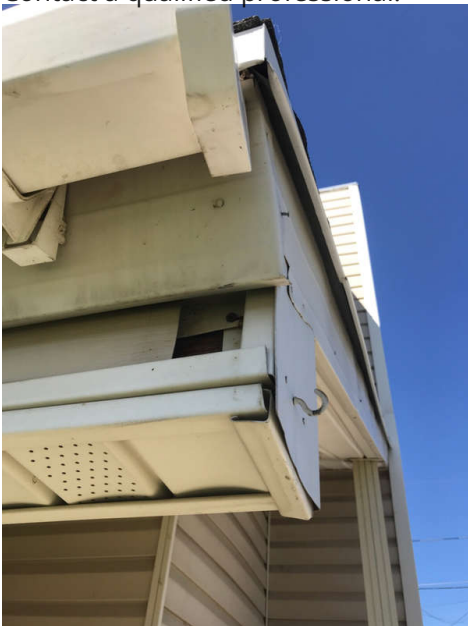
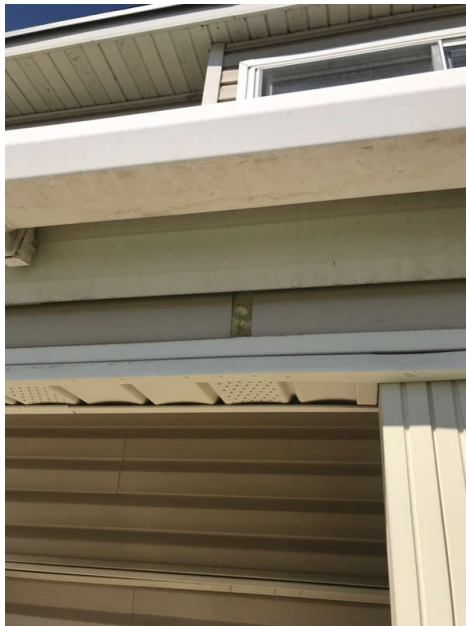
3.1.1 Siding, Flashing & Trim

MINOR DAMAGE TO SIDING AND OR CORRESPONDING CHANNELING

Recommendation

Contact a qualified professional.

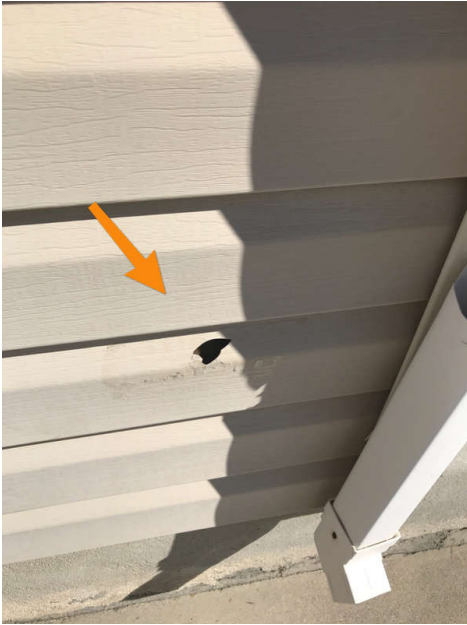
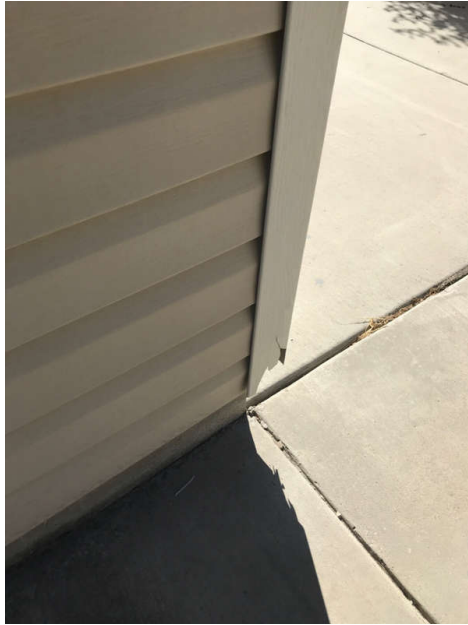
3.1.2 Siding, Flashing & Trim

DAMAGE TO SIDING

Recommendation

Contact a qualified professional.

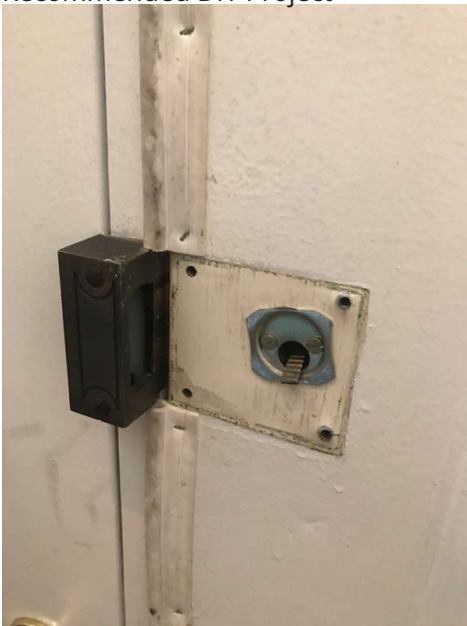
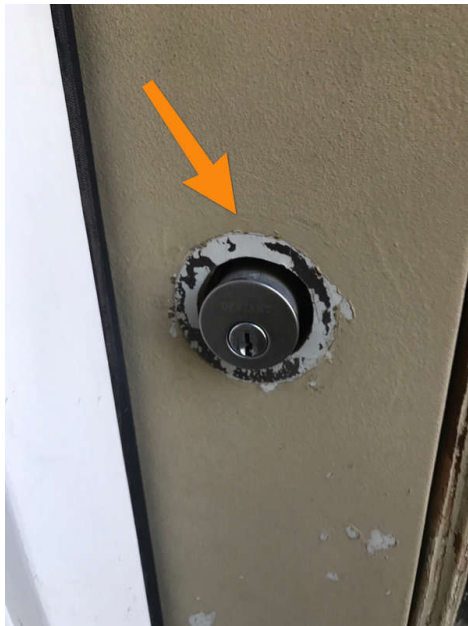
3.2.1 Exterior Doors

HARDWARE DAMAGED

One or more pieces of door hardware are damaged. Recommend repair or replace.

Recommendation

Recommended DIY Project

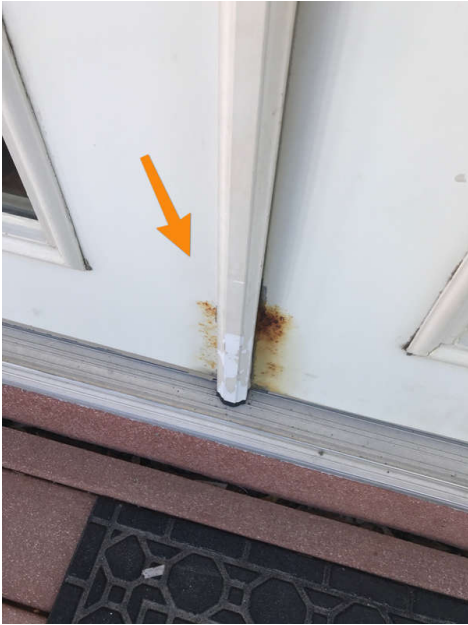
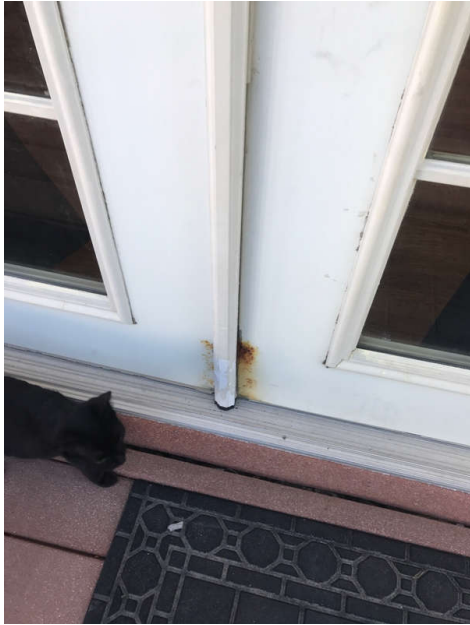
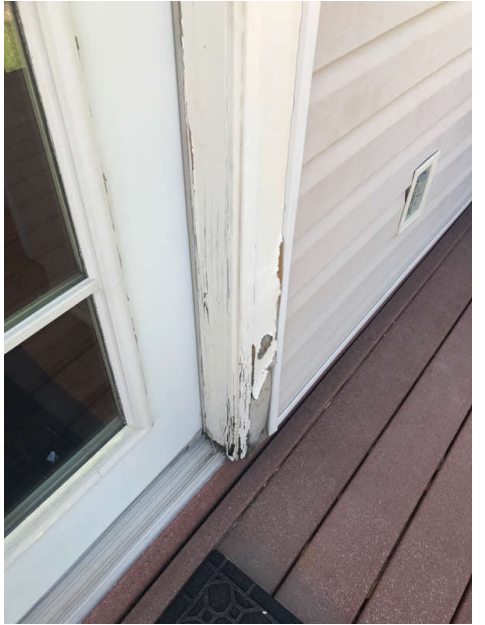
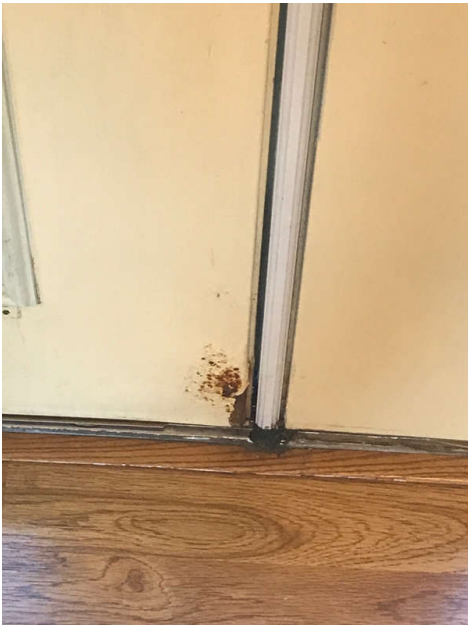
3.2.2 Exterior Doors

PAINT/REFINISH NEEDED

Door finish is worn. Recommend refinish and/or paint to maximize service life.

Recommendation

Contact a qualified door repair/installation contractor.

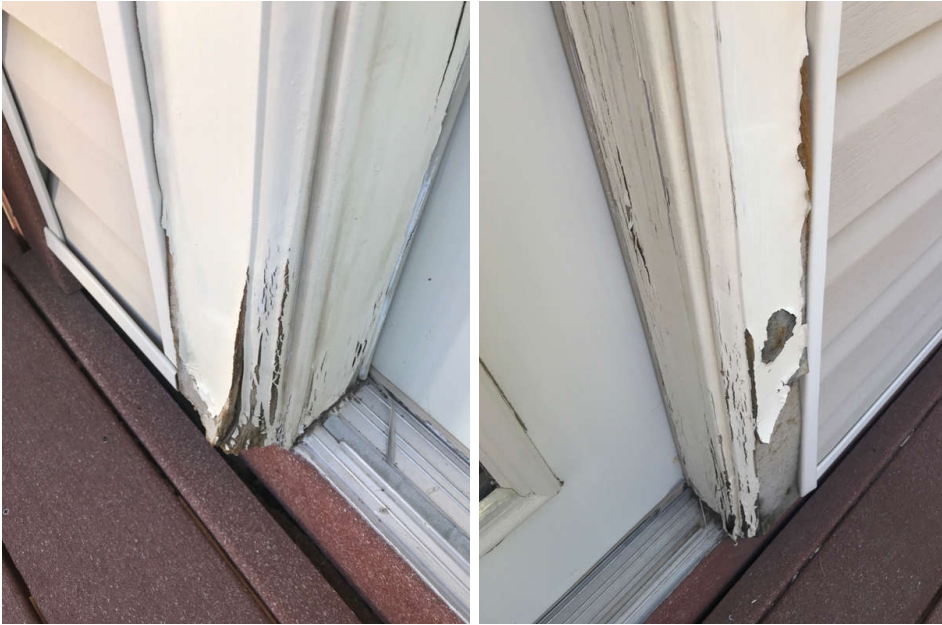
3.2.3 Exterior Doors

DAMAGE/CORROSION

Recommendation

Contact a qualified professional.

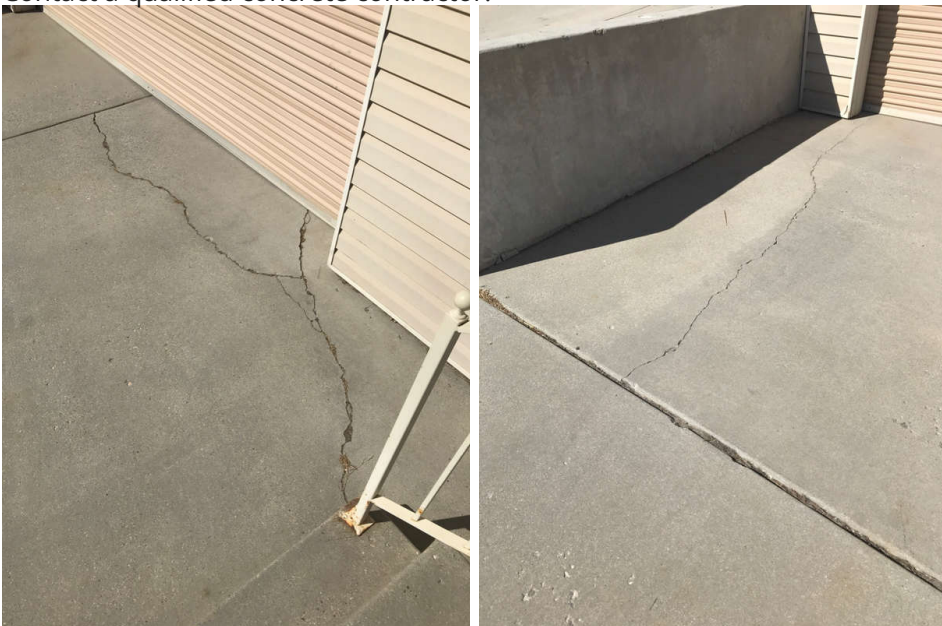
3.3.1 Walkways, Patios & Driveways

DRIVEWAY CRACKING - MINOR

Minor cosmetic cracks observed, which may indicate movement in the soil. Recommend monitor and/or have concrete contractor patch/seal.

Recommendation

Contact a qualified concrete contractor.

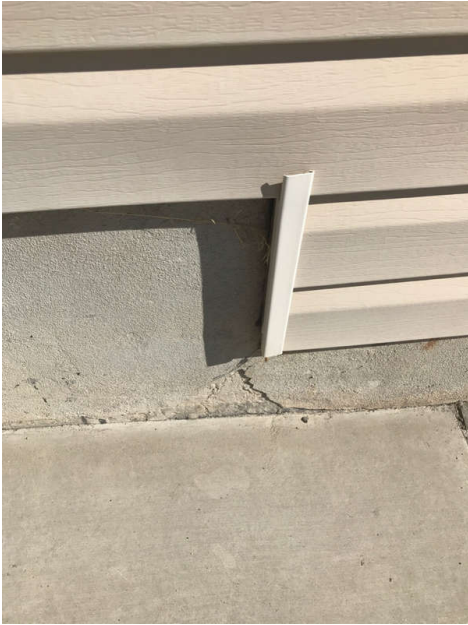
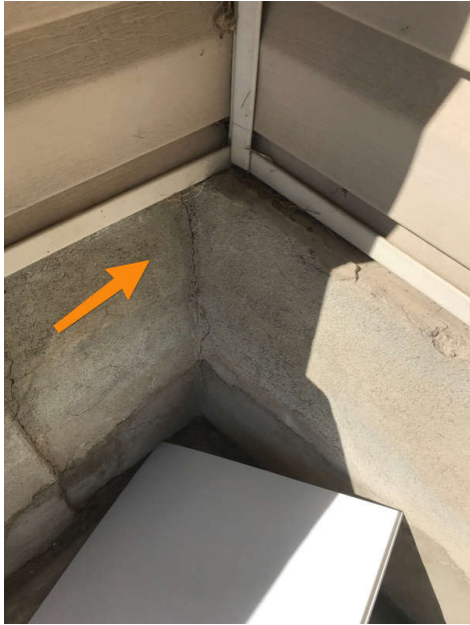
4.1.1 Foundation

FOUNDATION CRACKS - MINOR

Minor cracking was noted at the foundation. This is common as concrete ages and shrinkage surface cracks are normal. Recommend monitoring for more serious shifting/displacement.

Recommendation

Contact a qualified structural engineer.

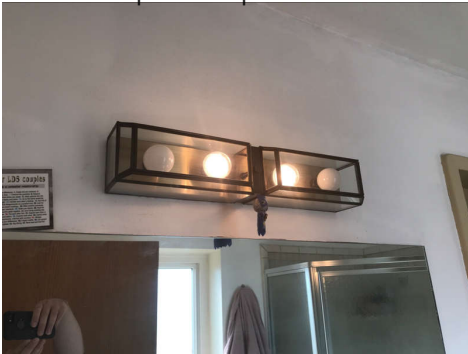
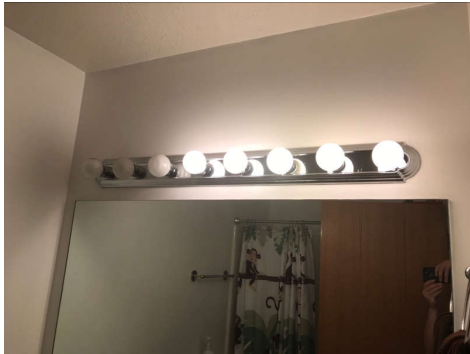
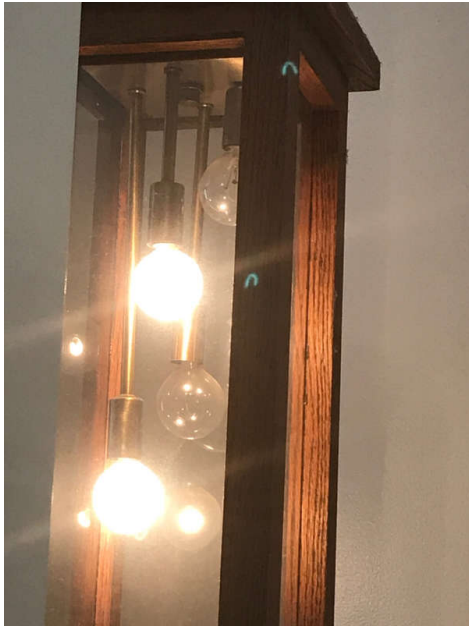
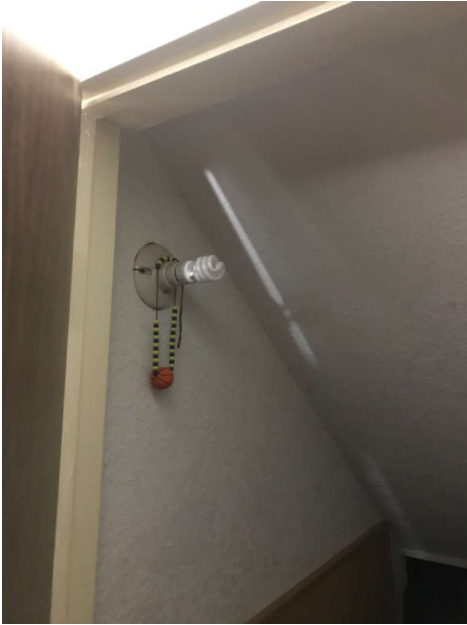
8.4.1 Lighting Fixtures, Switches & Receptacles

LIGHTBULBS MISSING/BURNT OUT

Recommendation
Contact a qualified professional.

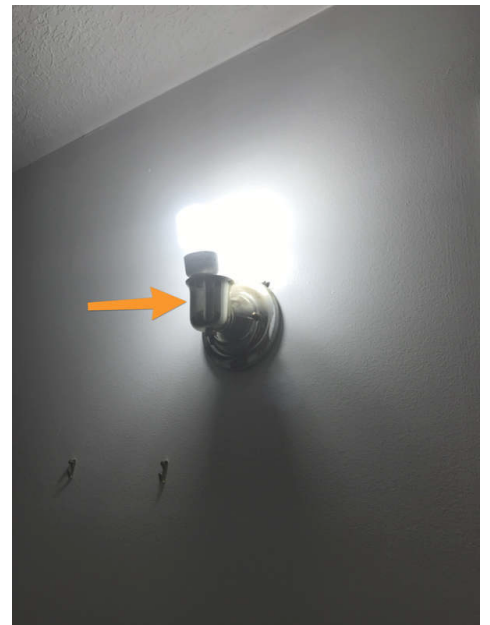
8.4.2 Lighting Fixtures, Switches & Receptacles

LIGHT FIXTURE LENS MISSING/DAMAGED

Recommendation

Contact a qualified professional.

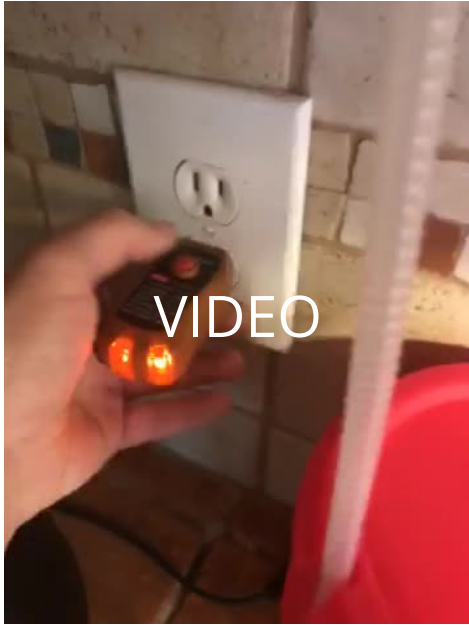
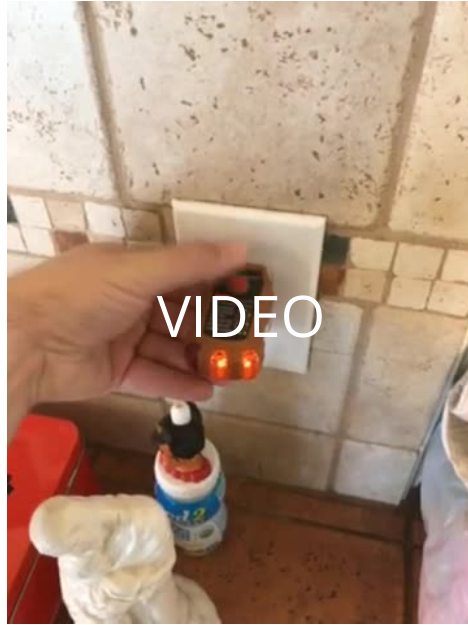
8.5.1 GFCI & AFCI

NO GFCI PROTECTION INSTALLED IN KITCHEN

Recommendation

Contact a qualified professional.

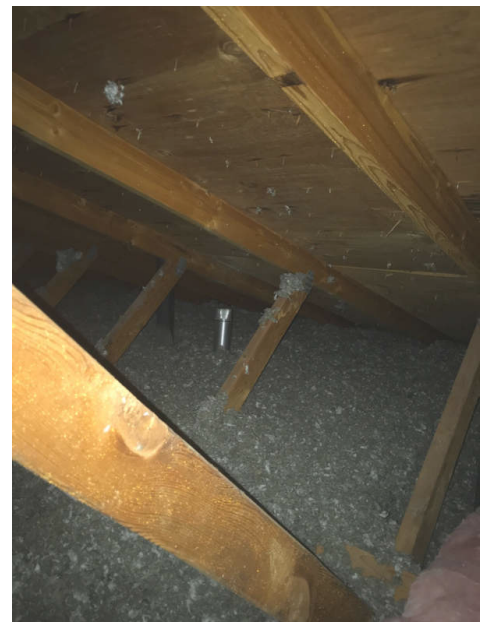
9.4.1 Exhaust Systems

BATHROOM VENTS INTO ATTIC

Bathroom fan vents into the attic, which can cause moisture and mold. Recommend a qualified attic contractor properly install exhaust fan to terminate to the exterior.

Recommendation

Contact a qualified HVAC professional.

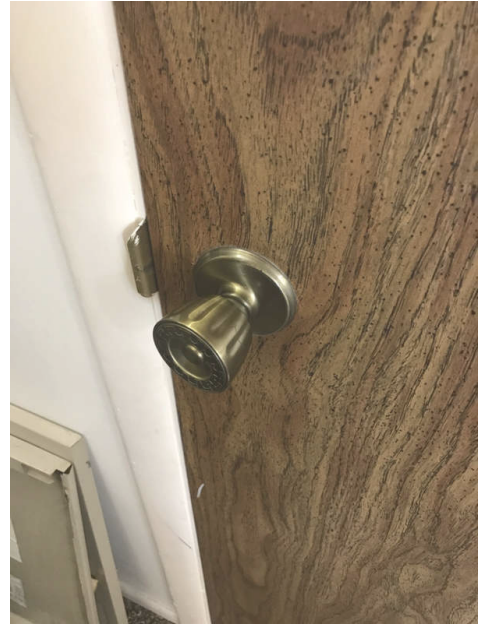
10.1.1 Doors

DAMAGE TO DOOR KNOB

Recommendation

Contact a qualified professional.

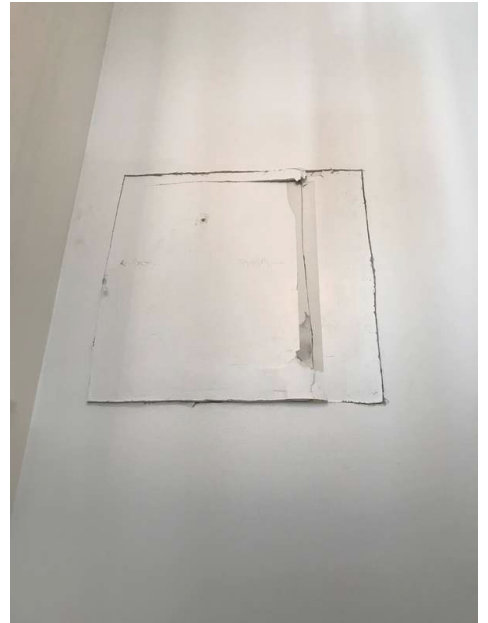
10.4.1 Walls

POOR PATCHING

Sub-standard drywall patching observed at time of inspection. Recommend re-patching.

Recommendation

Contact a qualified drywall contractor.

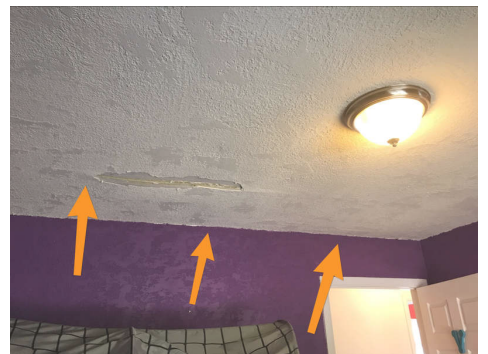
10.5.1 Ceilings

SAGGING DRYWALL

Ceiling drywall sagged visibly at the time of the inspection. This appears to be due to leakage from above. The source of moisture intrusion should be identified and corrected, and the damaged section of drywall replaced.

Recommendation

Contact a qualified drywall contractor.

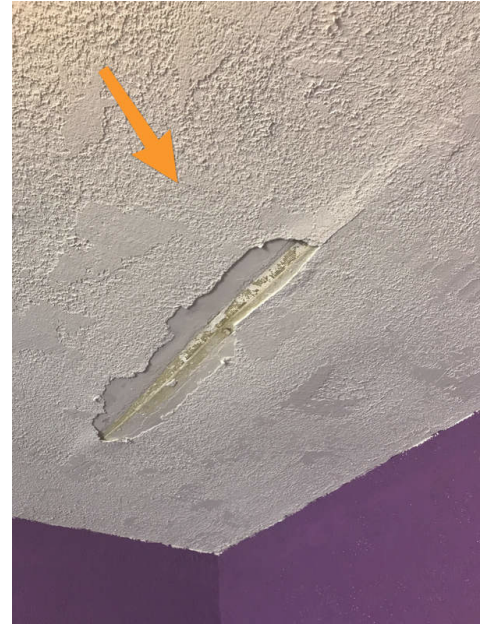
10.5.2 Ceilings

SEVERE DAMAGE

Severe ceiling damage observed. Recommend a qualified drywall or structural engineer evaluate and advise.

Recommendation

Contact a qualified structural engineer.

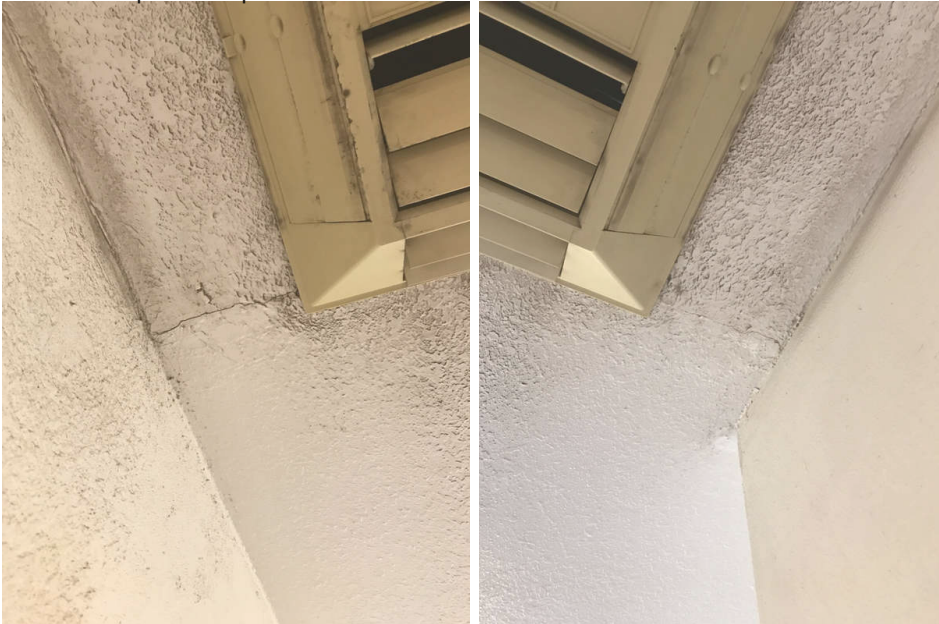
10.5.3 Ceilings

MINOR CRACKING

Cracks in the ceiling were visible at time of inspection.

Recommendation

Contact a qualified professional.

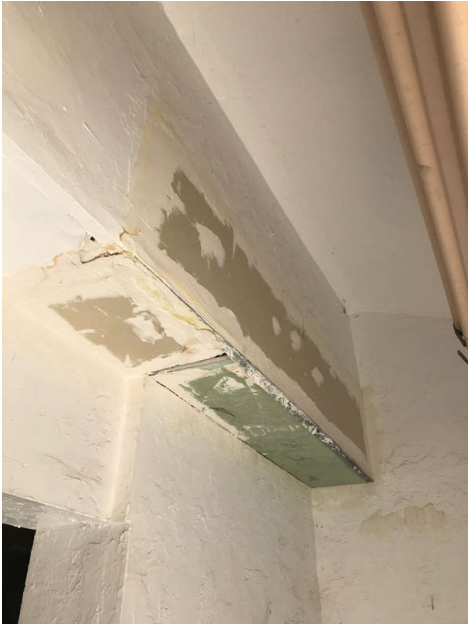
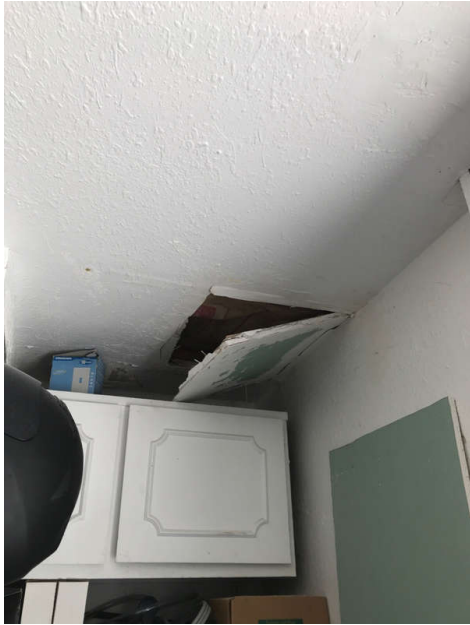
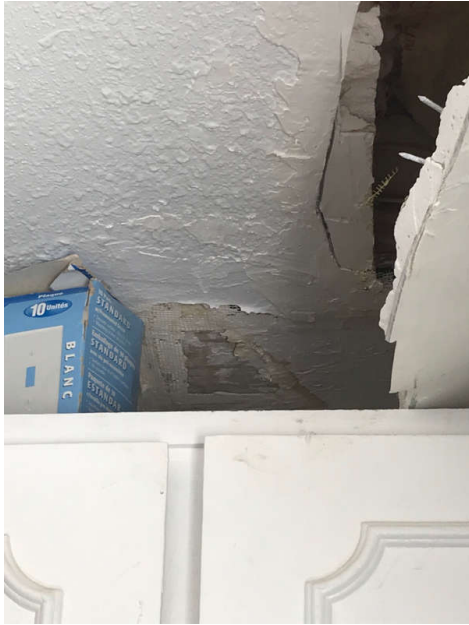
10.5.4 Ceilings

EVIDENCE OF PRIOR WATER DAMAGE

Evidence of prior water damage.

Recommendation

Contact a qualified professional.

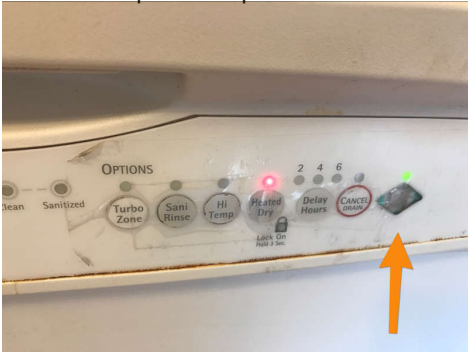
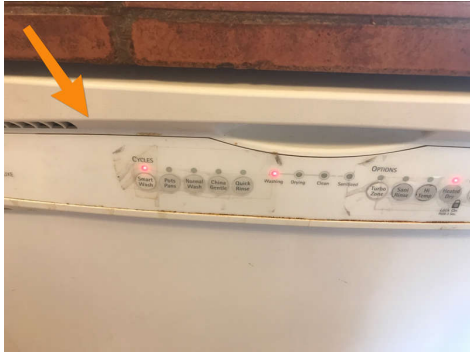
11.1.1 Dishwasher

MODERATE WEAR TO DISHWASHER

Panel and buttons show signs of moderate wear/damage.

Recommendation
Contact a qualified professional.
