Forest Home Inspection Page 1 of 3

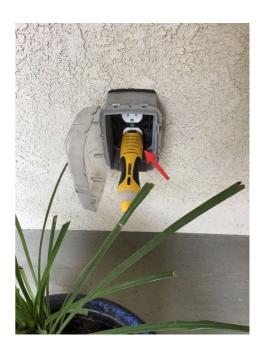
8.5.1 GFCI & AFCI

I observed indications of gfci protection problems with on or more outlets. Recommend licensed electrician inspect and further advise.

Recommendation

Contact a qualified electrical contractor.

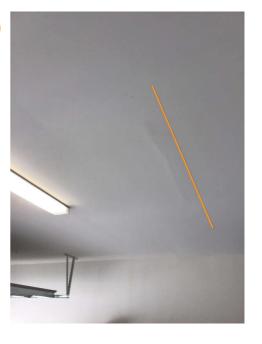
# 12.1.1 Ceiling **PREVIOUS REPAIRS**

Previous repairs were observed in the garage ceiling near the door operator. Recommend getting more information from seller.
